MVMA SIDE IMPACT TESTING

MDB-TO-CAR SIDE IMPACT TEST OF
A 26° CRABBED MOVING DEFORMABLE BARRIER
TO A 1985 FORD LTD
AT 33.4 MPH

TEST NO.: 850617
TEST DATE: JUNE 17, 1985
TEST CONDITIONS: BASELINE STRUCTURE, DUMMY
SEATED 5 INCHES FROM HARDBOARD DOOR PANEL

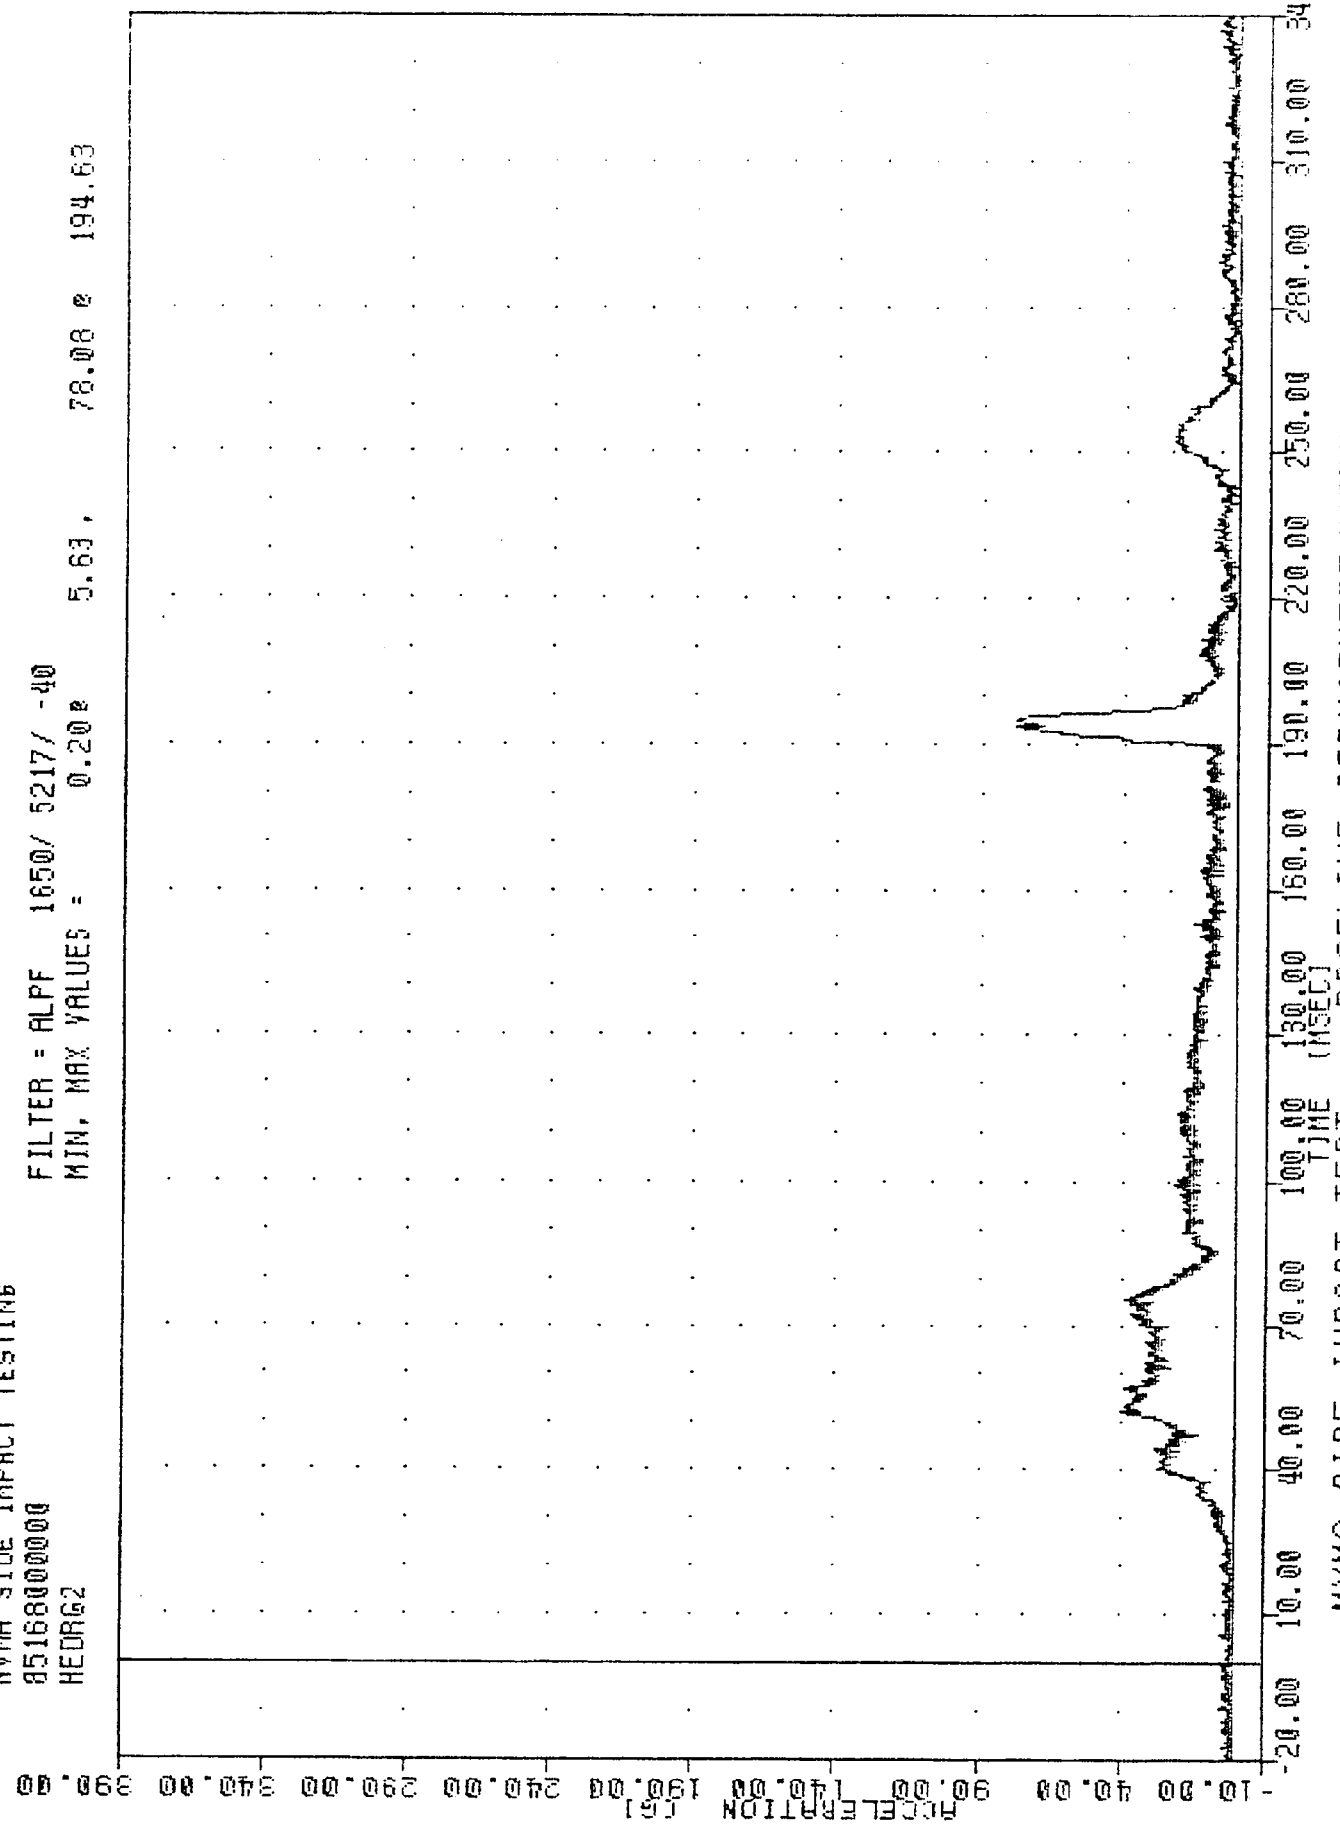
FILTER = ALPF 1650/ 5217/ -40
MIN. MAX VALUES = 0.20e 5.63, 78.08 e 194.63

NYMA SIDE IMPACT TEST -- BASELINE STRUCTURE/HARDBOARD/FAR SEATING
PASSENGER HEAD RESISTANT ACCELERATION

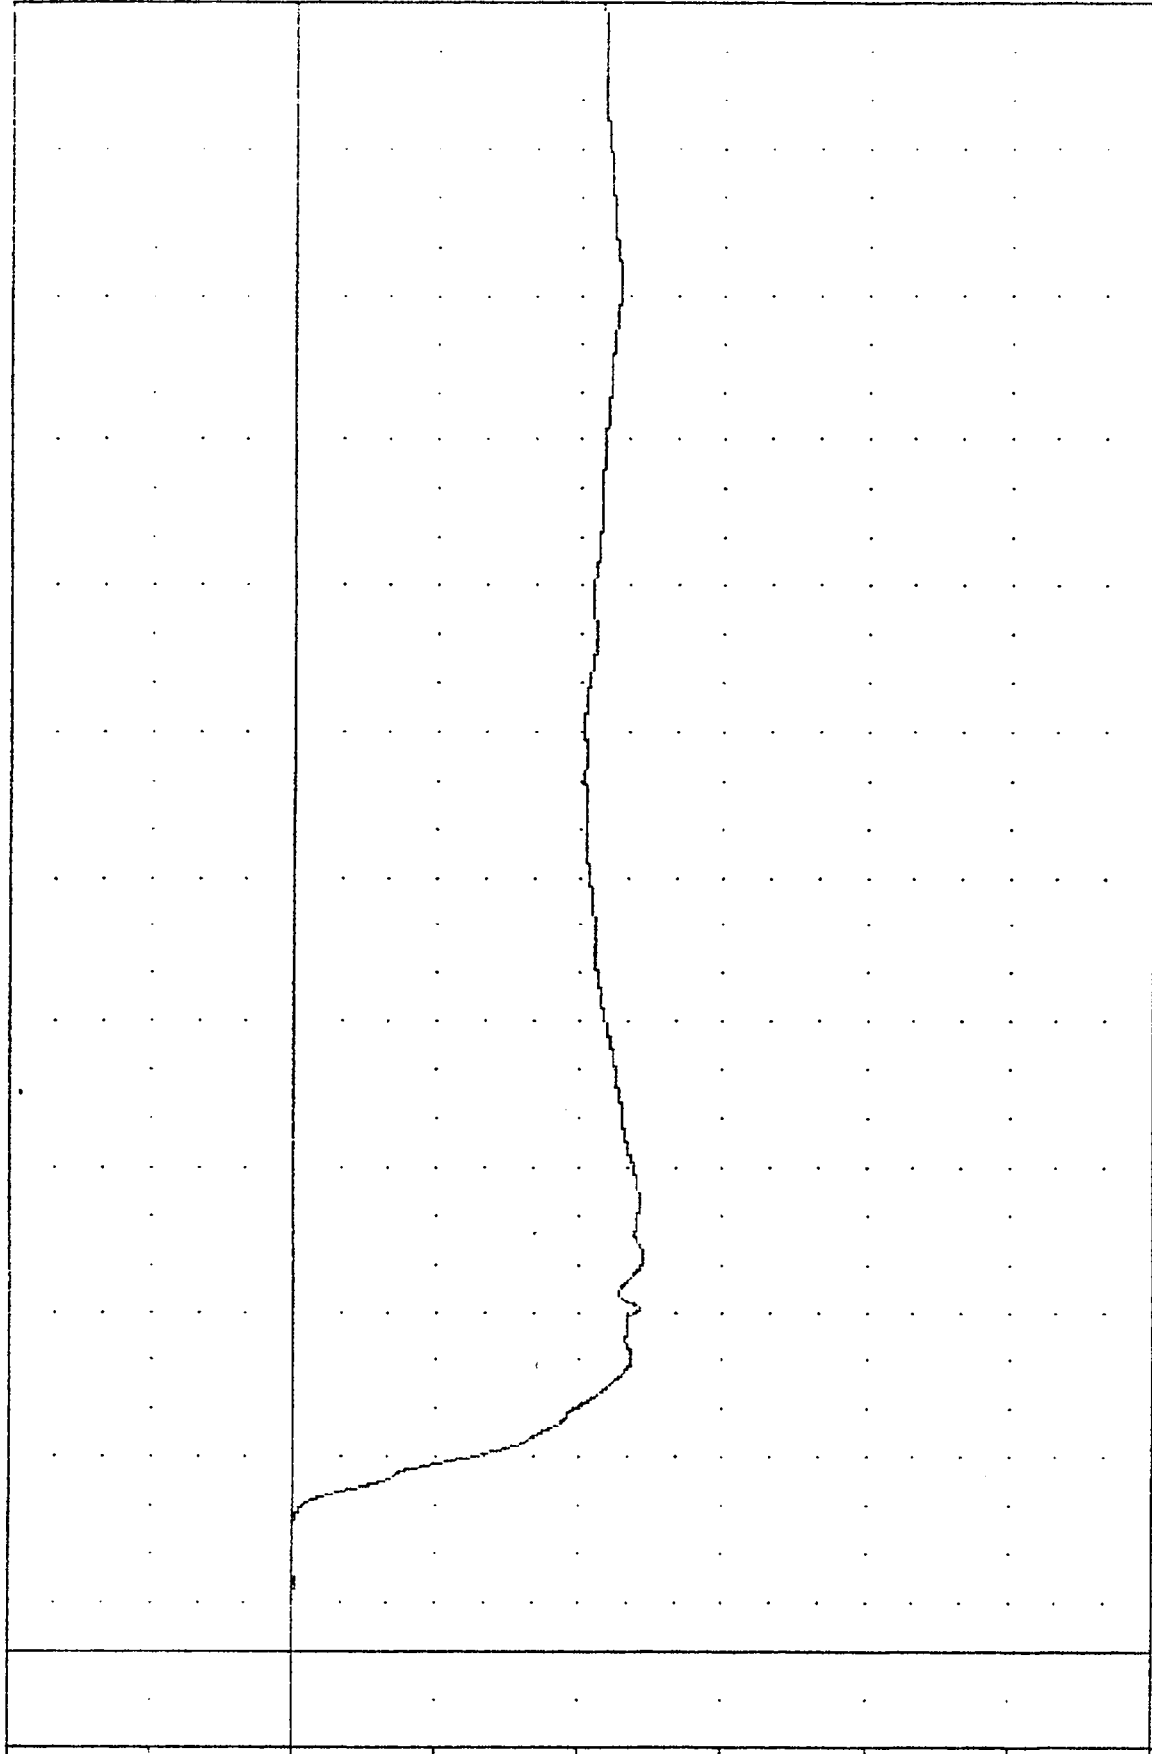
VELOCITY (IN/MS) TIME (MSEC)

MWMA SIDE IMPACT TEST -- BASELINE STRUCTURE/HARDBOARD/FAR SEATING
 PLOT 1 OVER 210 VELOCITY IN/MS

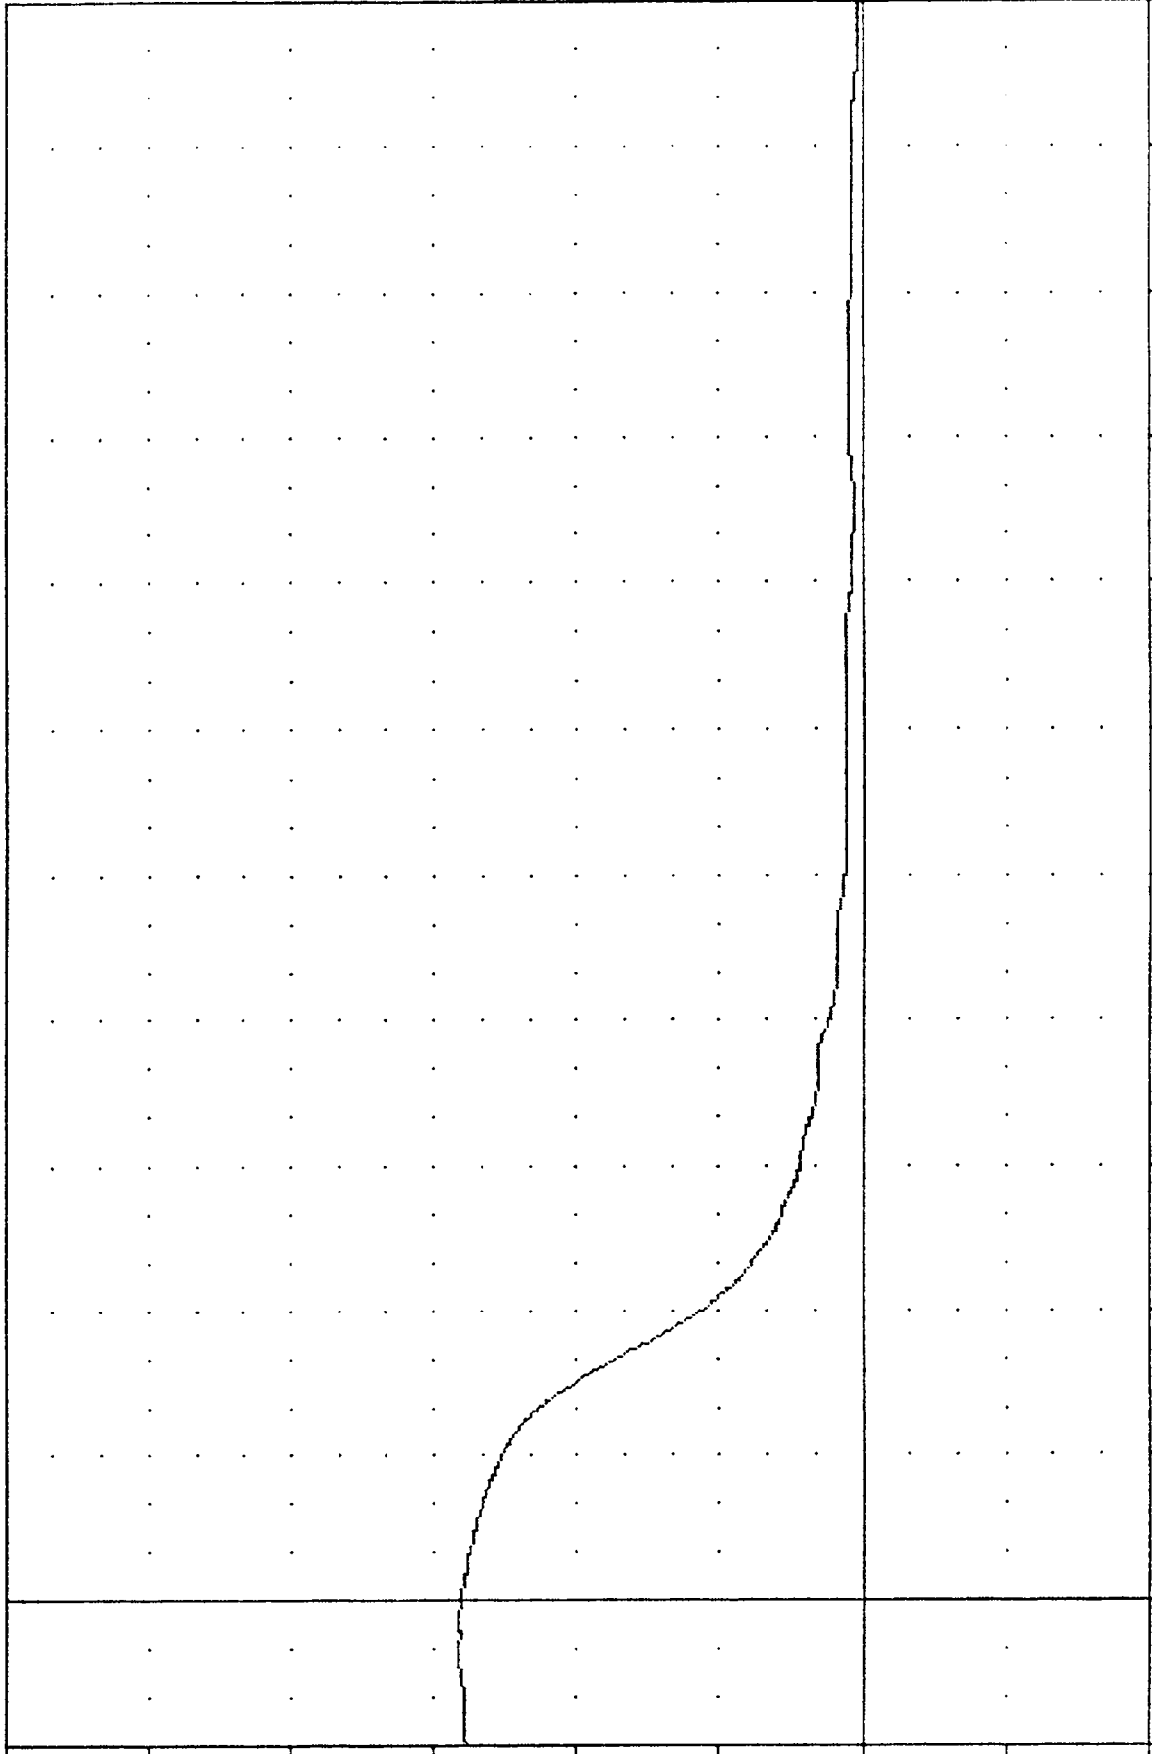
VELOCITY (FT/SEC)

-10.00 0.00 10.00 20.00 30.00 40.00 50.00 60.00 70.00 80.00 90.00 100.00 110.00
TIME (MSEC)

MVNA SIDE IMPACT DUMMY CALIBRATION
DISTANCE VELOCITY
