LABORATORY PROCEDURES TO DETERMINE THE  
BREAKAWAY BEHAVIOR OF LUMINAIRE SUPPORTS  
IN MINI-SIZED VEHICLE COLLISIONS

THIRTY MPH BROADSIDE  
IMPACT OF A VW RABBIT  
AND A BREAKAWAY LUMINAIRE SUPPORT

TEST RESULTS REPORT

TEST NUMBER 1469-SI#5-85

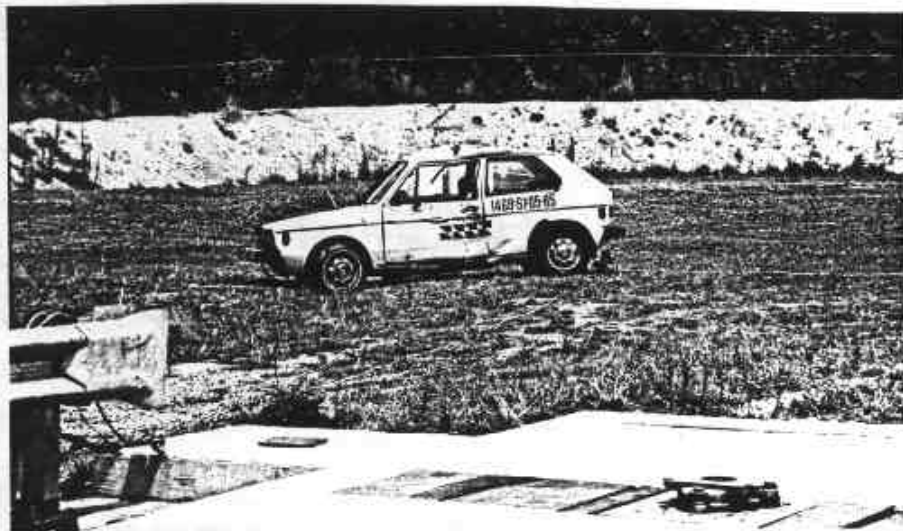
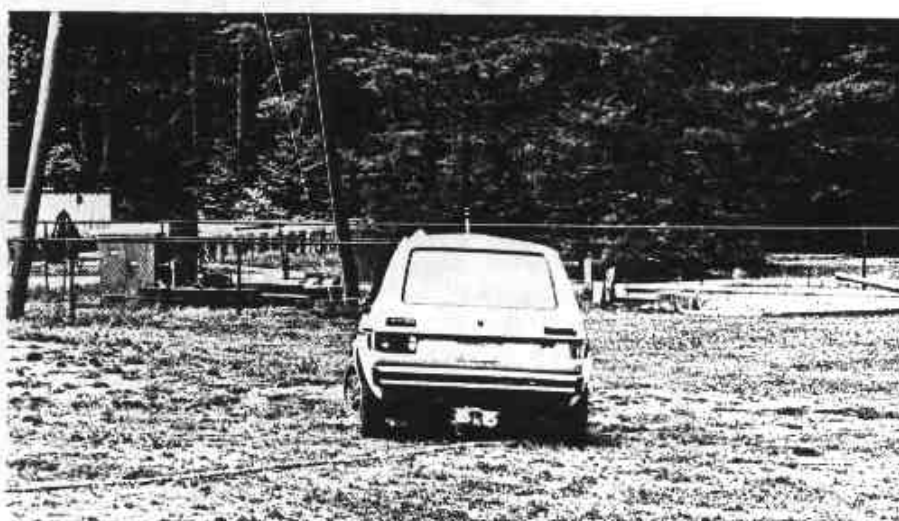
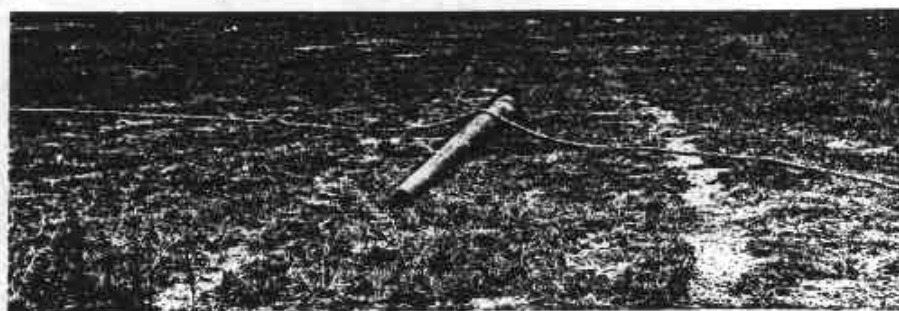
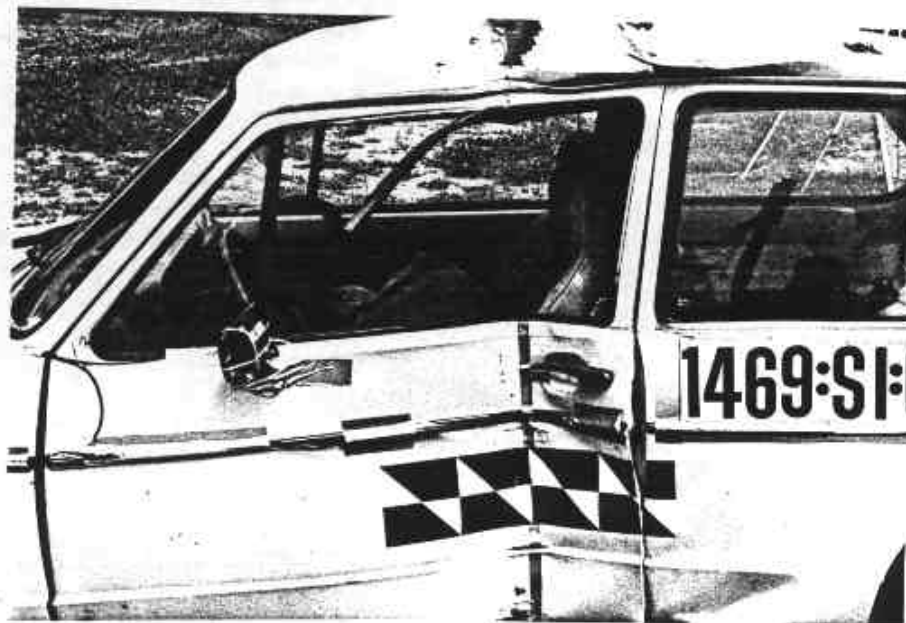
Figure 2. Post Test Photos of Vehicle

The impact conditions were 28.4 mph (12.7 m/s) at a point on the left door in line with the occupant 18.75 in (.48 m) behind the longitudinal location of the center of gravity of the vehicle measured with the dummy in the vehicle. The vehicle had a 7° roll angle as it leaned toward the test pole due to the side sliding forces acting on the tires. The maximum residual crush of the vehicle at the impact point was 11.1 inches (.28 m). Photographs of the vehicle and luminaire support after the collision event are shown in figure 2.

Figure 2 (Cont'd). Post-Test Photographs of Vehicle
