LABORATORY PROCEDURES TO DETERMINE THE
BREAKAWAY BEHAVIOR OF LUMINAIRE SUPPORTS
IN MINI-SIZED VEHICLE COLLISIONS

THIRTY MPH BROADSIDE
IMPACT OF A DODGE COLT
AND A BREAKAWAY LUMINAIRE SUPPORT

TEST RESULTS REPORT

TEST NUMBER 1469-SI#6-85

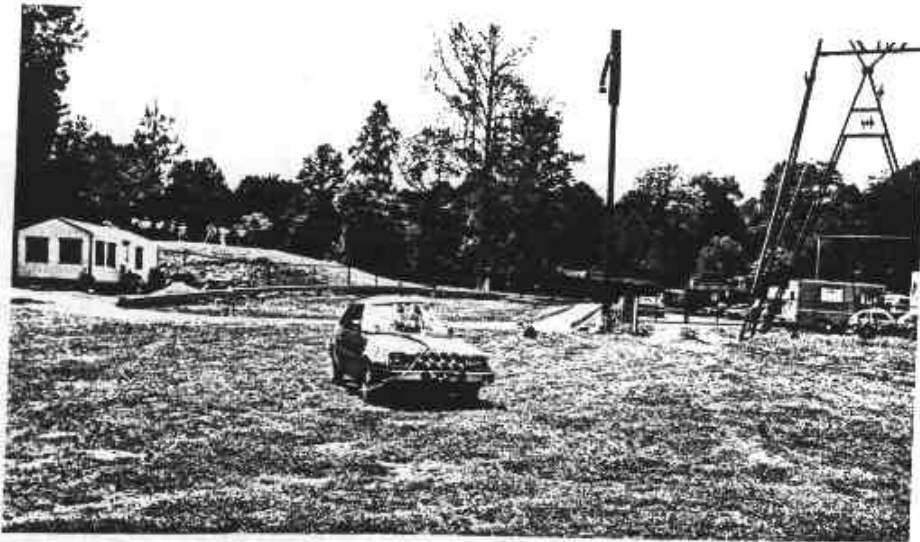
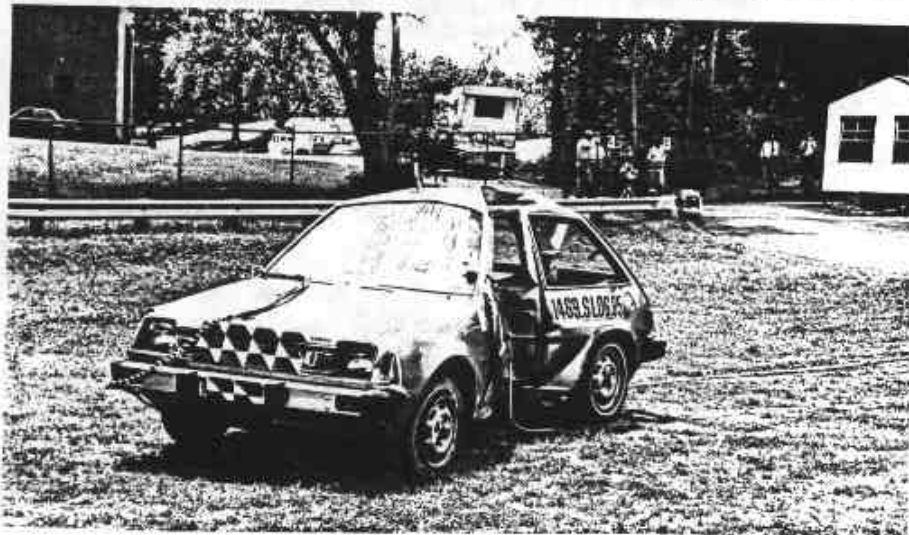
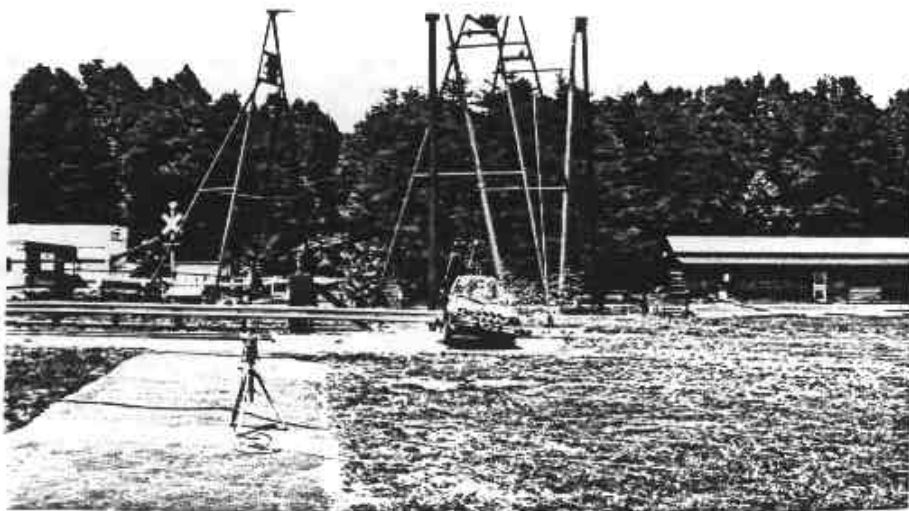
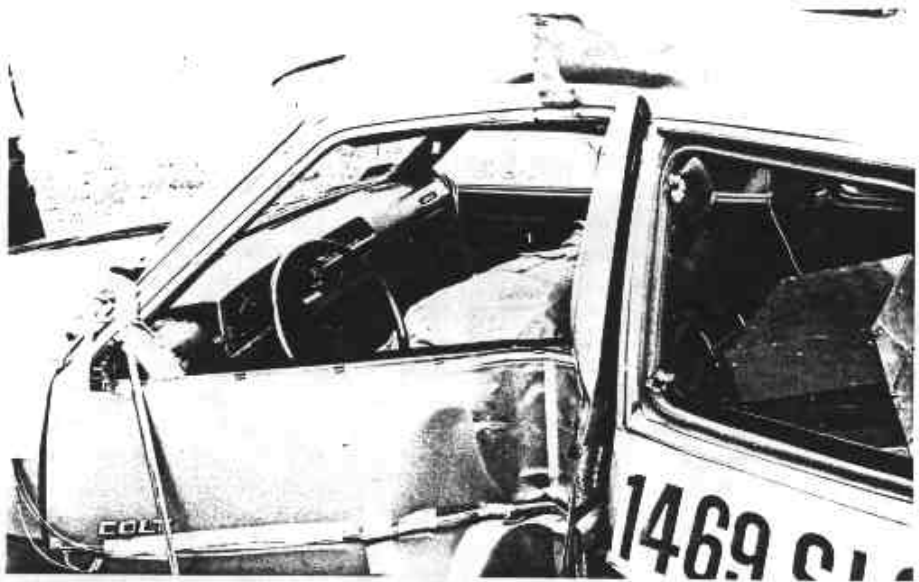
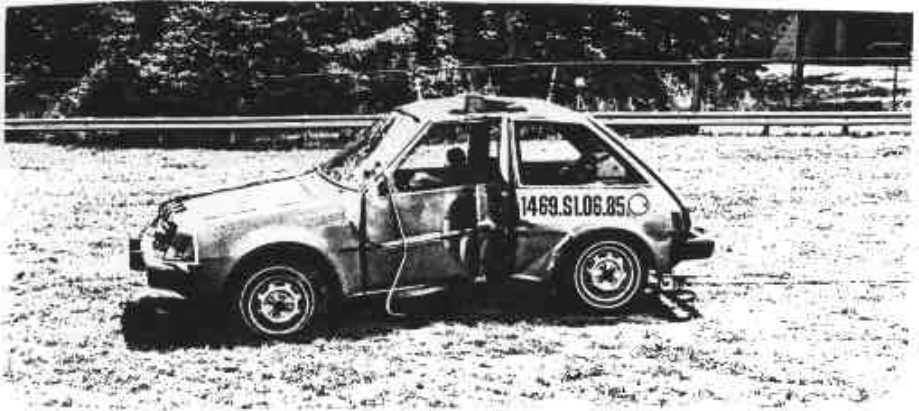
Figure 2. Post-Test Photos of Vehicle

The impact conditions were 30.1 mph (13.45 m/s) at a point on the left door in line with the occupant 17.3 in (.44 m) behind the longitudinal location of the center of gravity of the vehicle measured with the dummy in the vehicle. The vehicle had a 6° roll angle as it leaned toward the test pole due to the side sliding forces acting on the tires. The maximum residual crush of the vehicle at the impact point was 17.3 inches (.44 m). Photographs of the vehicle and luminaire support after the collision event are shown in figure 2.

The test vehicle momentum change due to impacting the pole at a speed of 30.1 mph (13.5 m/s) was 597 lb-sec. The velocity change corresponding to the observed vehicle momentum change was 6.7 mph or 9.8 ft/sec. The integrity of the vehicle was maintained throughout the test although severe intrusions occurred at the center of the driver's door. Maximum residual crush of the side of the vehicle was 17.25 inches.

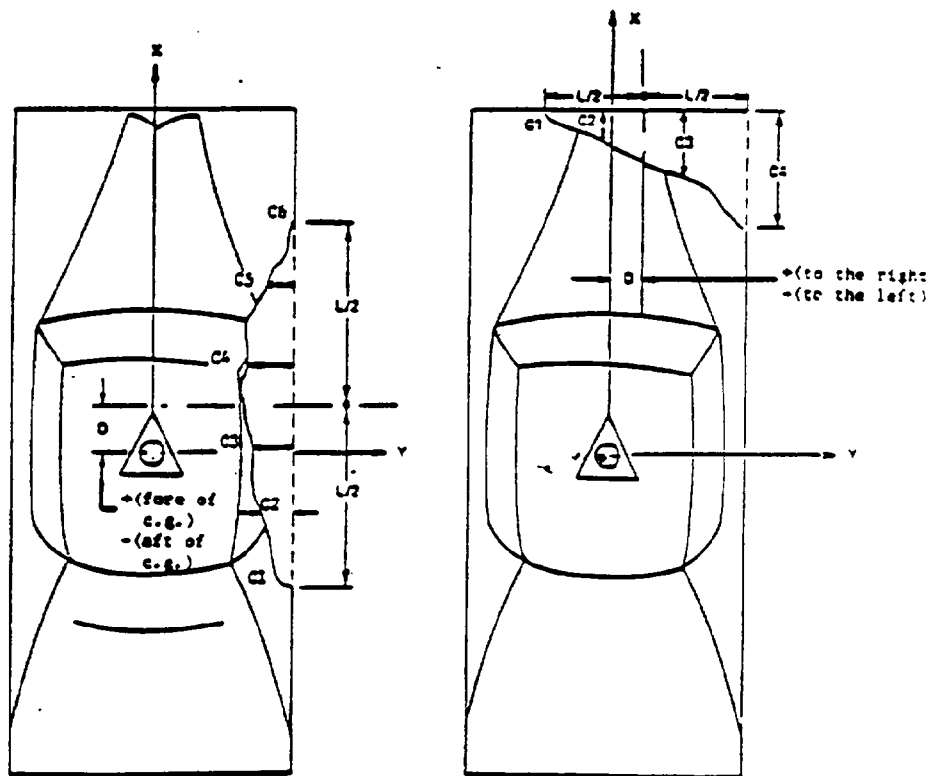
Figure 3. NHTSA Vehicle Damage Measurements

C1 = 0.0	L = 70.00
C2 = 6.0"	D = -17.25"
C3 = 15.0"	
C4 = 5.0"	
C5 = 1.5"	
C6 = 0.0	
Max = 17.3"

After the initial separation from the vehicle the luminaire support translated forward at a speed of 13.6 f/s (4.15 m/s) with a rotation rate of 1.36 rad/sec. The luminaire support rotated up and over the test vehicle with the top of the pole hitting the ground about 1.25 seconds after impact. As the support rotated away, vehicle yawed counter clockwise and rolled up on its left tires and wheels. The maximum roll angle was about 15° based on film analysis. The vehicle then settled back on all 4 tires and continued forward away from the impact area after yawing a total of about 90°. The final resting position of the vehicle was about 75 feet downstream from the impact point. The residual test vehicle crush measured using the 6 point NHTSA guide is given in table 6. See figure 3 for reference.

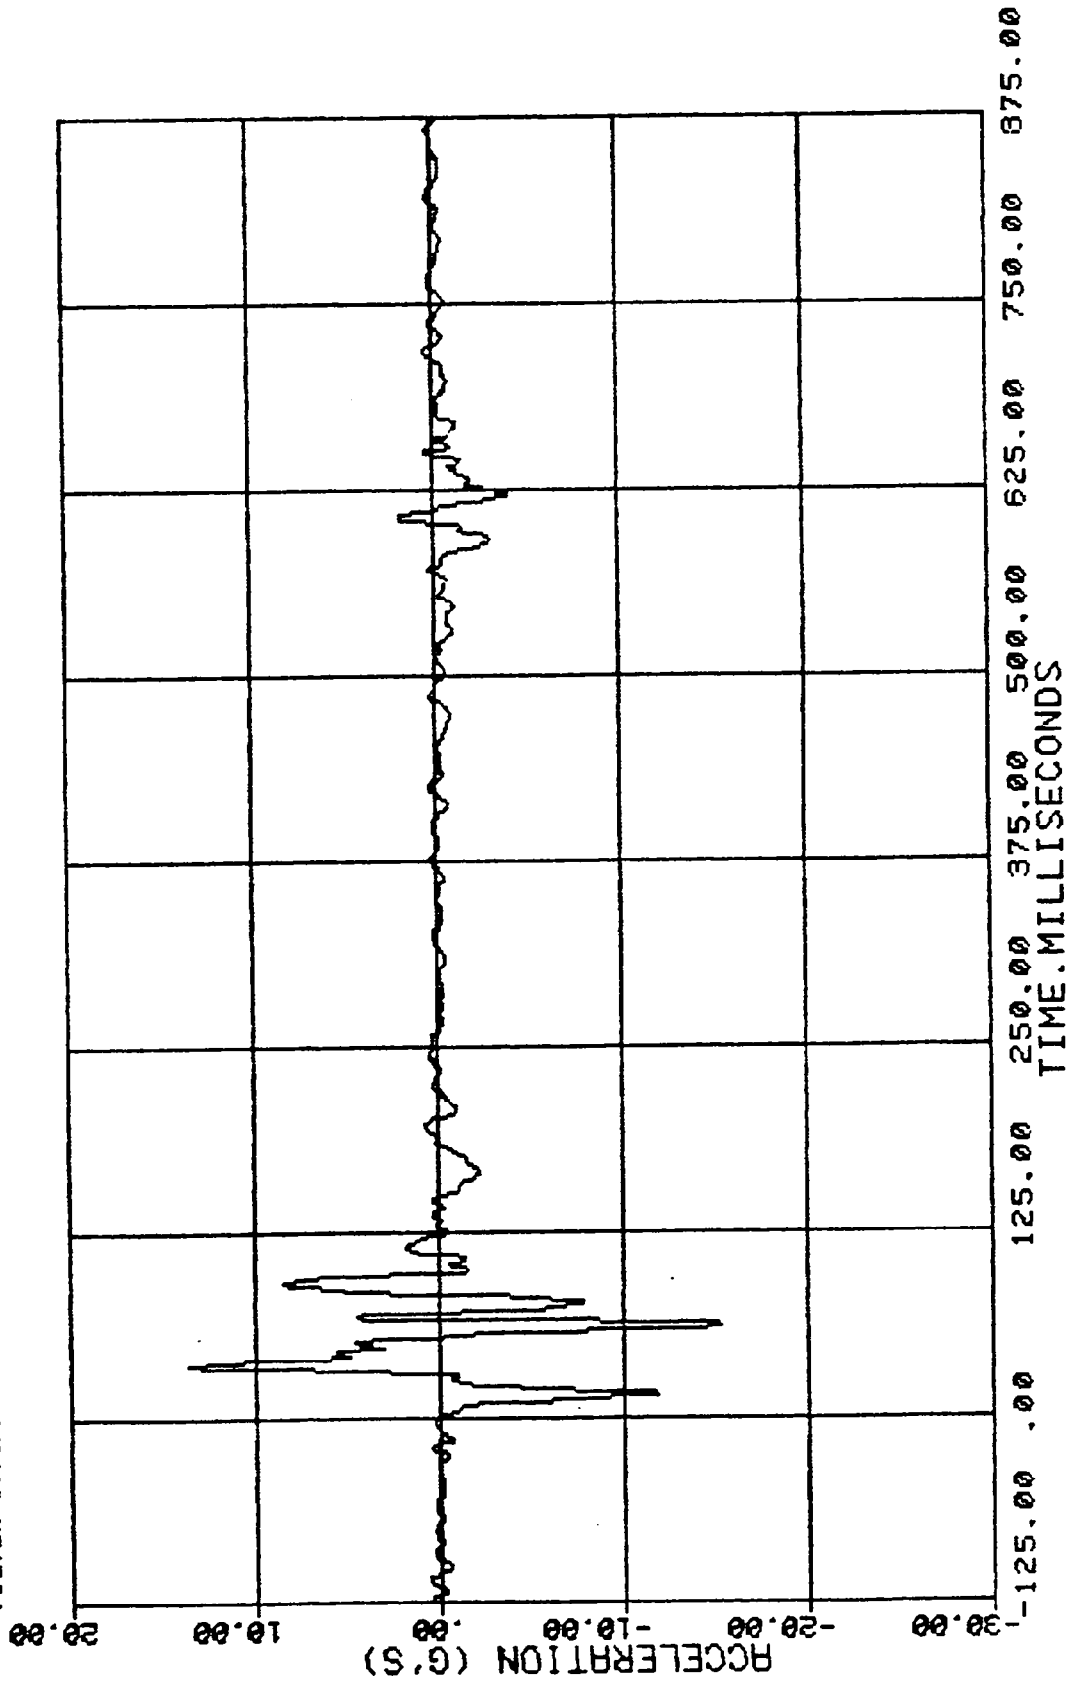
Figure 4. Vehicle Acceleration, X-Axis, 100 Hz

ENSO, INC. CONTRACT NUMBER DTFH61-81-0-00036 TEST NUM#1469-SI*6
 30 MPH BROADSIDE IMPACT OF 79 DODGE COLT INTO LUMINAIRE SUPPORT
 CHANNEL 17 VEHICLE O.G. ACCELERATION, X-AXIS
 FILTER CUTOFF FREQ. 100 PEAKS -15.22 , 13.66

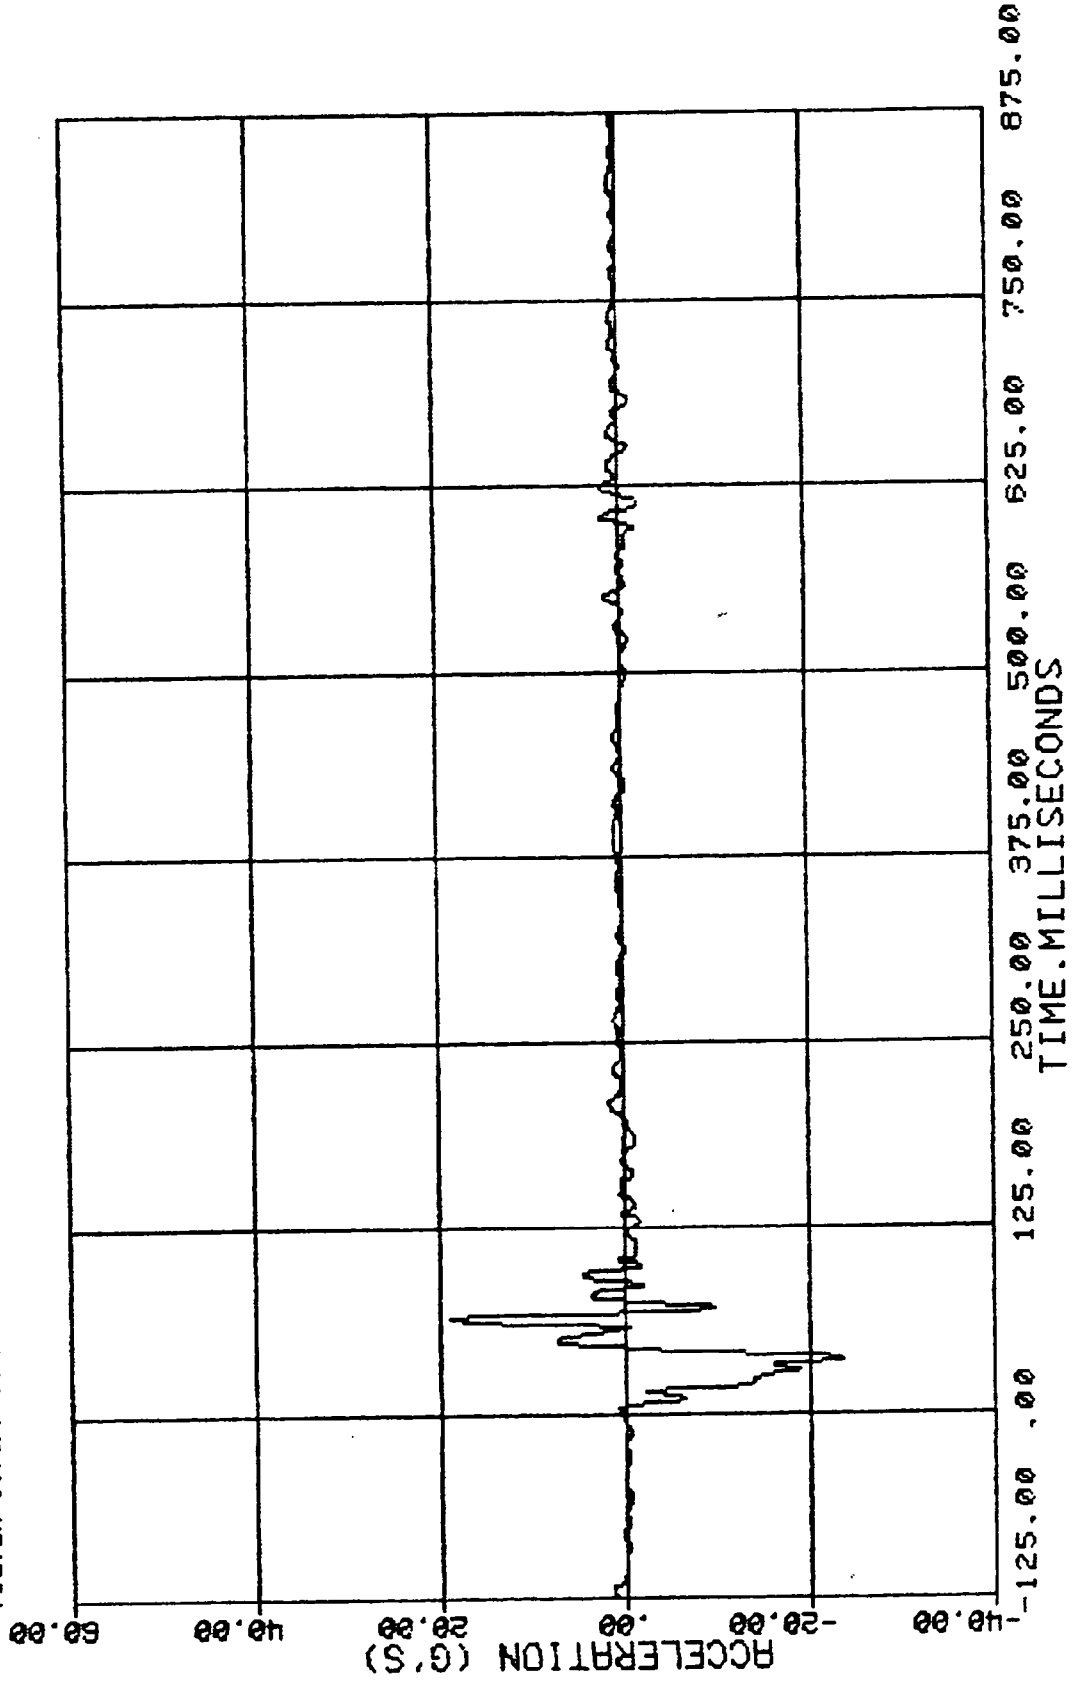
Figure 5. Vehicle Acceleration, Y-Axis, 100 Hz

ENSOO, INC. CONTRACT NUMBER DTFH61-81-O-00036 TEST NUM#1469-SI#6
 30 MPH BROADSIDE IMPACT OF 79 DODGE DOLT INTO LUMINAIRE SUPPORT
 CHANNEL 18 VEHICLE O.G. ACCELERATION, Y-AXIS
 FILTER CUTOFF FREQ. 100 PEAKS -23.58 , 18.80

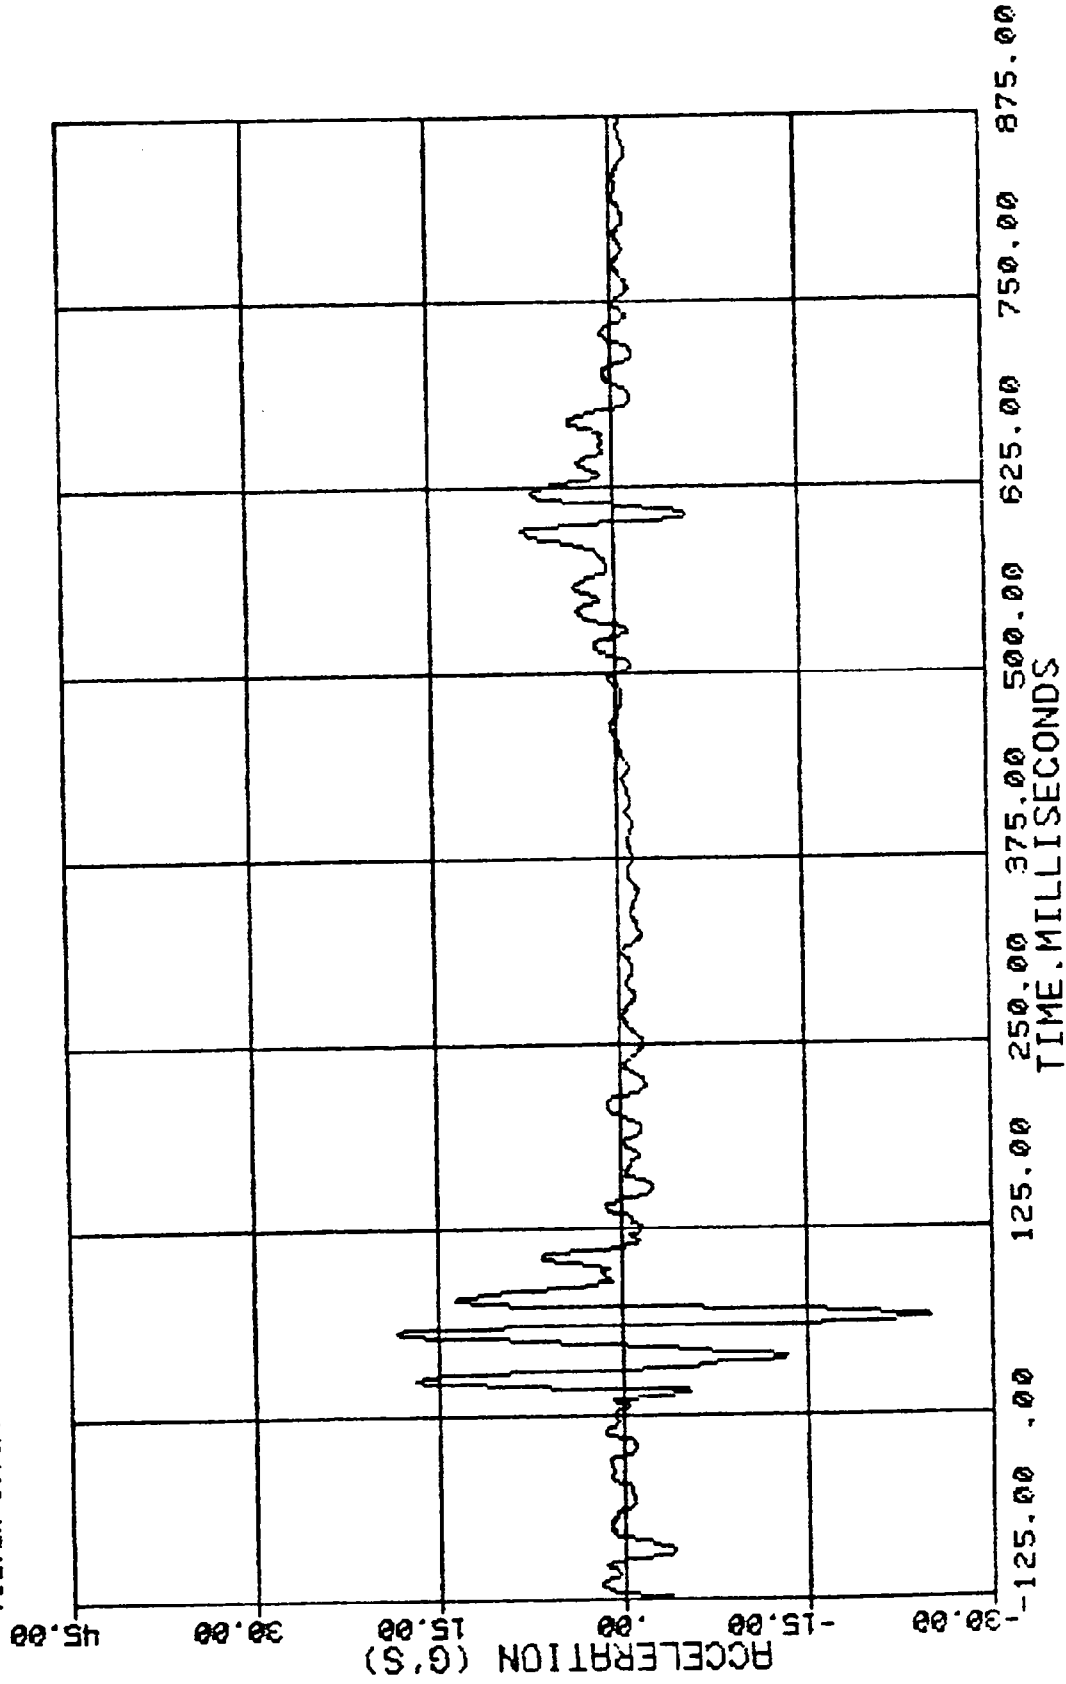
Figure 6. Vehicle Acceleration, Z-Axis, 100 Hz

ENSO, INC. CONTRACT NUMBER DTFH61-81-0-00036 TEST NUM 1469-SI 6
 30 MPH BROADSIDE IMPACT OF 79 DODGE COLT INTO LUMINAIRE SUPPORT
 CHANNEL 13 VEHICLE O.G. ACCELERATION, Z-AXIS
 FILTER CUTOFF FREQ. 100 PEAKS -24.91 18.41

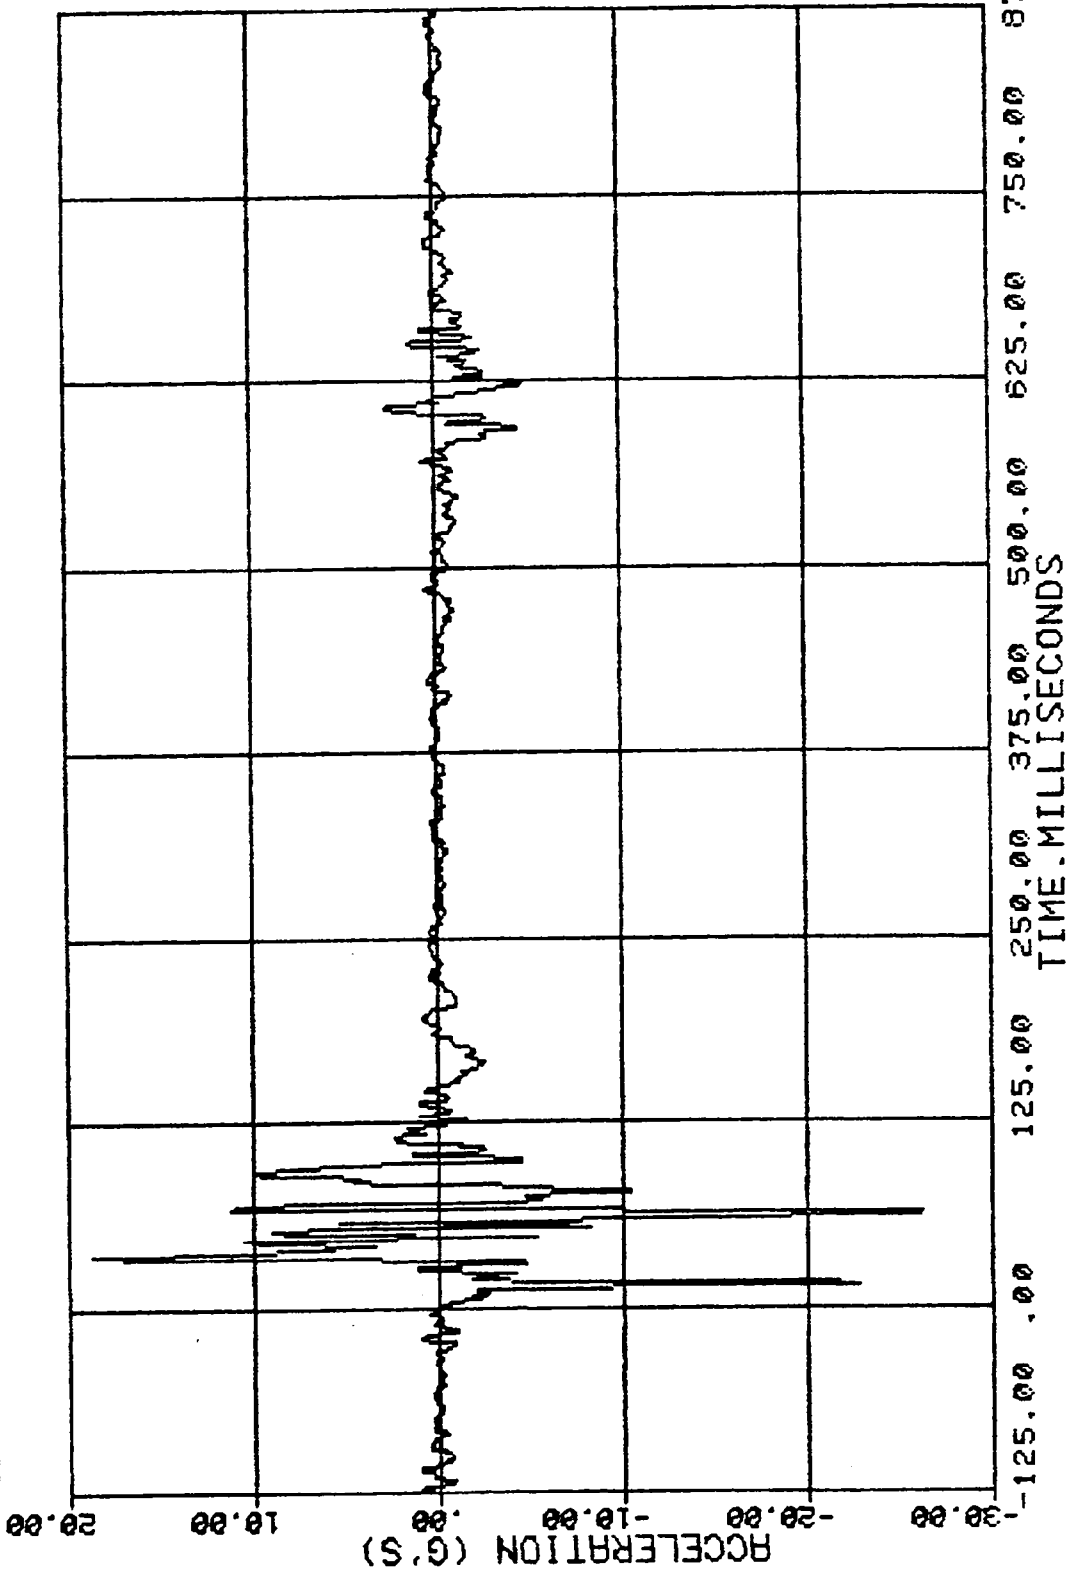
Figure 7. Vehicle Acceleration, X-Axis, 300 Hz

ENSO, INC. CONTRACT NUMBER DTFH61-81-O-00036 TEST NUM#1469-SI*6
 30 MPH BROADSIDE IMPACT OF 79 DODGE COLT INTO LUMINAIRE SUPPORT
 CHANNEL 17 VEHICLE C.O. ACCELERATION, X-AXIS
 FILTER CUTOFF FREQ. 300 PEAKS -26.30 , 18.80

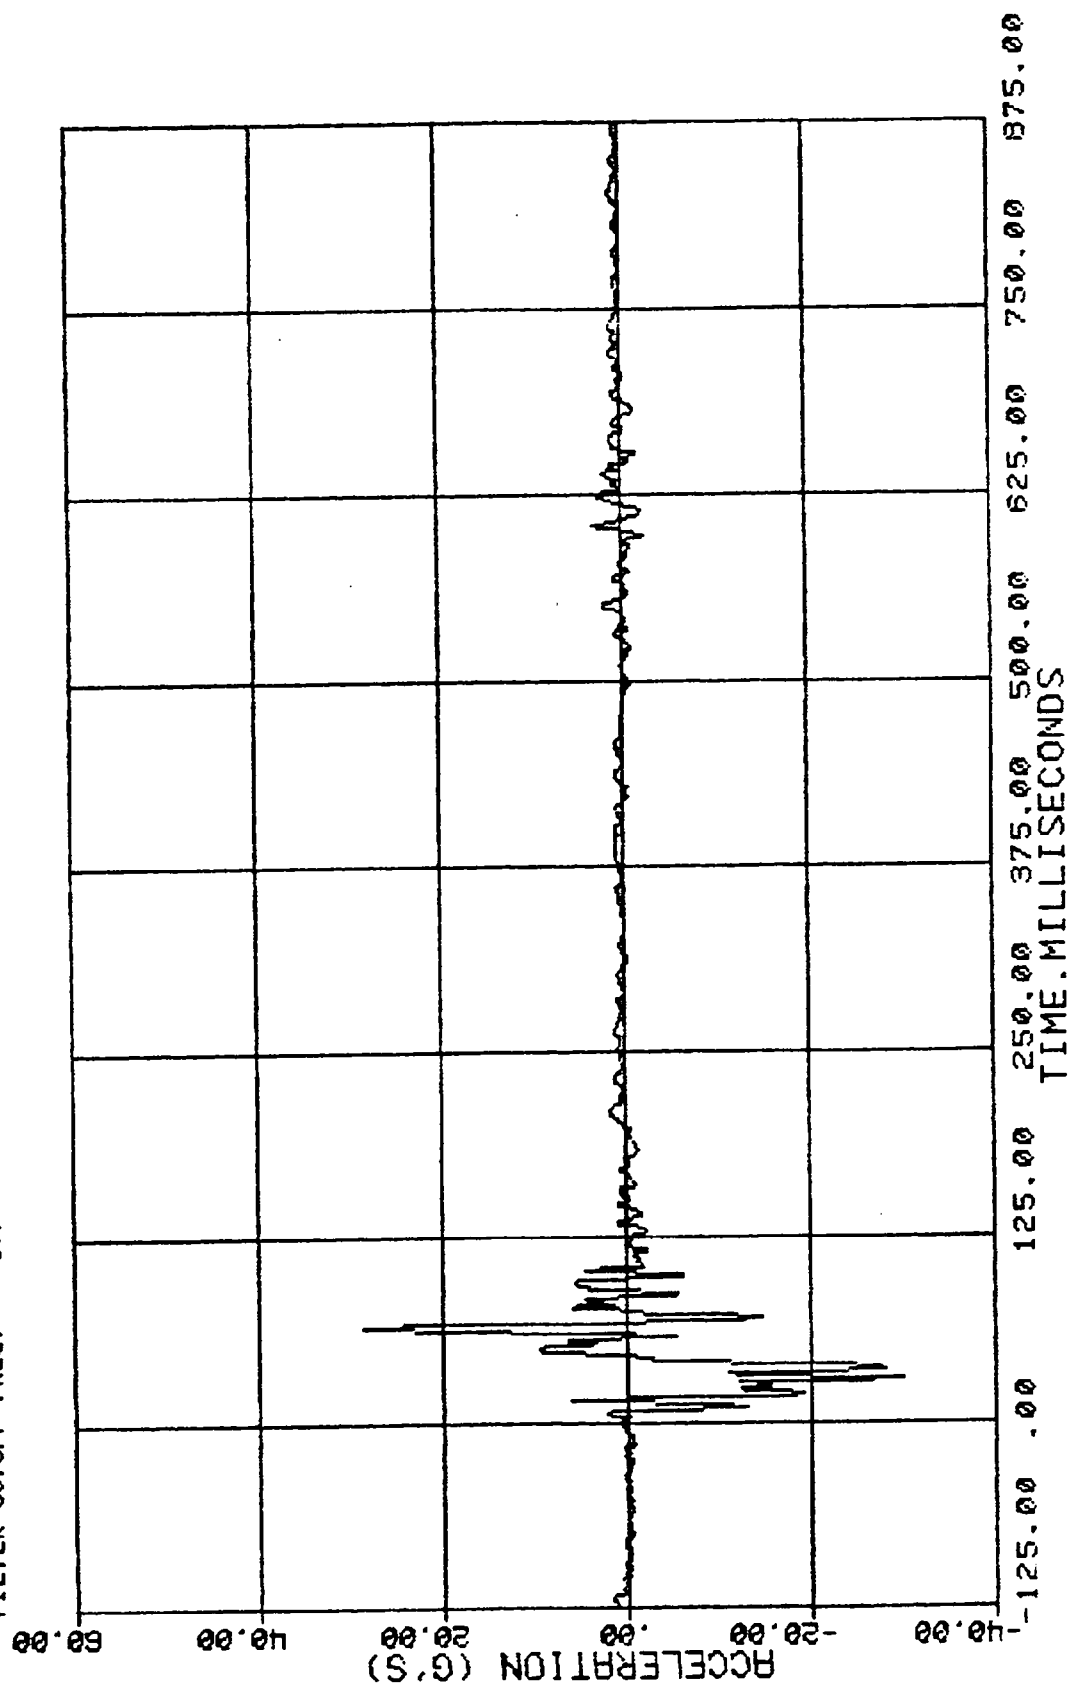
Figure 8. Vehicle Acceleration, Y-Axis, 300 Hz

ENSO, INC. CONTRACT NUMBER DTFH61-81-D-00036 TEST NUM#1469-SI#6
 30 MPH BROADSIDE IMPACT OF 79 P000E COLT INTO LUMINAIRE SUPPORT
 CHANNEL 18 VEHICLE O.O. ACCELERATION, Y-AXIS
 FILTER CUTOFF FREQ. 300 PEAKS -29.90 , 29.69

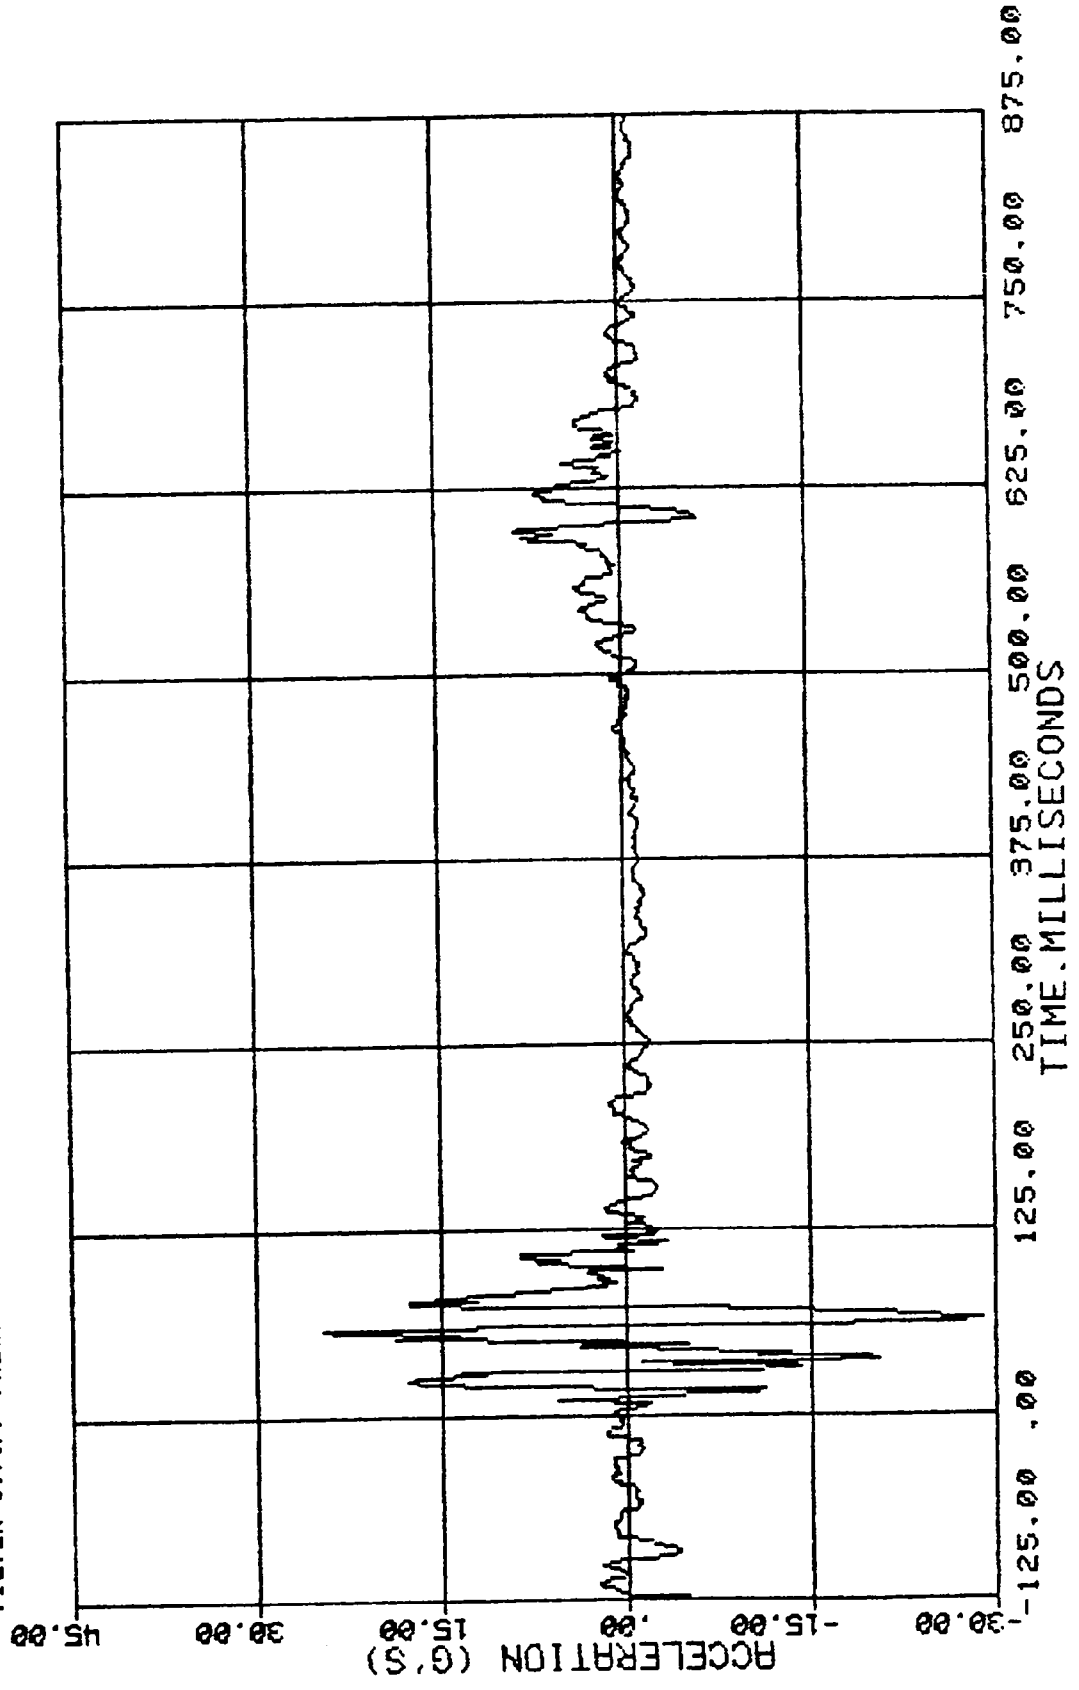
Figure 9. Vehicle Acceleration, Z-Axis, 300 Hz

ENSO, INC. CONTRACT NUMBER DTFH61-81-C-00036 TEST NUM#1469-SI*6
 30 MPH BROADSIDE IMPACT OF 79 DODGE COLT INTO LUMINAIRE SUPPORT
 CHANNEL 19 VEHICLE O.G. ACCELERATION, Z-AXIS
 FILTER CUTOFF FREQ. 300 PEAKS -23.95 24.50

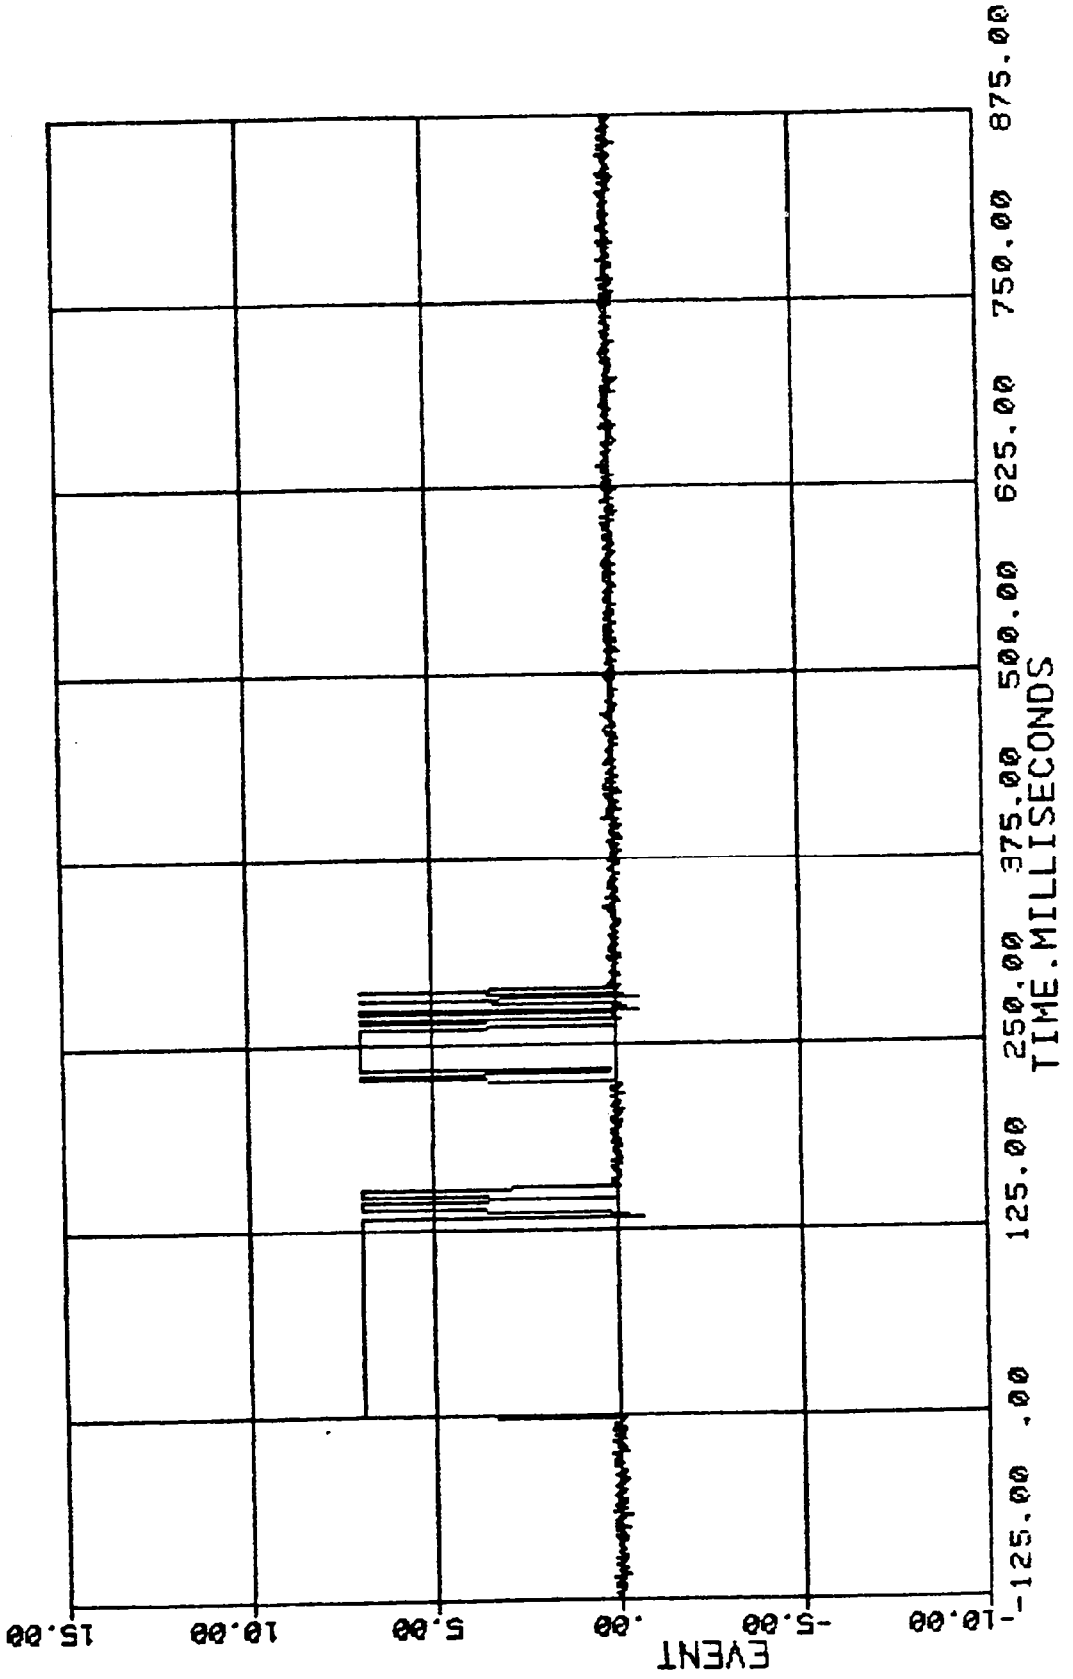
Figure 10. Event Marker, Impact

ENSO0.I.NO. CONTRACT NUMBER DTFH61-81-O-00036 TEST NUM#1469-SI#6
 30 MPH BROADSIDE IMPACT OF 79 DODGE COLT INTO LUMINAIRE SUPPORT
 CHANNEL 20 IMPACT
 FILTER CUTOFF FREQ. 1650 PEAKS -0.70 6.95

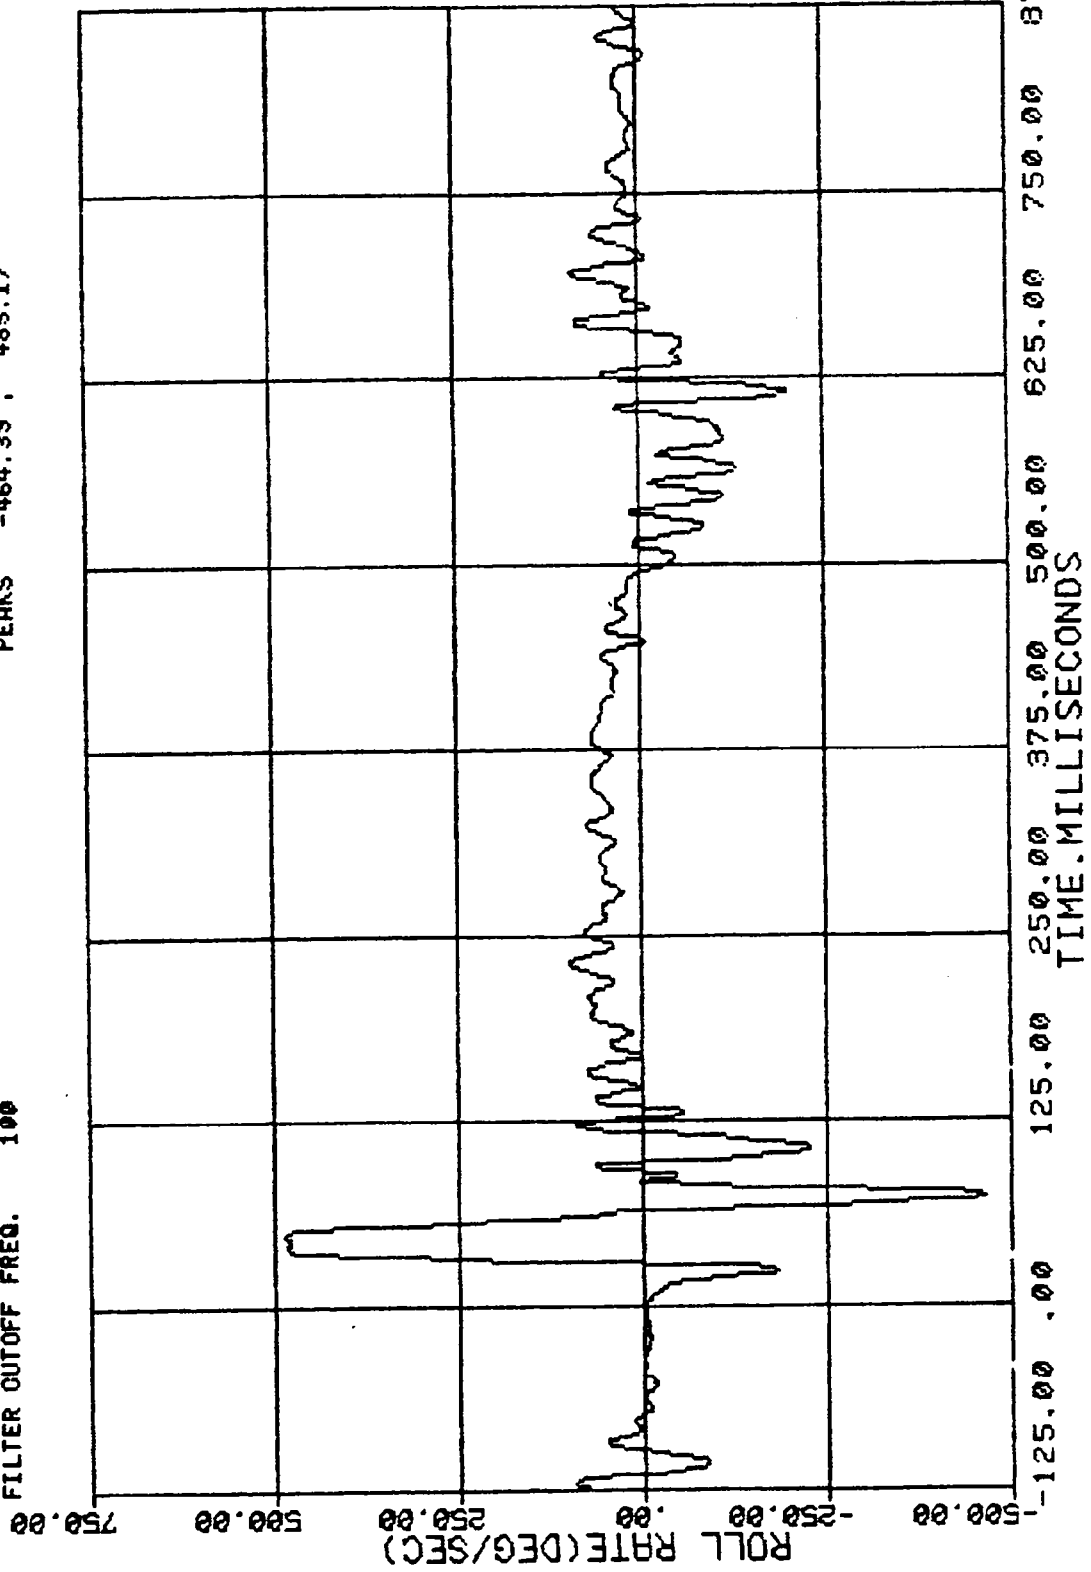
Figure 11. Vehicle Roll Rate, 100 Hz

ENS00.ING. CONTRACT NUMBER DTFH61-81-C-00036 TEST NUM*1469-SI*6
 30 MPH BROADSIDE IMPACT OF 79 DODGE COLT INTO LUMINAIRE SUPPORT
 CHANNEL 21 VEHICLE ROLL RATE PEAKS -464.39 , 485.17
 FILTER CUTOFF FREQ. 100

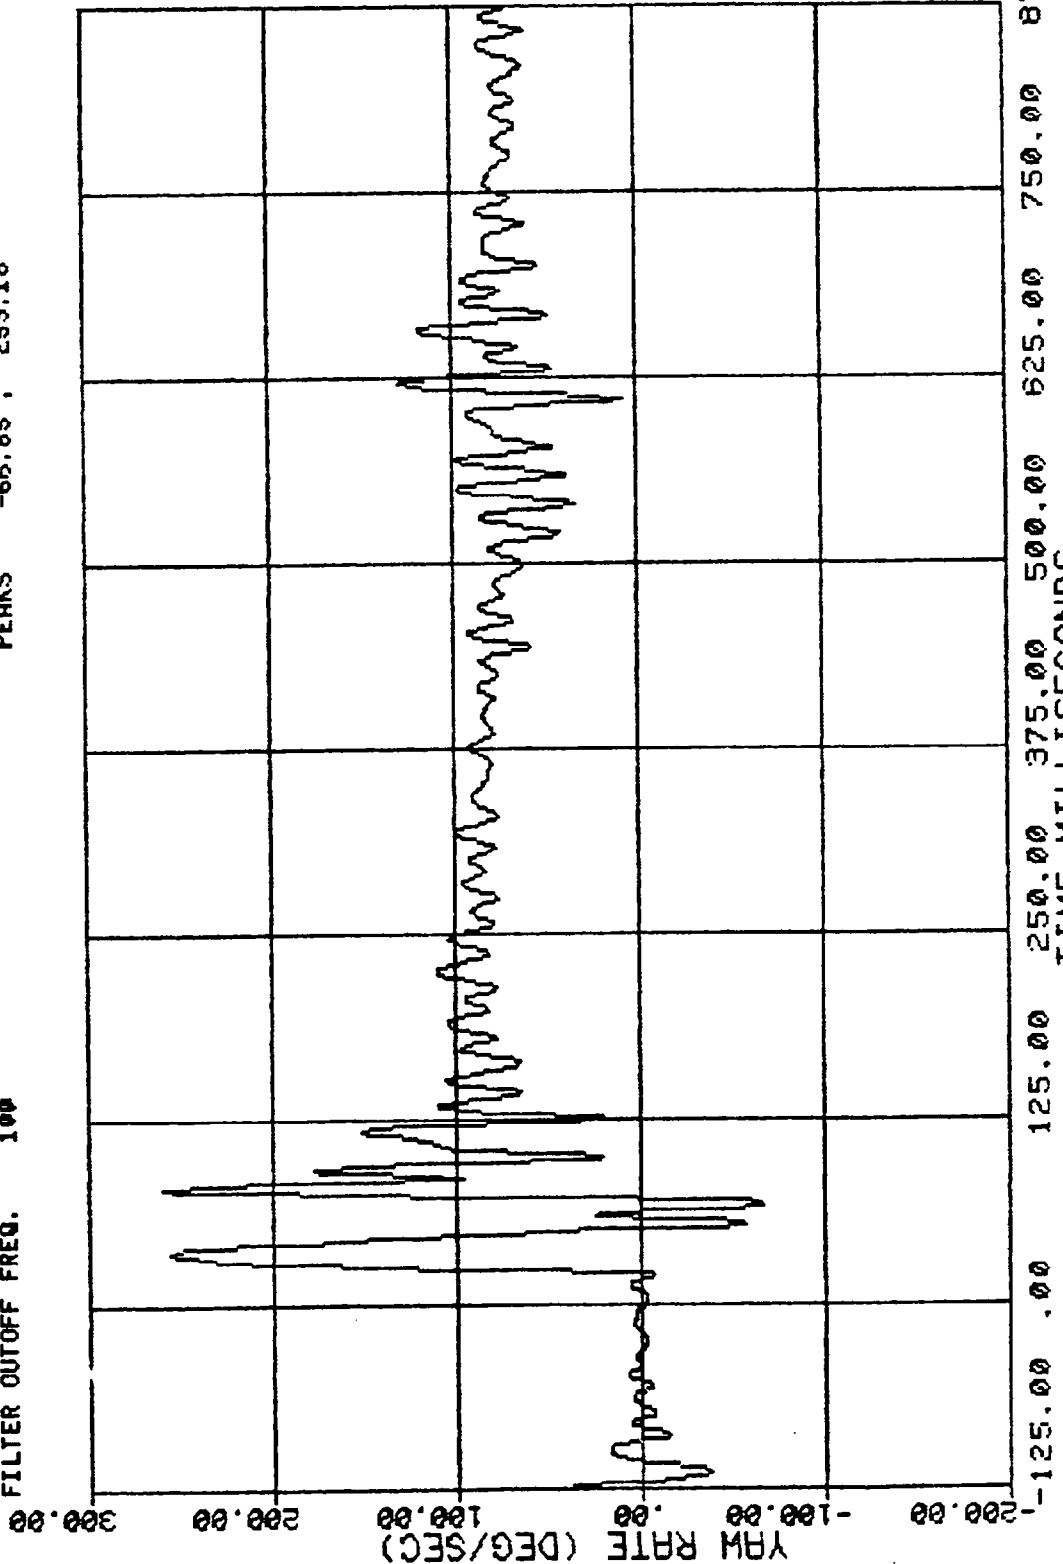
Figure 12. Vehicle Yaw Rate, 100 Hz

ENSOO, INC. CONTRACT NUMBER DTFH61-81-O-00036 TEST NUM#1469-SI#6
 30 MPH BROADSIDE IMPACT OF 79 DODGE COLT INTO LUMINAIRE SUPPORT
 CHANNEL 22 VEHICLE YAW RATE
 FILTER CUTOFF FREQ. 100 PEAKS -66.85 , 259.18

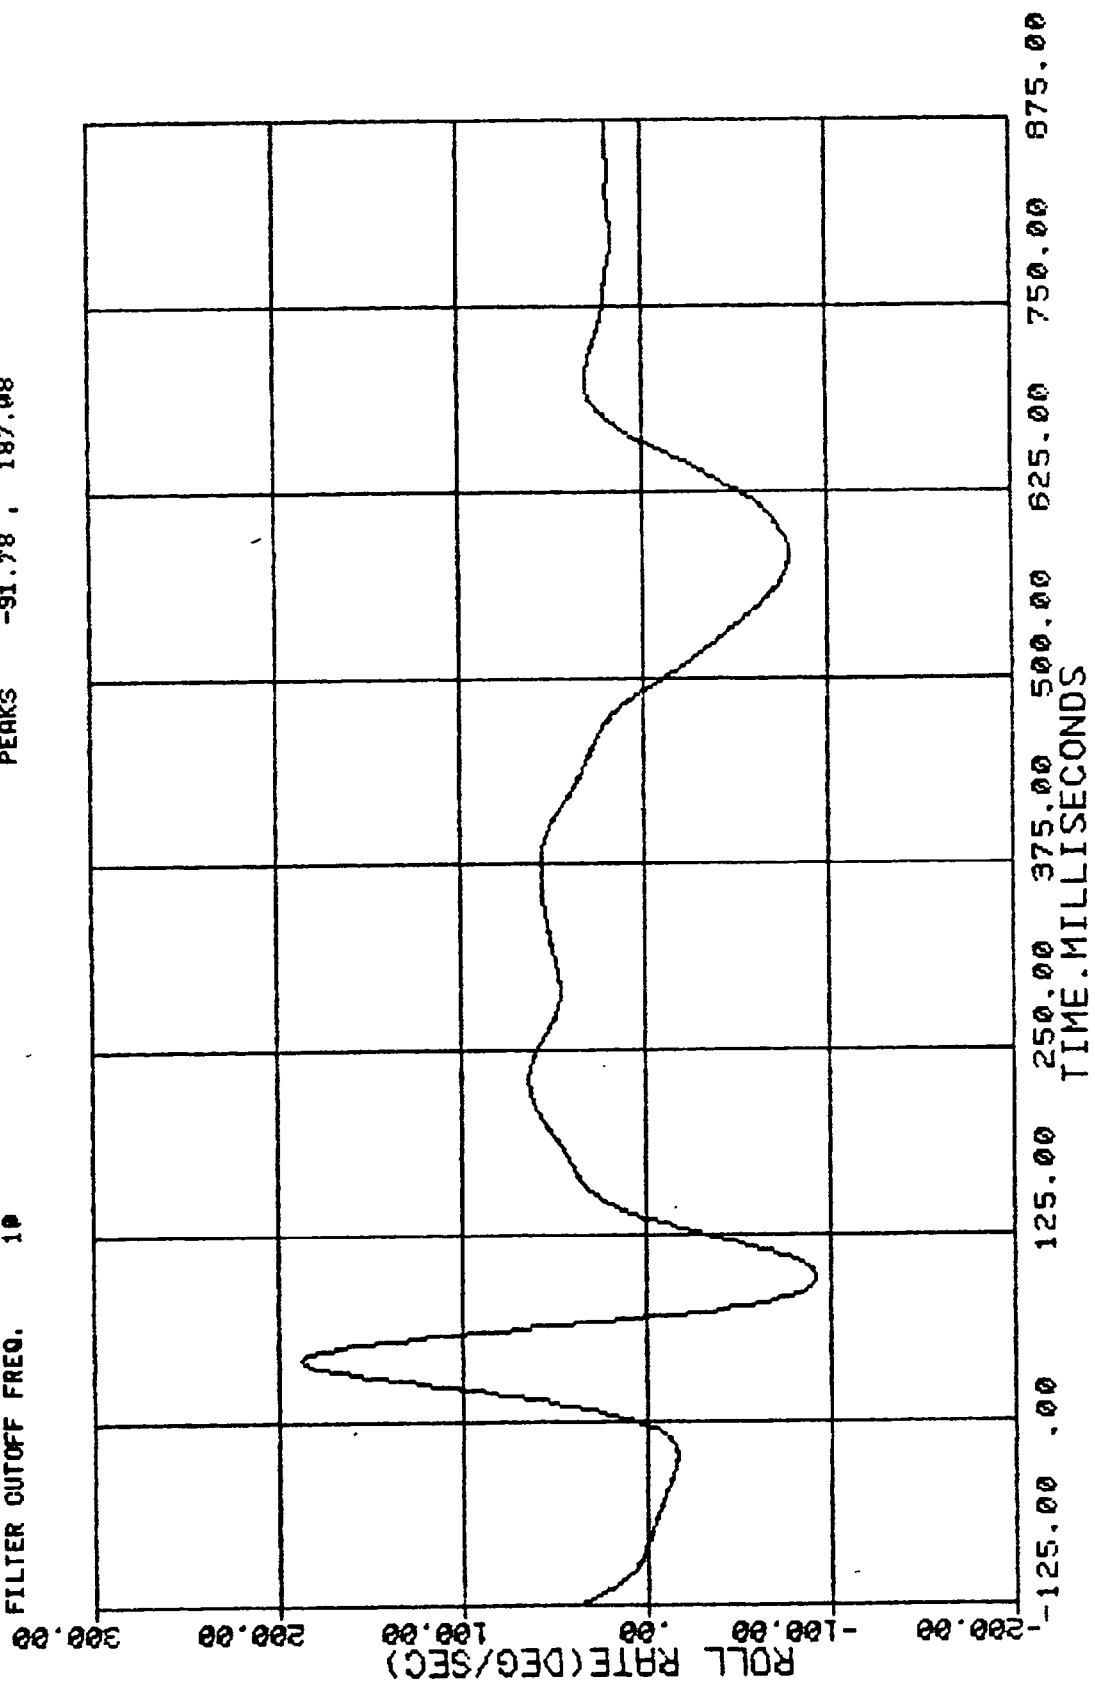
Figure 13. Vehicle Roll Rate, 10 Hz

ENS00,INO. CONTRACT NUMBER DTFH61-81-D-00036 TEST NIJM1469-SI*6
 30 MPH BROADSIDE IMPACT OF 79 D000E COLT INTO LUMINAIRE SUPPORT
 CHANNEL 21 VEHICLE ROLL RATE
 FILTER CUTOFF FREQ. 10 PEAKS -91.78 , 187.08
