LABORATORY PROCEDURES TO DETERMINE THE
BREAKAWAY BEHAVIOR OF LUMINAIRE SUPPORTS
IN MINI-SIZED VEHICLE COLLISIONS

THIRTY MPH BROADSIDE
IMPACT OF A DODGE COLT
AND A BREAKAWAY LUMINAIRE SUPPORT

TEST RESULTS REPORT

TEST NUMBER 1469-SI#6-85

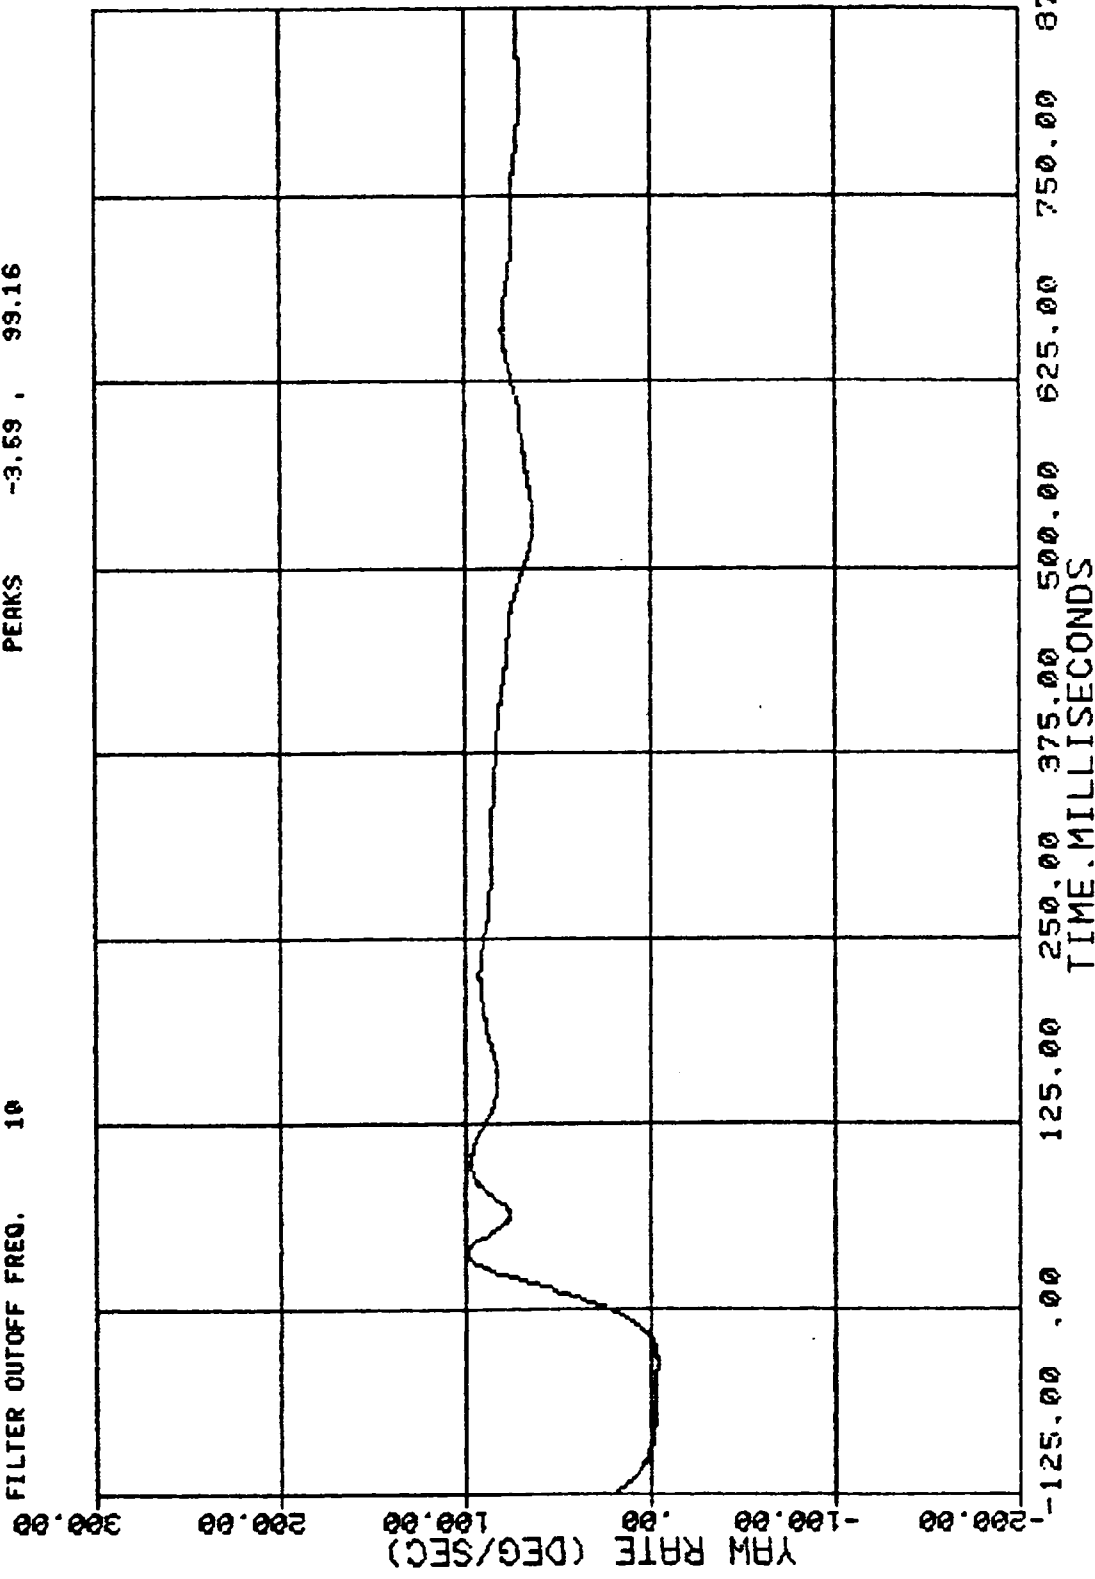
Figure 14. Vehicle Yaw Rate, 10 Hz

ENSCO, INC. CONTRACT NUMBER DTFH61-81-0-00036 TEST NUM#1469-SI#6
 30 MPH BROADSIDE IMPACT OF 79 DODGE COLT INTO LUMINAIRE SUPPORT
 CHANNEL 22 VEHICLE YAW RATE
 FILTER CUTOFF FREQ. 10 PEAKS -3.59 , 99.16

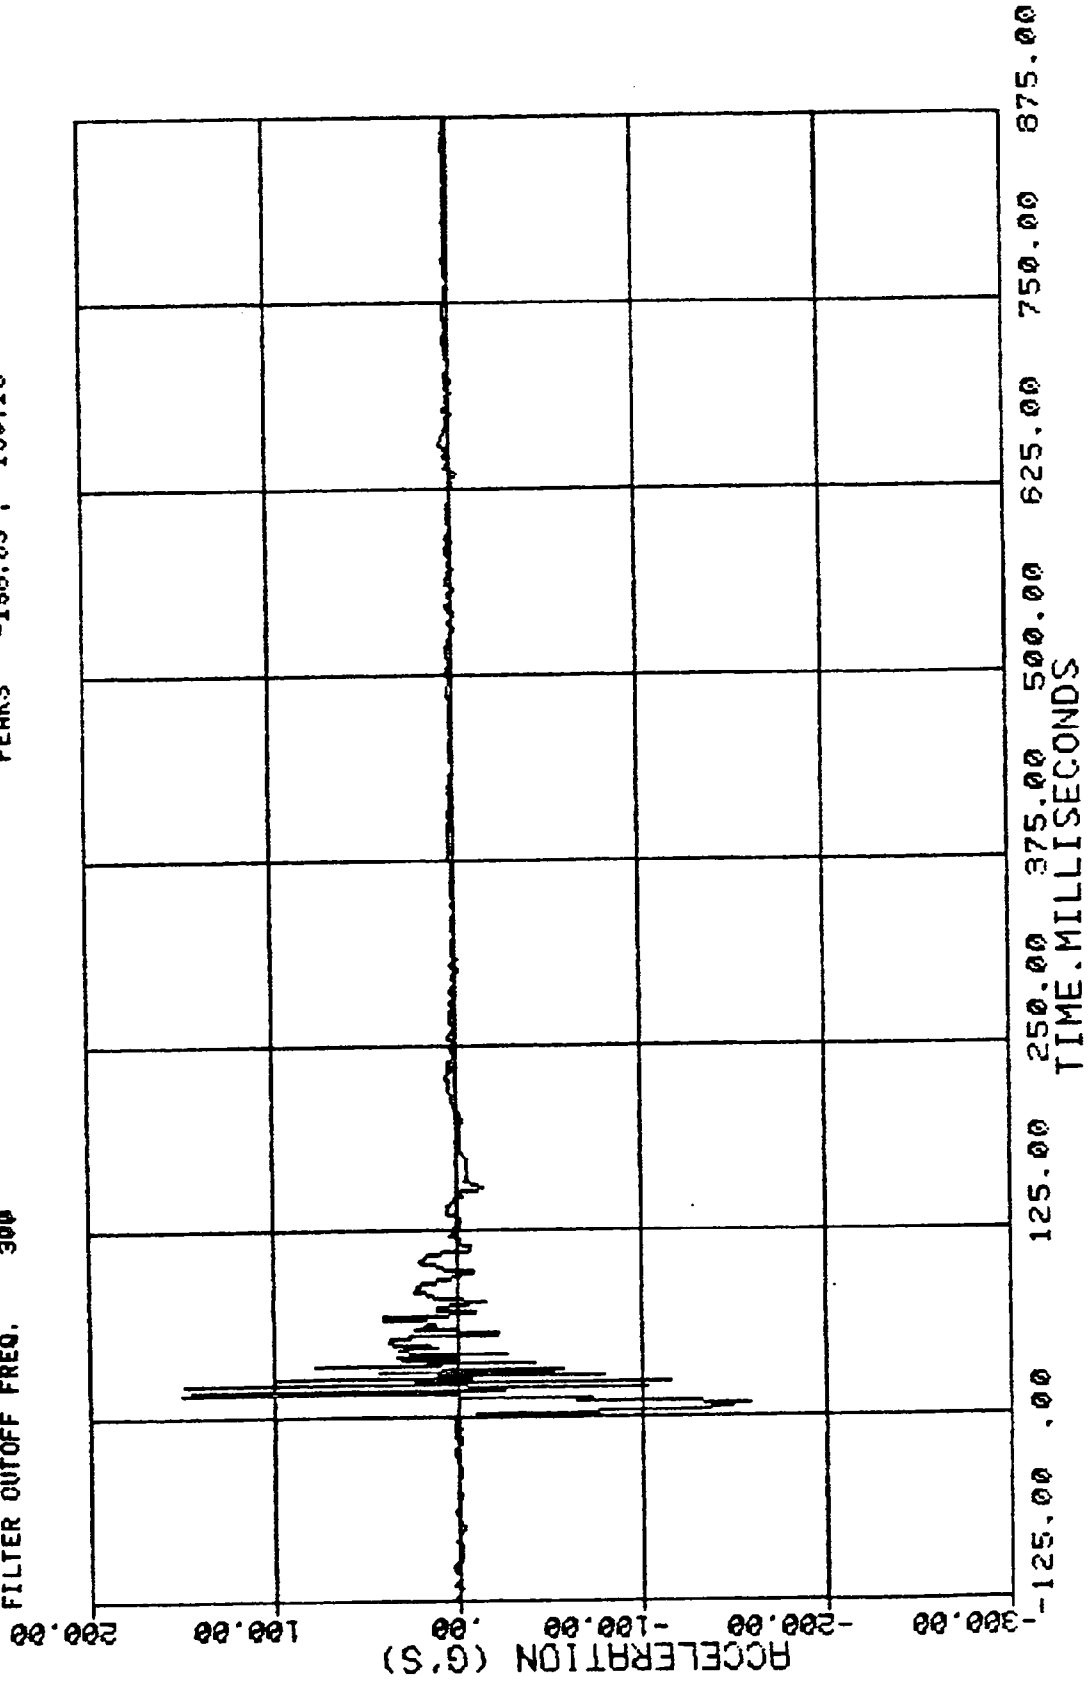
Figure 15. Vehicle Driver's Door Acceleration, Upper Center, 300 Hz

ENSCO, INC. CONTRACT NUMBER DTFH61-81-O-00036 TEST NUM#1469-SI#6
 30 MPH BROADSIDE IMPACT OF 79 DODGE COLT INTO LUMINAIRE SUPPORT
 CHANNEL 13 DRIVER LEFT DOOR ACCELERATION, UPPER CENTER
 FILTER CUTOFF FREQ. 300 PEAKS -158.83 , 150.16

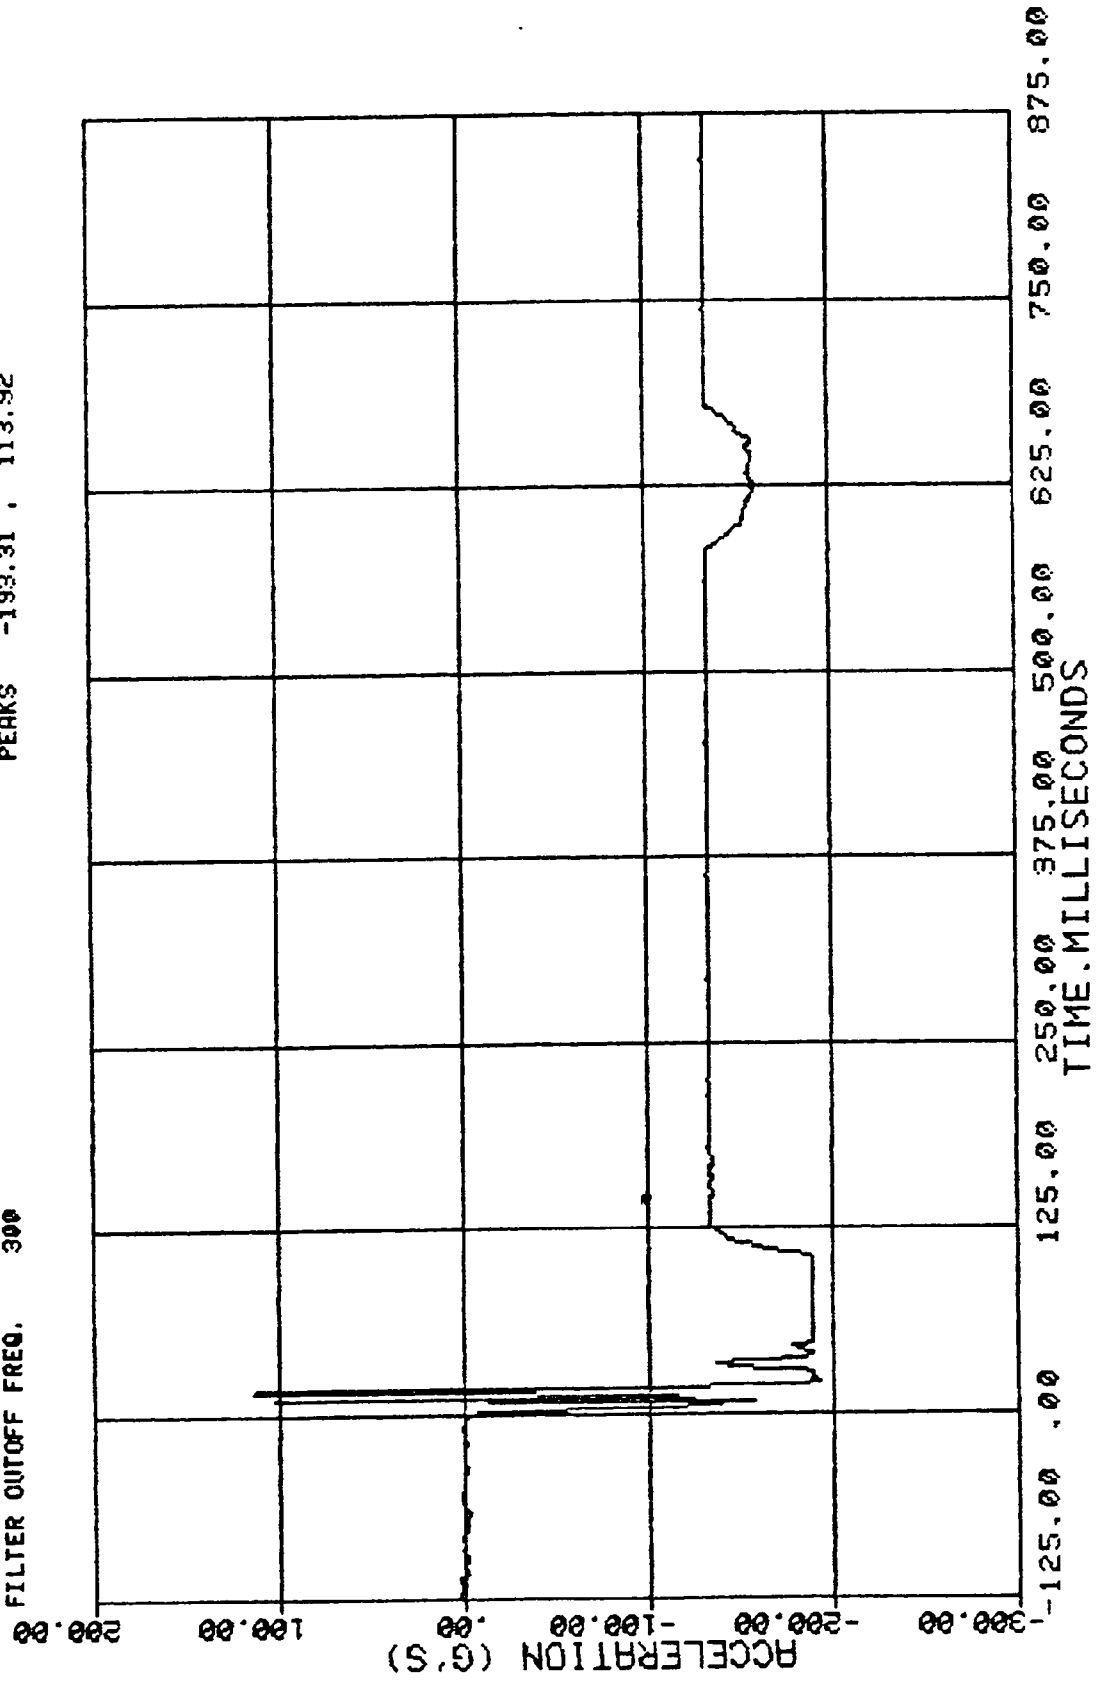
Figure 16. Vehicle Driver's Door Acceleration, Middle Forward, 300 Hz

ENSOO, INC. CONTRACT NUMBER DTFH51-81-0-00036 TEST NUM*1469-SI*6
 30 MPH BRODSIDE IMPACT OF 79 DODGE COLT INTO LUMINAIRE SUPPORT
 CHANNEL 14 DRIVER LEFT DOOR ACCELERATION, MIDDLE FORWARD
 FILTER CUTOFF FREQ. 300 PEAKS -193.31 , 113.92

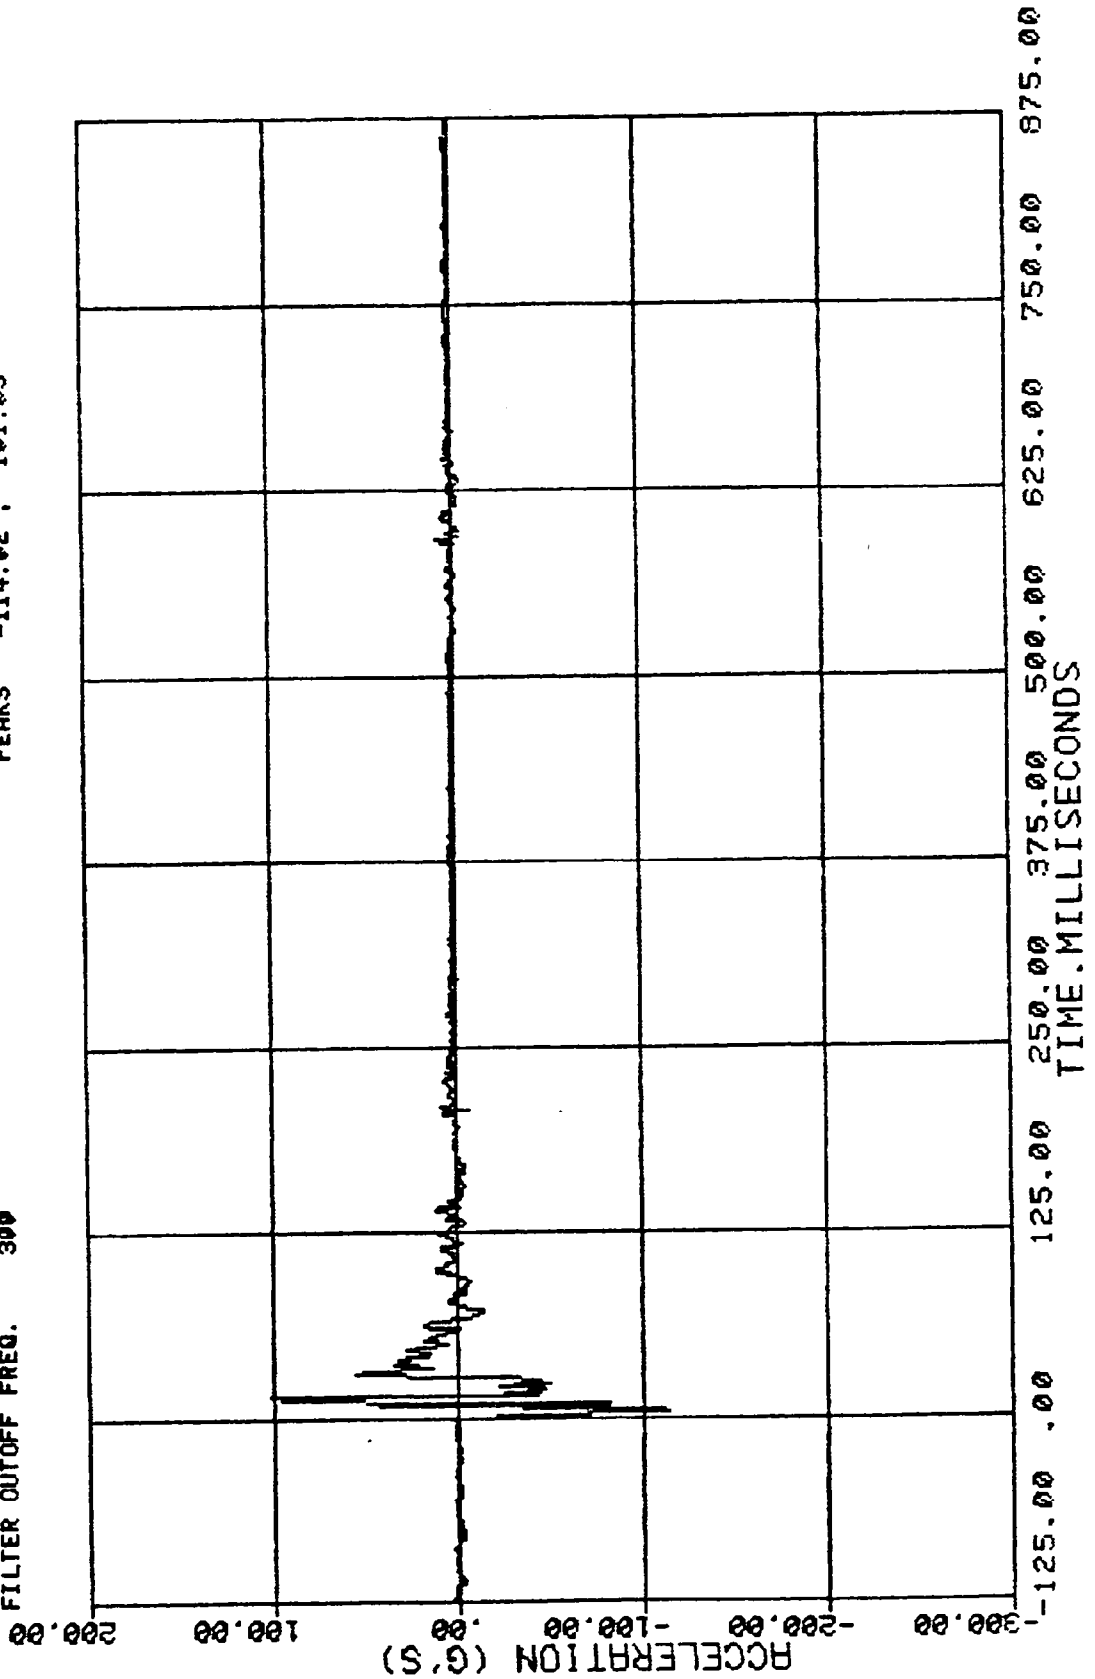
Figure 17. Vehicle Driver's Door Acceleration, Middle Rear, 300 Hz

ENSO, INC. CONTRACT NUMBER DTFH61-81-O-00036 TEST NUM#1469-SI#6
 30 MPH BROADSIDE IMPACT OF 79 DODGE COLT INTO LUMINAIRE SUPPORT
 CHANNEL 15 DRIVER LEFT DOOR ACCELERATION, MIDDLE REARWARD
 FILTER CUTOFF FREQ. 300 PEAKS -114.02 , 101.03

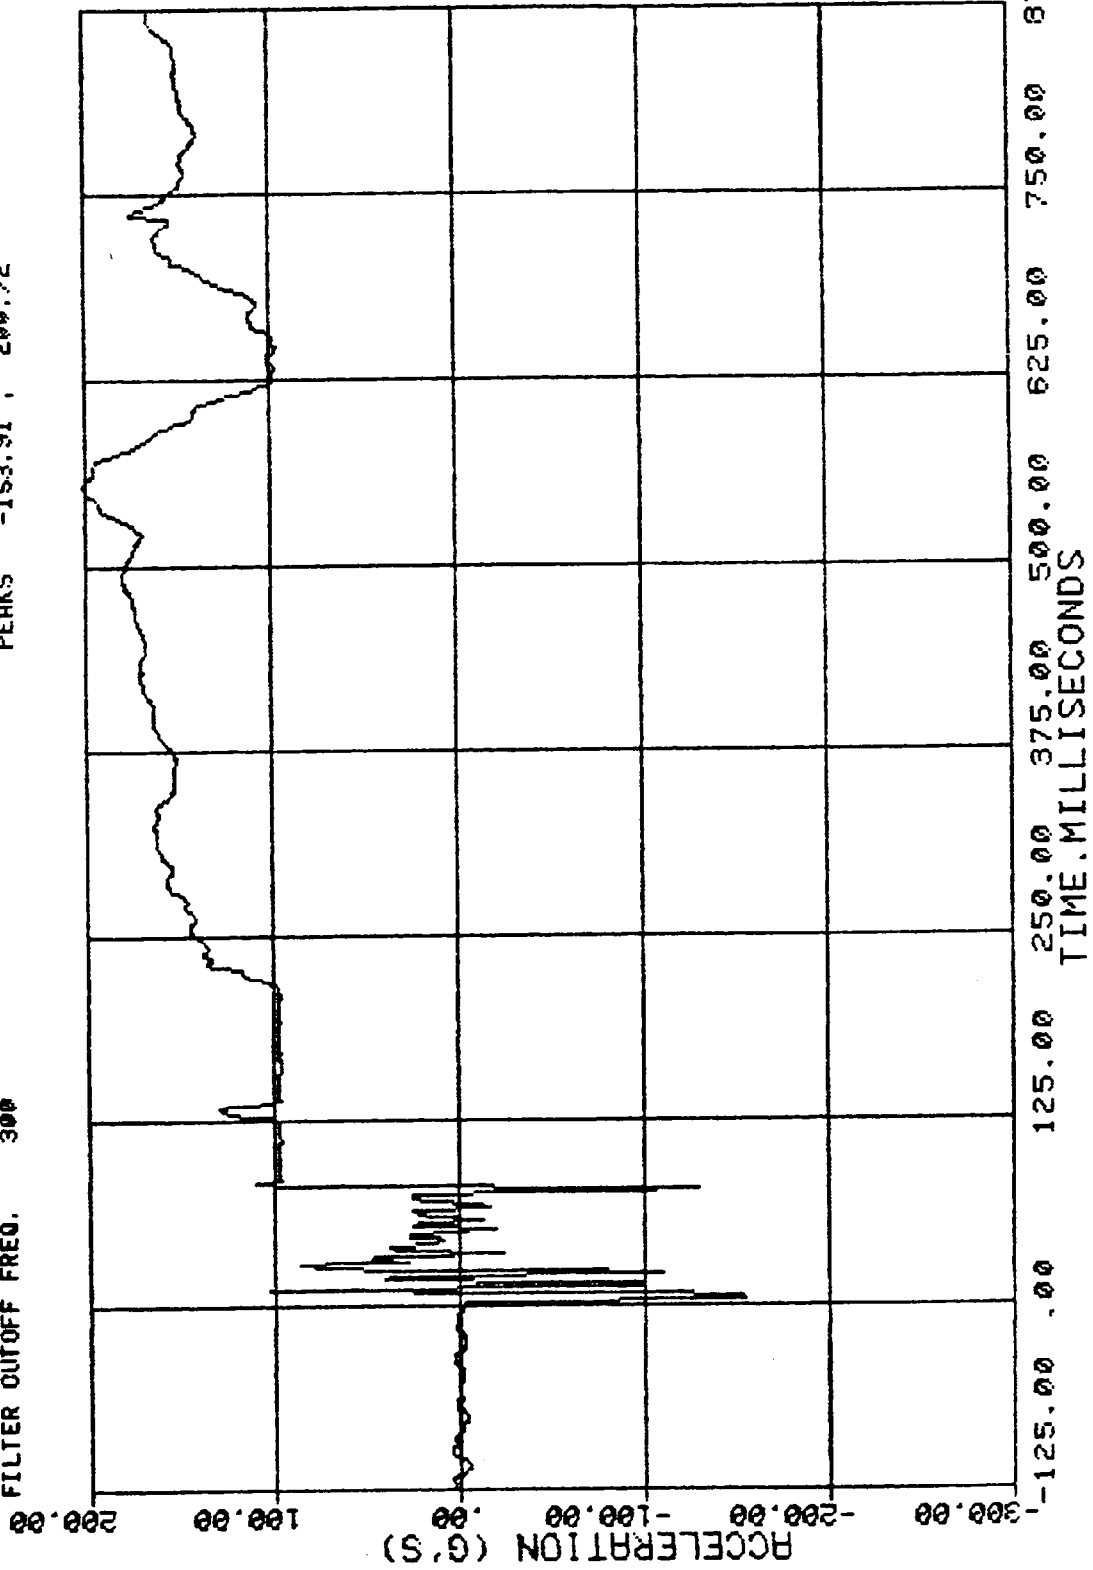
Figure 18. Vehicle Driver's Door Acceleration, Lower Center, 300 Hz

ENSCO, INC. CONTRACT NUMBER DTFH61-81-O-00036 TEST NUM#1469-SI#6
 30 MPH BROADSIDE IMPACT OF 79 DODGE COLT INTO LUMINAIRE SUPPORT
 CHANNEL 16 DRIVER LEFT DOOR ACCELERATION, LOWER CENTER
 FILTER CUTOFF FREQ. 300 PEAKS -153.91 , 200.72

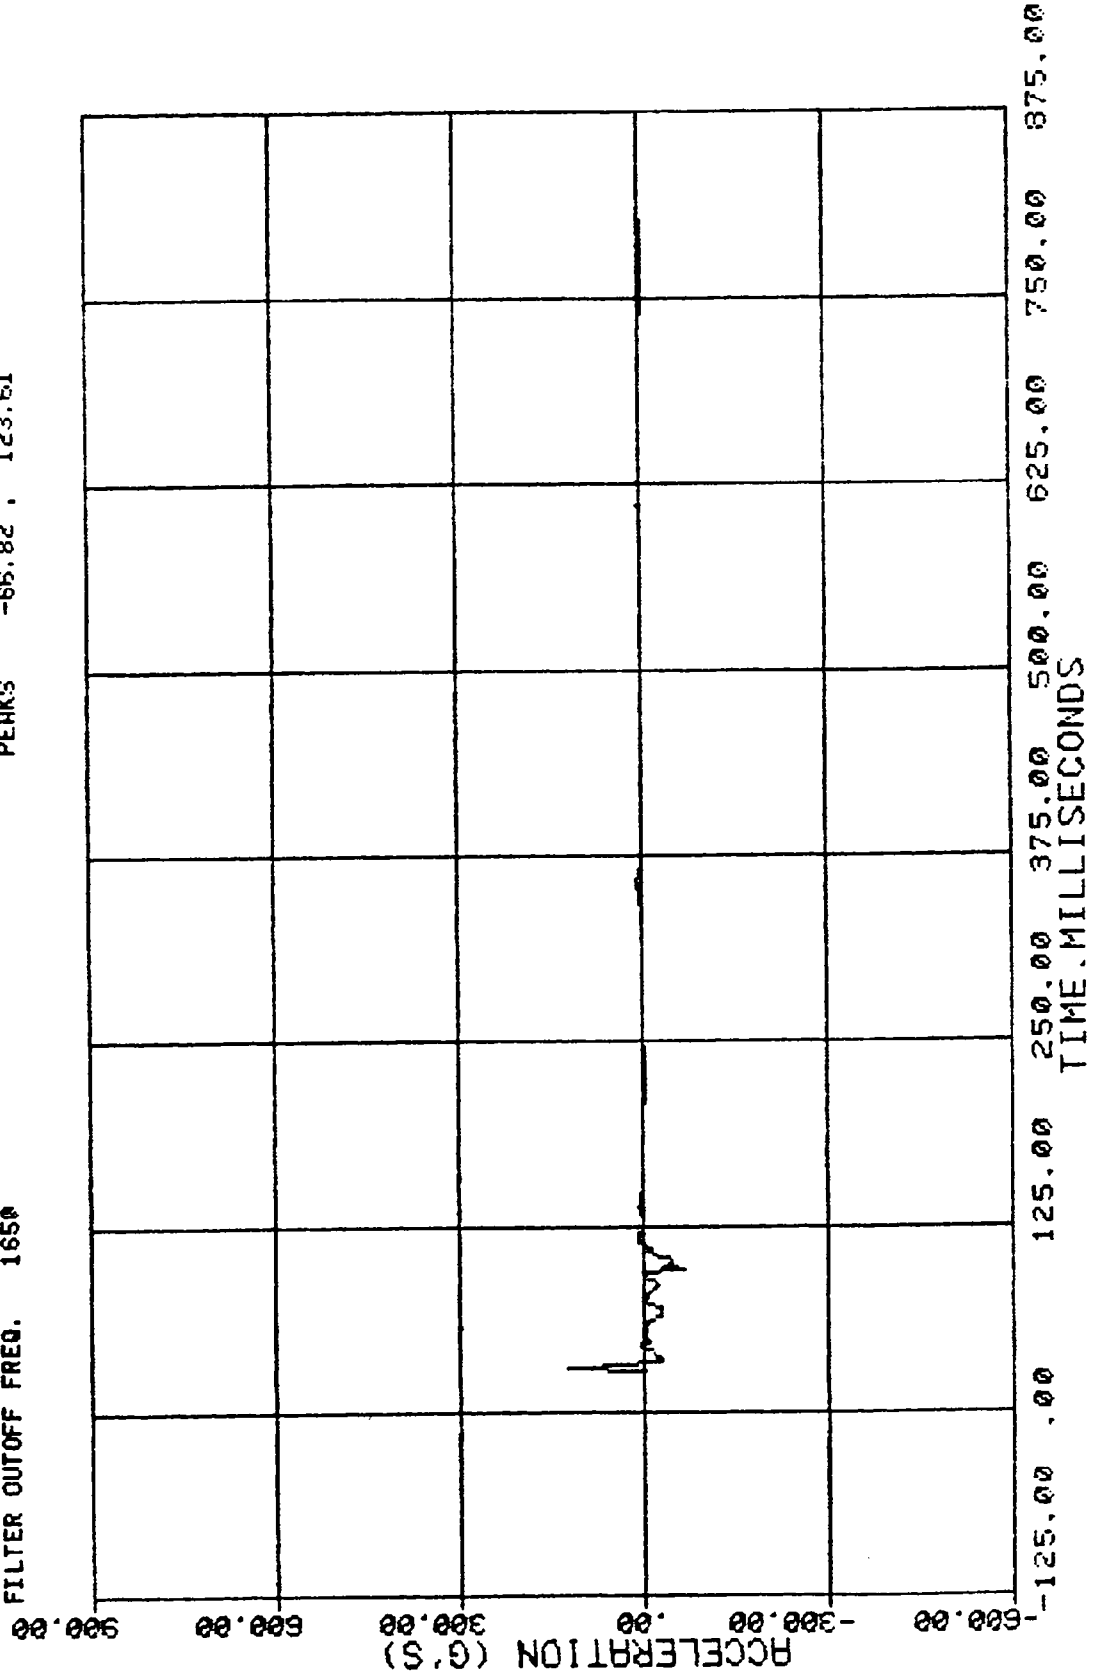
Figure 19. Driver's Head Acceleration, X-Axis, 1650 Hz

ENS00, INC. CONTRACT NUMBER DTFH61-81-D-00036 TEST NUM 1469-SI#6
 30 MPH BROADSIDE IMPACT OF 79 DODGE COLT INTO LUMINAIRE SUPPORT
 CHANNEL 25 DRIVER HEAD ACCELERATION, X-AXIS
 FILTER OUTOFF FREQ. 1650 PEAKS -65.82 , 123.61

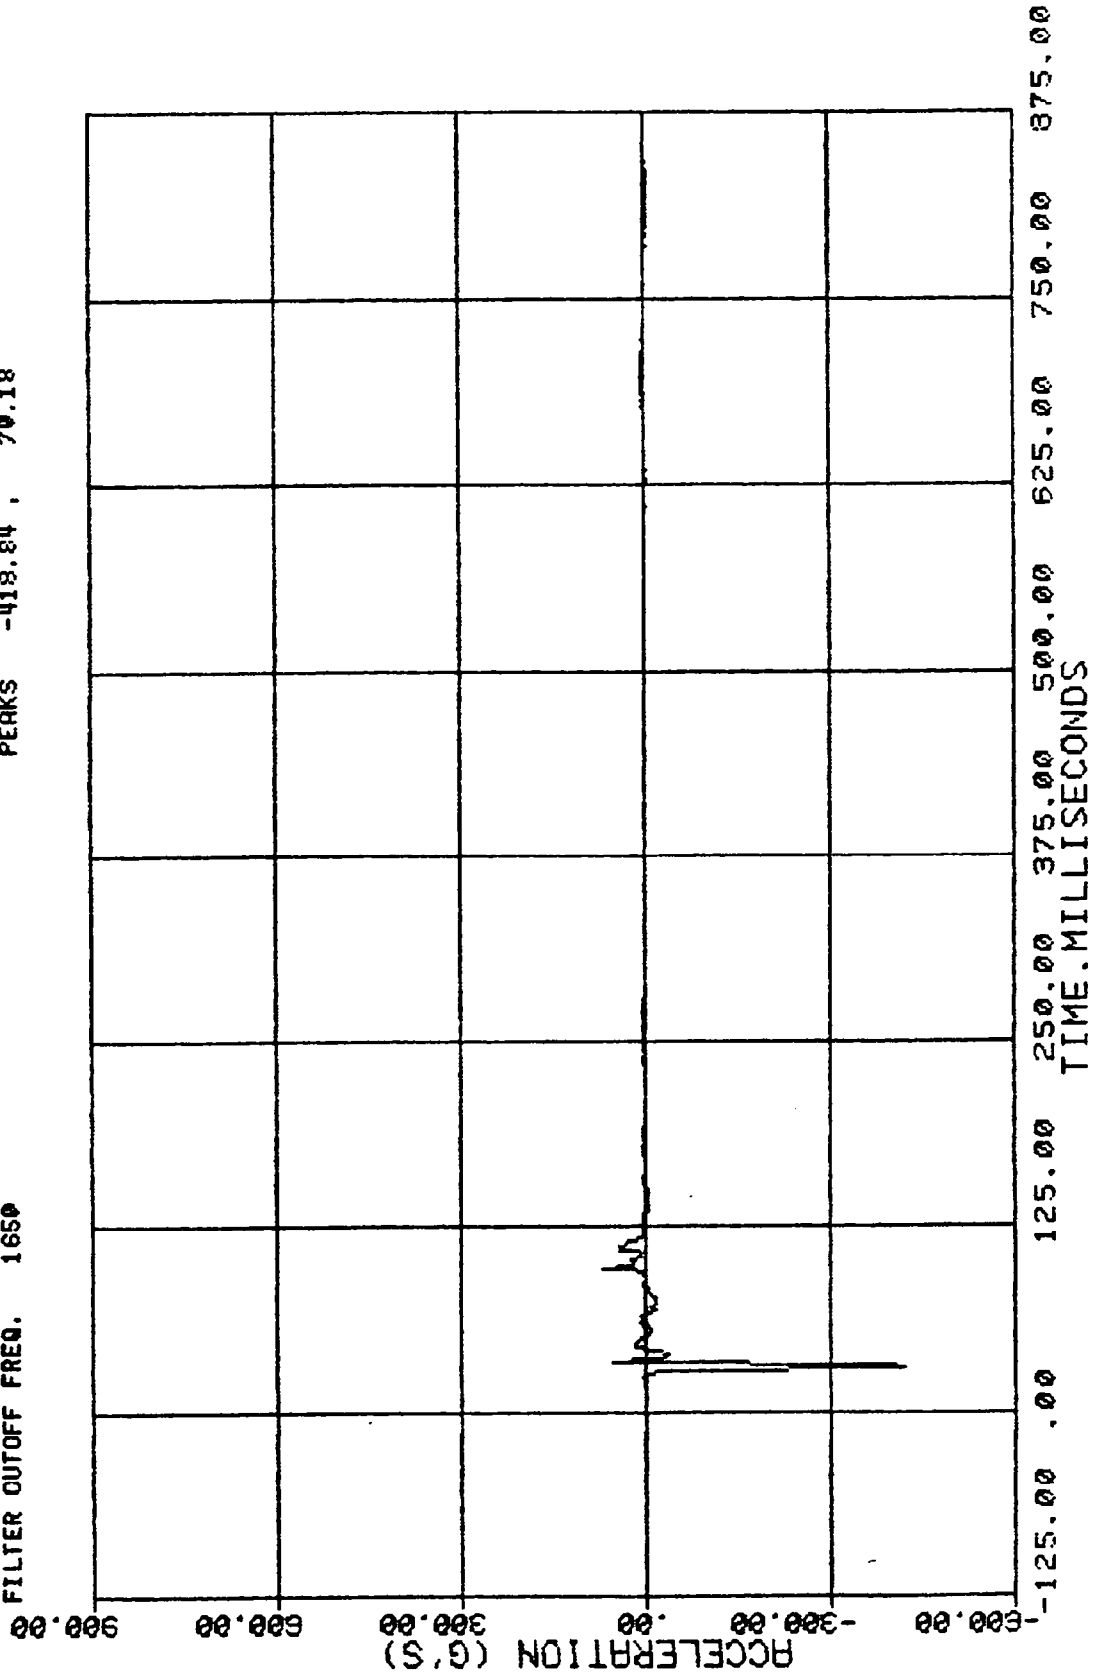
Figure 20. Driver's Head Acceleration, Y-Axis 1650 Hz

ENSOO, INC. CONTRACT NUMBER DTFH61-81-C-00036 TEST NUM 1469-SI#6
 30 MPH BROADSIDE IMPACT OF 79 DODGE COLT INTO LUMINAIRE SUPPORT
 CHANNEL 26 DRIVER HEAD ACCELERATION, Y-AXIS
 FILTER CUTOFF FREQ. 1650 PEAKS -418.84 ; 70.18

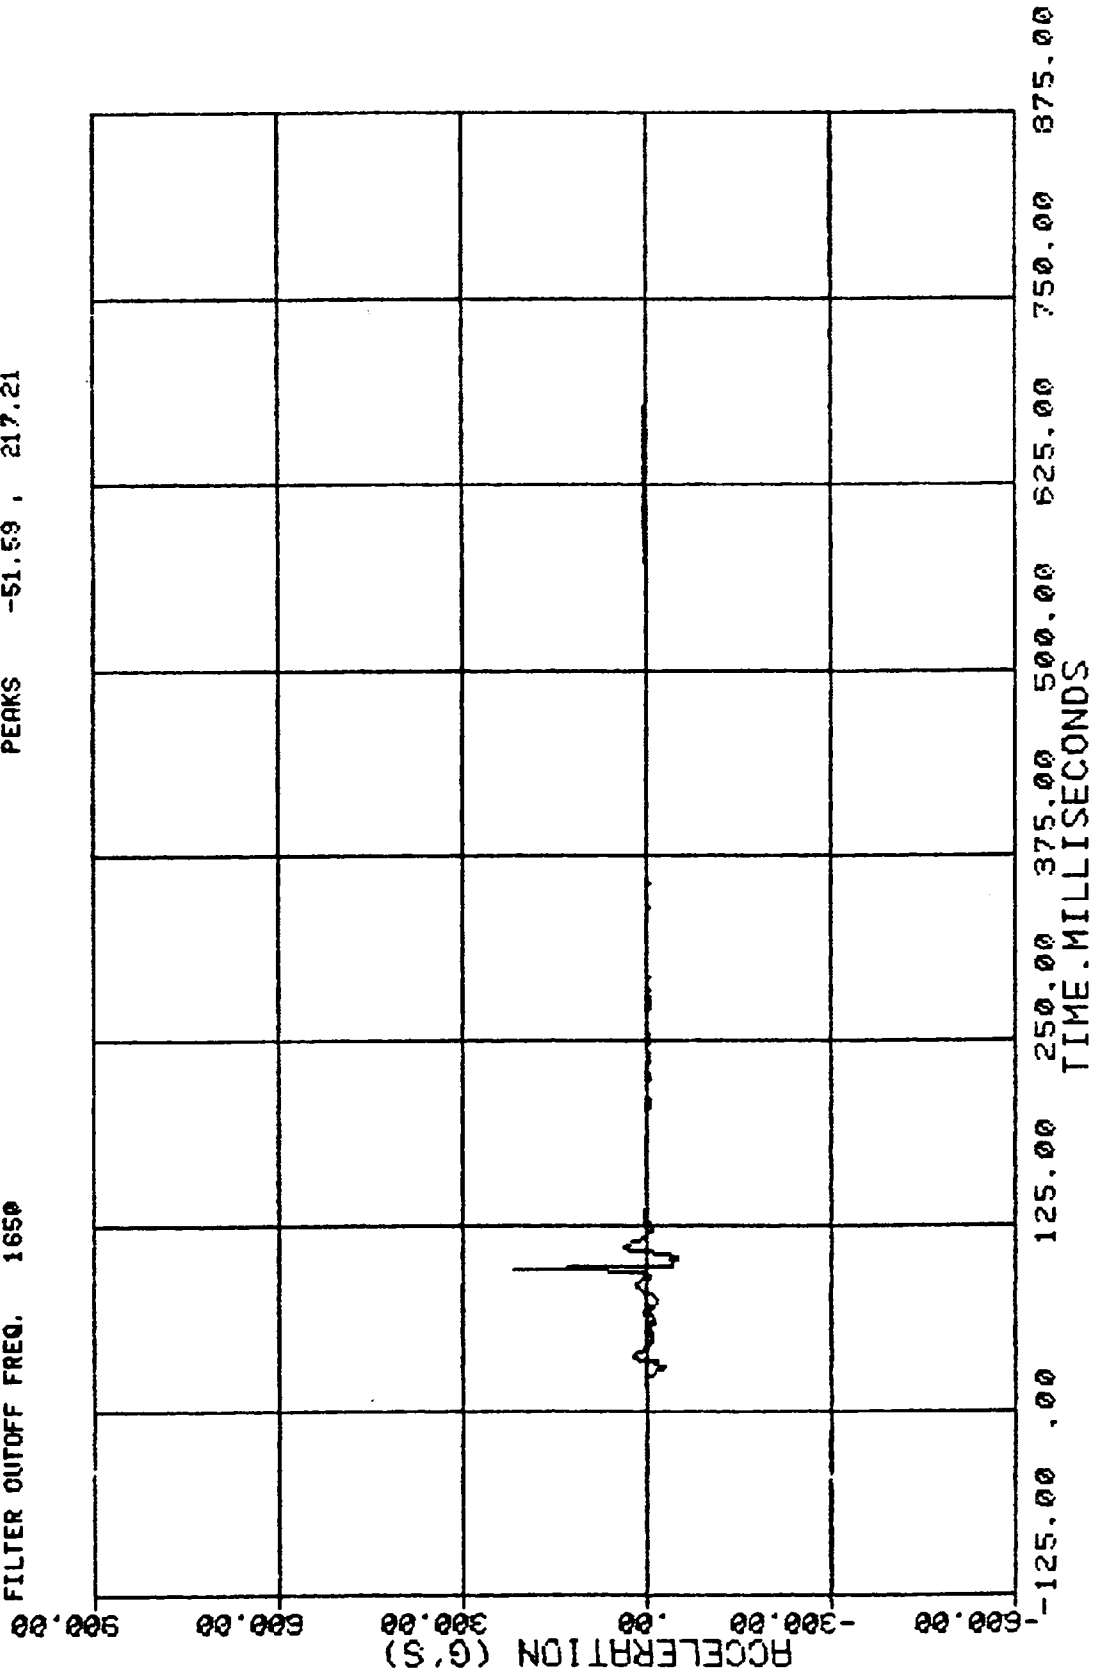
Figure 21. Driver's Head Acceleration, Z-Axis, 1650 Hz

ENS00, INO. CONTRACT NUMBER DTFFH61-81-0-00036 TEST NUM 1469-SI#6
 30 MEH BROADSIDE IMPACT OF 79 DODGE COLT INTO LUMINAIRE SUPPORT
 CHANNEL 27 DRIVER HEAD ACCELERATION, Z-AXIS
 FILTER CUTOFF FREQ. 1650 PEAKS -51.59 , 217.21

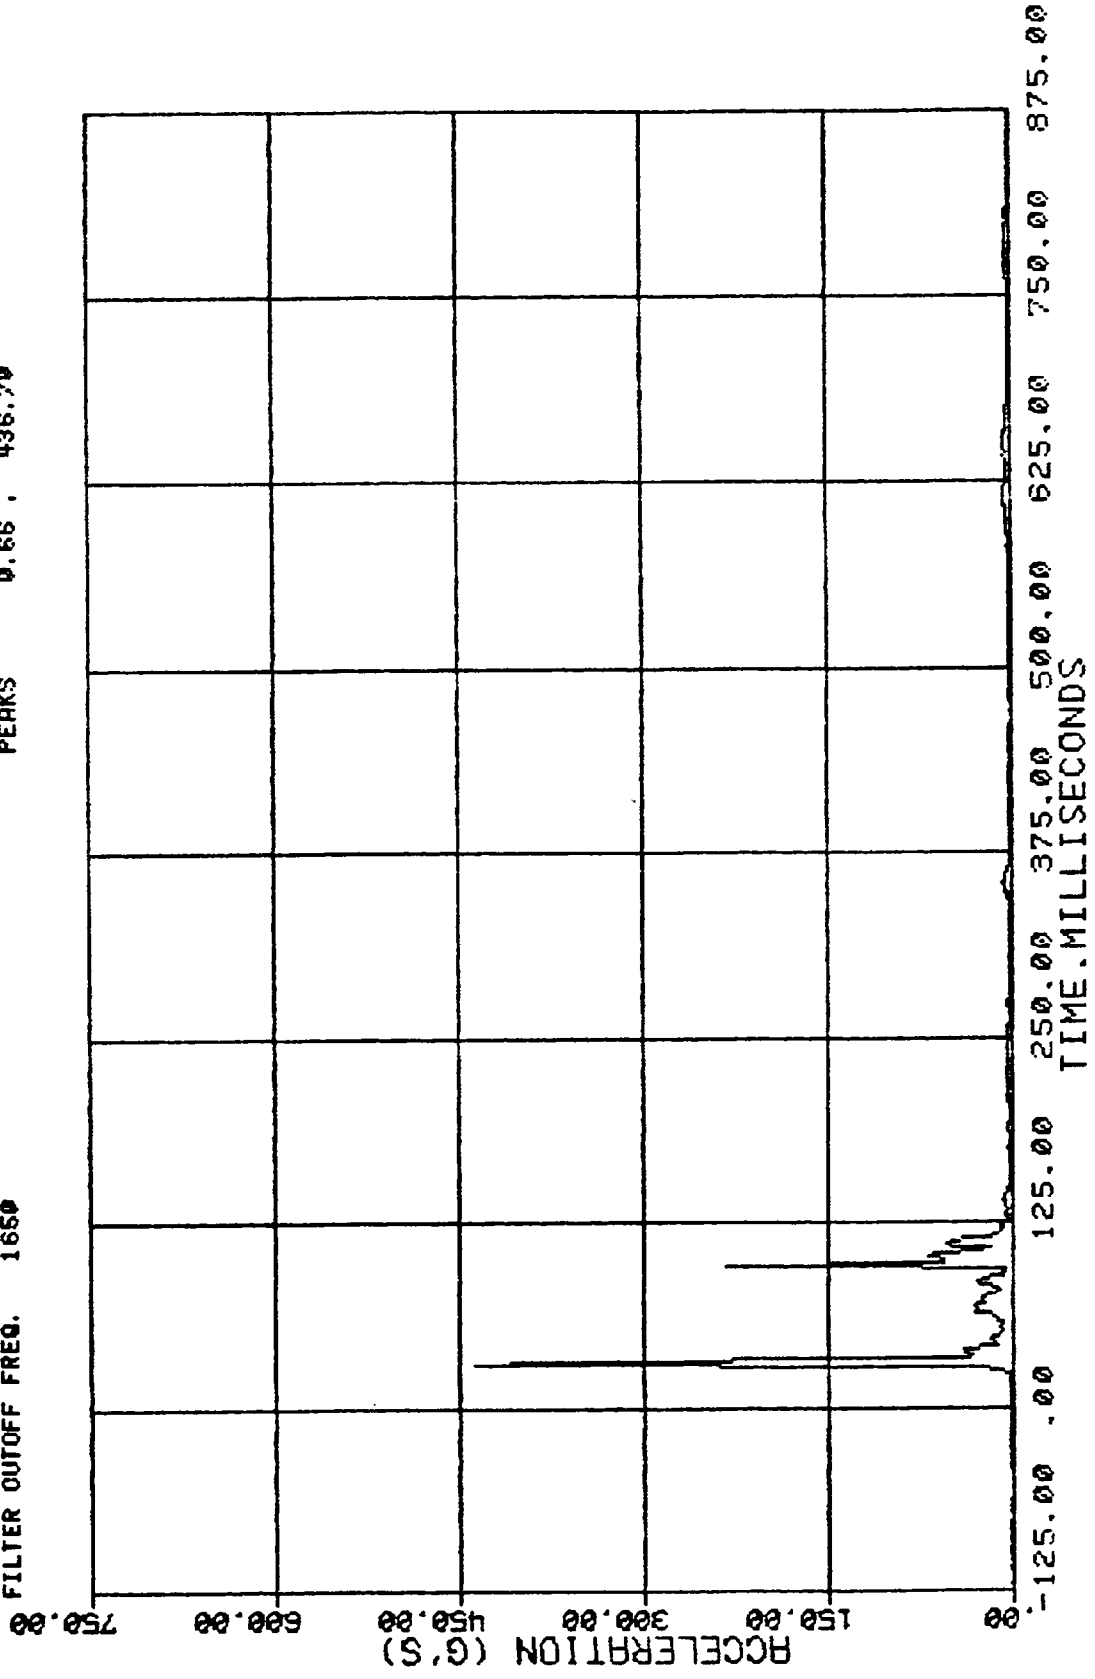
Figure 22. Driver's Head Acceleration, Resultant, 1650 Hz

ENSOO, INC. CONTRACT NUMBER DTFH61-81-0-00036 TEST NUM 1469-SI#6
 30 MPH BROADSIDE IMPACT OF 79 DODGE COLT INTO LUMINAIRE SUPPORT
 CHANNEL DRIVER HEAD ACCELERATION, RESULTANT PEAKS 0.66 436.70
 FILTER CUTOFF FREQ. 1650
