LABORATORY PROCEDURES TO DETERMINE THE
BREAKAWAY BEHAVIOR OF LUMINAIRE SUPPORTS
IN MINI-SIZED VEHICLE COLLISIONS

THIRTY MPH BROADSIDE
IMPACT OF A DODGE COLT
AND A BREAKAWAY LUMINAIRE SUPPORT

TEST RESULTS REPORT

TEST NUMBER 1469-SI#6-85

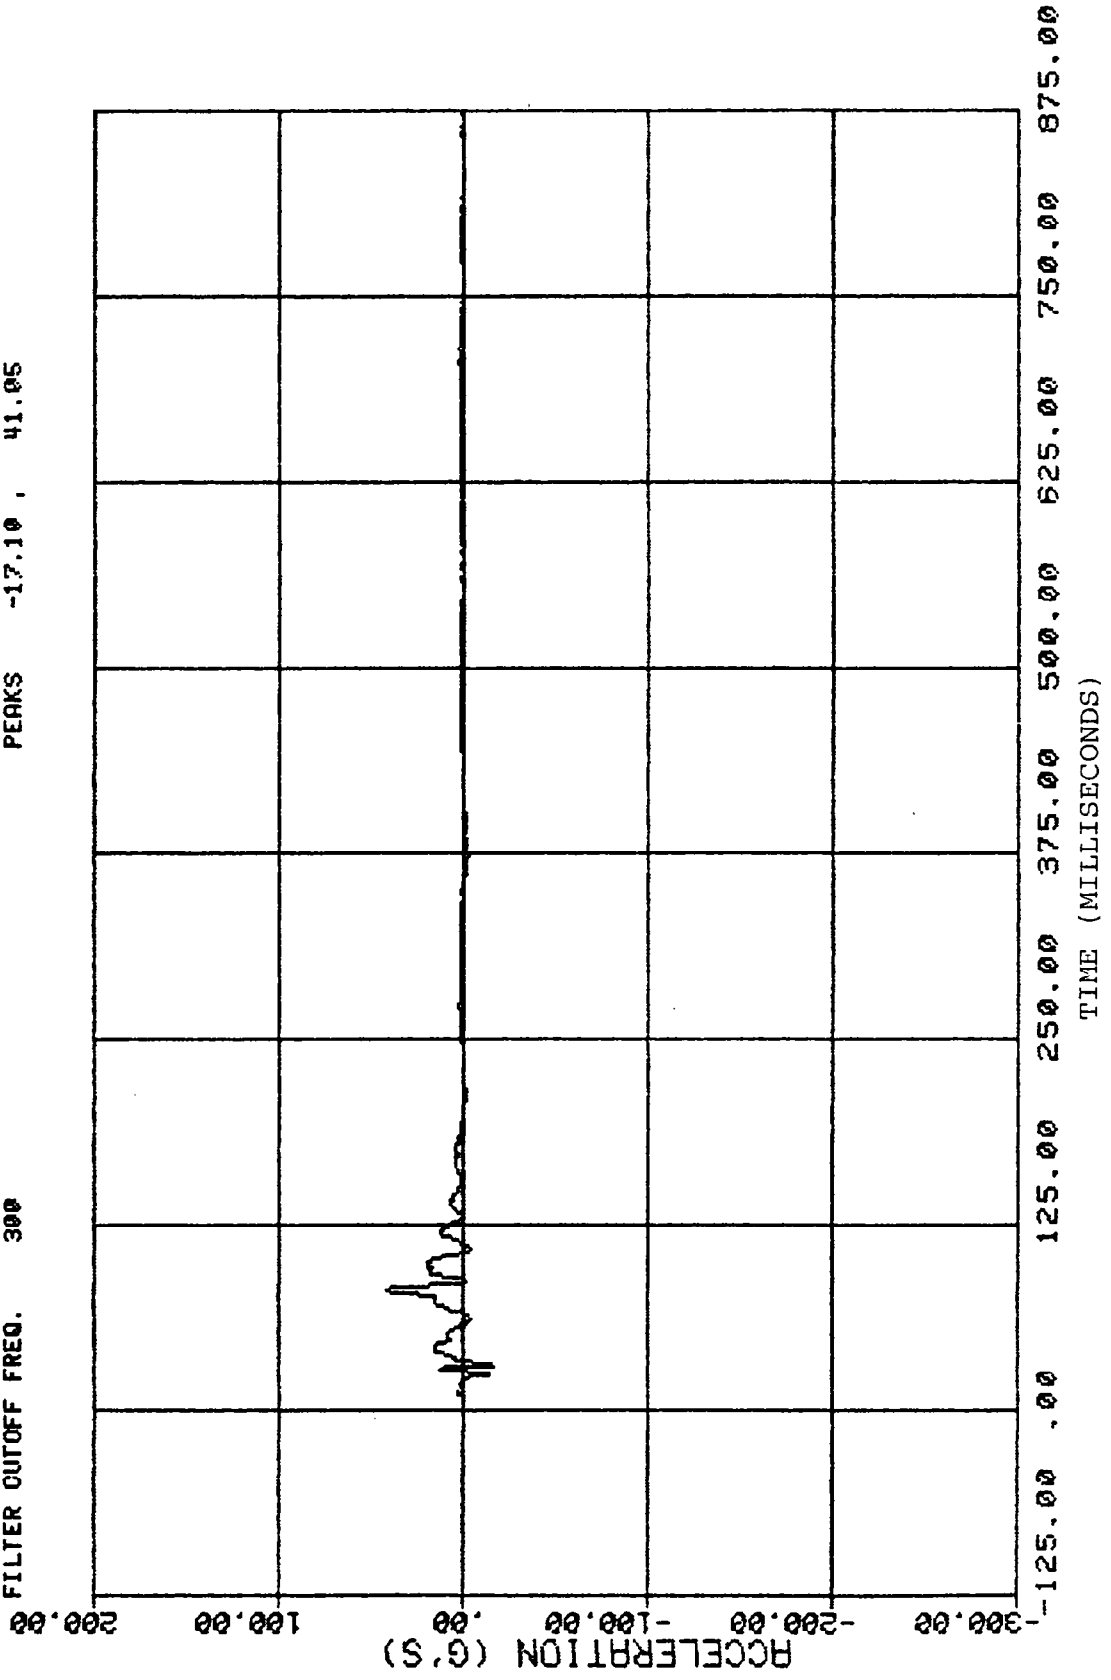
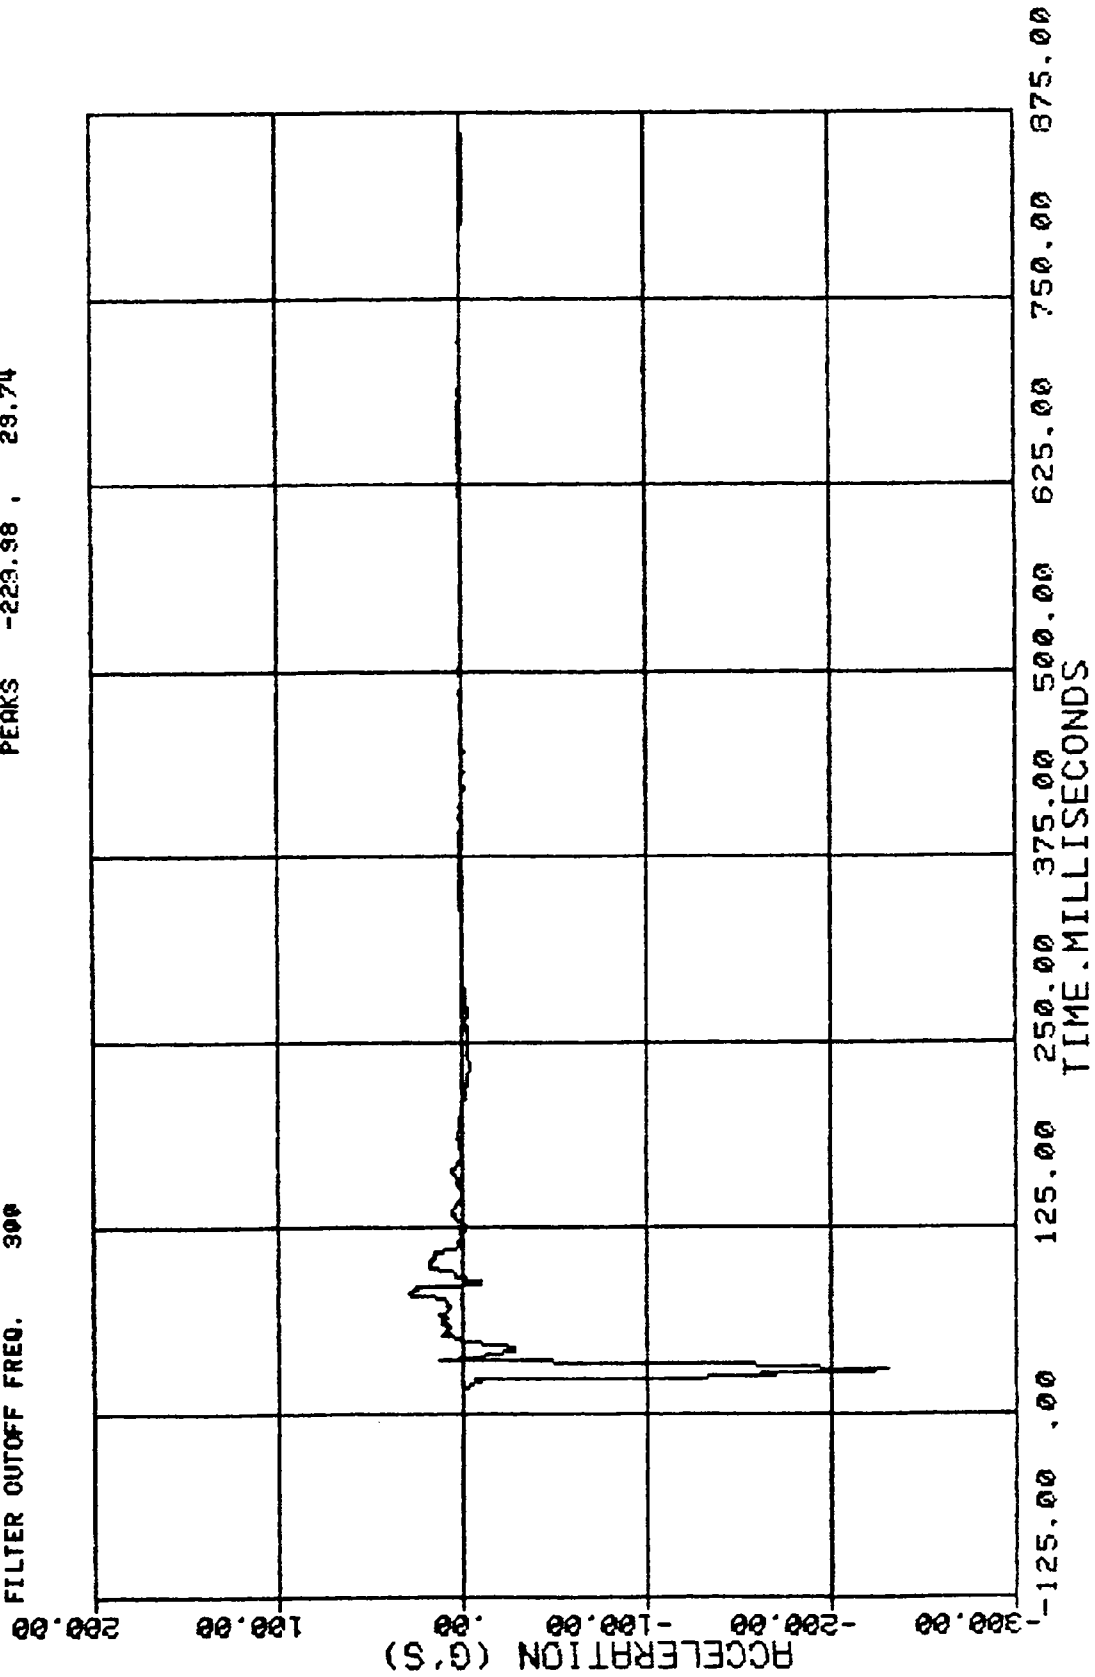
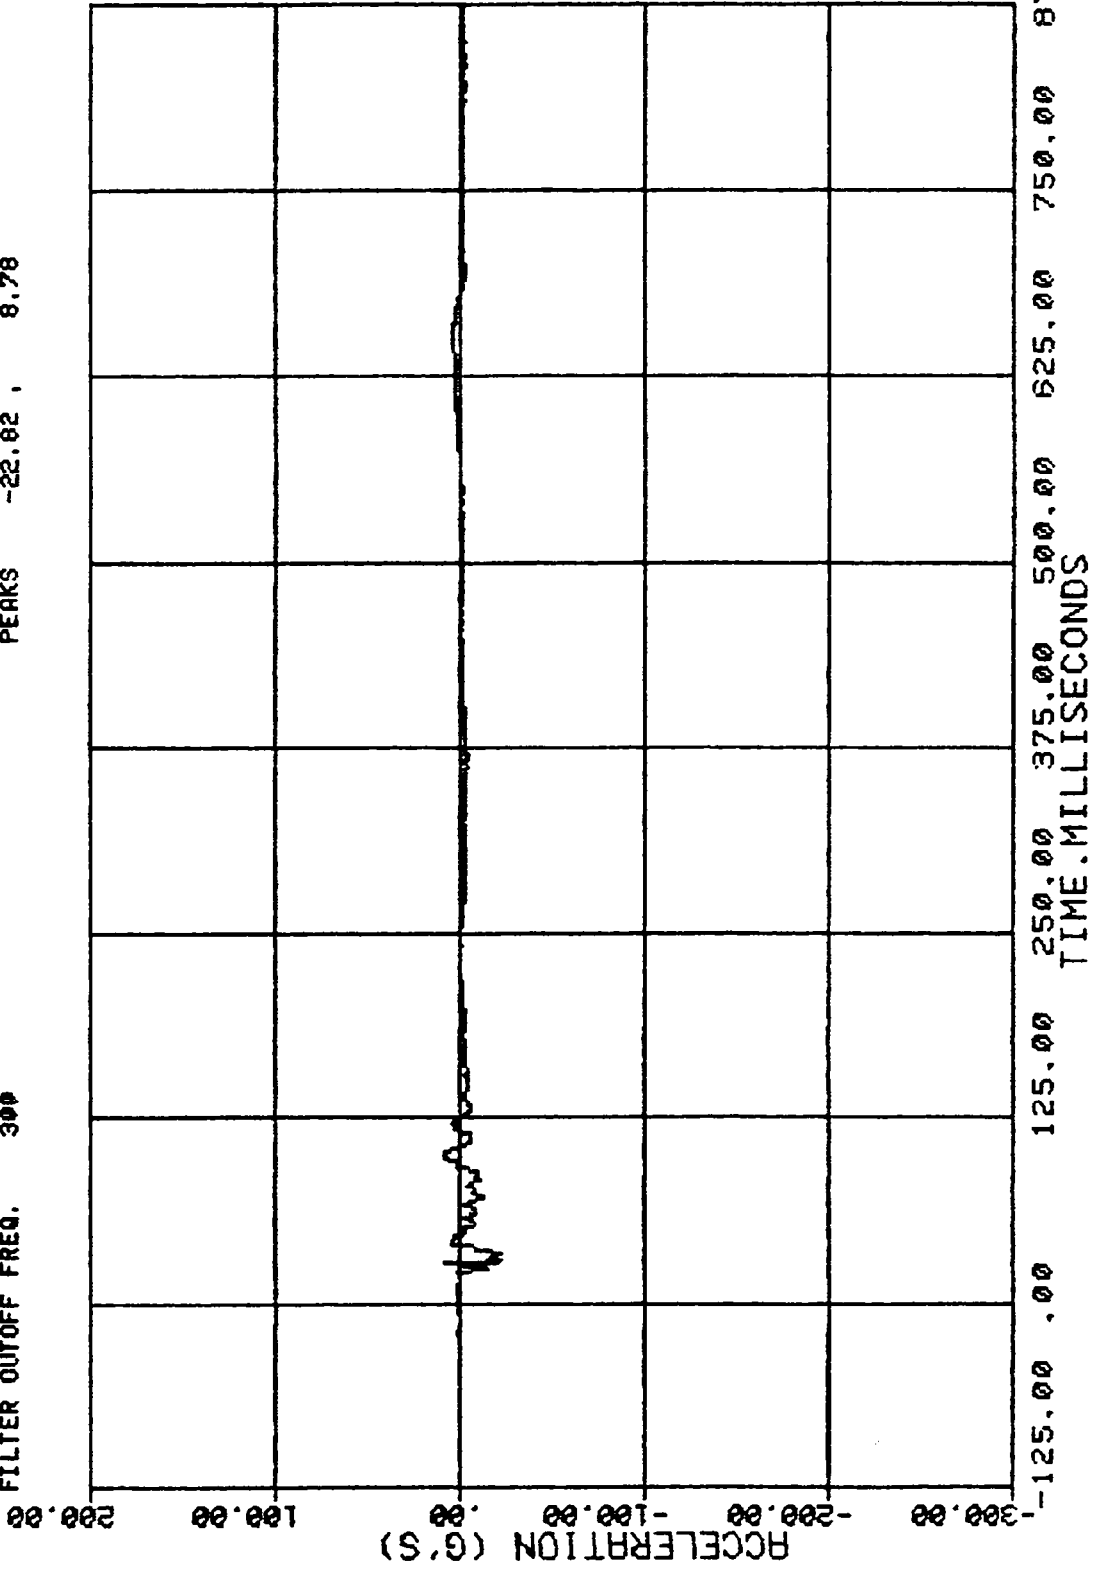
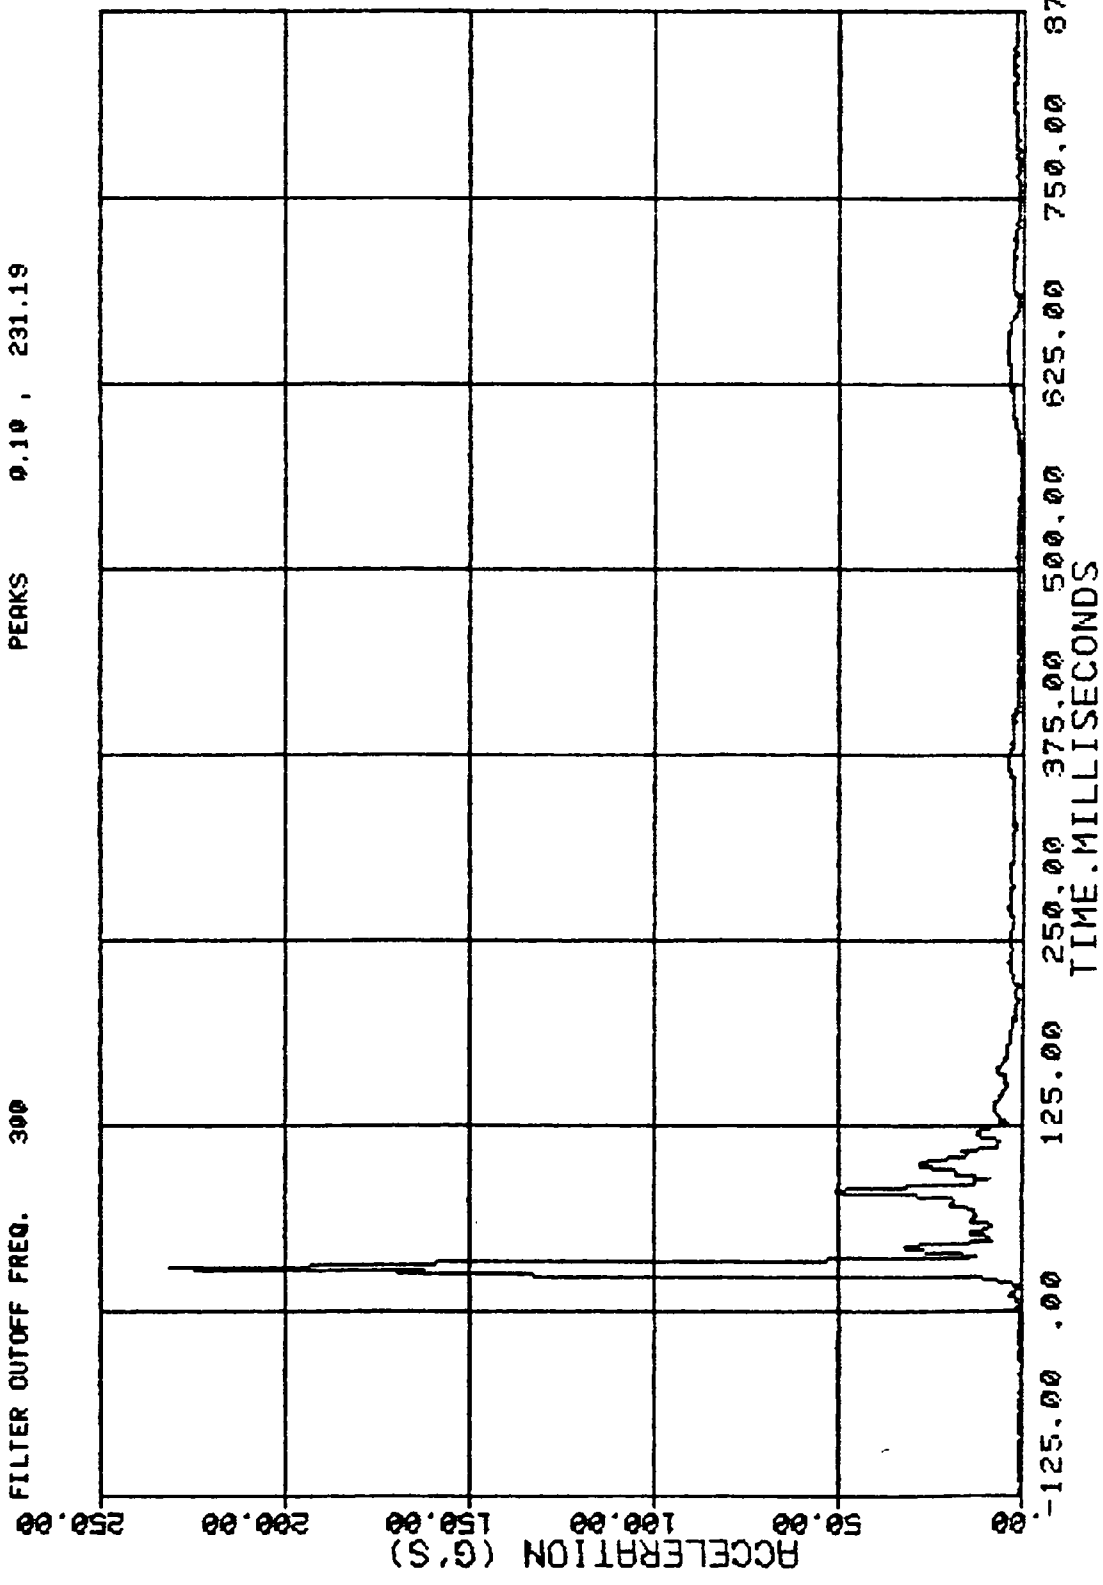
The acceleration traces and associated resultants obtained with the use of the SAE Class 180 ($f_c = 300$ Hz) filtering techniques are presented in figures 23 through 26 for the upper spine location, figures 27 through 30 for the lower spine location and figures 31 through 34 for the pelvis location. The lower spine z-axis accelerometer failed during the test and is not presented here. Also, the resultant for the lower spine is based on the x-axis by y-axis only.

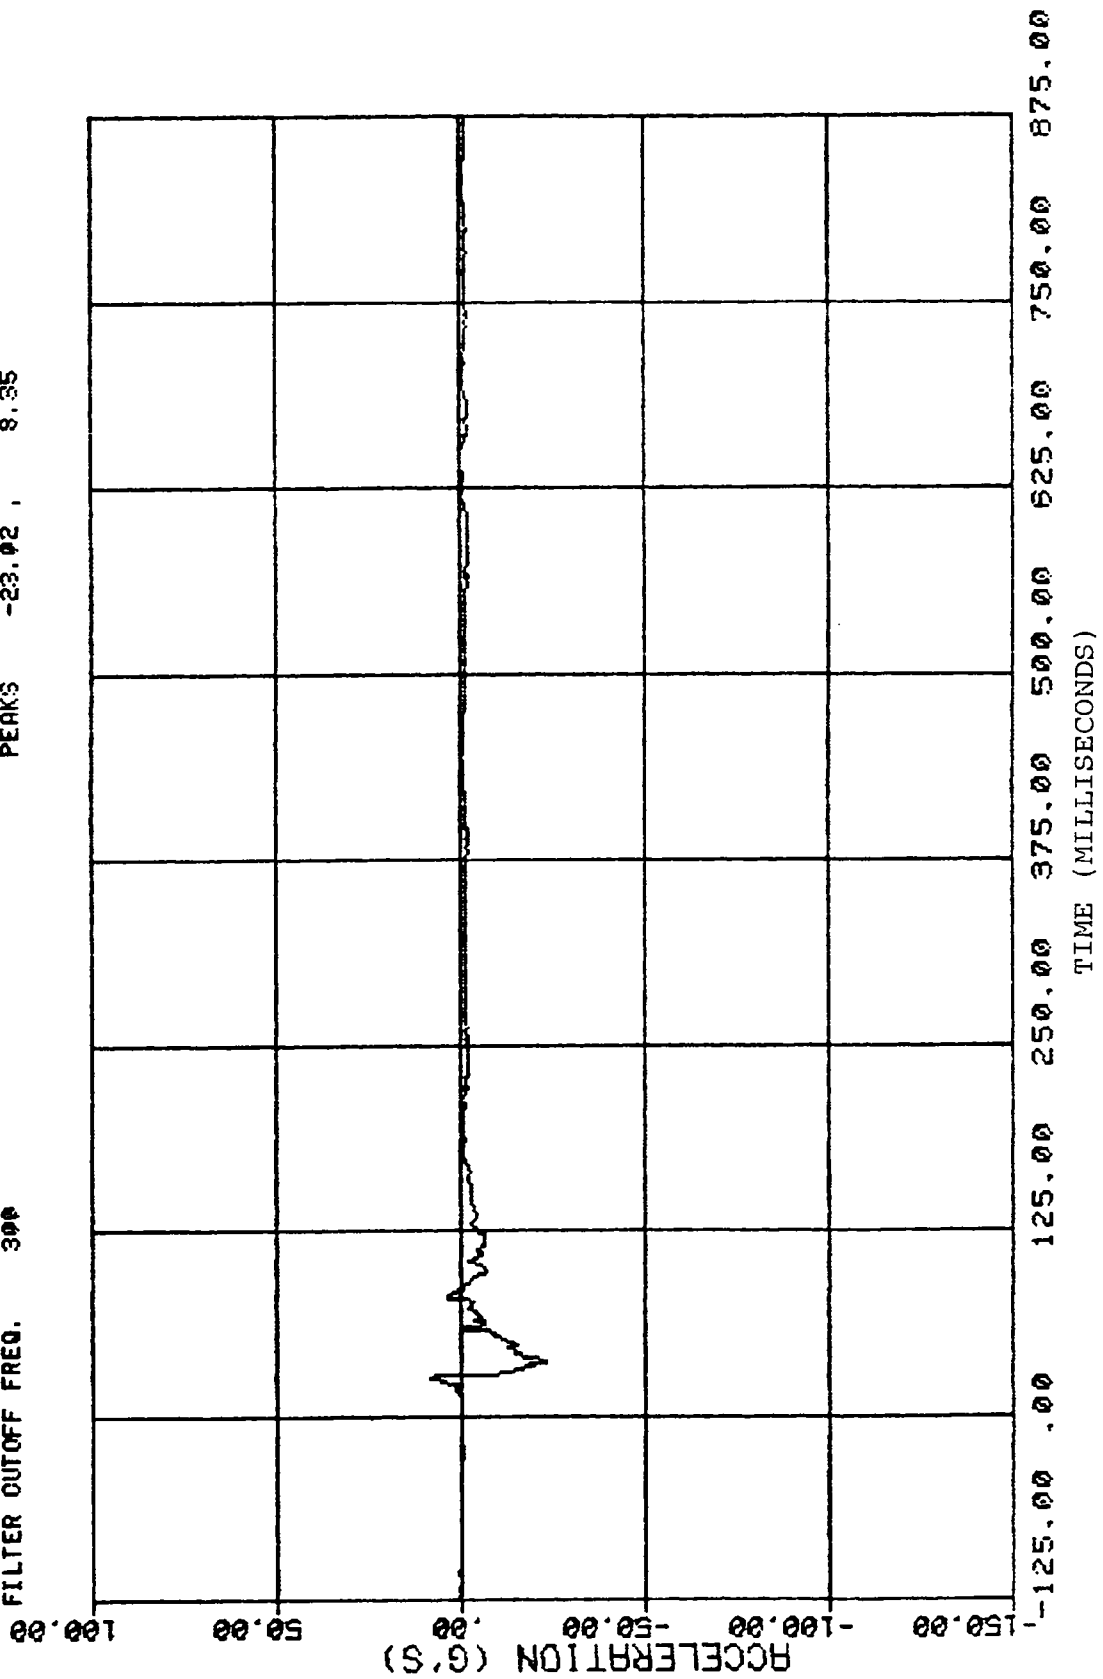
Figure 31. Driver's Pelvis Acceleration, X-Axis, 300 Hz

ENSCO, INC. CONTRACT NUMBER DTFH61-81-0-00036 TEST NUM#1469-SI#6
 30 MPH BROADSIDE IMPACT OF 79 DODGE COLT INTO LUMINAIRE SUPPORT
 CHANNEL 28 DRIVER PELVIC ACCELERATION, X-AXIS
 FILTER CUTOFF FREQ. 300 PEAKS -23.02 8.35

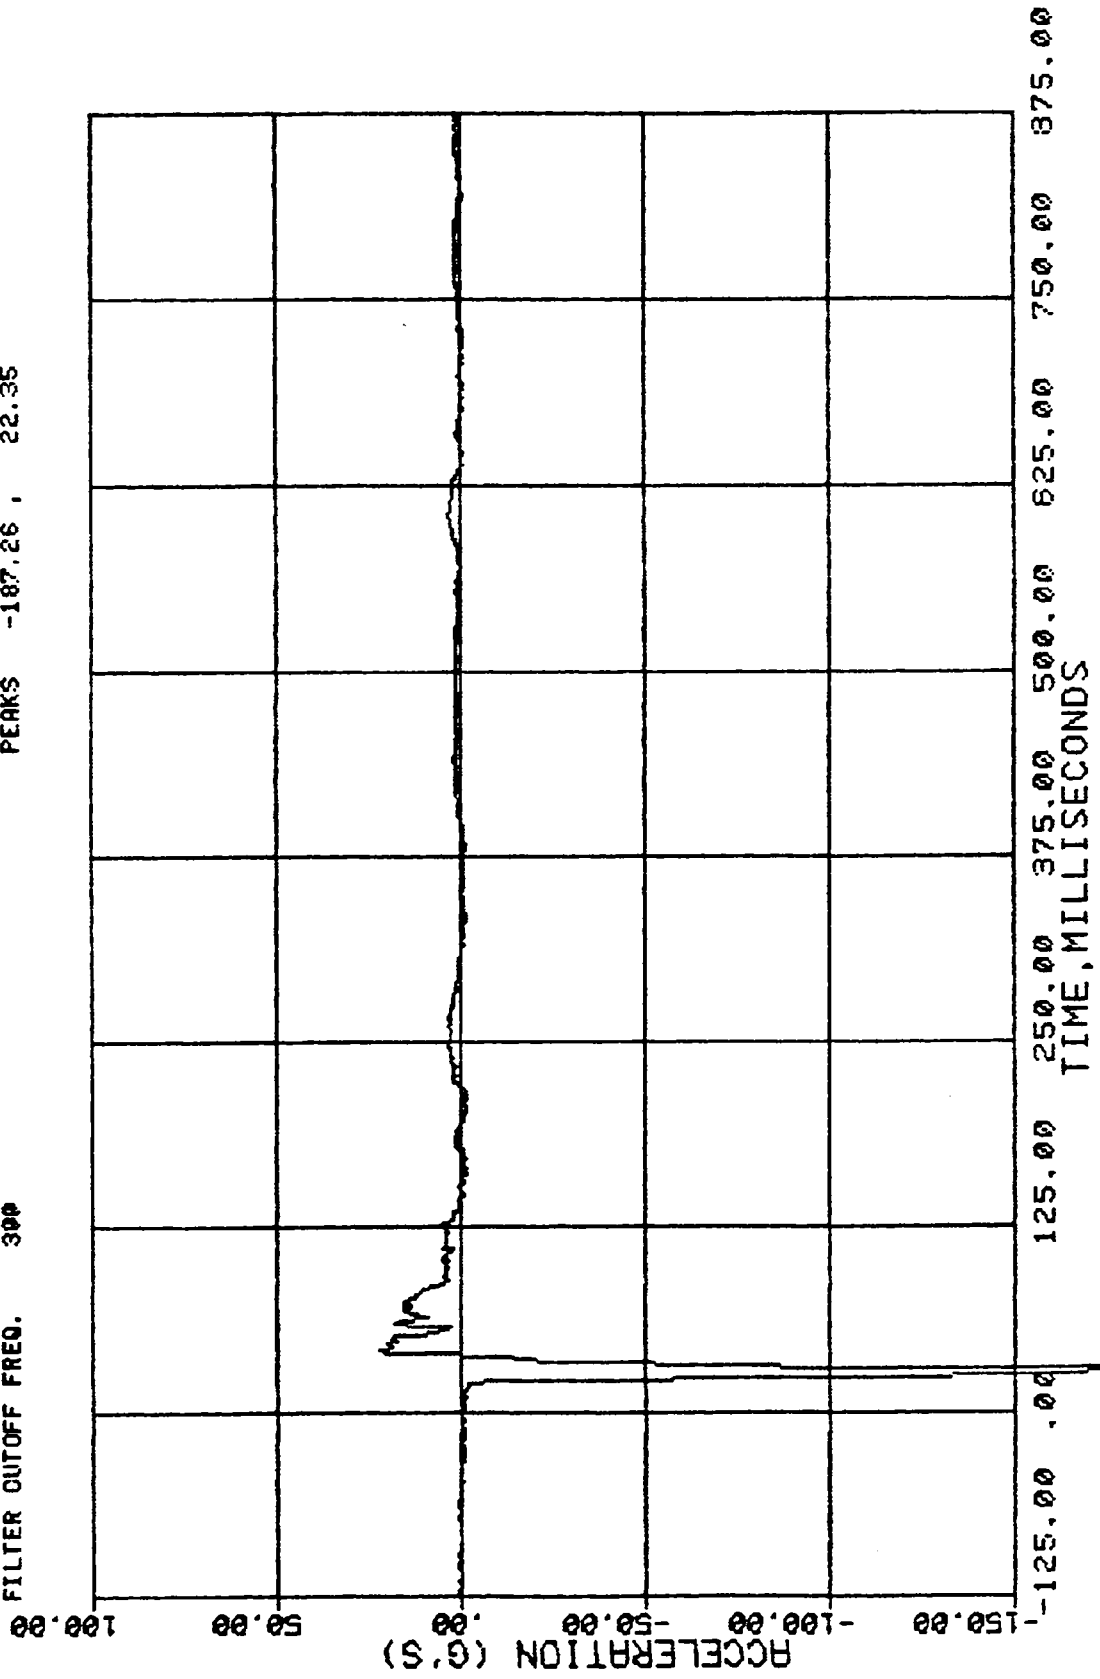
Figure 32. Driver's Pelvis Acceleration, Y-Axis, 300 Hz

ENSO, INC. CONTRACT NUMBER DTFH61-81-0-00036 TEST NUM#1469-SI*6
 30 MPH BROADSIDE IMPACT OF 79 DODGE COLT INTO LUMINAIRE SUPPORT
 CHANNEL 29 DRIVER PELVIO ACCELERATION, Y-AXIS
 FILTER CUTOFF FREQ. 300 PEAKS -107.26 , 22.35

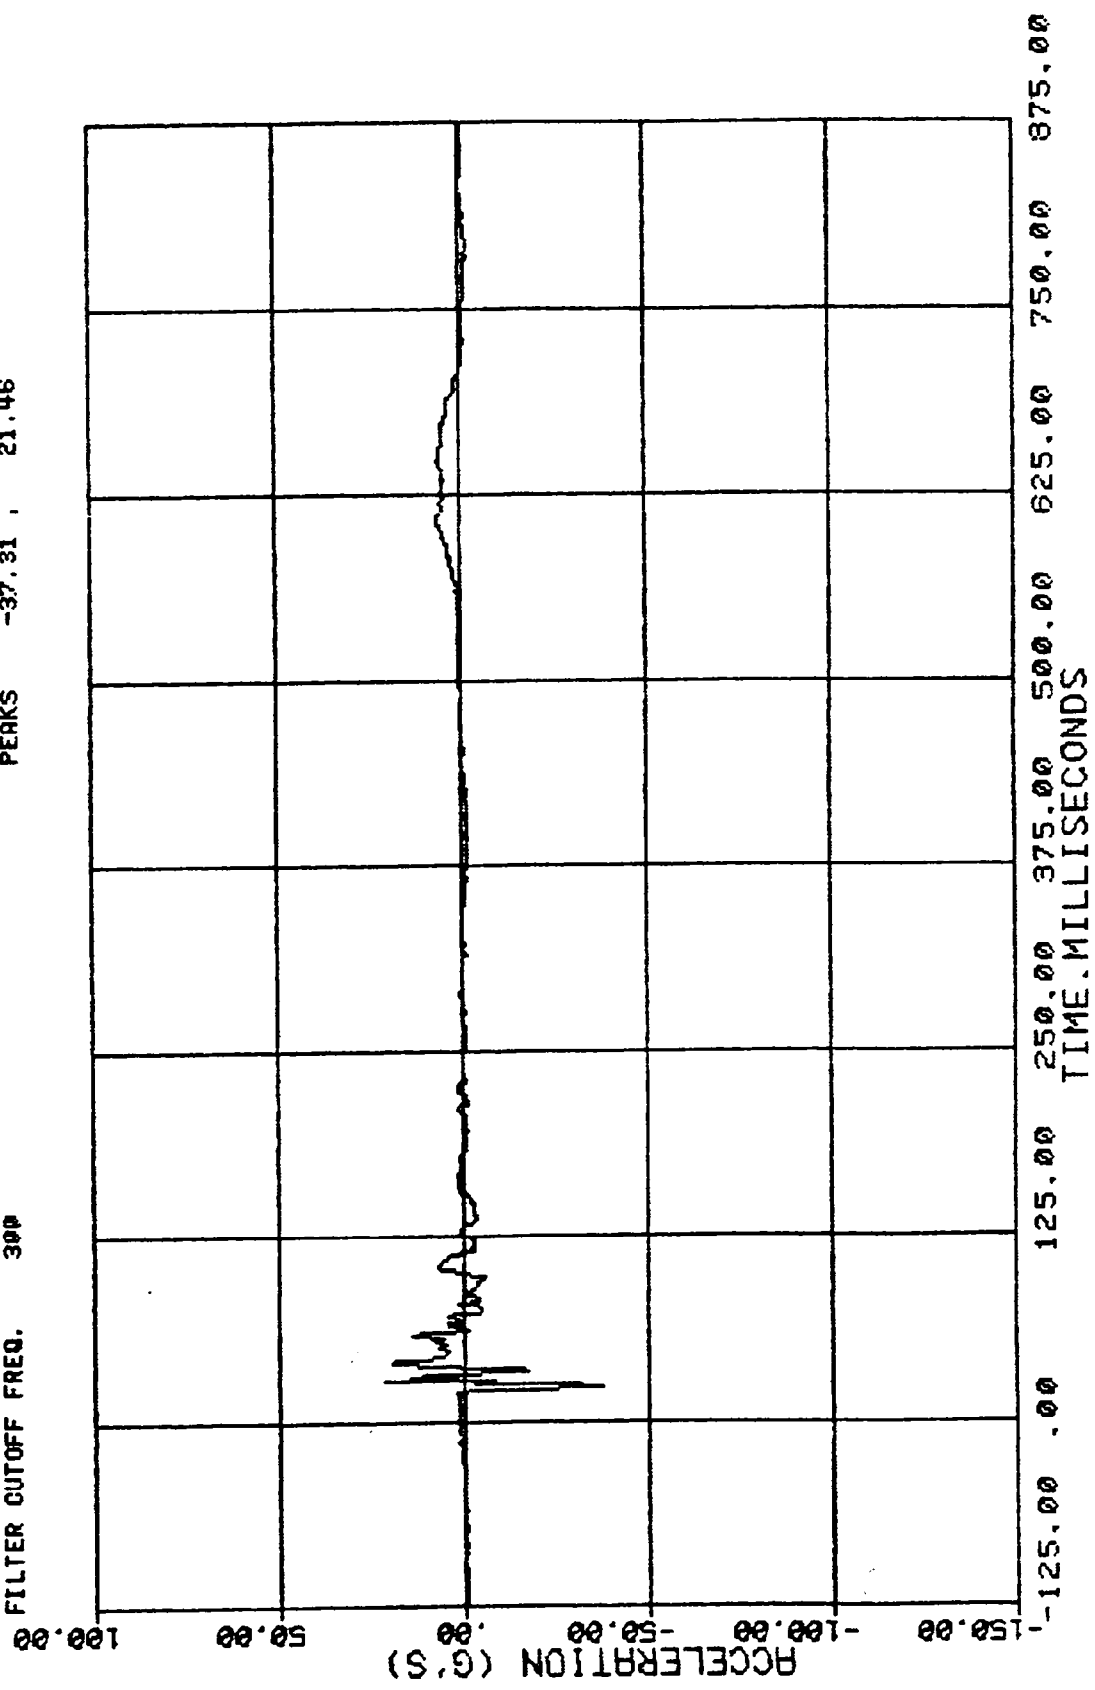
Figure 33. Driver's Pelvis Acceleration, Z-Axis, 300 Hz

ENSCO, INC. CONTRACT NUMBER DTFH61-81-D-00036 TEST NUM#1469-SI#6
 30 MPH BROADSIDE IMPACT OF 79 DODGE COLT INTO LUMINAIRE SUPPORT
 CHANNEL 30 DRIVER PELVIO ACCELERATION, Z-AXIS PEAKS -37.31 21.46
 FILTER CUTOFF FREQ. 300

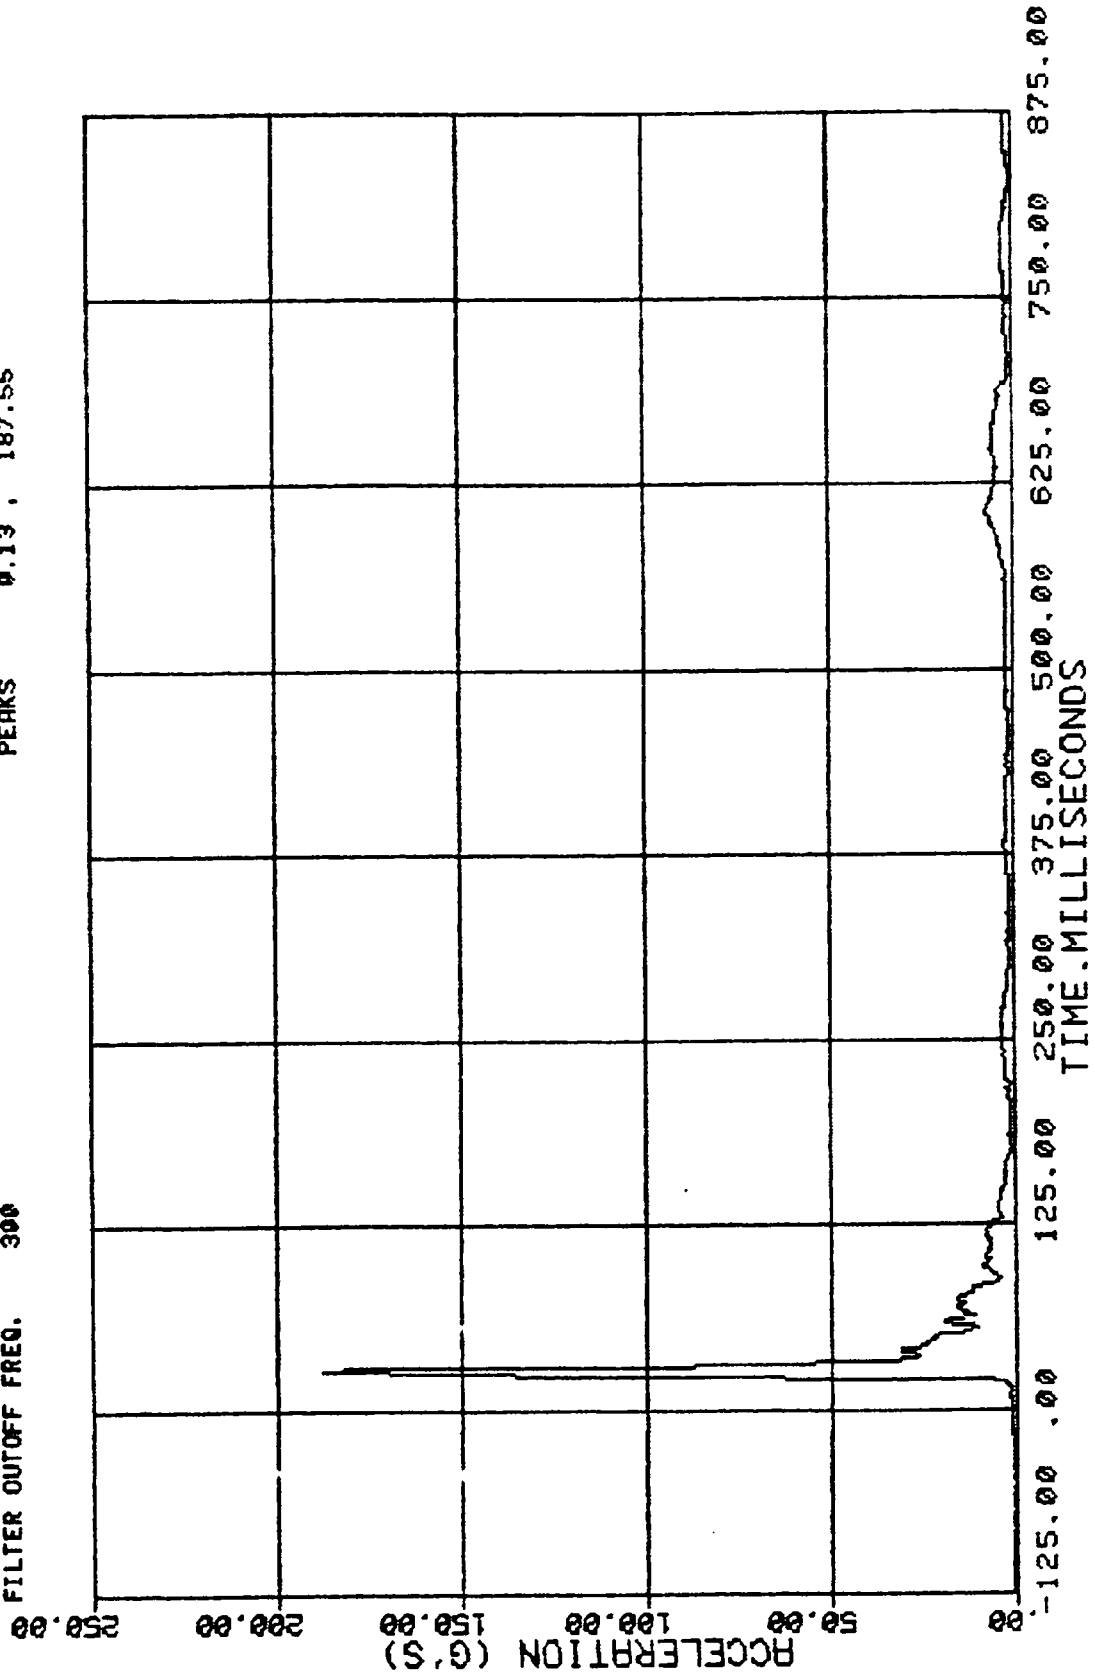
Figure 34. Driver's Pelvis Acceleration, Resultant, 300 Hz

ENSCO, INC. CONTRACT NUMBER DTFHS1-81-C-00036 TEST NUM#1463-SI#6
 30 MPH BROADSIDE IMPACT OF 79 DODGE COLT INTO LUMINAIRE SUPPORT
 CHANNEL # DRIVER PELVIO ACCELERATION, RESULTANT PEAKS 0.13 , 187.55
 FILTER OFF FREQ. 300

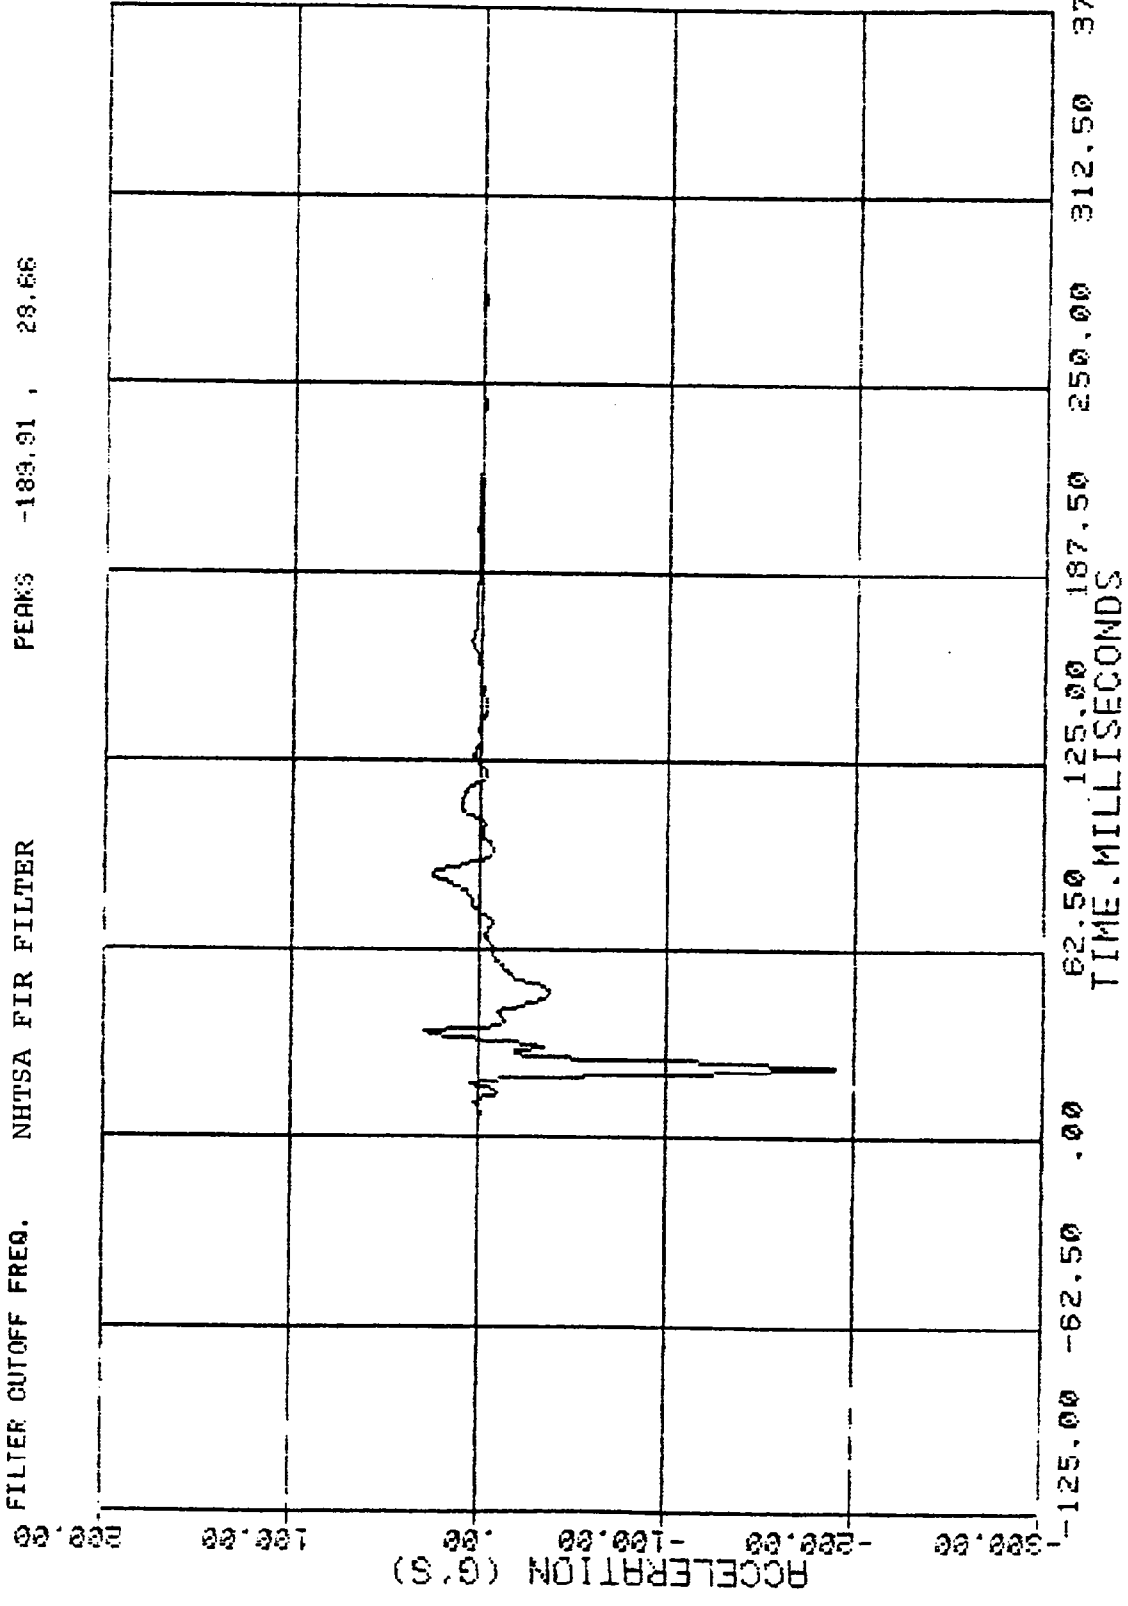
Figure 35. Driver's Left Upper Rib Acceleration, LURY, NHTSA FIR Filter

ENSO, INC. CONTRACT NUMBER DTFH61-83-C-00140 TEST NUM1489-SI*6-85
 30 MPH BROADSIDE IMPACT OF A DODGE COLT AND A BREAKAWAY LUMINAIRE SUPPORT
 CHANNEL 24 DRIVER THORAX-LURY
 FILTER CUTOFF FREQ. NHTSA FIR FILTER PEAKS -189.91 , 28.66

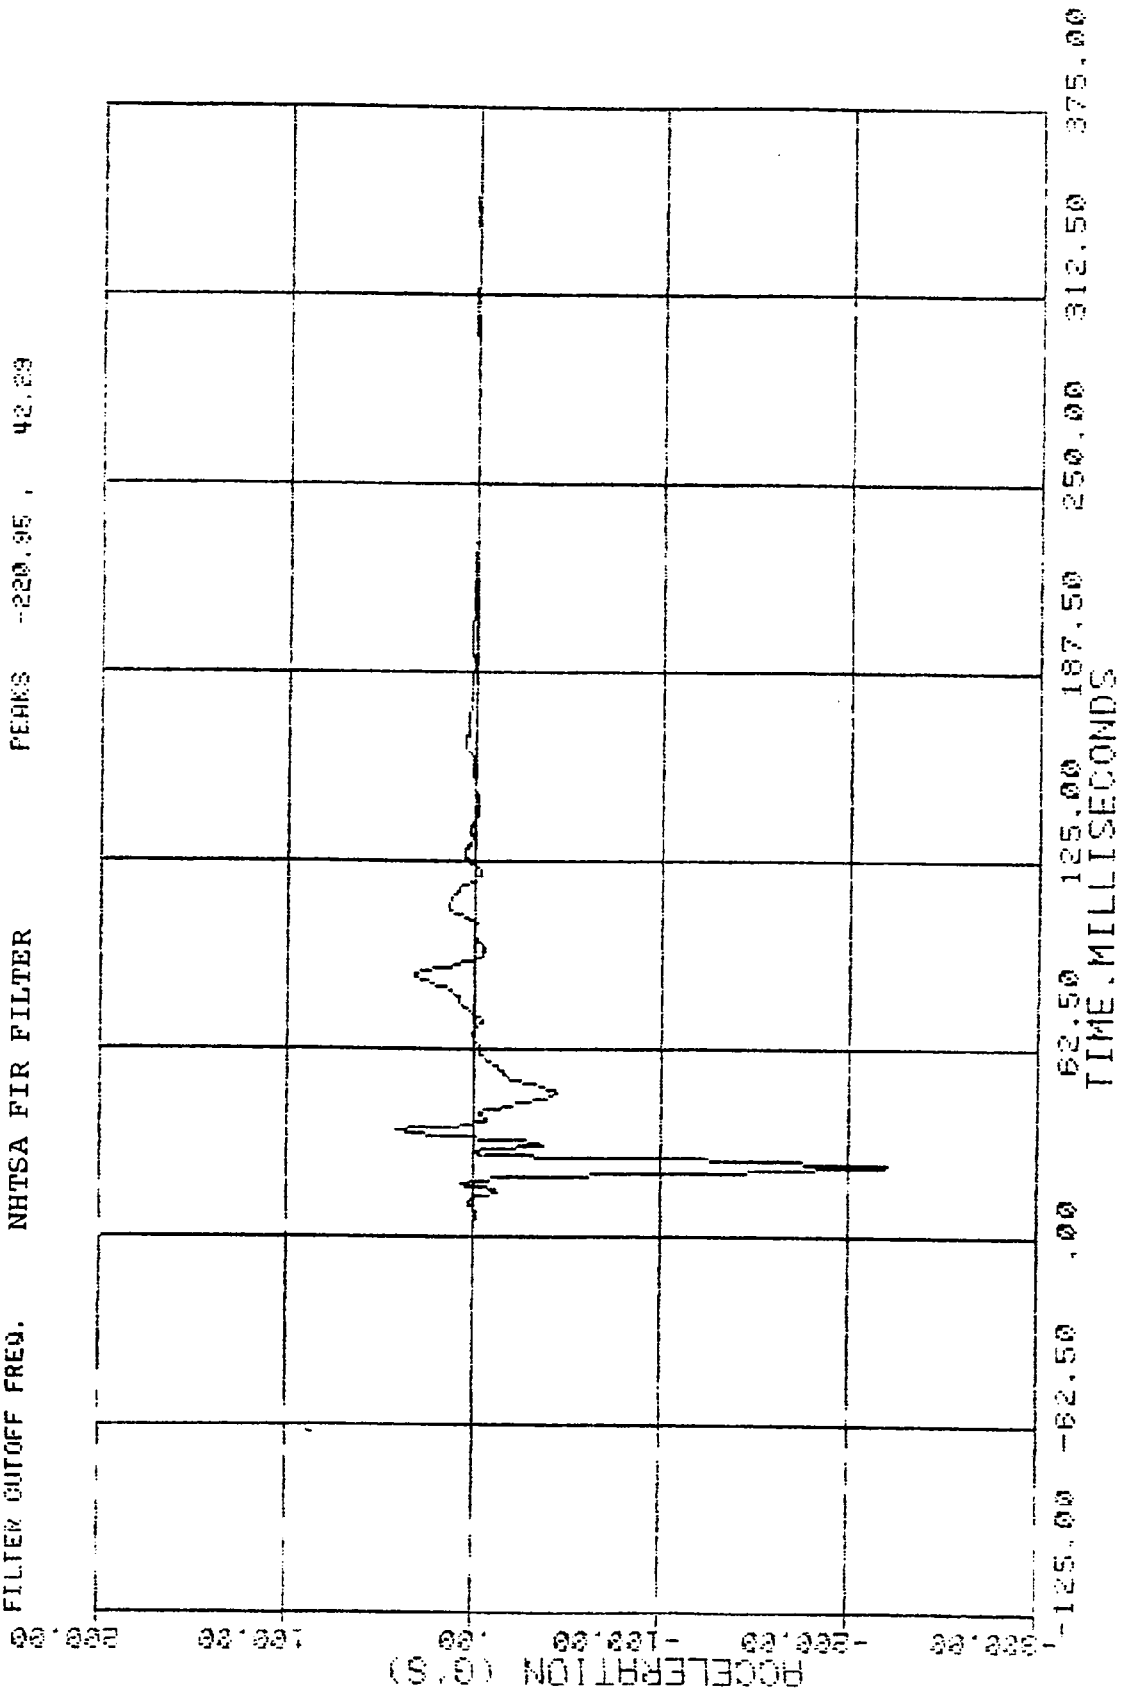
Figure 36. Driver's Left Upper Rib Acceleration, LURYA, NHTSA FIR Filter

ENSCO, INC. CONTRACT NUMBER DTFH61-83-0-00148 TEST NUM1489-SI-6-85
 30 MPH BROADSIDE IMPACT OF A DODGE COLT AND A BREAKAWAY LUMINAIRE SUPPORT
 CHANNEL 23 DRIVER THORAK-LURYA
 FILTER CUTOFF FREQ. NHTSA FIR FILTER PEAKS -220.95 42.29

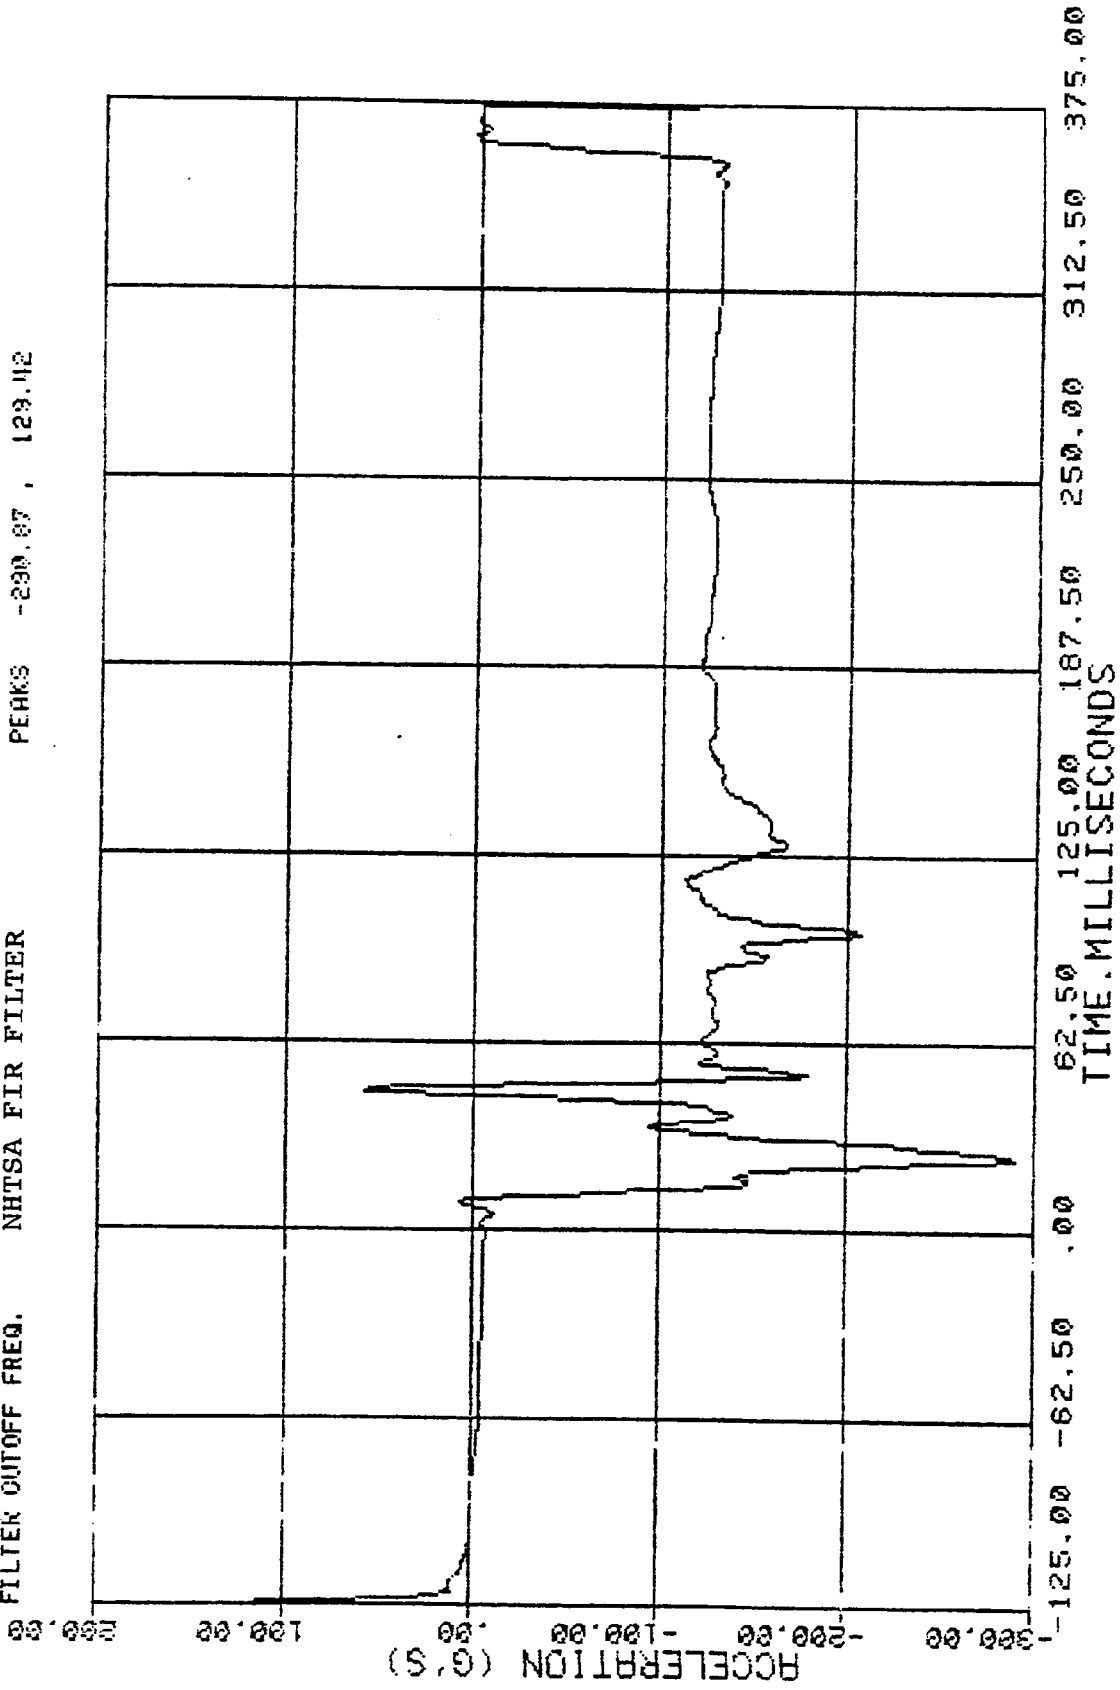
Figure 37. Driver's Left Upper Rib Acceleration, LLRY, NHTSA FIR Filter

ENSDD, INC. CONTRACT NUMBER DTFHS1-83-D-00140 TEST NUM1469-SI#6-85
 30 MPH BROADSIDE IMPACT OF A DODGE COLT AND A BREAKAWAY LUMINAIRE SUPPORT
 CHANNEL 6 DRIVER THORAX-LLRY
 FILTER CUTOFF FREQ. NHTSA FIR FILTER PEAKS -200.87 , 129.112

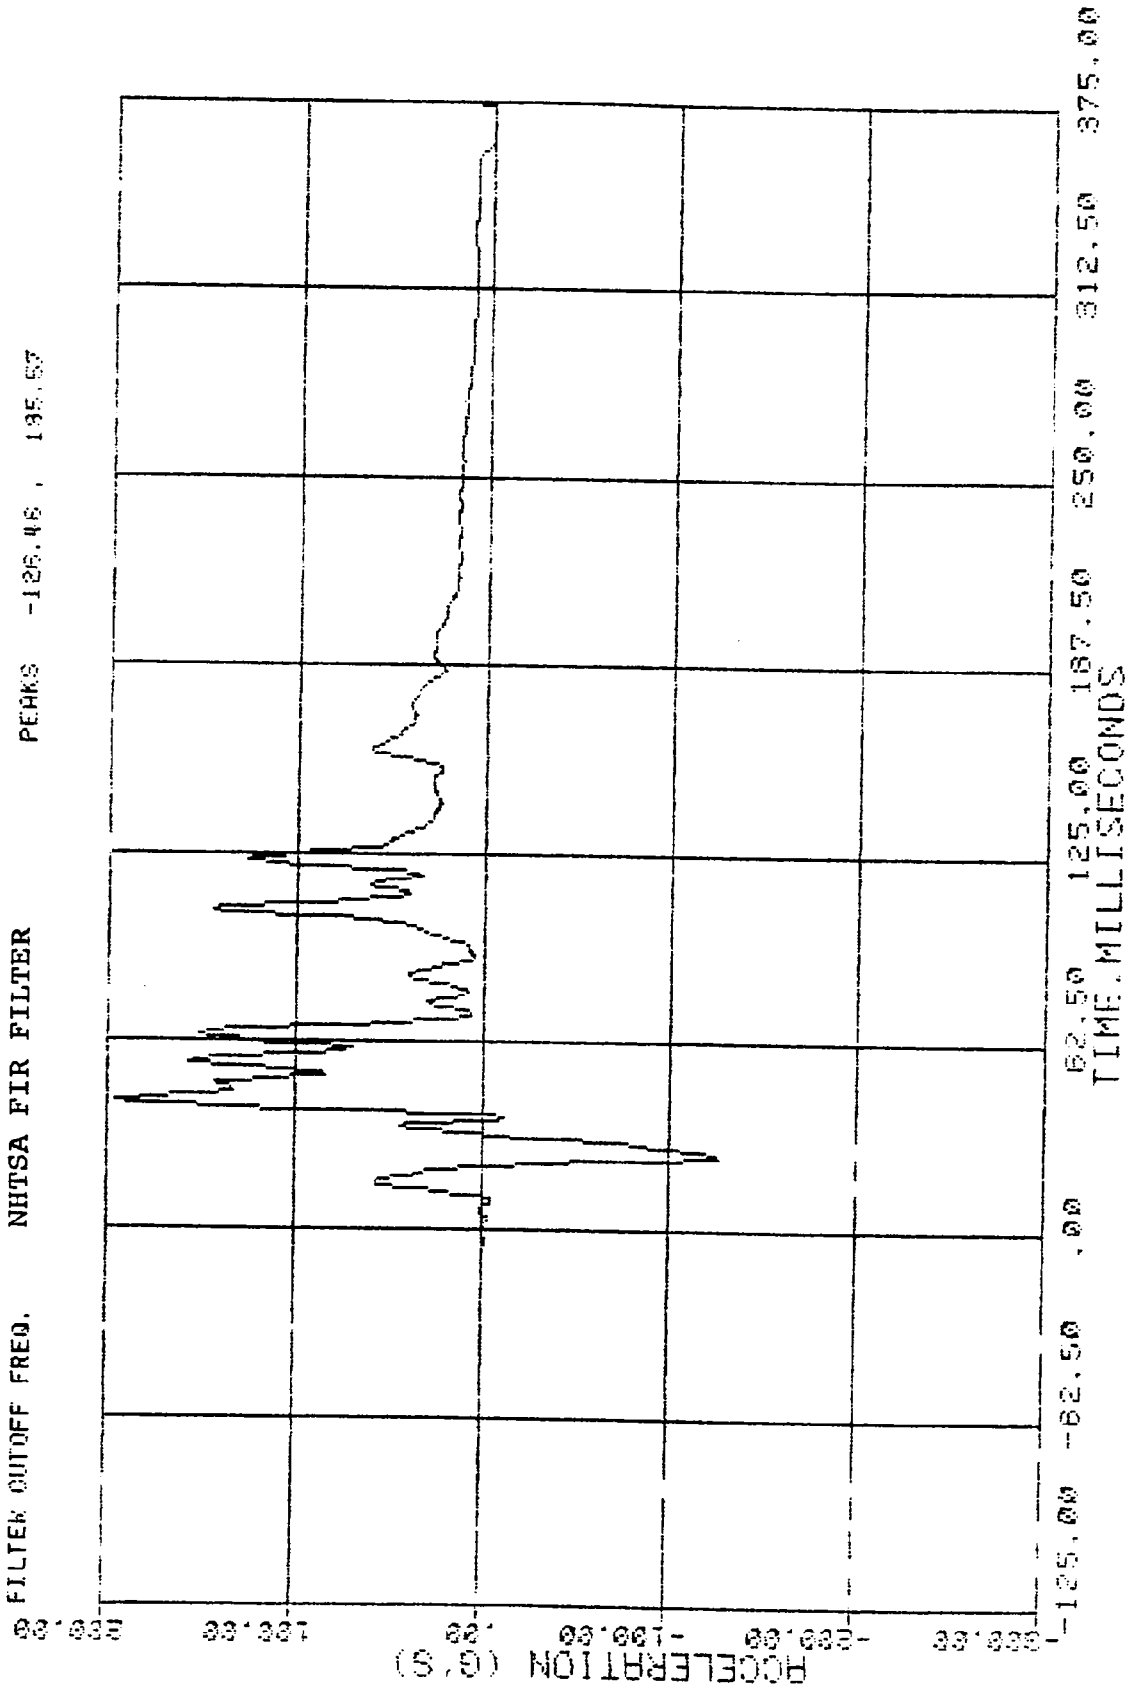
Figure 38. Driver's Left Upper Rib Acceleration, LLRYA, NHTSA FIR Filter

ENSCO, INC. CONTRACT NUMBER DTFH61-83-C-00140 TEST NUMBER SI-85-85
 30 MPH BROADSIDE IMPACT OF A DODGE COLT AND A BREAKAWAY LUMINAIRE SUPPORT
 CHANNEL 5 DRIVER THORAX-LLRYA
 FILTER CUTOFF FREQ. NHTSA FIR FILTER PEAKS -126.46 , 135.57
