LABORATORY PROCEDURES TO DETERMINE THE
BREAKAWAY BEHAVIOR OF LUMINAIRE SUPPORTS
IN MINI-SIZED VEHICLE COLLISIONS

THIRTY MPH BROADSIDE
IMPACT OF A DODGE COLT
AND A BREAKAWAY LUMINAIRE SUPPORT

TEST RESULTS REPORT

TEST NUMBER 1469-SI#6-85

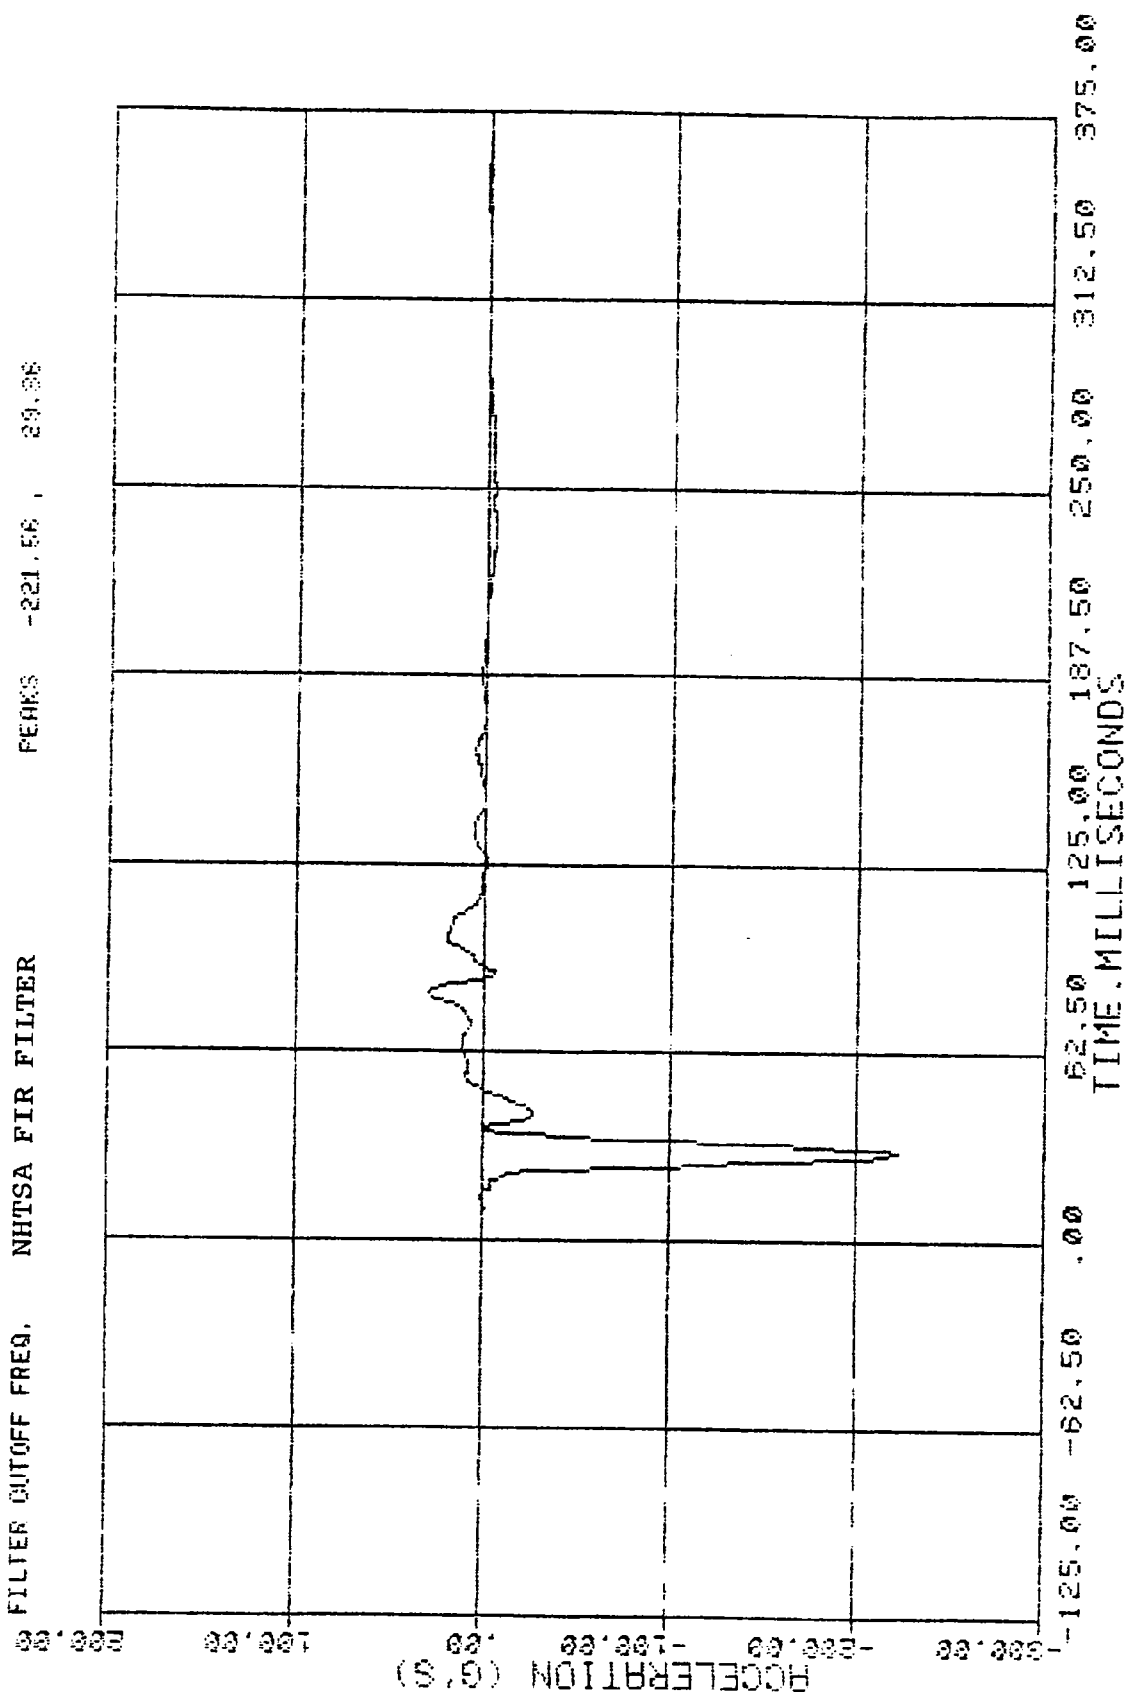
Figure 39. Driver's Upper Spine Acceleration, T01Y, NHTSA FIR Filter

ENSO, INC. CONTRACT NUMBER DTFR1-83-0-00140 TEST NUM1469-SI*6-85
 30 MPH BROADSIDE IMPACT OF A DODGE CULT AND A BREAKAWAY LUMINAIRE SUPPORT
 CHANNEL 3 DRIVER THORAX-T01Y
 FILTER CUTOFF FREQ. NHTSA FIR FILTER PEAKS -221.56 29.36

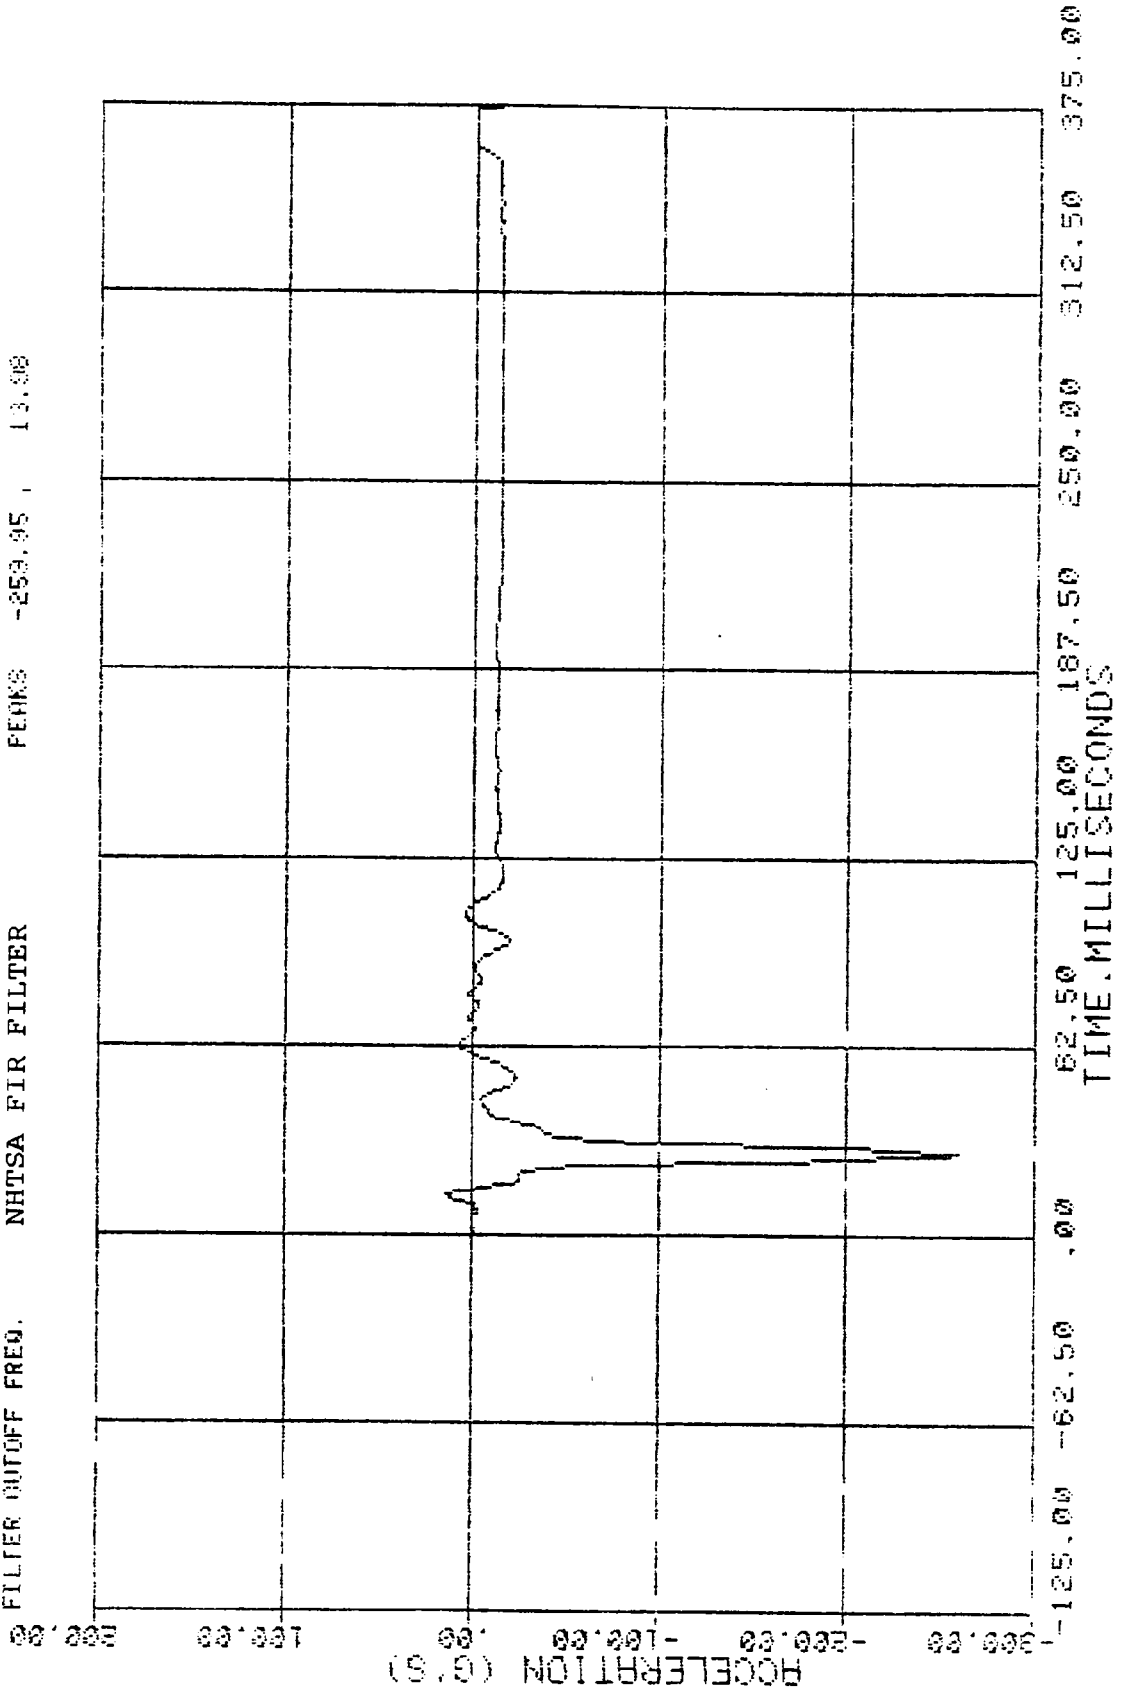
Figure 40. Driver's Lower Spine Acceleration, T12Y, NHTSA FIR Filter

ENSO, INC. CONTRACT NUMBER DTFA81-83-0-00140 TEST NUM 469-S1*6-85
 30 MPU BROADSIDE IMPACT OF A DODGE CULOT AND A BREAKAWAY LUMINOIRE SUPPORT
 CHANNEL 11 DRIVER THORAX-T12Y
 FILTER CUTOFF FREQ. NHTSA FIR FILTER PEAKS -259.95 13.98
