NEW CAR ASSESSMENT PROGRAM (NCAP)  
FRONTAL BARRIER IMPACT TEST

1986 MAZDA 323 LX

NHTSA NO. MG5401  
CALSPAN TEST NO. 7457-3

FINAL REPORT

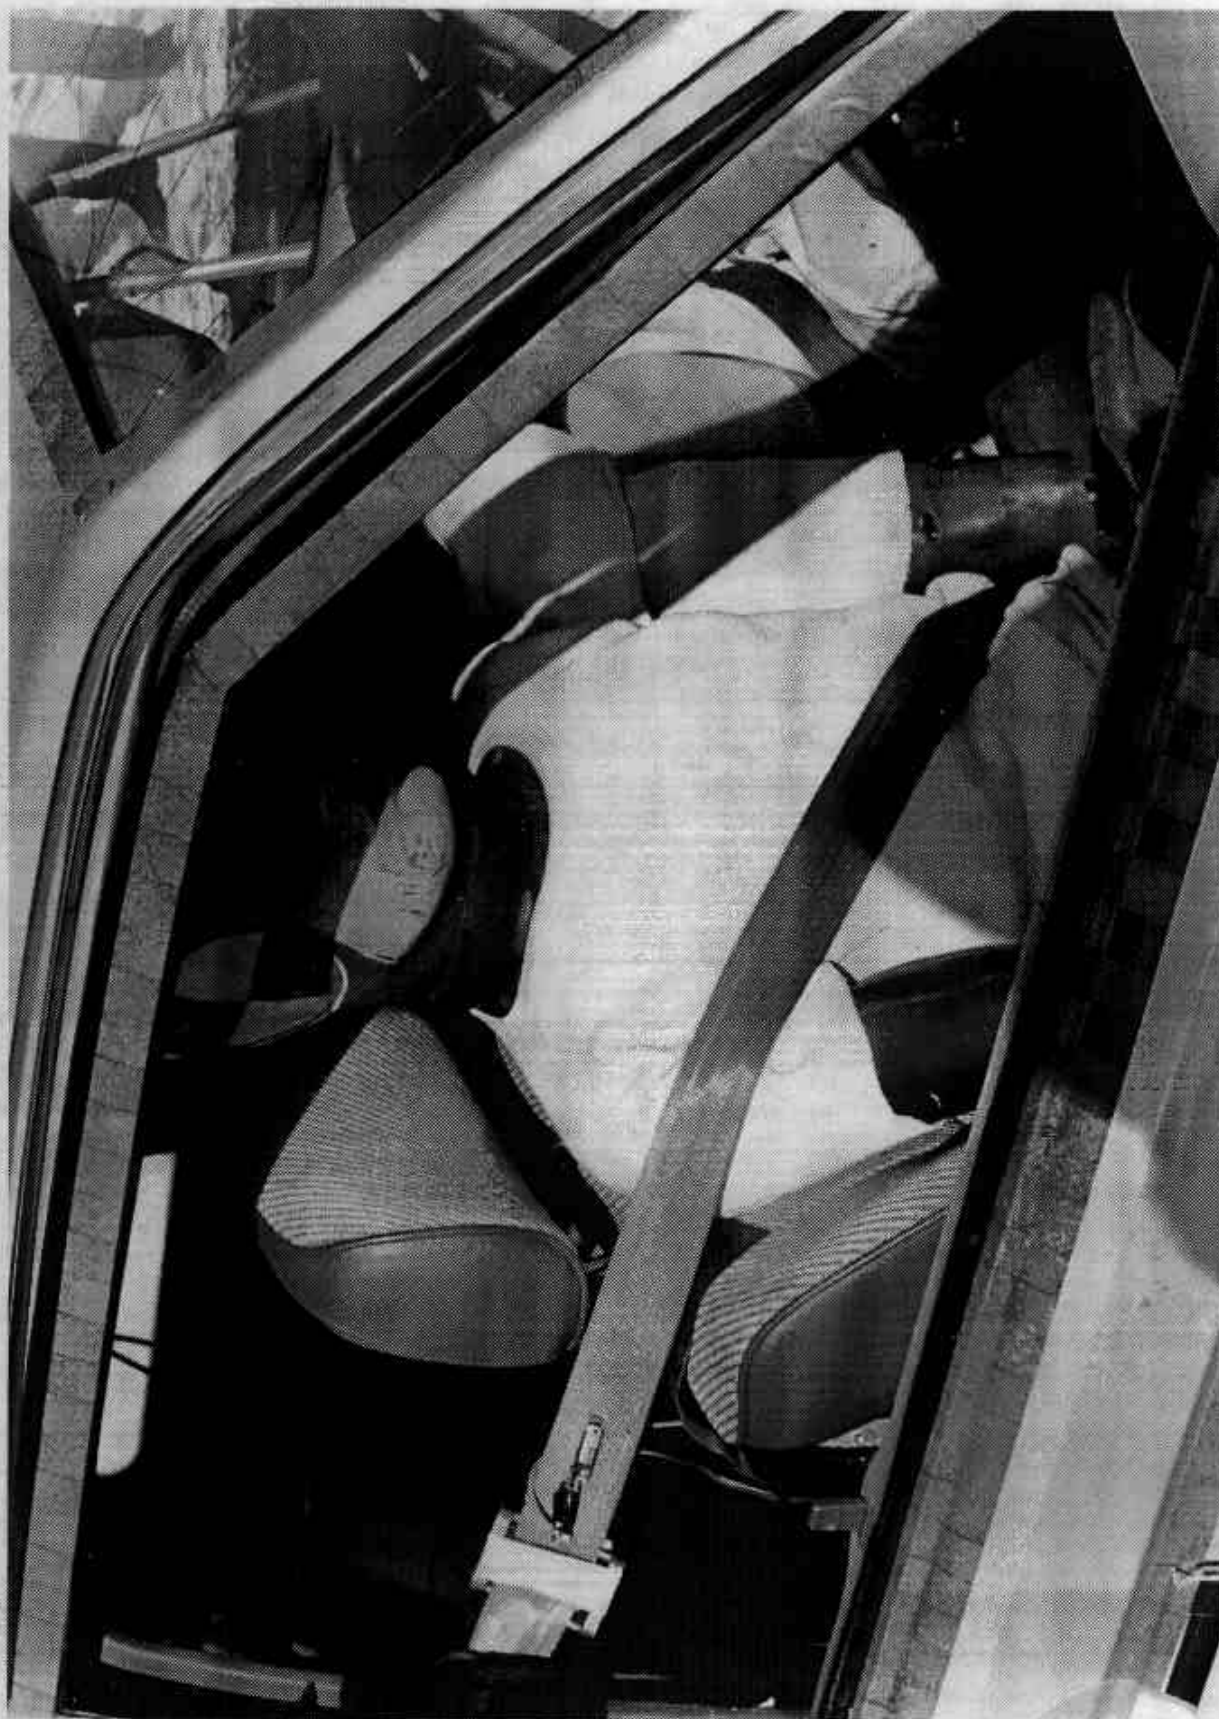
Figure A-25 POST-TEST PASSENGER POSITION VIEW

The right-front passenger HIC was 894 and maximum chest deceleration over 3 milliseconds was 47 g's. Femur loads were 325 and 200 pounds.

| | <u>Driver</u> | <u>Passenger</u> |
|---|---|---|
| Head | <u>Upper Steering Wheel</u><br><u>Rim and Hub</u> | <u>Dash Panel</u> |
