REPORT NO. CAL-86-N05

NEW CAR ASSESSMENT PROGRAM (NCAP)  
FRONTAL BARRIER IMPACT TEST

1986 ISUZU I MARK  
4-DOOR SEDAN

NHTSA NO. MG5701  
CALSPAN TEST NO. 7457-5

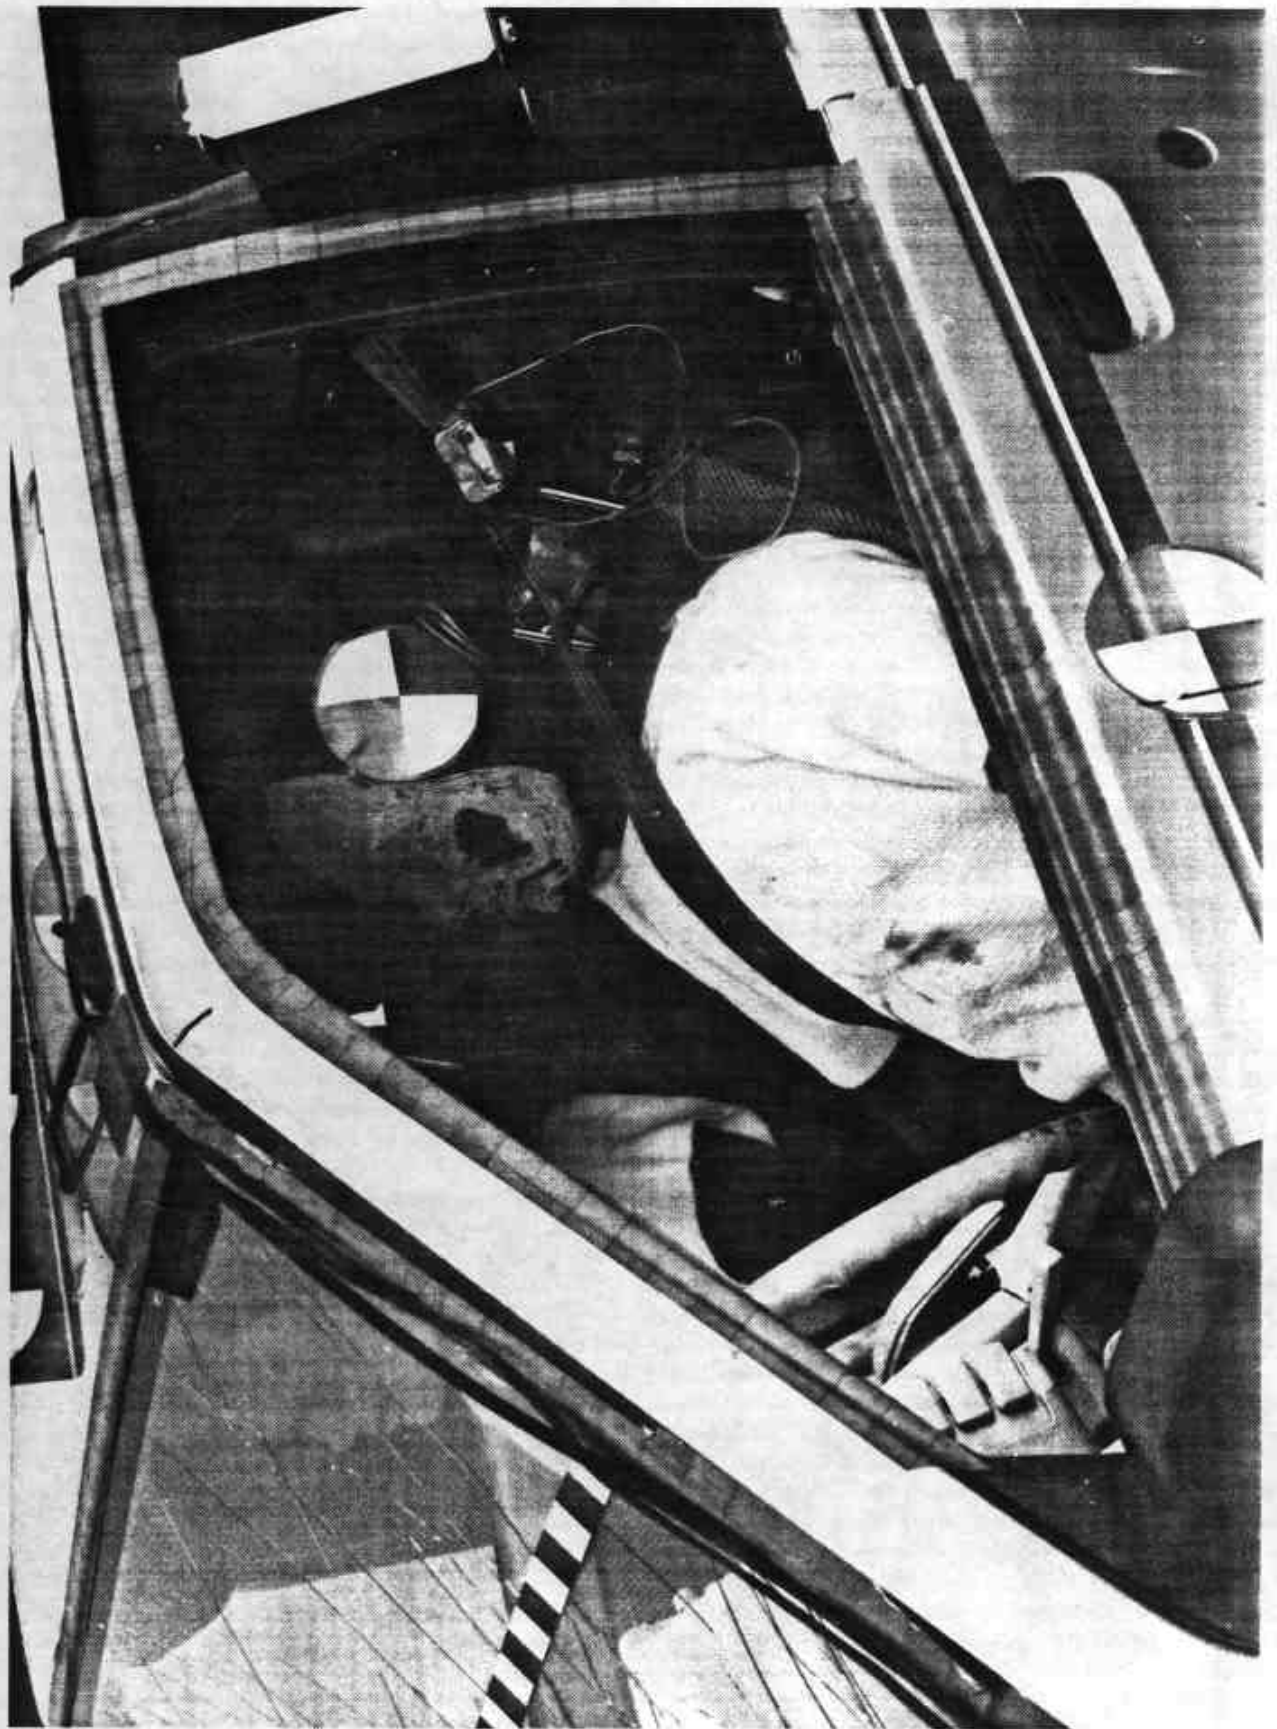
Figure A-24 POST-TEST DRIVER POSITION VIEW

The driver's head struck the steering wheel hub; the HIC was 2172. The maximum chest deceleration over 3 milliseconds was 43 g's and femur loads were 176 and 486 pounds.

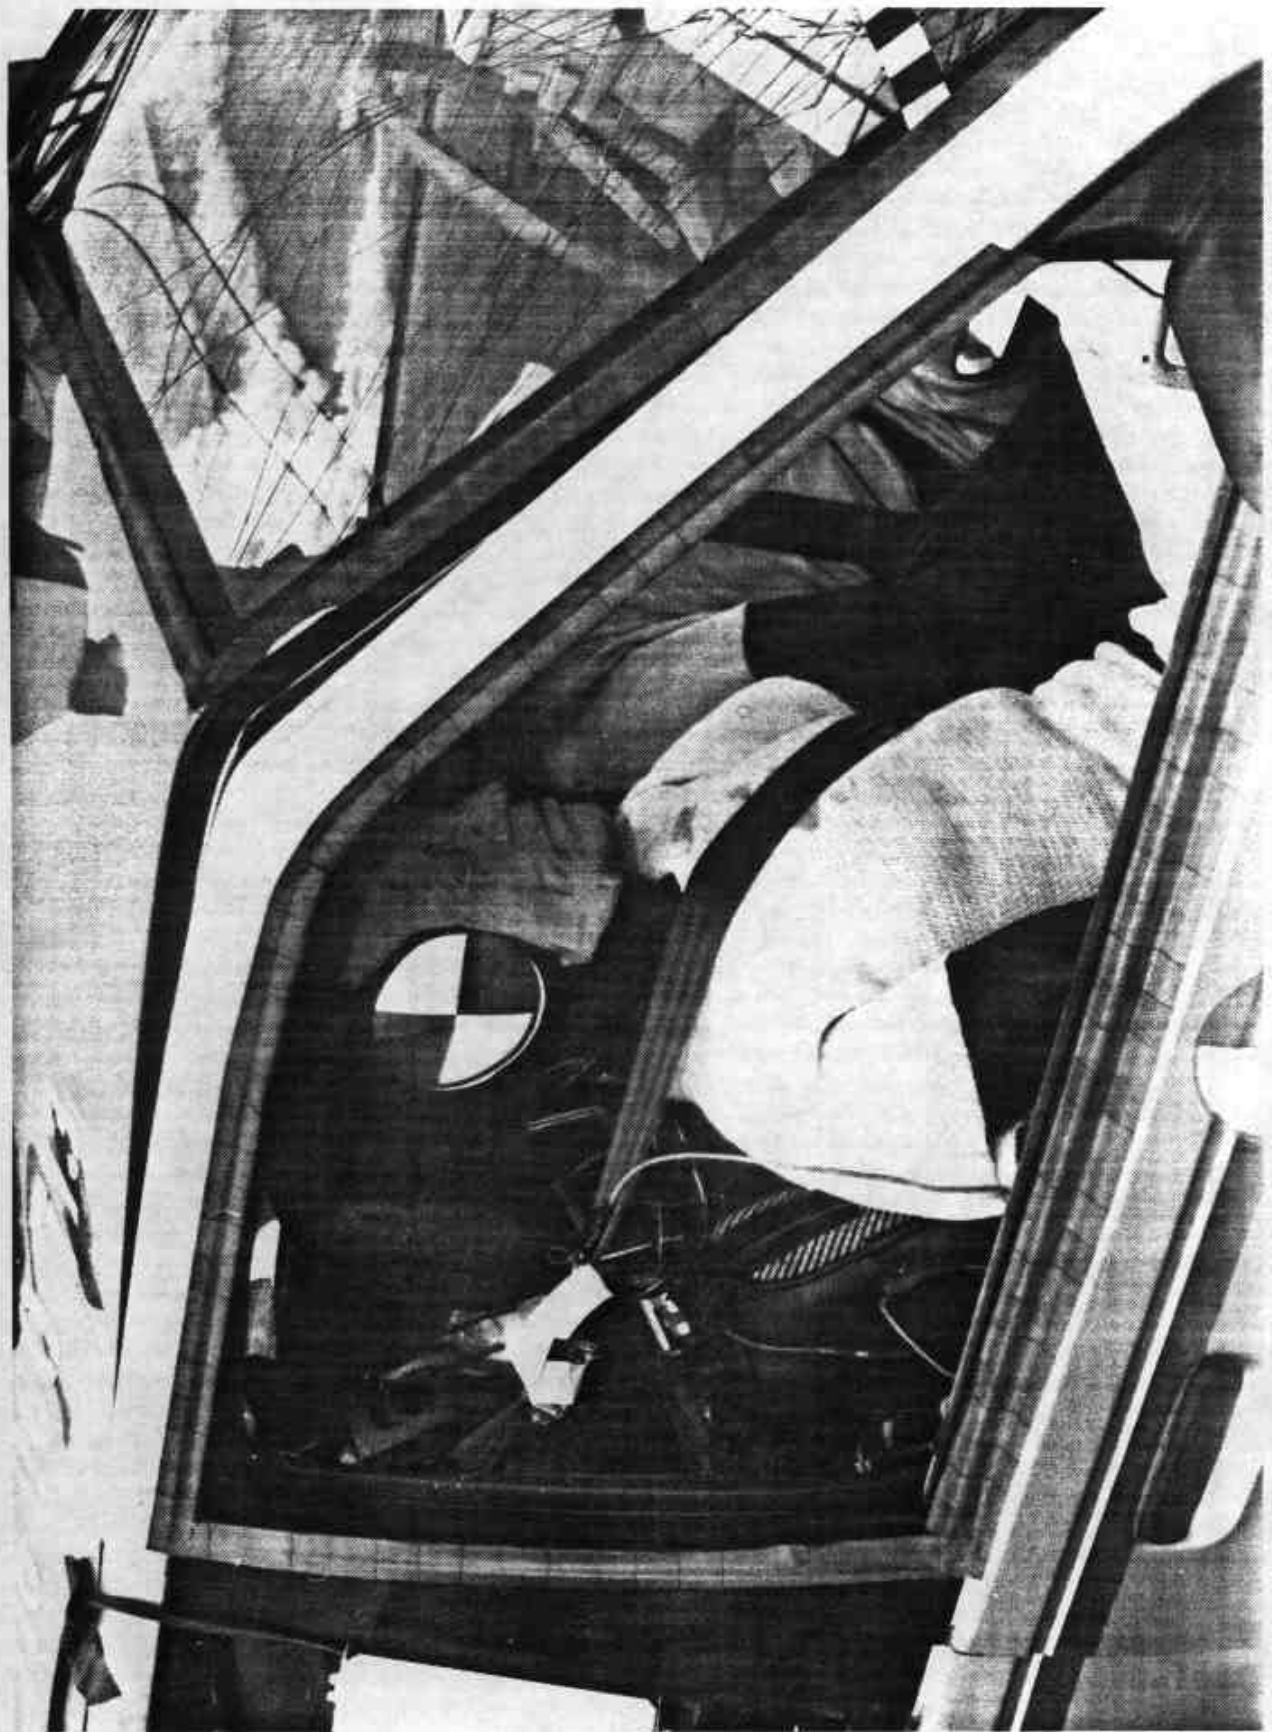
Figure A-26 POST-TEST PASSENGER POSITION VIEW

The right-front passenger's head struck the front edge of the dash; the HIC was 1146 and maximum chest deceleration over 3 milliseconds was 43 g's. Both the passengers' knees contacted the glove box door and femur loads were 260 and 275 pounds.
