LABORATORY PROCEDURES TO DETERMINE THE  
BREAKAWAY BEHAVIOR OF LUMINAIRE SUPPORTS  
IN MINI-SIZED VEHICLE COLLISIONS

SIDE IMPACT - RIGID POLE  
TEST RESULTS REPORT  
TEST NO'S: SI#1, SI#2, SI#3, AND SI#8  
PHASE II - TASK C

February 1986

ENSCO, INC.  
Applied Technology and Engineering Division  
5400 Port Royal Road  
Springfield, VA 22151

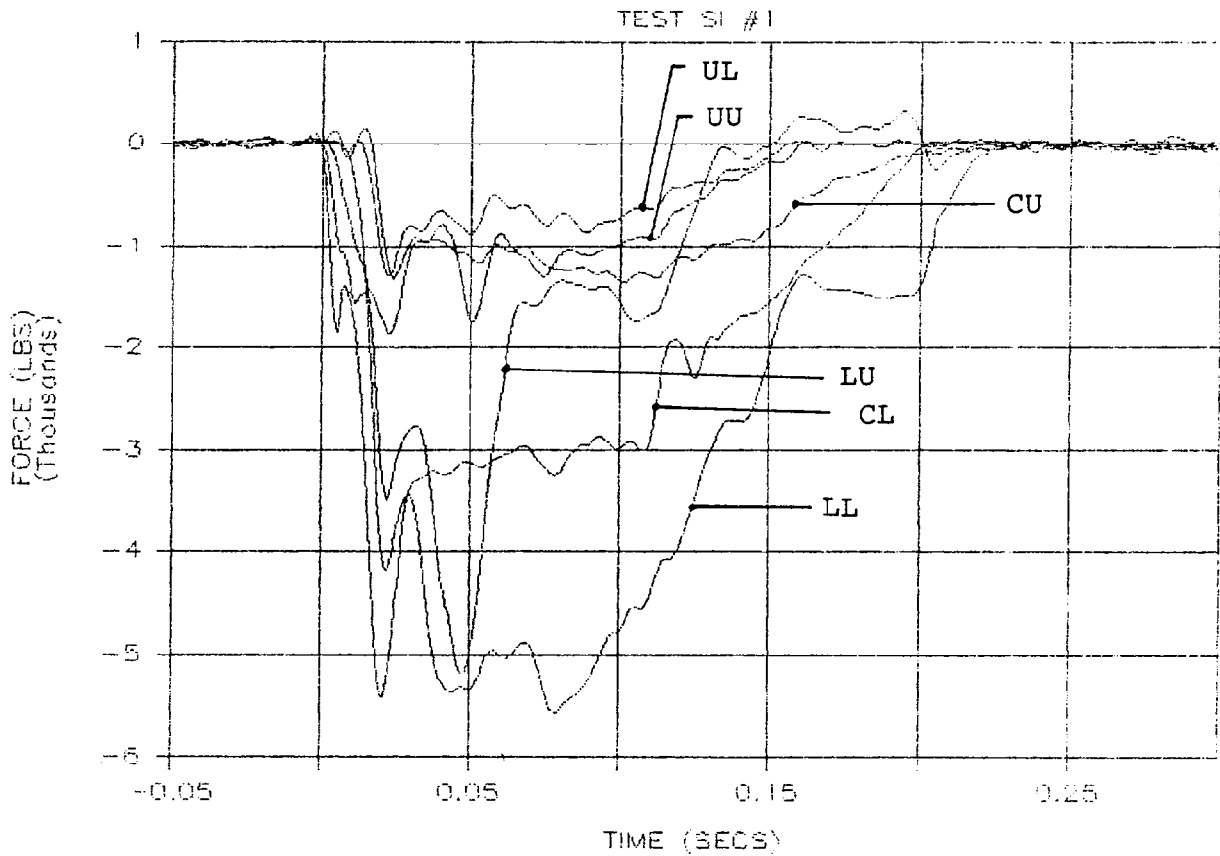
Figure 27. Load Cell Outputs for Test SI#1

LL = Lower Segment Lower Load Cell  
 LU = Lower Segment Upper Load Cell  
 CL = Center Segment Lower Load Cell  
 CU = Center Segment Upper Load Cell  
 UL = Upper Segment Lower Load Cell  
 UU = Upper Segment Upper Load Cell
