LABORATORY PROCEDURES TO DETERMINE THE
BREAKAWAY BEHAVIOR OF LUMINAIRE SUPPORTS
IN MINI-SIZED VEHICLE COLLISIONS

THIRTY MPH BROADSIDE
IMPACT OF A DODGE ST. REGIS
AND A BREAKAWAY LUMINAIRE SUPPORT

TEST RESULTS REPORT

TEST NUMBER 1469-SI#7-85

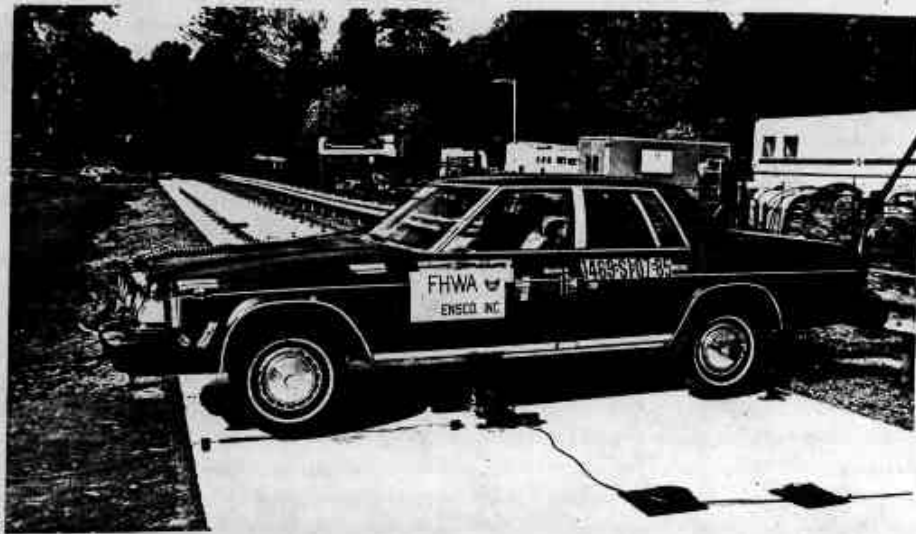
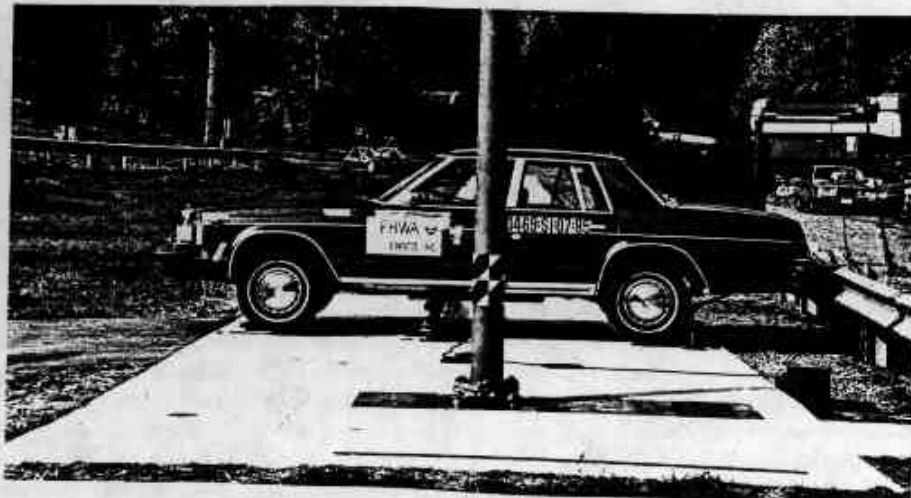
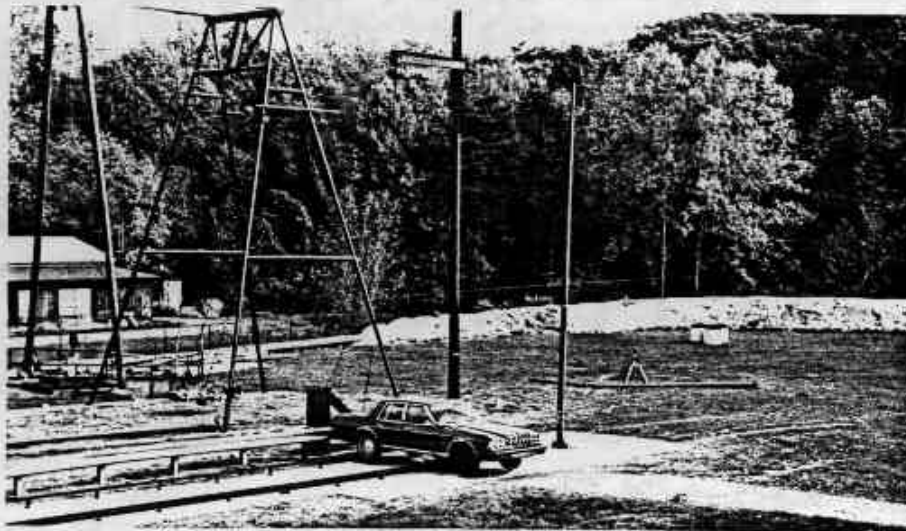
Figure 1. Pre-Test Photos of Vehicle

The vehicle was equipped with a triaxial accelerometer package mounted on the lateral centerline of the vehicle at the longitudinal location of the center of gravity. Two rate gyros were also installed to the same mounting block to measure roll and yaw rates. The vehicle was also equipped with a contact switch mounted on the left door to permit vehicle and occupant data to be measured relative to the time of impact. The test vehicle is shown in figure 1.

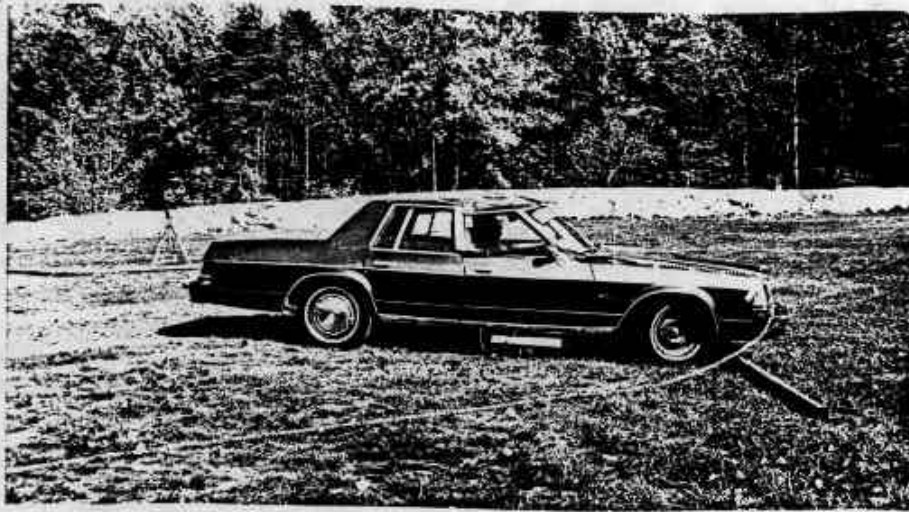
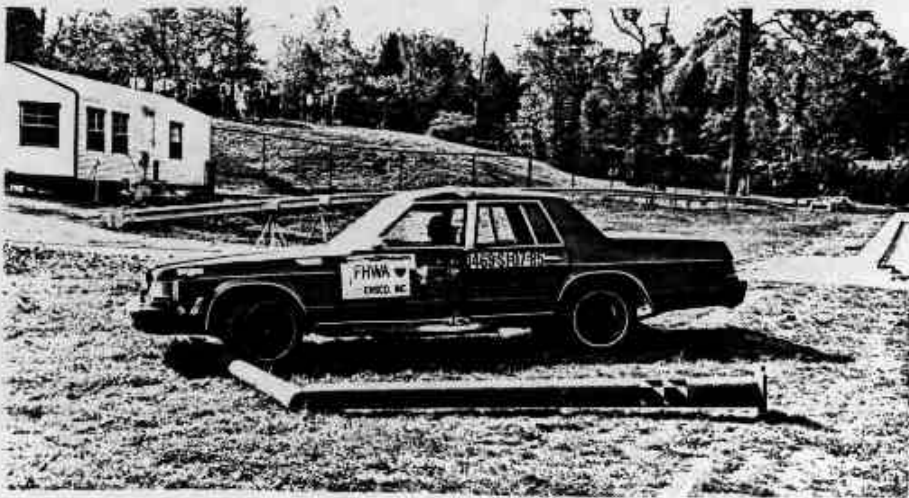
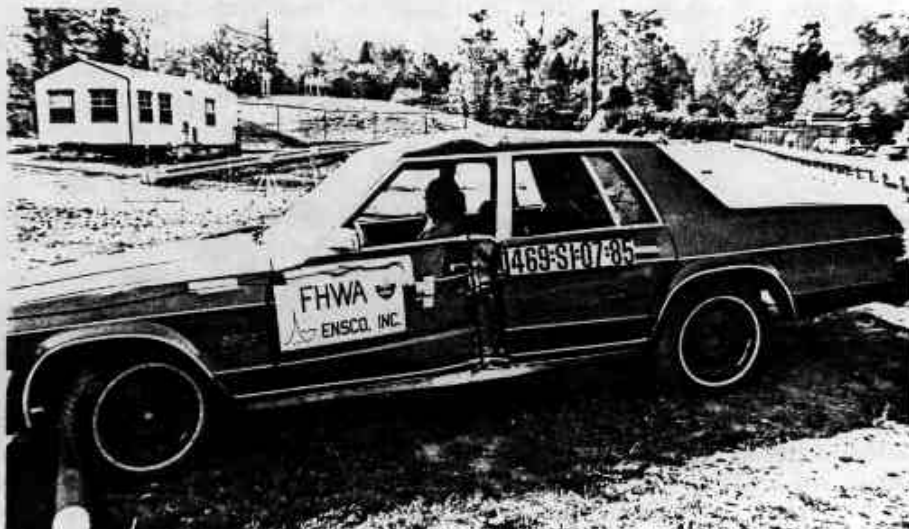
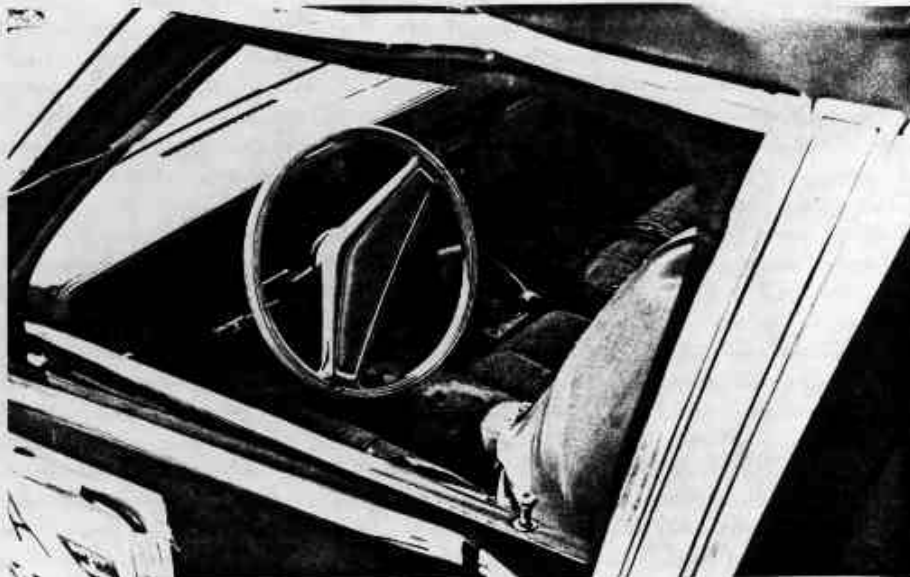
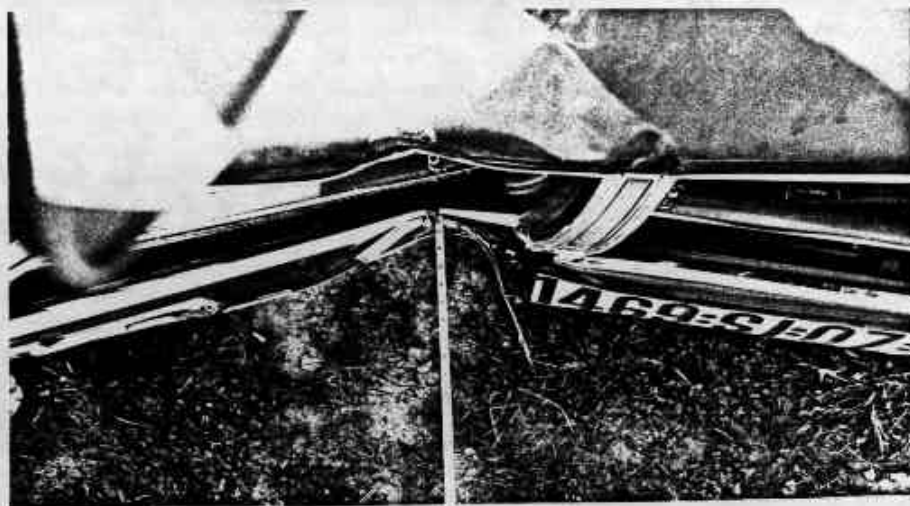
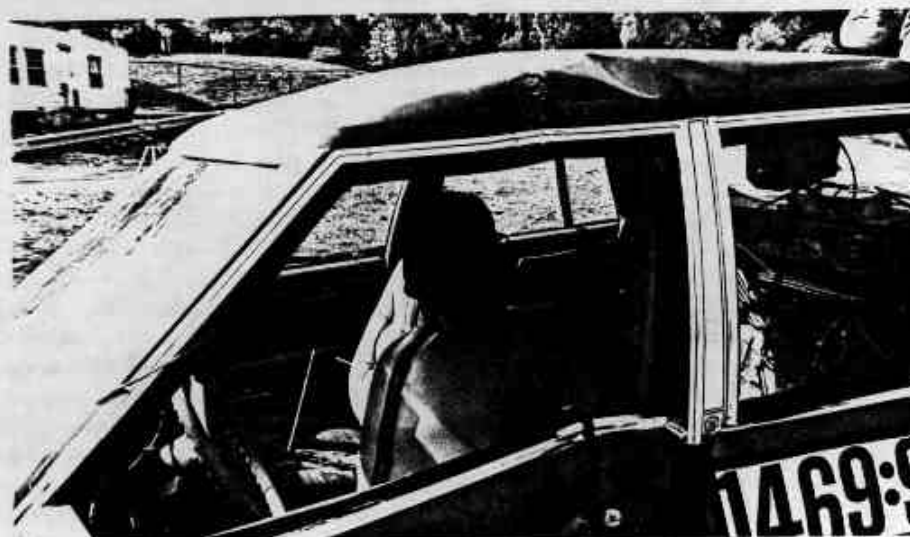
Figure 2. Post-Test Photos of Vehicle

The test vehicle momentum change due to impacting the pole at a speed of 31.8 mph (14.2 m/s) was 685 lb-sec. The velocity change corresponding to the observed vehicle momentum change was 3.3 mph or 4.9 ft/sec. The integrity of the vehicle was maintained throughout the test although some intrusions occurred at the center of the driver's door. Maximum residual crush of the side of the vehicle was 8.5 inches.

The impact conditions were 31.8 mph (14.2 m/s) at a point on the left door in line with the occupant 10.7 inches (.27 m) behind the longitudinal location of the center of gravity of the vehicle measured with the dummy in the vehicle. The vehicle had a 7° roll angle as it leaned toward the test pole due to the side sliding forces acting on the tires. The maximum residual crush of the vehicle at the impact point was 8.5 inches (.22 m). Photographs of the vehicle and luminaire support after the collision event are shown in figure 2.

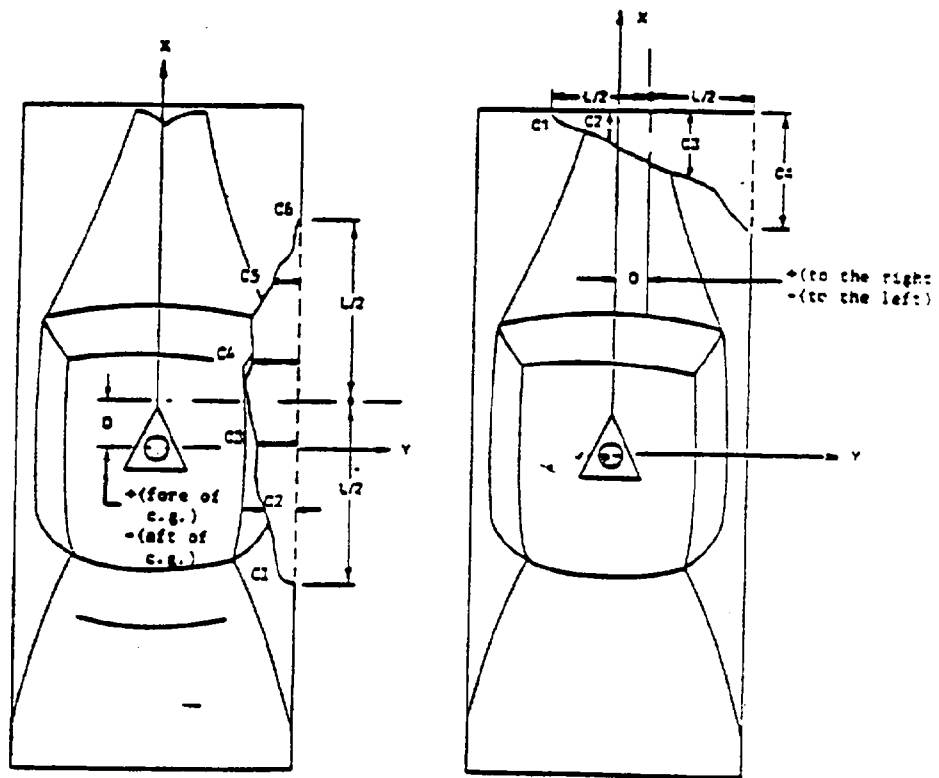
Figure 3. NHTSA Vehicle Damage Measurements

After the initial separation from the vehicle the luminaire support translated forward at a speed of 26.7 f/s (8.14 m/s) with a rotation rate of 2.7 rad/sec. The luminaire support rotated up and over the test vehicle with the top of the pole hitting the runway near the impact point about .7 second after impact. The pole broke as it hit the runway and then fell on the roof of the car bending at the break. As the support rotated away, the vehicle slid off the end of the runway with very little yawing. The final resting position of the vehicle was about 8 feet to the right of the impact approach path and 28 feet downstream. The residual test vehicle crush measured using the 6 point NHTSA guide is given in table 6. See figure 3 for reference.

C1 = 0.00	L = 94.00"
C2 = -1.50"	D = -14.10"
C3 = 2.25"	
C4 = 8.50"	
C5 = 3.00"	
C6 = 0.00	
Max = 8.50"

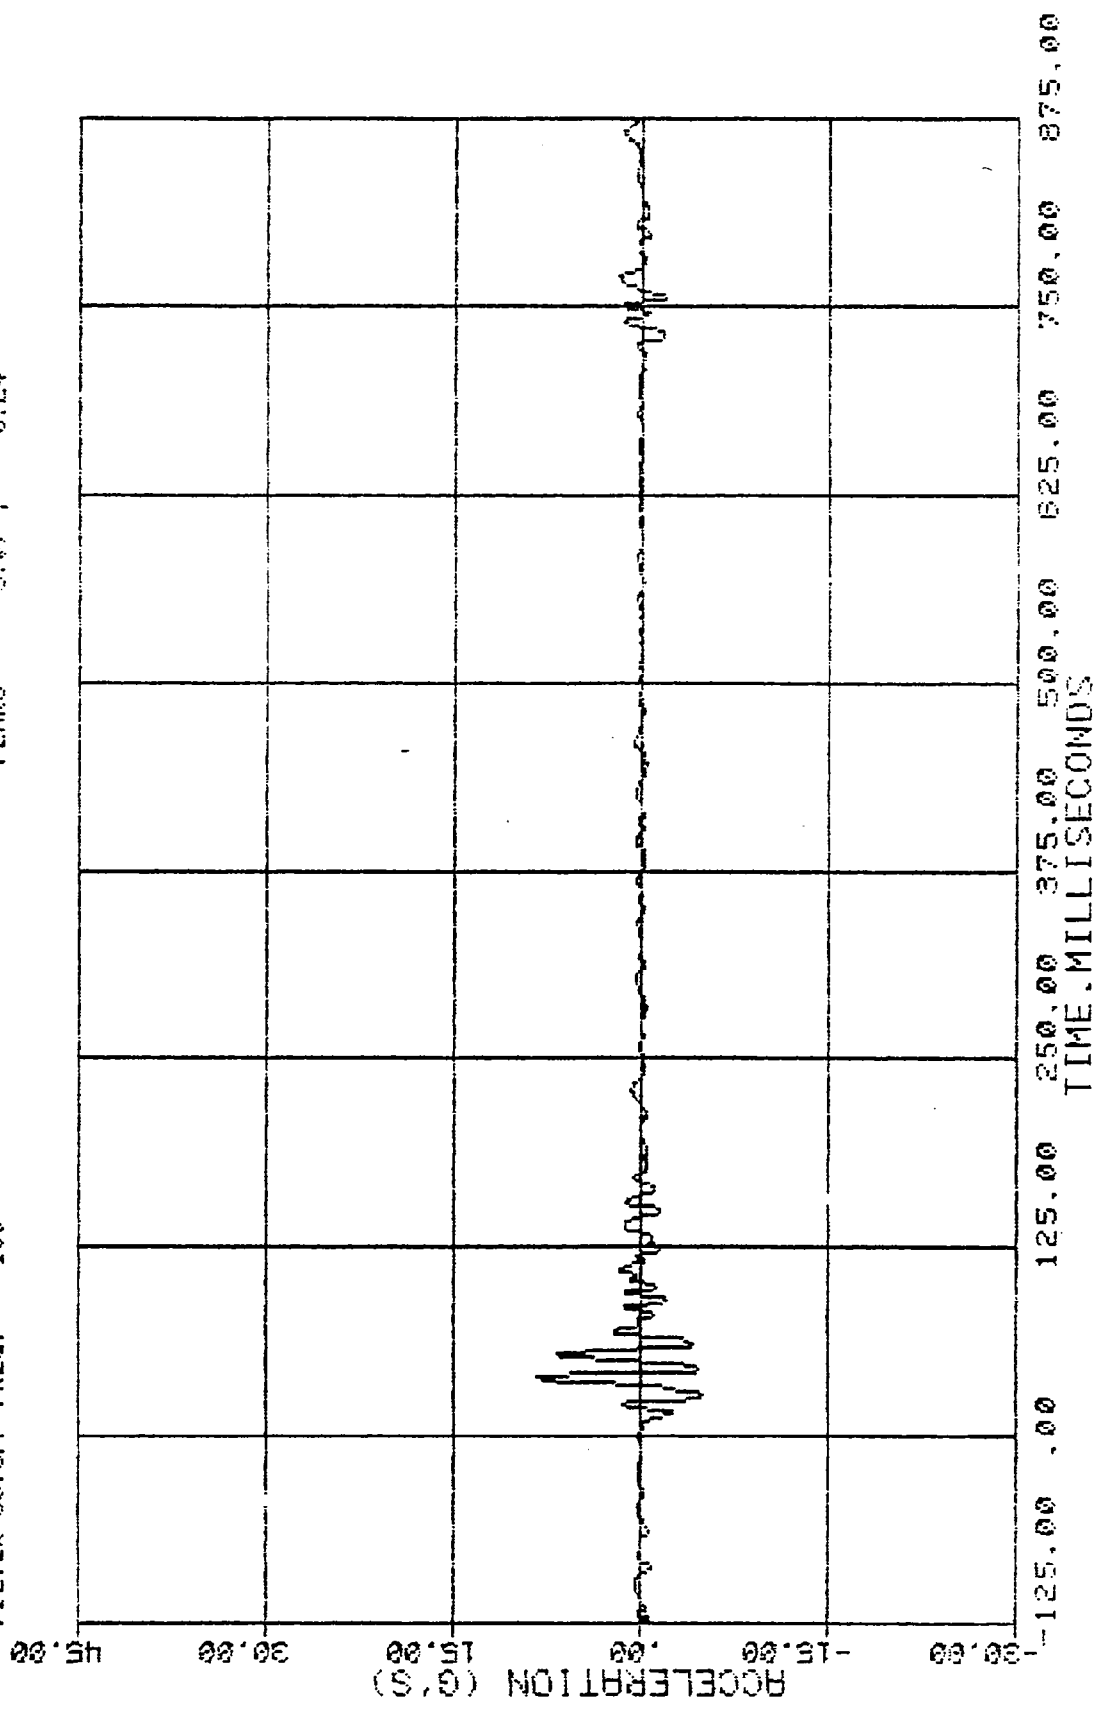
Figure 4. Vehicle Acceleration, X-Axis, 100 Hz

CHANNEL 17 VEHICLE O.O. ACCELERATION, X-AXIS
FILTER CUTOFF FREQ. 100 PEAKS -5.07, 8.24

The data collected from the accelerometers mounted to the vehicle were filtered at SAE Class 60 and 180 per TRC 191 and NCHRP 230 requirements, respectively. The acceleration traces obtained with the use of the SAE Class 60 ($f_c = 100$ Hz) filtering technique are presented in figures 4 through 6. The acceleration traces obtained with the use of the SAE Class 180 ($f_c = 300$ Hz) filtering technique are presented in figures 7 through 9. Figure 10 presents the impact marker channel. Figures 11 through 14 contain the rate gyro data filtered at 100 Hz and 10 Hz (SAE Class 60 and 6).

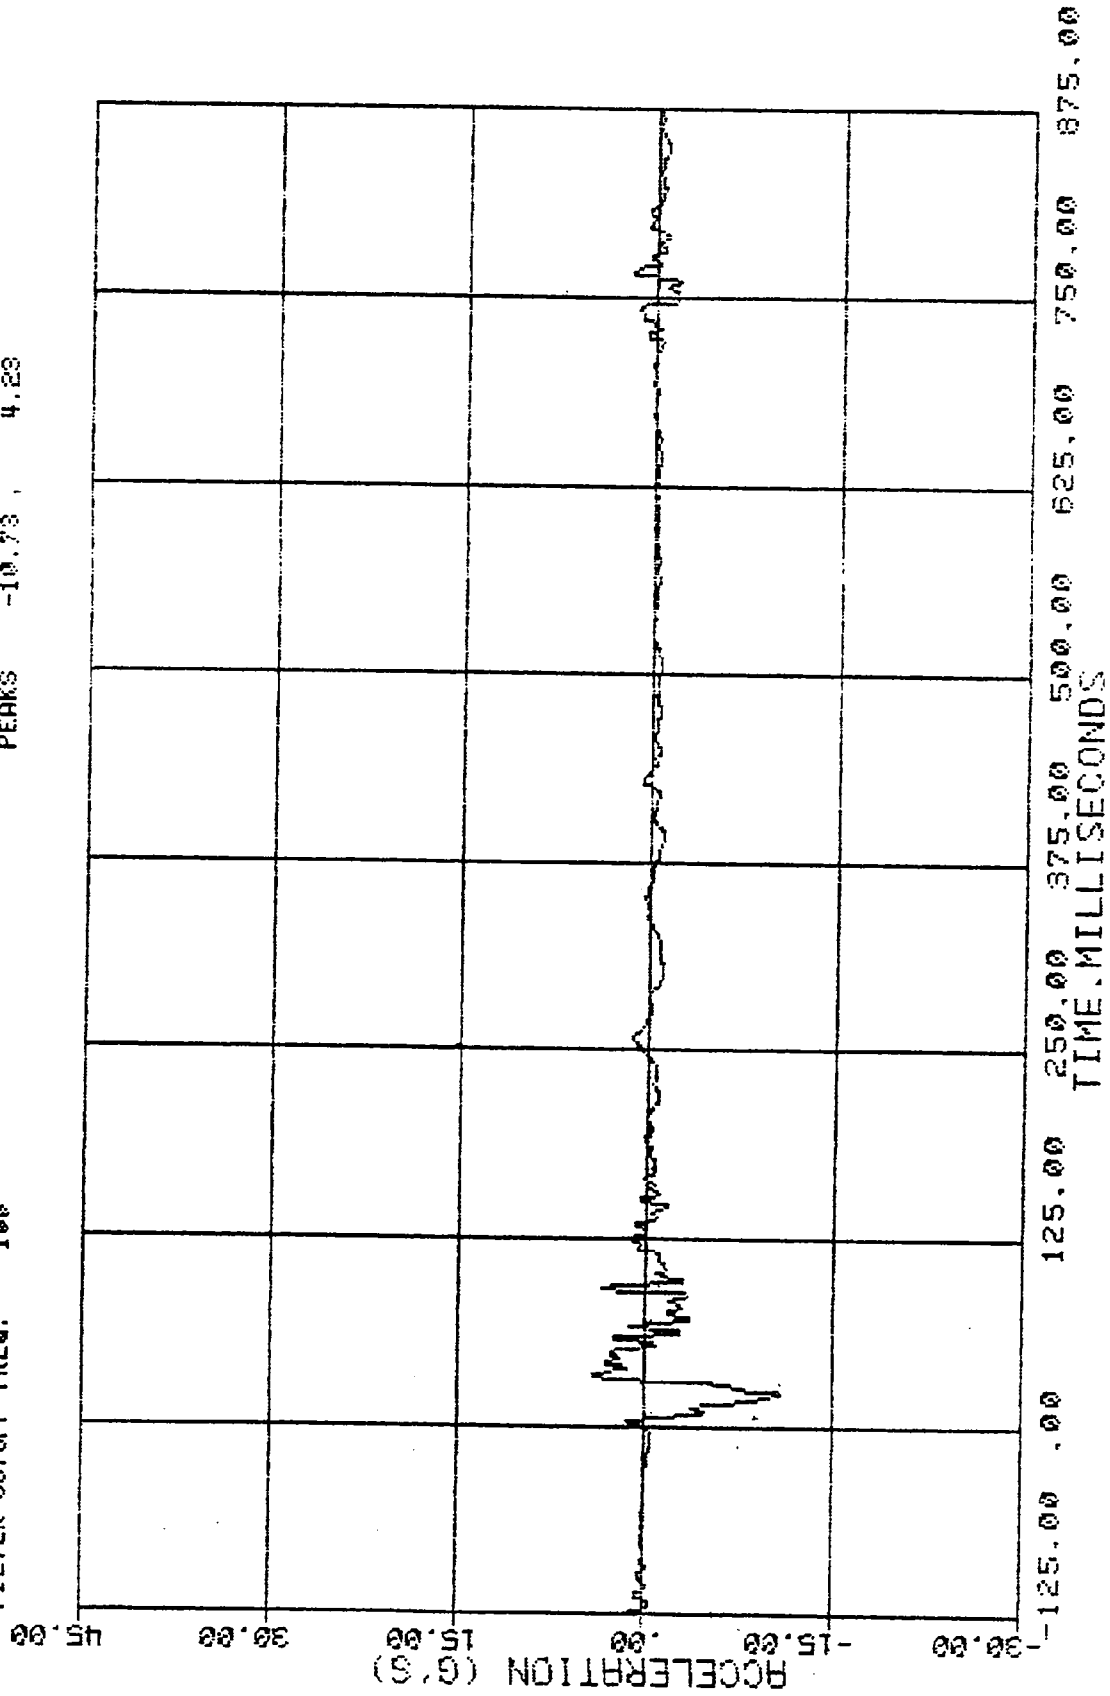
Figure 5. Vehicle Acceleration, Y-Axis, 100 Hz

CHANNEL 18 VEHICLE O.O. ACCELERATION, Y-AXIS
FILTER CUTOFF FREQ. 100 PEAKS -10.73 4.23

The resulting change in velocity and momentum change of the vehicle based upon integrating the lateral Class 60 acceleration signal in the fixed vehicle coordinate system was 4.9 ft/sec and 685 lb-sec, respectively. This does not account for the tire sliding forces since the accelerometer signal was debiased during

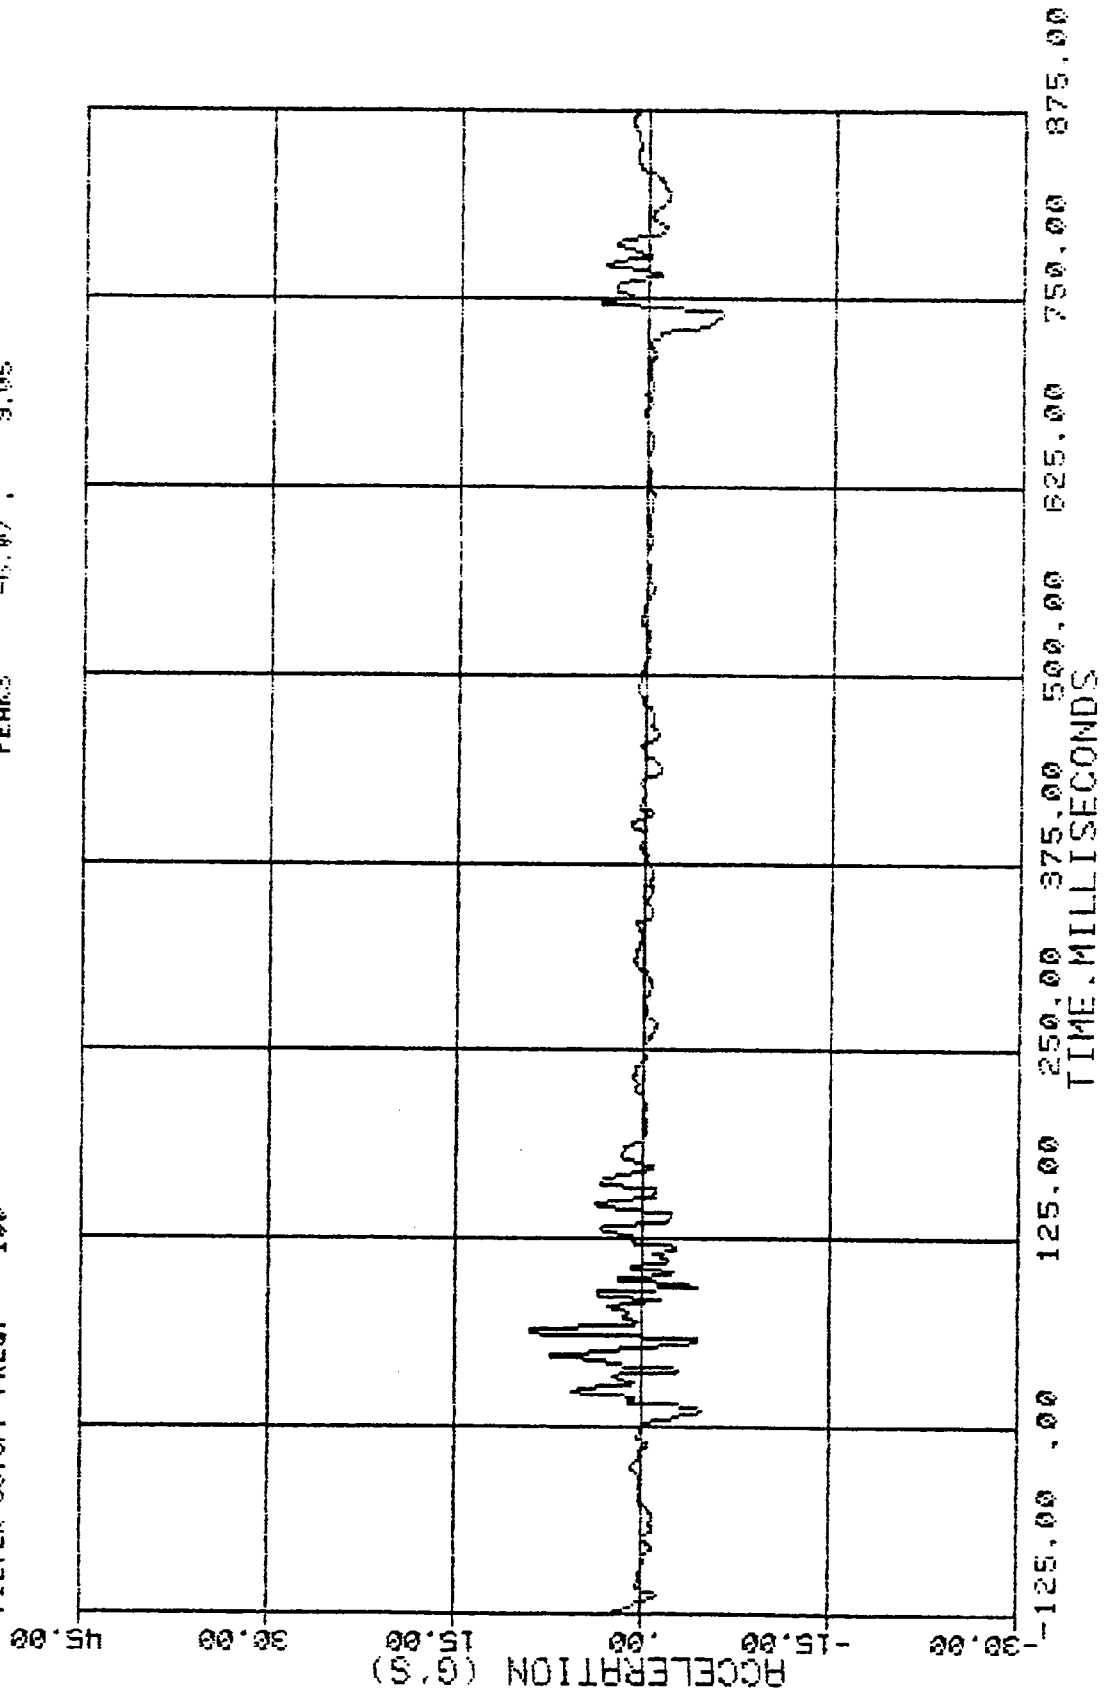
Figure 6. Vehicle Acceleration, Z-Axi, 100 Hz

CHANNEL 19 VEHICLE O.B. ACCELERATION, Z-AXIS
FILTER CUTOFF FREQ. 100 PEAKS -16.07 9.05

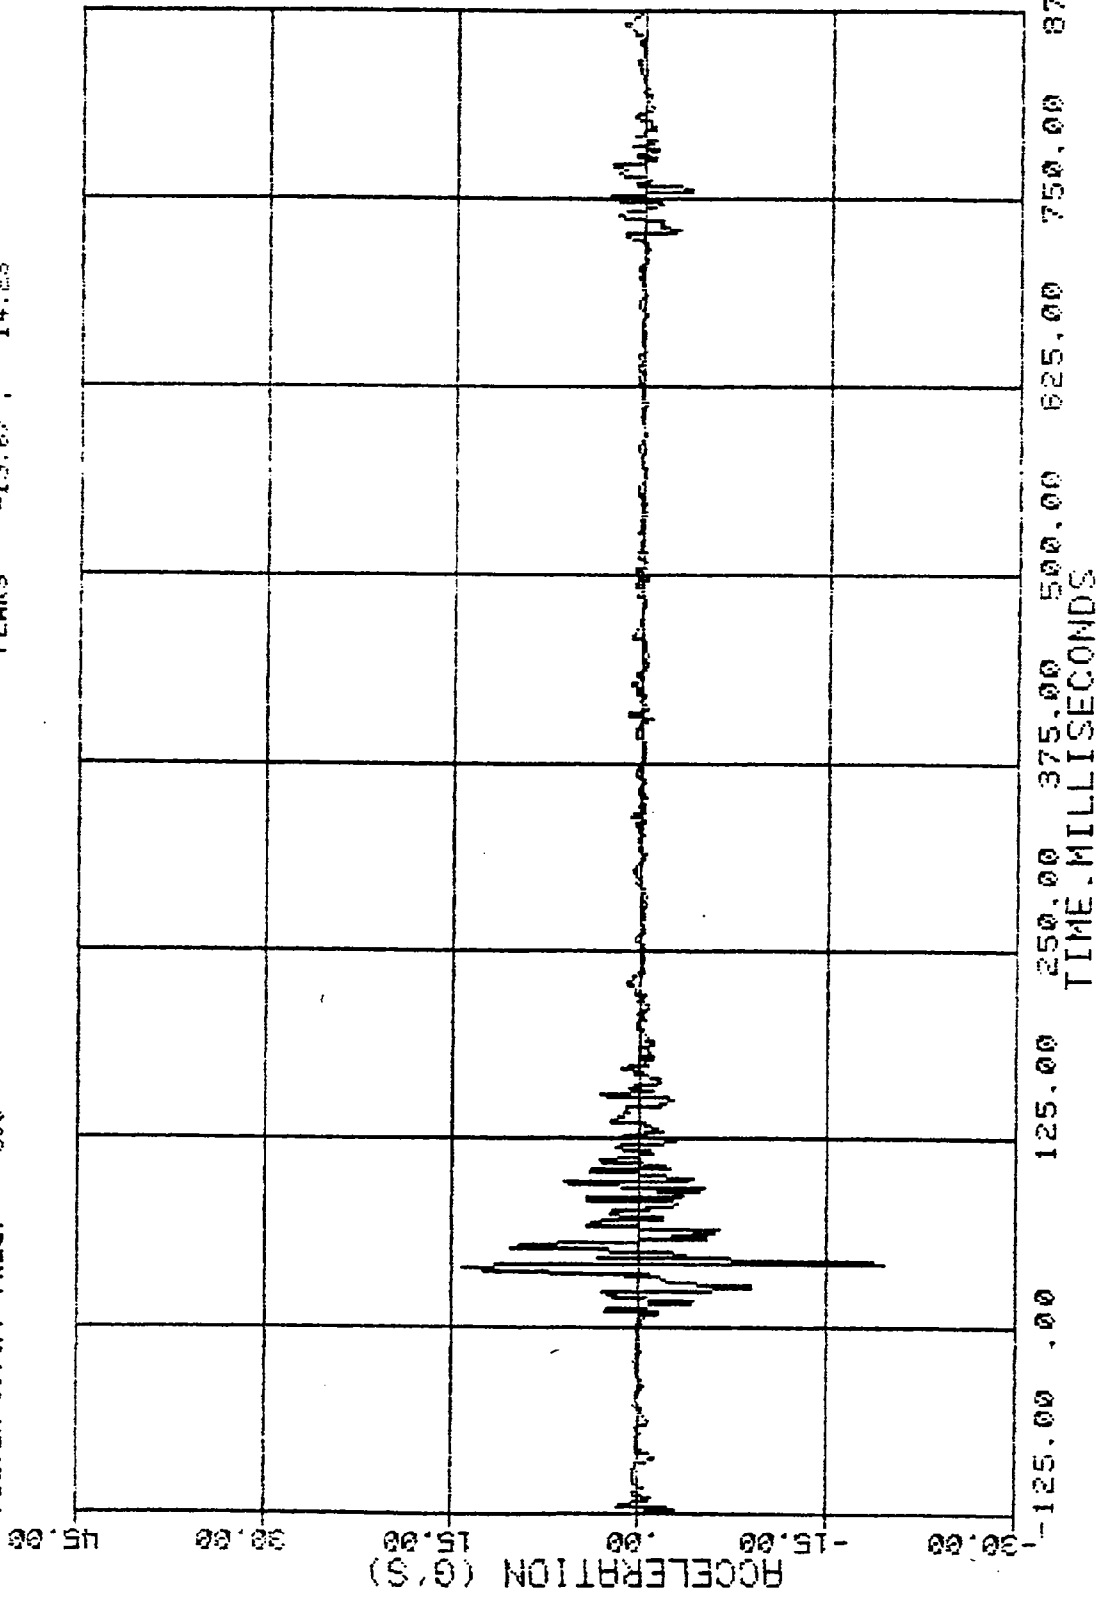
Figure 7. Vehicle Acceleration, X-Axis, 300 Hz

CHANNEL 17 VEHICLE O.G. ACCELERATION, X-AXIS
FILTER CUTOFF FREQ. 300 PEAKS -13.67 , 14.23

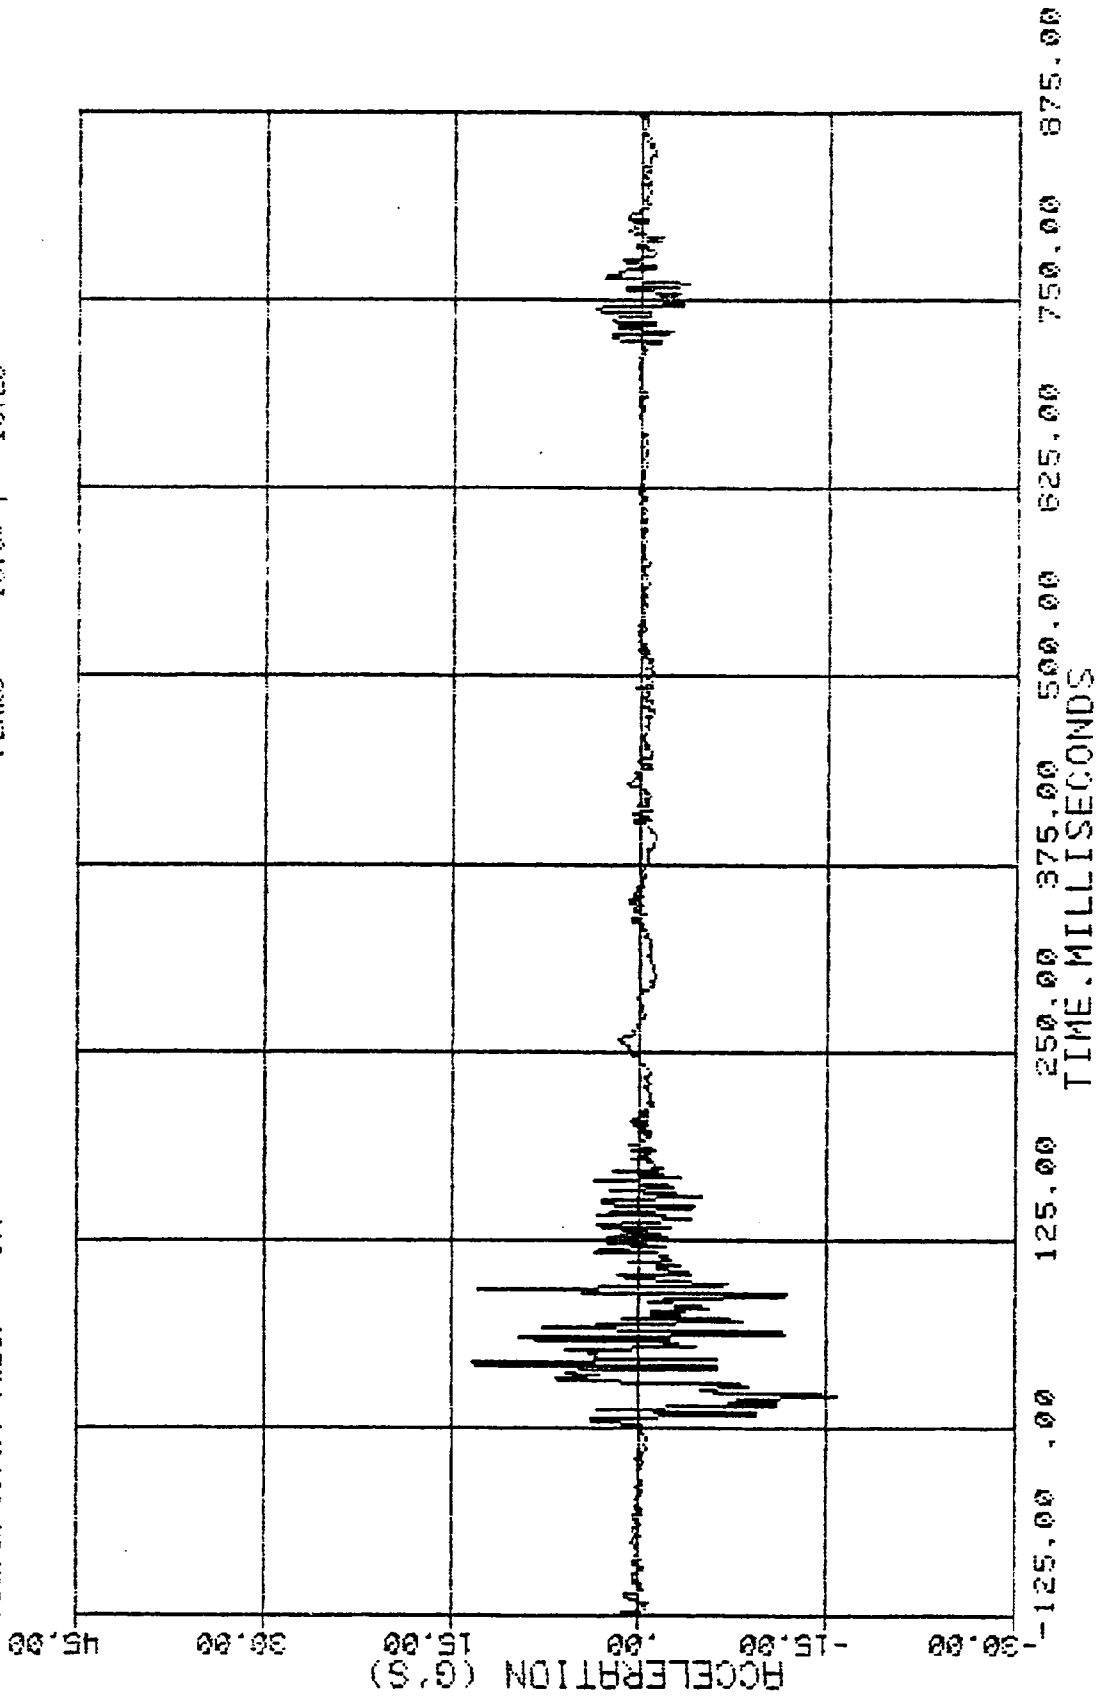
Figure 8. Vehicle Acceleration, Y-Axis, 300 Hz

CHANNEL 13 VEHICLE 0.0. ACCELERATION, Y-AXIS

PEAKS -15.90 , 13.25

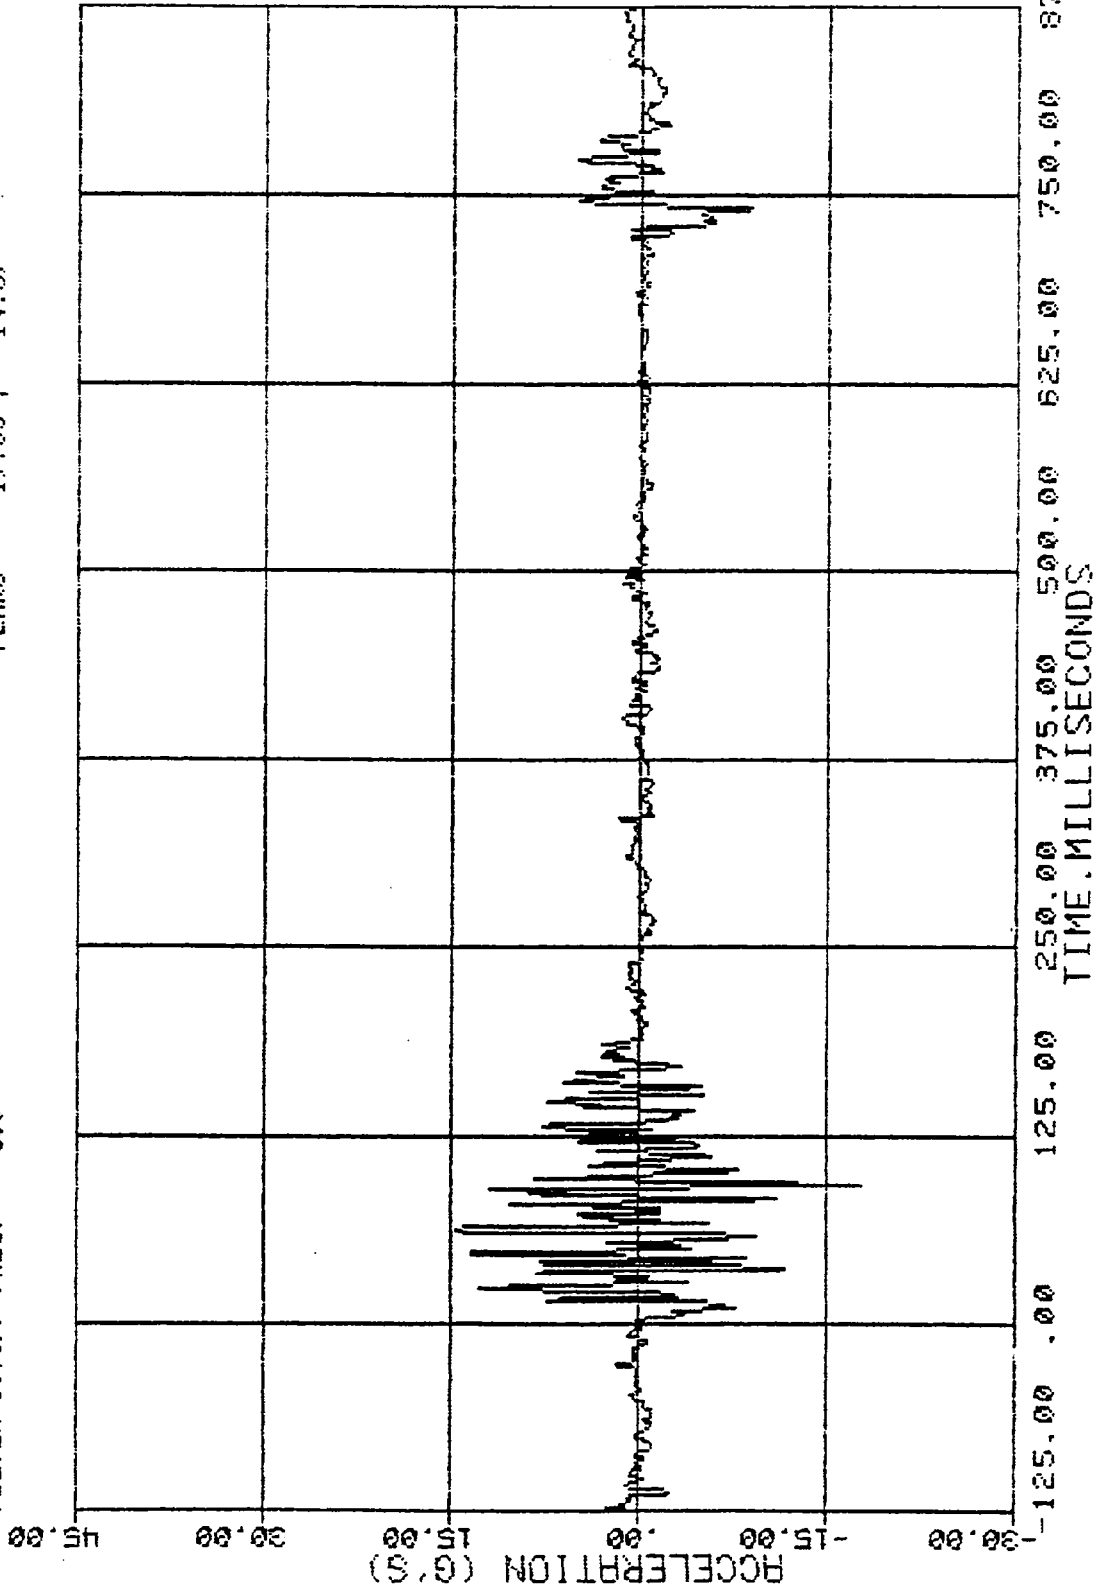
Figure 9. Vehicle Acceleration, Z-Axis, 300 Hz

CHANNEL 13 VEHICLE O.G. ACCELERATION, Z-AXIS
FILTER CUTOFF FREQ. 300

PEAKS -17.63, 14.57

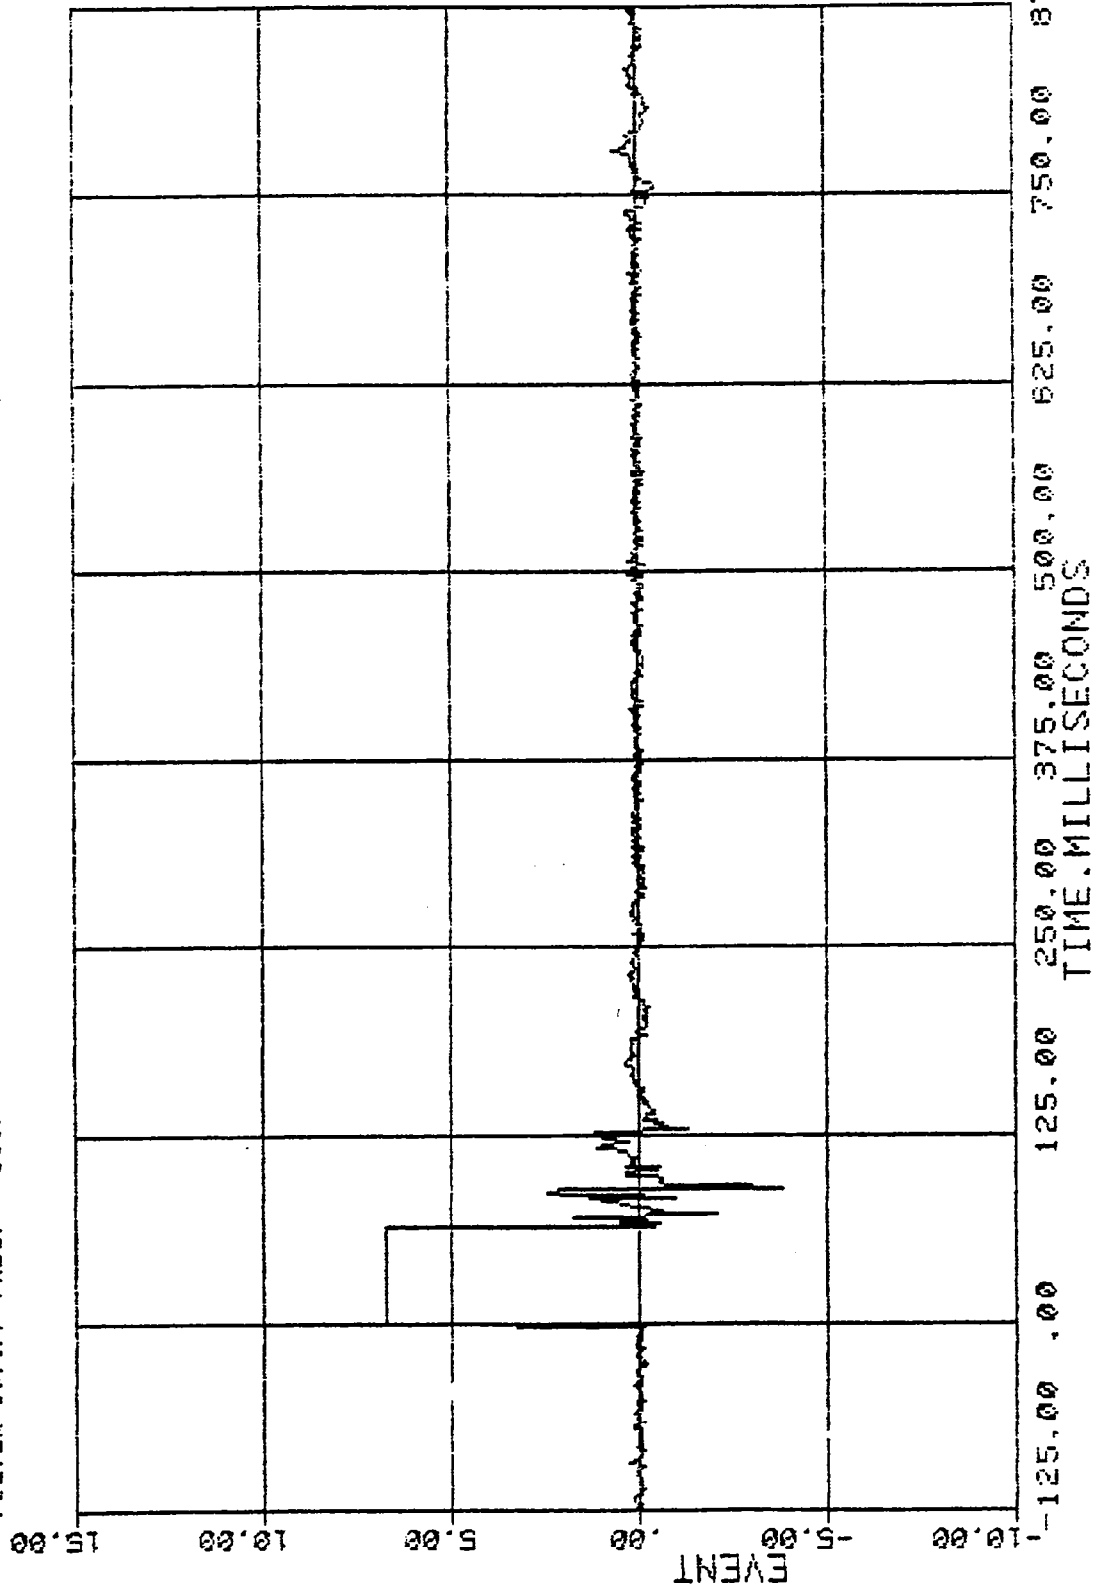
Figure 10. Event Marker, Impact

CHANNEL 20 IMPACT
FILTER CUTOFF FREQ. 1650

PEAKS -3.80 , 6.75

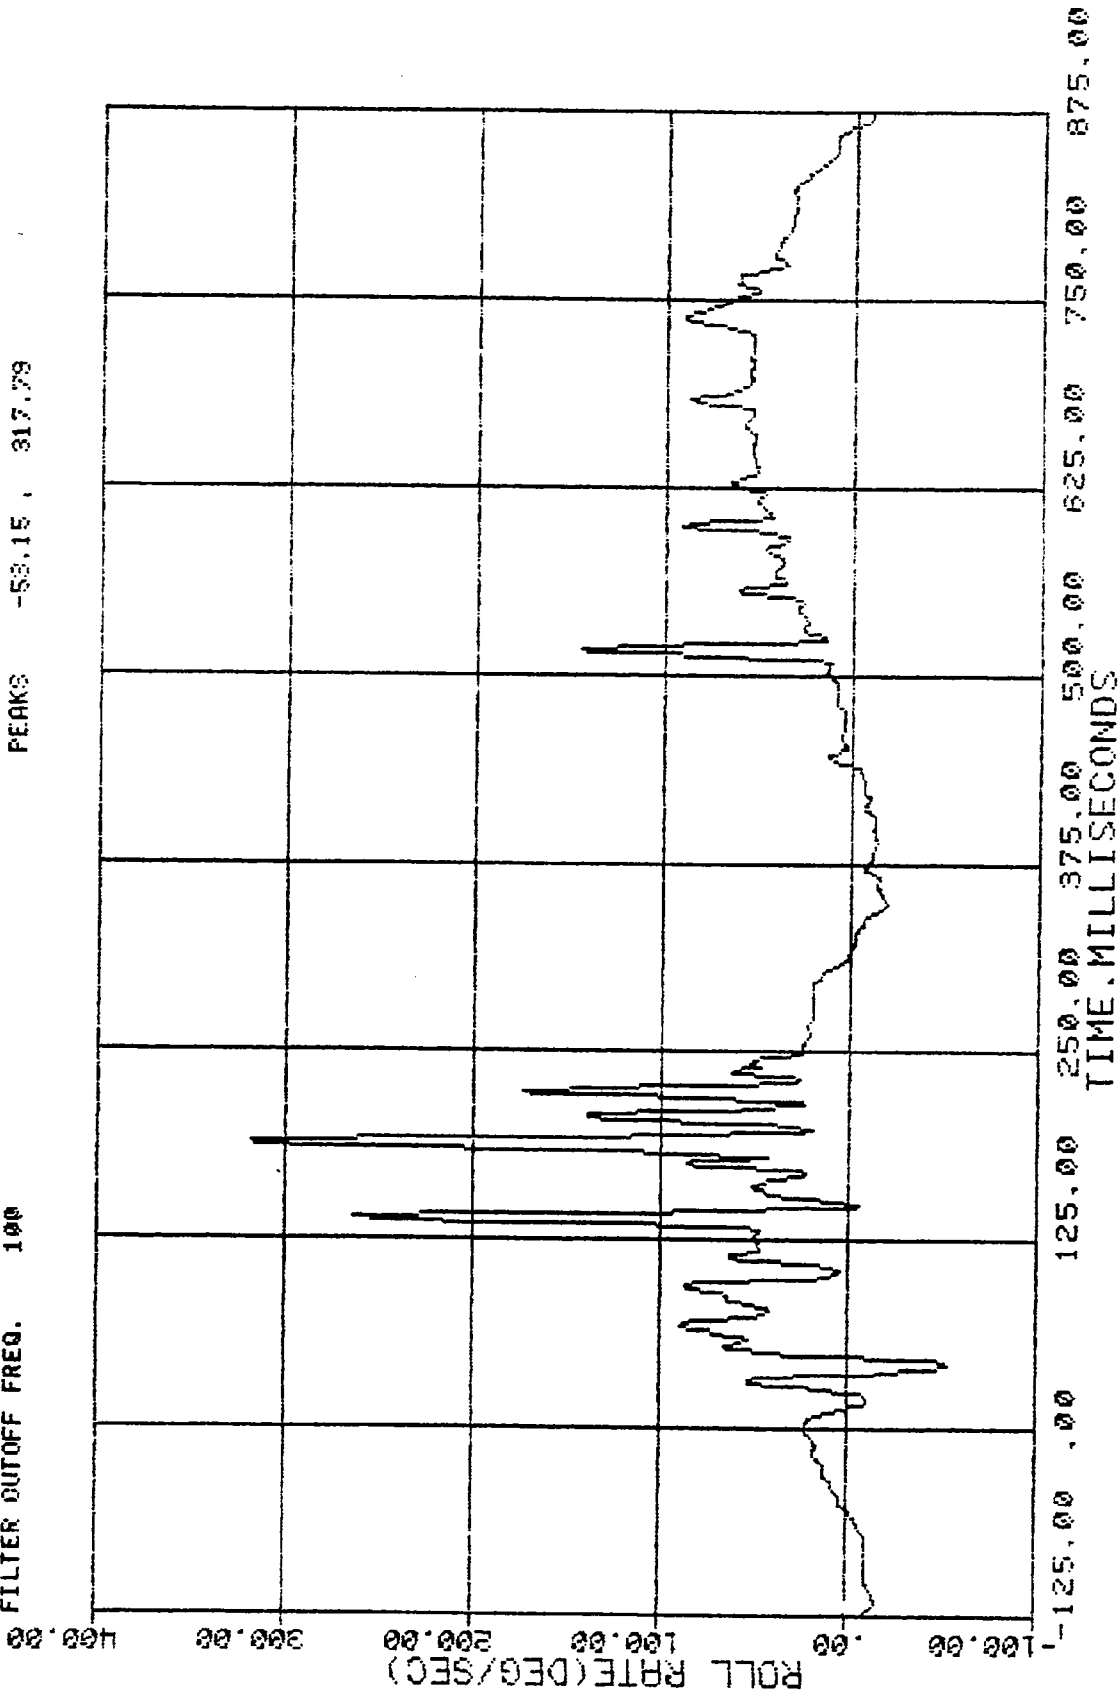
Figure 11. Vehicle Roll Rate, 100 Hz

CHANNEL 21 VEHICLE ROLL RATE
FILTER CUTOFF FREQ. 100

PEAKS -53.15 , 317.79

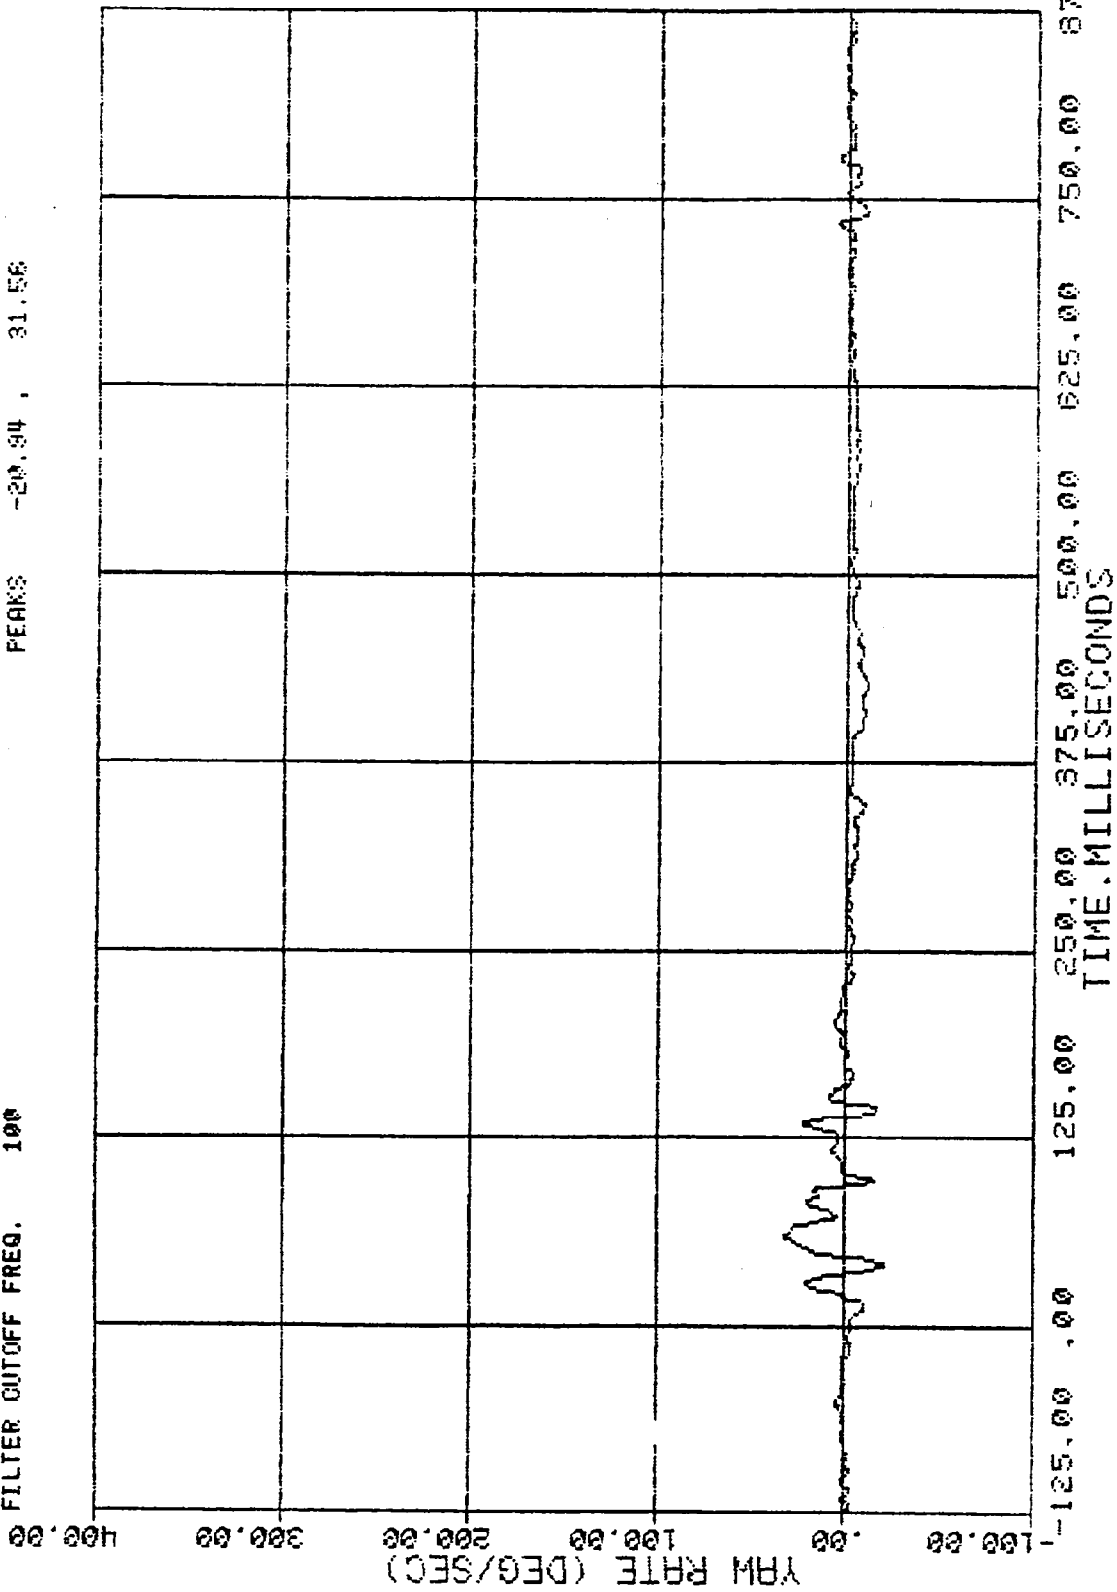
Figure 12. Vehicle Yaw Rate, 100 Hz

CHANNEL 22 VEHICLE YAW RATE
FILTER CUTOFF FREQ. 100

PEAKS -20.94 , 31.56
