LABORATORY PROCEDURES TO DETERMINE THE
BREAKAWAY BEHAVIOR OF LUMINAIRE SUPPORTS
IN MINI-SIZED VEHICLE COLLISIONS

THIRTY MPH BROADSIDE
IMPACT OF A DODGE ST. REGIS
AND A BREAKAWAY LUMINAIRE SUPPORT

TEST RESULTS REPORT

TEST NUMBER 1469-SI#7-85

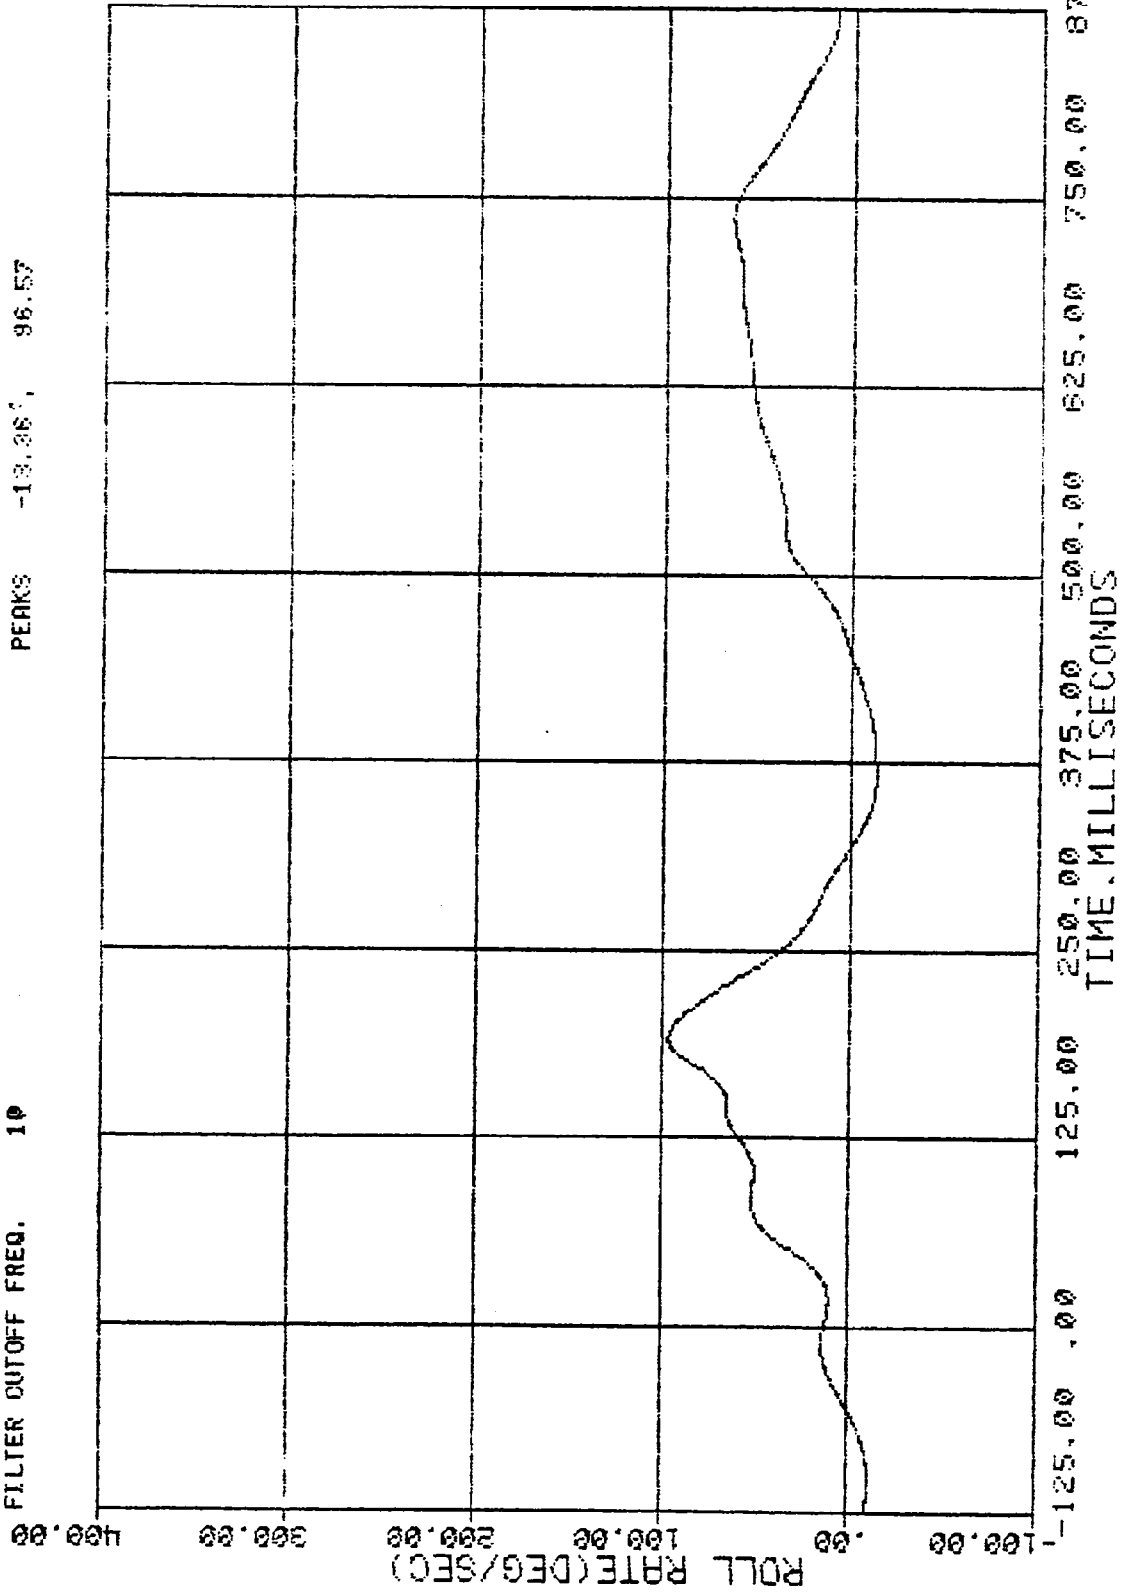
Figure 13. Vehicle Roll Rate, 10 Hz

CHANNEL 21 VEHICLE ROLL RATE
FILTER CUTOFF FREQ. 10

PEAKS -13.36°, 96.57

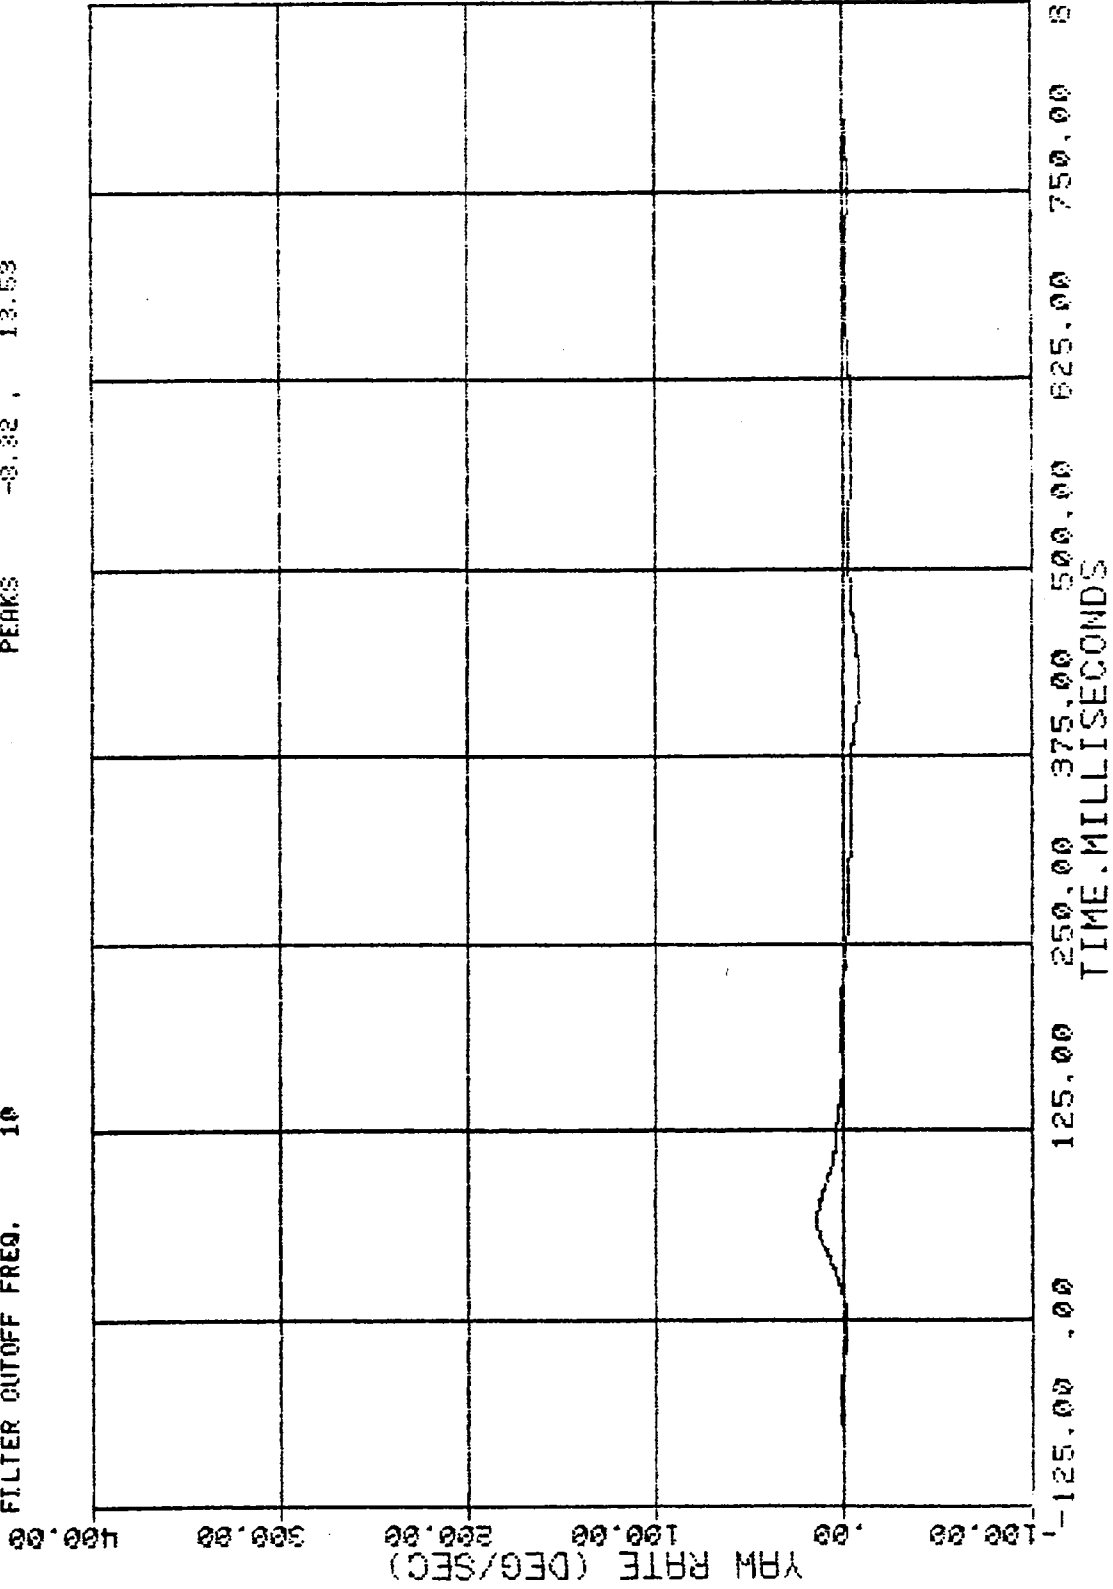
Figure 14. Vehicle Yaw Rate, 10 Hz

CHANNEL 22 VEHICLE YAW RATE

PEAKS -0.32 , 13.53

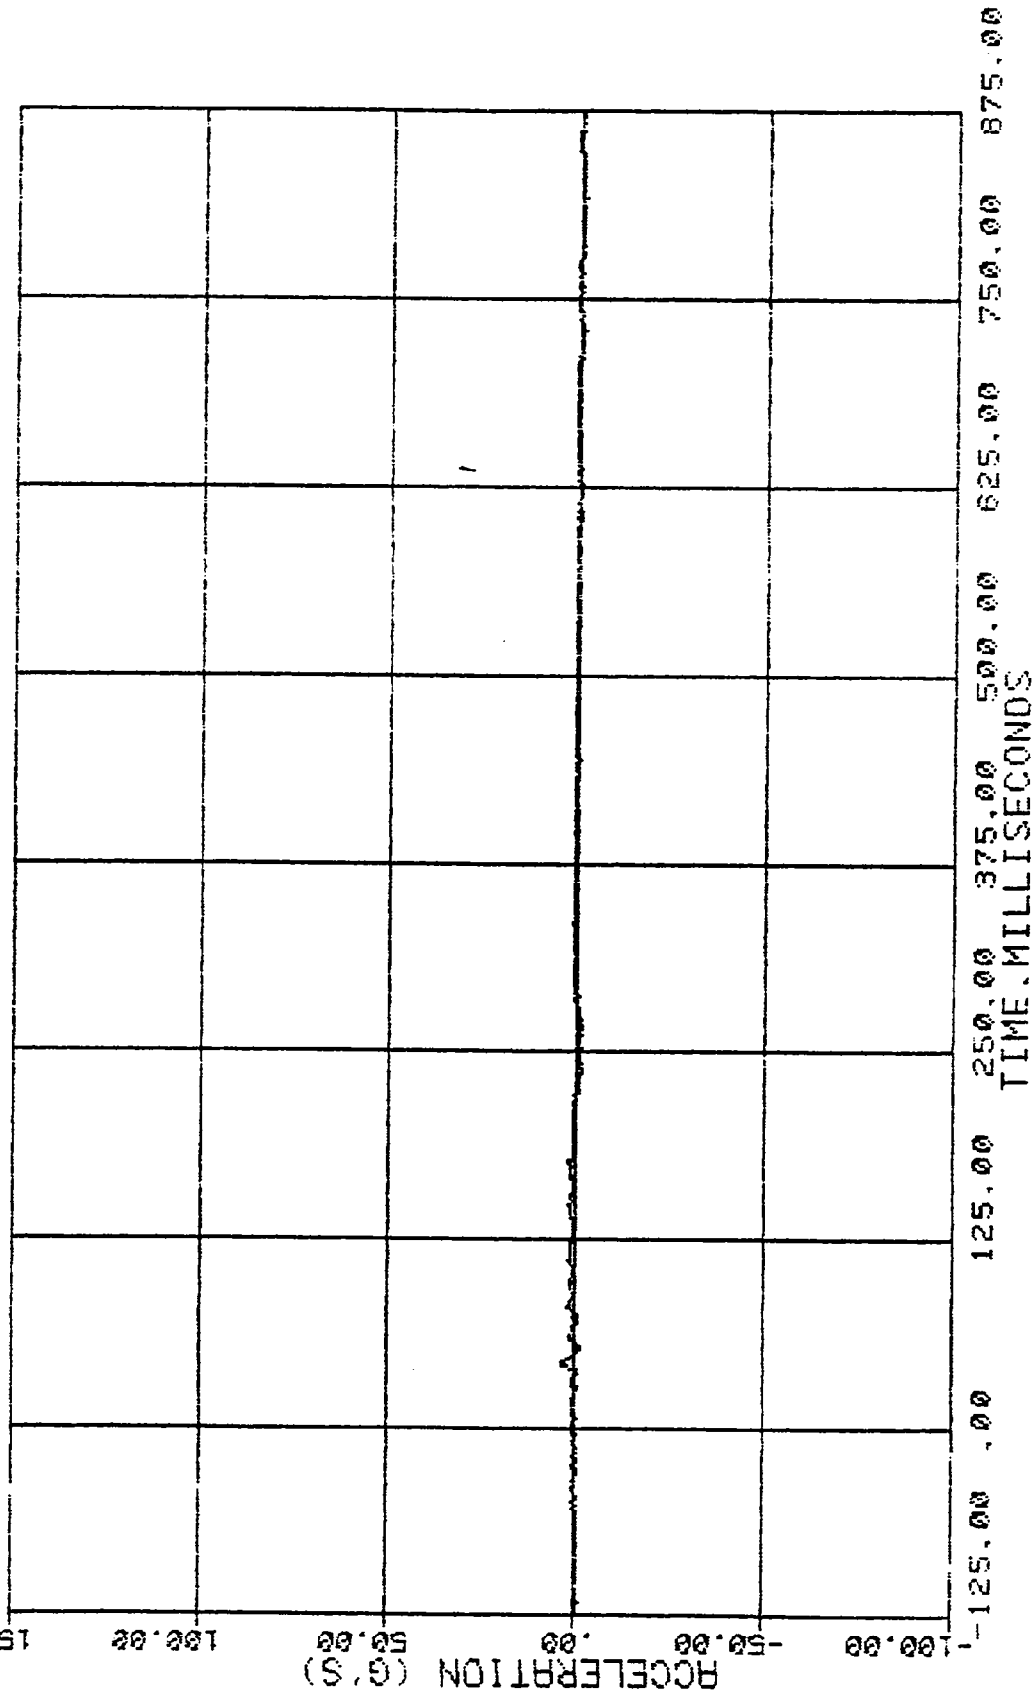
Figure 15. Driver's Head Acceleration, X-Axis, 1650 Hz

CHANNEL 25 DRIVER HEAD ACCELERATION, X-AXIS

PEAKS -1.18 , 3.59

The data obtained from the three accelerometers located in the head of the occupant during the test were filtered at SAE Class 1000 and combined to yield a resultant acceleration occurring during the impact event. The HIC was evaluated in accordance with the procedures outlined in FMVSS 208. The acceleration traces and resultant obtained with the use of the SAE Class 1000 ($f_c = 1,650$ Hz) filtering techniques are presented in figures 15 through 18. The results of the HIC evaluation calculated for the occupant during this test is shown in table 9. Comparing the results to the acceptable limit of 1000 indicates that the collision event was very mild.

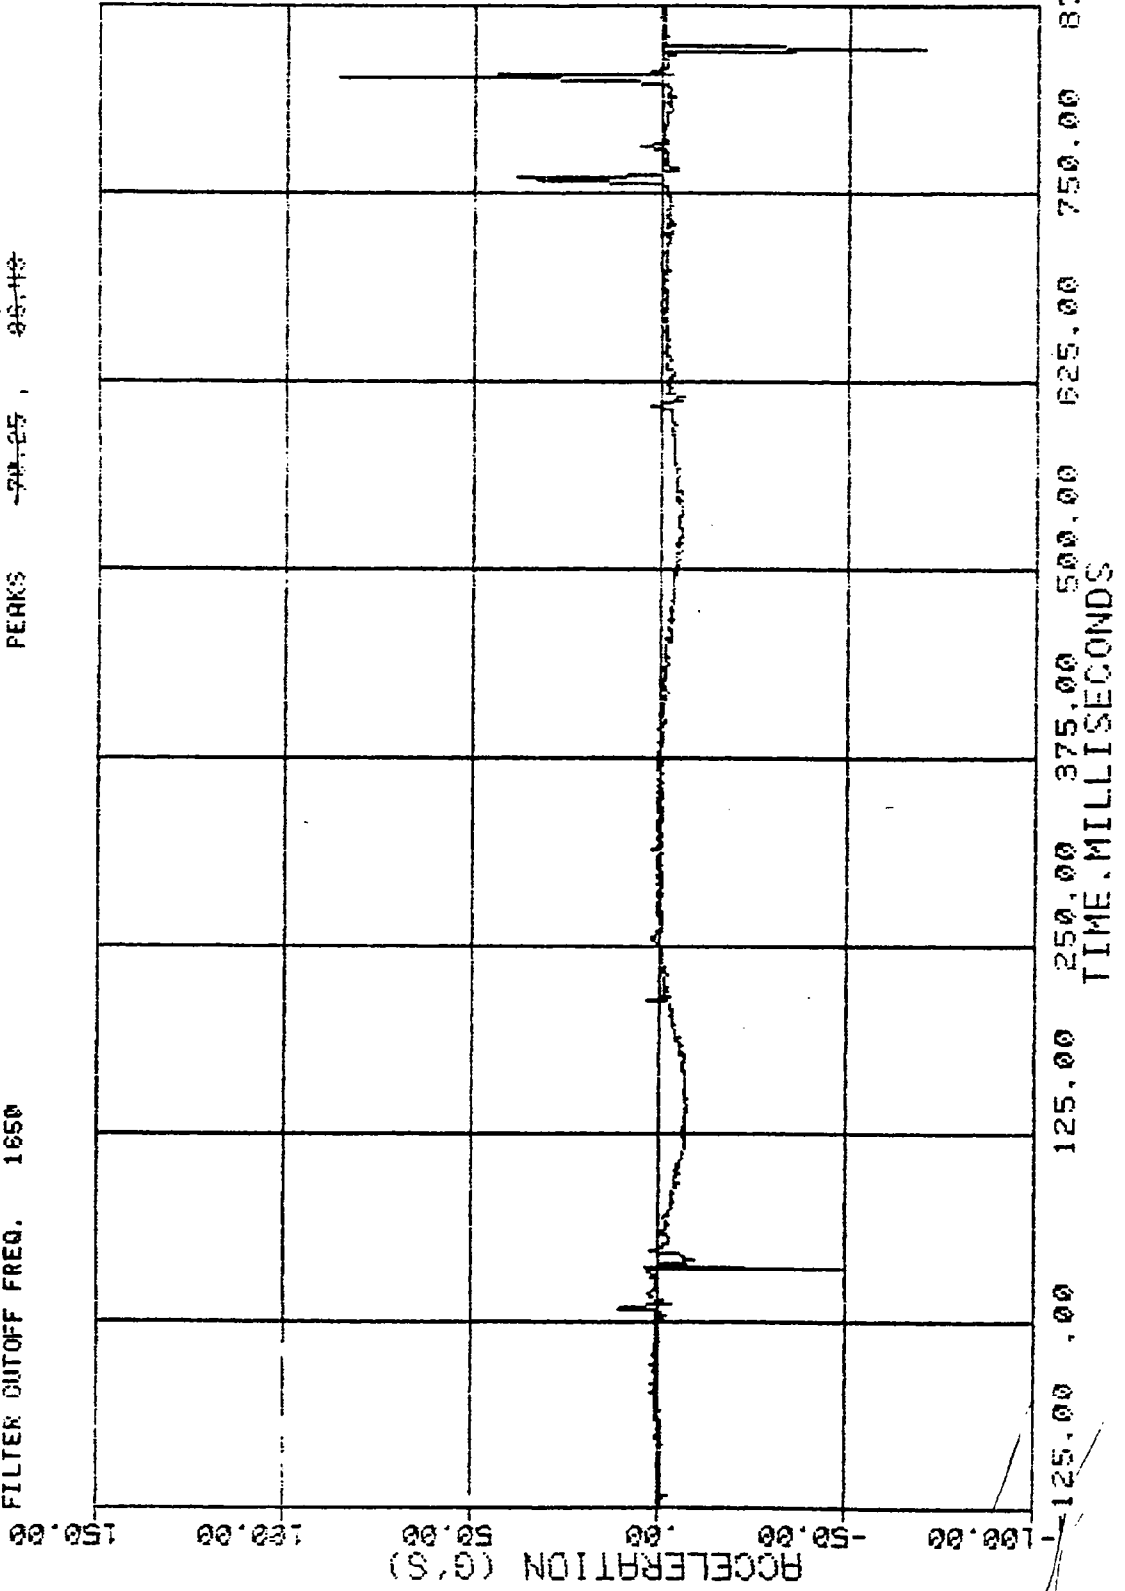
Figure 16. Driver's Head Acceleration, Y-Axis 1650 Hz

CHANNEL 26 DRIVER HEAD ACCELERATION, Y-AXIS
FILTER CUTOFF FREQ. 1650

PEAKS
-49.37 10.22
-74.25 25.44

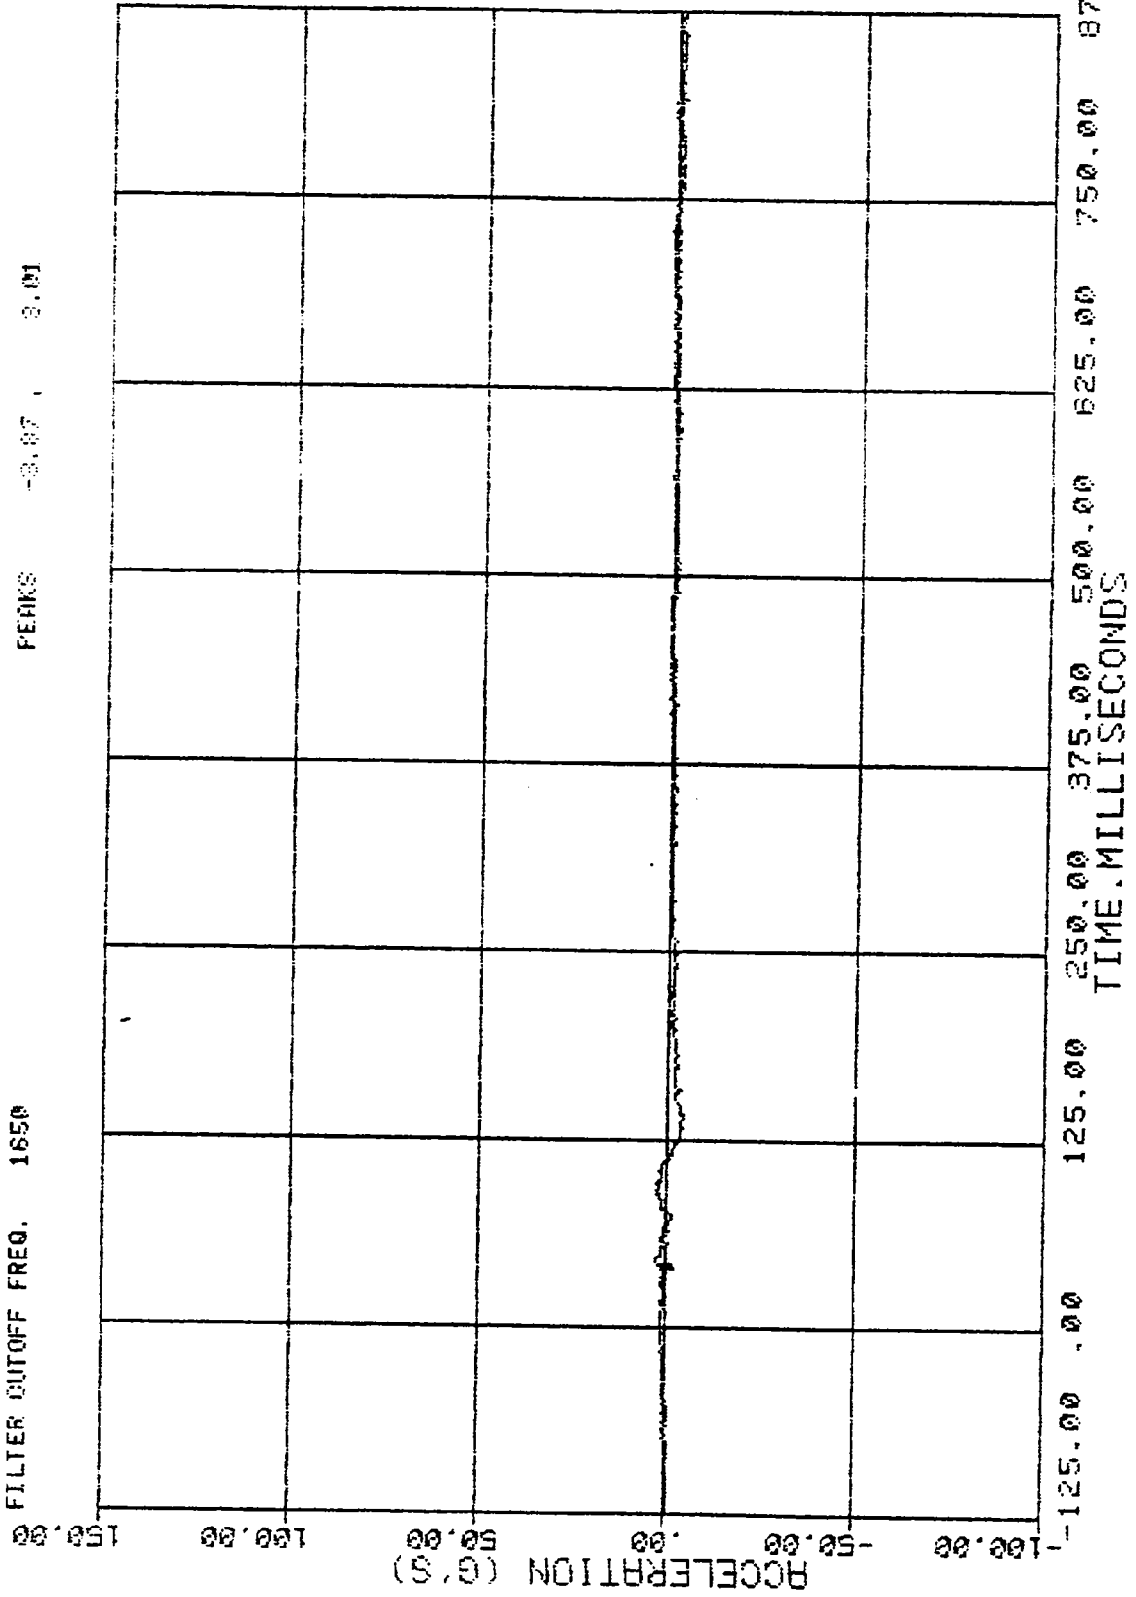
Figure 17. Driver's Head Acceleration, Z-Axi, 1650 Hz

CHANNEL 27 DRIVER HEAD ACCELERATION, Z-AXIS

PEAKS -3.07 3.01

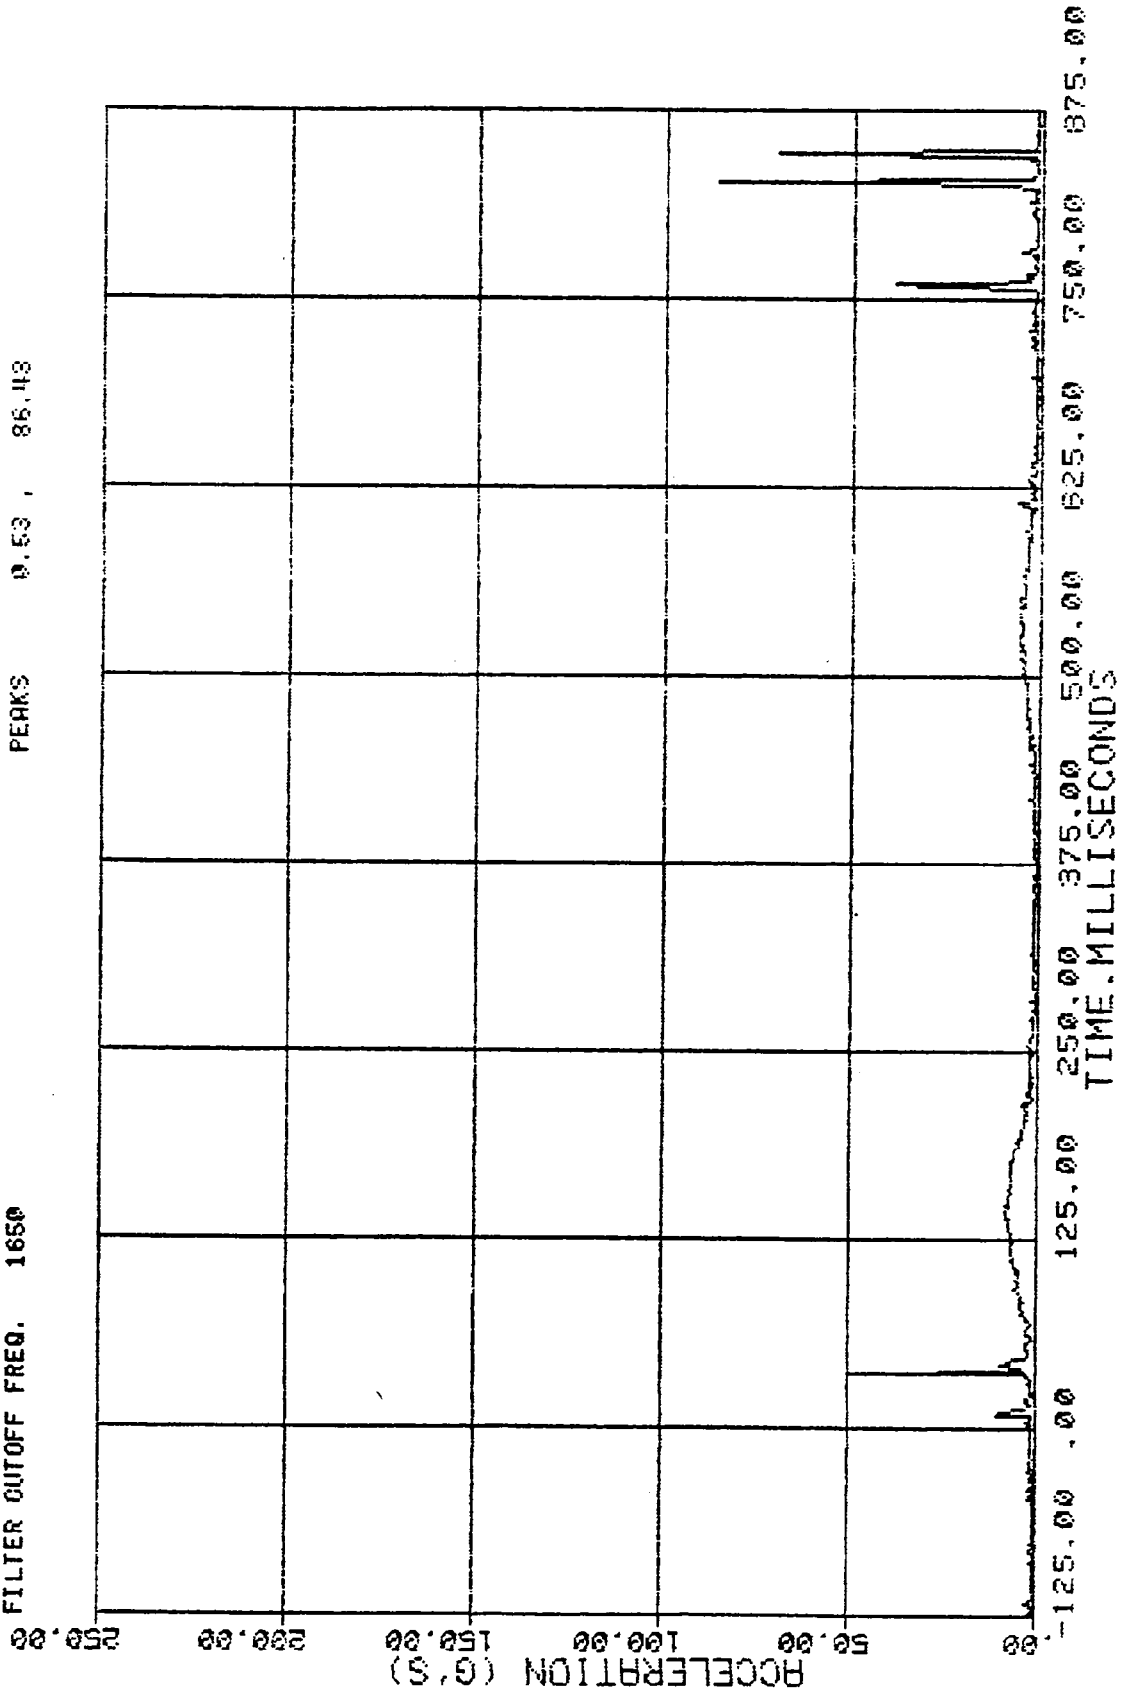
Figure 18. Driver's Head Acceleration, Resultant, 1650 Hz

30 MPH BROADSIDE IMPACT OF 79 DODGE ST REGIS INTO LUMINAIRE SUPPORT
 CHANNEL 0 DRIVER HEAD ACCELERATION, RESULTANT
 FILTER CUTOFF FREQ. 1650 PEAKS 0.53 , 86.43

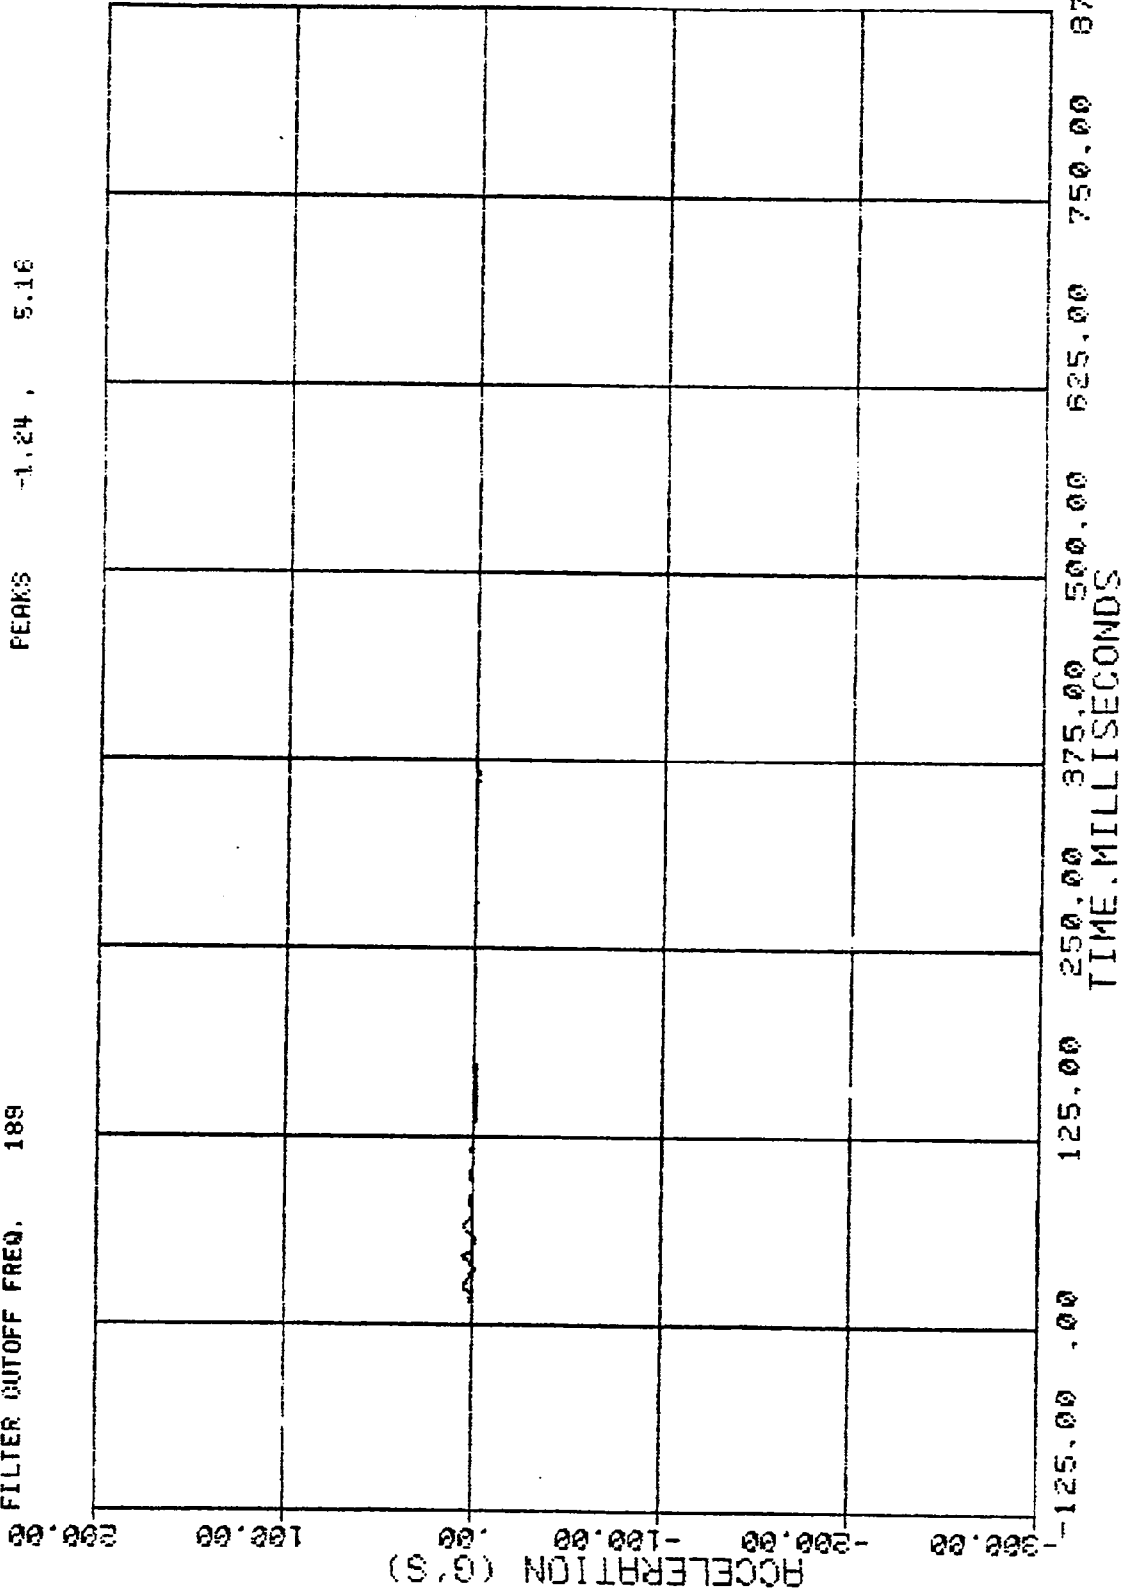
Figure 19. Driver's Upper Spine Acceleration, T01X, 189 Hz

PEAKS -1.24 , 5.16

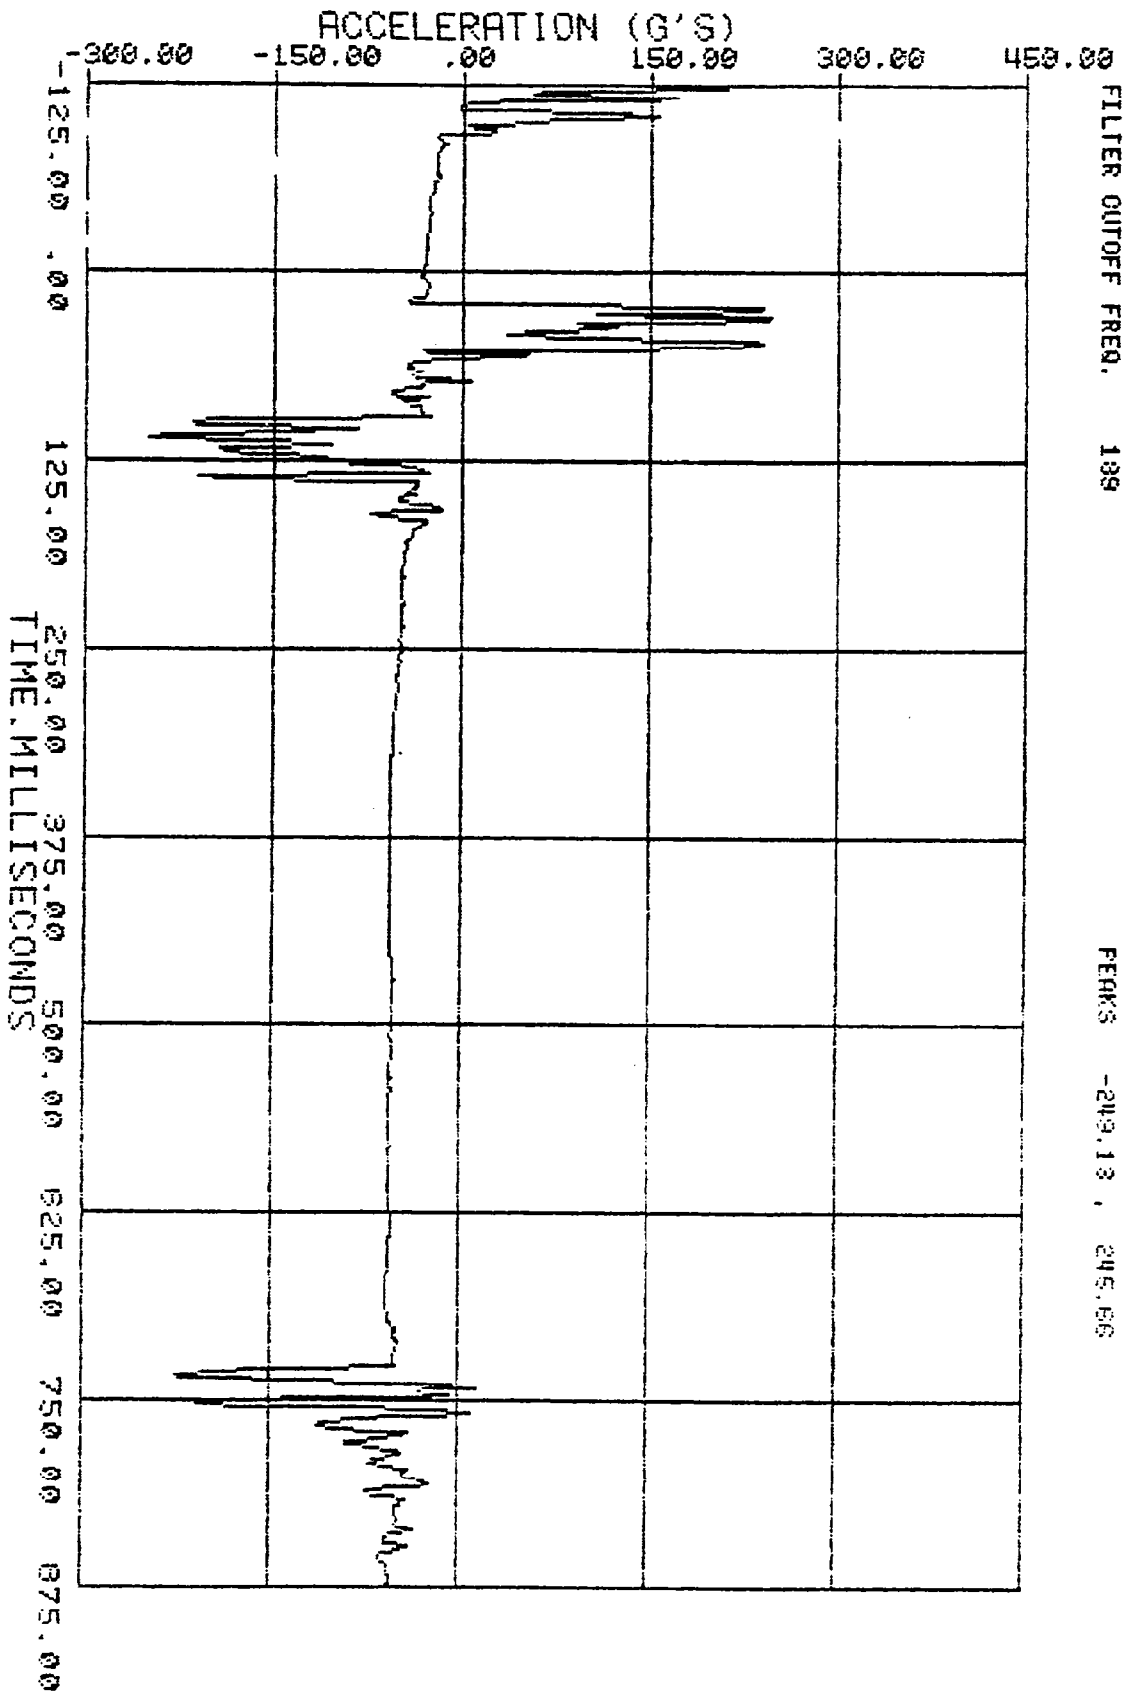
Figure 20. Driver's Upper Spine Acceleration, T01Y, 189 Hz

30 MPH BROADSIDE IMPACT OF 79 DODGE ST REGIS INTO LUMINAIRE SUPPORT
 CHANNEL 2 DRIVER THORAX-T01YH
 FILTER CUTOFF FREQ. 189
 PEAKS -249.13 , 245.66

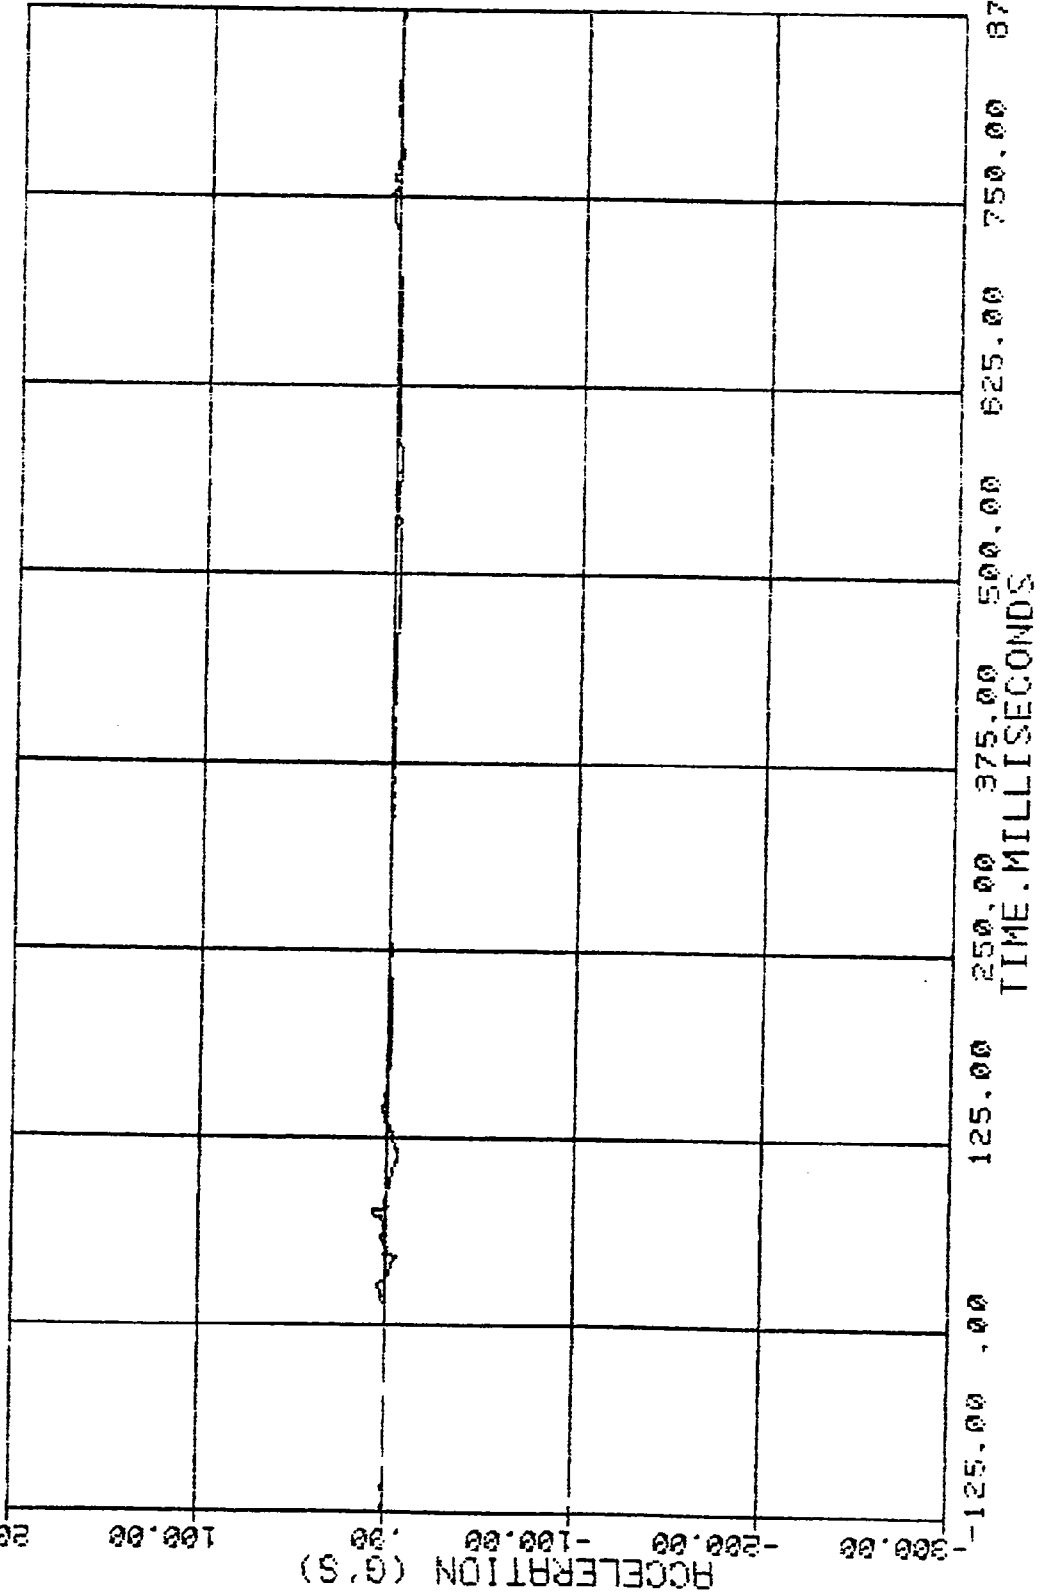
Figure 21. Driver's Upper Spine Acceleration, T01YA, 189 Hz

3P MPH BROADSIDE IMPACT OF 79 PODGE ST REDIS INTO LUMINAIRE SUPPORT
 CHANNEL 3 DRIVER THORAX-T01Y01
 FILTER CUTOFF FREQ. 189

PEAKS -6.14 , 6.98

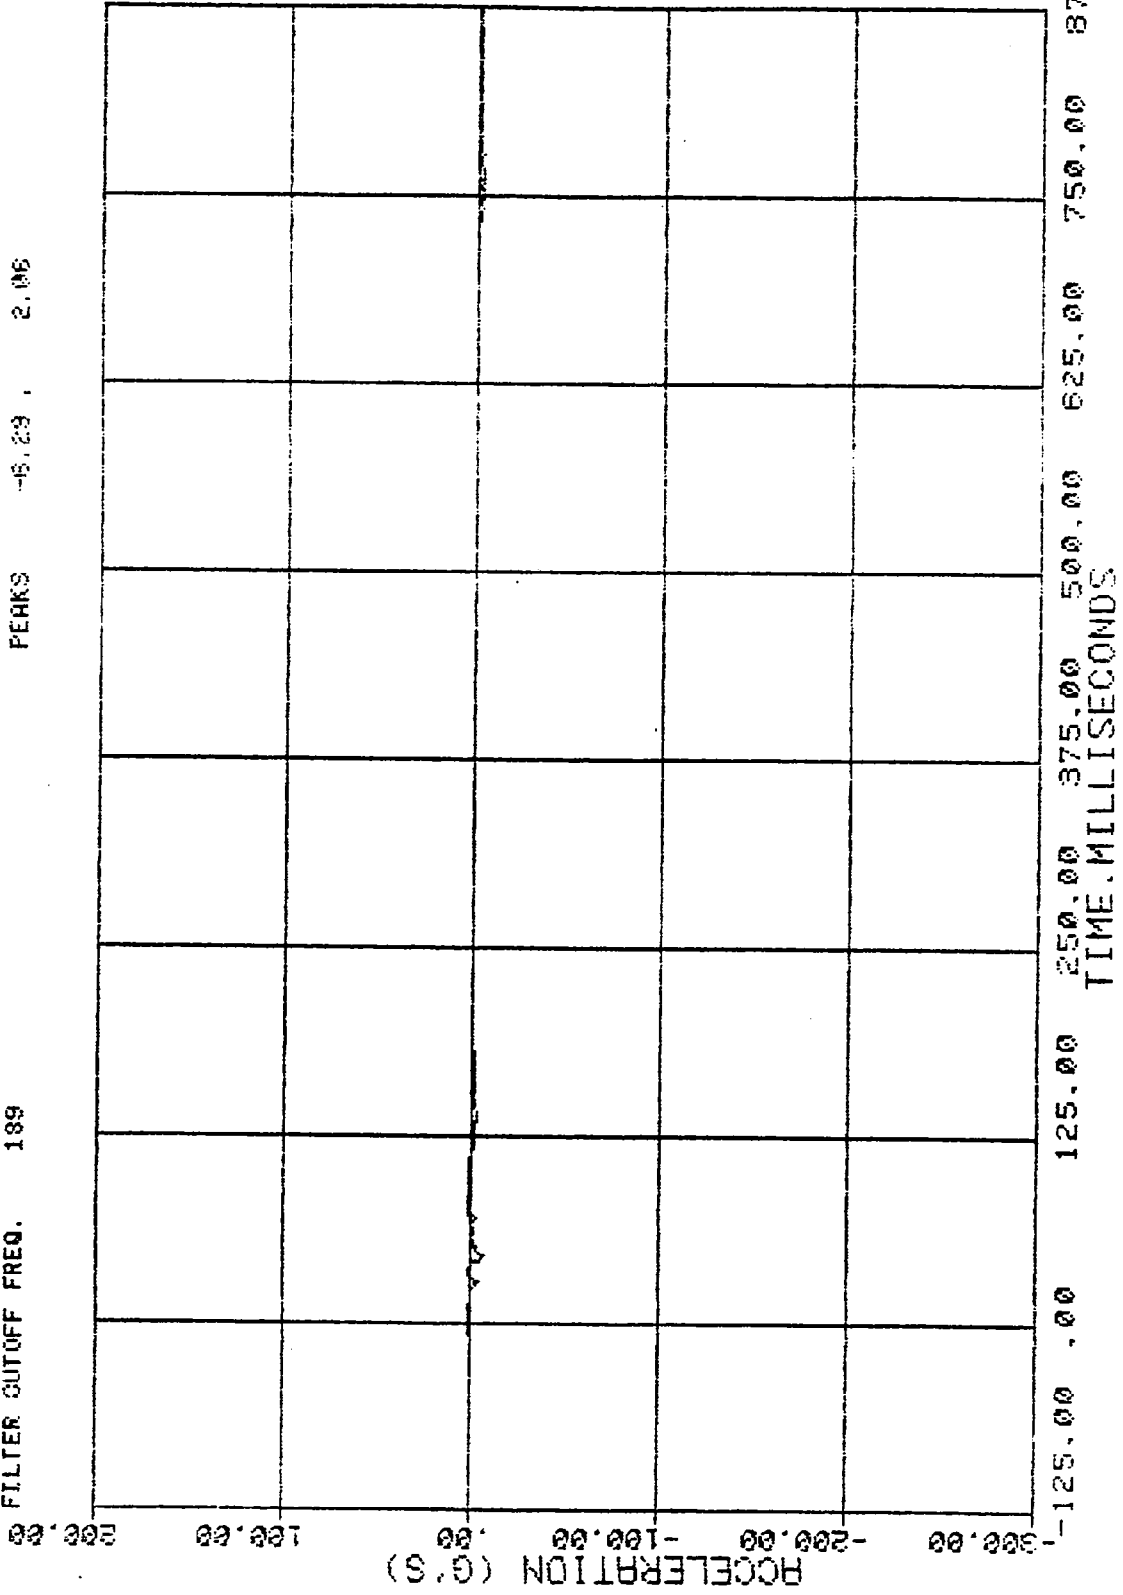
Figure 22. Driver's Upper Spine Acceleration, T01Z, 189 Hz

PEAKS -5.29 , 2.06

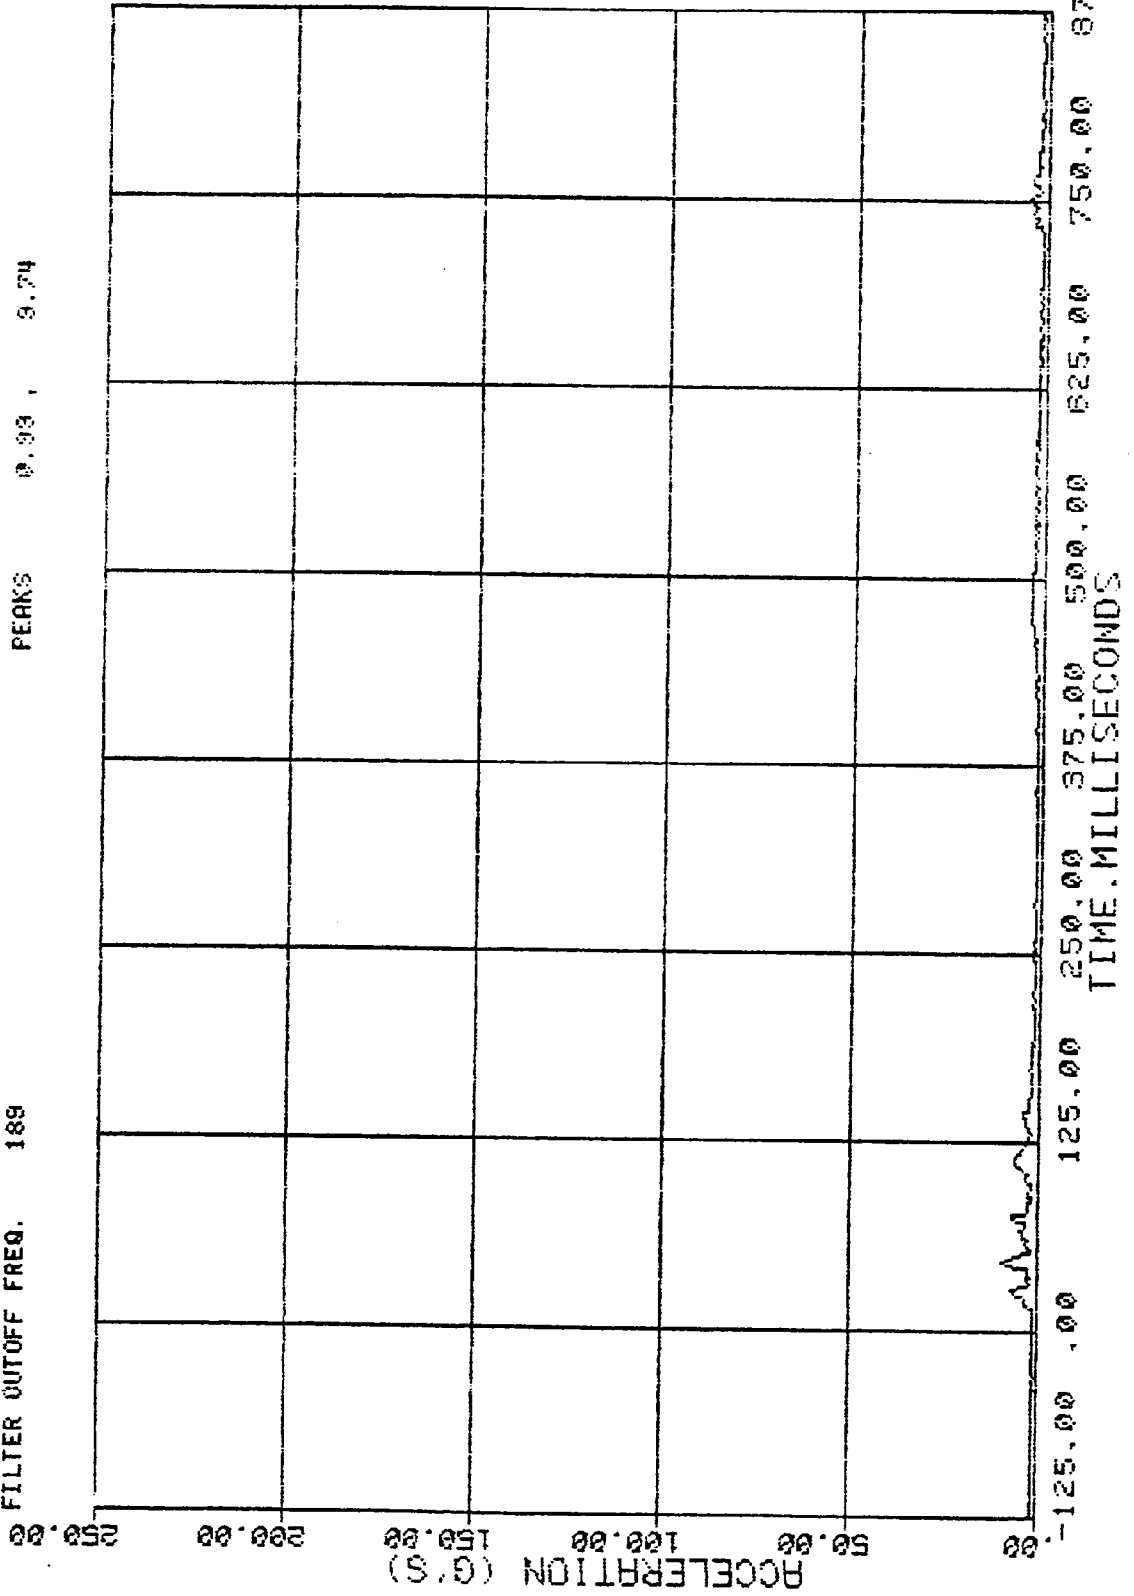
Figure 23. Driver's Upper Spine Acceleration, Resultant, 189 Hz

30 MPH BROADSIDE IMPACT OF 79 DODGE ST REOIS INTO LUMINAIRE SUPPORT
 CHANNEL 8 DRIVER UPPER SPINE, RESULTANT
 FILTER CUTOFF FREQ. 189 PEAKS 0.00 , 9.74

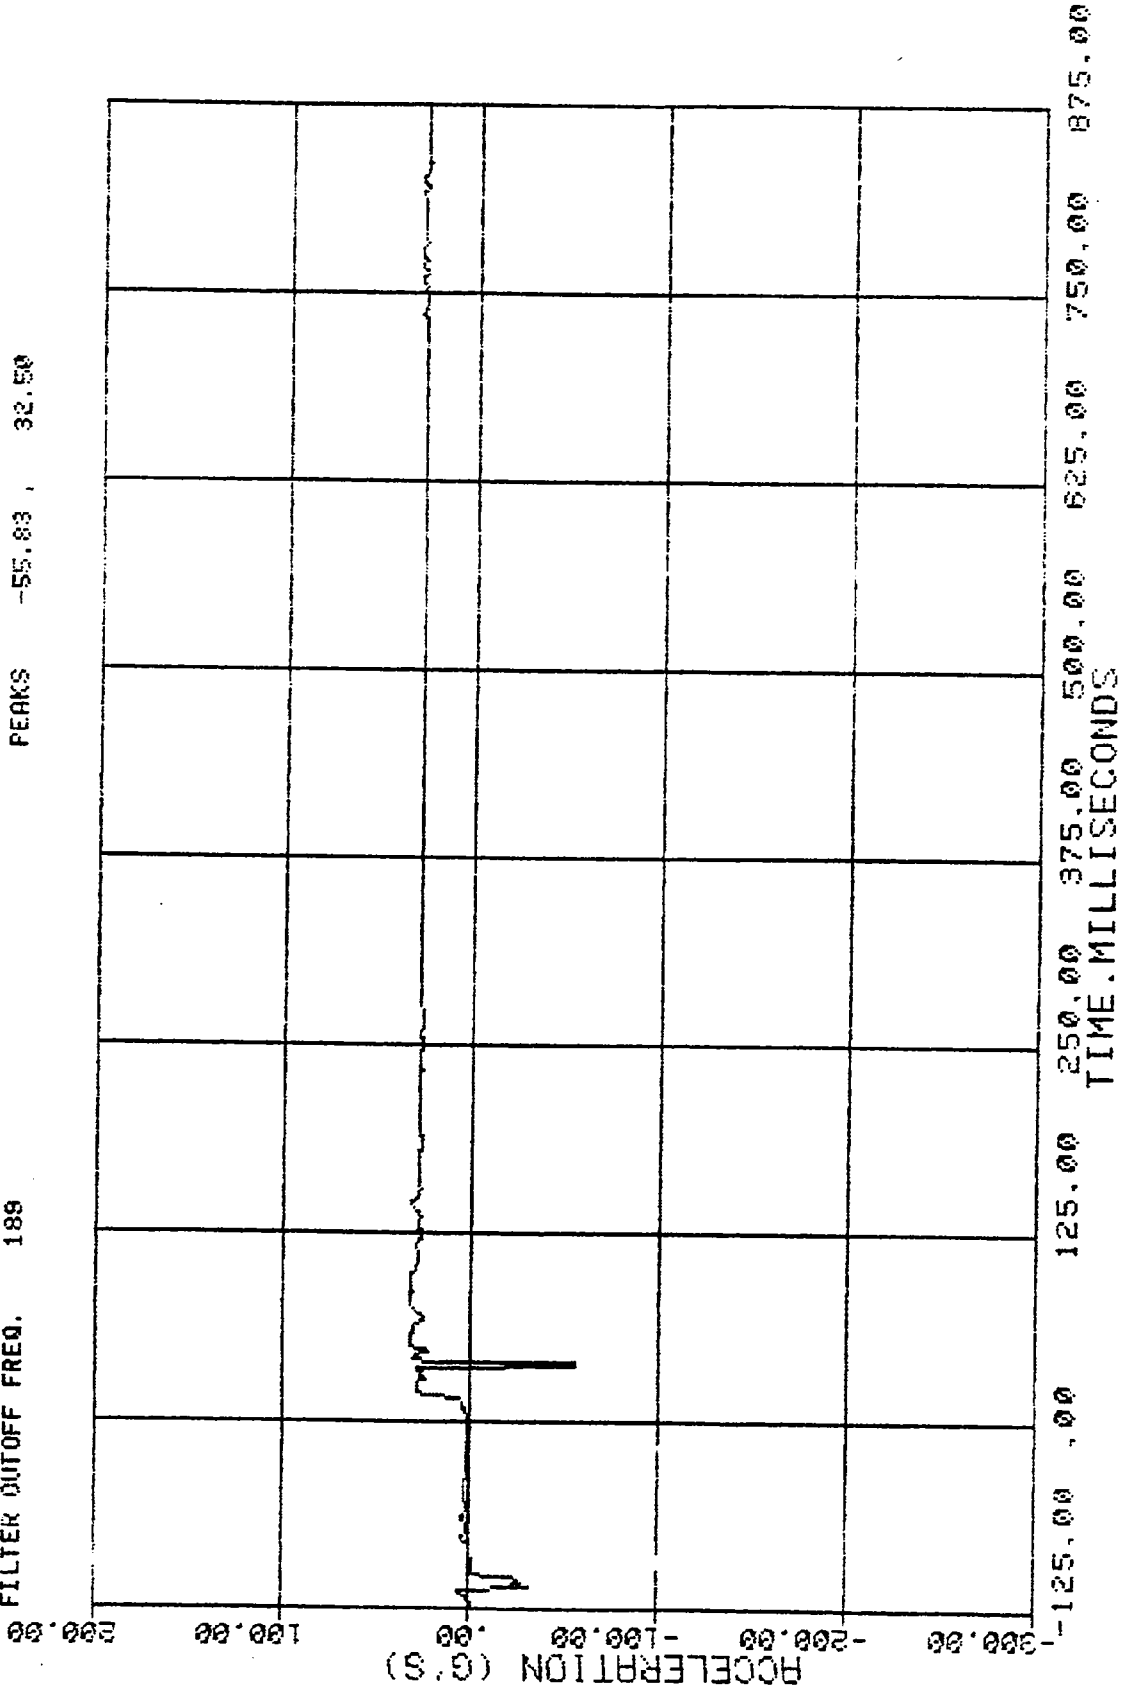
Figure 24. Driver's Lower Spine Acceleration, T12X, 189 Hz

PEAKS -55.83 , 32.50
