LABORATORY PROCEDURES TO DETERMINE THE
BREAKAWAY BEHAVIOR OF LUMINAIRE SUPPORTS
IN MINI-SIZED VEHICLE COLLISIONS

THIRTY MPH BROADSIDE
IMPACT OF A DODGE ST. REGIS
AND A BREAKAWAY LUMINAIRE SUPPORT

TEST RESULTS REPORT

TEST NUMBER 1469-SI#7-85

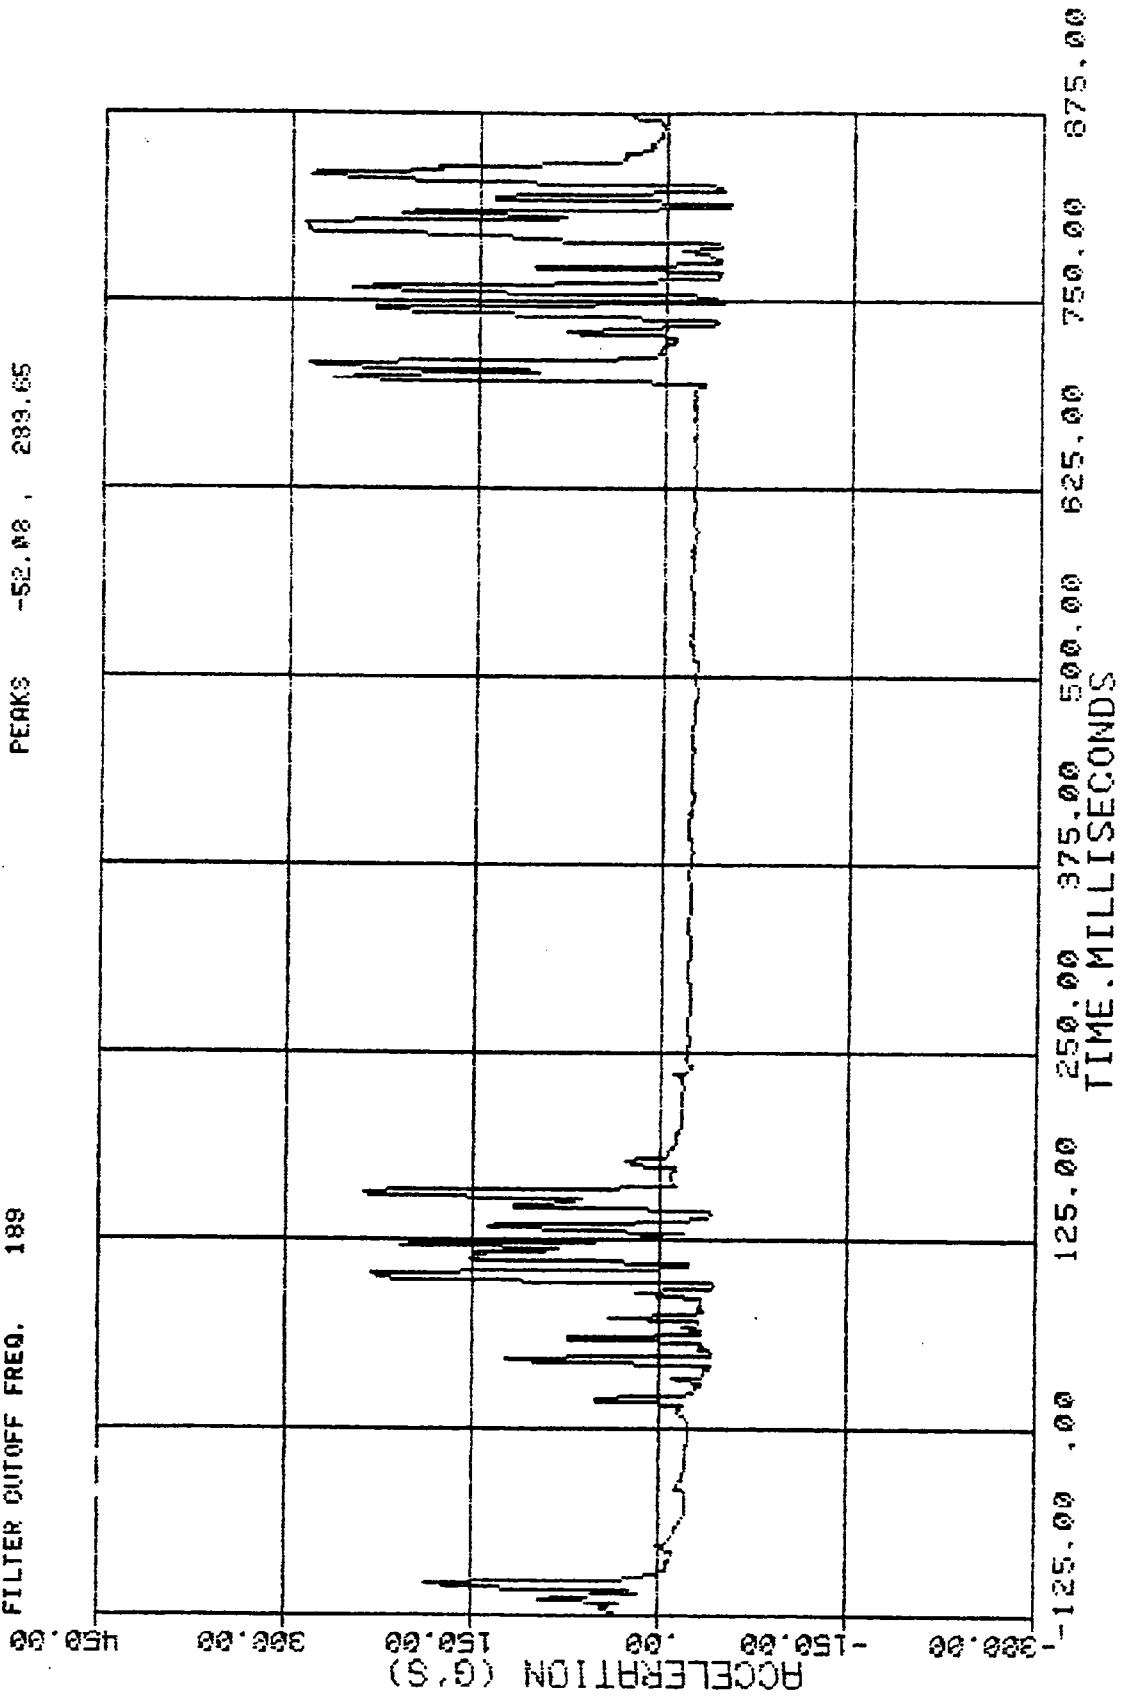
Figure 23. Driver's Lower Spine Acceleration, T12YA, 189 Hz

CHANNEL 10 DRIVER THORAX-T12Y0A
FILTER CUTOFF FREQ. 189

PEAKS -52.48 289.65

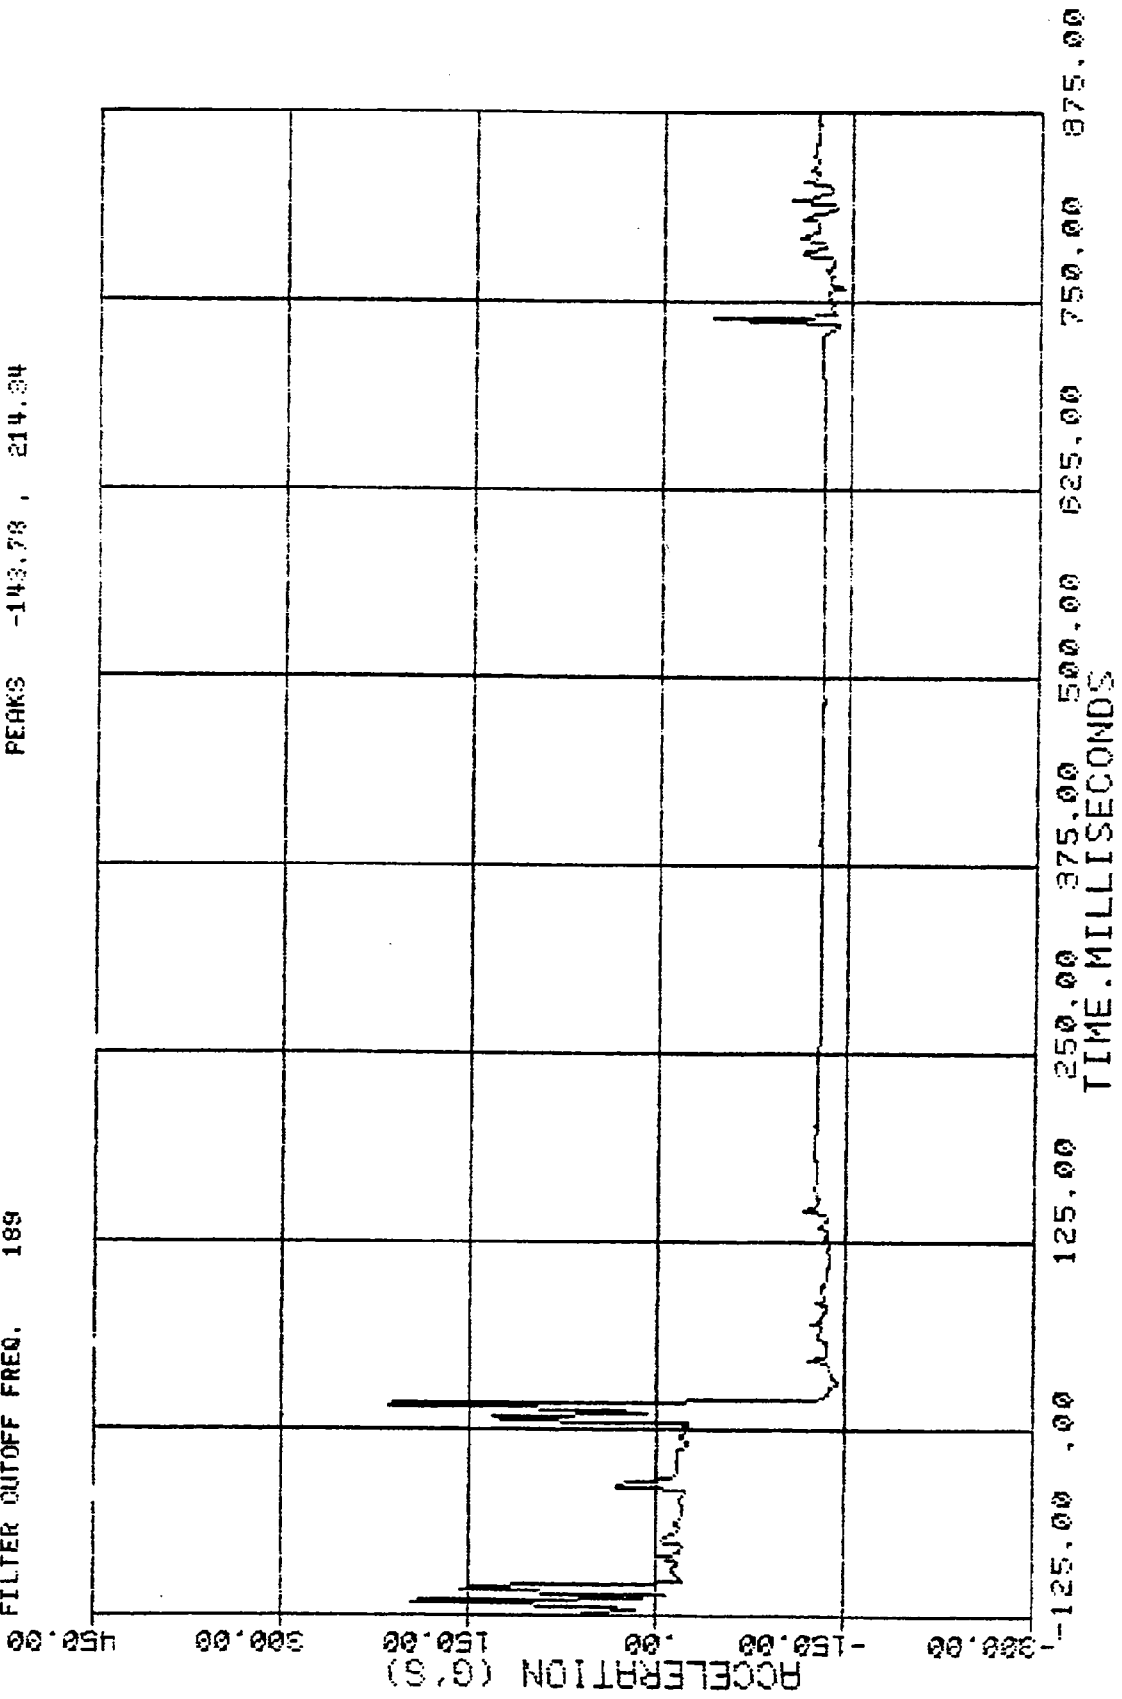
Figure 26. Driver's Lower Spine Acceleration, T12Y, 189 Hz

CHANNEL 11 DRIVER THORAX-T12Y01

PEAKS -143.78 , 214.34

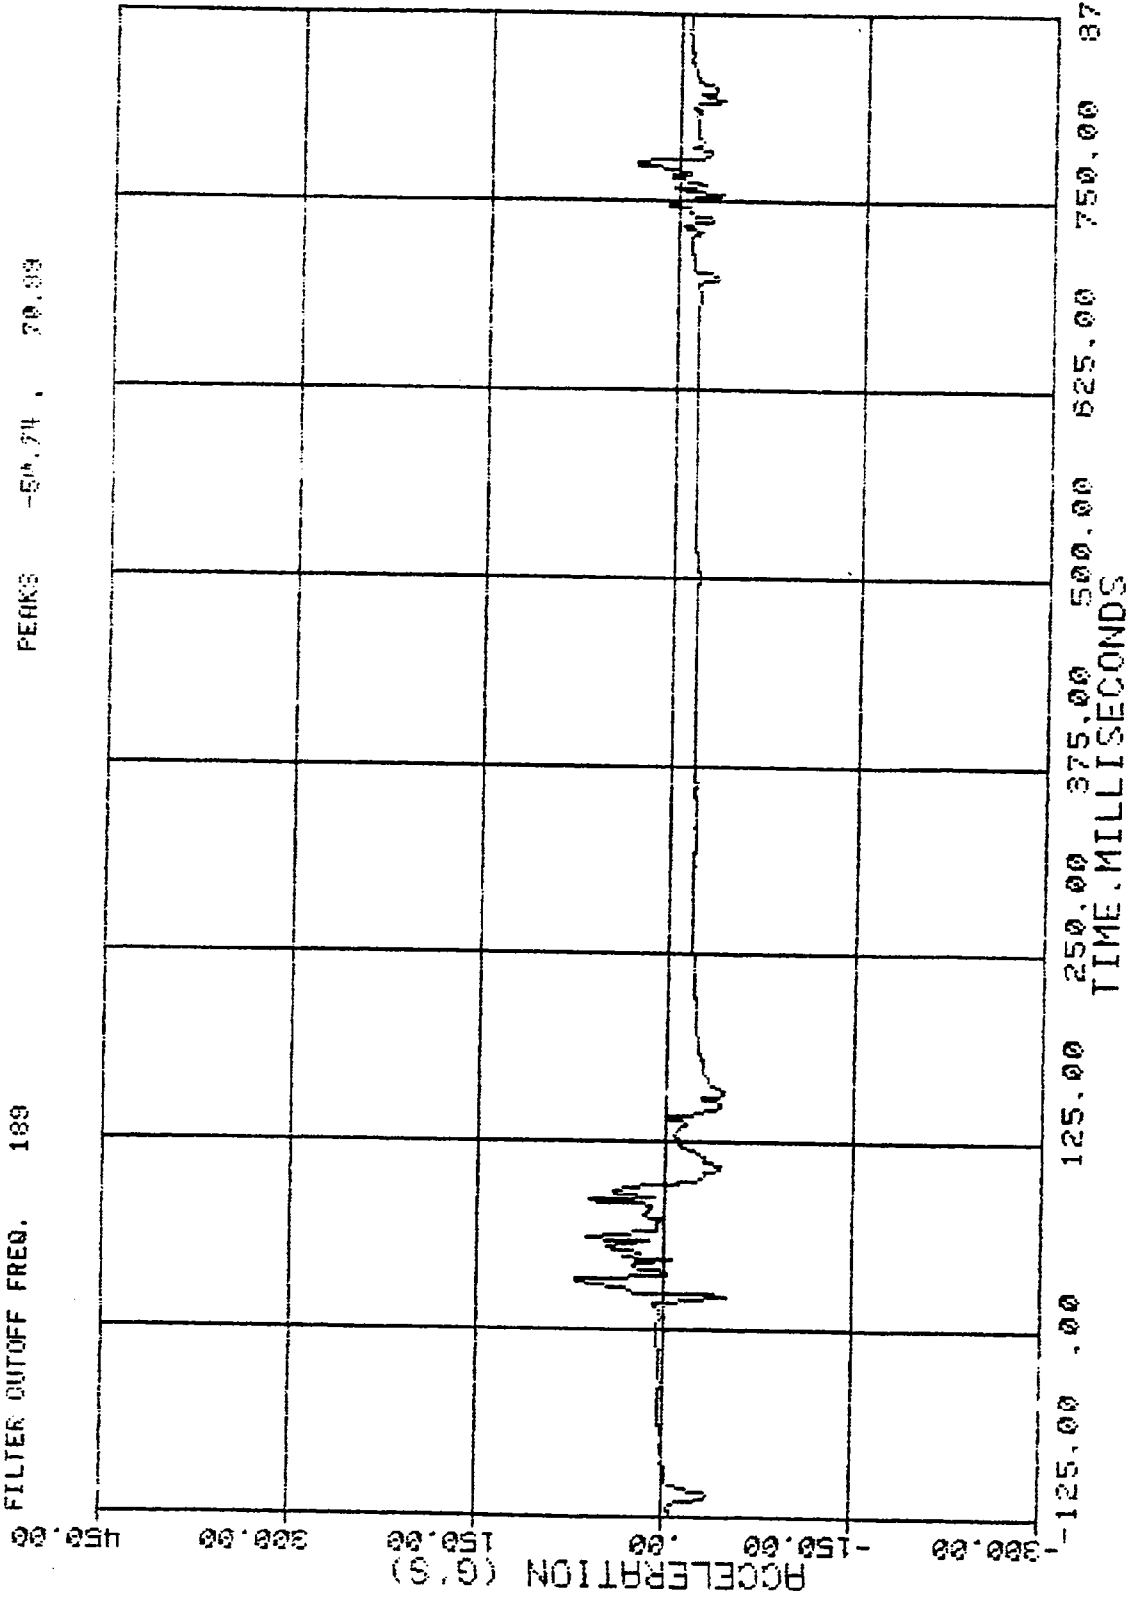
Figure 27. Driver's Lower Spine Acceleration, T12Z, 189 Hz

CHANNEL 12 DRIVER THORAX-T12201
FILTER CUTOFF FREQ. 189

PEAKS -54.74, 30.03

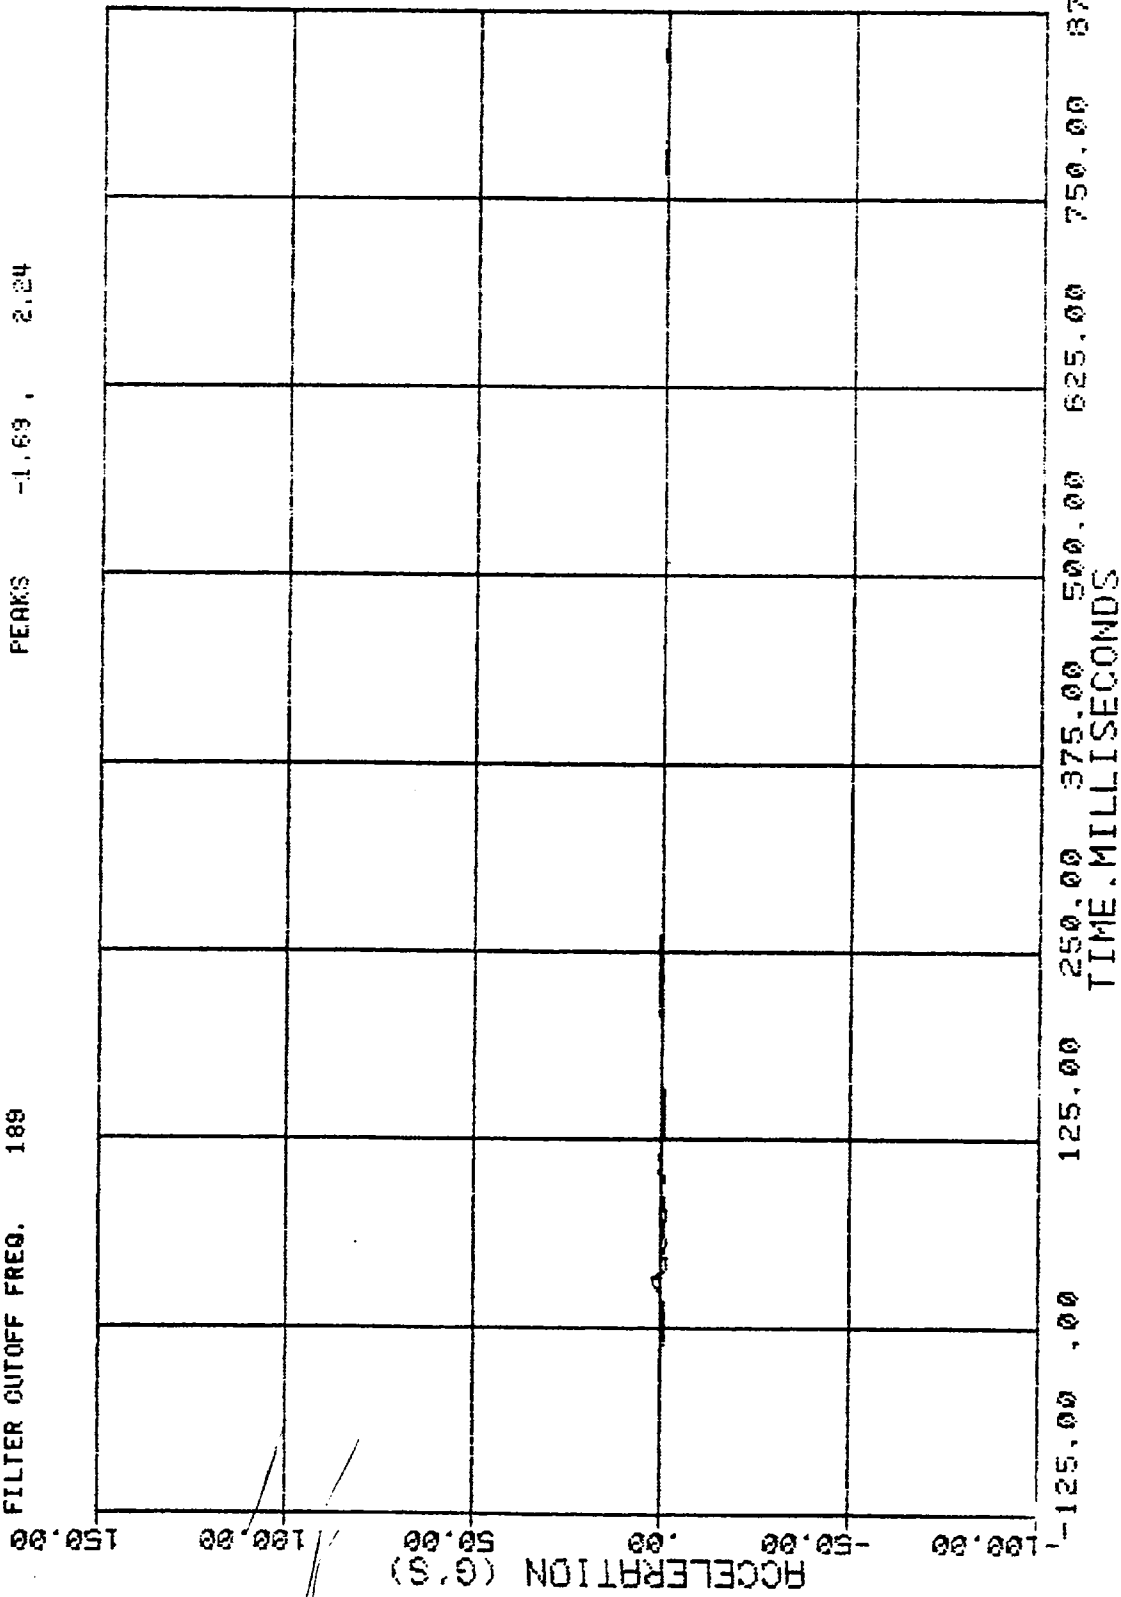
Figure 28. Driver's Pelvic Acceleration, X-Axis, 189 Hz

CHANNEL 28 DRIVER PELVIC ACCELERATION, X-AXIS
FILTER CUTOFF FREQ. 189 PEAKS -1.69 , 2.24

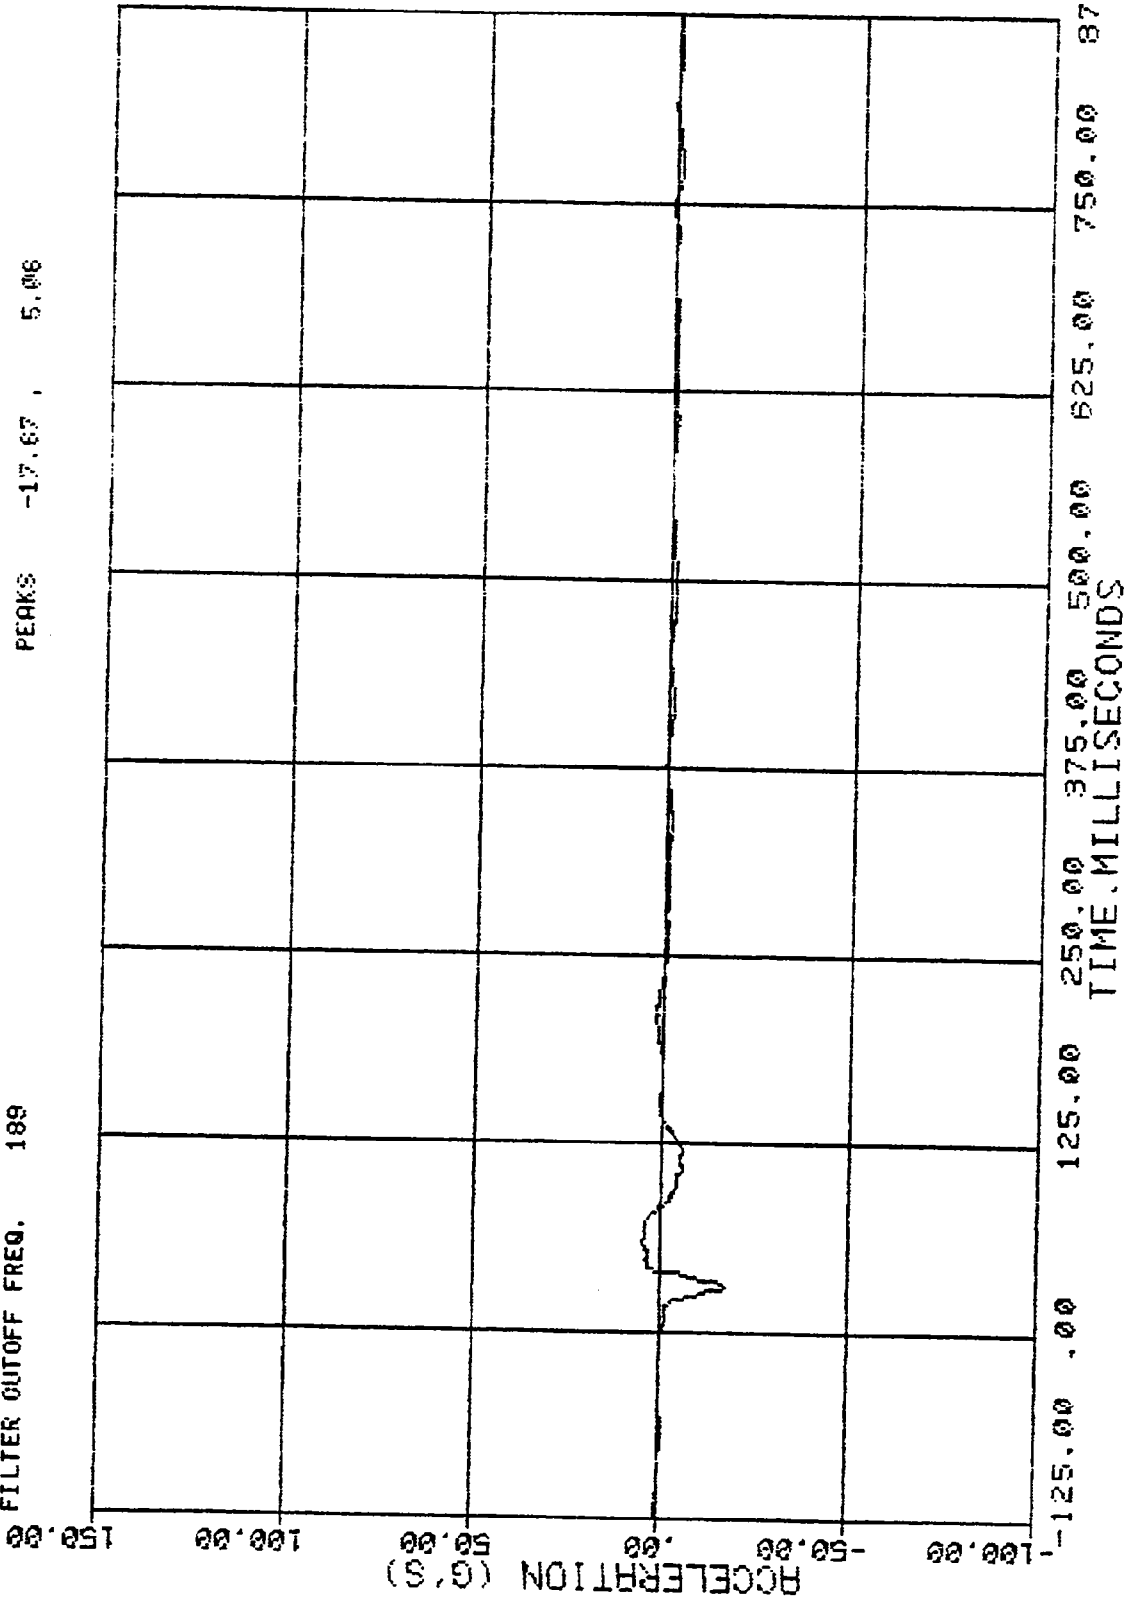
Figure 29. Driver's Pelvis Acceleration, Y-Axis, 189 Hz

CHANNEL 29 DRIVER PELVIC ACCELERATION, Y-AXIS
FILTER CUTOFF FREQ. 189

PEAKS -17.67 , 5.06

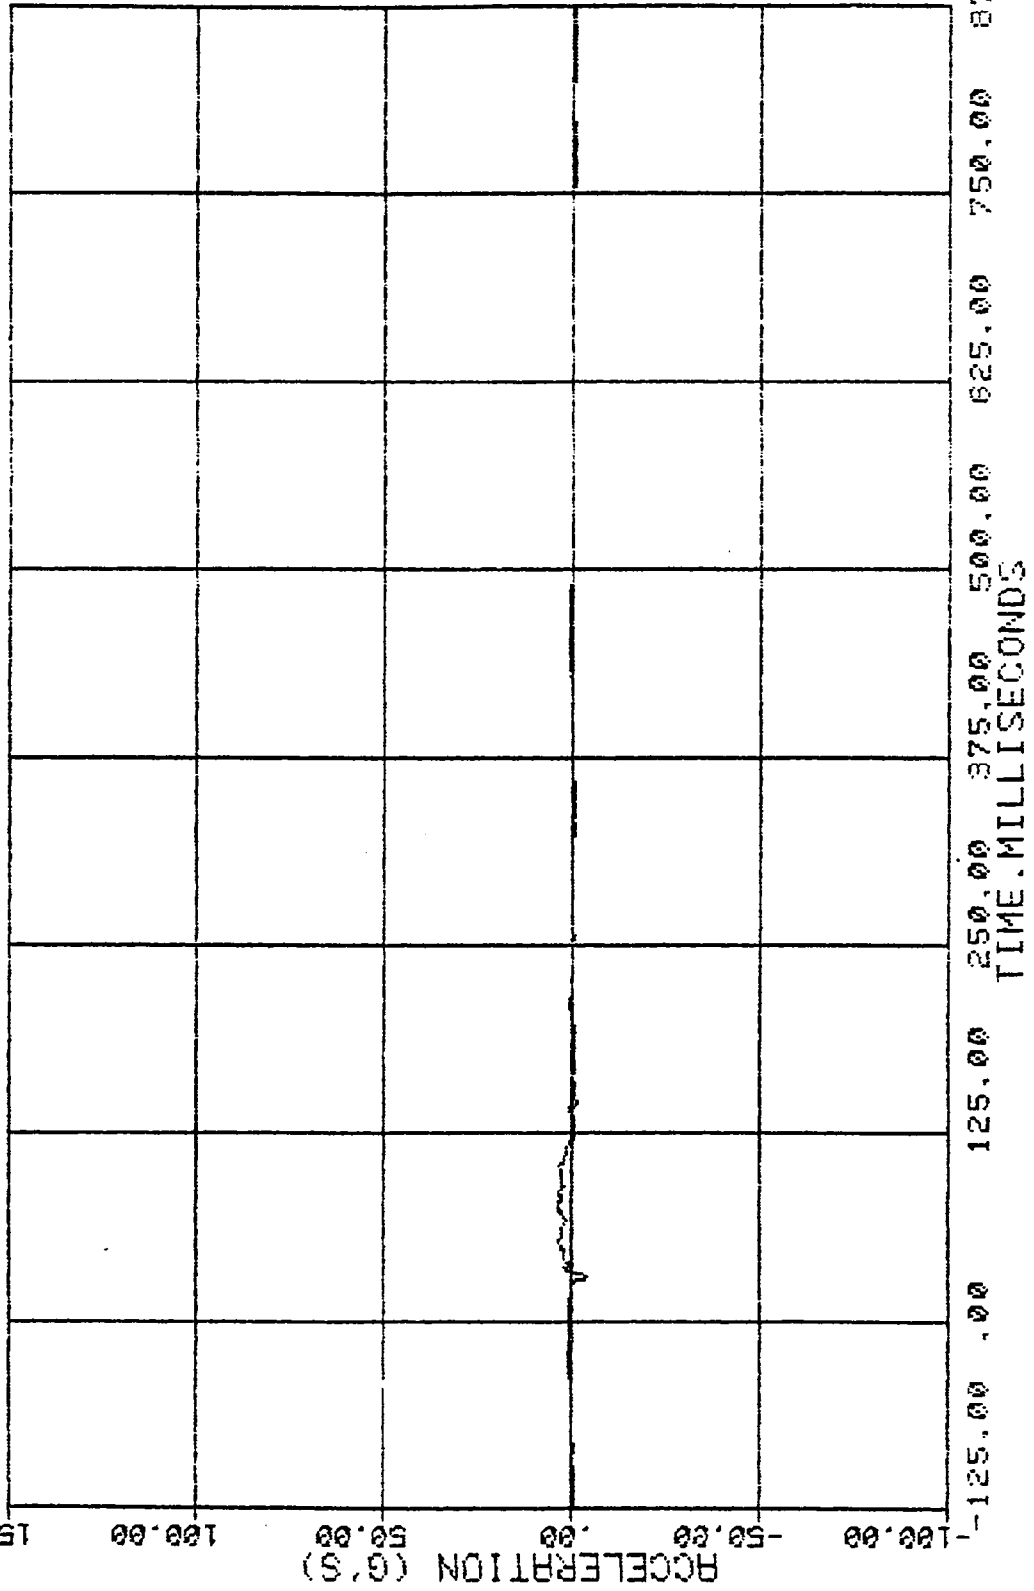
Figure 30. Driver's Pelvis Acceleration, Z-Axis, 189 Hz

PEAKS -3.89 , 3.57

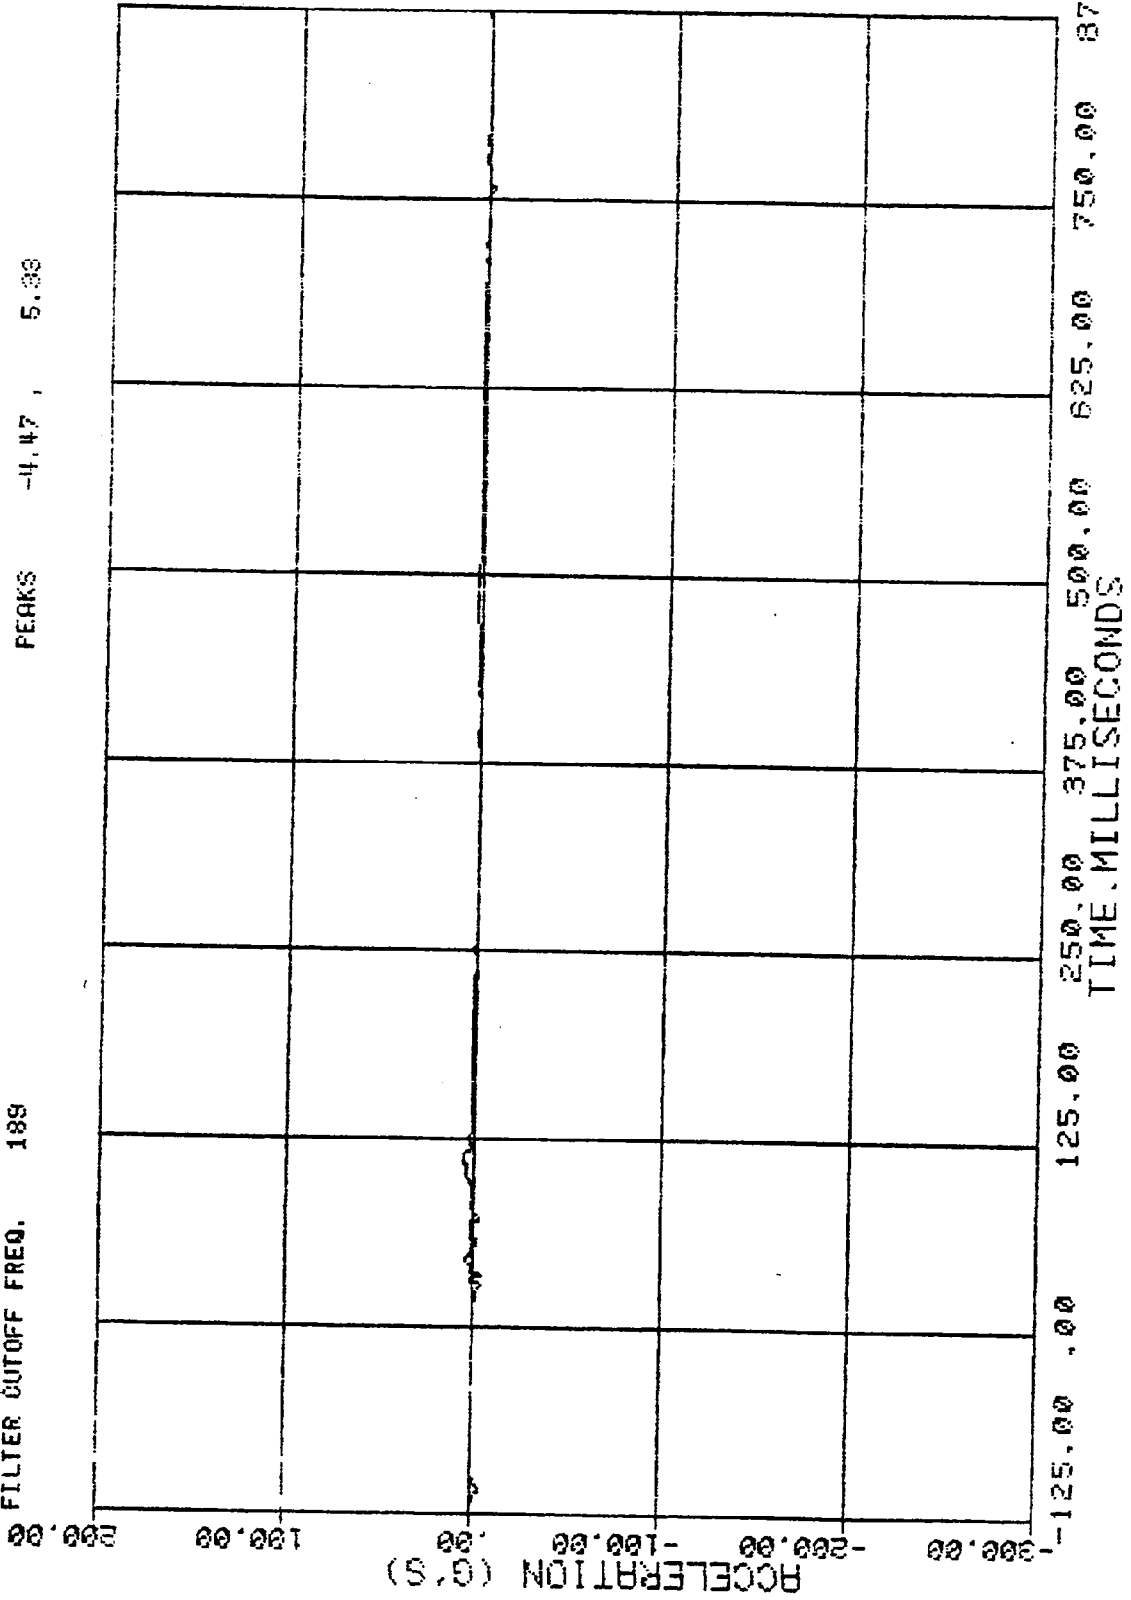
Figure 31. Driver's Left Upper Rib Acceleration, LURY, 189 Hz

PEAKS -4.47 , 5.33

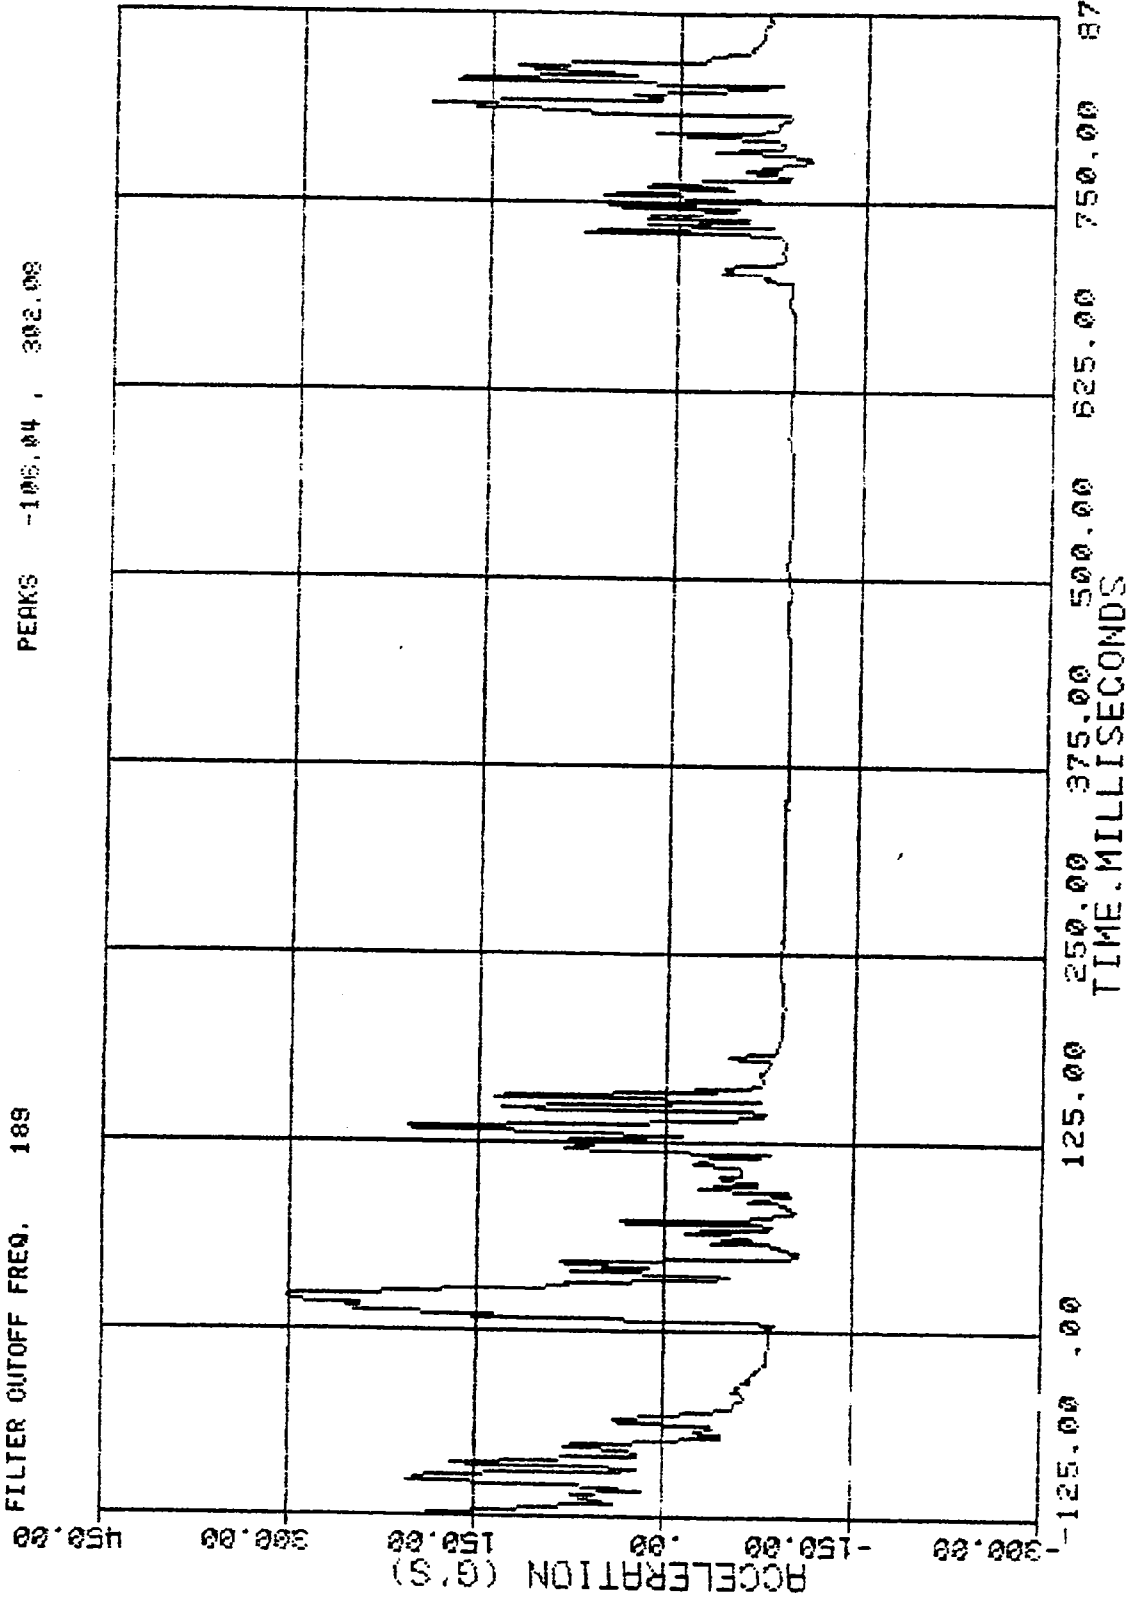
Figure 32. Driver's Left Upper Rib Acceleration, LURYA, 189 Hz

CHANNEL 7 DRIVER THORAX-LURYA
FILTER CUTOFF FREQ. 189

PEAKS -106.04 , 302.08

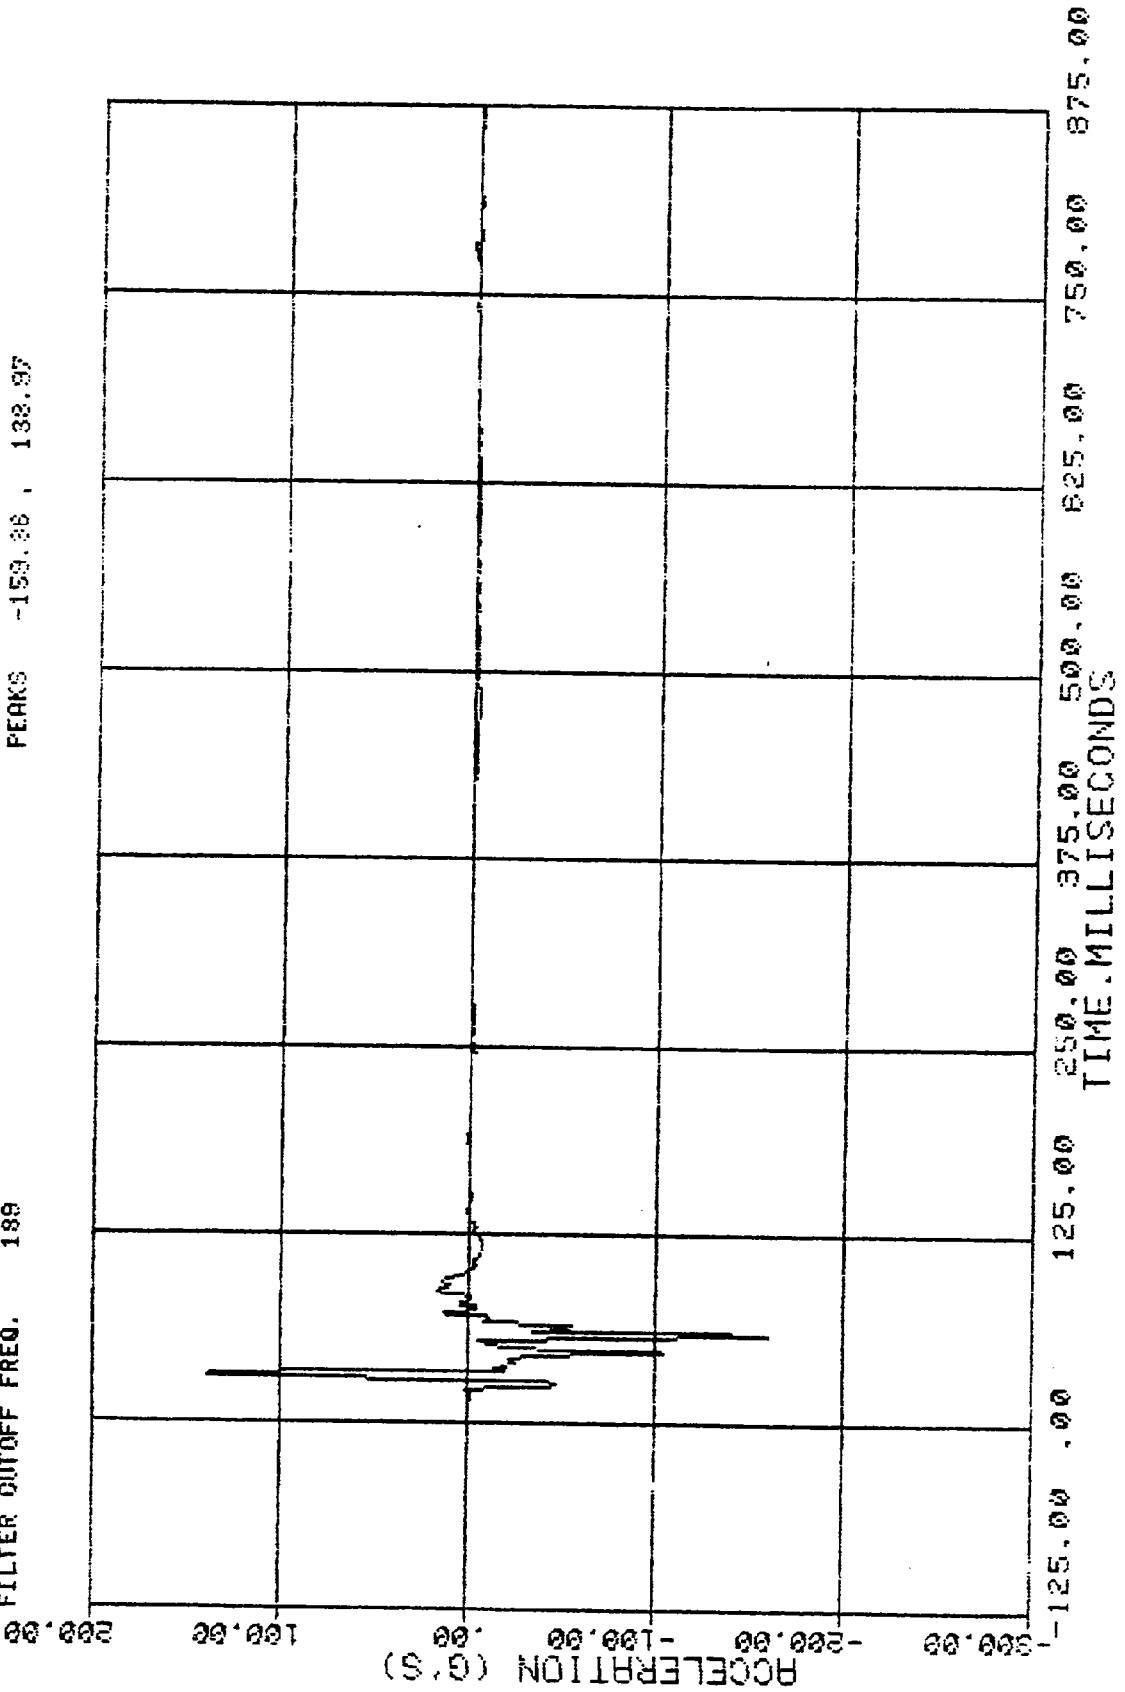
Figure 33. Driver's Left Lower Rib Acceleration, LLRY, 189 Hz

PEAKS -159.86 , 138.97

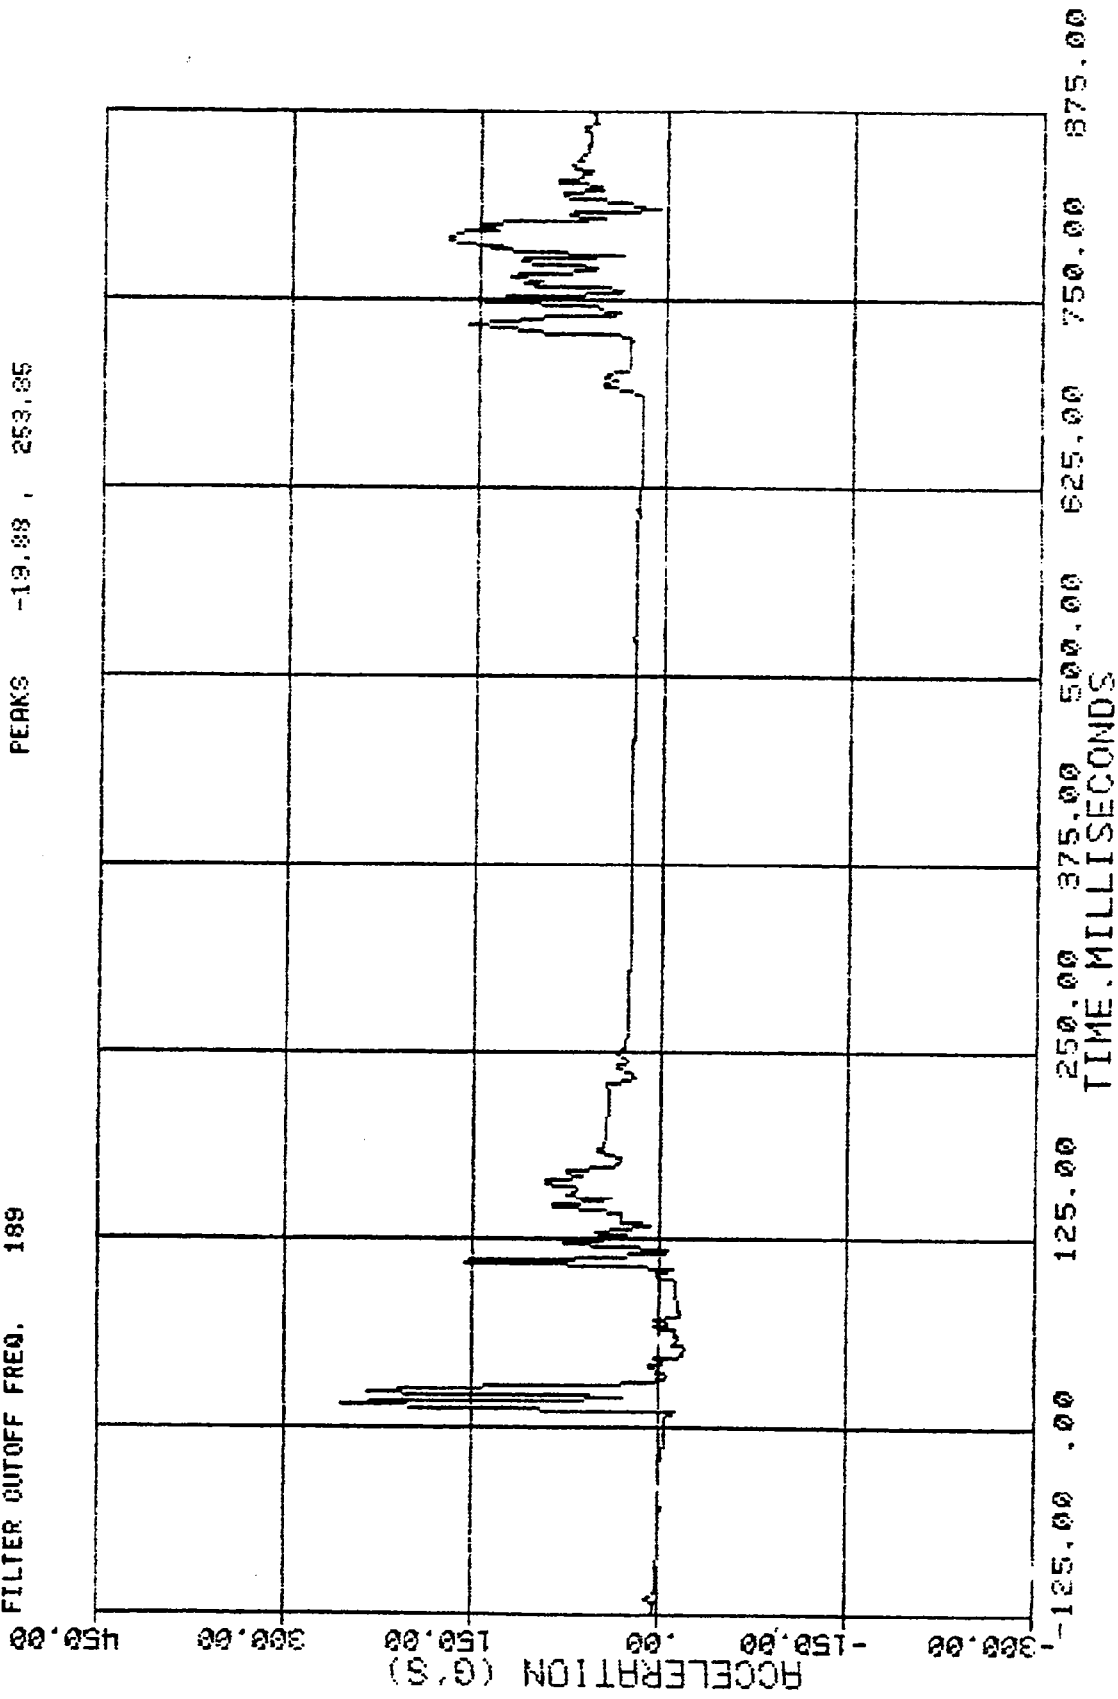
Figure 34. Driver's Left Lower Rib Acceleration, LLRYA, 189 Hz

CHANNEL 5 DRIVER THORAX-LLRY0A

PEAKS -19.88 , 253.85

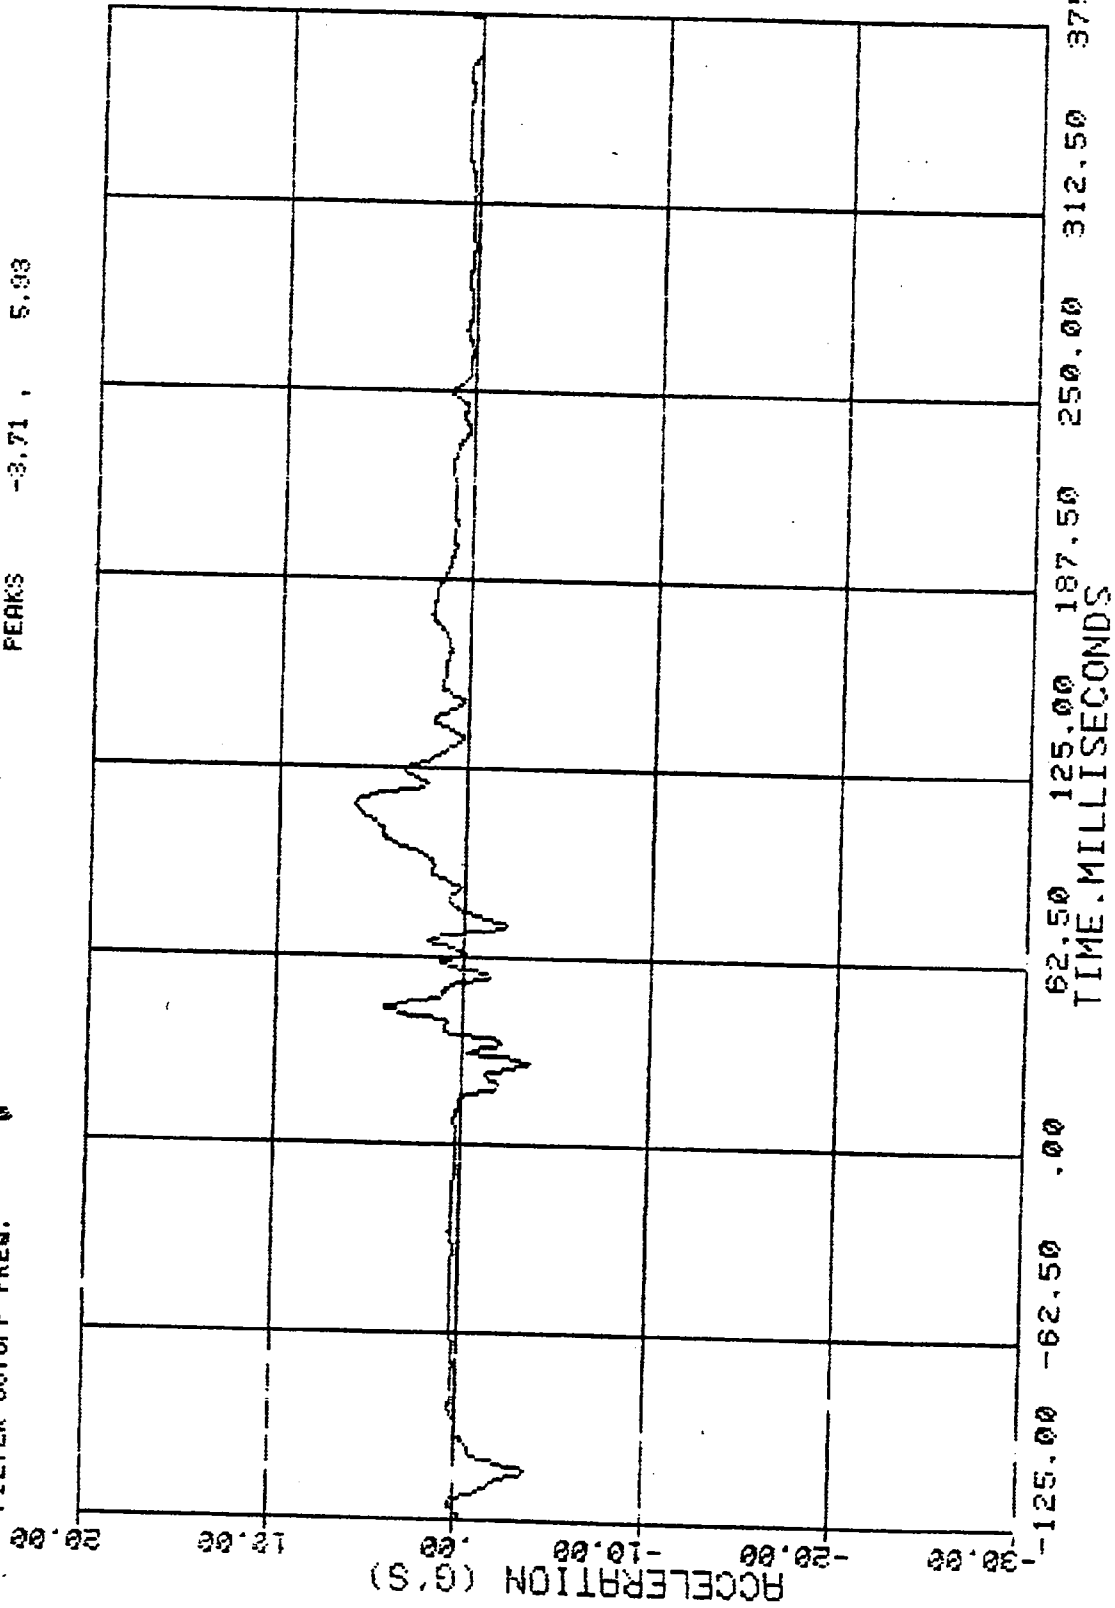
Figure 35. Driver's Left Upper Rib Acceleration, LURY, NHTSA
FIR Filter

DRIVER THORAX-LURY

PEAKS -3.71 , 5.93

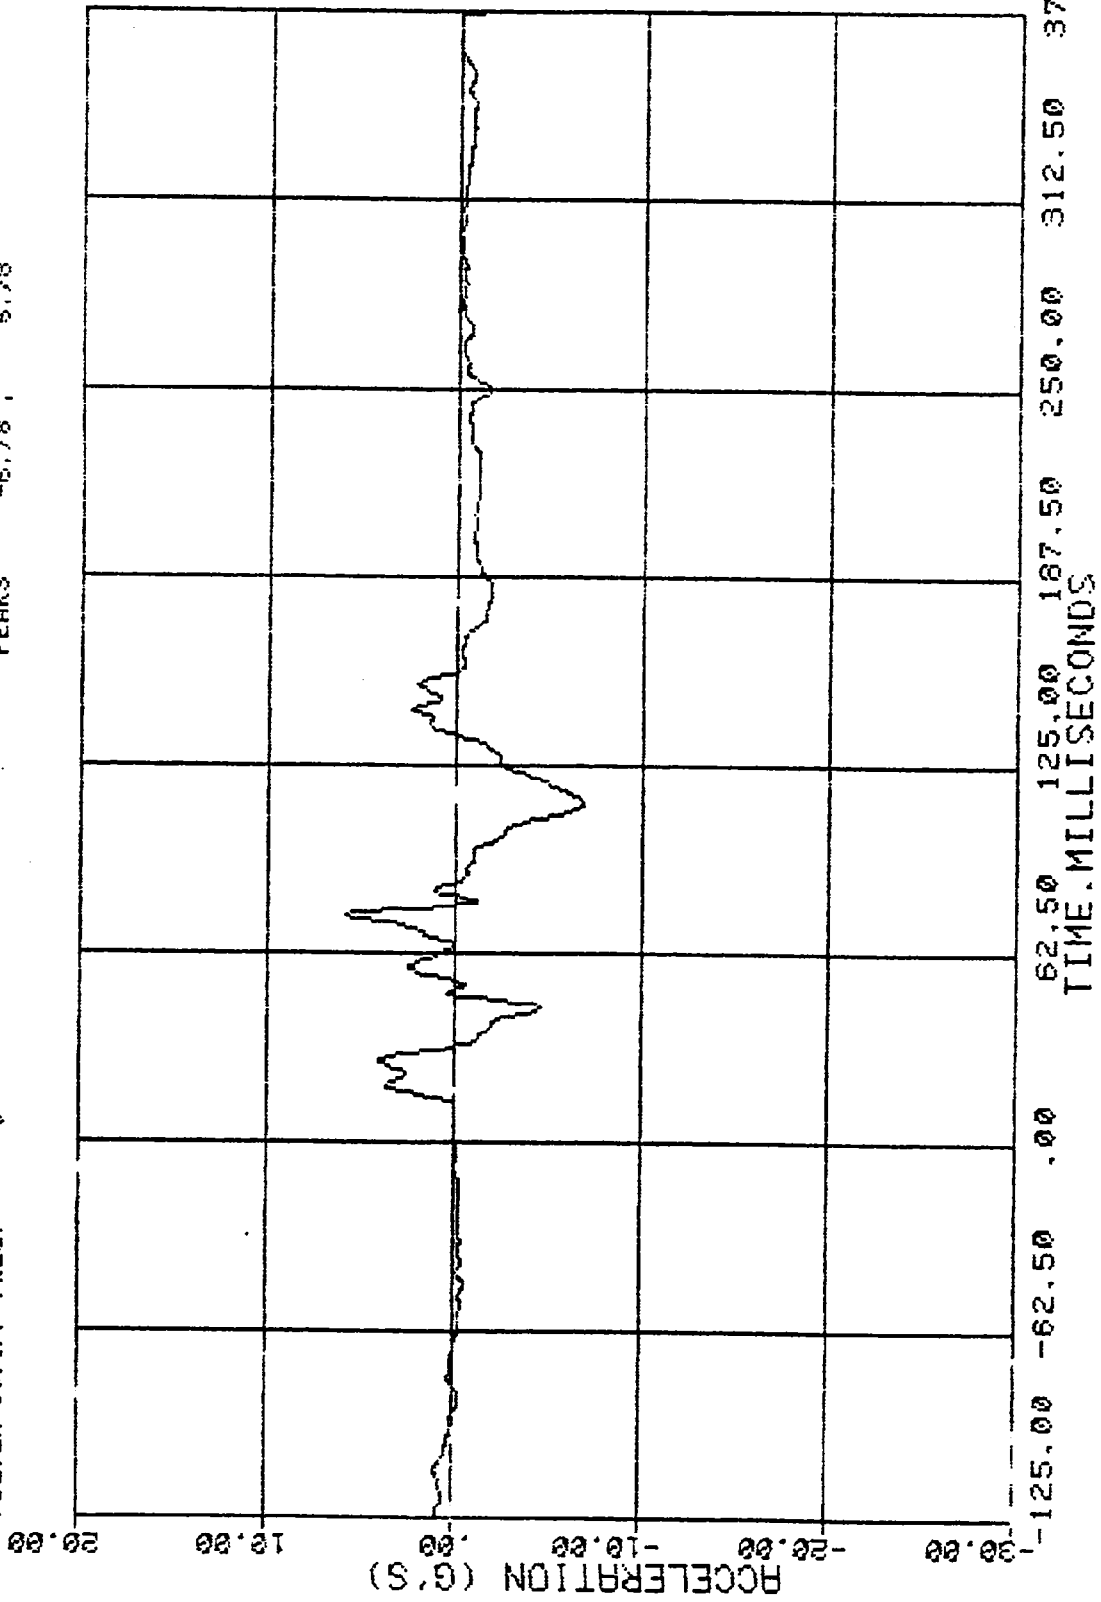
Figure 36. Driver's Upper Spine Acceleration, T01Y, NHTSA
FIR Filter

CHANNEL 3 DRIVER THORAX-T01Y
FILTER CUTOFF FREQ. 0

PEAKS -6.78 5.78
