LABORATORY PROCEDURES TO DETERMINE THE
BREAKAWAY BEHAVIOR OF LUMINAIRE SUPPORTS
IN MINI-SIZED VEHICLE COLLISIONS

SIDE IMPACT - RIGID POLE
TEST RESULTS REPORT
TEST NO'S: SI#1, SI#2, SI#3, AND SI#8
PHASE II - TASK C

February 1986

ENSCO, INC.
Applied Technology and Engineering Division
5400 Port Royal Road
Springfield, VA 22151

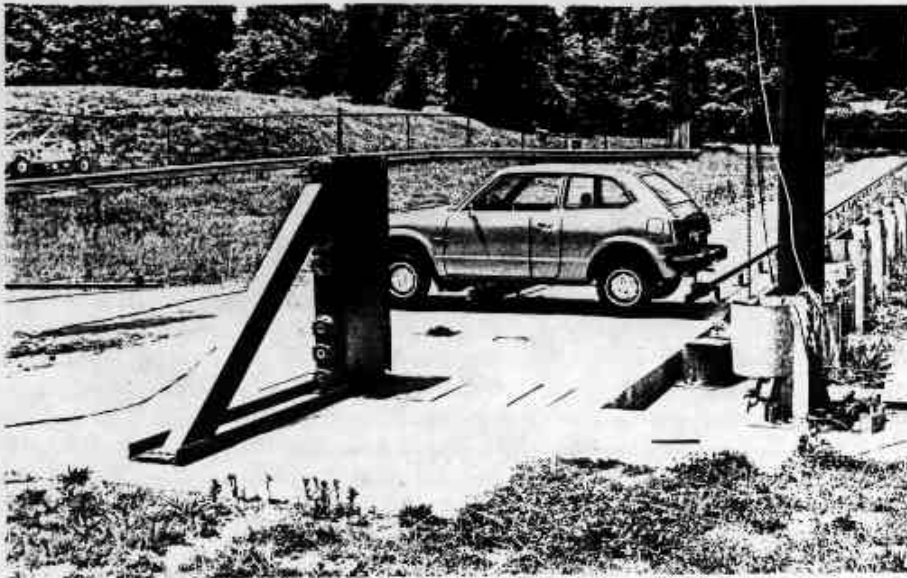
Figure 6. Pre-Test Photos for Test 1469-SI#1

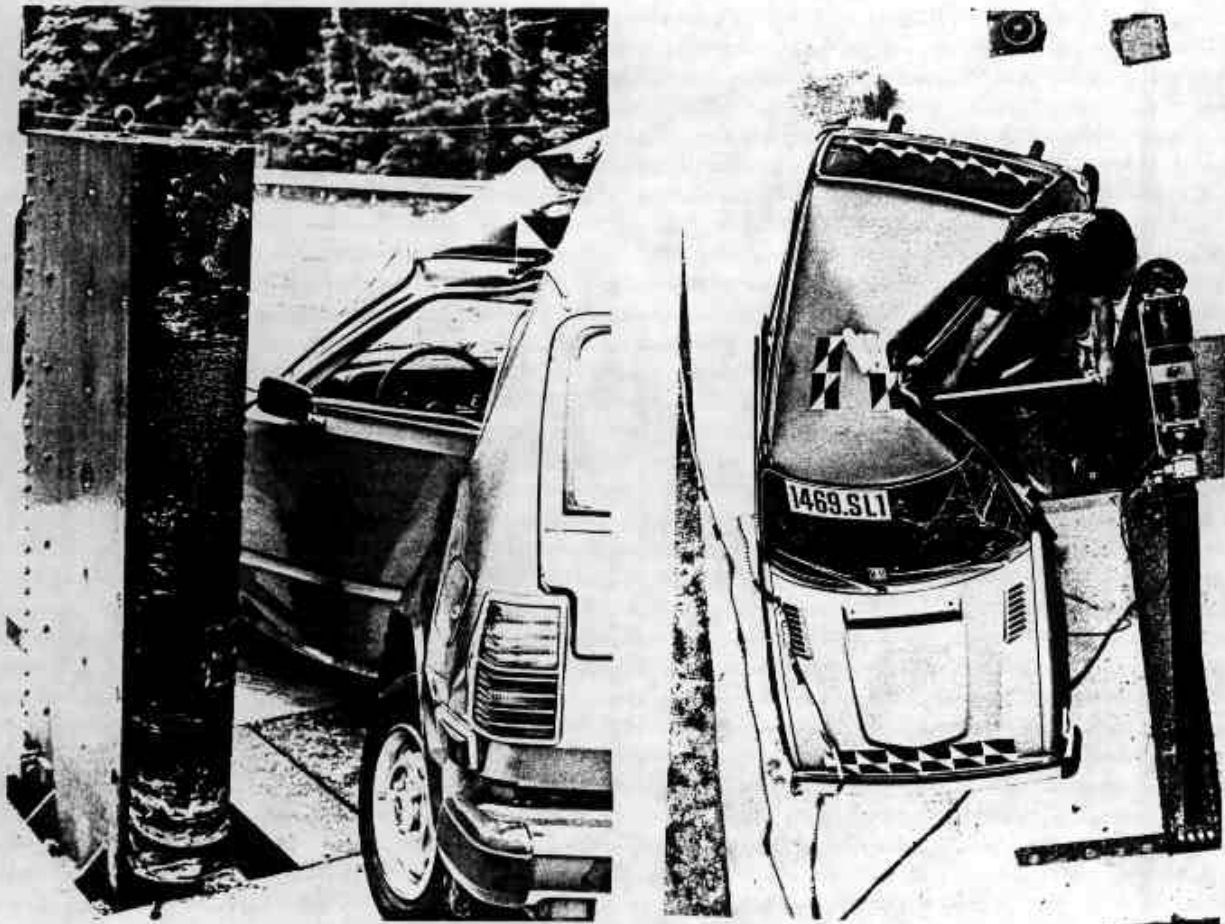
Figure 8. Post-Test Photos for Test 1469-SI#1

During the impact the vehicle actually bent about the longitudinal centerline. There was considerable dynamic deflection beyond the static deflection. The static deflection of the test vehicle measured using the NHTSA 6 point technique is presented in Table 5. Figure 7 is presented as reference for these measurements. Figure 8 presents photos of the vehicle after the test. The vehicle damage index was 09 LPAN3. The NCHRP 230 delta V for a 1 foot flail space was -22.8 ft/sec. The associated ridedown acceleration was -6.3 g's at .193 seconds.

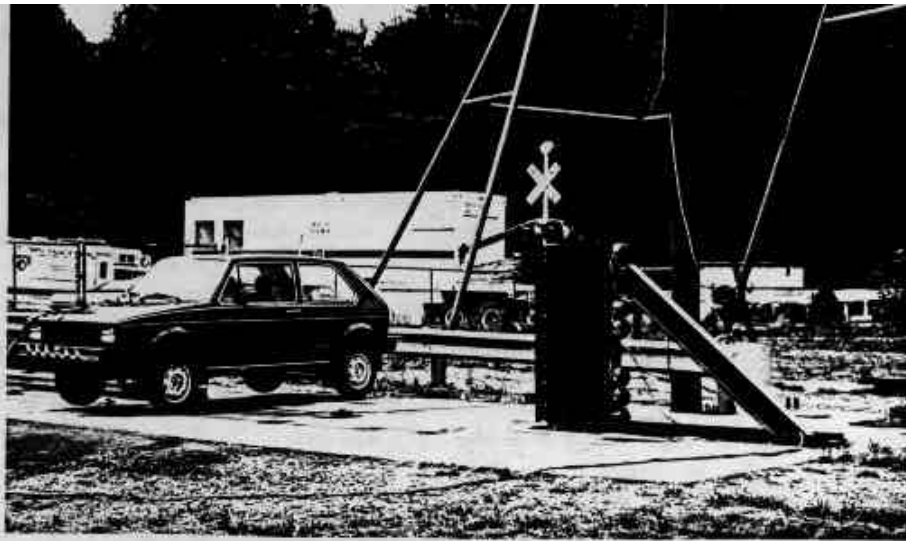
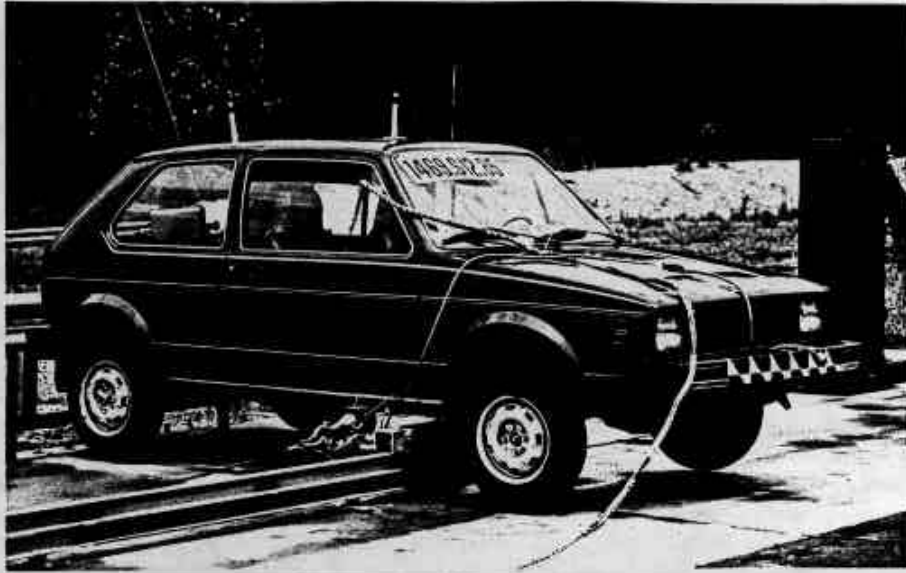
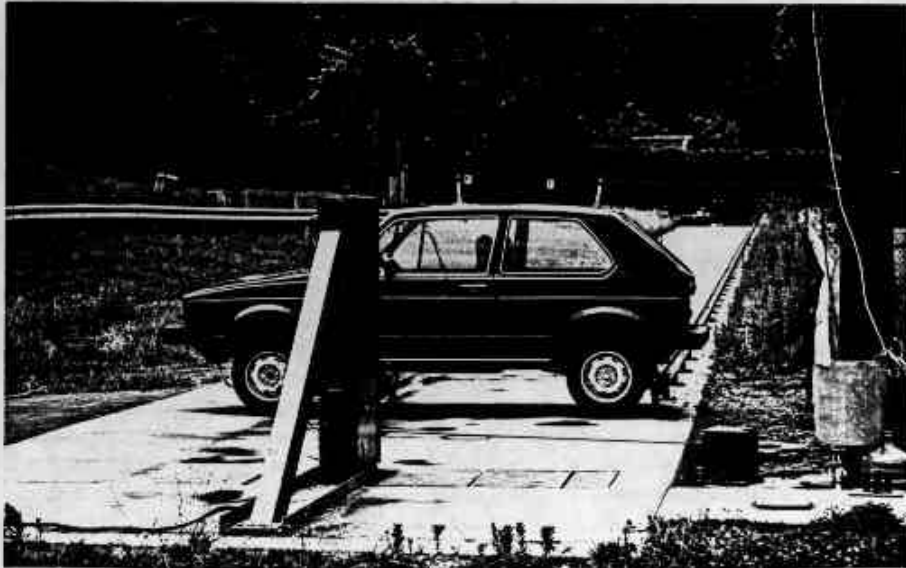
Figure 9. Pre-Test Photos for Test 1469-SI#1

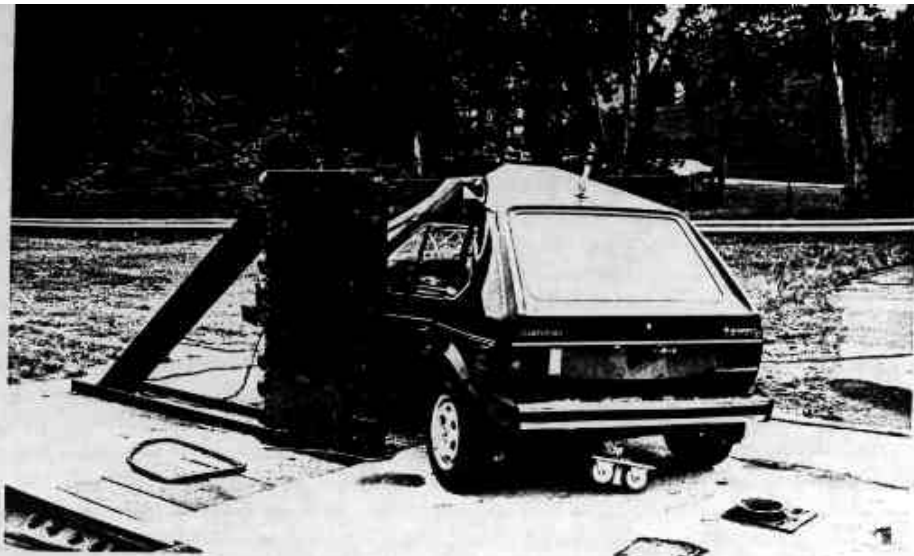
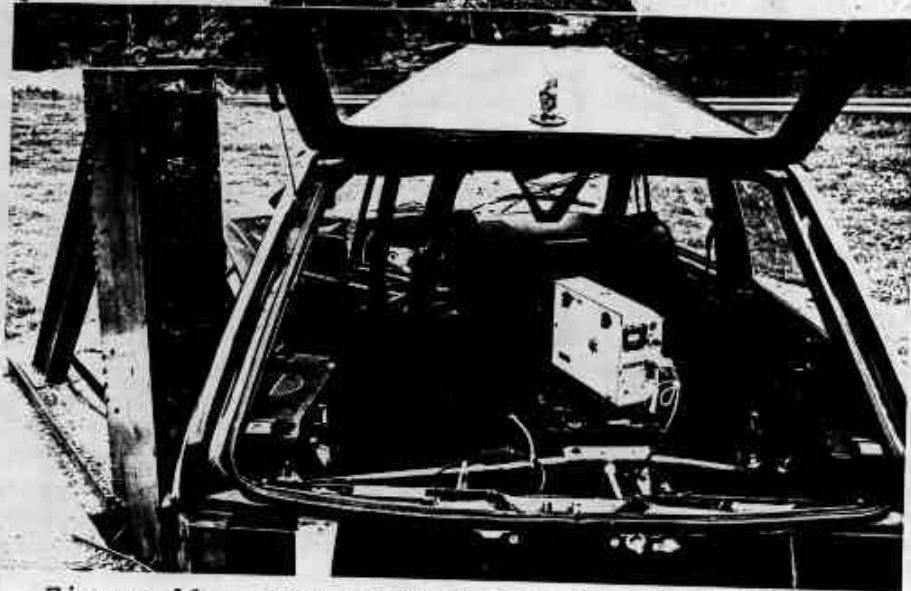
Figure 11. Post-Test Photos for Test 1469-SI#2

During the impact the vehicle actually bent about the longitudinal centerline. There was considerable dynamic deflection beyond the static deflection. The static deflection of the test vehicle measured using the NHTSA 6 point technique is presented in table 7. Figure 10 is presented as reference for these measurements. Figure 11 presents photos of the vehicle after the test. The vehicle damage index was 09LPAN3. The NCHRP 230 delta V for a one foot flail space was -23.9 ft/sec. The associated ridedown acceleration was -5.7 g's at .209 seconds.

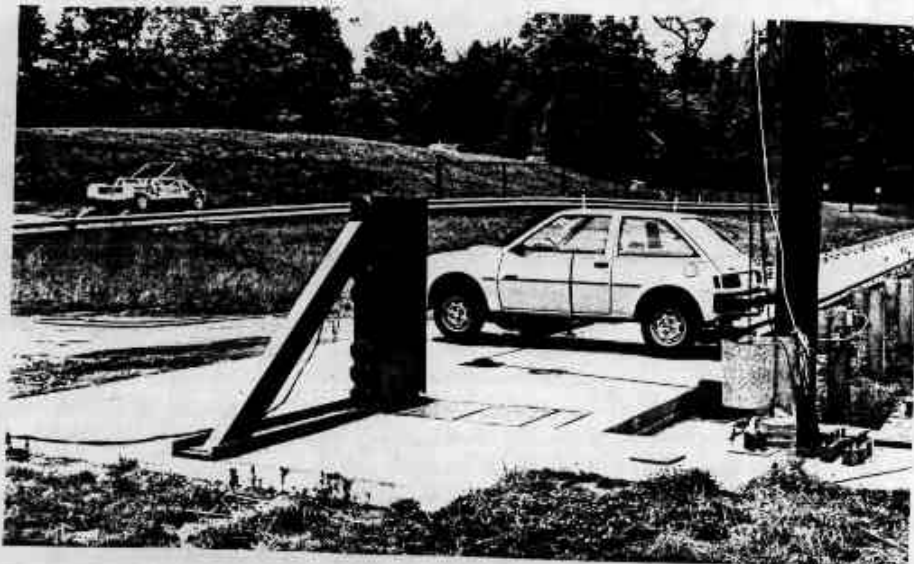
Figure 12. Pre-Test Photos for Test 1469-SI#3

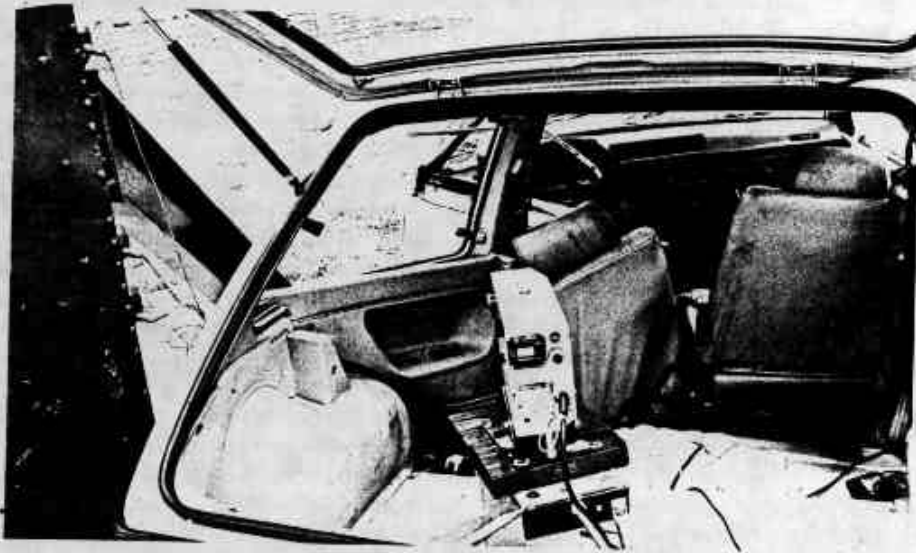
Figure 14. Post-Test Photos for Test 1469-SI#3

During the impact the vehicle actually bent about the longitudinal centerline. There was considerable dynamic deflection beyond the static deflection. The static deflection of the test vehicle measured using the NHTSA 6 point technique is presented in table 9. Figure 13 is presented as reference for these measurements. Figure 14 presents photos of the vehicle after the test. The vehicle damage index was 09LPAN3. The NCHRP 230 delta V for a one foot flail space was -20.8 ft/sec. The associated ridedown acceleration was -6.5 g's at .198 seconds.

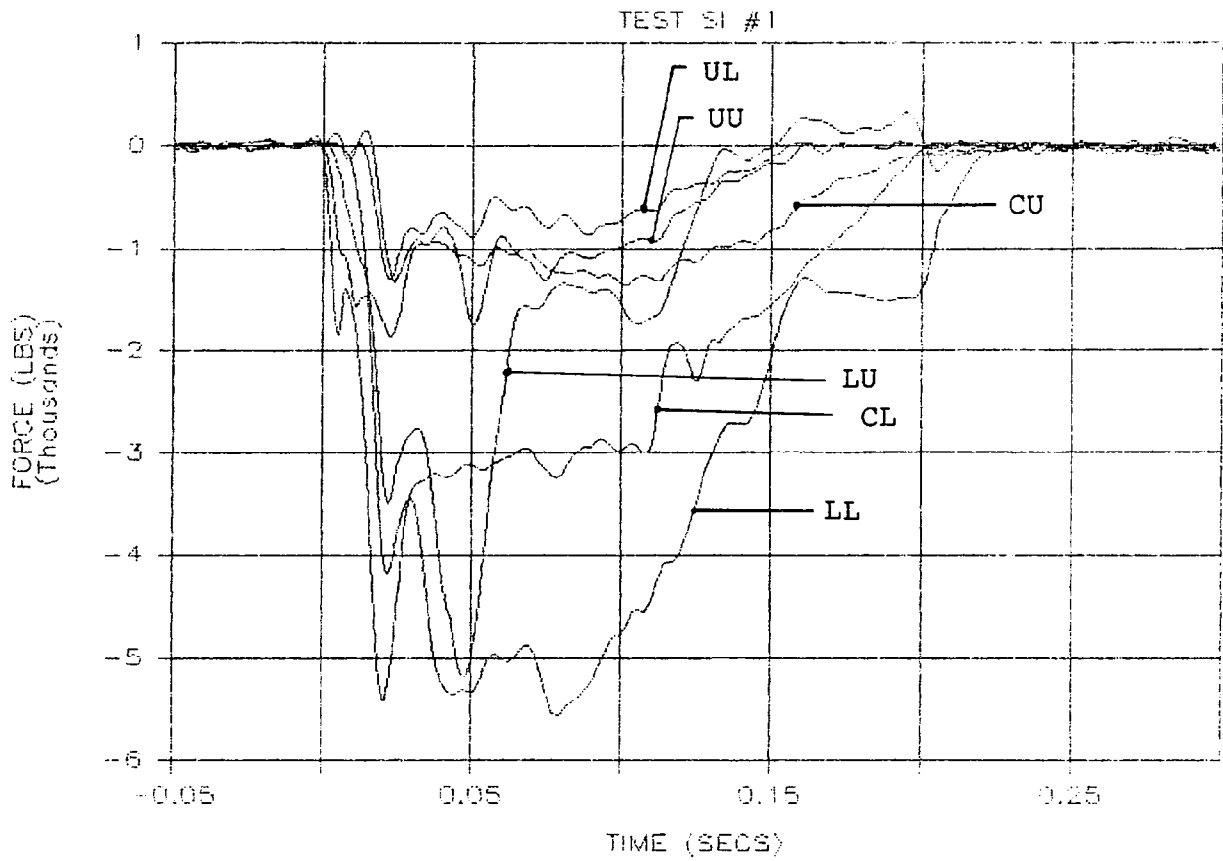
LL = Lower Segment Lower Load Cell
 LU = Lower Segment Upper Load Cell
 CL = Center Segment Lower Load Cell
 CU = Center Segment Upper Load Cell
 UL = Upper Segment Lower Load Cell
 UU = Upper Segment Upper Load Cell

Figure 27. Load Cell Outputs for Test SI#1

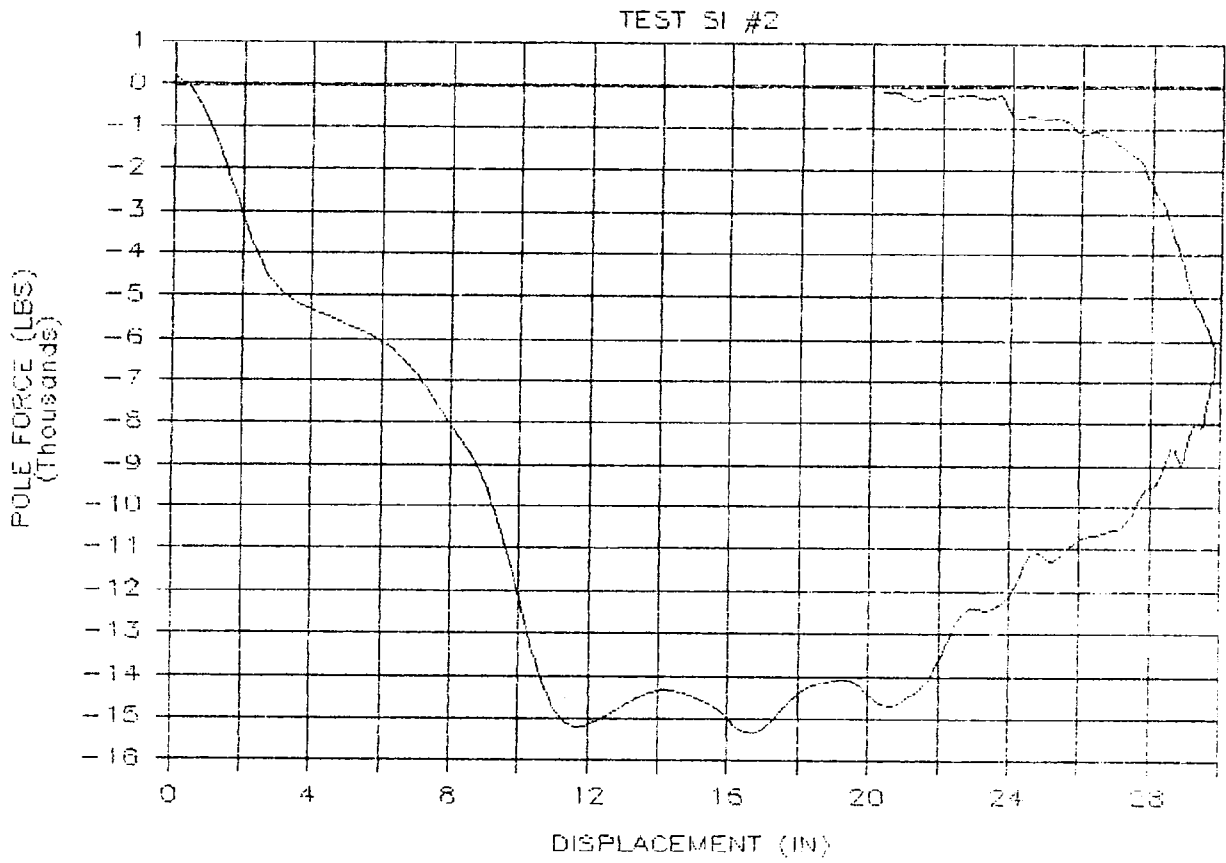
Figure 29. Overall Force Displacement Characteristics for Test SI#2

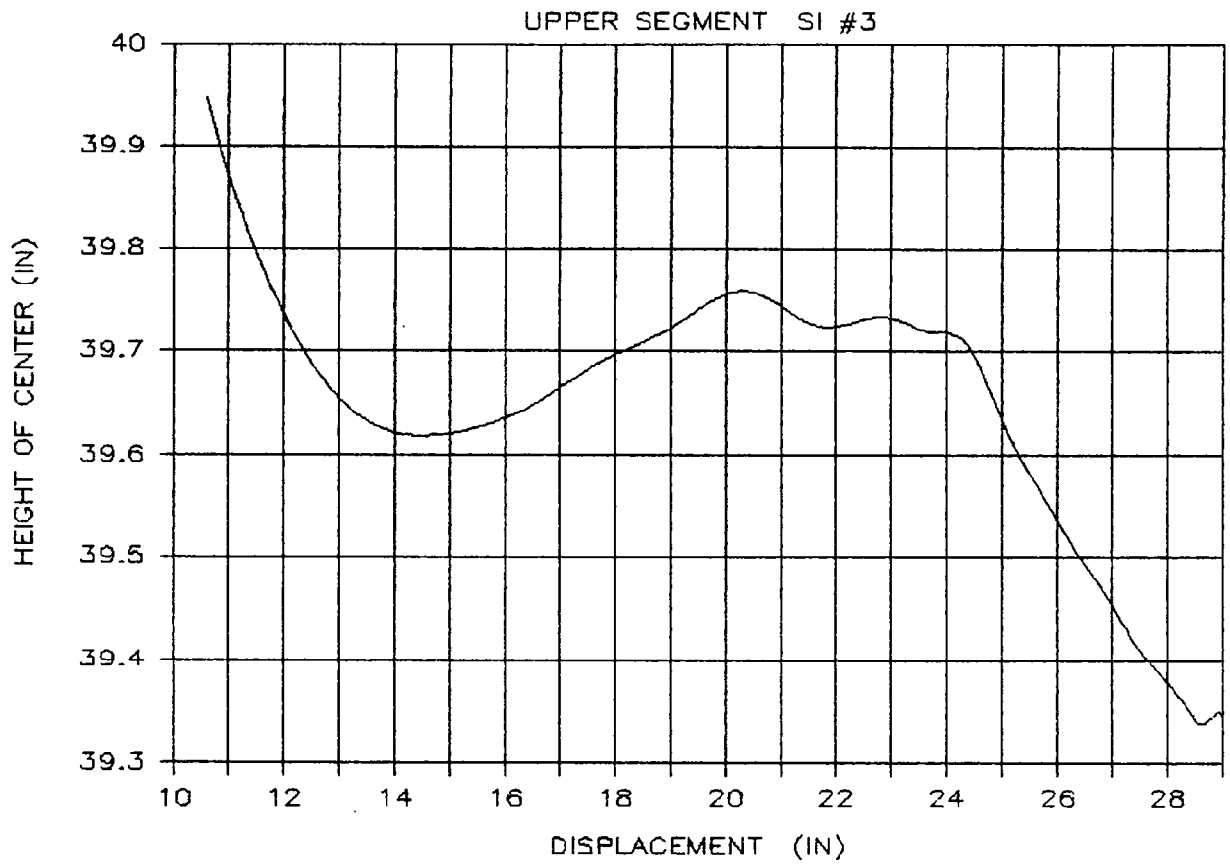
Figure 45. Effective Center of Force for Upper Segment for Test SI#3

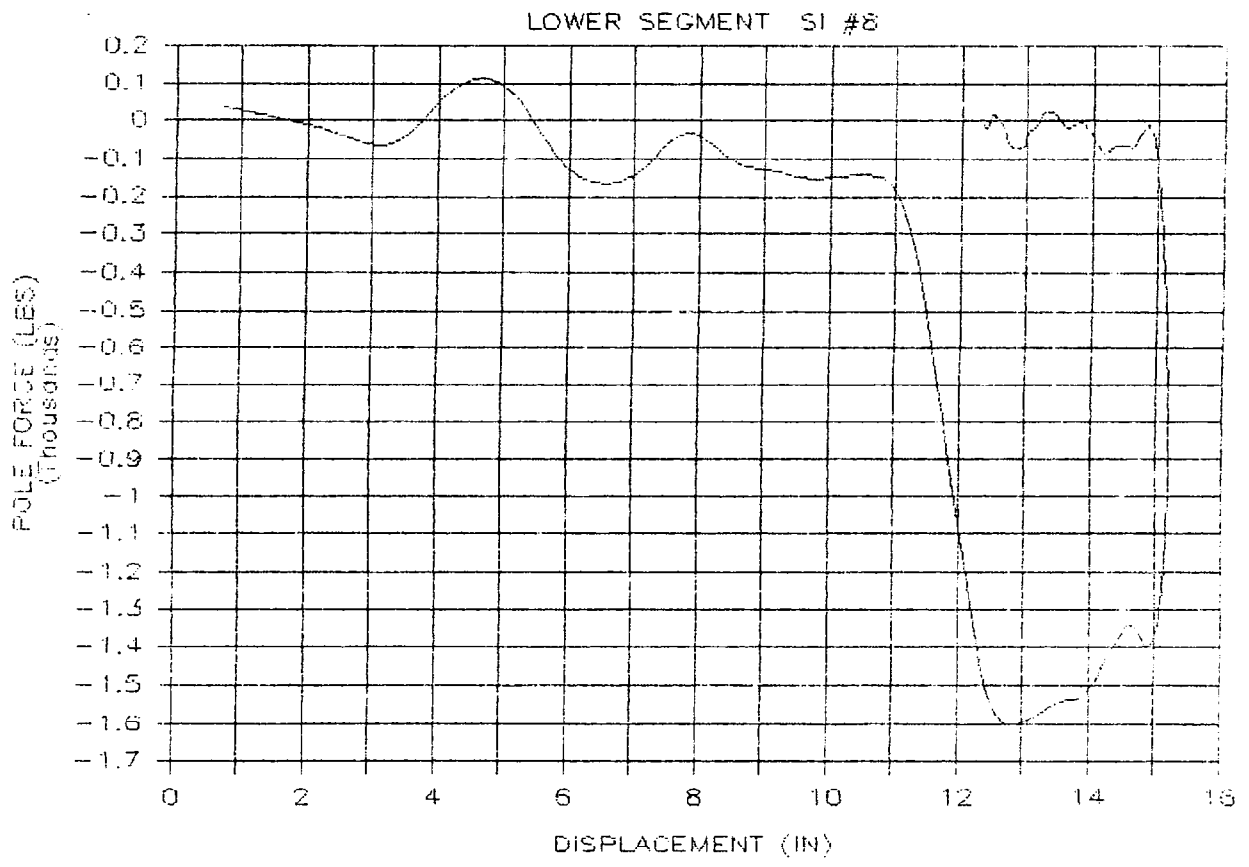
Figure 55. Force Displacement of Lower Segment for Test SI#8

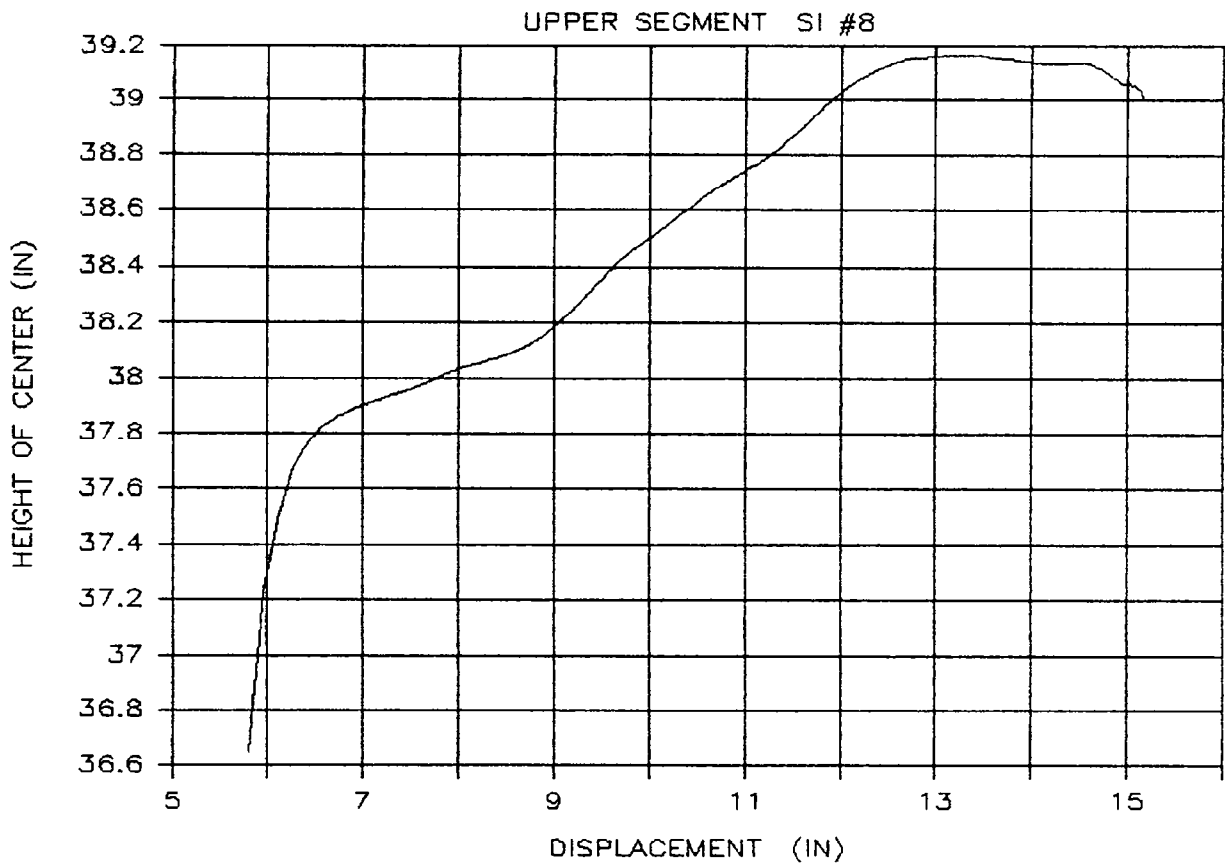
Figure 56. Effective Center of Force for Upper Segment for Test SI#8

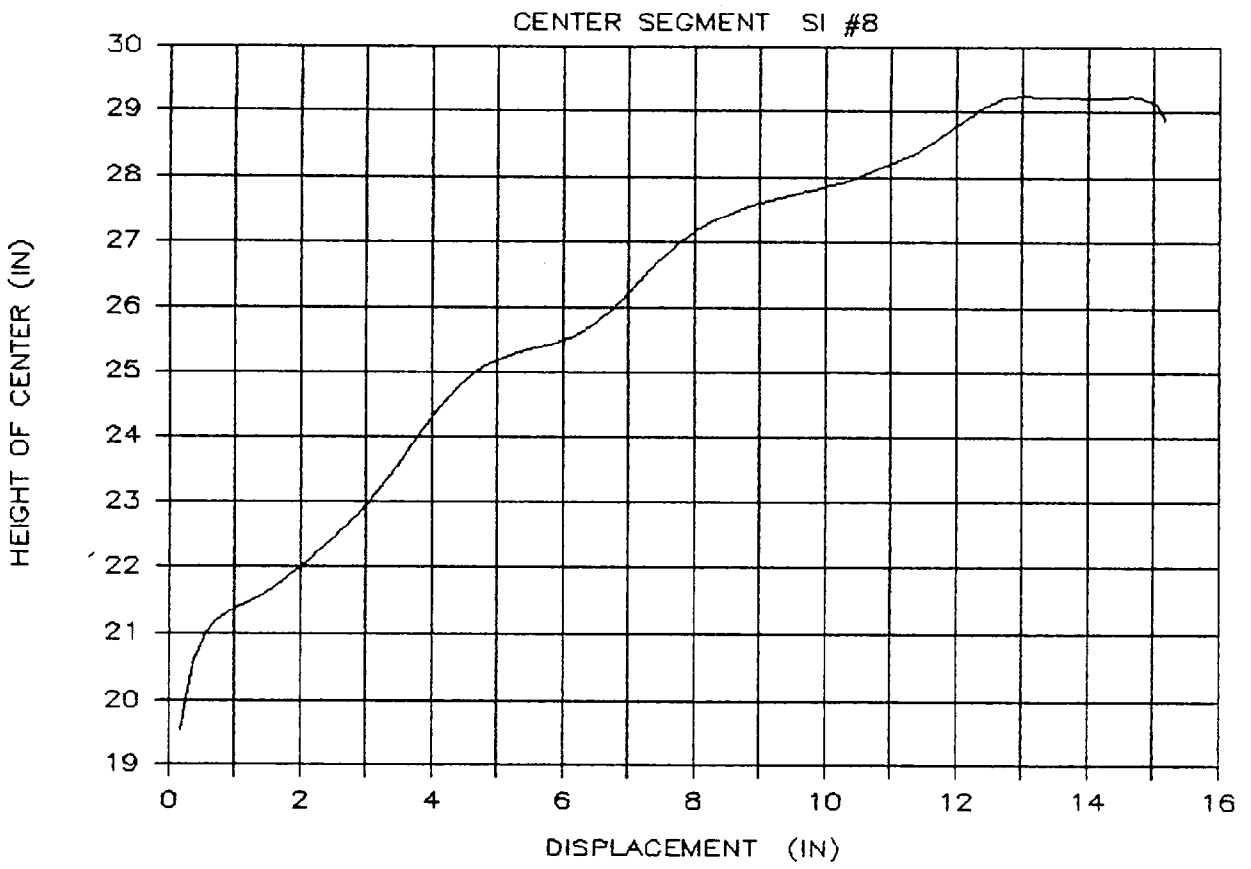
Figure 57. Effective Center of Force for Center Segment for Test SI#8

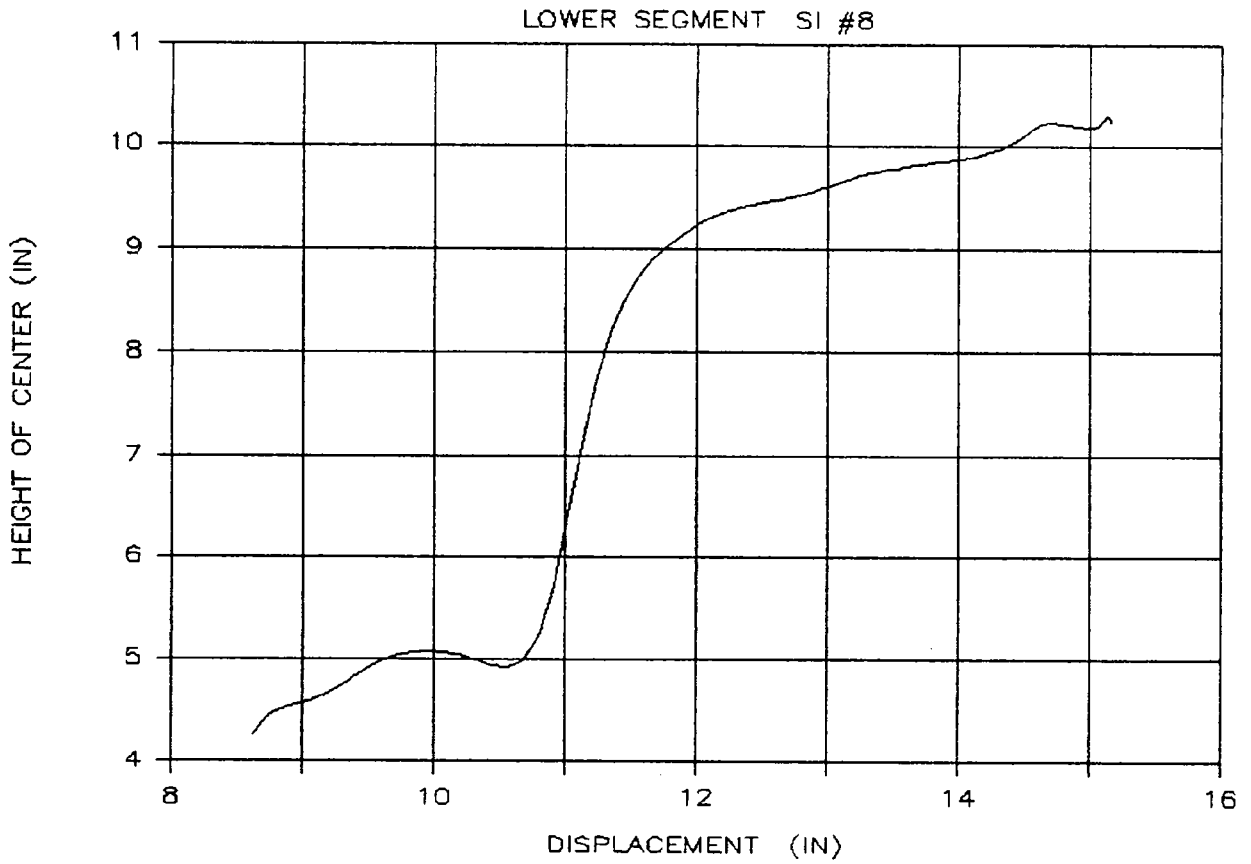
Figure 58. Effective Center of Force for Lower Segment for Test SI#8

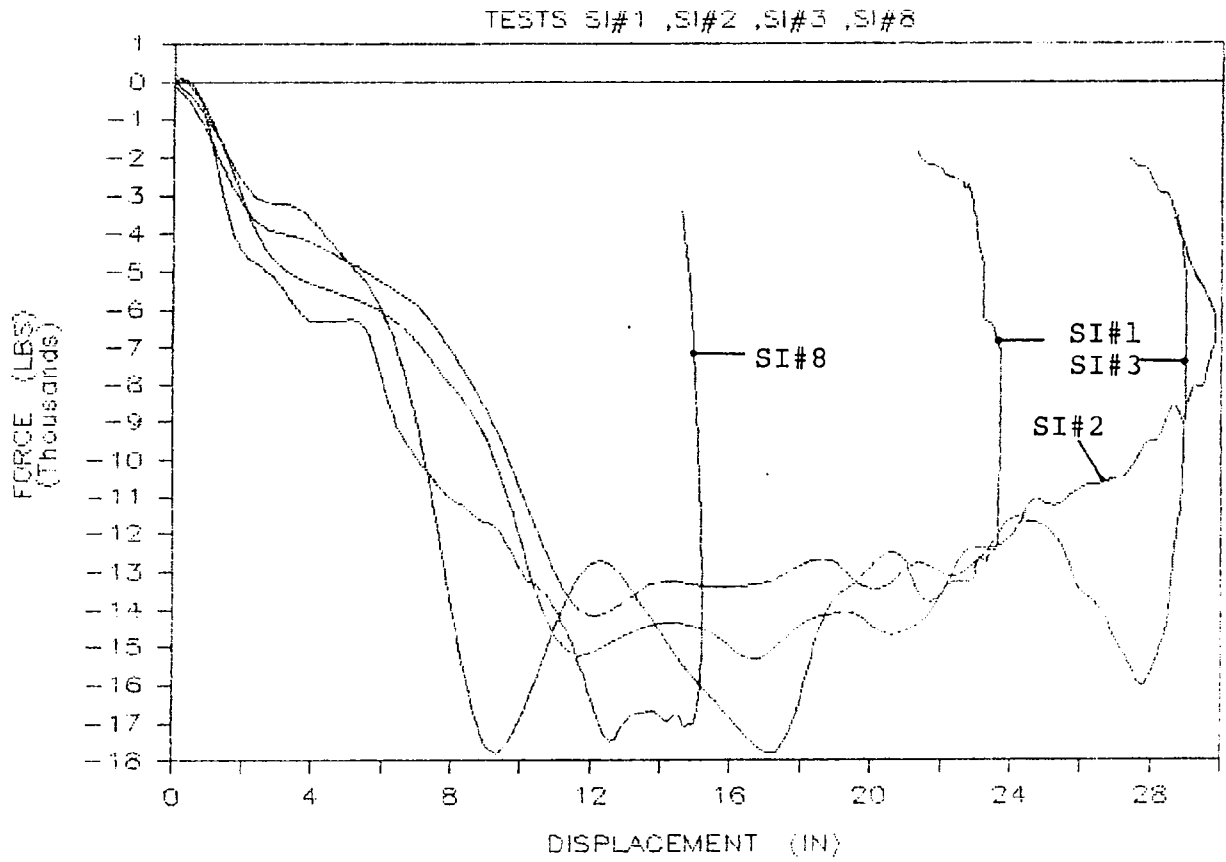
Figure 61. Comparison of Force Displacement Characteristic for all Tests
