**IMPACT ATTENUATORS
A CURRENT ENGINEERING EVALUATION**

Test Results Report for
Test #1625-C-04-85
Task C

FEDERAL HIGHWAY ADMINISTRATION
Department of Transportation
400 Seventh Street, SW
Washington, D. C. 20590

ENSCO, Inc.
Applied Technology and Engineering Division
5400 Port Royal Road
Springfield, VA 22151

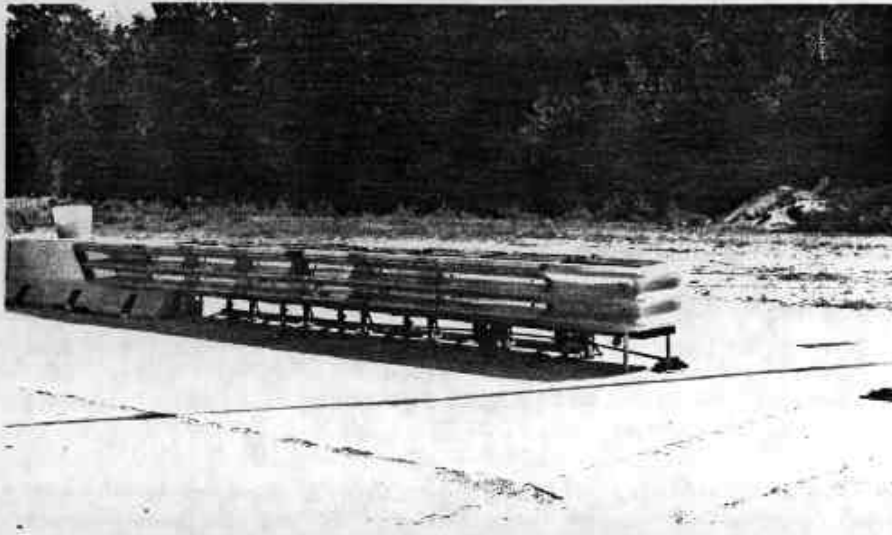
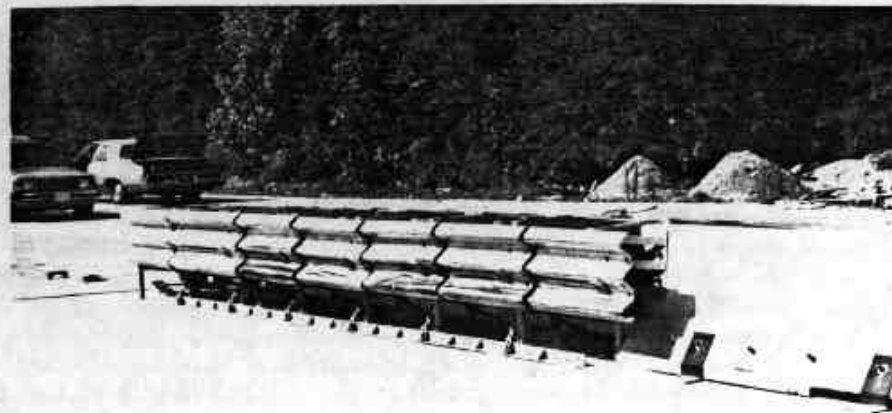
Figure 2-7. Pre-Test Photographs of GREAT System

A plan view of the back-up structure is shown in Figure 2-6. Figure 2-7 shows the GREAT system prior to the test.

The GREAT system was installed from the Installation Instructions. However, the anchor bolts provided with the system for the chain rail were replaced by the Hilti Expansion Anchors. The expansion bolts provided with the GREAT system provide a threaded stud above ground level. The use of these bolts would have required that the studs be cut off each time the test configuration was moved on the pad. The Hilti anchors are installed with the female end of the fastener in the pad flush with the top of the pad. The substitute anchor was approved by Energy Absorption Systems, Inc.

The GREAT system for the test was used in three previous 60 mph tests of mini-compact sedans. It is considered in excellent condition. Installation of the system was achieved without difficulty in an eight hour period with a three man crew. A crane was used to position the two temporary CMB's.

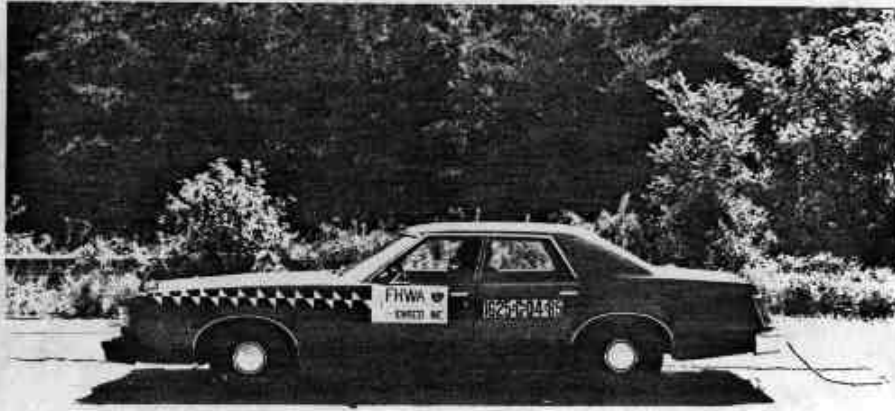
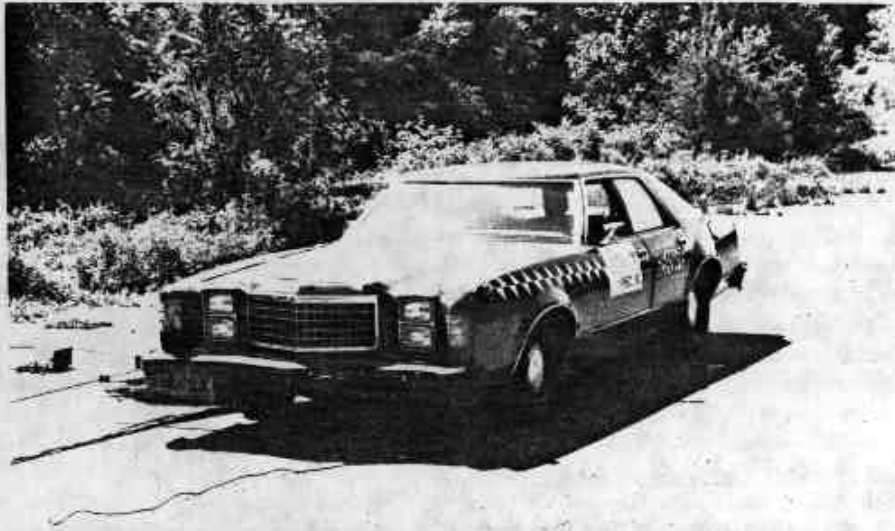
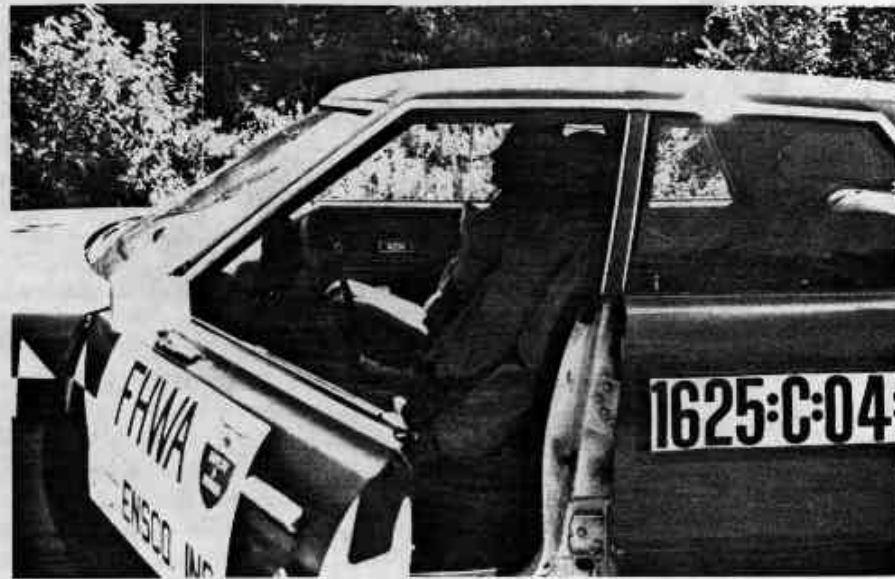
Figure 2-8. Pre-Test Photographs of Test Vehicle

The test vehicle was a dark blue 1979 Ford LTD II, (see Figure 2-8) corresponding to the NCHRP 230 classification of 4500S. The initial weight of the vehicle was 3945 pounds. The vehicle was prepared for testing by removing the gas tank and battery. The weight of the vehicle after incorporating the instrumentation and 370 pounds of ballast was 4346 pounds. The weight distributions of the vehicle with and without occupant are given in Tables 2-1 and 2-2.

The vehicle was equipped with a triaxial accelerometer package mounted on the lateral centerline of the vehicle at the longitudinal location of the center of gravity. Roll and yaw rate gyros were located on the same mounting block as the accelerometers. A high speed movie camera (500 frames per second) was mounted onboard to observe the movements of the dummies. The vehicle was also equipped with contact switches mounted on the front bumper to mark the impact and to trigger strobe flashes for movie film alignment and analysis. Distance decals were also installed for post-test film analysis of vehicle speed.

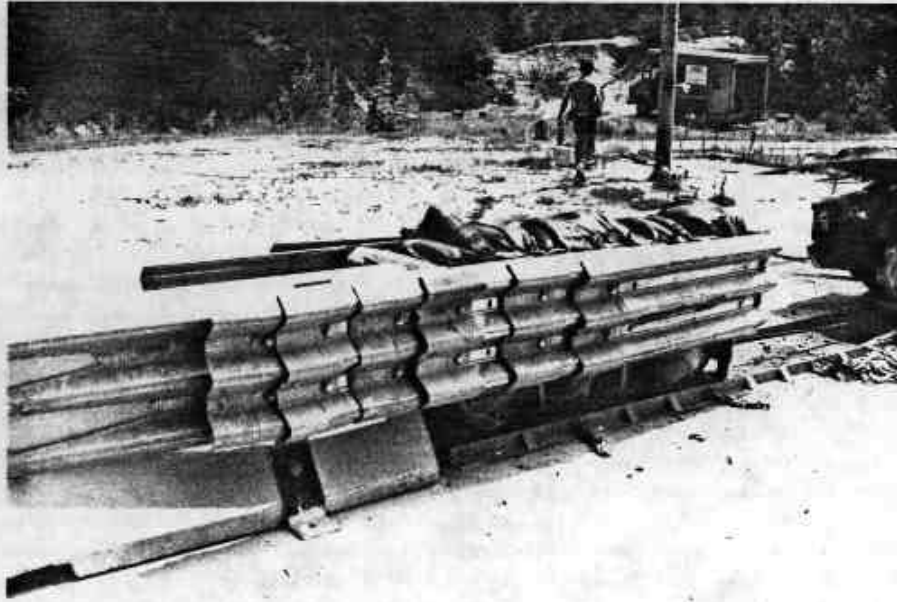
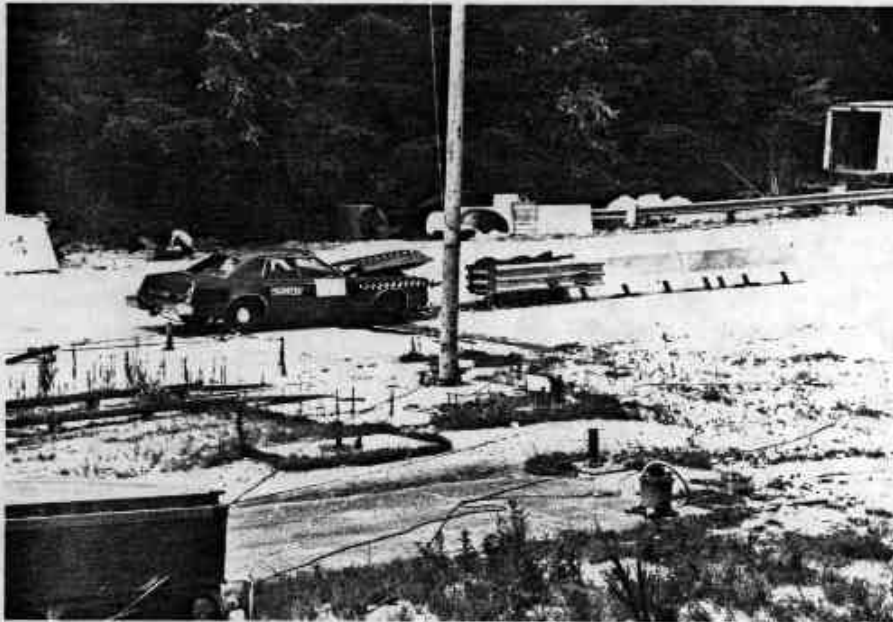
Figure 3-4. Post-Test Photographs of GREAT System and Vehicle, Attenuator and Pad

The GREAT system performed exactly as designed. The nose piece and cartridges were crushed and the guard rail side panels collapsed properly. No structural damage to the system was observed and the fixity of the CMB's was good. The CMB's shifted longitudinally 1/8 inch. It is believed that this was mainly due to slack in the system taken up by the impact. Figure 3-4 shows the GREAT system and the vehicle, attenuator and pad after the crash.
