**NEW CAR ASSESSMENT PROGRAM (NCAP)**

**FRONTAL BARRIER IMPACT TEST**

1986 Saab 9000 4-Door  
Hatchback Sedan

CALSPAN TEST NO. 7457-10

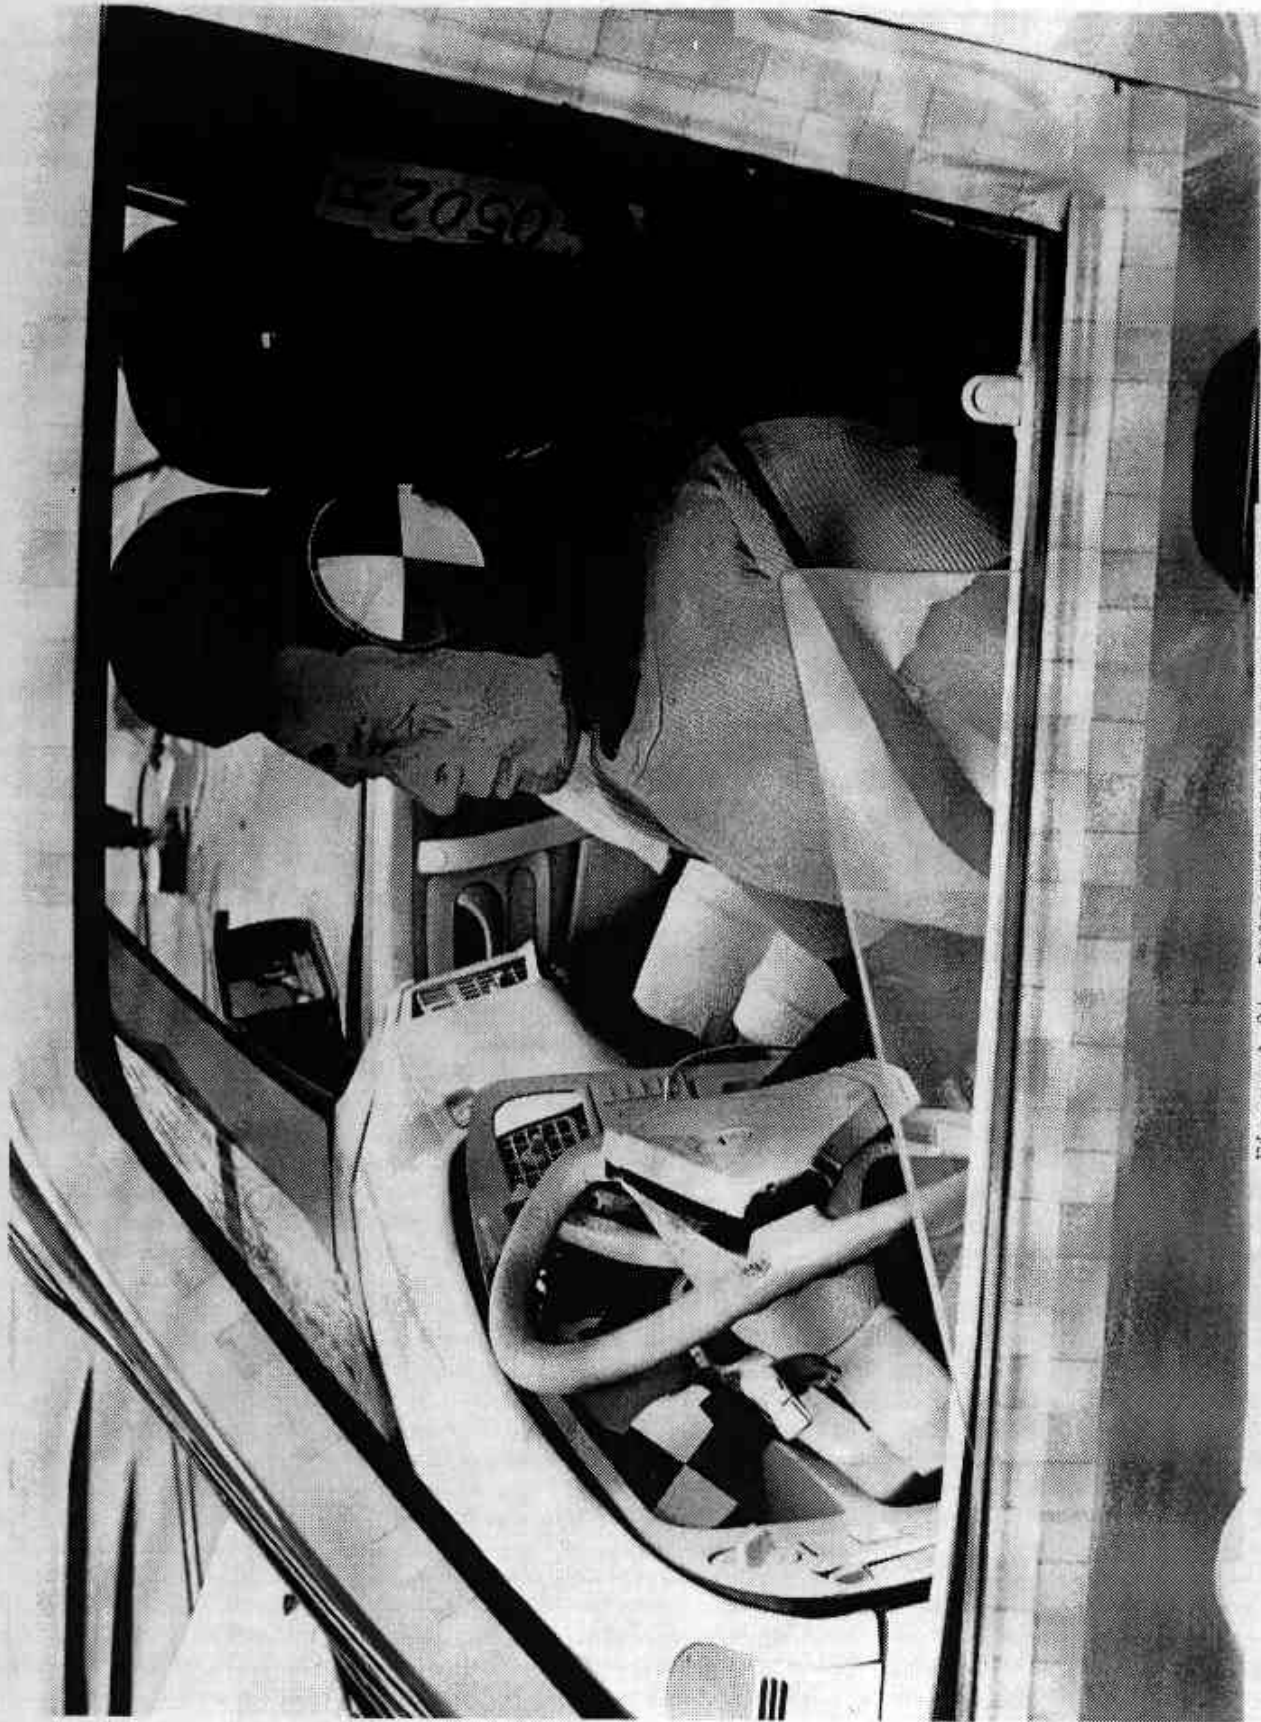
The driver's head struck the steering wheel rim and hub; the HIC was 773. The maximum chest deceleration over 3 milliseconds was 71 g's.

<u>Driver</u>	<u>Passenger</u>
Head	<u>Rim &amp; Hub</u>	<u>Dash</u>
Chest	<u>No Contact</u>	<u>No Contact</u>
Abdomen	<u>No Contact</u>	<u>No Contact</u>
Left Knee	<u>Dash</u>	<u>Glove Box</u>
Right Knee	<u>Dash</u>	<u>Glove Box</u>

Figure A-24. POST-TEST DRIVER POSITION VIEW

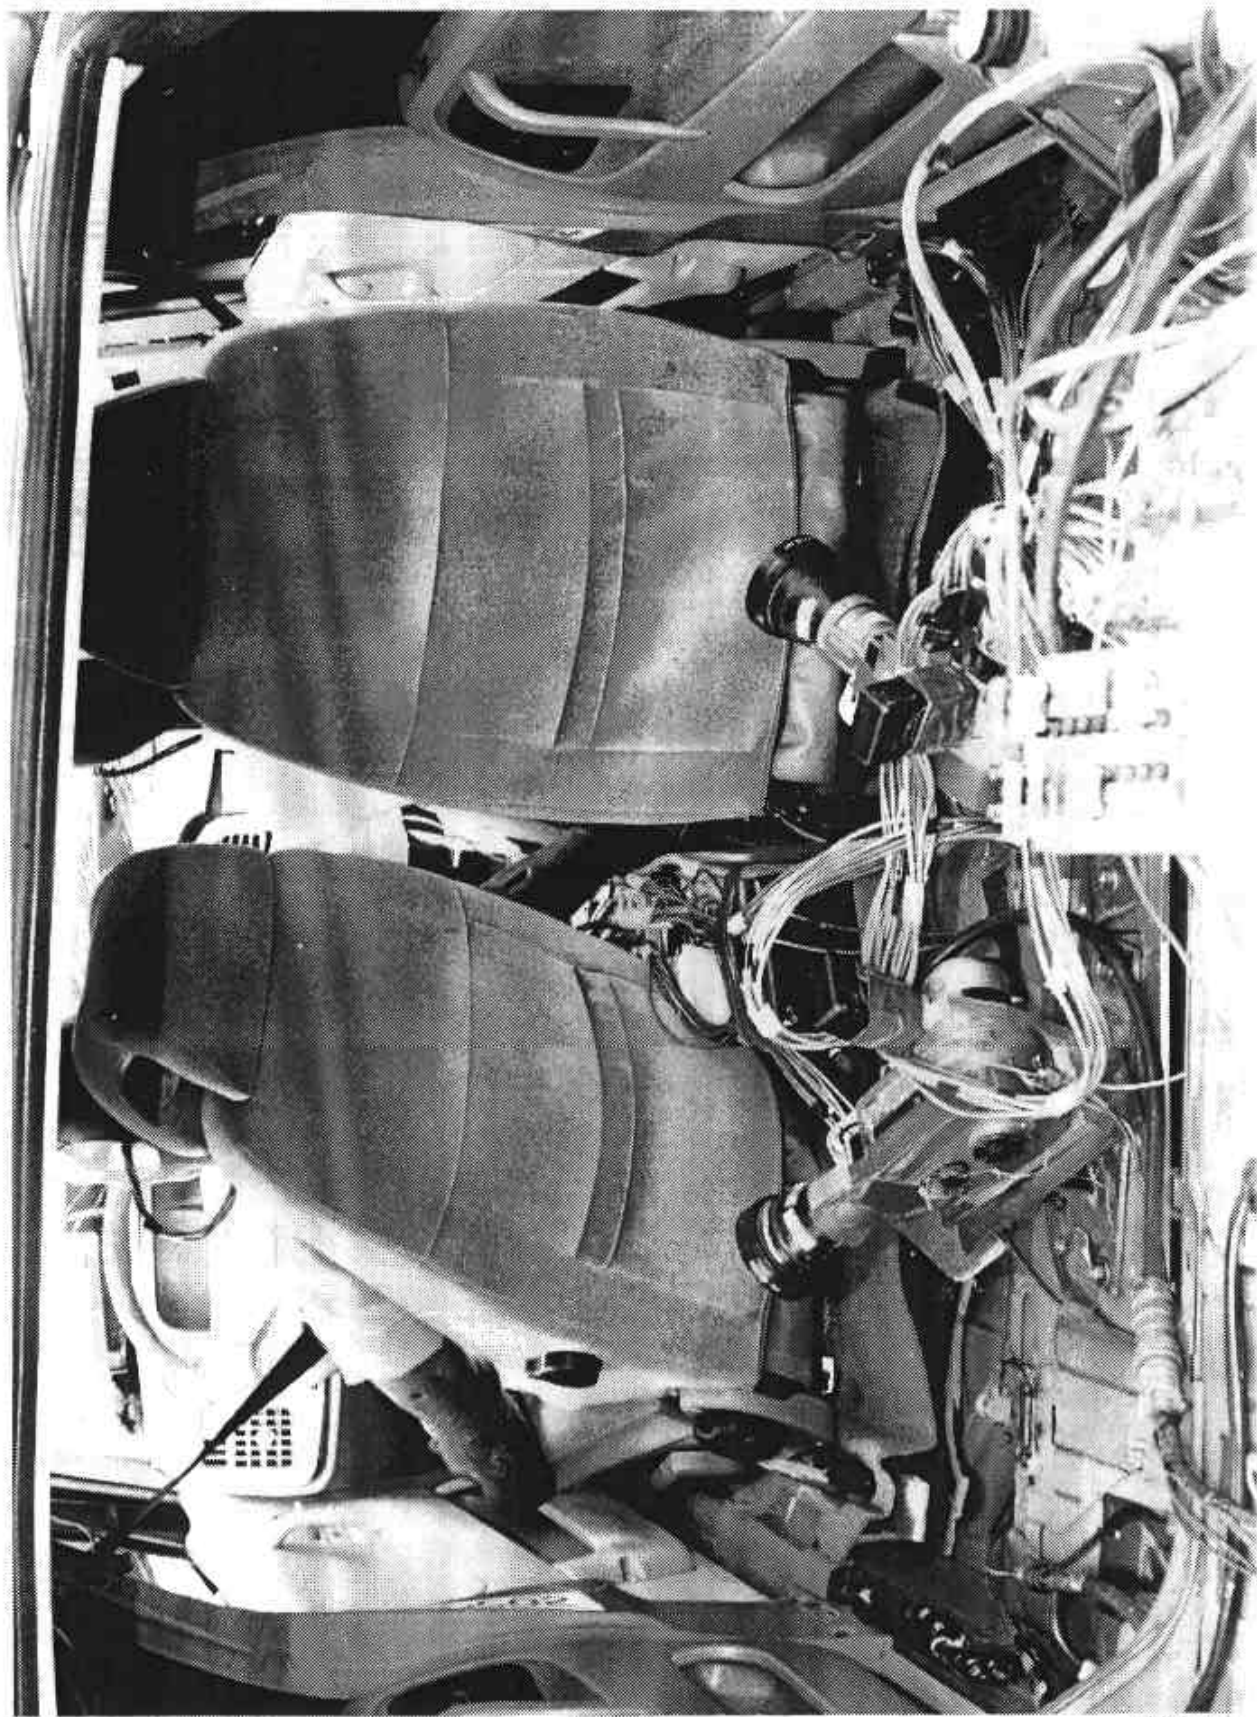
Other notable impact effects: Driver's seat came off inboard seat tracks (see Figure A-31).

FIGURE A-31 POST-TEST REAR INTERIOR VIEW
