REPORT NO. CAL-86-N19

**NEW CAR ASSESSMENT PROGRAM (NCAP)**

**FRONTAL BARRIER IMPACT TEST**

1986 Hyundai Excel

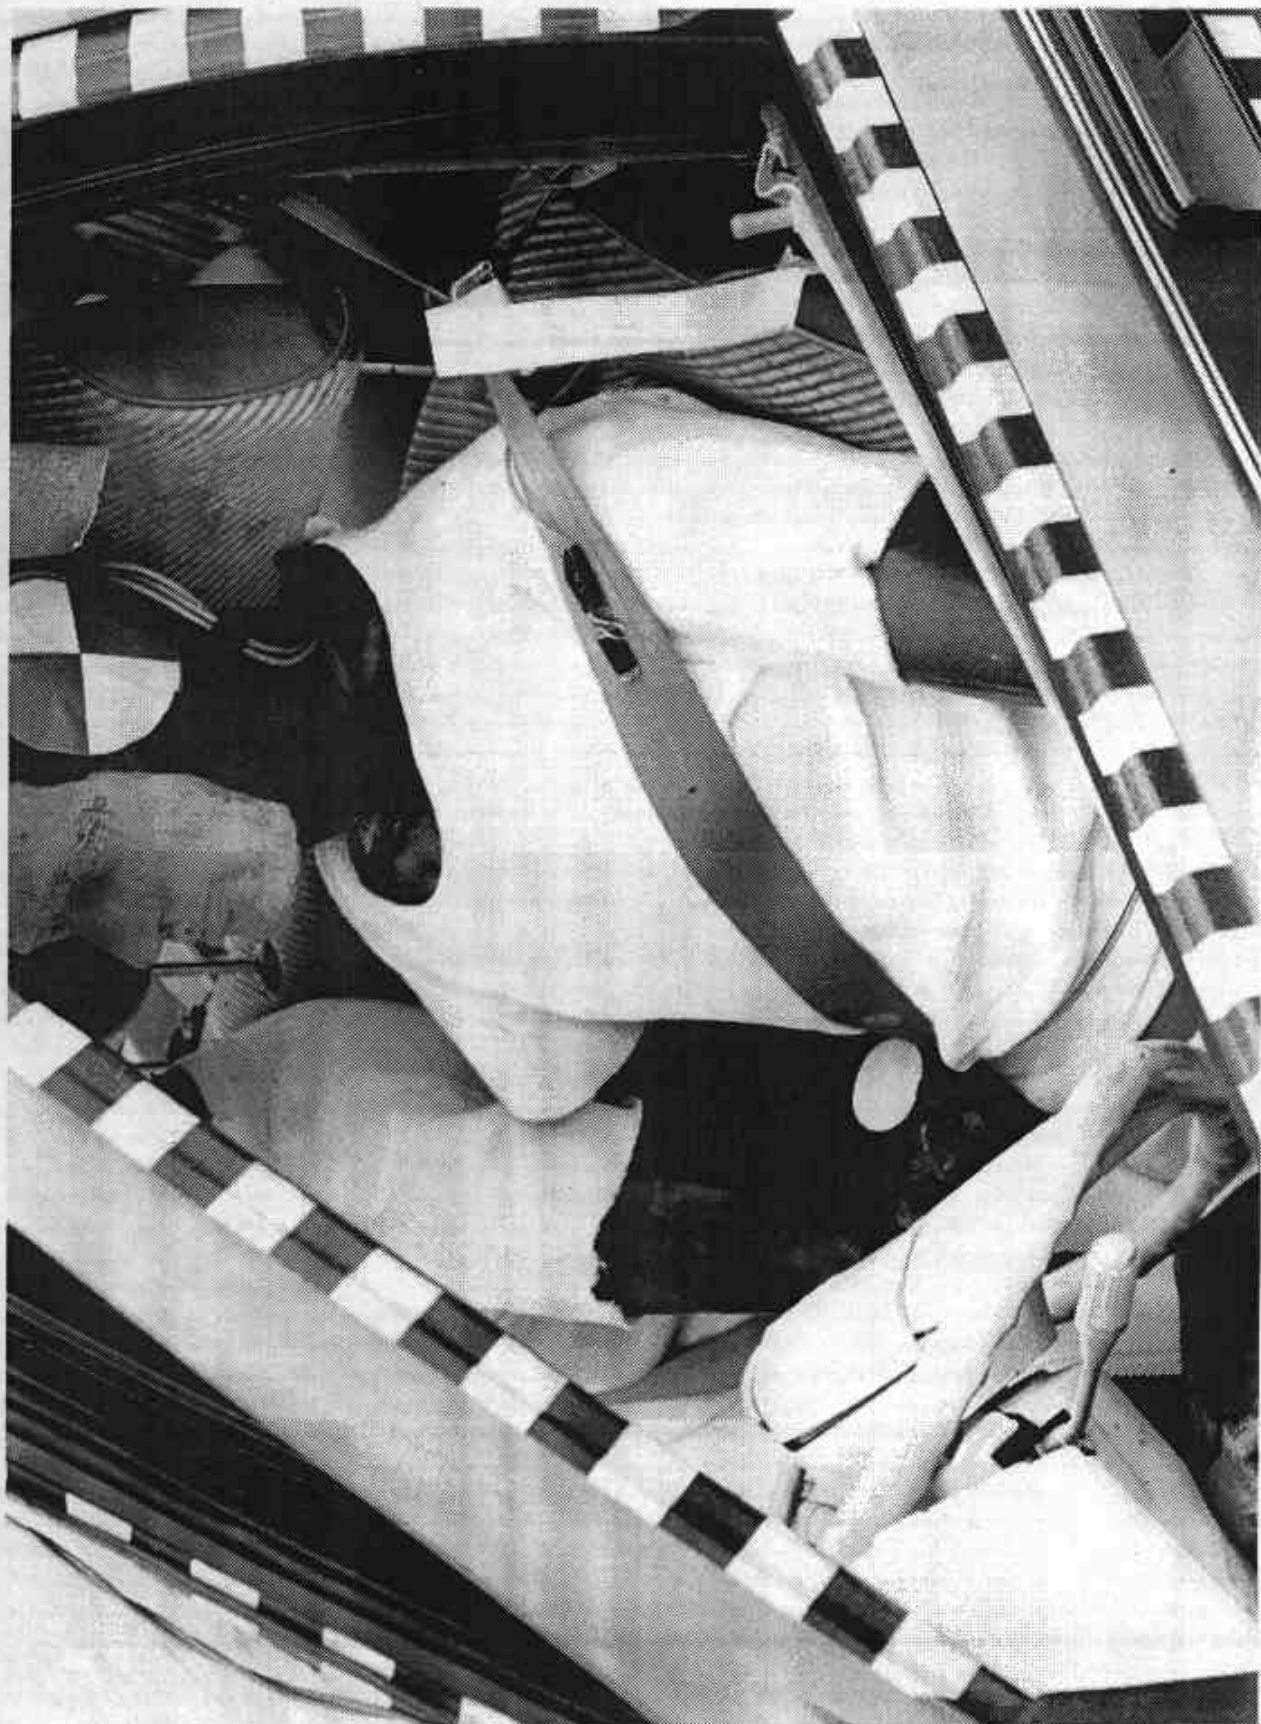
Figure A-24 POST-TEST DRIVER POSITION VIEW

The driver's head struck the steering wheel rim and hub; the HIC was 998.9. The maximum chest deceleration over 3 milliseconds was 73 g's and femur loads were 785 and 2248 pounds.

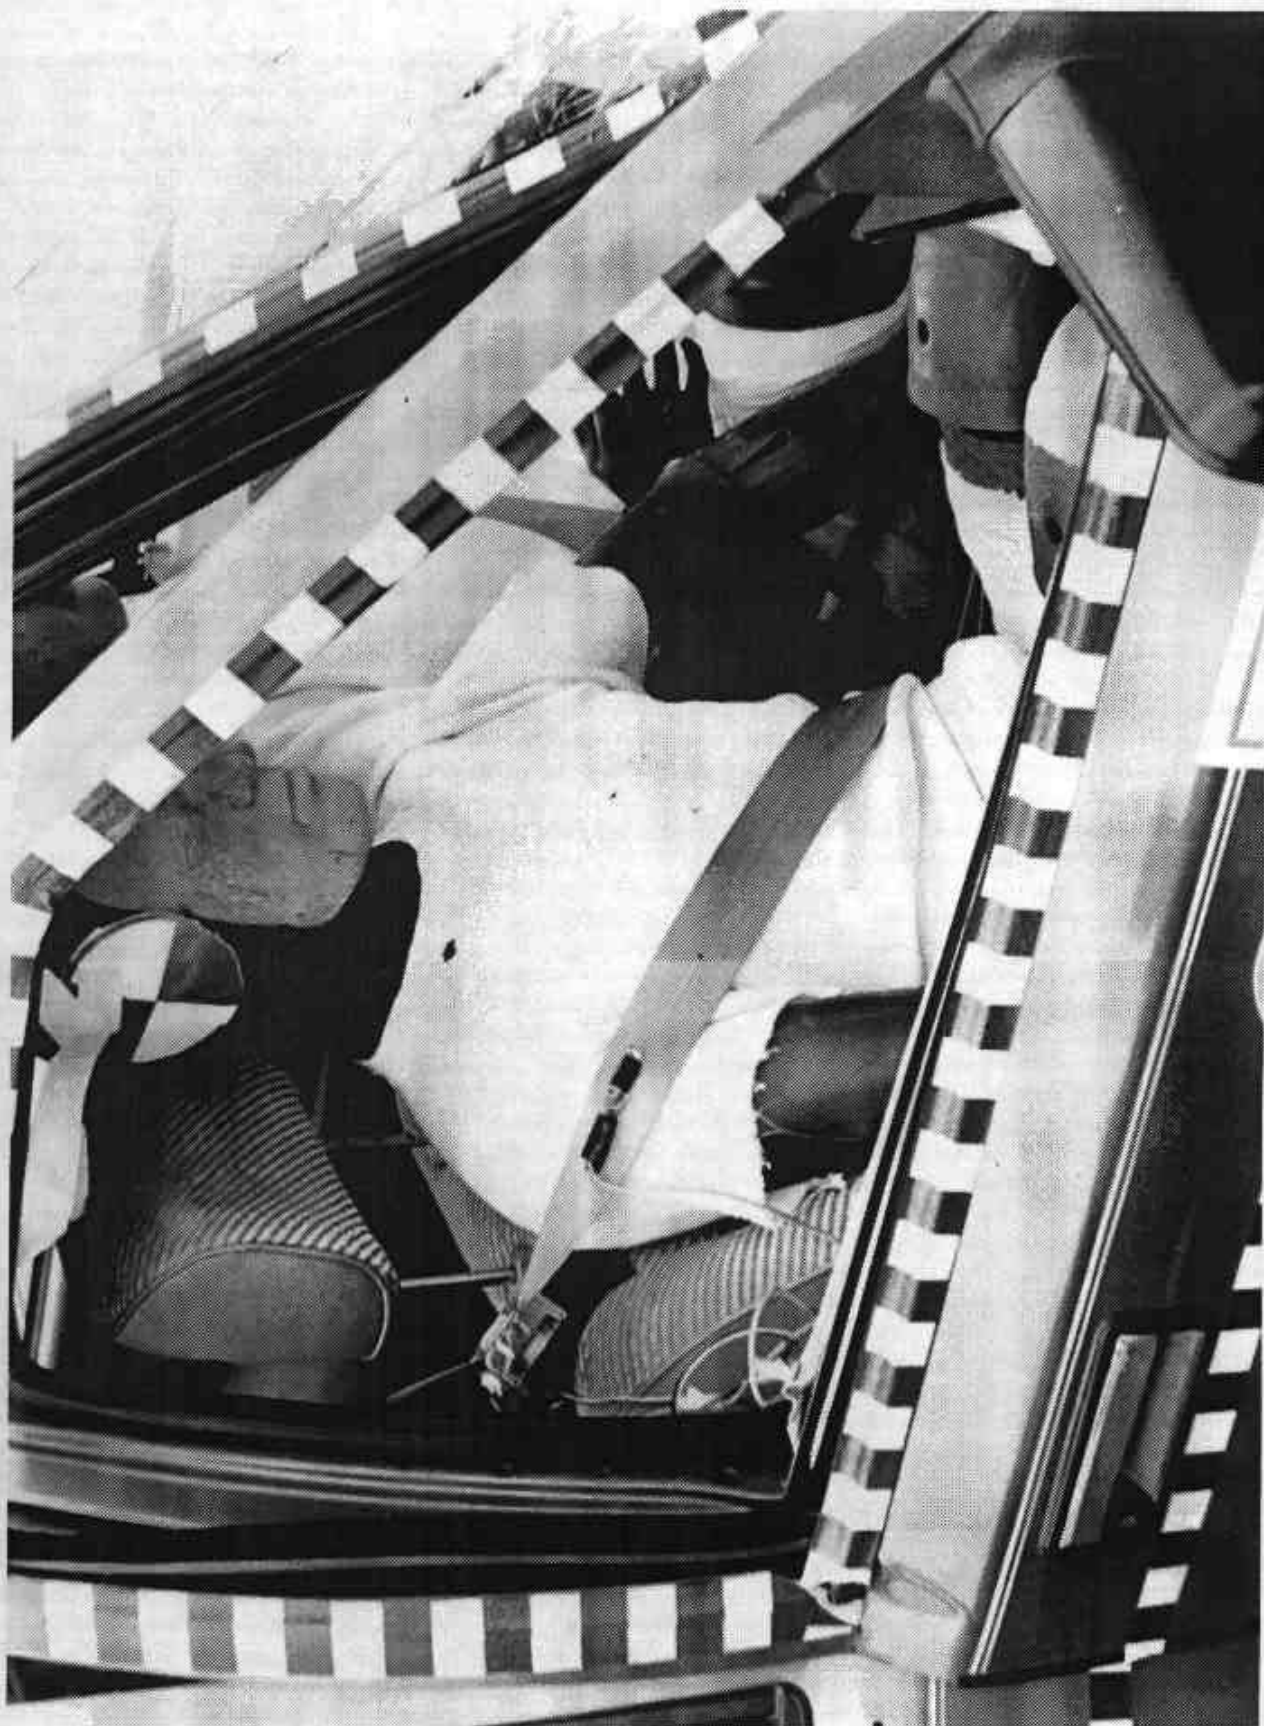
Figure A-26 POST-TEST PASSENGER POSITION VIEW

The right-front passenger HIC was 2662 and maximum chest deceleration over 3 milliseconds was 55 g's. Femur loads were 520 and 1597 pounds.
