DYNAMIC TESTING FOR  
SIDE CRUSH

MRB-TO-CAR SIDE IMPACT TEST OF  
A 90° MOVING RIGID BARRIER  
TO A 1983 FORD ESCORT  
TEST #1 16.1 MPH  
TEST #2 32.2 MPH

PREPARED BY:  
VEHICLE RESEARCH AND TEST CENTER  
ST. RT. 33 LOGAN COUNTY  
EAST LIBERTY, OHIO 43319

TEST REPORT  
JUNE 1986

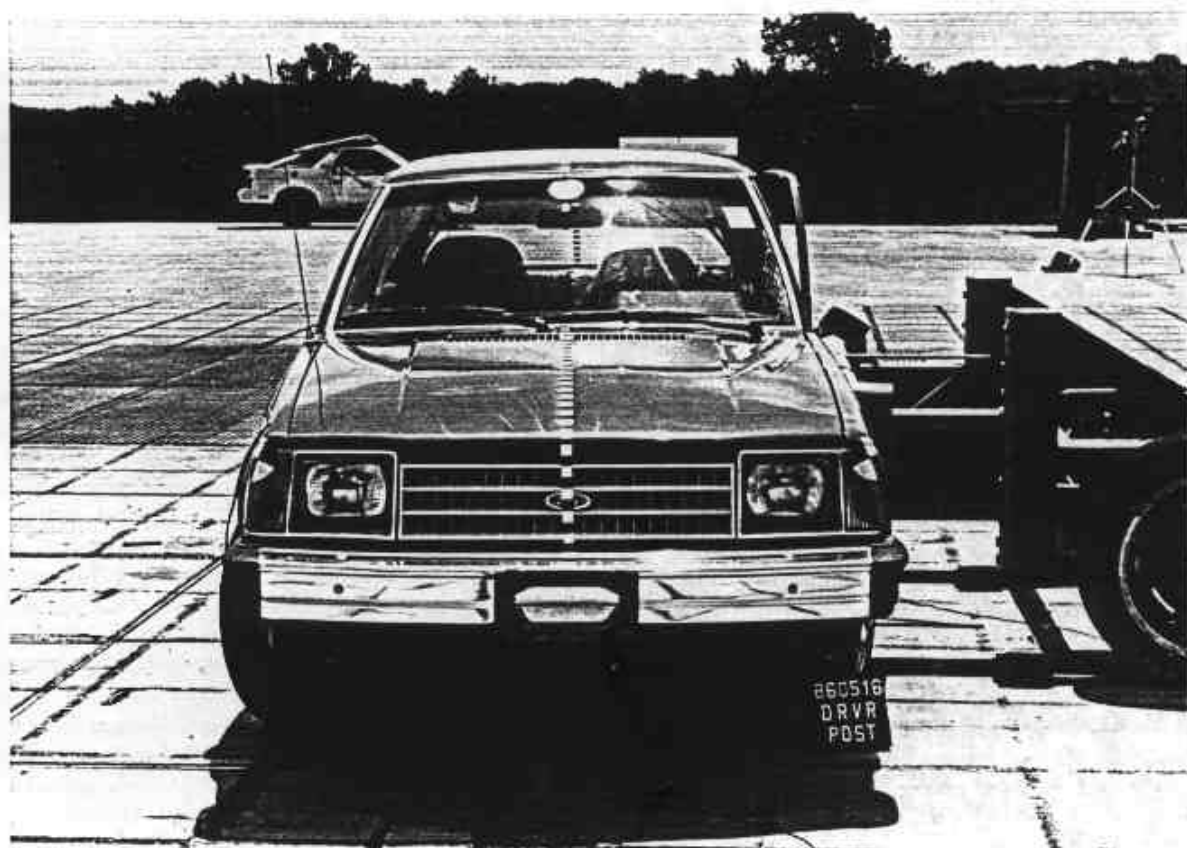
Figure A-2. POST-TEST FRONT VIEW  
A-2

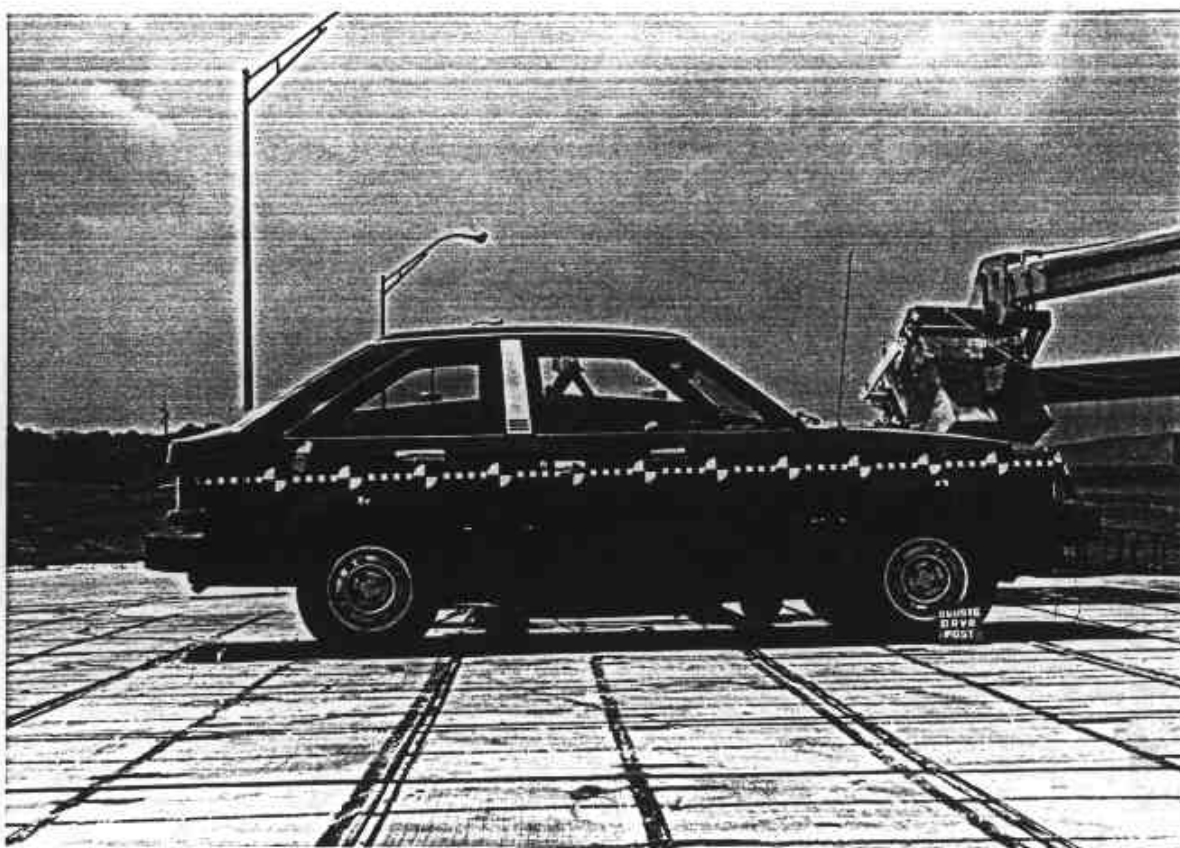
Figure A-4. POST-TEST PASSENGER SIDE VIEW  
A-3

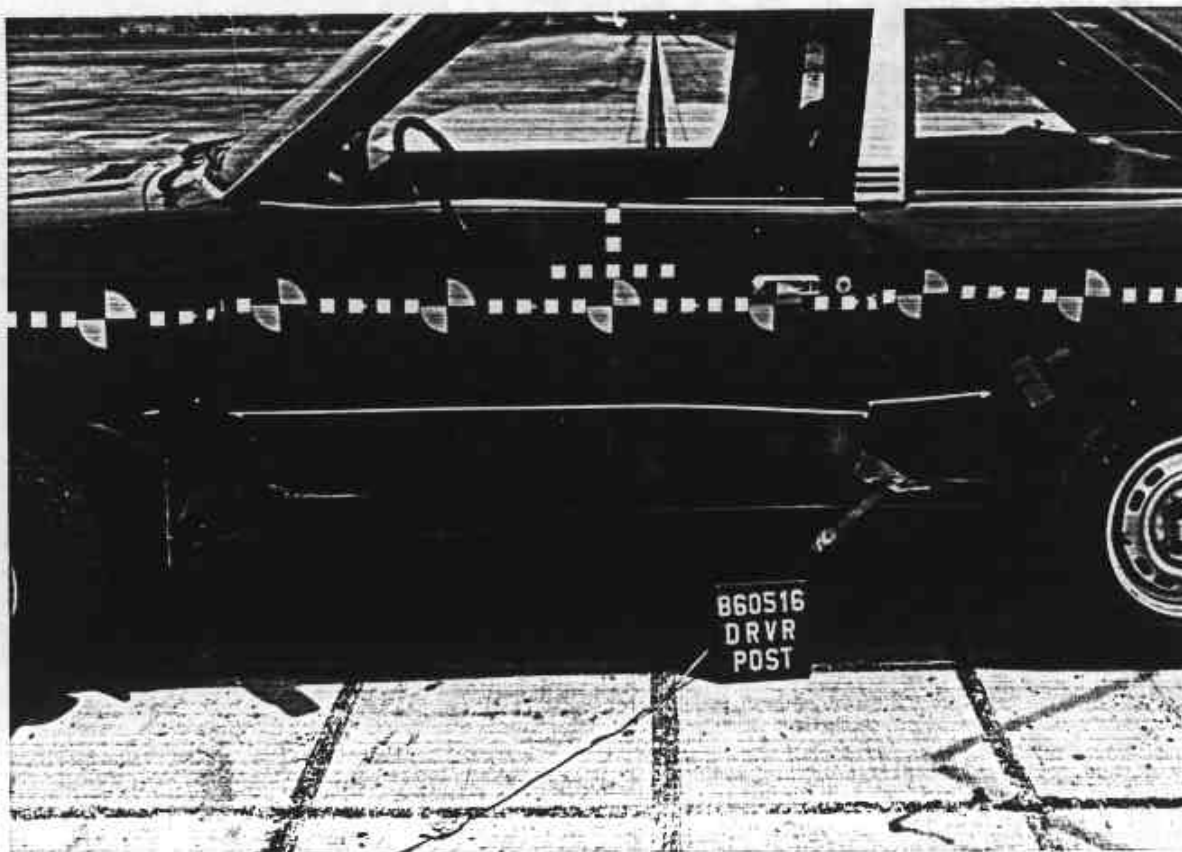
Figure A-15. POST-TEST FRONT DRIVER DOOR VIEW

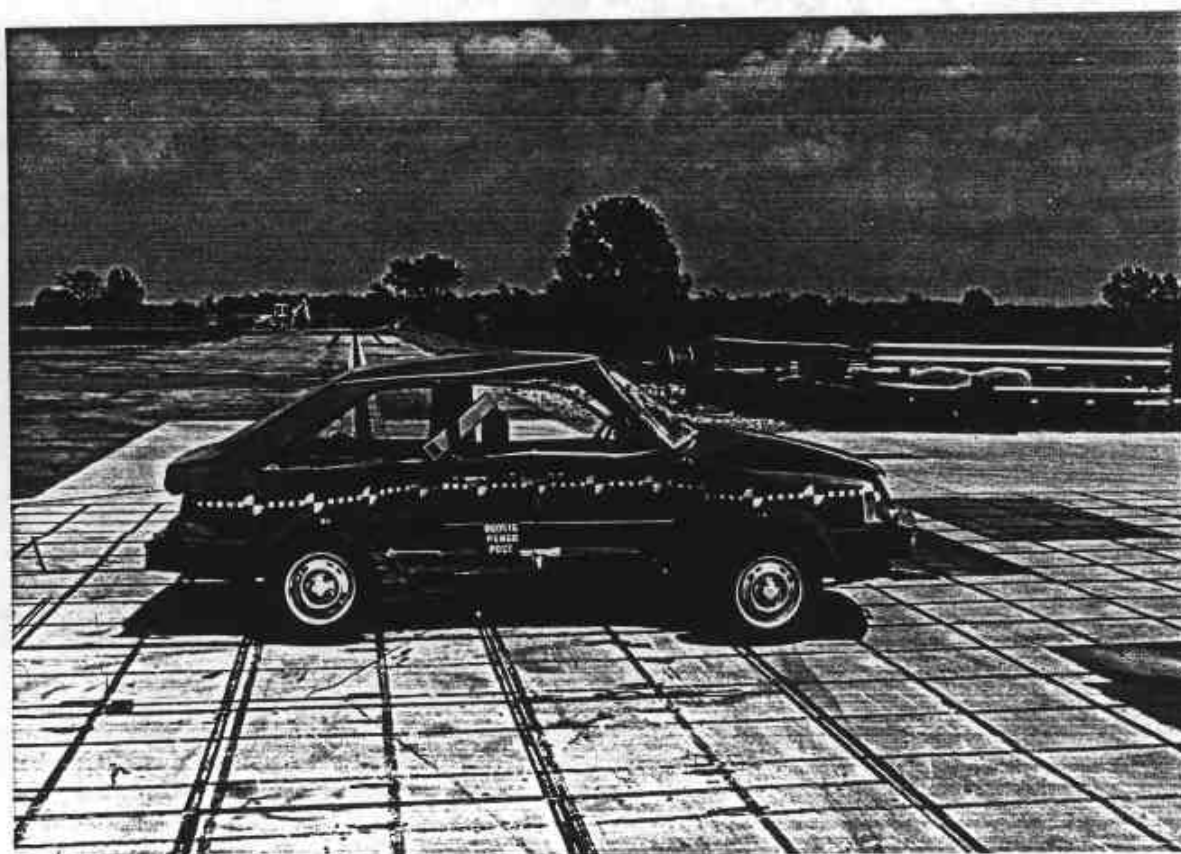
Figure B-4. POST-TEST PASSENGER SIDE VIEW
