VEHICLE SAFETY COMPLIANCE TESTING FOR
FMVSS 301-75 FOR FUEL SYSTEM INTEGRITY

MAZDA MOTOR CORPORATION
1986 MAZDA 323
3-DOOR HATCHBACK
NHTSA NO. G5401
TRCO TEST NO. 870707

THE TRANSPORTATION RESEARCH CENTER OF OHIO
ST. RT. 33, LOGAN COUNTY
EAST LIBERTY, OHIO 43319

JULY 1987
TEST REPORT

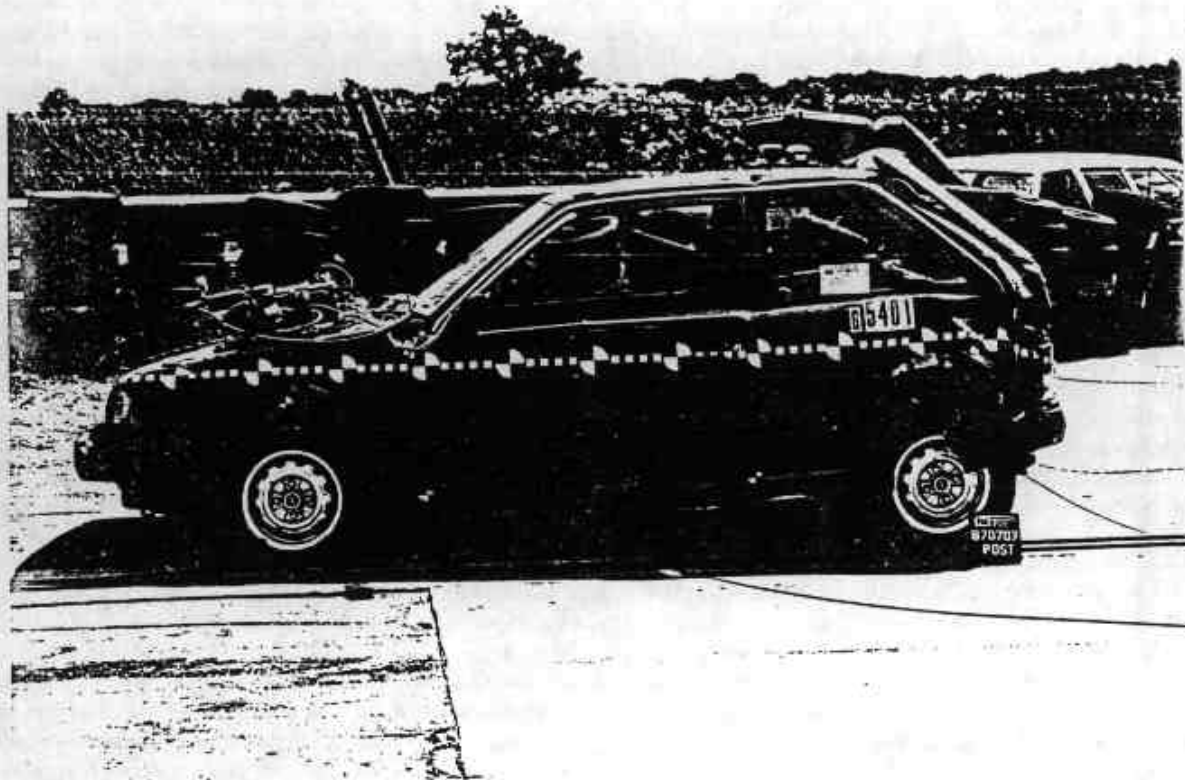
Figure 8. POST-TEST LEFT SIDE VIEW
