VEHICLE SAFETY COMPLIANCE TESTING  
FOR OCCUPANT CRASH PROTECTION,  
WINDSHIELD MOUNTING, WINDSHIELD ZONE  
INTRUSION, AND FUEL SYSTEM INTEGRITY

1987 SUBARU XT DL

NHTSA NO. CH5502

FINAL REPORT

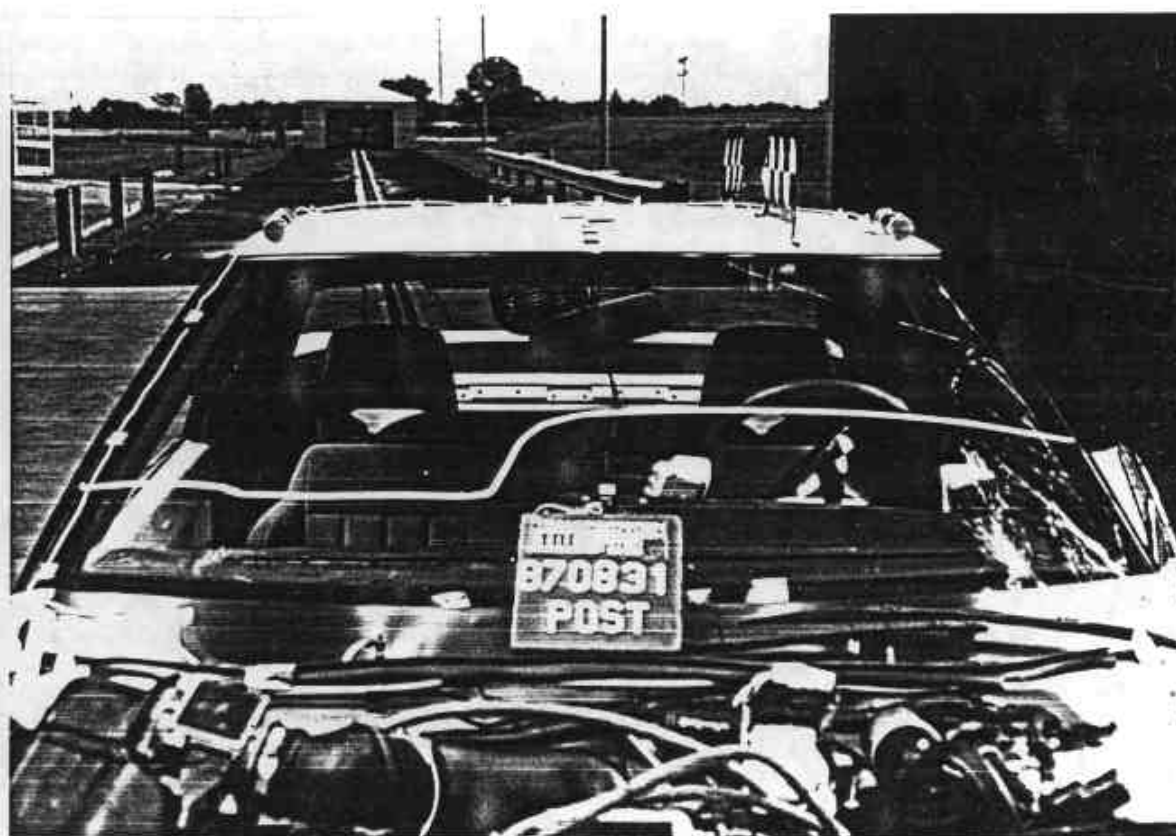
Figure 14. POST-TEST WINDSHIELD VIEW  
A-9

GLAZING DAMAGE: The windshield was cracked along each side.
