VEHICLE SAFETY COMPLIANCE TESTING
FOR OCCUPANT CRASH PROTECTION,
WINDSHIELD MOUNTING, WINDSHIELD ZONE
INTRUSION, AND FUEL SYSTEM INTEGRITY

ZASTAVA
1988 YUGO GV
3-DOOR HATCHBACK
NHTSA NO. CH0506
TRC TEST NO. 870923

THE TRANSPORTATION RESEARCH CENTER OF OHIO
U.S. RT. 33, LOGAN COUNTY
EAST LIBERTY, OHIO 43319

OCTOBER, 1987
FINAL REPORT

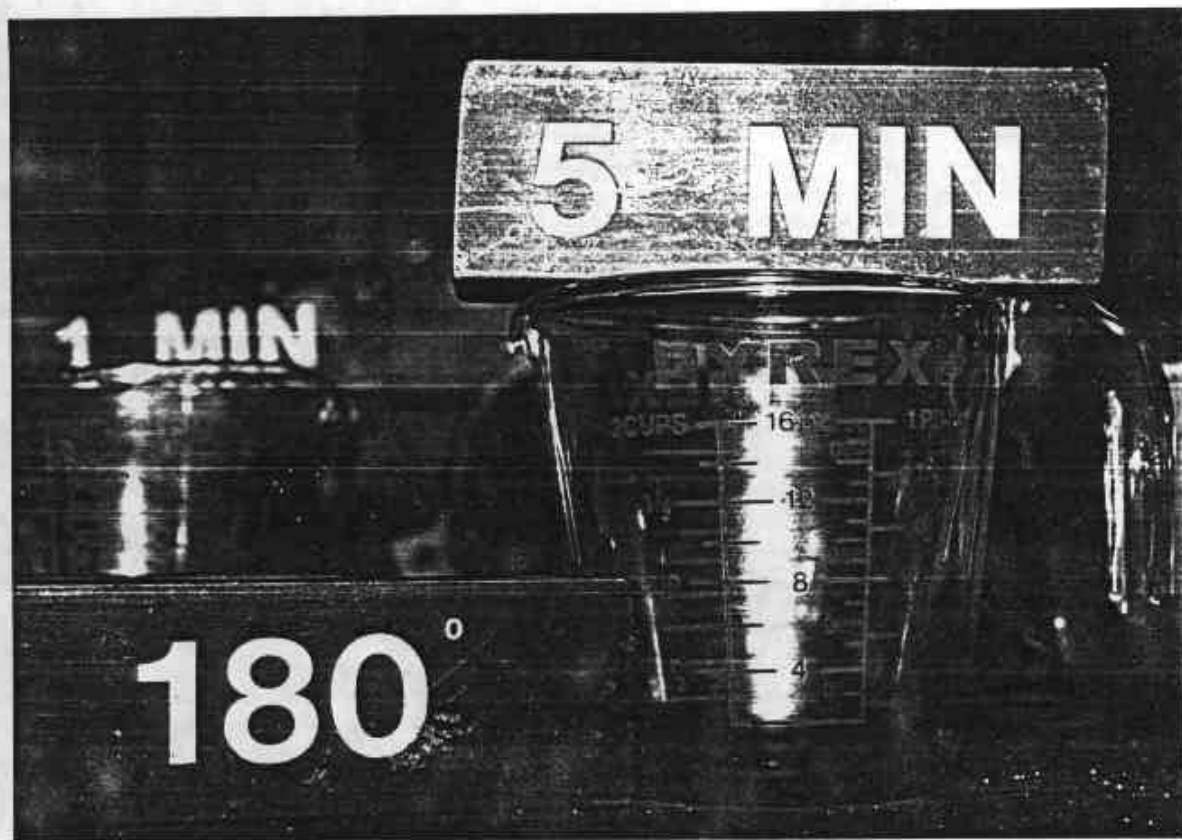
Figure 44. POST-TEST STODDARD LEAKAGE - VIEW 3
A-23

There was no Stoddard fluid leakage following the crash test event. There was .25 ounces of Stoddard leakage during the first five minutes of the 0° to 90° rollover and a trace of Stoddard leakage during the next two one-minute increments of the 0° to 90° rollover. There was .18 ounces of Stoddard leakage during the first five minutes of the 90° to 180° rollover.
