CAL REPORT NO. 7581-2

CRASHWORTHINESS TESTING AND ANALYSIS  
25 MPH FRONTAL BARRIER IMPACT

1987 Hyundai Excel GSL  
4-Door Hatchback

CALSPAN TEST NO. Y23-1-793

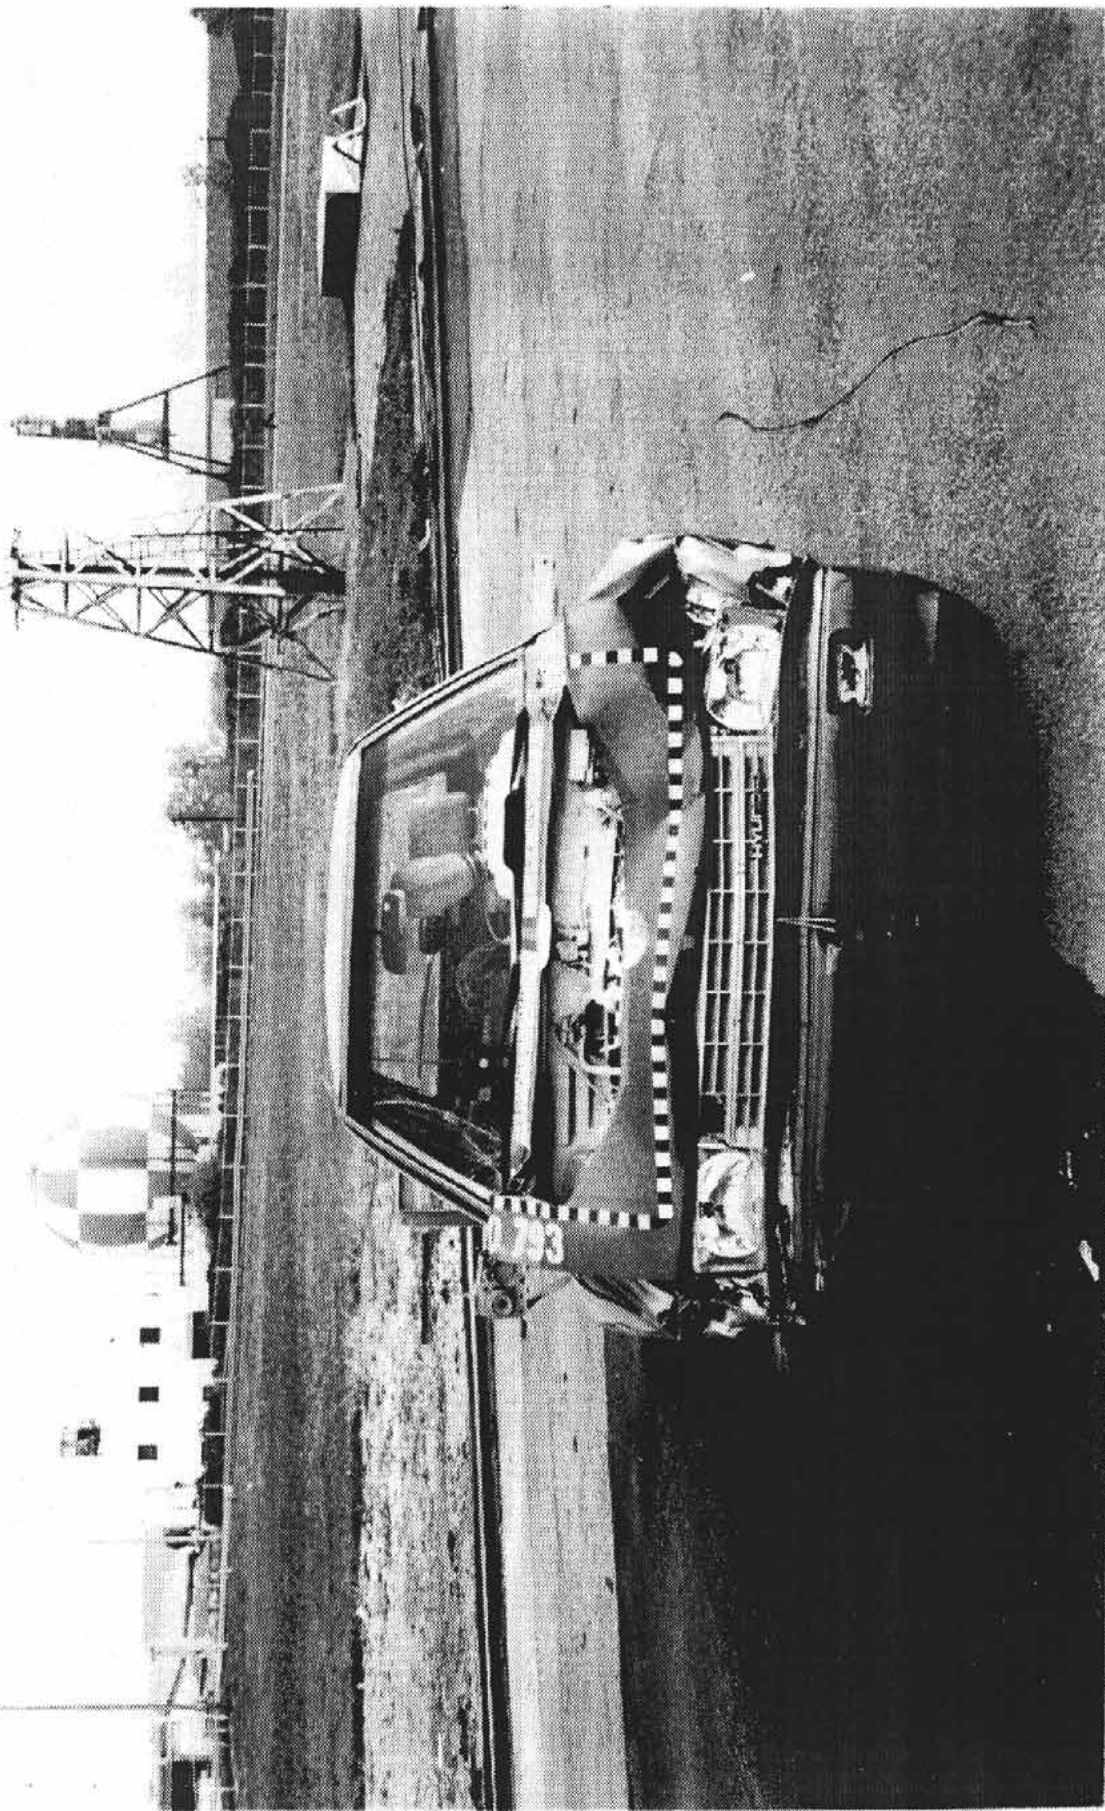
Figure A-2 POST-TEST FRONT VIEW

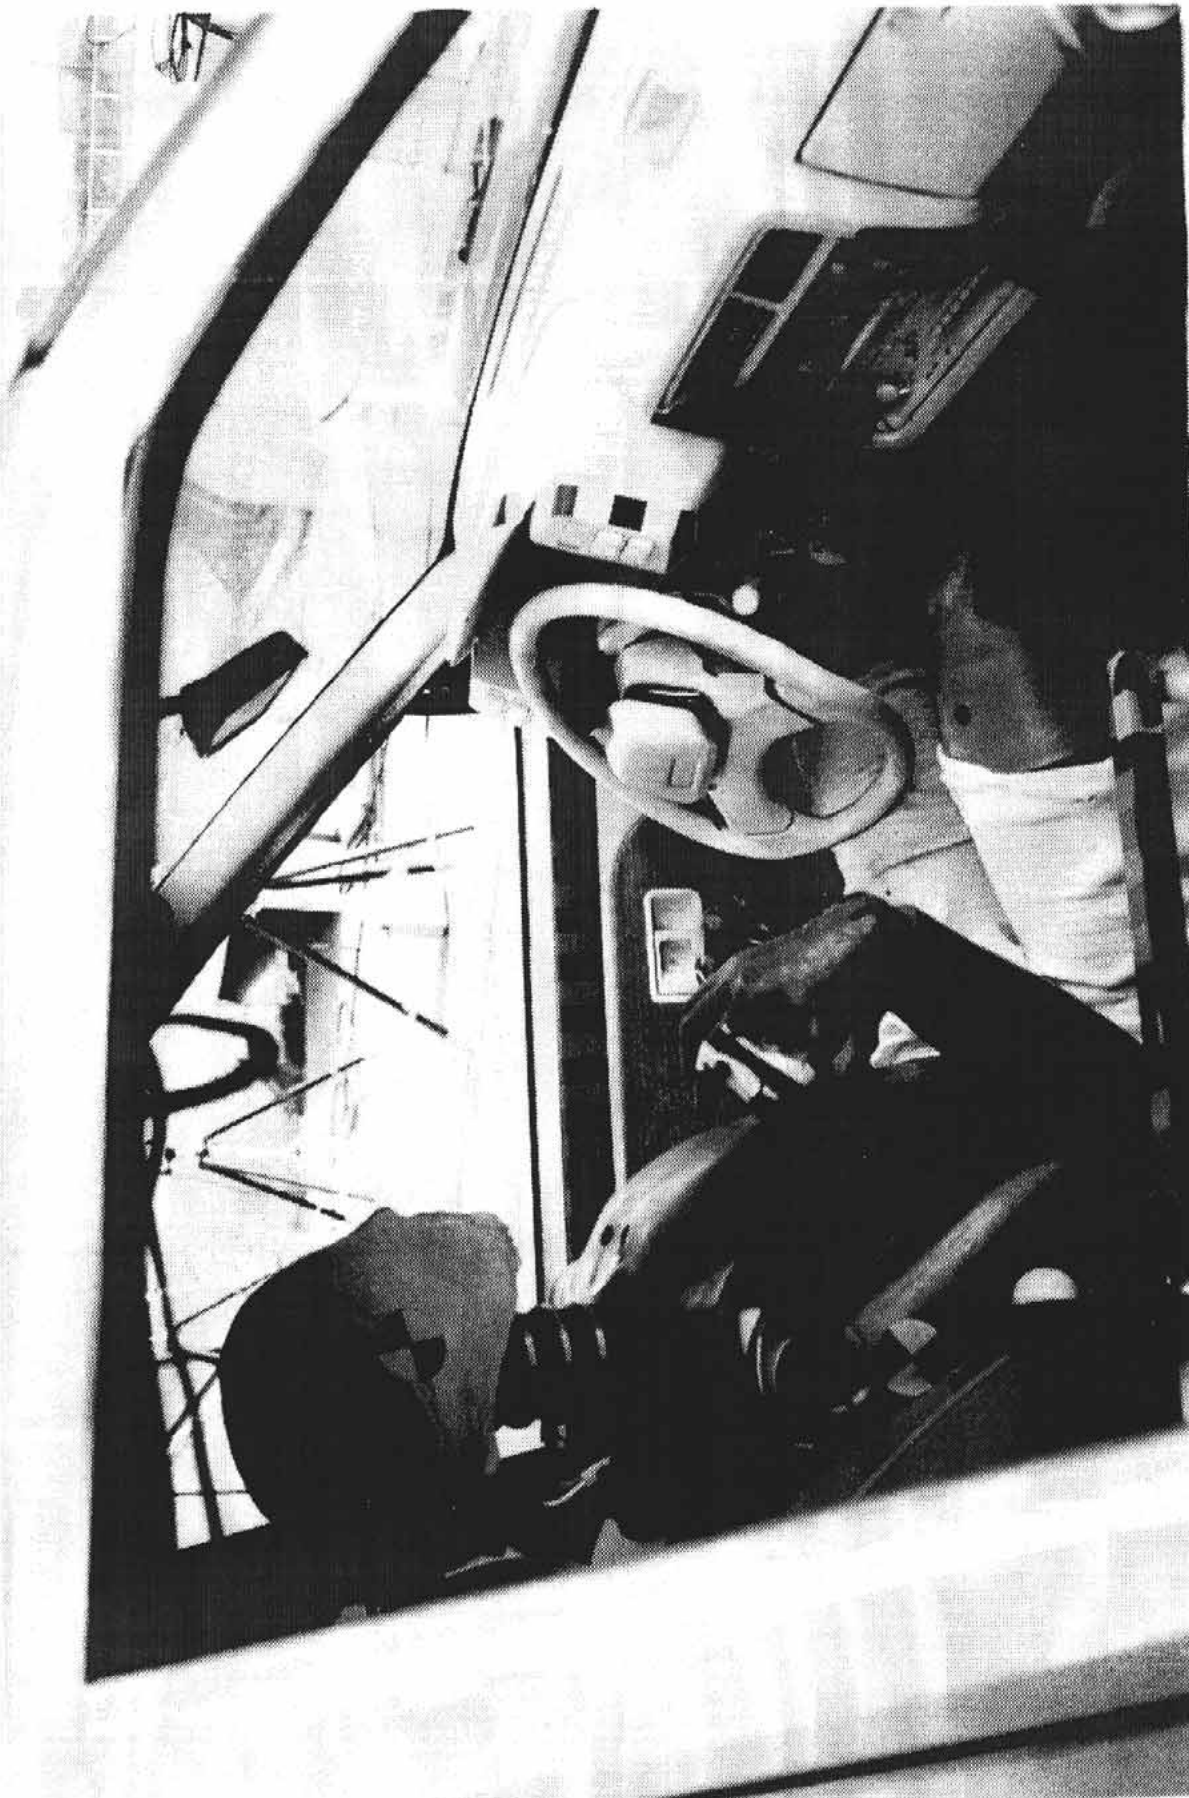
Figure A-22 POST-TEST RIGHT SIDE VIEW OCCUPANT POSITION
