CAL REPORT NO. 7581-5  
CRASHWORTHINESS TESTING AND ANALYSIS  
35 MPH FRONTAL BARRIER IMPACT

1987 Hyundai Excel GSL  
4-Door Hatchback

CALSPAN TEST NO. Y23-4-797

FINAL REPORT

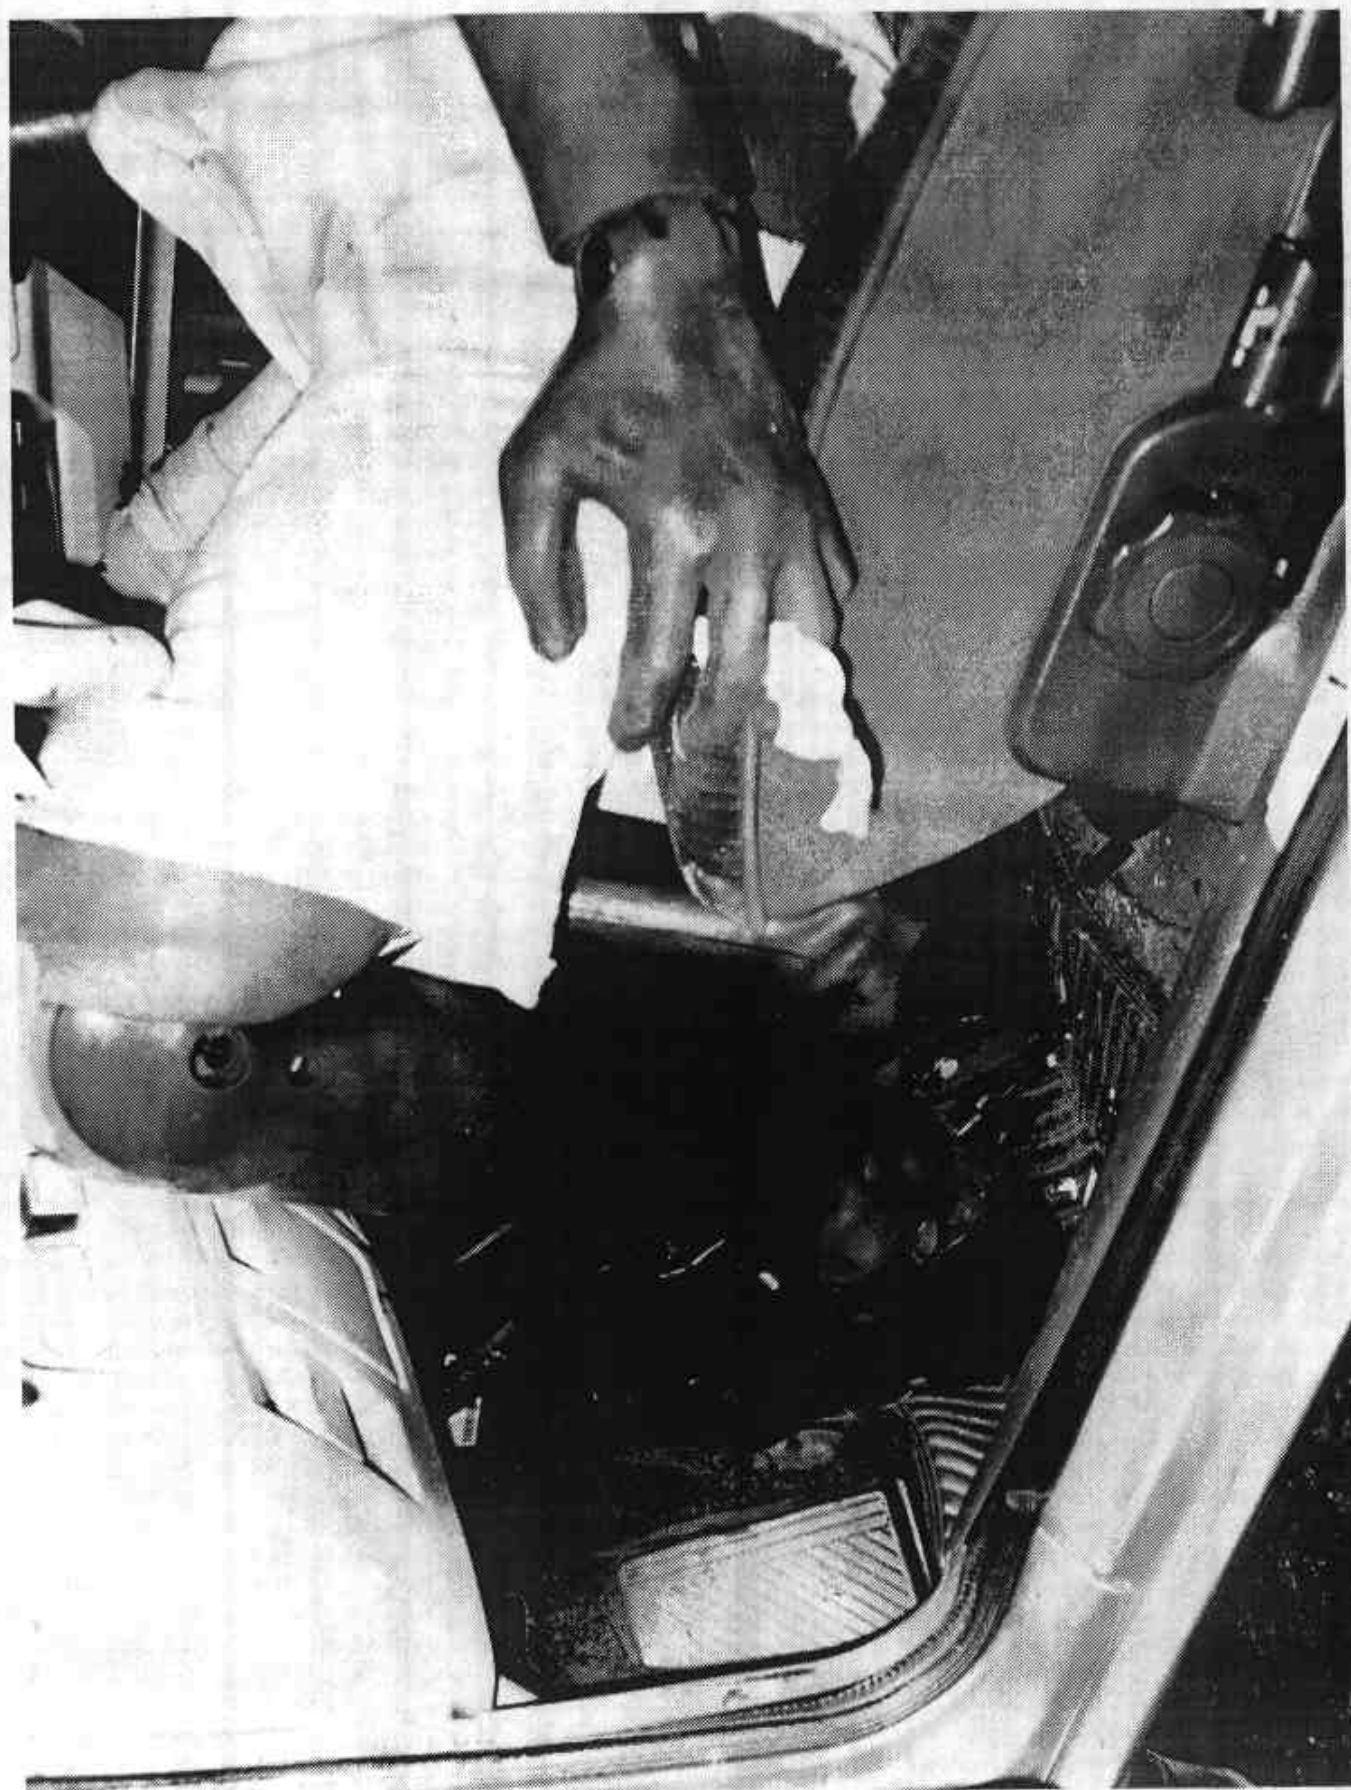
Figure A-33 POST-TEST OCCUPANT LOWER LEG POSITION

The driver's head struck the steering wheel rim and dashboard. The driver's HIC was 1424. The maximum chest deceleration over 3 milliseconds was 78.2 g's and femur loads were 1676 and 2583 pounds. The Laceration Index (TLI) equaled 6.31. The ATD's right ankle was broken during the impact; a post-test photograph of the lower legs can be found in Appendix A.
