FHWA CONTRACT NO.  
DTFH61-86-Z-00046

THIRTY MPH BROADSIDE  
IMPACT OF A MINI-SIZED VEHICLE  
AND A BREAKAWAY LUMINAIRE SUPPORT

TEST RESULTS REPORT  
TEST NUMBER 1785-SI#2-87

August 1987

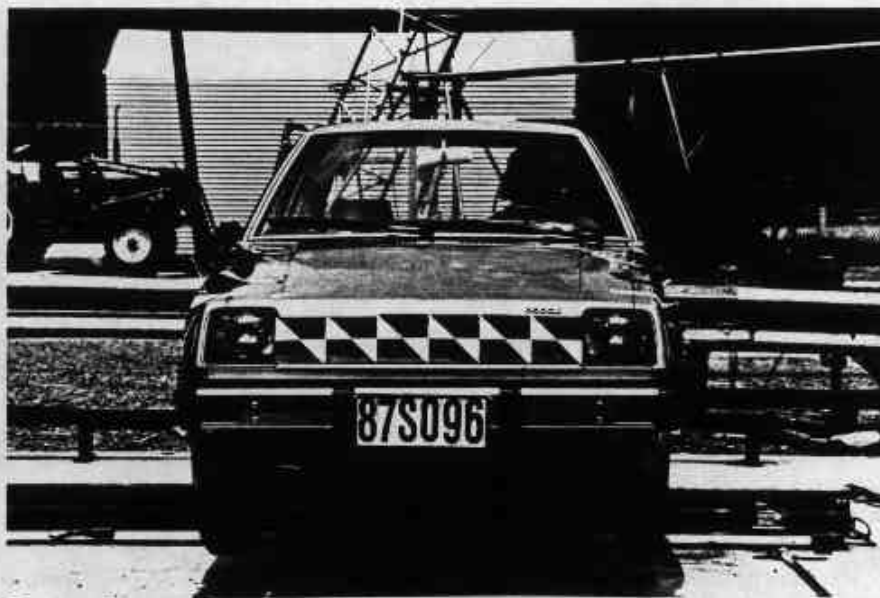
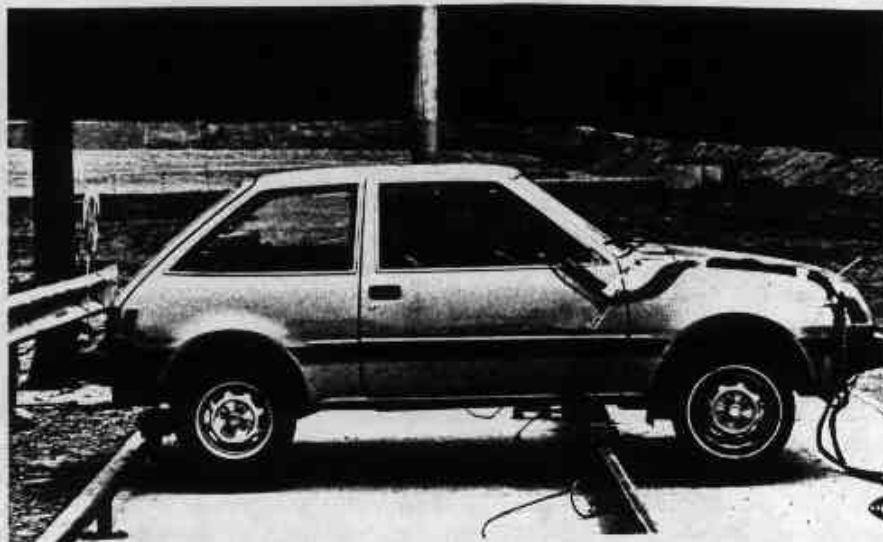
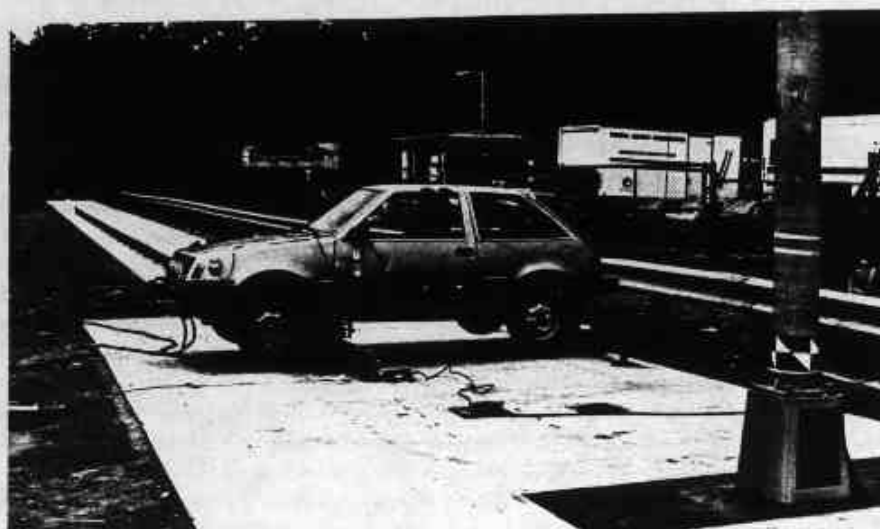
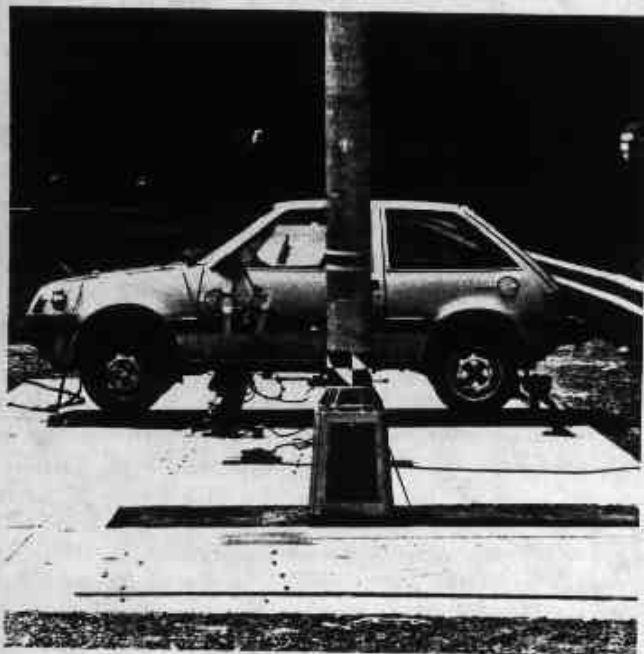
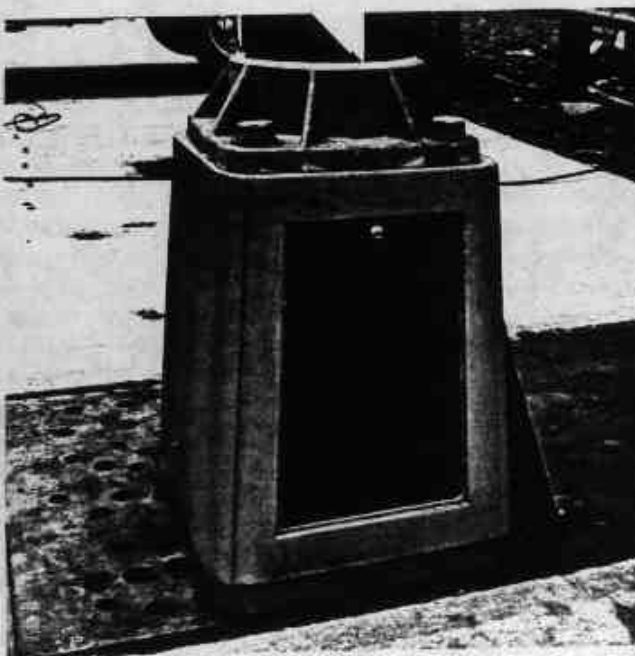
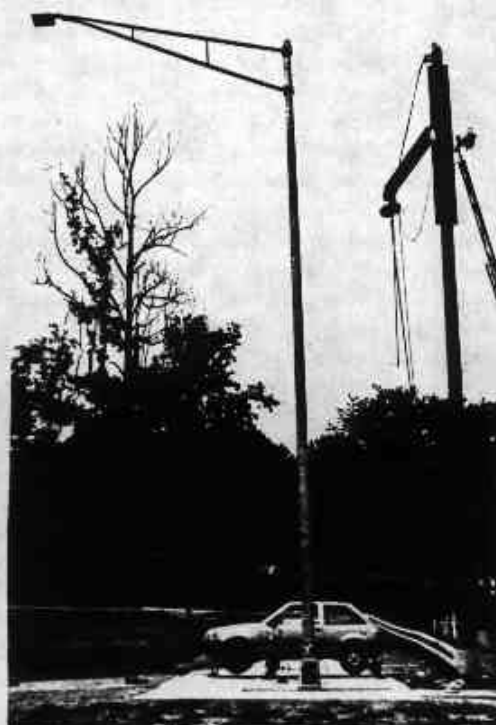
Figure 2. Pre-Test Photos of Vehicle & Pole

The vehicle was equipped with a triaxial accelerometer package mounted on the lateral centerline of the vehicle at the longitudinal location of the center of gravity. Two rate gyros were also installed to the same mounting block to measure roll and yaw rates. The vehicle was also equipped with a contact switch mounted on the left door to permit vehicle and occupant data to be measured relative to the time of impact. A second triaxial accelerometer package was attached to the floor board located in front of the front right hand seat. This data was collected using the FOIL data system. The test vehicle is shown in figure 2.

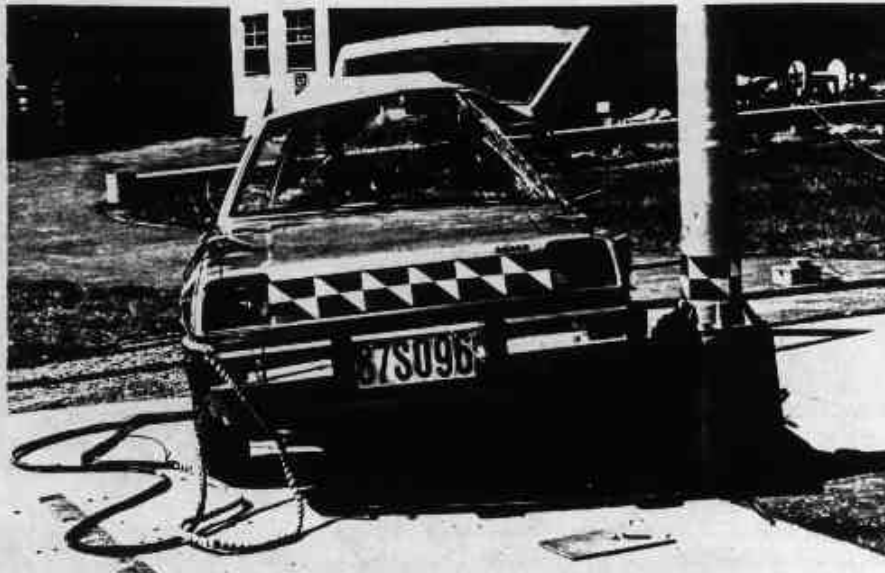
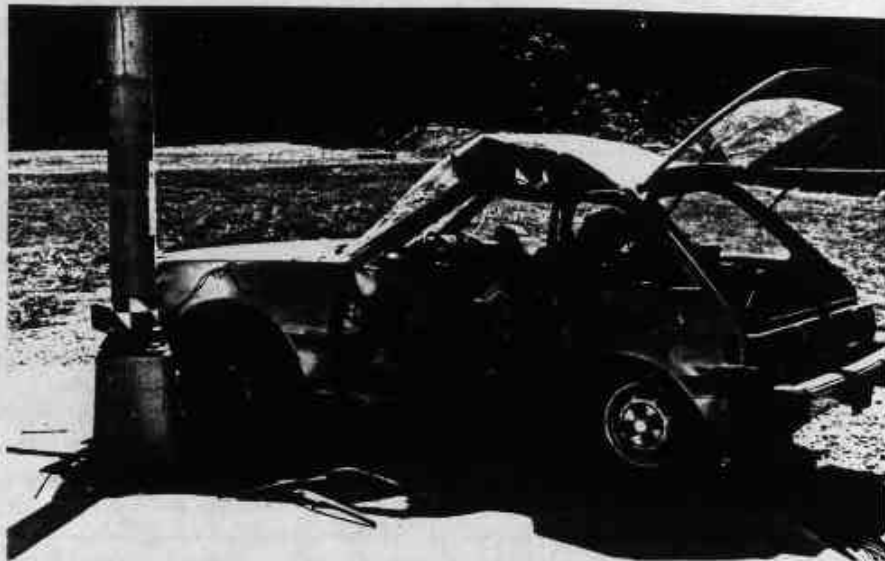
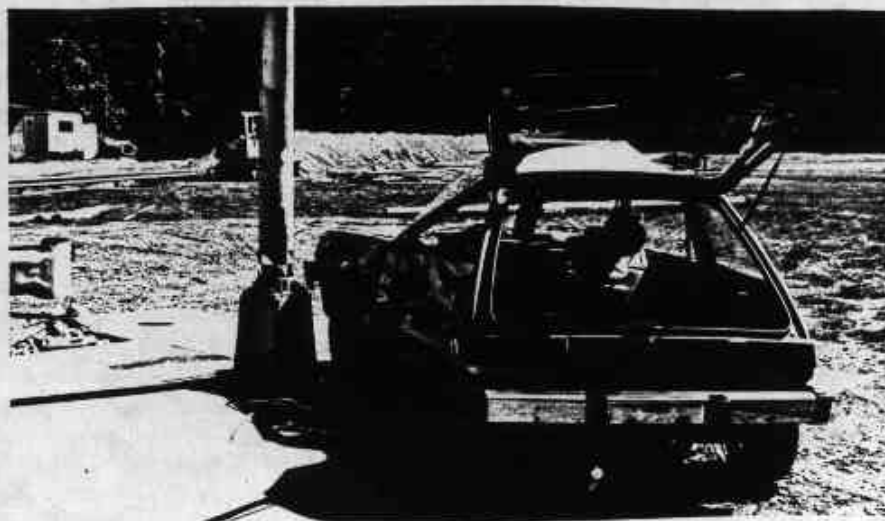
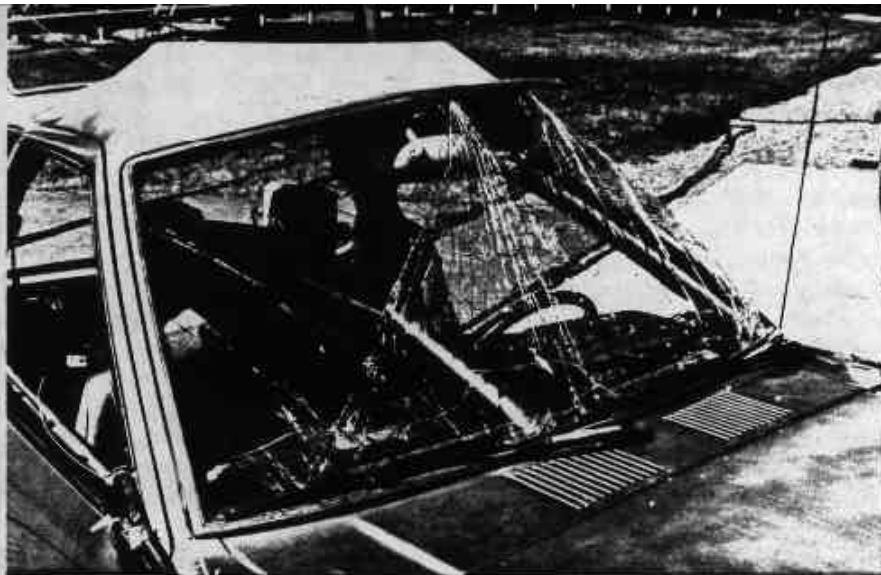
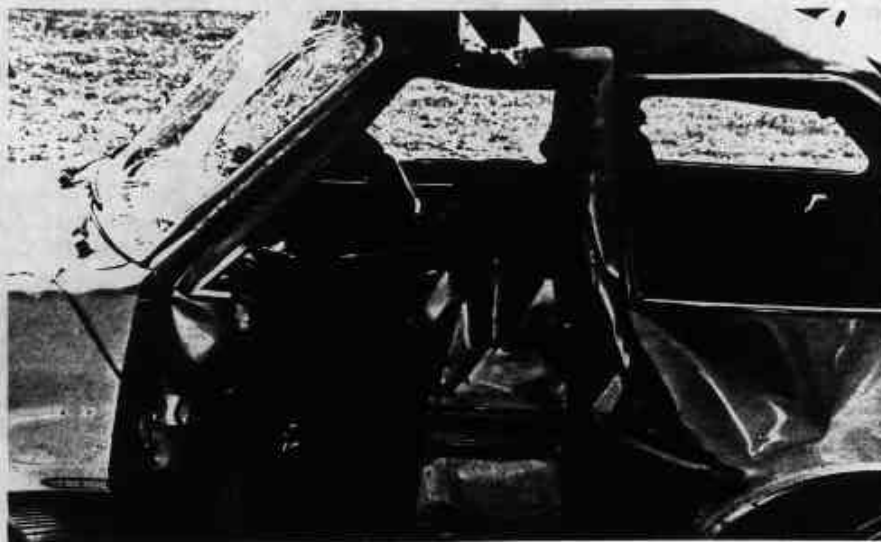
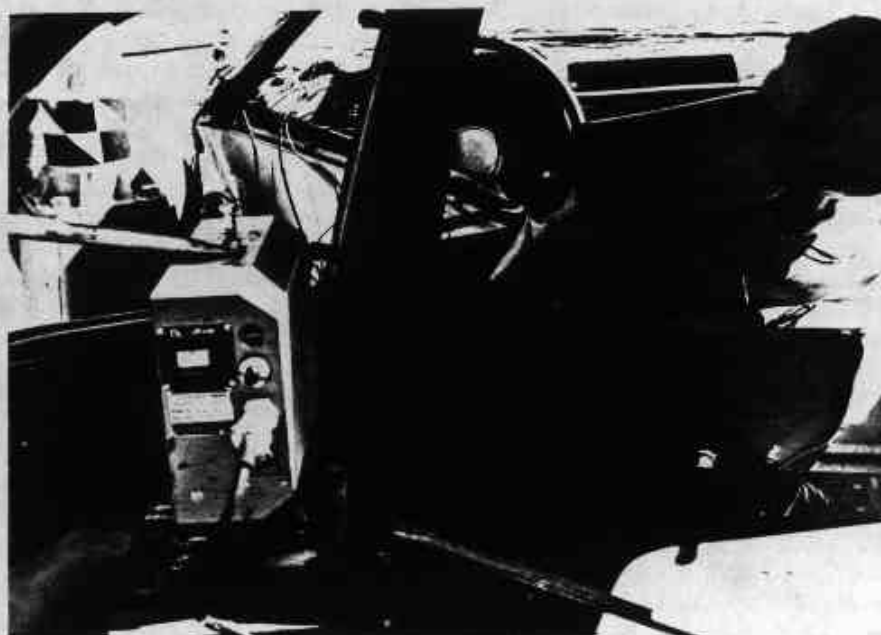
Figure 3. Post-Test Photos of Vehicle

The impact conditions were 28.64 mph (12.81 m/s) at a point on the left door in line with the occupant 19 in (.46 m) behind the longitudinal location of the center of gravity of the vehicle measured without the dummy in the vehicle. The vehicle had a  $6.4^{\circ}$  roll angle as it leaned toward the test pole due to the side sliding forces acting on the tires. The maximum residual crush of the vehicle at the impact point was 26 inches (.66 m). Photographs of the vehicle and luminaire support after the collision event are shown in figure 3.

Upon impact the vehicle began to crush followed by the dummy's head striking the pole. Shortly after impact the vehicle began to yaw clockwise around the pole. The transformer base pole combination did not break away, although the T-base did have several cracks around the bottom. The vehicle continued to yaw coming to a rest after about  $153^{\circ}$  of total rotation. Its final resting position was with the impact point approximately 2' to the right of the pole. The vehicle was bent about the impact point with the wheel base shortened almost 20" on the impact side. The residual test vehicle crush measured using the 6 point NHTSA guide is given in table 7. See figure 4 for reference.

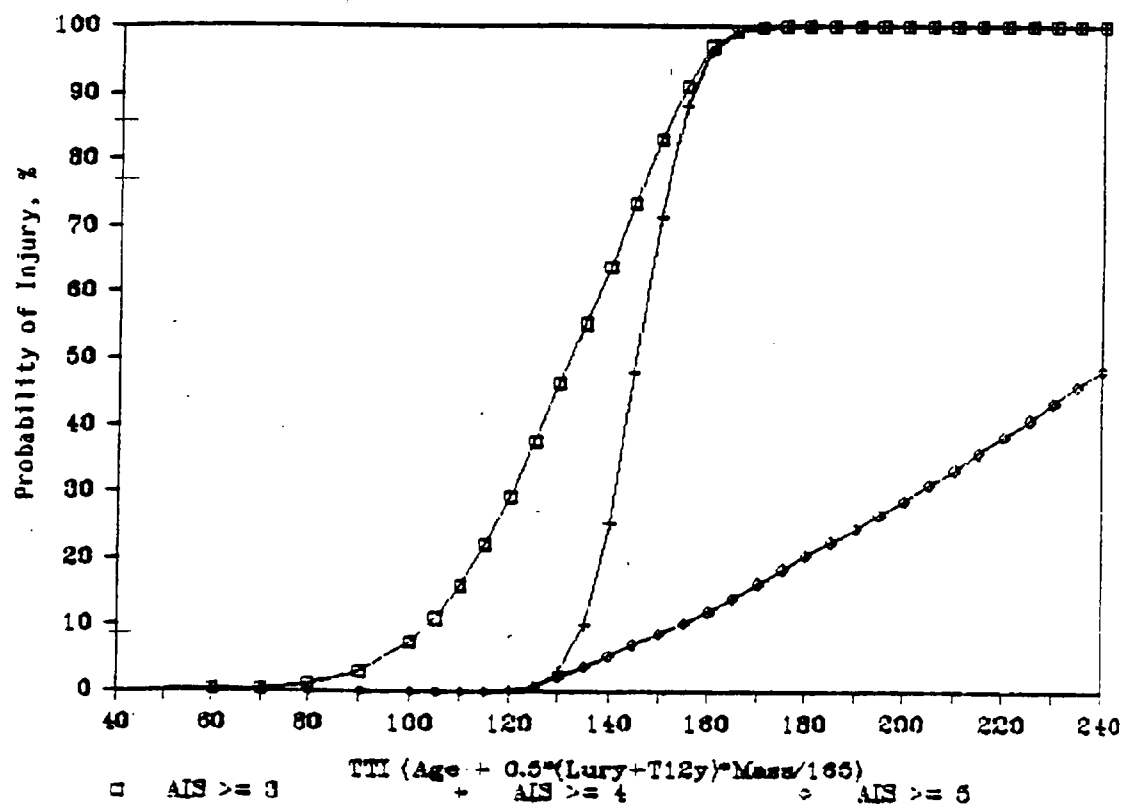
Figure 5. Thoracic Trauma Index Scale

The LURY data was taken from figures A27 and A28. The peak value of each was 252 g's and 330 g's. The average is 291. Thus the TTI index in this test is 291 plus occupant age. This value produces a 100% probability of injury of an AIS greater than 3 or 4. The probability of injury of an AIS greater than 5 is at least 50% since the figure ends at the 240 index level.

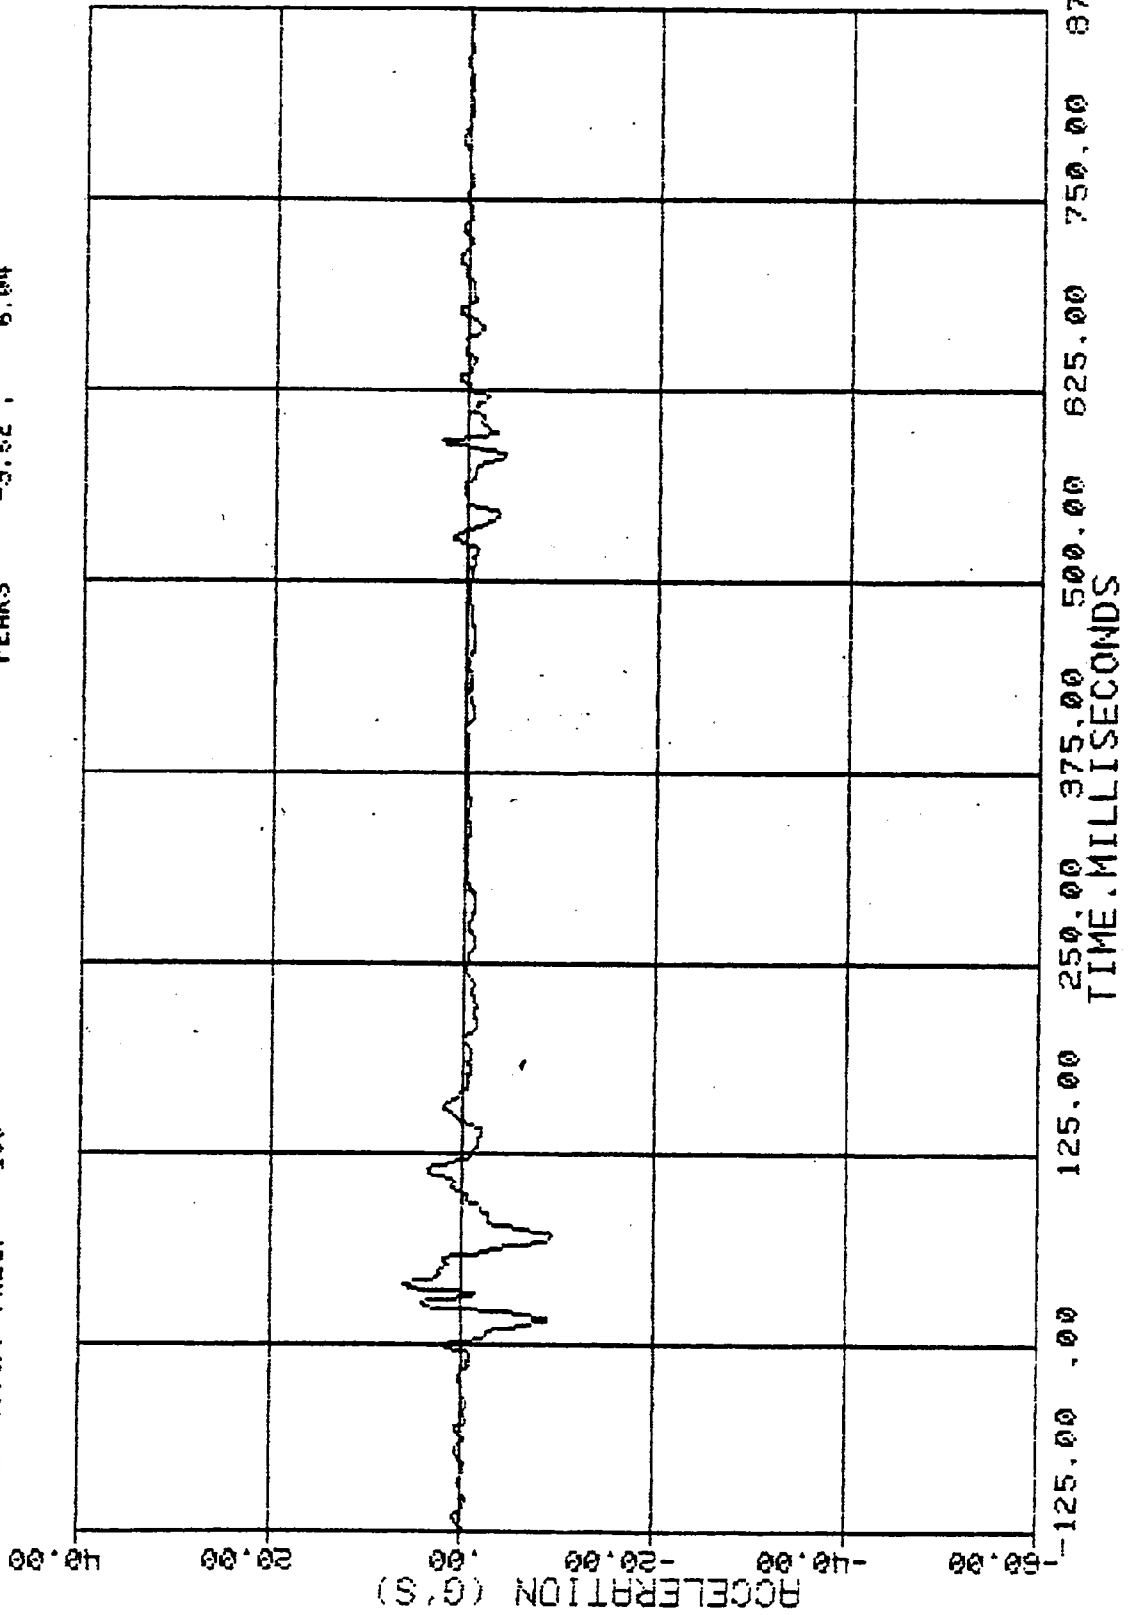
Figure A-1. Vehicle Acceleration, x-axis, 100 Hz

ENSCO, INC.      CONTRACT NUMBER    DTH61-86-2-00047      TEST NUM 1785-SI-2-87  
 30 MI/H BROADSIDE IMPACT OF 80 DODGE COLT INTO LUMINAIRE SUPPORT  
 CHANNEL 13      VEHICLE C.O. ACCELERATION, X-AXIS  
 FILTER CUTOFF FREQ.    100      PEAKS    -3.52    5.04

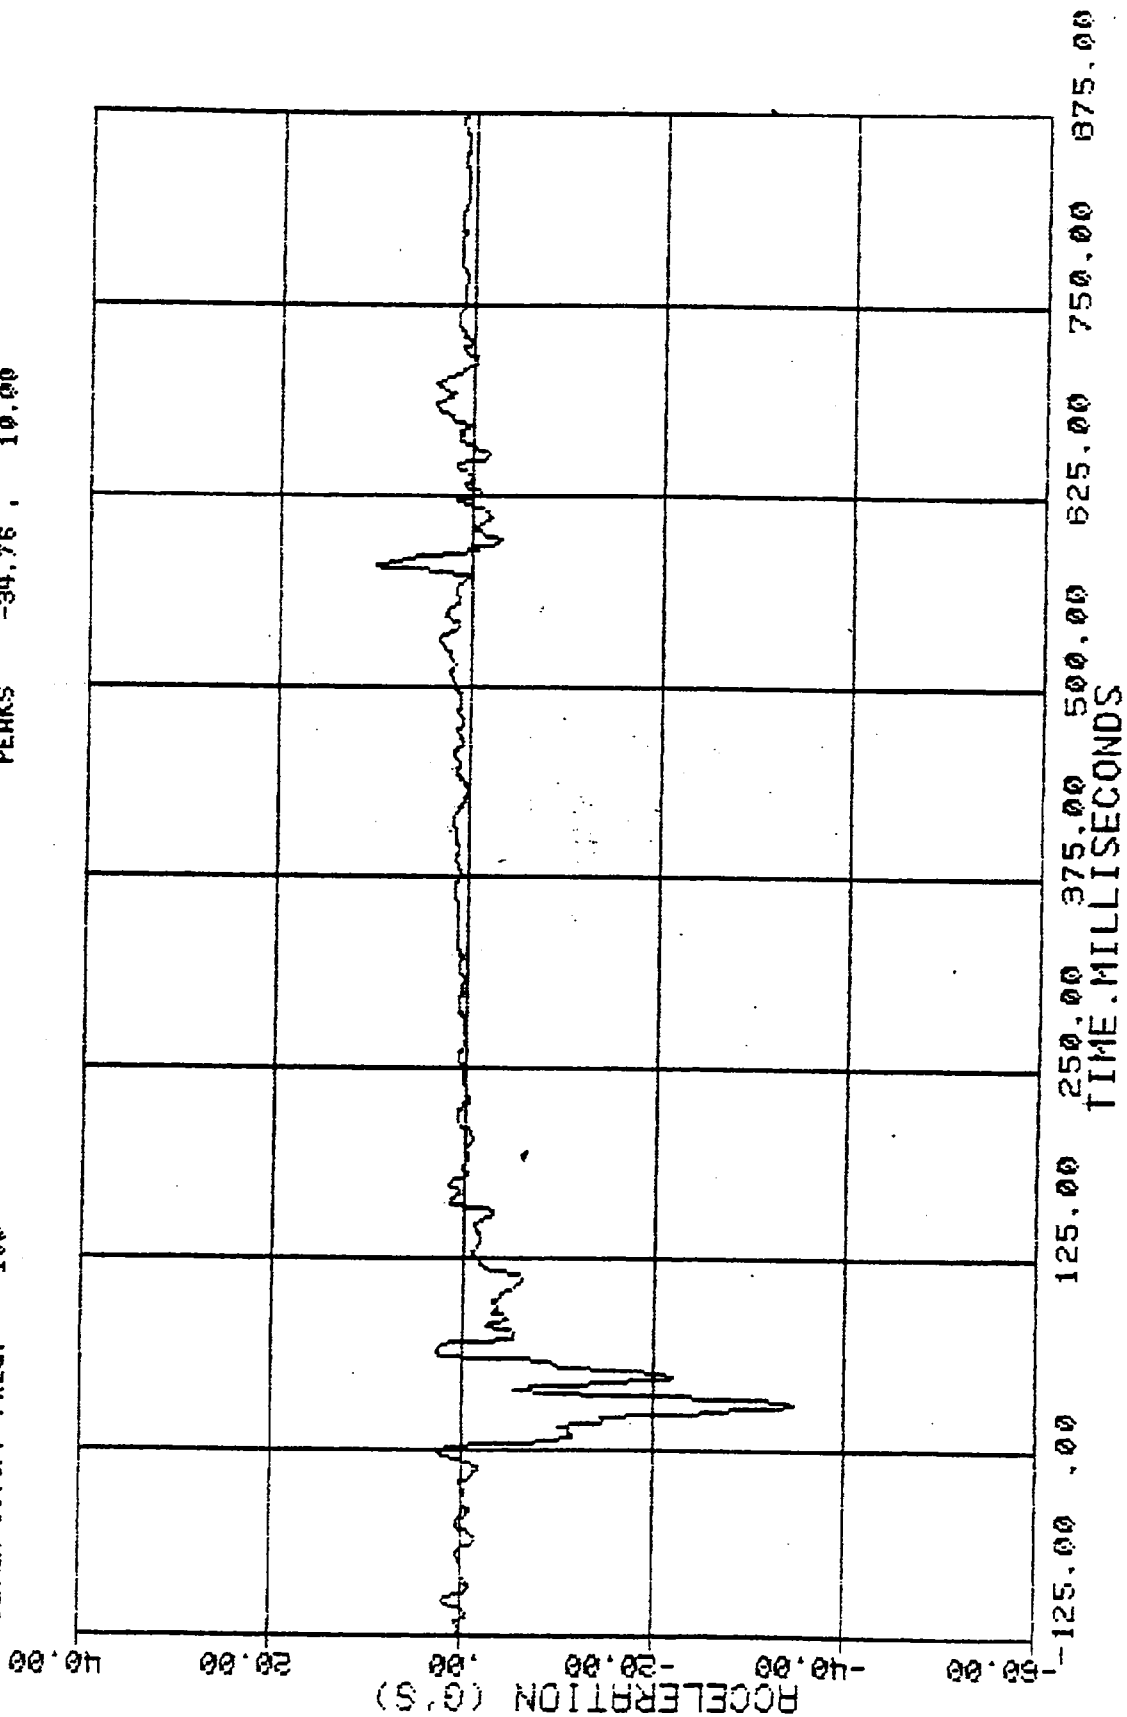
Figure A-2. Vehicle Acceleration, Y-Axis, 100 Hz

ENSCO, INC.      CONTRACT NUMBER    DTFH61-88-Z-00047      TEST NUM 1785-SI-2-87  
 30 MI/H BROADSIDE IMPACT OF 80 DODGE GOLF INTO LUMINAIRE SUPPORT  
 CHANNEL    20    VEHICLE C.O. ACCELERATION, Y-AXIS  
 FILTER CUTOFF FREQ.    100      PEAKS    -34.76    10.00

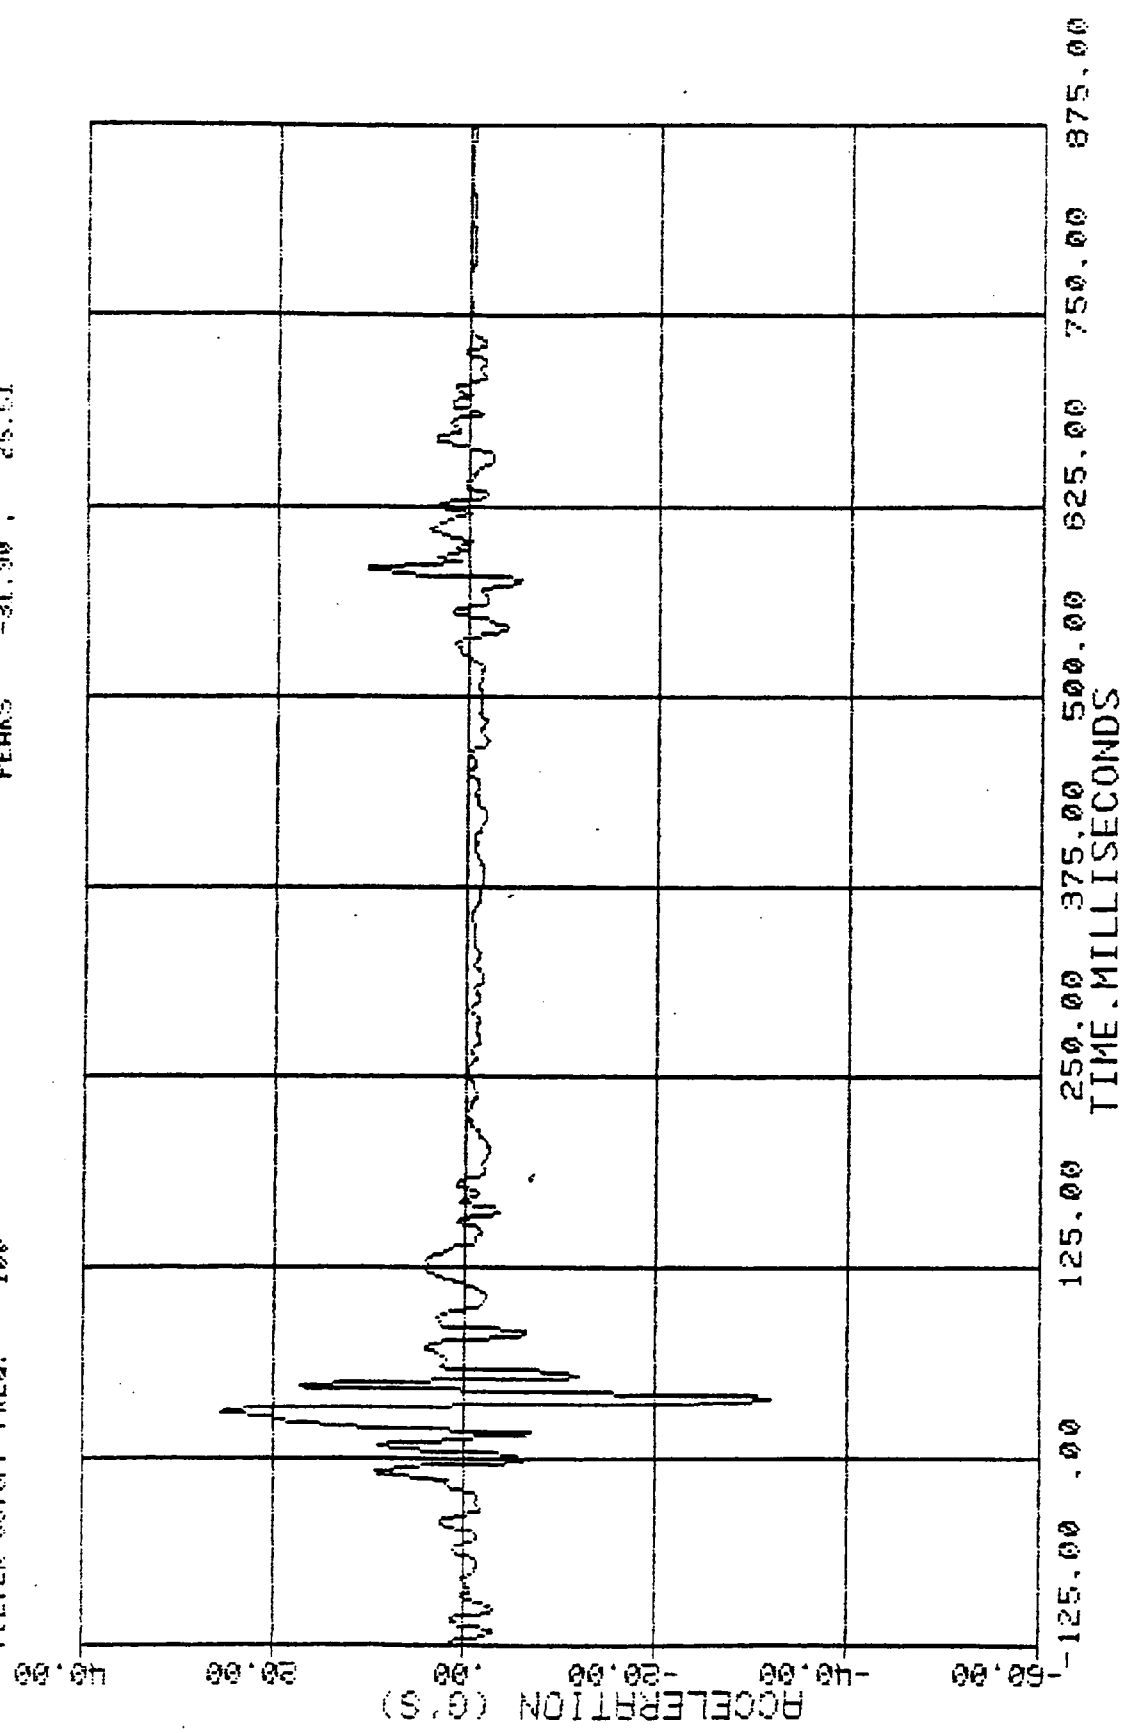
Figure A-3. Vehicle Acceleration, Z-Axis, 100 Hz

ENSCO, INC.      CONTRACT NUMBER      DTFH61-86-Z-00047      TEST NUM 1785-SI-2-87  
 30 MI/H BROADSIDE IMPACT OF 80      DODGE COLT INTO LUMINAIRE SUPPORT  
 CHANNEL 24      VEHICLE O.B. ACCELERATION, Z-AXIS  
 FILTER CUTOFF FREQ.      100      PEAKS      -31.00      25.01

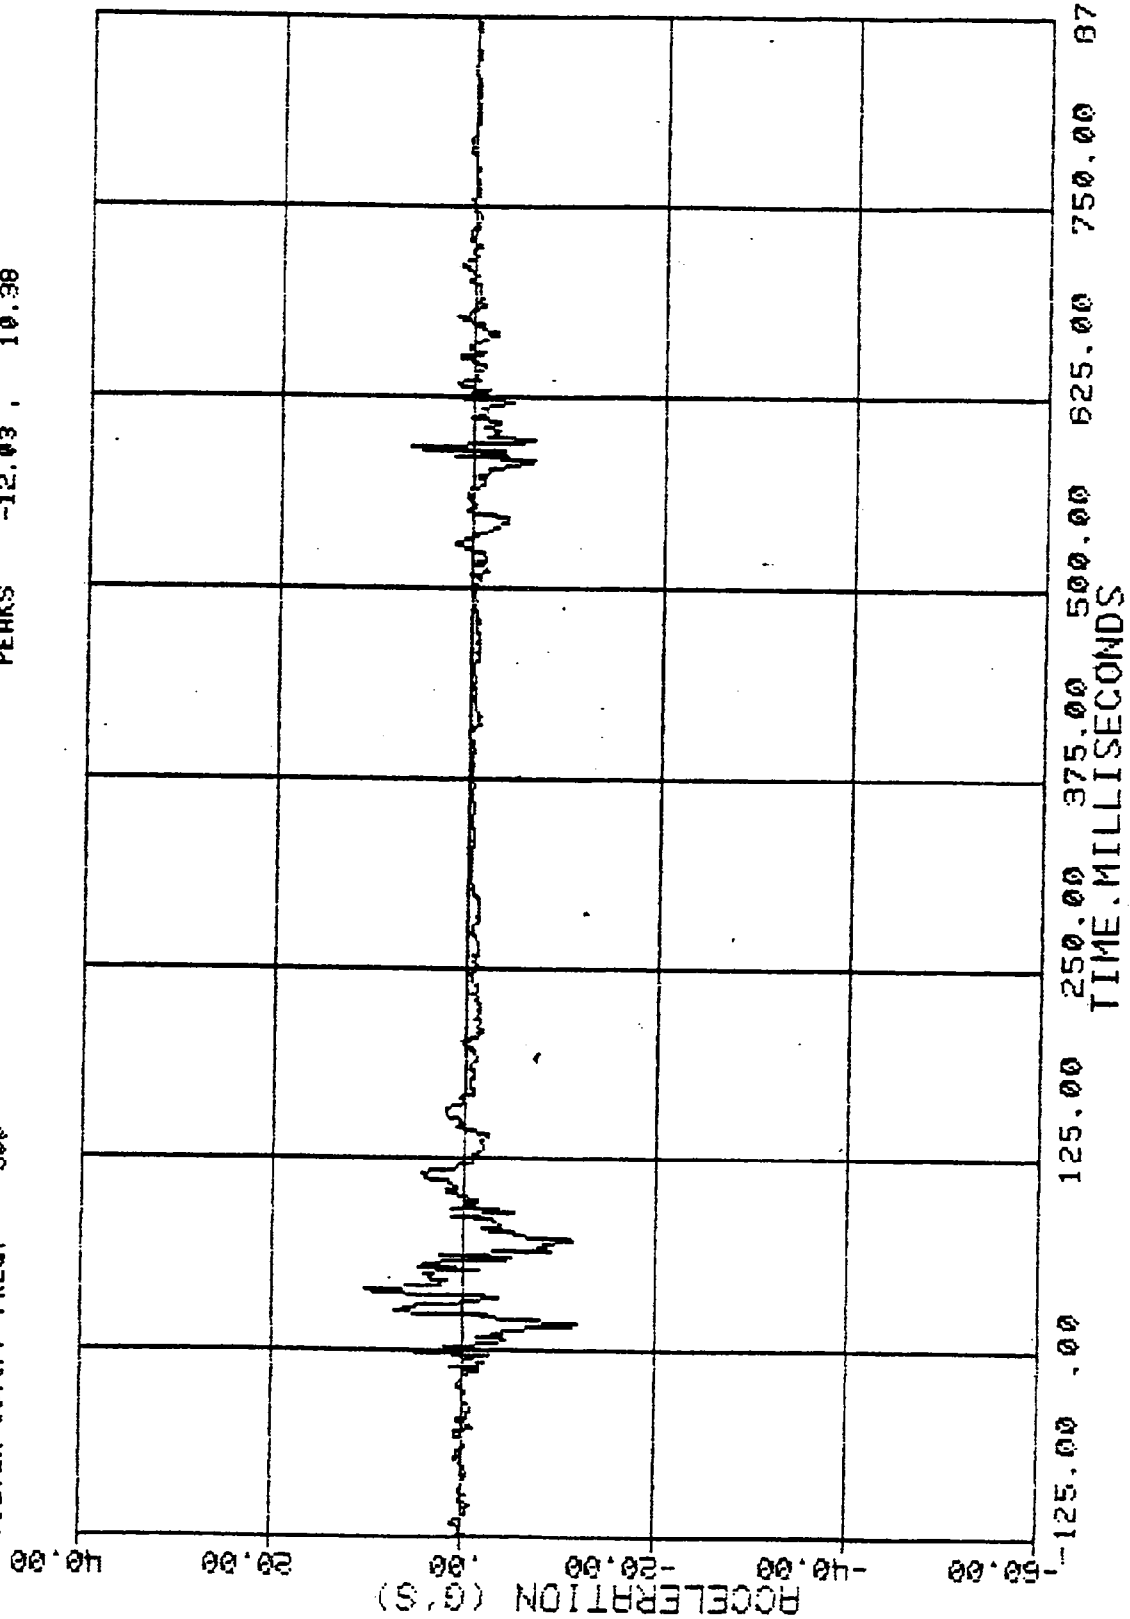
Figure A4. Vehicle Acceleration, X-Axis, 300 Hz

ENSOO, INC. CONTRACT NUMBER DTFH61-86-Z-00047 TEST NUM 1785-SI-2-87  
 30 MI/H BROADSIDE IMPACT OF 80 DODGE COLT INTO LUMINAIRE SUPPORT  
 CHANNEL 13 VEHICLE O.O. ACCELERATION, X-AXIS  
 FILTER CUTOFF FREQ. 300 PEAKS -12.03, 10.30

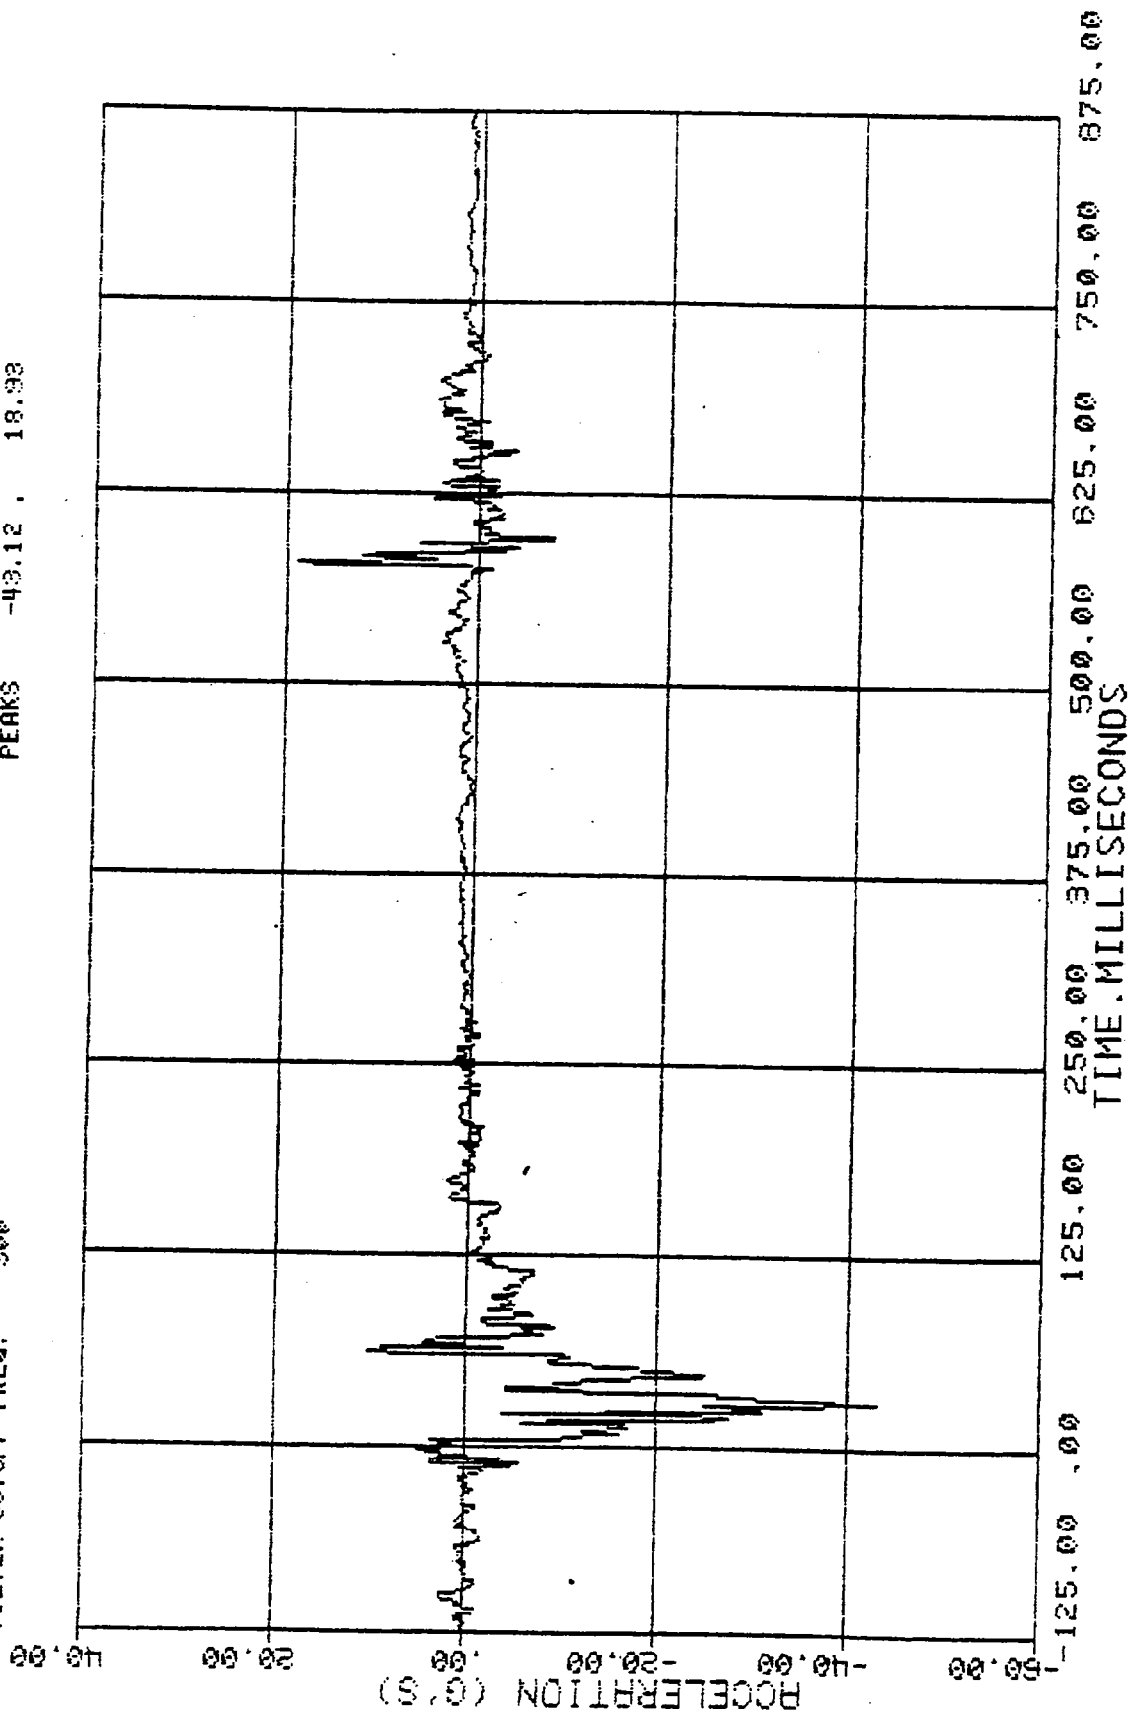
Figure A5. Vehicle Acceleration, Y-Axis, 300 Hz

ENSOO, INC.      CONTRACT NUMBER      DTFHSL-86-Z-00047      TEST NUM 1785-SI-2-87  
 3P HI/H BROADSIDE IMPACT OF 80 DODGE COLT INTO LUMINAIRE SUPPORT  
 CHANNEL 20      VEHICLE 0.0. ACCELERATION, Y-AXIS  
 FILTER CUTOFF FREQ.      300      PEAKS      -43.12      18.33

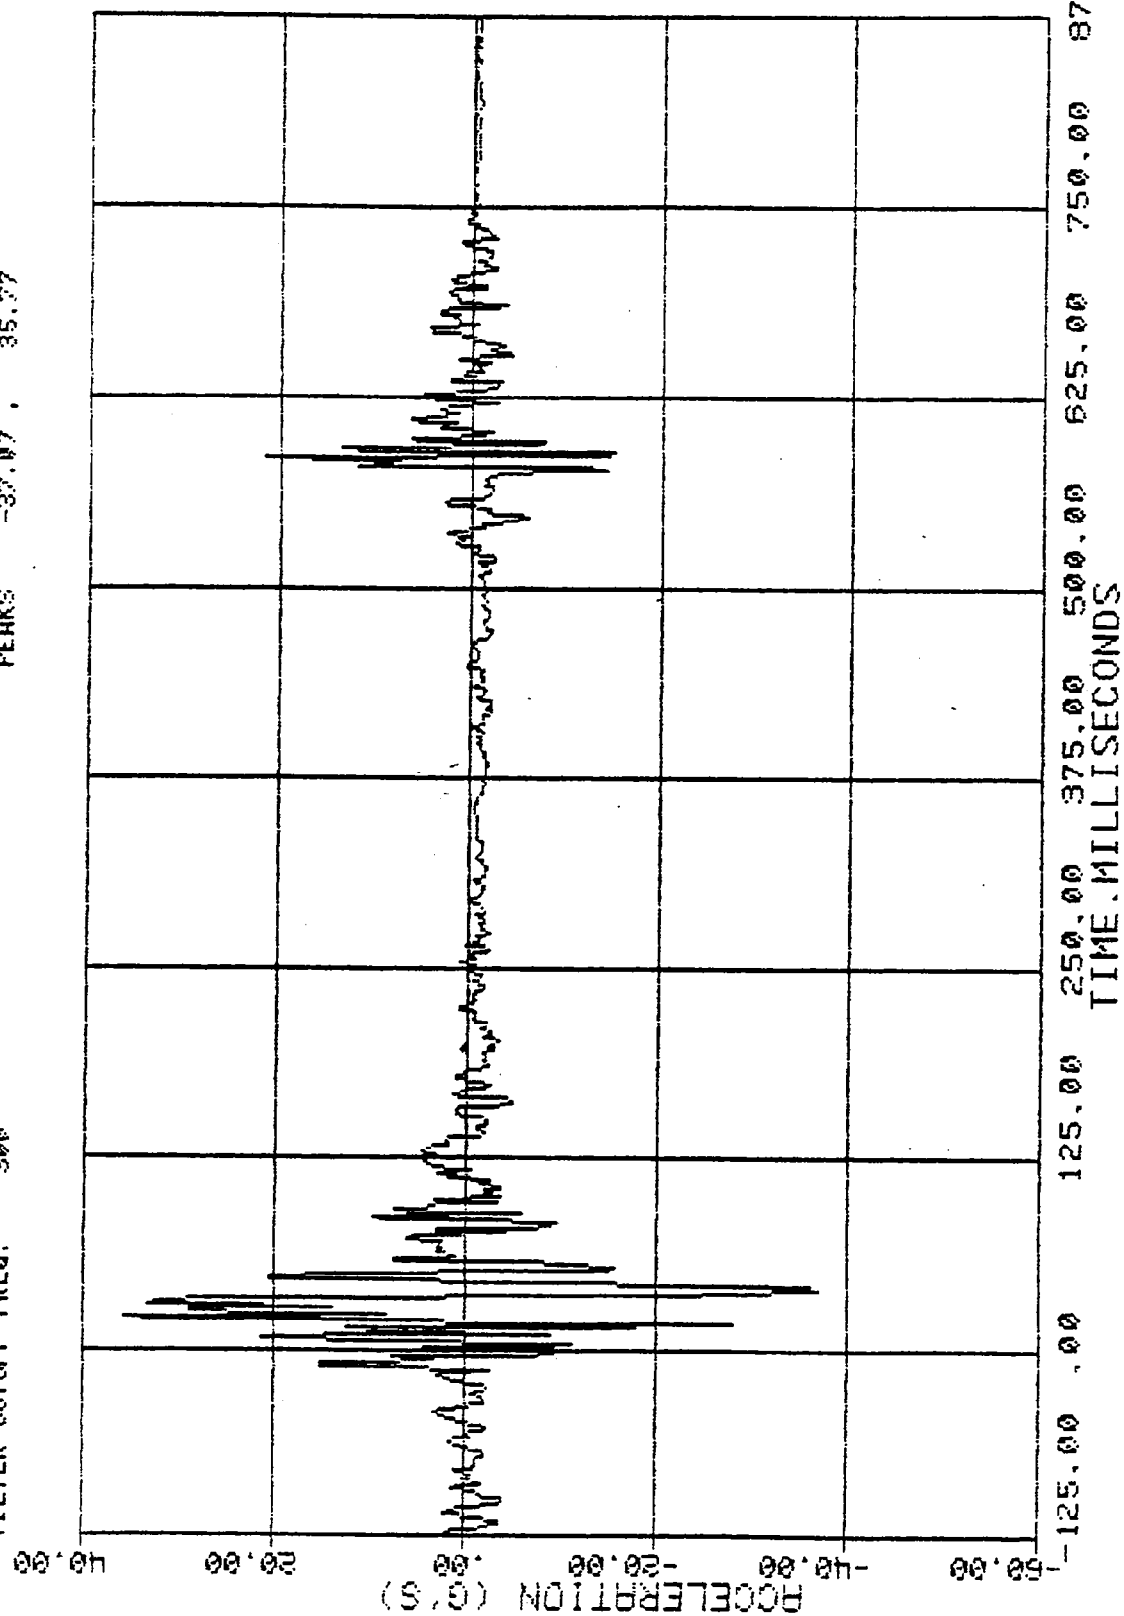
Figure A6. Vehicle Acceleration, Z-Axis, 300 Hz

ENSO, INC.      CONTRACT NUMBER    DTFH61-86-Z-00047      TEST NUM 1785-SI-2-87  
 3P M/H EROD SIDE IMPACT OF 90 DODGE COLT INTO LUMINAIRE SUPPORT  
 CHANNEL 24      VEHICLE C.O. ACCELERATION, Z-AXIS  
 FILTER CUTOFF FREQ.    300      PEAKS    -37.07    35.77

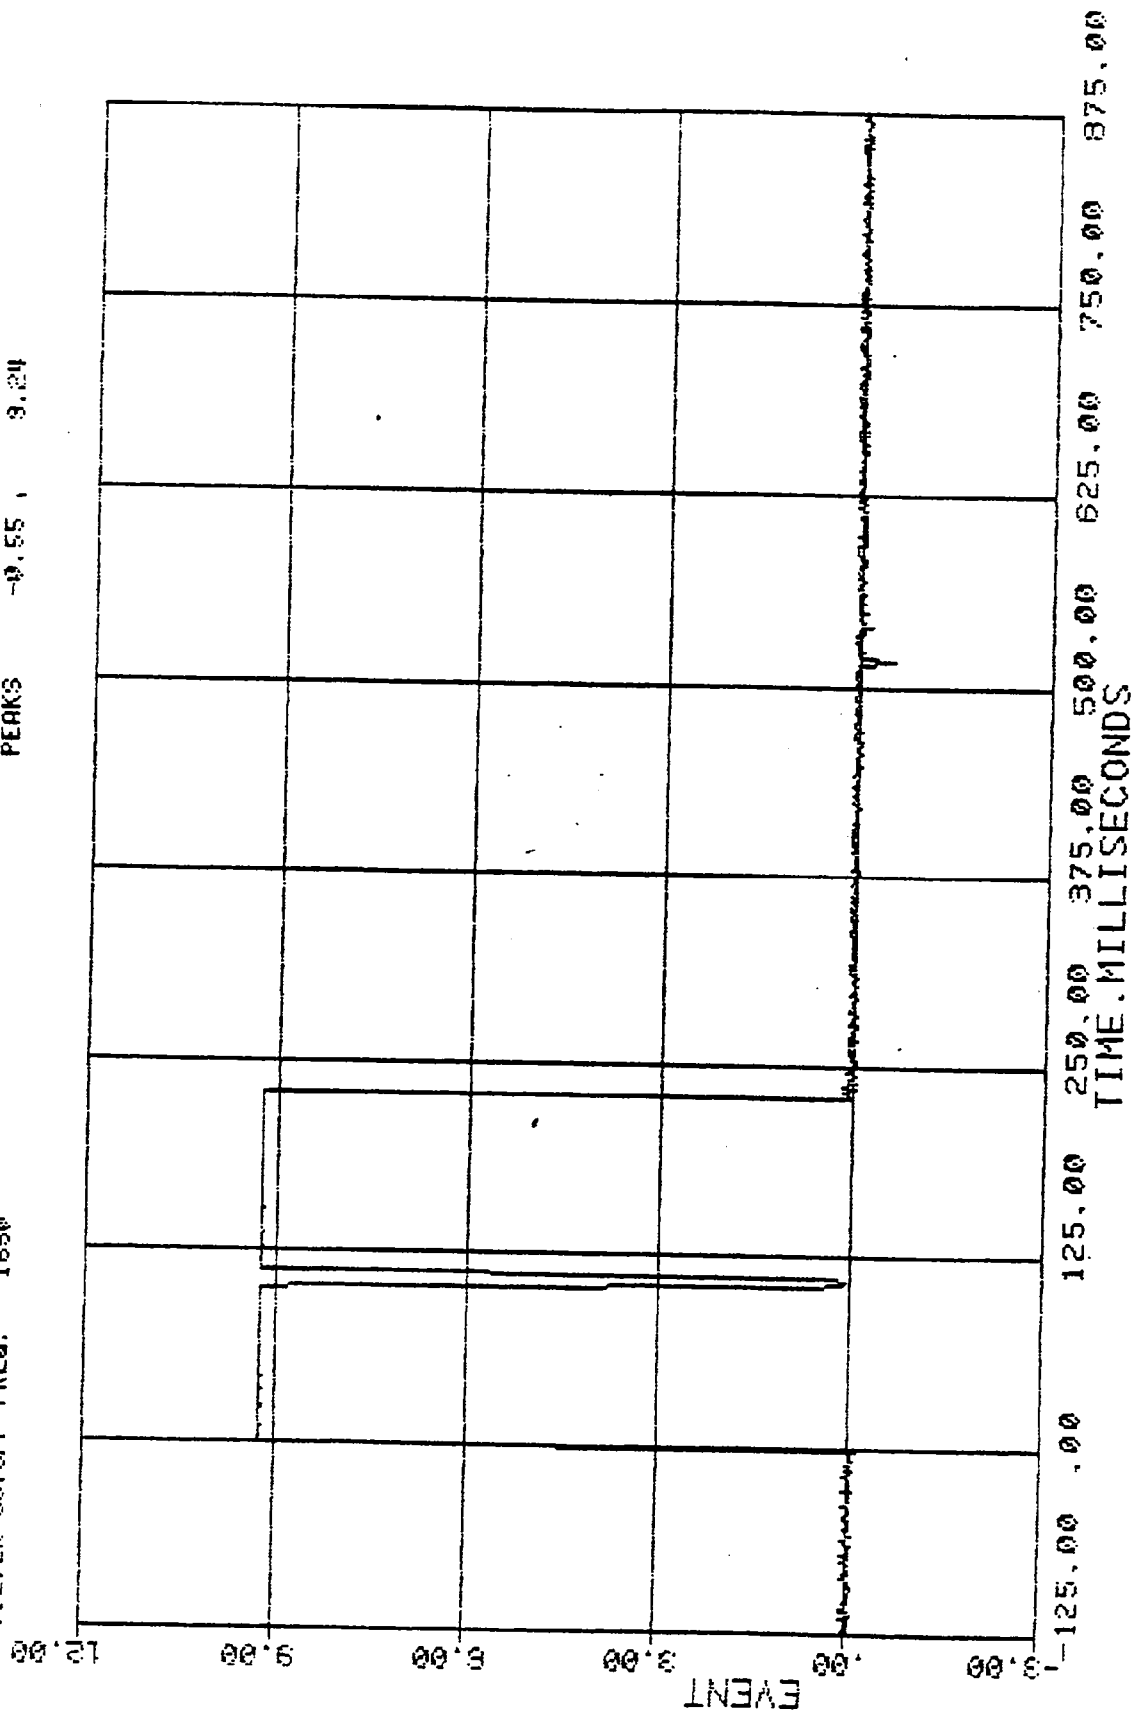
Figure A7. Event Marker, Impact

ENS00,1NO.    CONTRACT NUMBER    DTFH61-86-Z-00047    TEST NUM 1735-31-2-87  
 3P HI/H BROADSIDE IMPACT OF 80 DODGE GOLT INTO LUMINAIRE SUPPORT  
 CHANNEL 21    IMPHOT MARKER  
 FILTER CUTOFF FREQ. 1650    PEAKS    -0.55    9.24

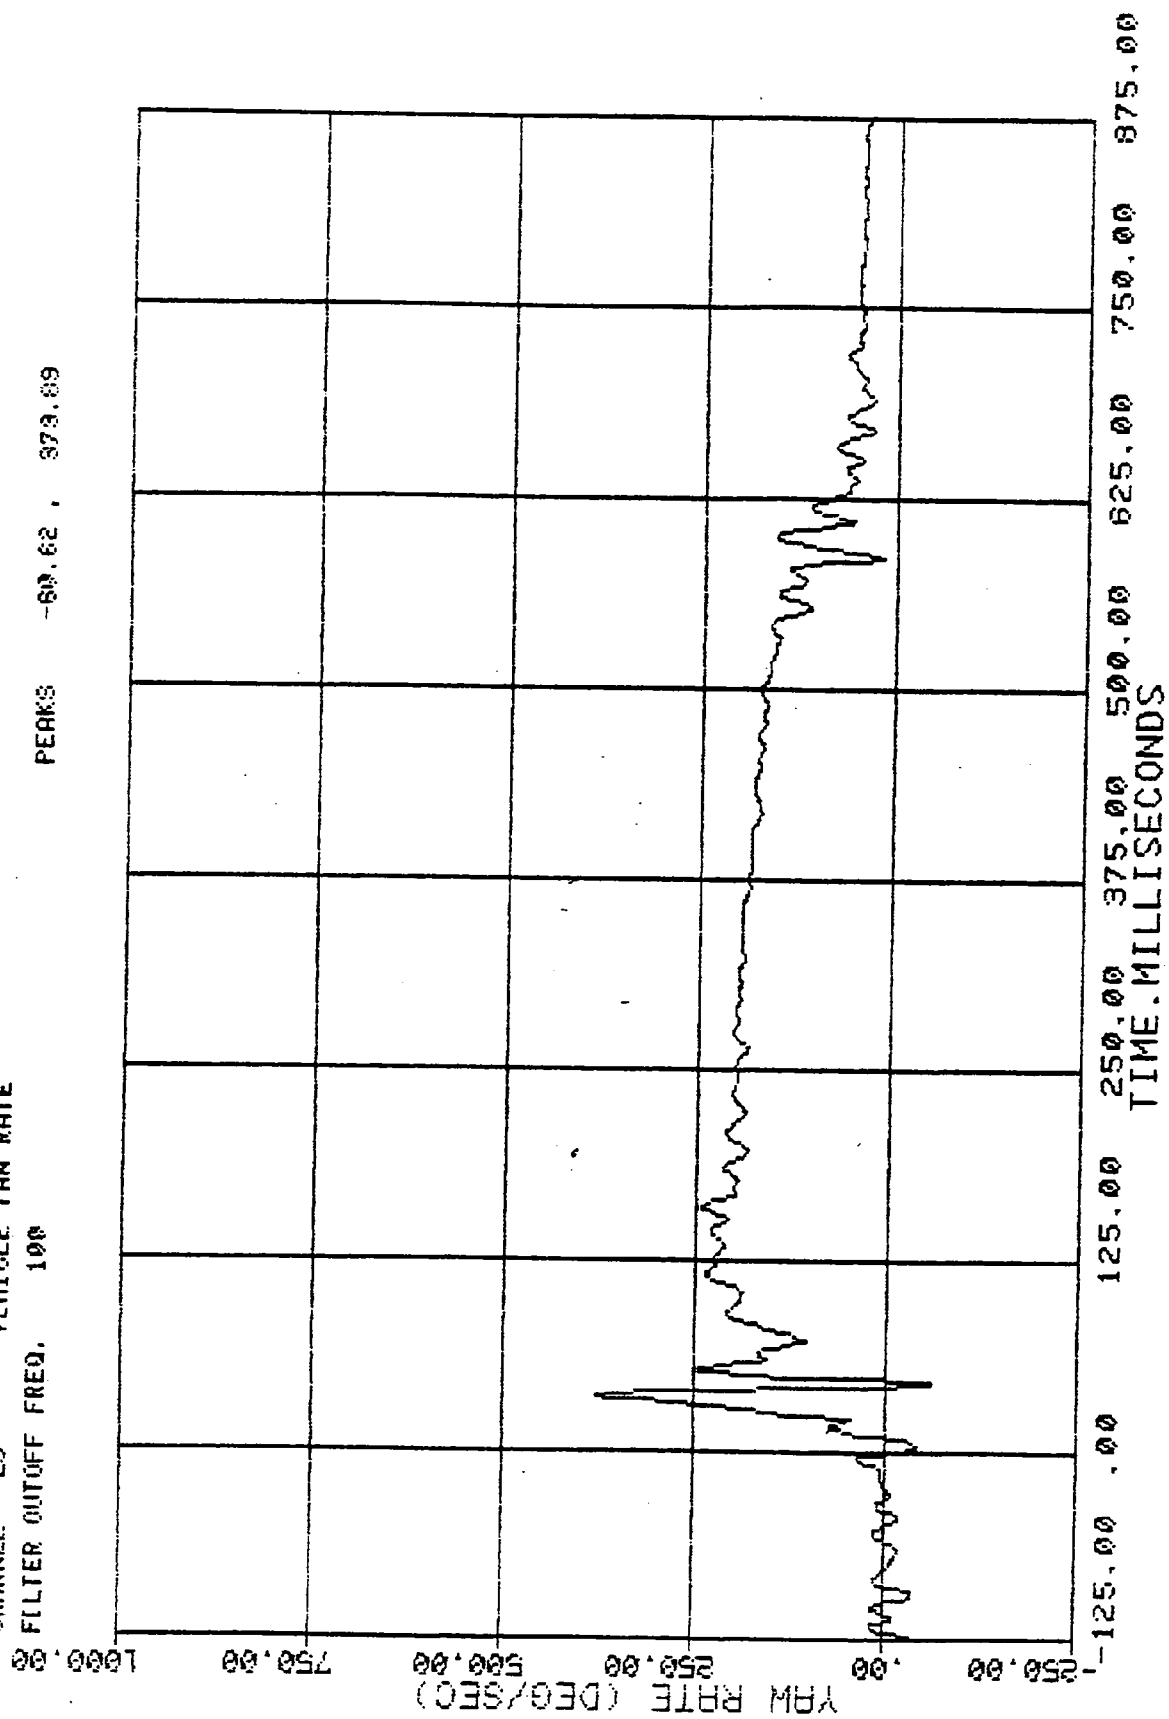
Figure A8. Vehicle Yaw Rate, 100 Hz

ENSCO, INC.      CONTRACT NUMBER    DTFH61-86-Z-00047      TEST NUM 1785-SI-2-87  
 30 MI/H BROADSIDE IMPACT OF 90 DODGE COLT INTO LUMINAIRE SUPPORT  
 CHANNEL 23      VEHICLE YAW RATE  
 FILTER CUTOFF FREQ.    100      PEAKS    -80.62 ,    373.89
