FHWA CONTRACT NO.  
DTFH61-86-Z-00046

THIRTY MPH BROADSIDE  
IMPACT OF A MINI-SIZED VEHICLE  
AND A BREAKAWAY LUMINAIRE SUPPORT

TEST RESULTS REPORT  
TEST NUMBER 1785-SI#2-87

August 1987

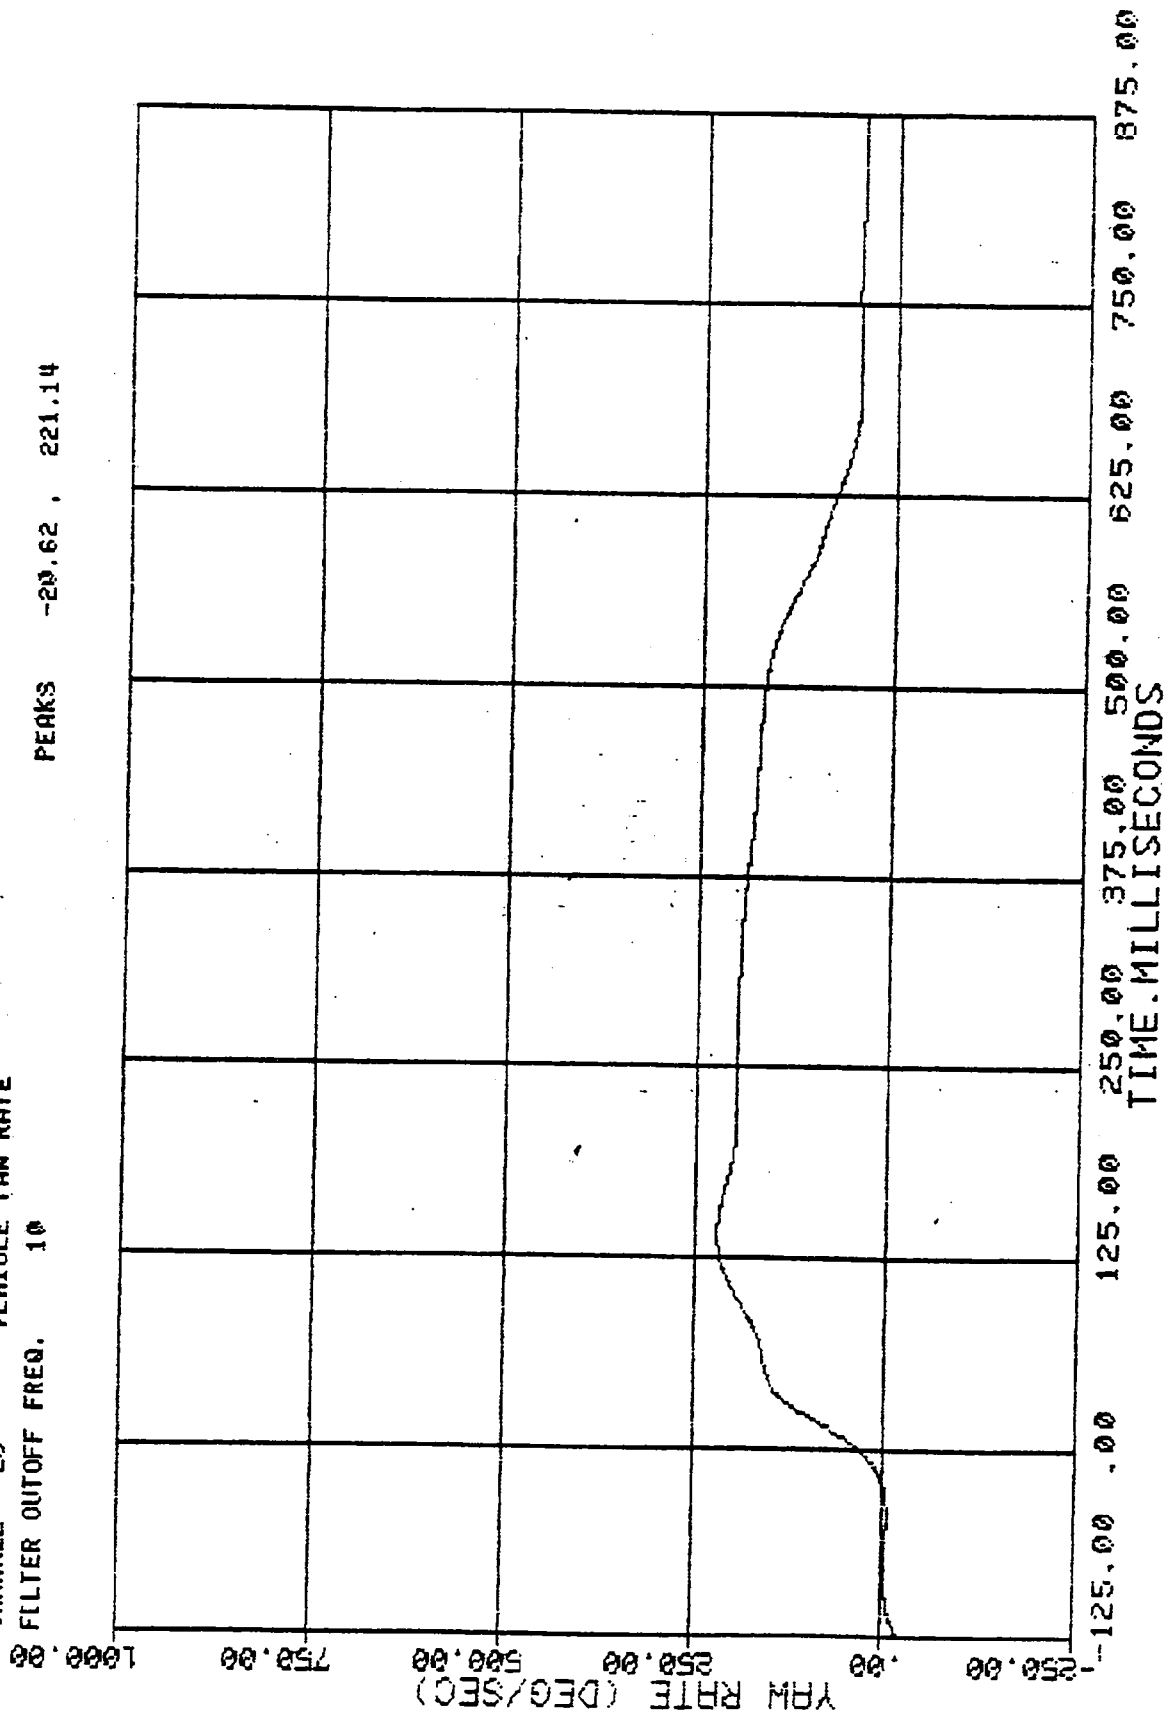
Figure A9. Vehicle Yaw Rate, 10 Hz

ENSCO, INC.    CONTRACT NUMBER    DTFH61-86-2-00007    TEST NUM 1785-SI-2-87  
 30 MI/H BROADSIDE IMPACT OF 80 DODGE COLT INTO LUMINAIRE SUPPORT  
 CHANNEL 23    VEHICLE YAW RATE  
 FILTER CUTOFF FREQ.    10    PEAKS    -20.62 ,    221.14

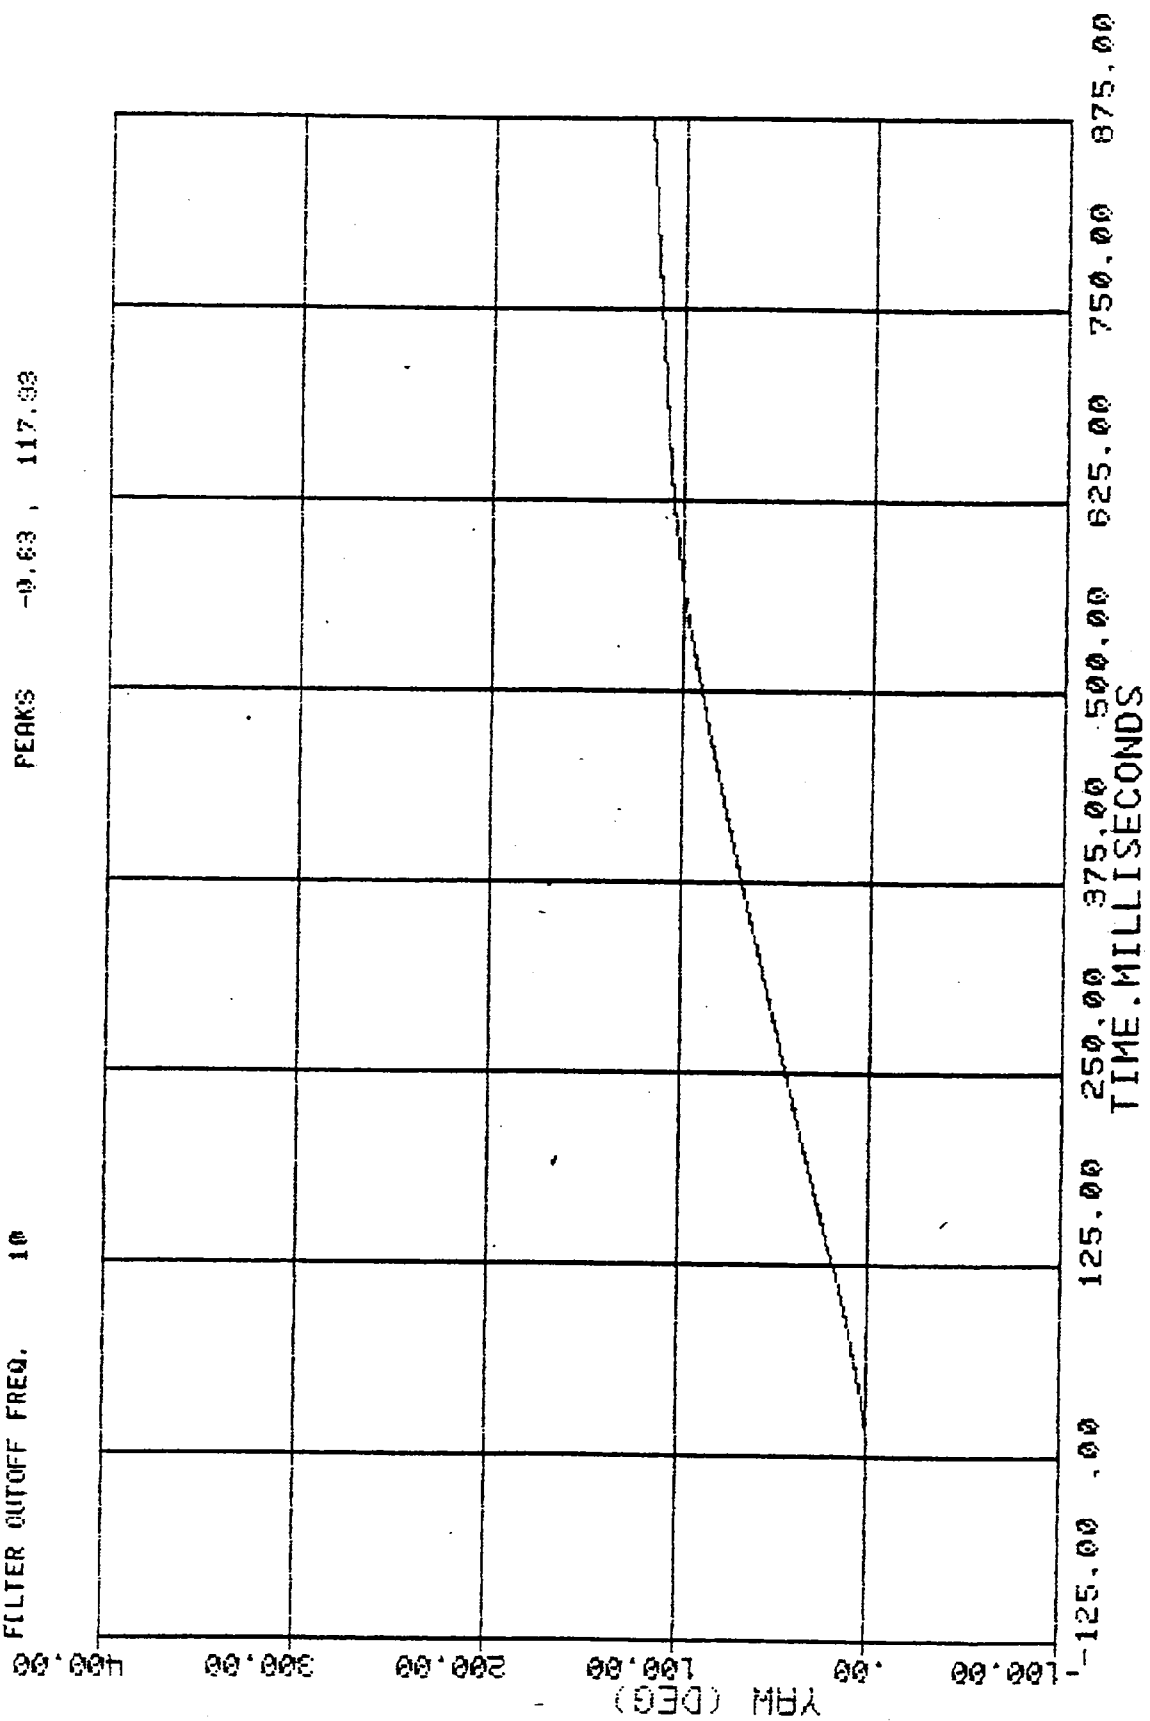
Figure A10. Vehicle Yaw, 10 Hz

ENSCO, INC.      CONTRACT NUMBER    DTFH61-86-Z-00047      TEST NUM 1785-SI-2-87  
 30 MI/H BROADSIDE IMPACT OF 80 DD006 COLT INTO LUMINAIRE SUPPORT  
 CHANNEL 23      VEHICLE YAW  
 FILTER CUTOFF FREQ.    10      PEAKS    -0.63 ,    117.93

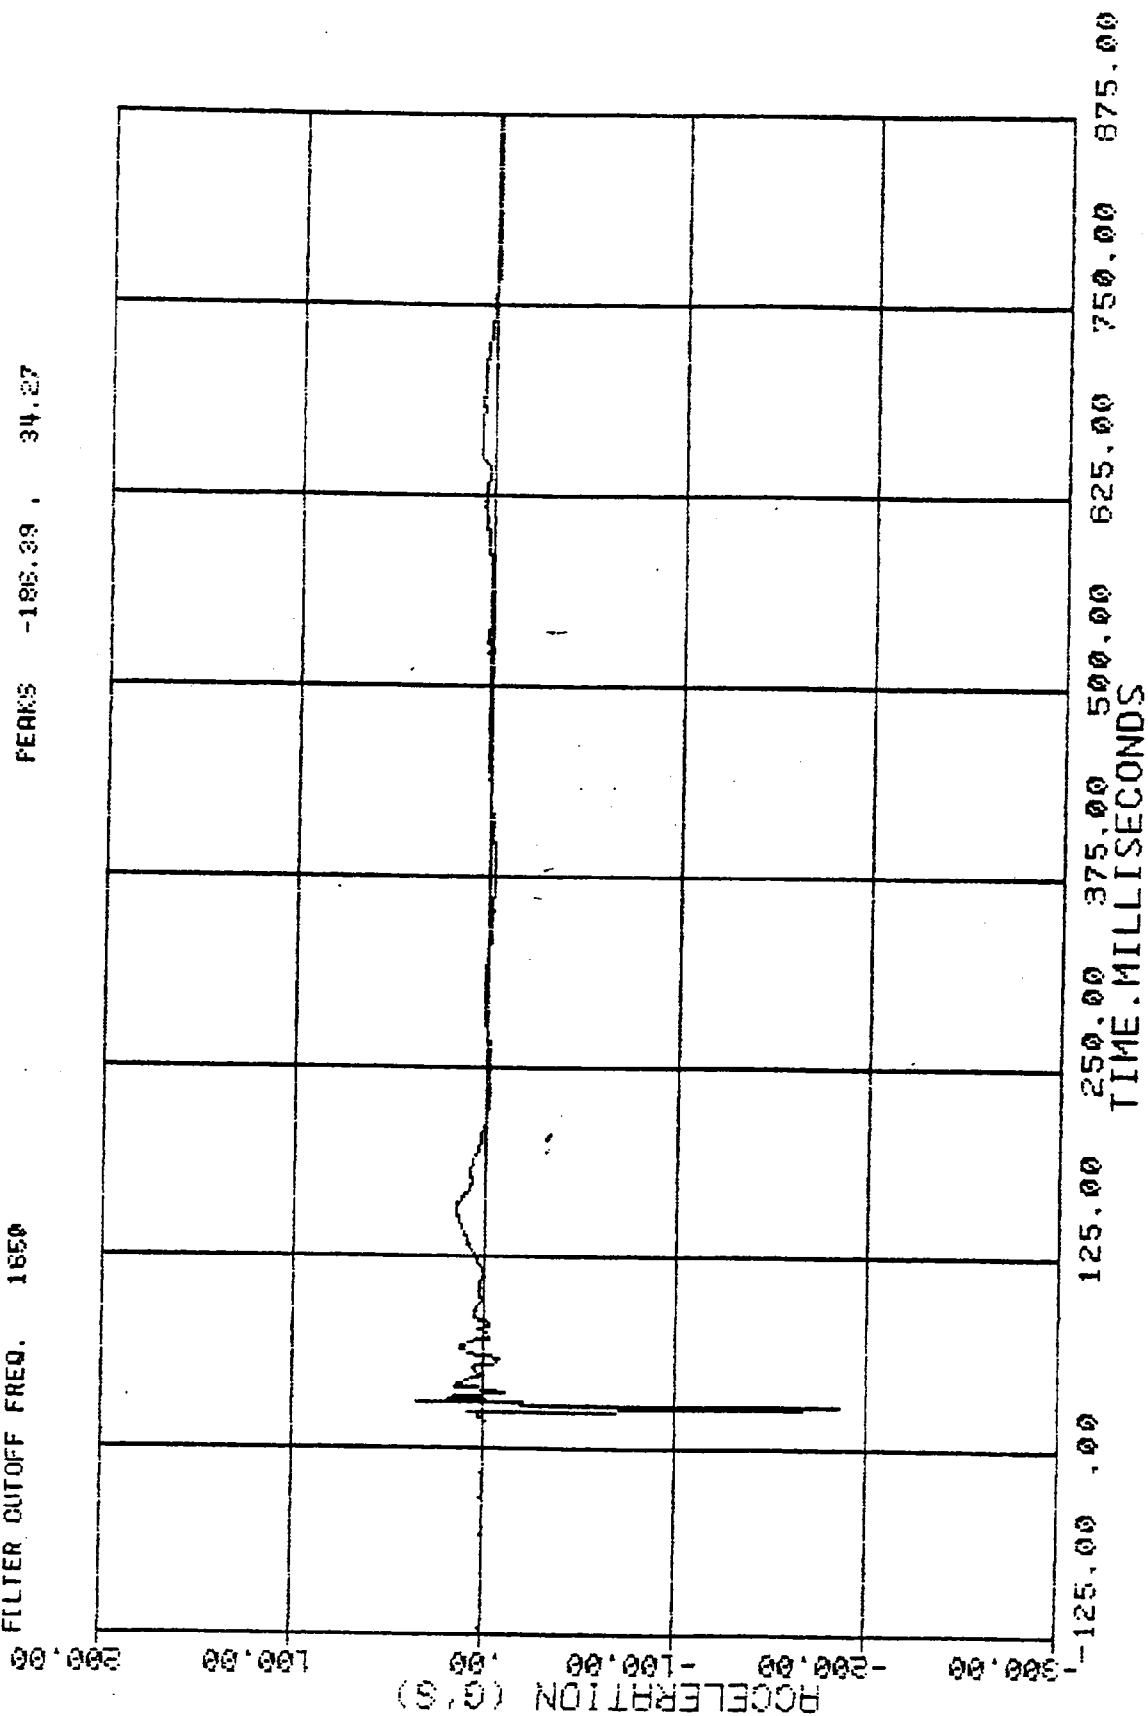
Figure All. Driver's Head Acceleration, X-Axis, 1650 Hz

ENSCO, INC.      CONTRACT NUMBER      DTFH61-86-Z-00047      TEST NUM 1785-SI-2-87  
 34 MI/H BROADSIDE IMPACT OF 80 DODGE COLT INTO LUMINAIRE SUPPORT  
 CHANNEL 13      DRIVER HEAD ACCELERATION, X-AXIS  
 FILTER CUTOFF FREQ. 1650      PEAKS -188.89 ,      34.27

The data from the triaxial accelerometer sensor assembly in the head of the test dummy was filtered at SAE Class 1000 and used to evaluate the HIC. The data obtained from the triaxial accelerometer sensor assemblies located in the upper spine of the occupant was filtered at SAE Class 180 and was used to evaluate severity indices and maximum sustained accelerations experienced by the occupant. The data obtained from the accelerometers located on the ribs of the occupant were filtered at SAE Class 180. In addition, thoracic injury parameters associated with side impact conditions were analyzed using NHTSA's latest technique to determine side impact occupant injury.

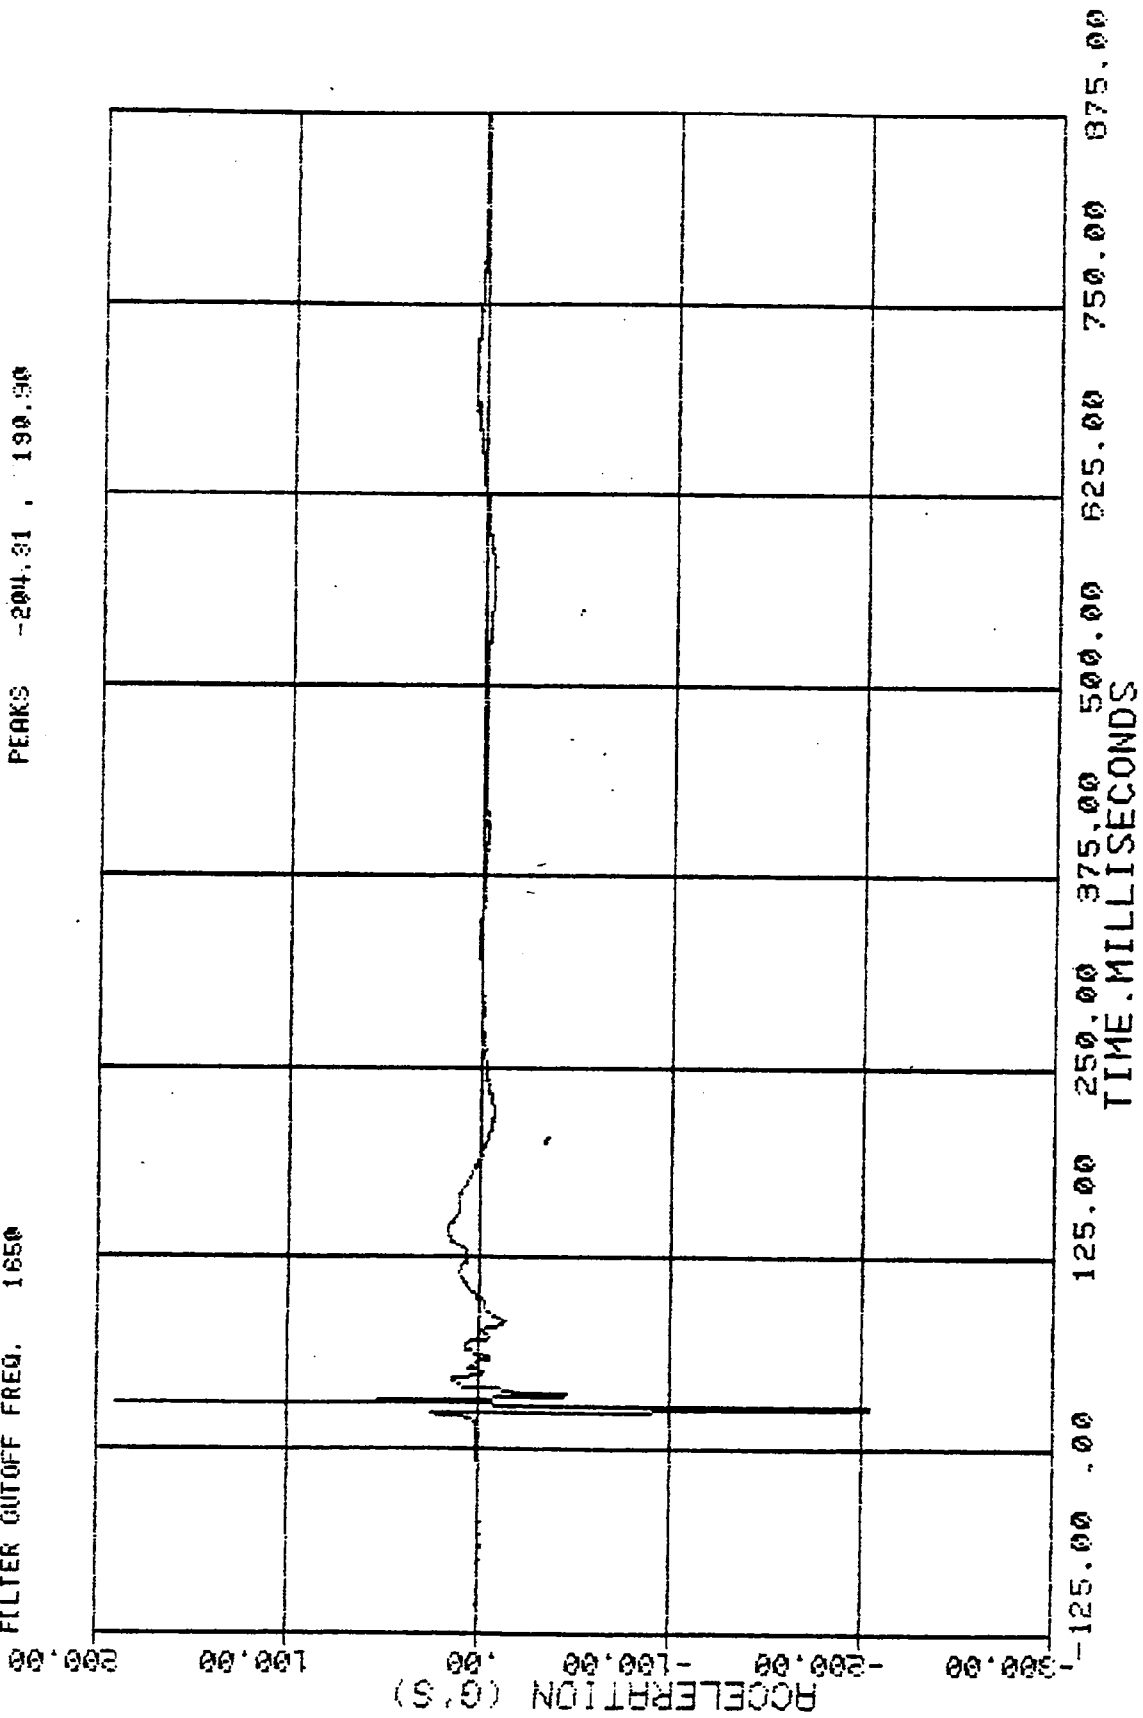
Figure A12. Driver's Head Acceleration, Y-Axis, 1650 Hz

ENSCO, INC.      CONTRACT NUMBER    DTFH61-86-Z-00047      TEST NUM 1735-SI-2-87  
 30 MI/H BROADSIDE IMPACT OF 80 DODGE GOLT INTO LUMINAIRE SUPPORT  
 CHANNEL 14      DRIVER HEAD ACCELERATION, Y-AXIS  
 FILTER CUTOFF FREQ.    1650      PEAKS    -204.31    190.90

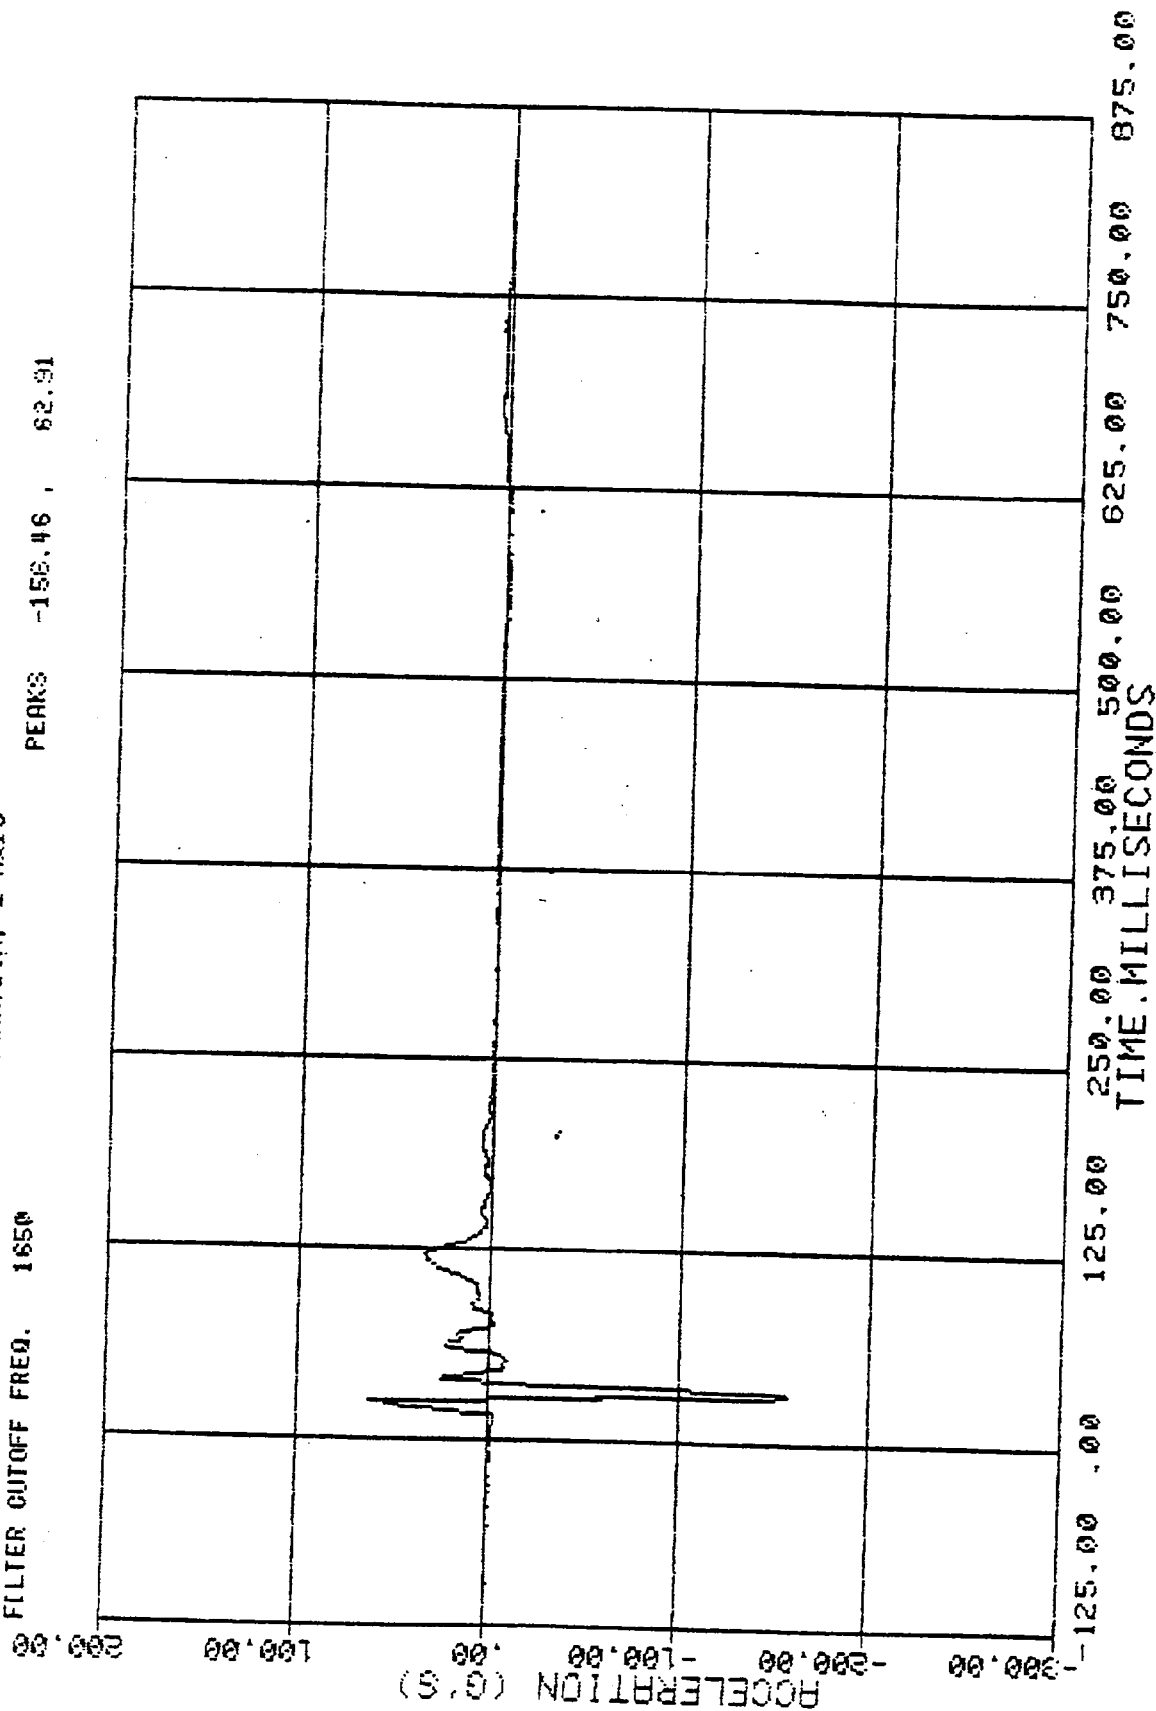
Figure A13. Driver's Head Acceleration, Z-Axis, 1650 Hz

ENSCO, INC.      CONTRACT NUMBER      DTFH61-86-Z-00047      TEST NUM 1785-SI-2-87  
 30 MI/H BROADSIDE IMPACT OF 80 DODGE GOLT INTO LUMINAIRE SUPPORT  
 CHANNEL 15      DRIVER HEAD ACCELERATION, Z-AXIS  
 FILTER CUTOFF FREQ. 1650      PEAKS -150.46 ,      62.91

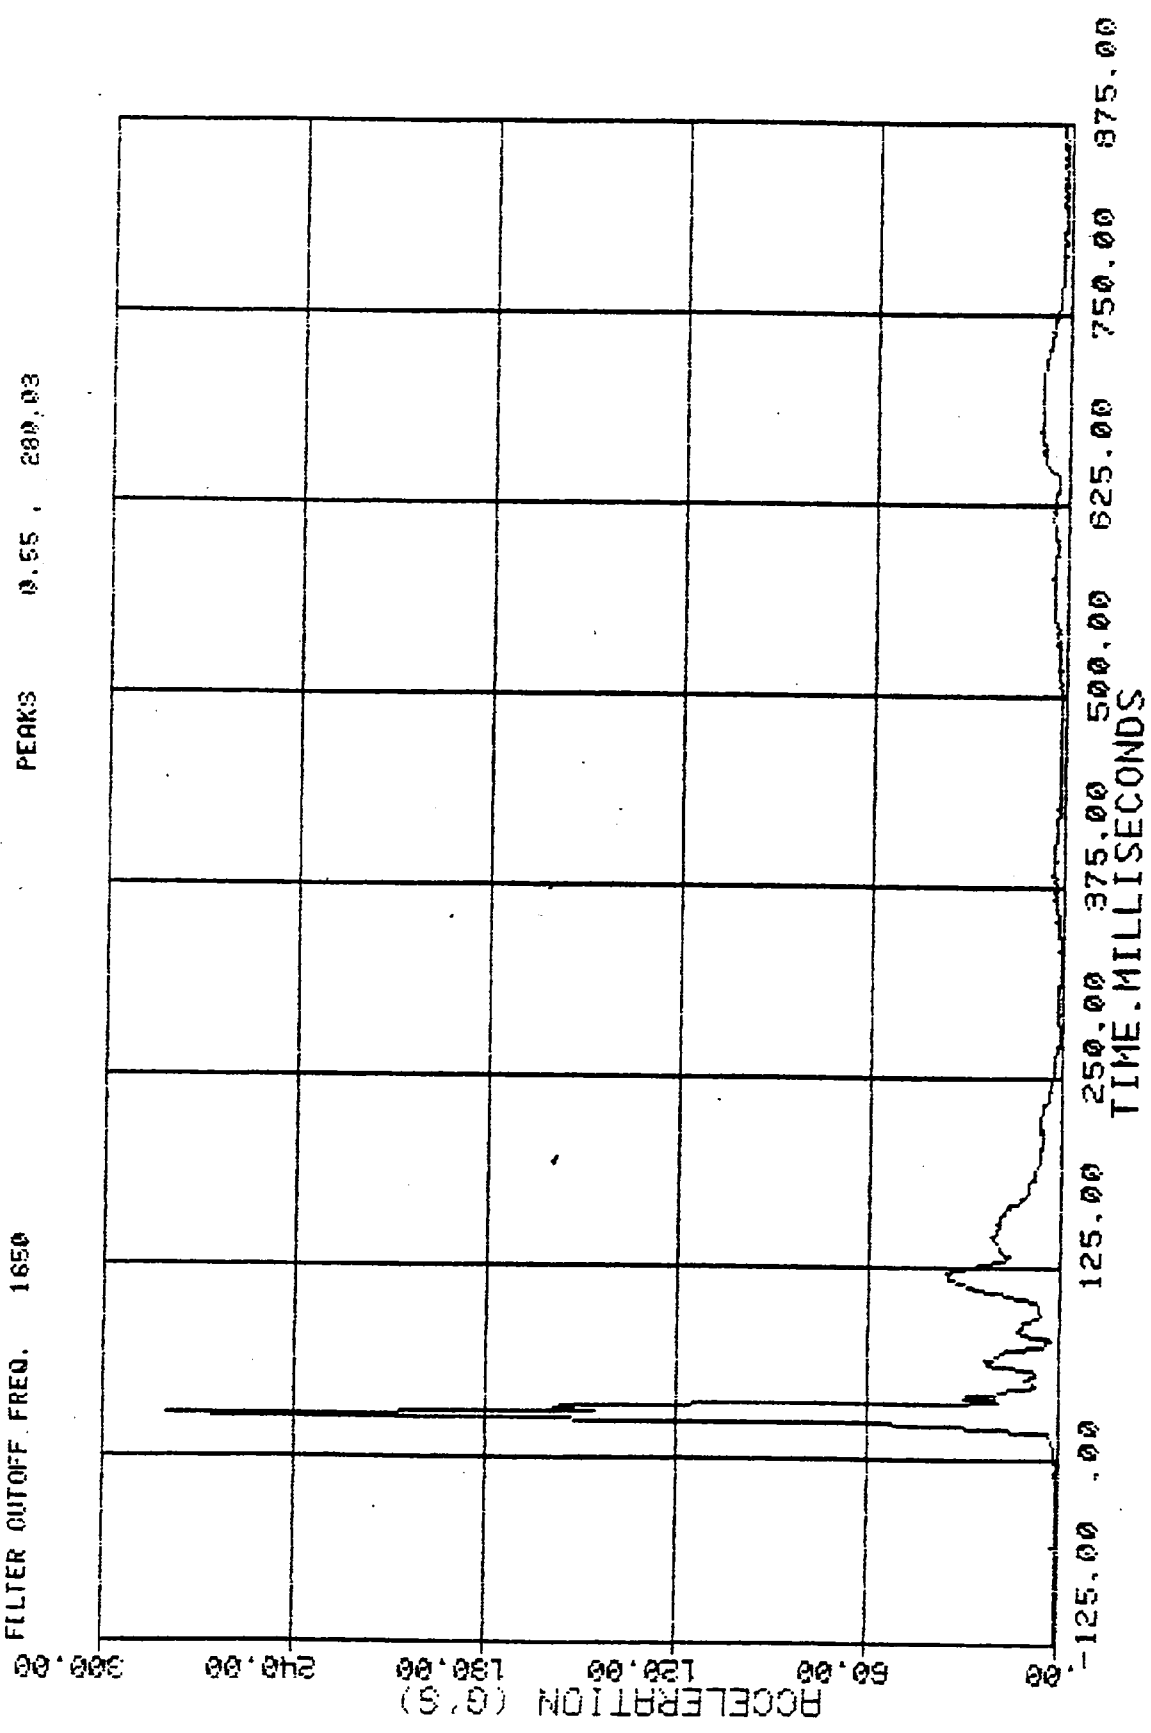
Figure A14. Driver's Head Acceleration, Resultant, 1650 Hz

ENSO, INC.    CONTRACT NUMBER    DTFH61-86-Z-00047    TEST NUM 1785-SI-2-87  
 30 M/H BROADSIDE IMPACT OF 30 DODGE GOLT INTO LUMINAIRE SUPPORT  
 CHANNEL 0    DRIVER HEAD ACCELERATION, RESULTANT  
 FILTER CUTOFF FREQ. 1650    PEAKS 0.55 , 200.03

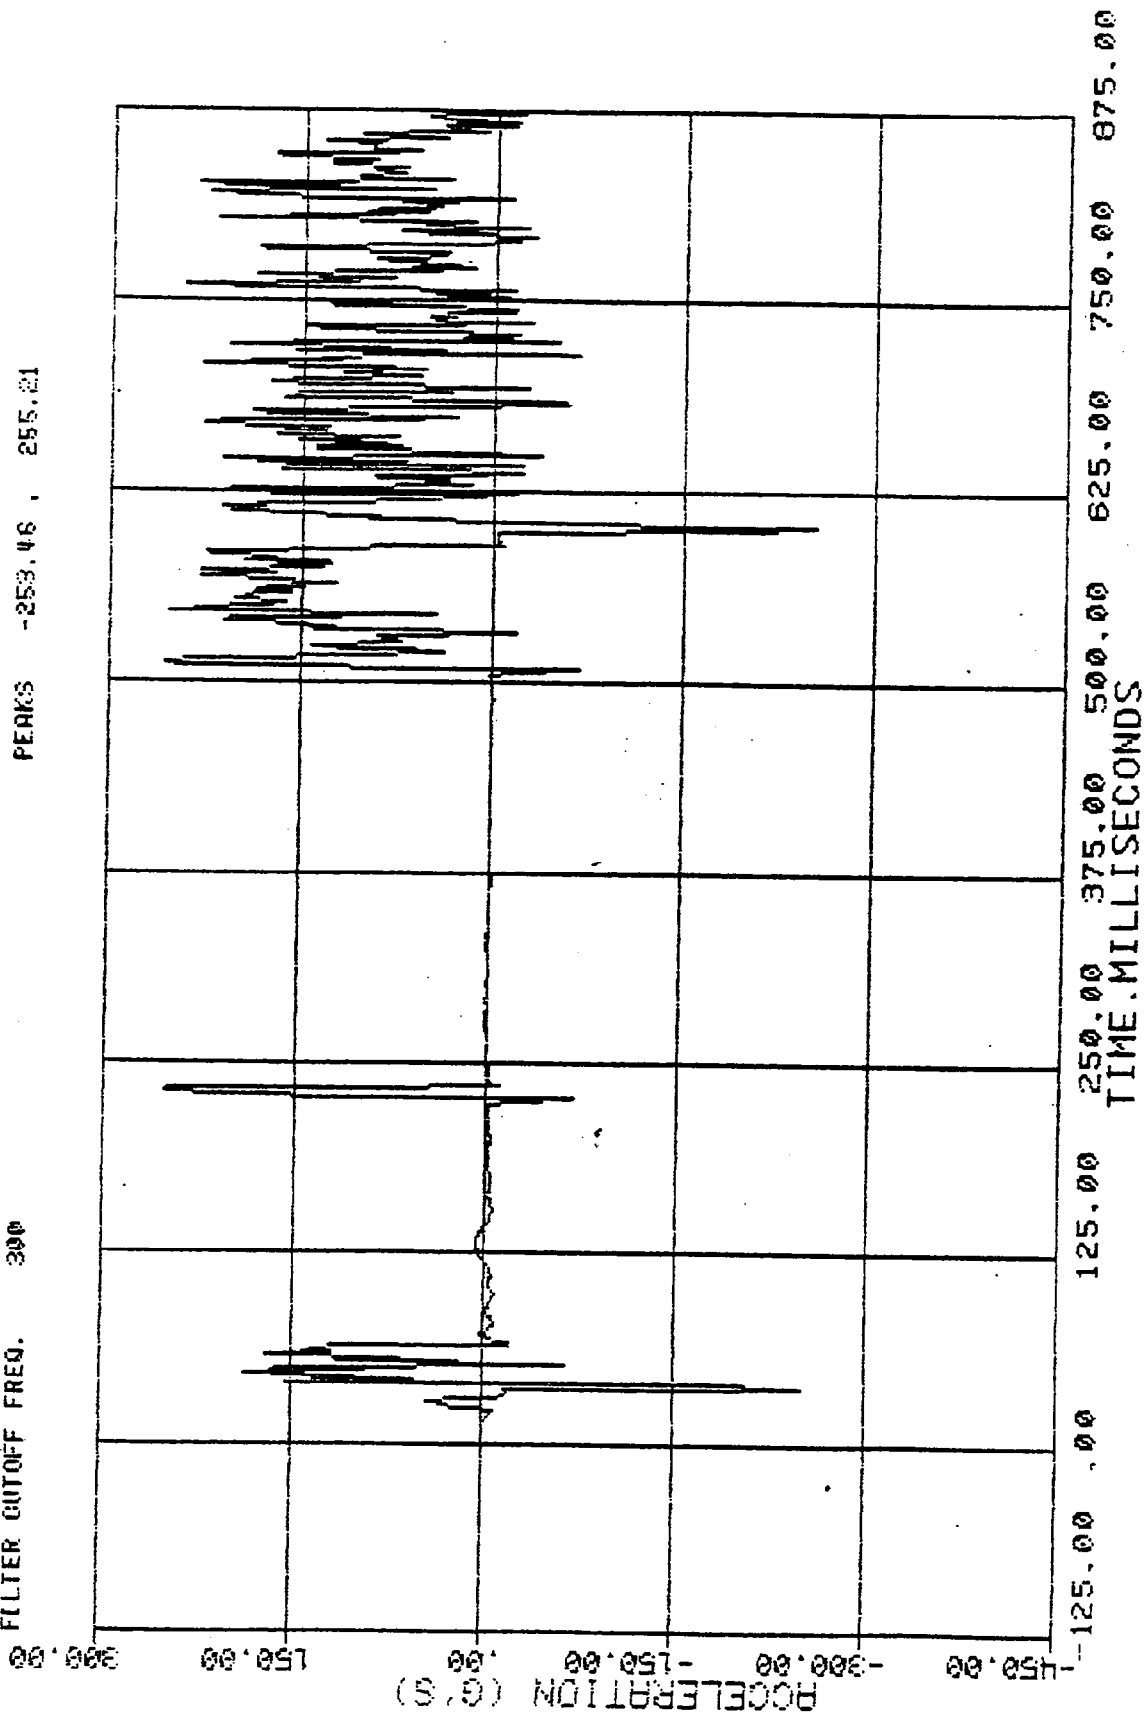
Figure A15. Driver's Upper Spine Acceleration, T01X, 300 Hz

ENSO, INC. CONTRACT NUMBER DTFH61-86-T-00047 TEST NUM 1785-SI-2-87  
 30 MI/H BROADSIDE IMPACT OF 80 DODGE COLT INTO LUMINAIRE SUPPORT  
 CHANNEL 5 DRIVER THORAX, T01X  
 FILTER CUTOFF FREQ. 300 PEAKS -253.46 , 255.21

The acceleration traces and associated resultants obtained with the use of the SAE Class 180 ( $f_c = 300$  Hz) filtering techniques are presented in figures A15 through A18 for the upper spine location (T01), figures A19 through A20 for the lower spine location (T12), and figures A21 through A24 for the pelvis location and figures A25 and A26 for the sternum location (LST and UST). The T12Y accelerometer malfunctioned during the test and the LSTX accelerometer failed shortly after impact.

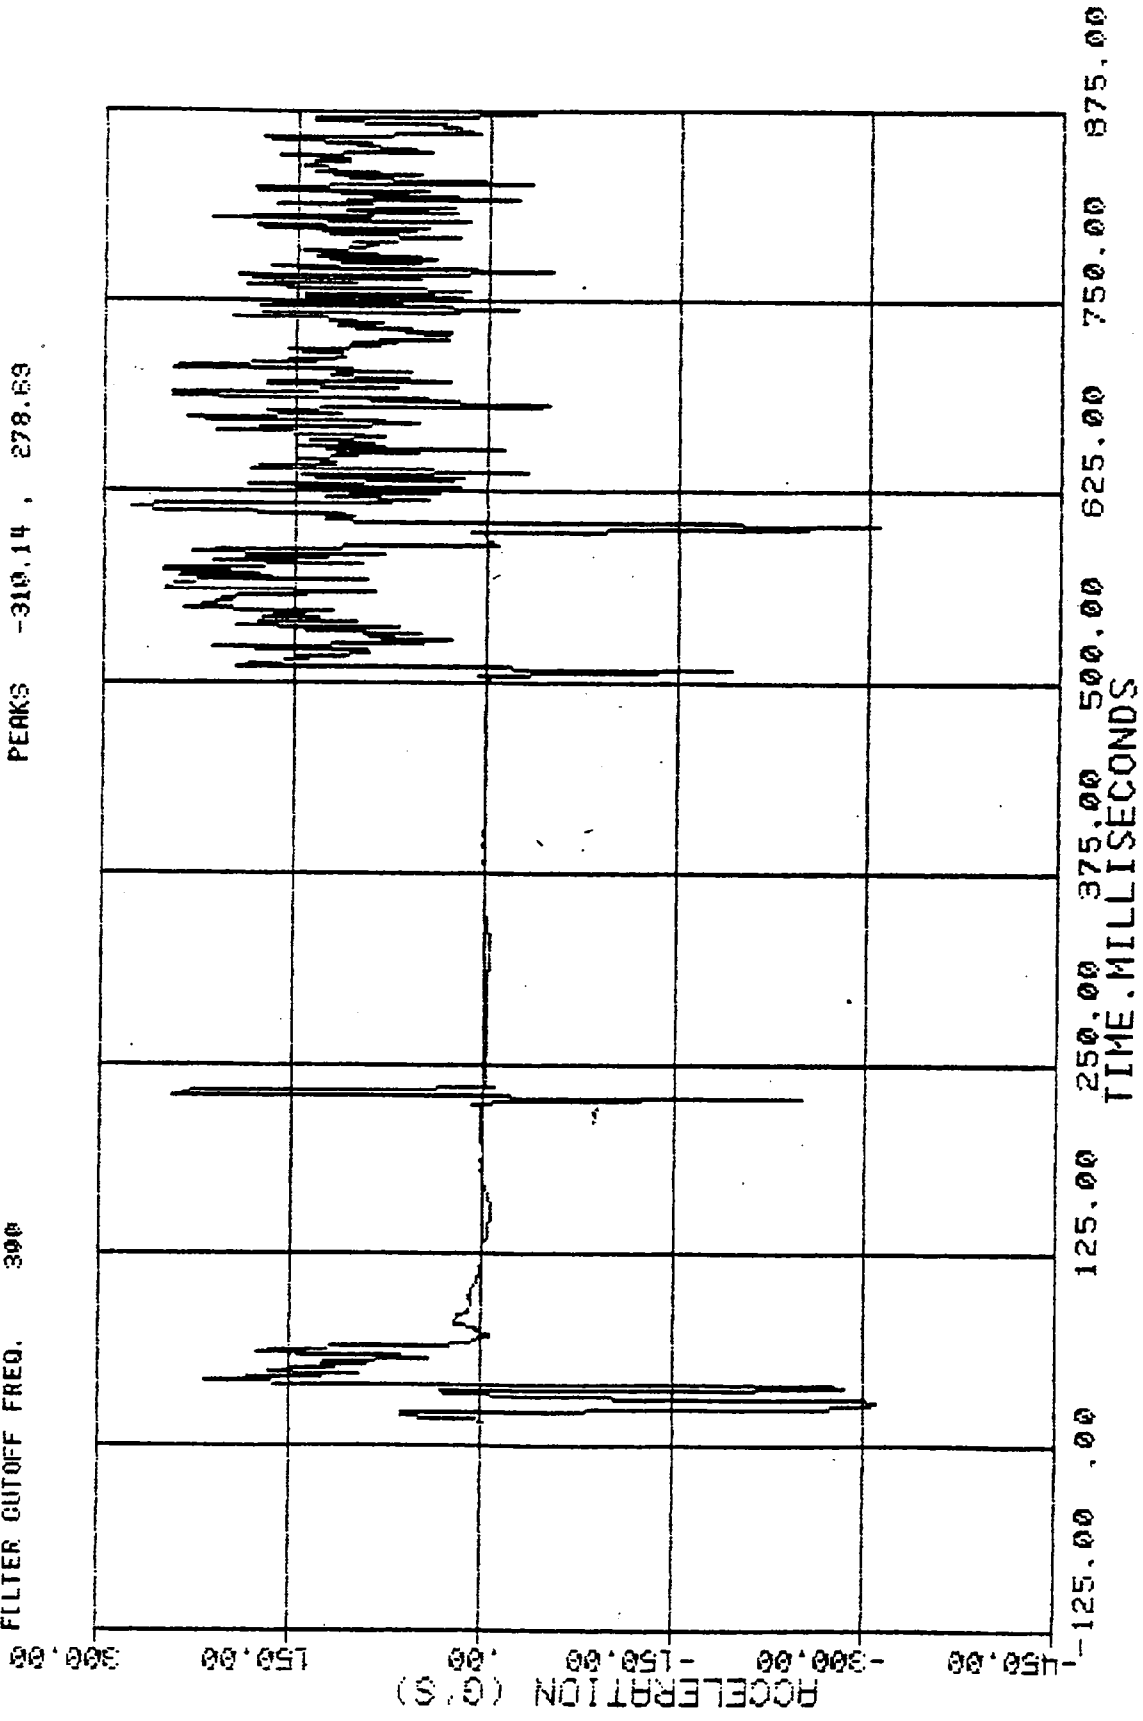
Figure A16. Driver's Upper Spine Acceleration, T01Y, 300 Hz

ENSO, INC.      CONTRACT NUMBER    DTFH61-86-2-00047      TEST NUM 1785-SI-2-87  
 3P MI/H BROADSIDE IMPACT OF 80 DODGE GOLT INTO LUMINAIRE SUPPORT  
 CHANNEL    6    DRIVER THORNA, T01Y  
 FILTER CUTOFF FREQ.    300      PEAKS    -310.14 ,    278.63

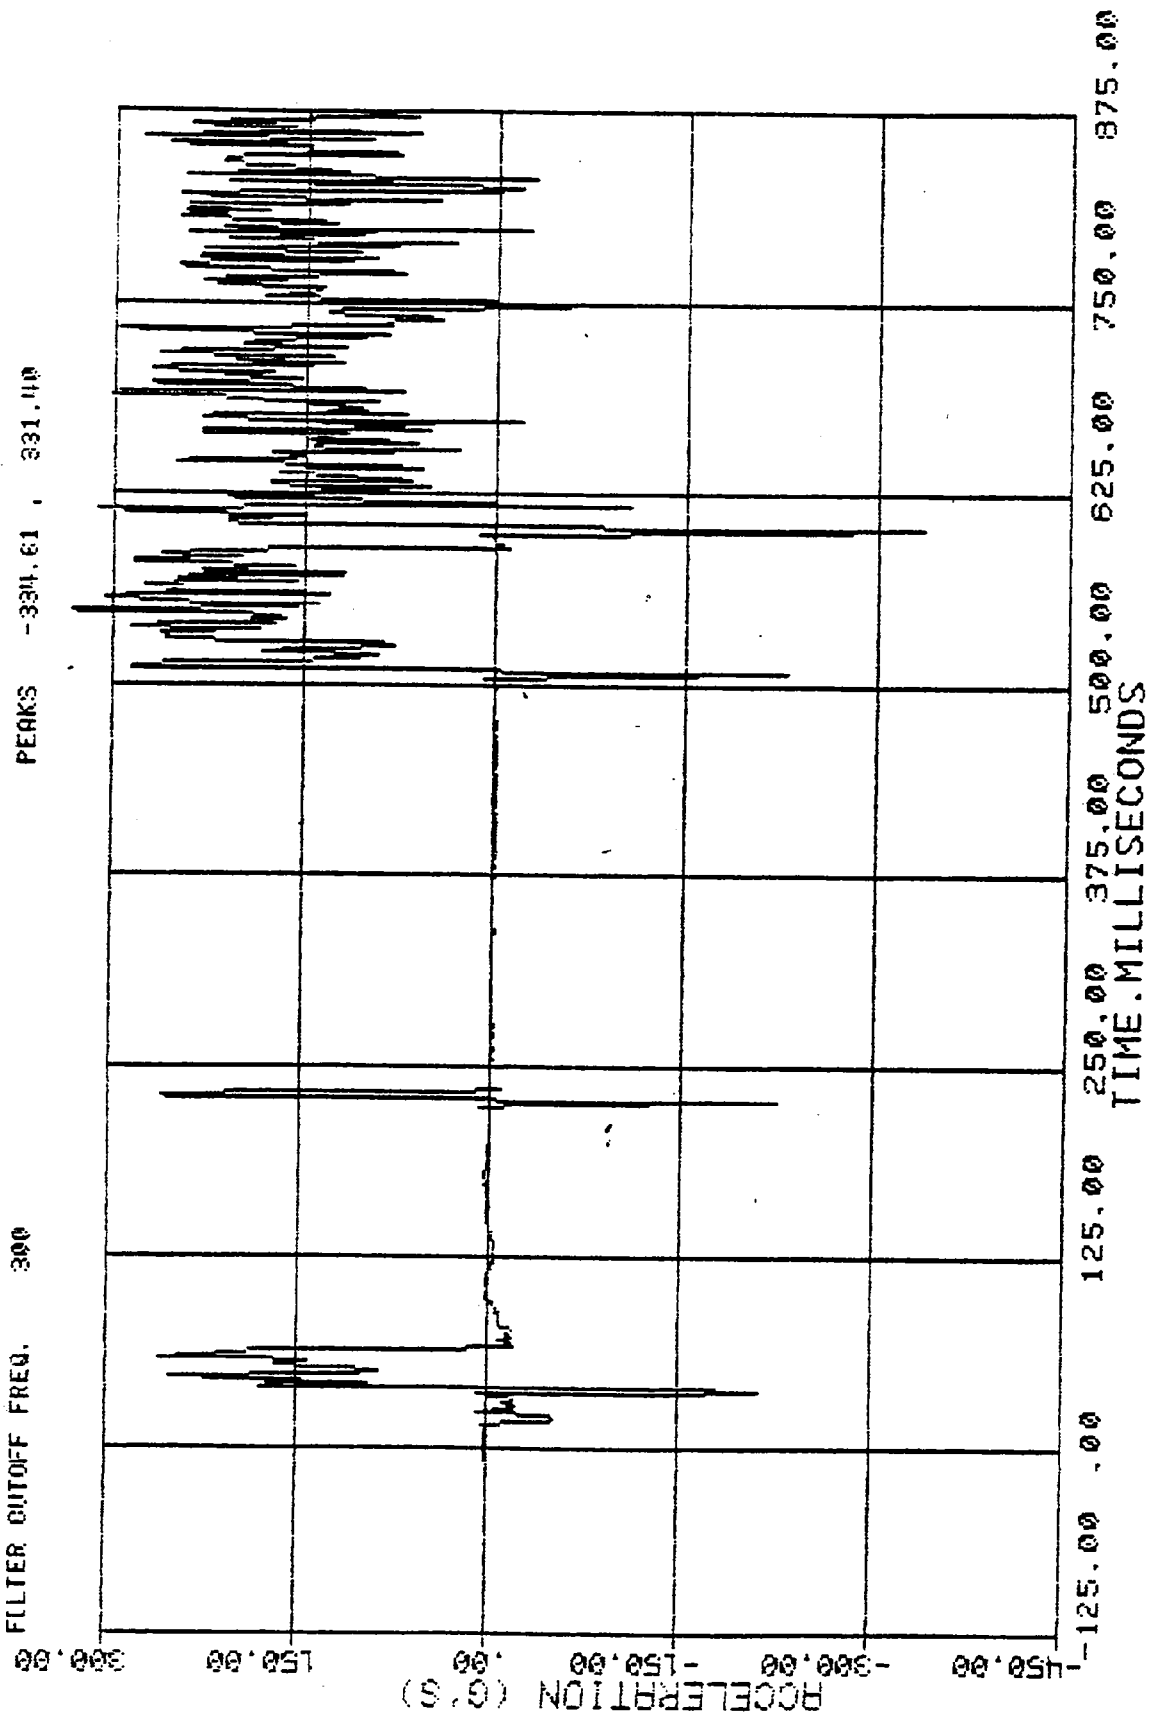
Figure A17. Driver's Upper Spine Acceleration, T01Z, 300 Hz

ENSCO, INC. CONTRACT NUMBER DTFH61-86-Z-00047 TEST NUM 1785-SI-2-87  
 30 MI/H BROADSIDE IMPACT OF 80 DODGE COLT INTO LUMINAIRE SUPPORT  
 CHANNEL 7 DRIVER THORAX, T01Z  
 FILTER CUTOFF FREQ. 300 PEAKS -334.61 , 331.40

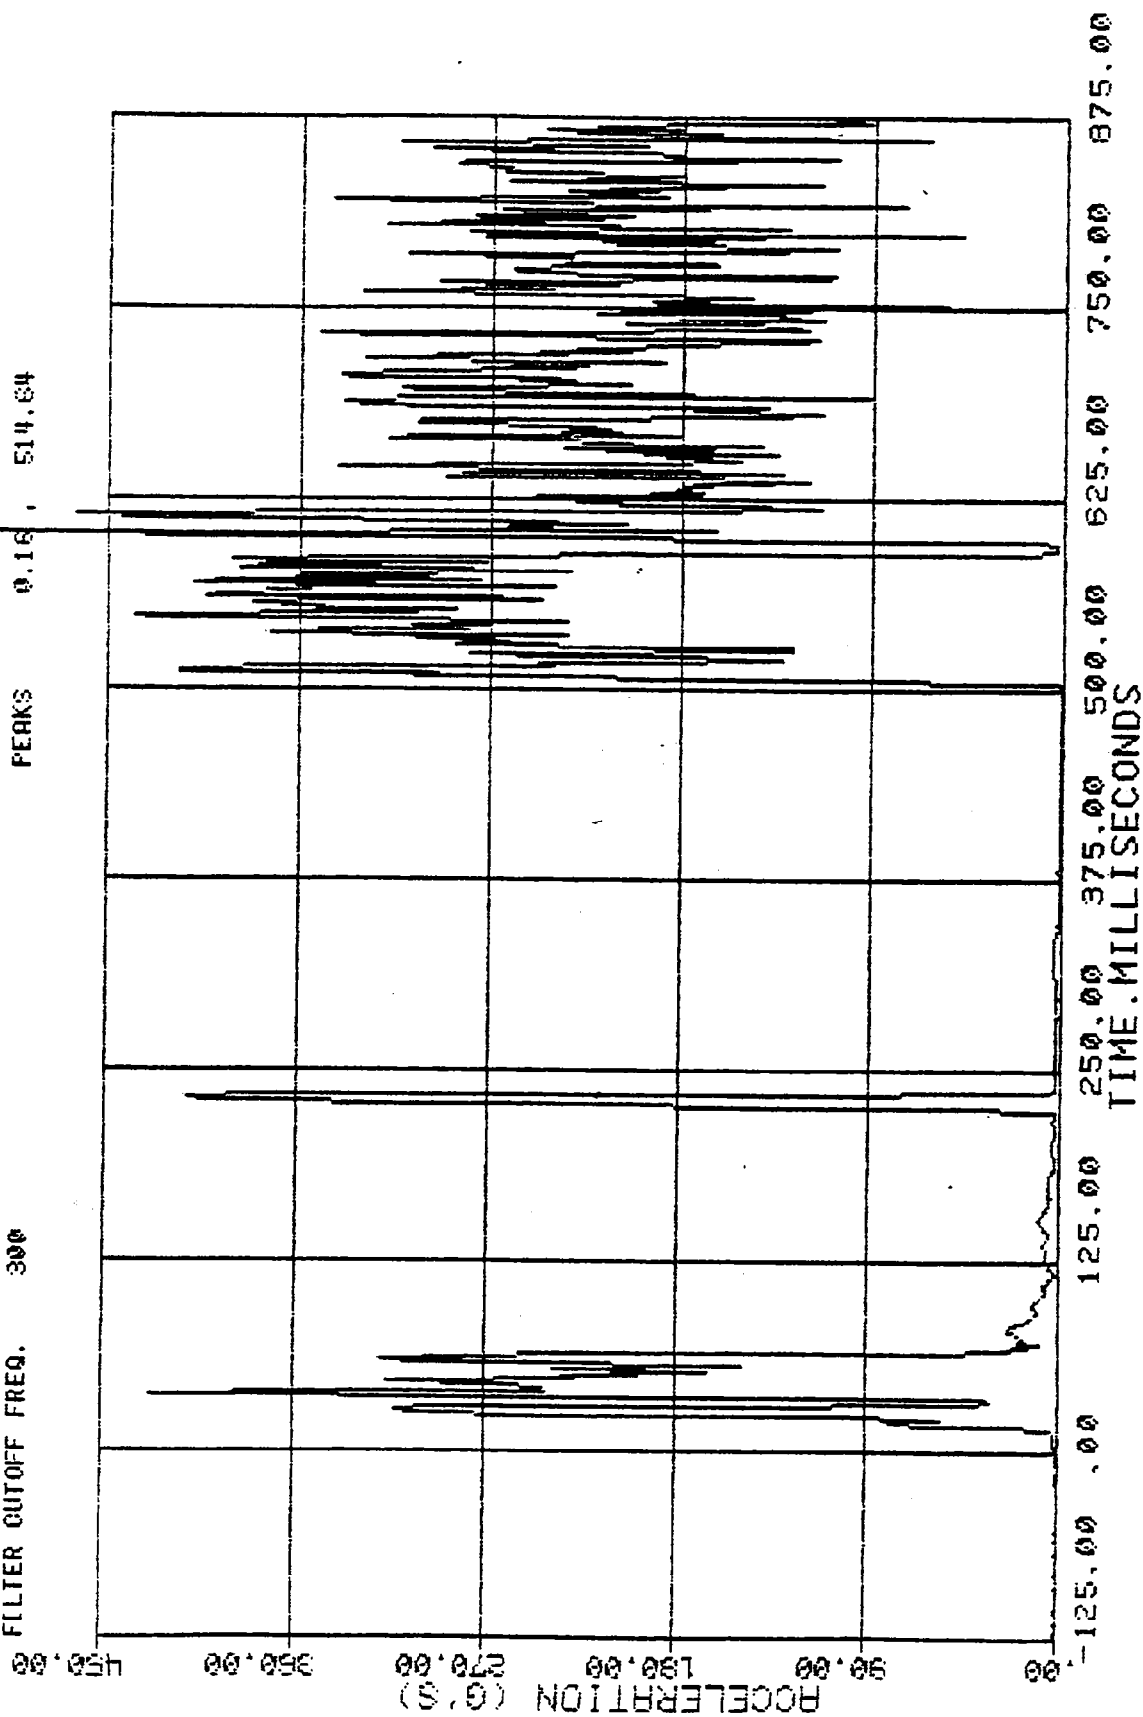
Figure A18. Driver's Upper Spine Acceleration, T01, Resultant, 300 Hz

EUSCO, INC. CONTRACT NUMBER DTIC81-86-Z-00047 TEST NUM 1785-SI-2-87  
 30 MI/H BROADSIDE IMPACT OF 80 DODGE COLT INTO LUMINAIRE SUPPORT  
 CHANNEL 0 DRIVER THORAX, T01, RESULTANT  
 FILTER CUTOFF FREQ. 300

PEAKS 0.16 , 514.84

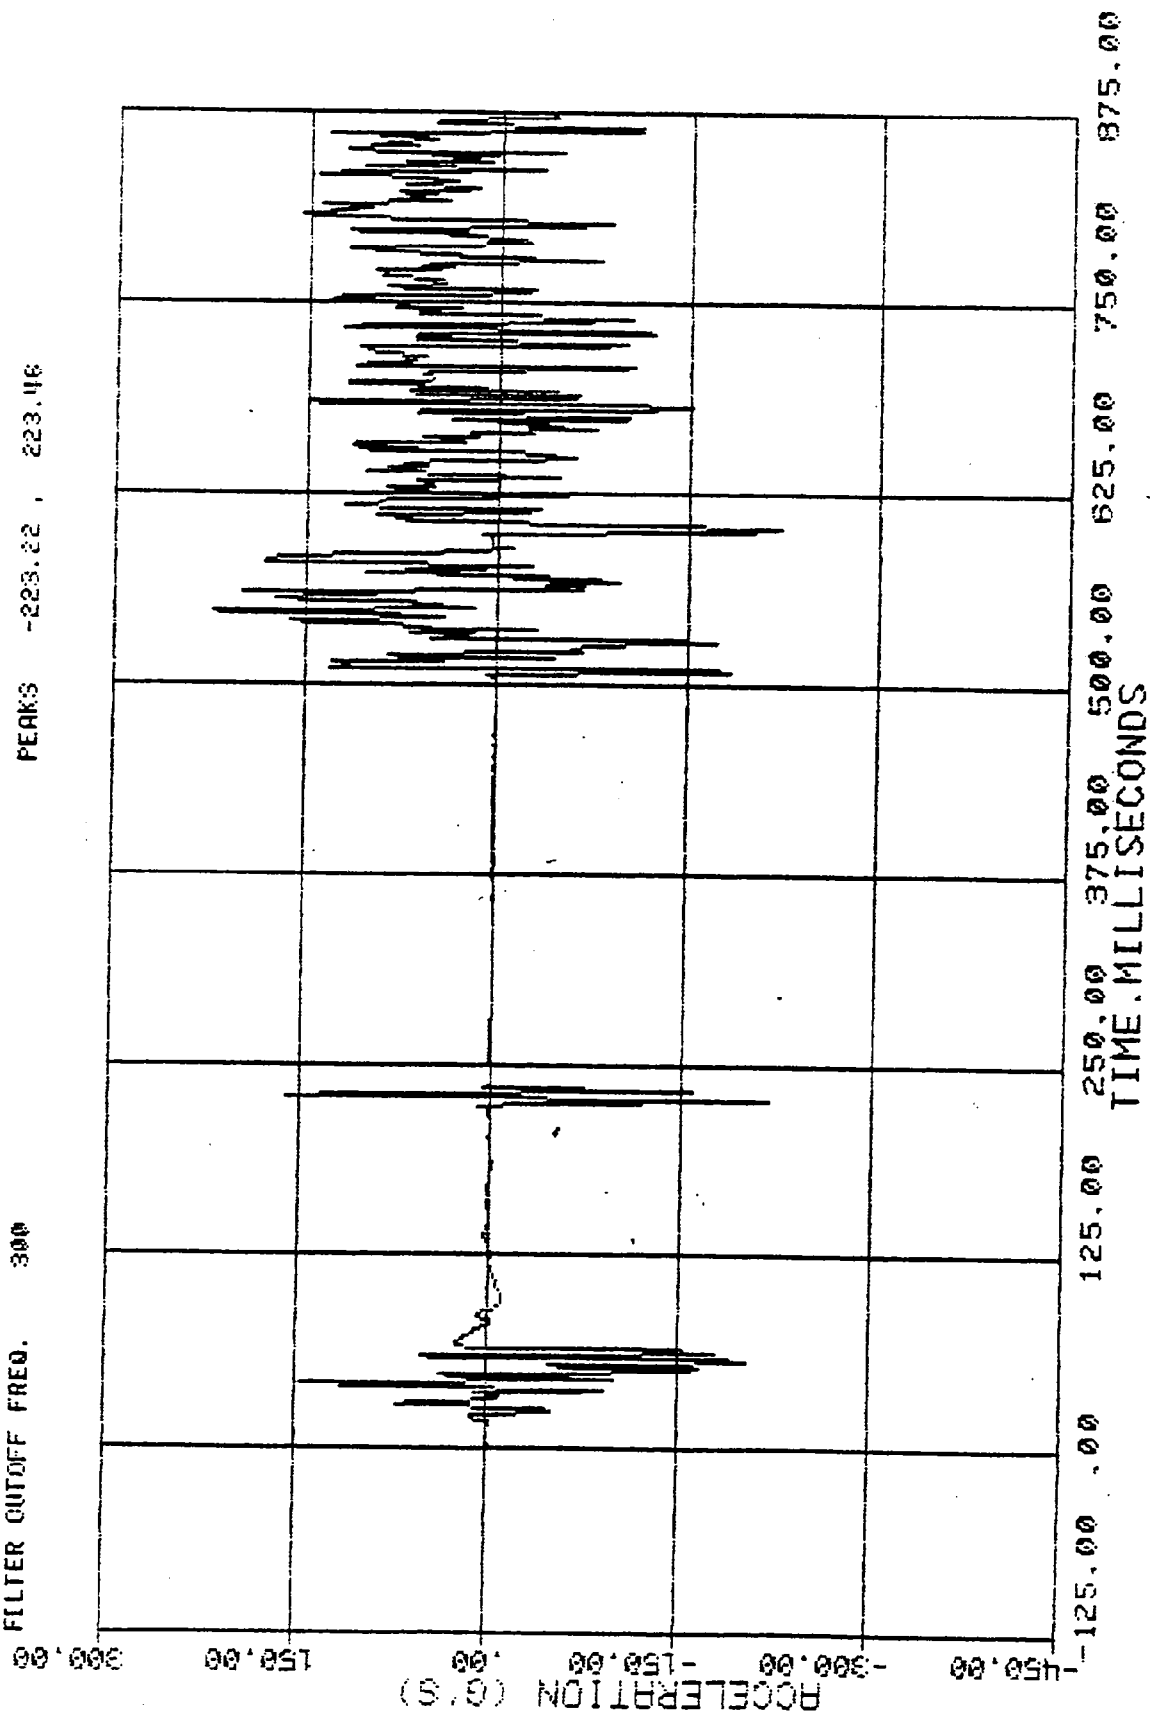
Figure A19. Driver's Lower Spine Acceleration, T12X, 300 Hz

ENSCO, INC.      CONTRACT NUMBER    DTFHSI-86-Z-00047      TEST NUM 1785-SI-2-87  
 30 MI/H BROADSIDE IMPACT OF 80 DODGE COLT INTO LUMINAIRE SUPPORT  
 CHANNEL 3      DRIVER THORAX, T12X  
 FILTER CUTOFF FREQ.    300      PEAKS    -223.22 ,    223.46
