FHWA CONTRACT NO.  
DTFH61-86-Z-00046

THIRTY MPH BROADSIDE  
IMPACT OF A MINI-SIZED VEHICLE  
AND A BREAKAWAY LUMINAIRE SUPPORT

TEST RESULTS REPORT  
TEST NUMBER 1785-SI#2-87

August 1987

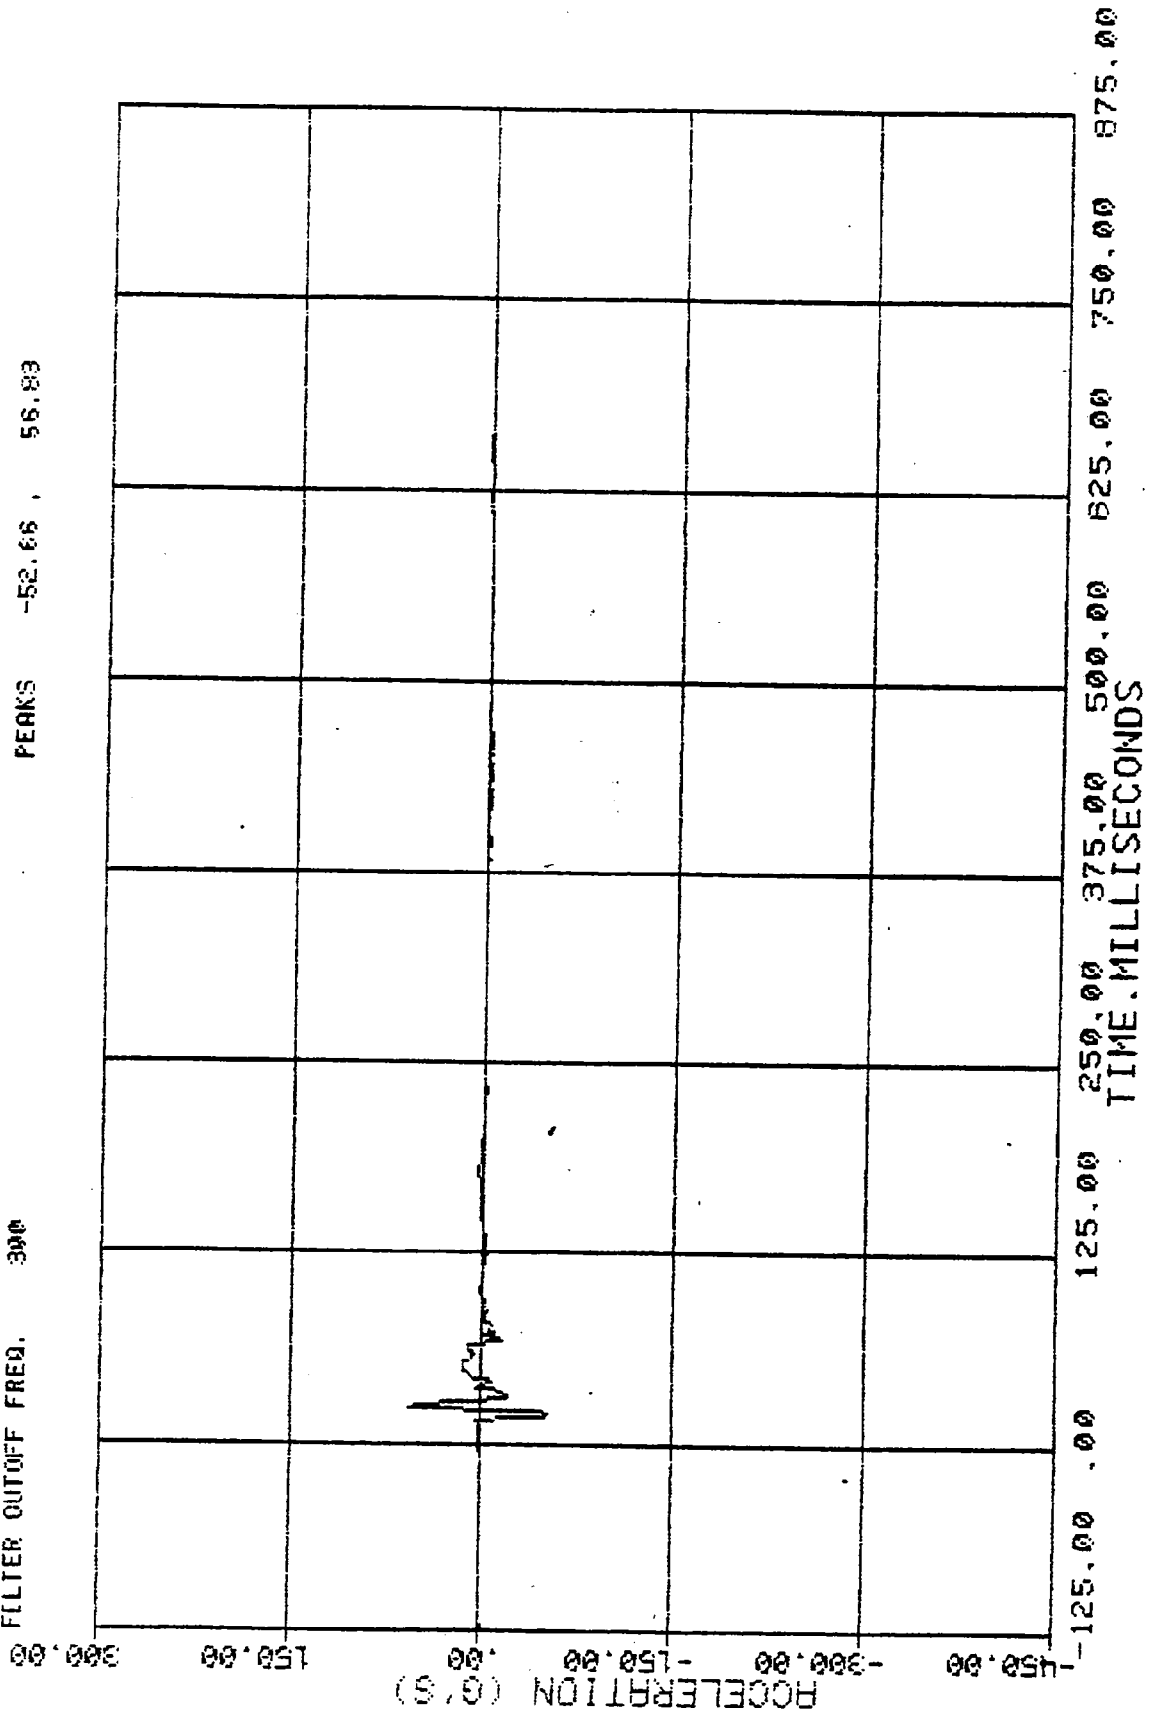
Figure 20. Driver's Lower Spine Acceleration, T12Z, 300 Hz

ENSOO, INC.      CONTRACT NUMBER    CTFH61-86-Z-00047      TEST NUM 1785-SI-2-87  
 30 MI/H BROADSIDE IMPACT OF 80 DODGE COLT INTO LUMINAIRE SUPPORT  
 CHANNEL 10    DRIVER THORAX, T12Z  
 FILTER CUTOFF FREQ.    300      PEAKS    -52.66 ,    56.83

The acceleration traces and associated resultants obtained with the use of the SAE Class 180 ( $f_c = 300$  Hz) filtering techniques are presented in figures A15 through A18 for the upper spine location (T01), figures A19 through A20 for the lower spine location (T12), and figures A21 through A24 for the pelvis location and figures A25 and A26 for the sternum location (LST and UST). The T12Y accelerometer malfunctioned during the test and the LSTX accelerometer failed shortly after impact.

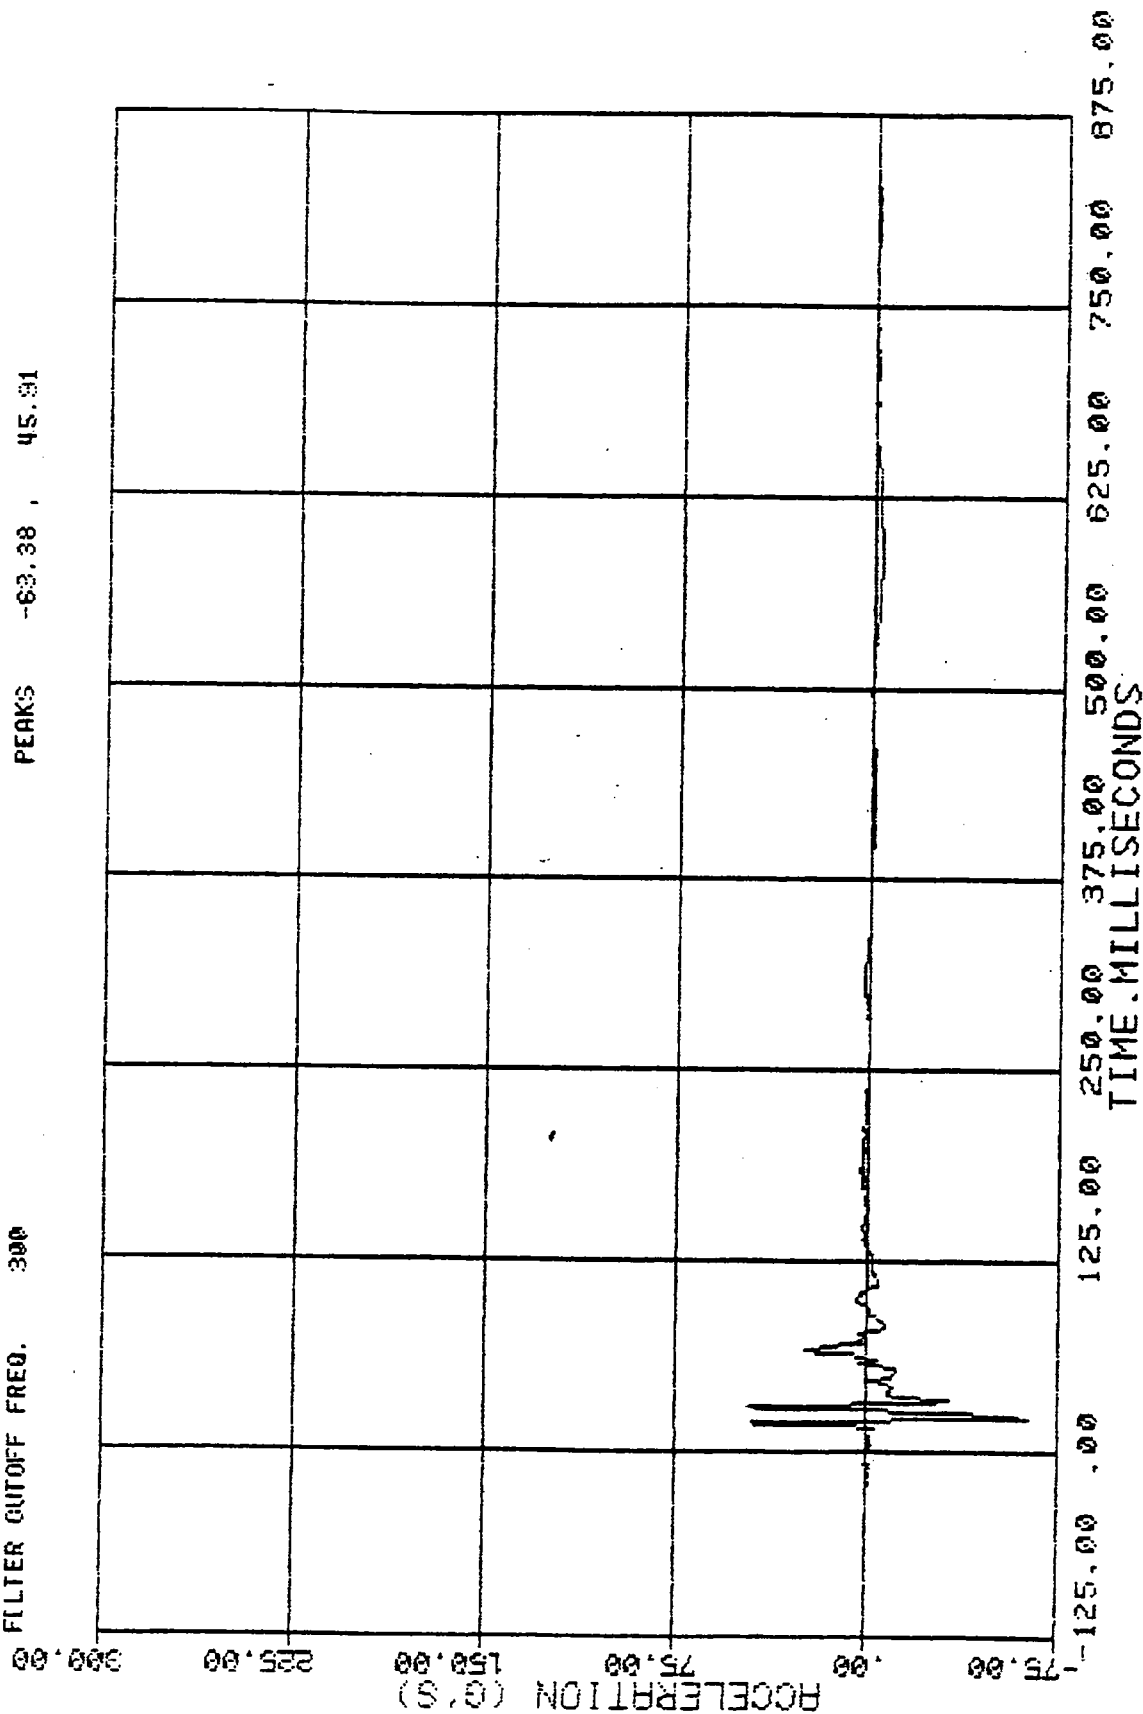
Figure A21. Driver's Pelvis Acceleration, X-Axis, 300 Hz

ENSO, INC.      CONTRACT NUMBER    DTFH61-86-Z-00047      TEST NUM 1785-SI-2-87  
 30 MI/H BROADSIDE IMPACT OF 80 DODGE COLT INTO LUMINAIRE SUPPORT  
 CHANNEL 16      DRIVER PELVIS ACCELERATION, X-AXIS  
 FILTER CUTOFF FREQ.    300      PEAKS    -63.38 ,    45.91

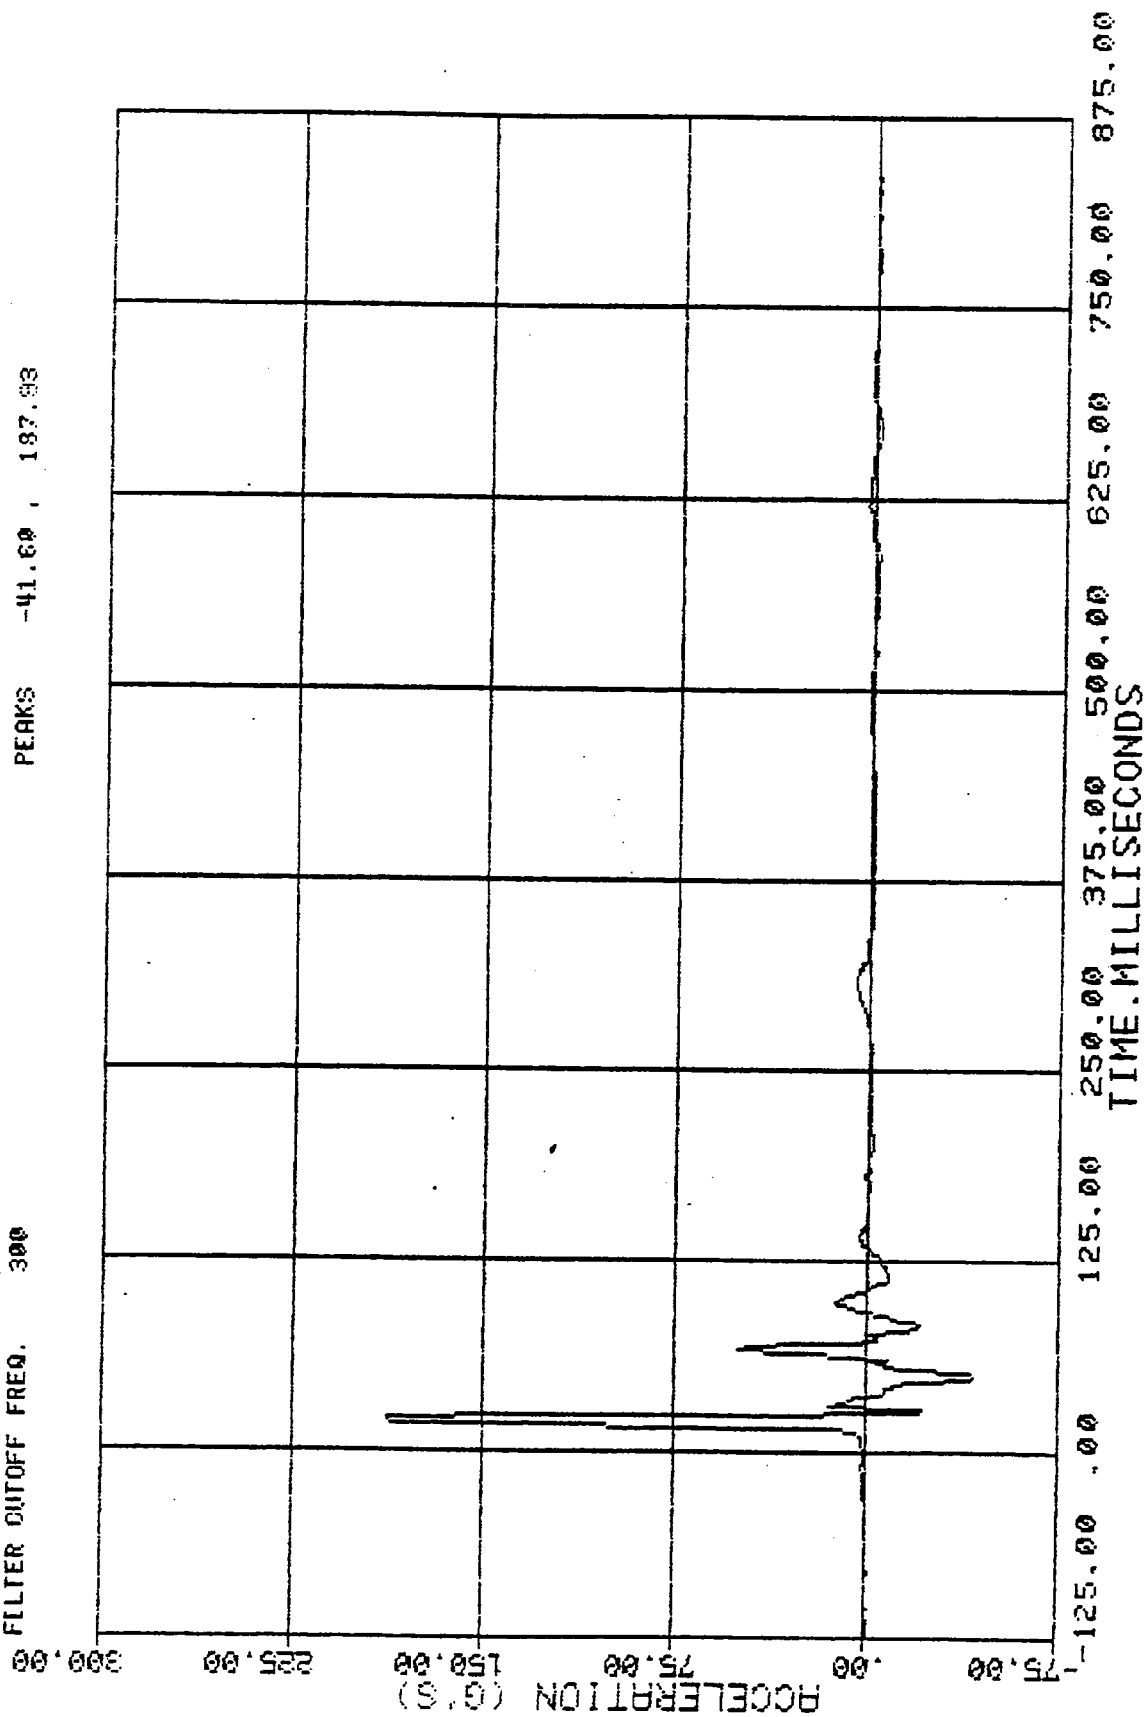
Figure A22. Driver's Pelvis Acceleration, Y-Axis, 300 Hz

EUSCO, INC.      CONTRACT NUMBER    DTFH61-86-Z-00047      TEST NUM 1785-SI-2-87  
 3" MI/H BROADSIDE IMPACT OF 80 POUND GOLT INTO LUMINAIRE SUPPORT  
 CHANNEL 17    DRIVER PELVIS ACCELERATION, Y-AXIS  
 FILTER CUTOFF FREQ.    300      PEAKS    -41.60 ,    187.93

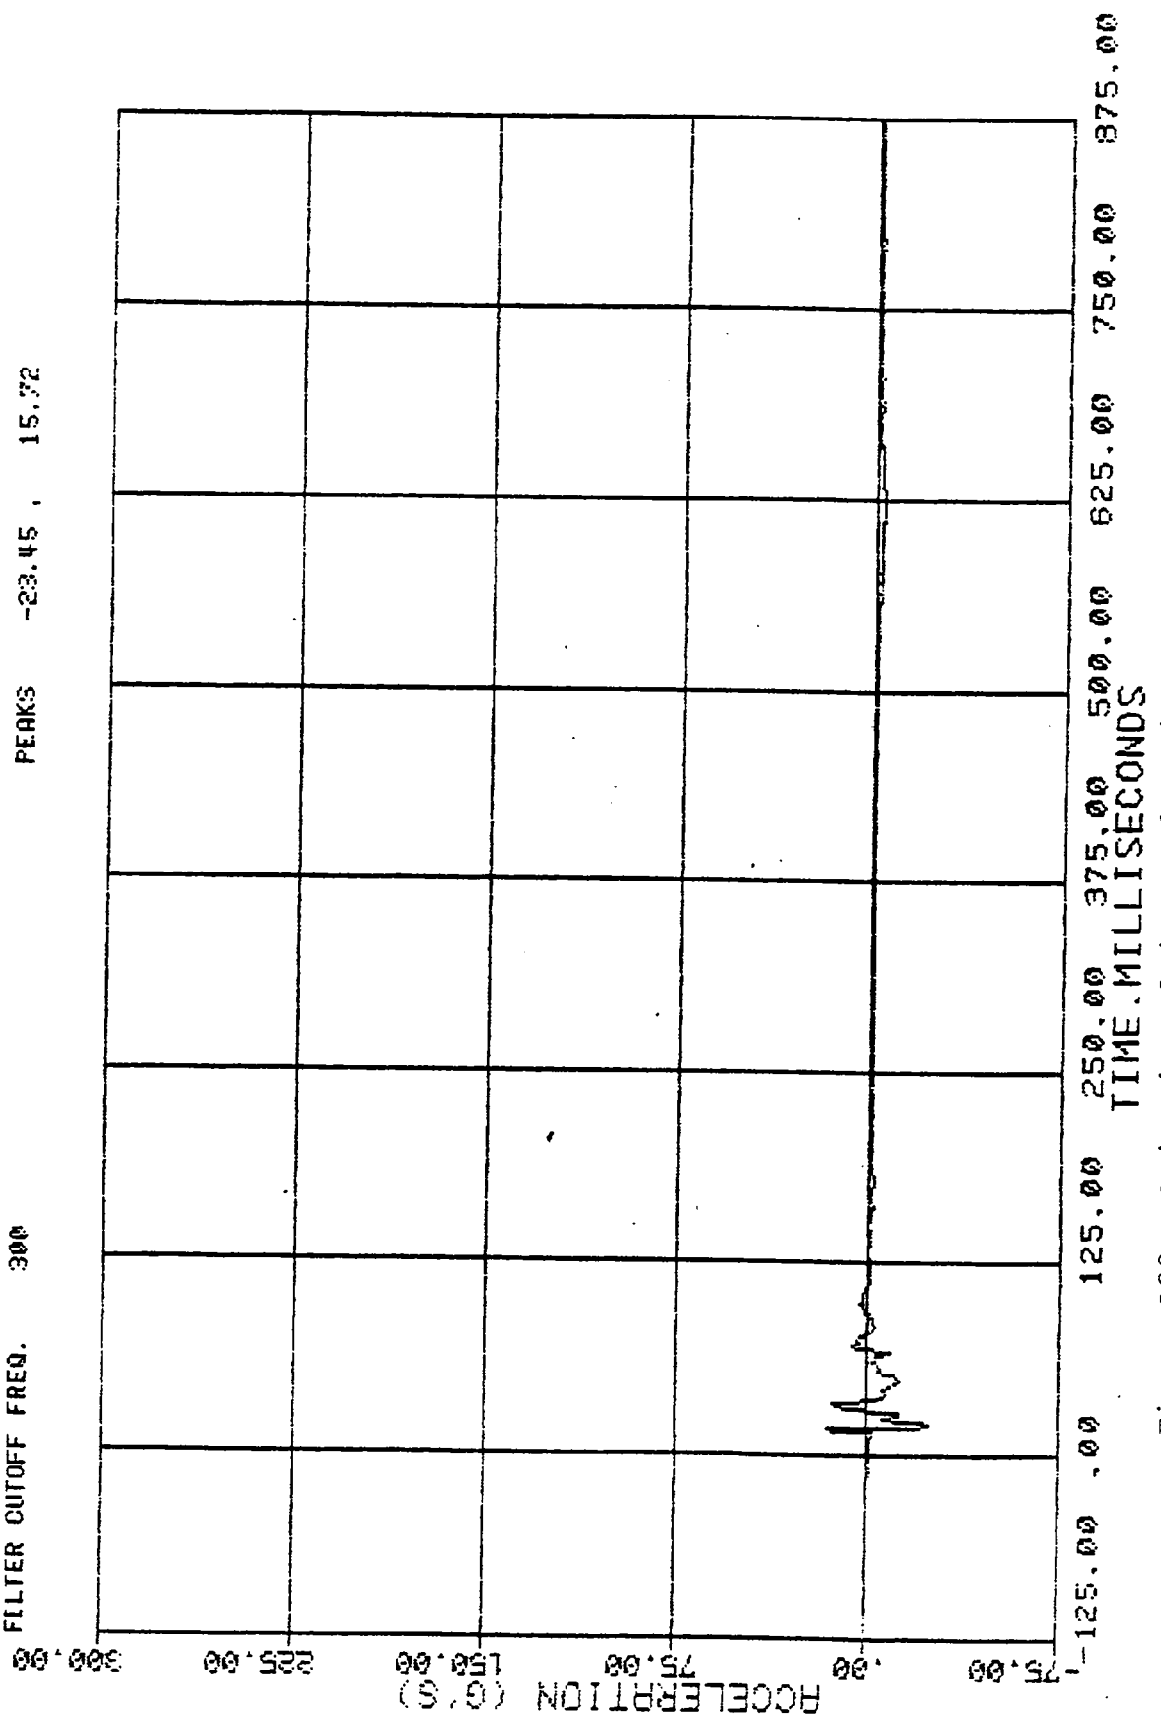
Figure A23. Driver's Pelvis Acceleration, Z-Axis, 300 Hz

ENSCO, INC.      CONTRACT NUMBER    DTFH61-86-Z-00047      TEST NUM 1785-SI-2-87  
 34 MI/H BROADSIDE IMPACT OF 80 0000E GOLT INTO LUMINAIRE SUPPORT  
 CHANNEL 18      DRIVER PELVIS ACCELERATION, Z-AXIS  
 FILTER CUTOFF FREQ.    300      PEAKS    -23.45 ,    15.72

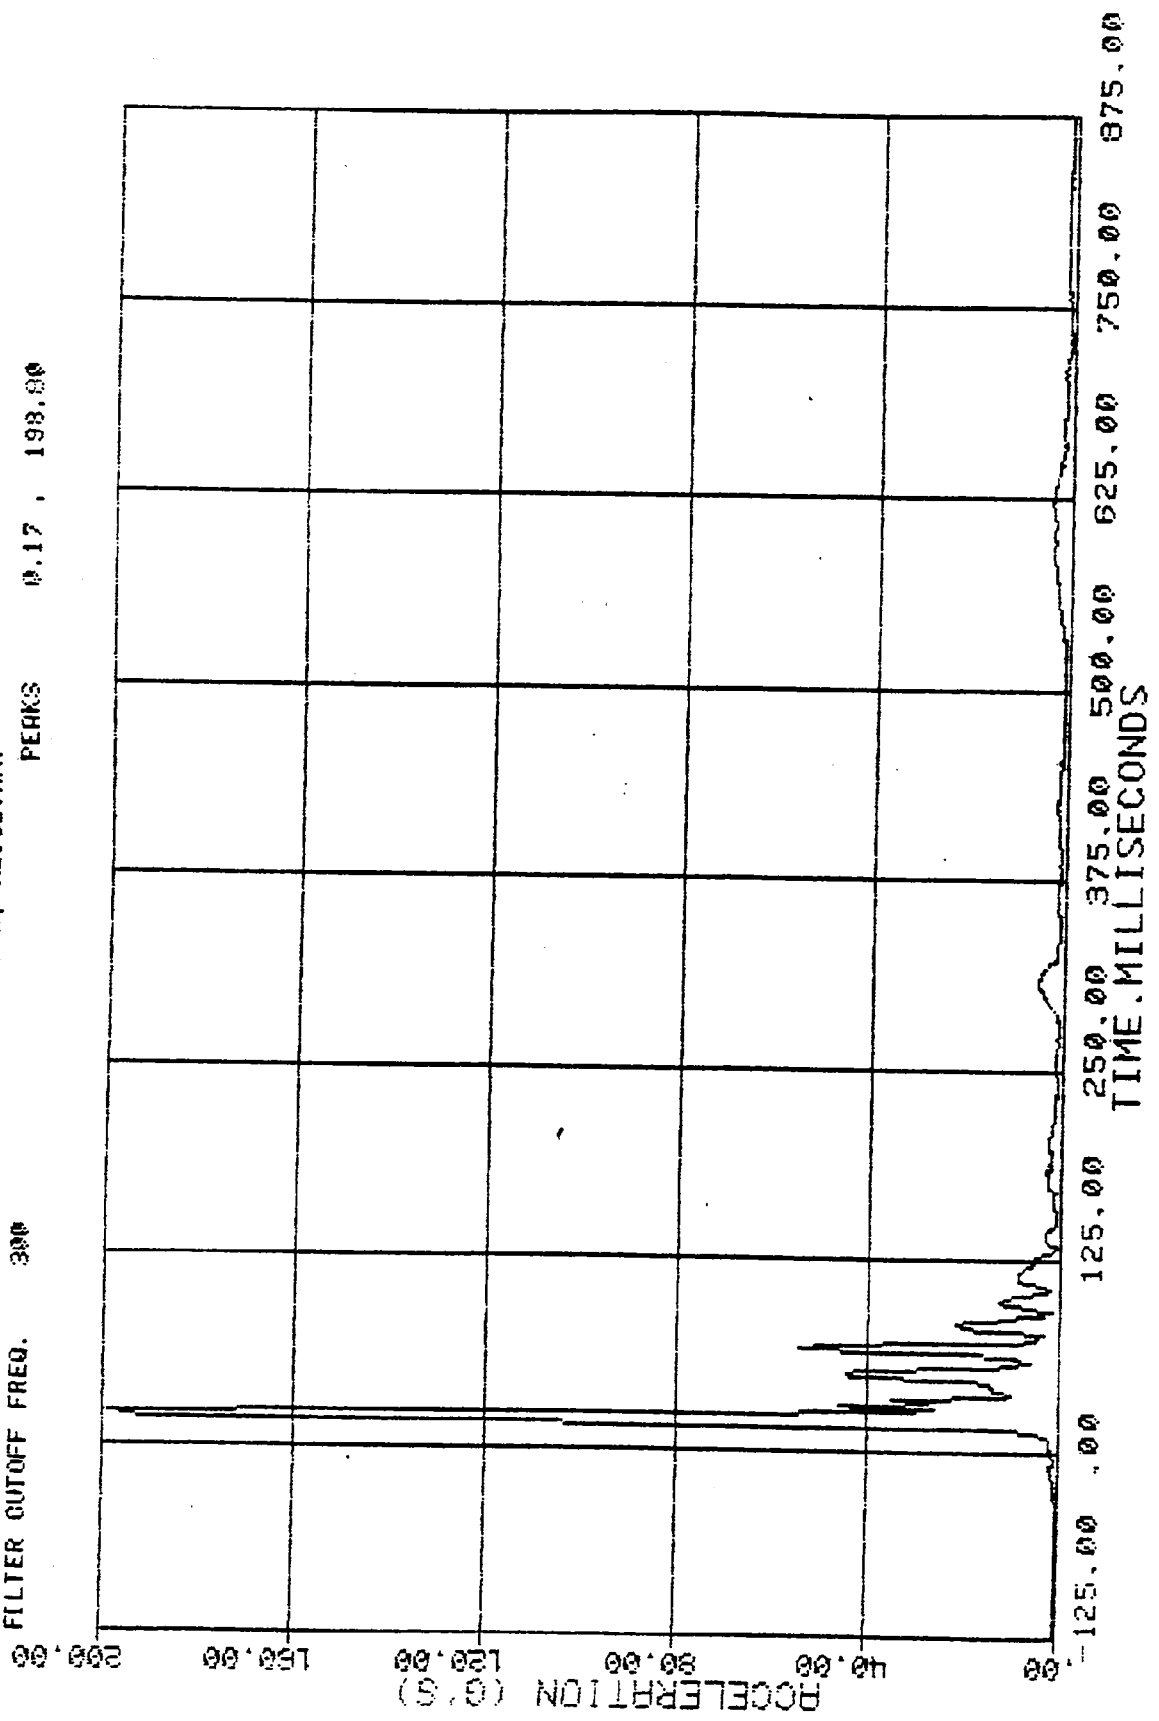
Figure A24. Driver's Pelvis Acceleration, Resultant, 300 Hz

ENSCO, INC.      CONTRACT NUMBER    DTFH61-86-Z-00047      TEST NUM 1785-SI-2-87  
 3 1/4 BROADSIDE IMPACT OF 80 DODGE COLT INTO LUMINAIRE SUPPORT  
 CHANNEL 0      DRIVER PELVIS ACCELERATION, RESULTANT  
 FILTER CUTOFF FREQ.    300      PEAKS    0.17 , 193.00

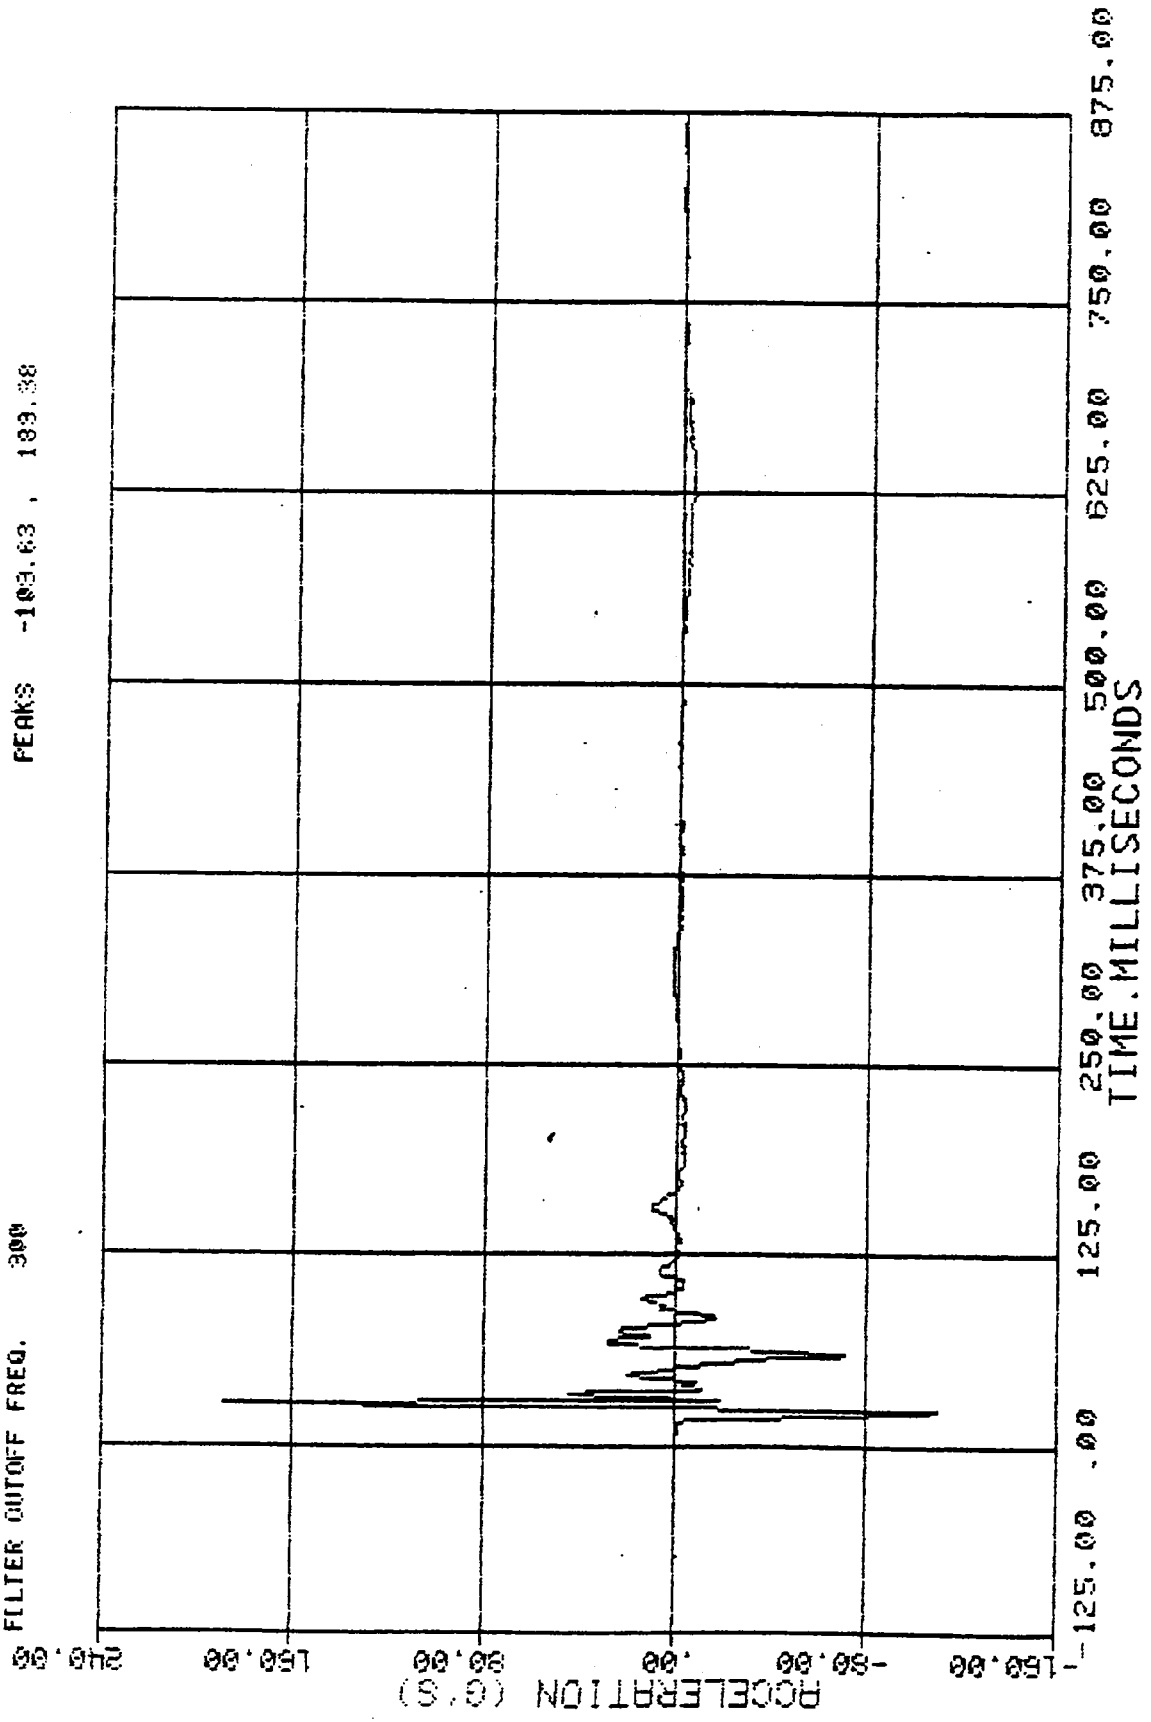
Figure A25. Driver's Upper Sternum Acceleration, USTX, 300 Hz

ENSCO, INC.      CONTRACT NUMBER    DTFH61-86-T-00047      TEST NUM 1785-SI-2-87  
 30 MI/H BROADSIDE IMPACT OF 80 DODGE COLT INTO LUMINAIRE SUPPORT  
 CHANNEL 11      DRIVER THORAX, USTX  
 FILTER CUTOFF FREQ.    300      PEAKS    -103.63 , 183.38

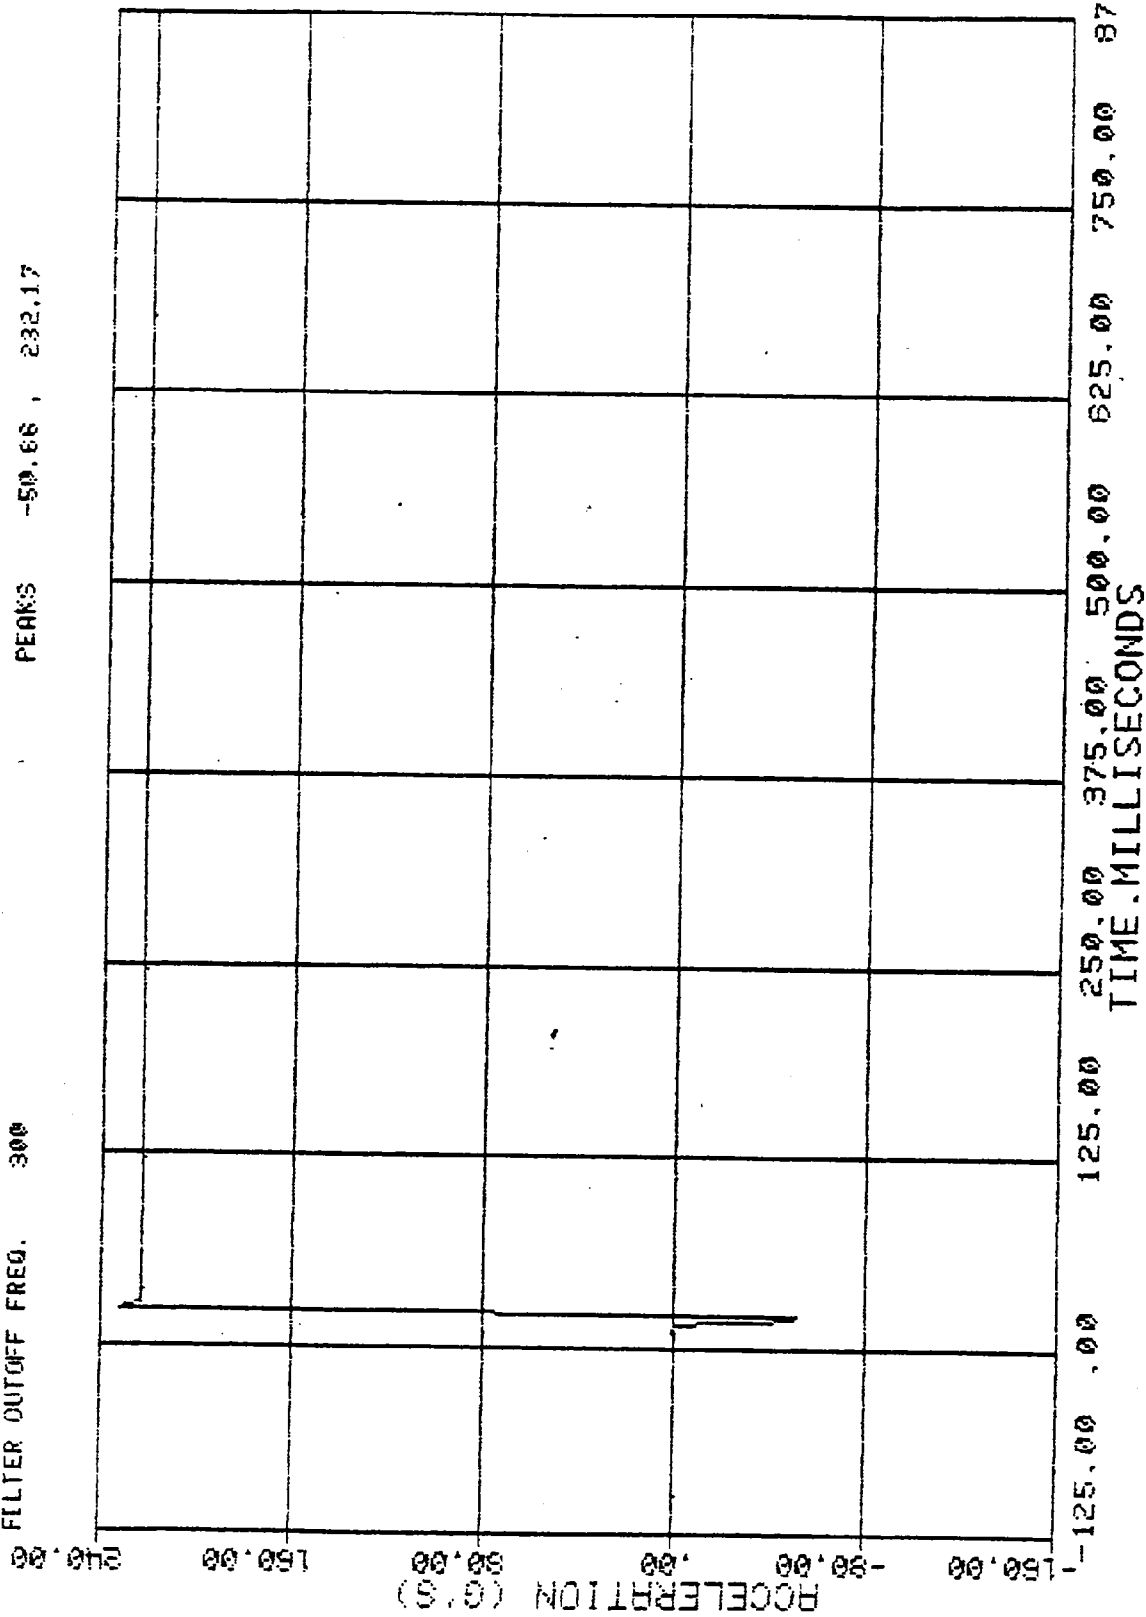
Figure A26. Driver's Lower Sternum Acceleration, LSTX, 300 Hz

ENSCO, INC.      CONTRACT NUMBER    DTFH81-86-Z-00047      TEST NUM 1785-SI-2-87  
 30 MI/H BROADSIDE IMPACT OF 80 DODGE COLT INTO LUMINAIRE SUPPORT  
 CHANNEL 12      DRIVER THORAX, LSTX  
 FILTER CUTOFF FREQ.    300      PEAKS    -50.68 ,    232.17

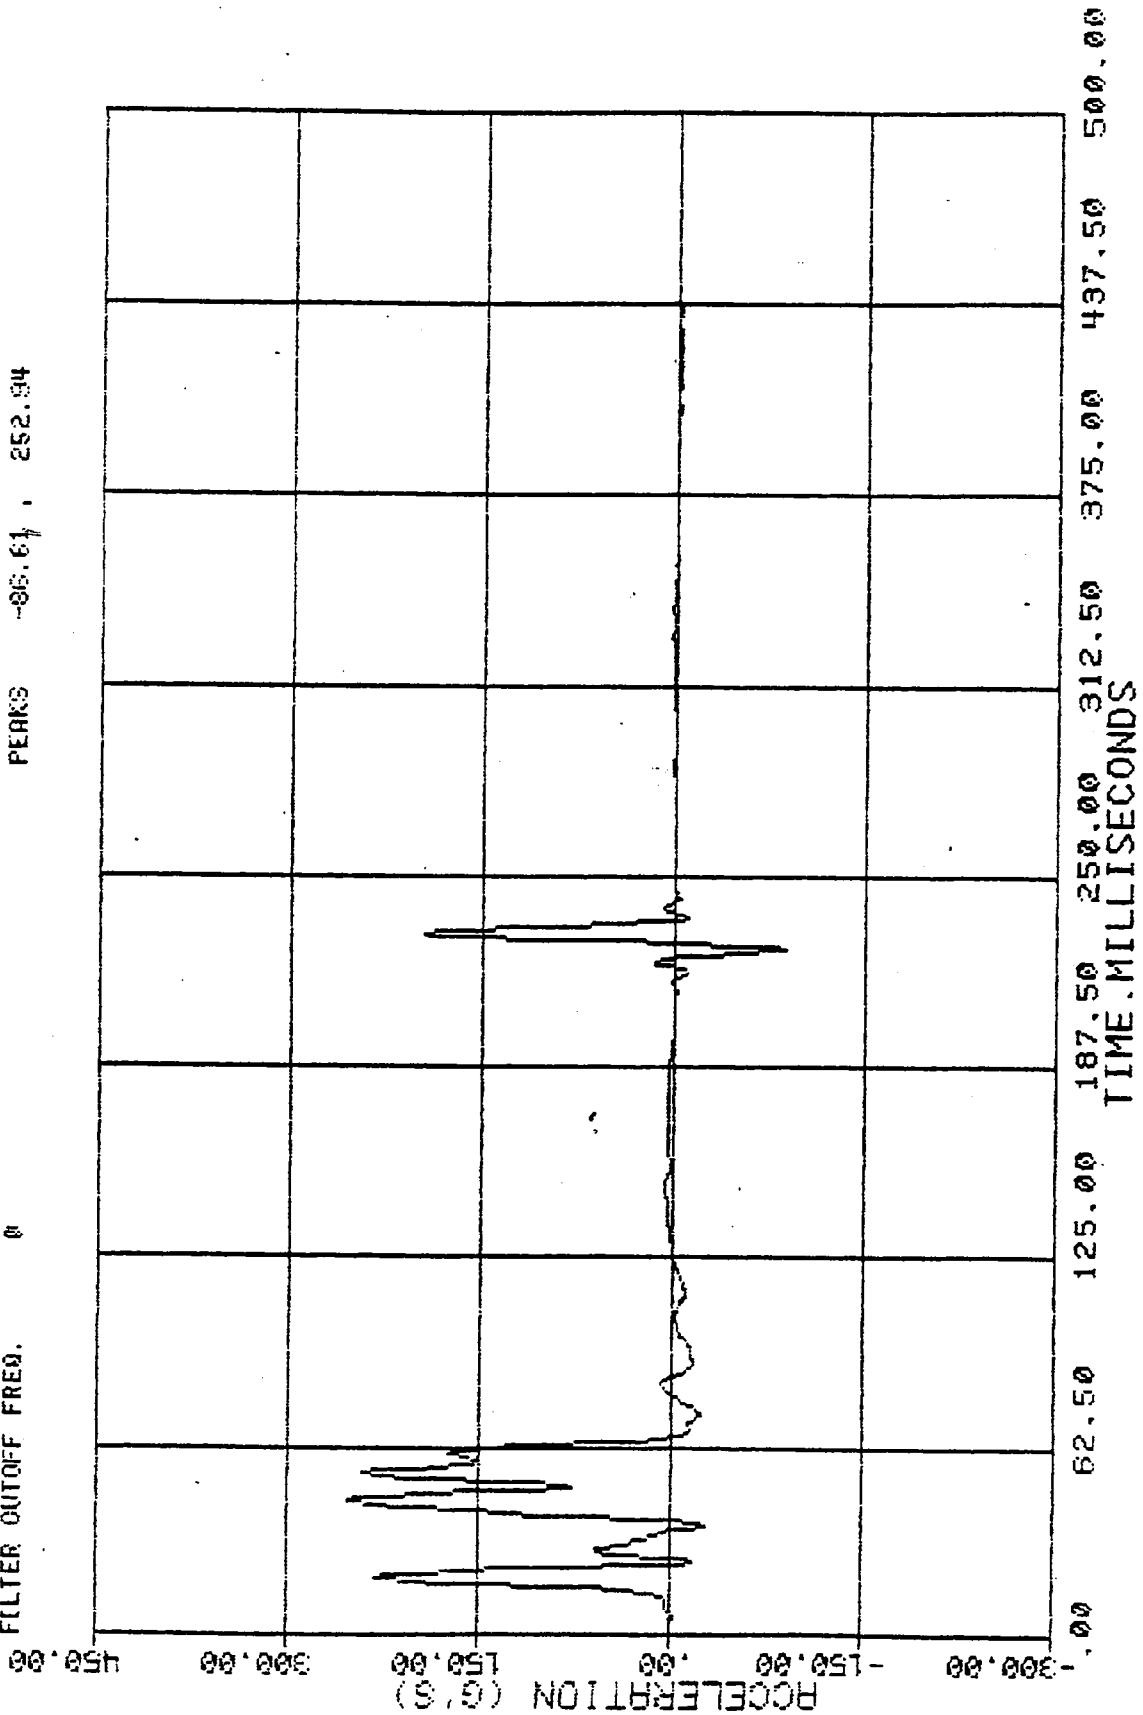
Figure A27. Driver's Upper Left Rib Acceleration, LURY, NHTSA FIR Filter

EISCO, INC.      CONTRACT NUMBER    E1FH61-88-Z-00047      TEST NUM 1785-SI-2-87  
 30 MHz BROADSIDE IMPACT OF 80 DQOE GOLT INTO LUMINAIRE SUPPORT  
 CHANNEL    3    LURY01  
 FILTER CUTOFF FREQ.    0    PEAKS    -86.61    252.94

The LURY data was taken from figures A27 and A28. The peak value of each was 252 g's and 330 g's. The average is 291. Thus the TTI index in this test is 291 plus occupant age. This value produces a 100% probability of injury of an AIS greater than 3 or 4. The probability of injury of an AIS greater than 5 is at least 50% since the figure ends at the 240 index level.

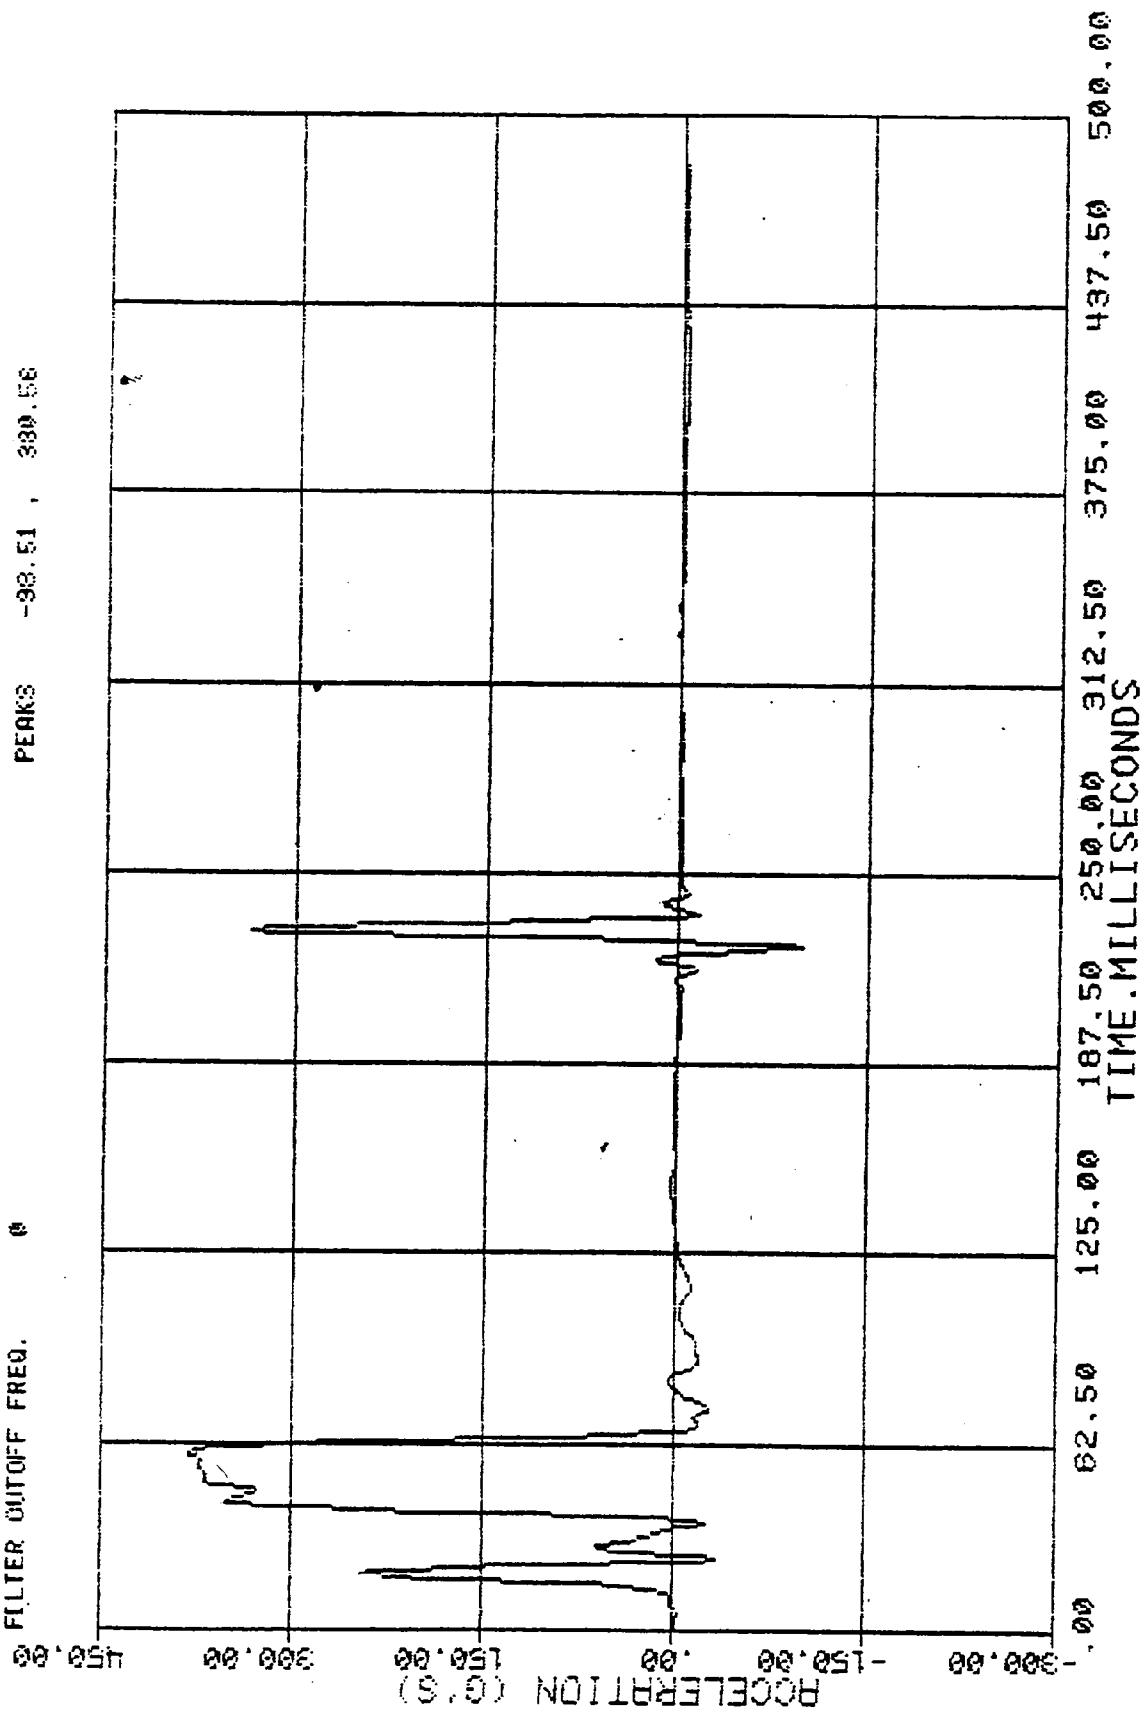
Figure A-28. Driver's Upper Left Rib Acceleration, LURYA, NHTSA Fir Filter

CONTRACT NUMBER DTFH61-86-2-0047 TEST NUM 1785-SI-2-87  
 30 MI/H BROADSIDE IMPACT OF 80 DODGE COLT INTO LUMINAIRE SUPPORT  
 CHANNEL 4 LURYGA  
 FILTER CUTOFF FREQ. 0 PEAKS -38.51 , 380.58

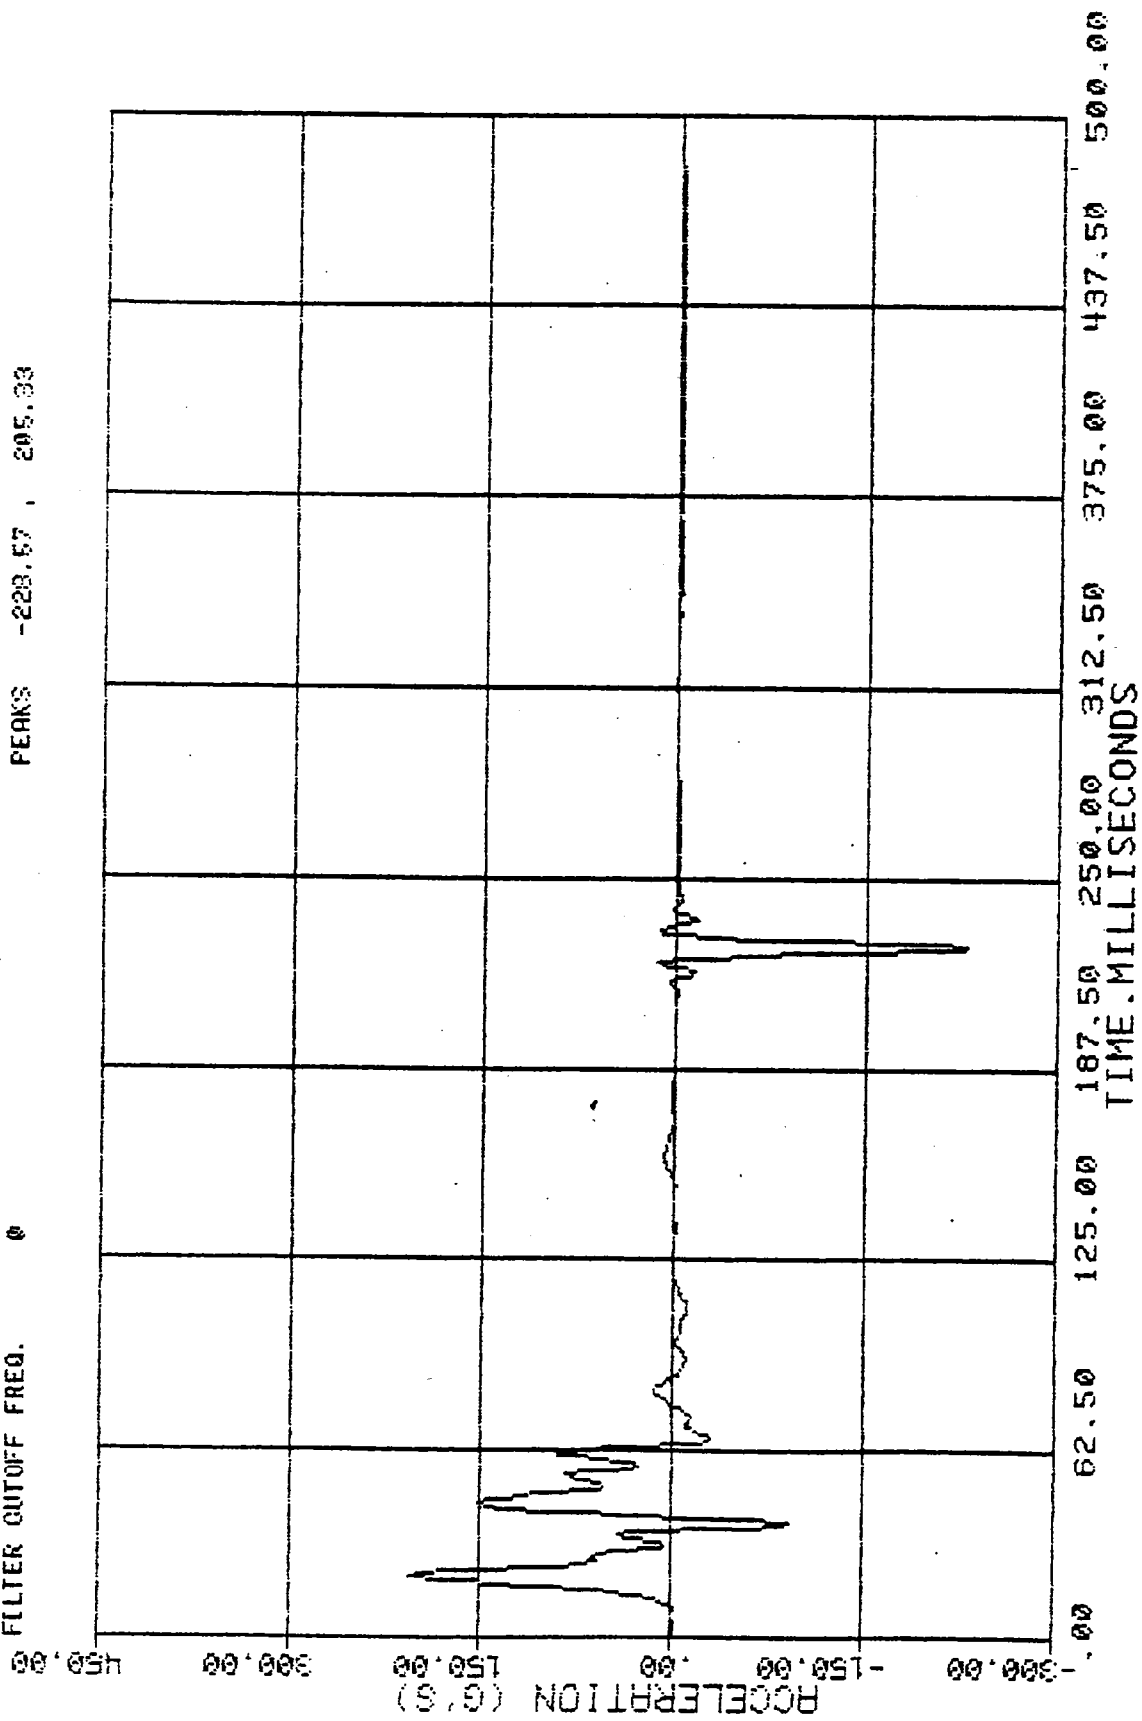
Figure A29. Driver's Lower Left Rib Acceleration, LLRY, NHTSA Fir Filter

ENSCO, INC. CONTRACT NUMBER DTFB61-86-2-00017 TEST RUN 1785-S1-2-87  
 30 MI/H BROADSIDE IMPACT OF 80 DODGE COLT INTO LUMINAIRE SUPPORT  
 CHANNEL 1 LLRY01  
 FILTER CUTOFF FREQ. 0 PEAKS -228.57 , 205.33

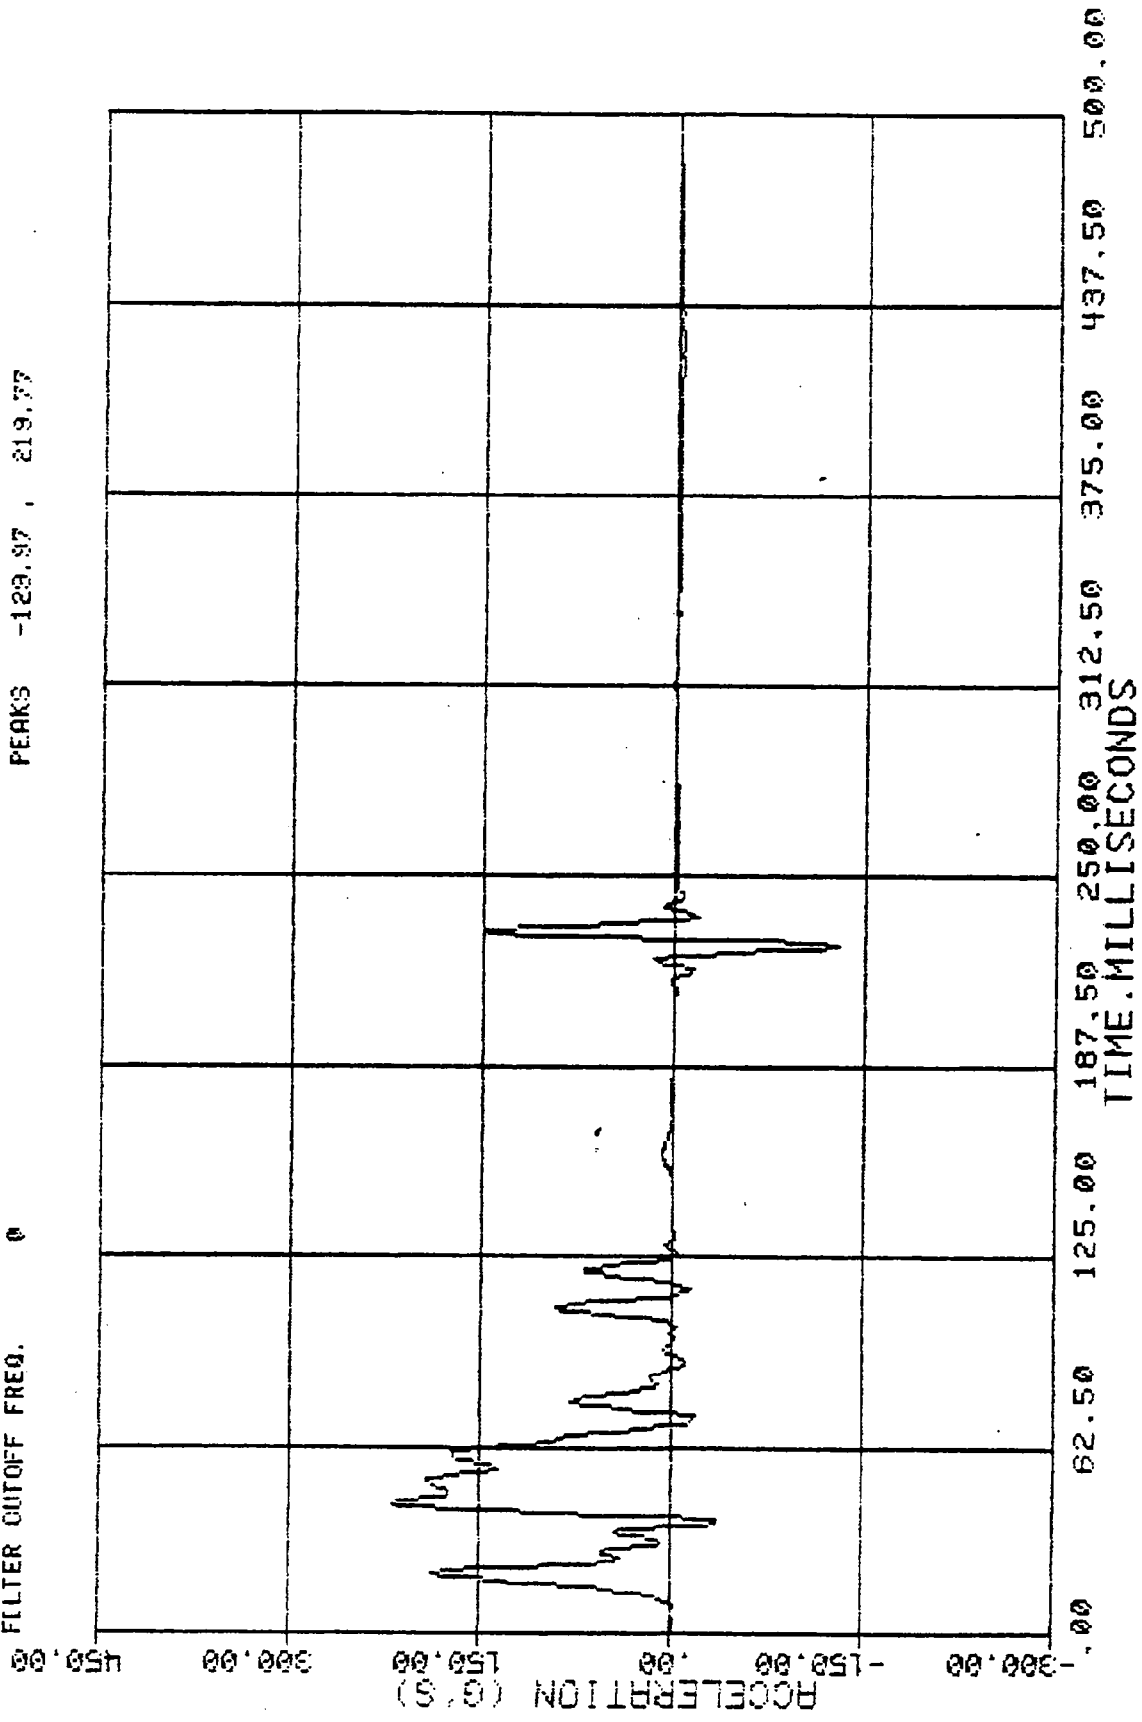
Figure A30. Driver's Lower Left Rib Acceleration, LLRYA, NHTSA Fir Filter

ENSO, INC. CONTRACT NUMBER DTFH61-86-Z-00047 TEST NUM 1785-SI-2-87  
 30 W/4 BROCSIDE IMPACT OF 80 DODGE COLT INTO LUMINAIRE SUPPORT  
 CHANNEL 2 LLRY8A  
 FILTER CUTOFF FREQ. 0 PEAKS -123.97, 219.77
