THIRTY MPH BROADSIDE  
IMPACT OF A MINI-SIZED VEHICLE  
AND A BREAKAWAY LUMINAIRE SUPPORT

TEST RESULTS REPORT

TEST NUMBER 1785-SI#3-87

Prepared by:  
ENSCO, INC.  
Applied Technology and Engineering Division  
5400 Port Royal Road  
Springfield, VA 22151

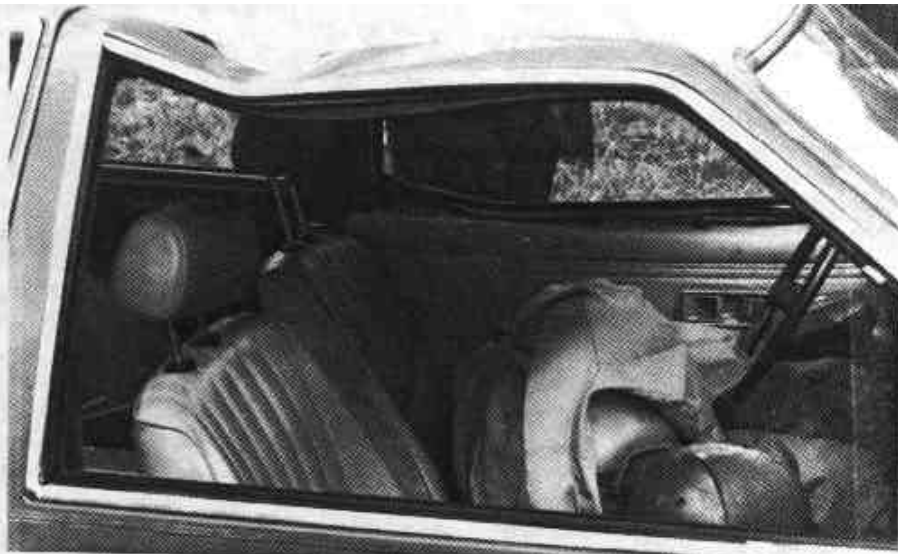
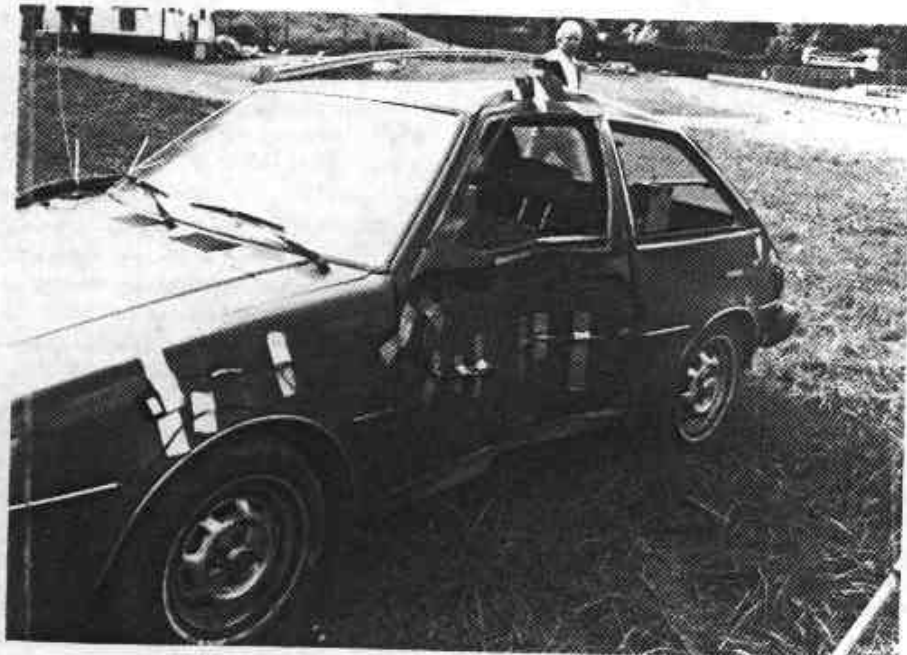
Figure 3. Post-Test Photos of Vehicle

The impact conditions were 30.5 mph (13.6 m/s) at a point on the left door in line with the occupant 28 in (.71 m) behind the longitudinal location of the center of gravity of the vehicle measured without the dummy in the vehicle. The vehicle had a  $4.9^{\circ}$  roll angle as it leaned toward the test pole due to the side sliding forces acting on the tires. The maximum residual crush of the vehicle at the impact point was 9.5 inches (.24 m). Photographs of the vehicle and luminaire support after the collision event are shown in figure 3.

After the initial separation from the vehicle the luminaire support translated forward and rotated up and over the test vehicle with the top of the pole hitting the ground about 1.1 seconds after impact. Just prior to impact with the ground, the center portion of the pole impacted on the left rear corner of the car. As the support rotated away, vehicle yawed counter clockwise and rolled to its left. The maximum roll angle was about  $5^{\circ}$  based on film observations. The vehicle then became stable and continued forward away from the impact area after yawing a total of about  $60^{\circ}$ . The vehicle did not pitch or roll very much but remained stable during this transition. The final resting position of the vehicle was about 55 feet downstream and 35' to the right of the impact point. The residual test vehicle crush measured using the 6 point NHTSA guide is given in table 7. See figure 4 for reference.
