THIRTY MPH BROADSIDE
IMPACT OF A MINI-SIZED VEHICLE
AND A BREAKAWAY LUMINAIRE SUPPORT

TEST RESULTS REPORT

TEST NUMBER 1785-SI#4-87

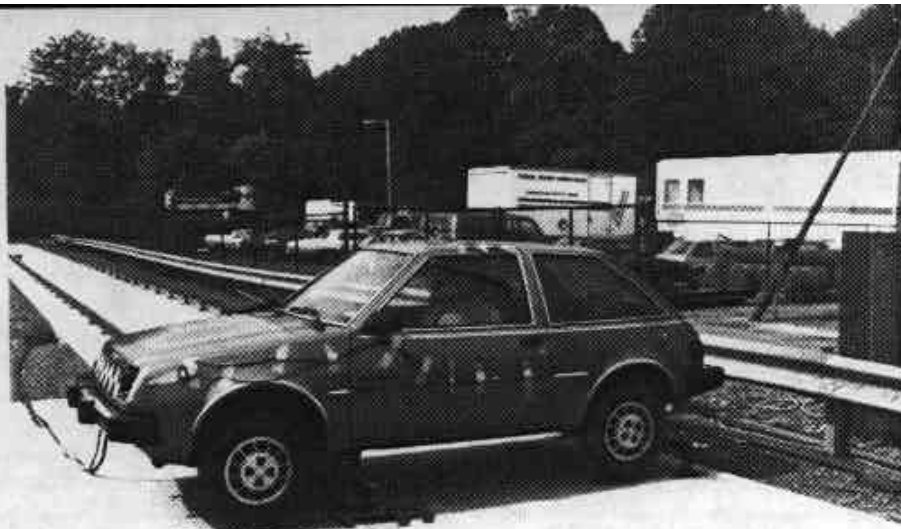
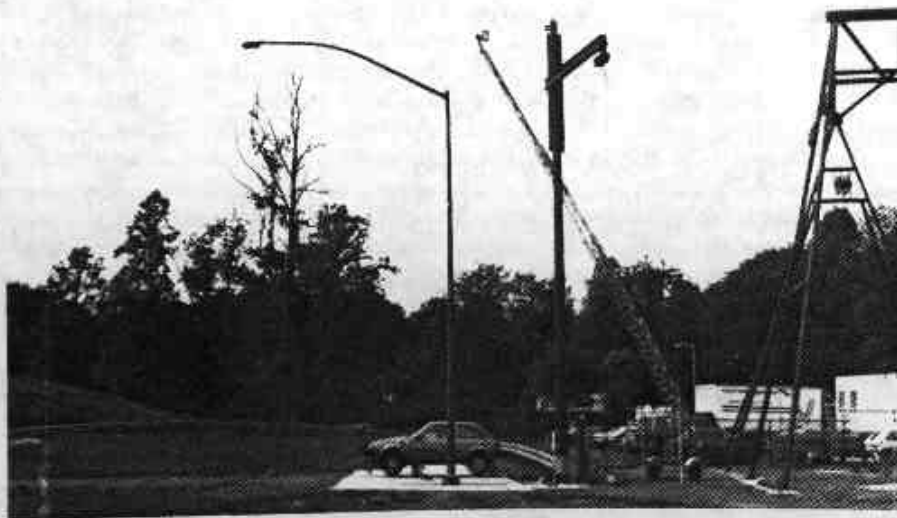
Figure 2. Pre-Test Photos of Vehicle

The vehicle was equipped with a triaxial accelerometer package mounted on the lateral centerline of the vehicle at the longitudinal location of the center of gravity. Two rate gyros were also installed to the same mounting block to measure roll and yaw rates. The vehicle was also equipped with a contact switch mounted on the left door to permit vehicle and occupant data to be measured relative to the time of impact. A second triaxial accelerometer package was attached to the floor board located in front of the front right hand seat. This data was collected using the FOIL data system. The test vehicle is shown in Figure 2.

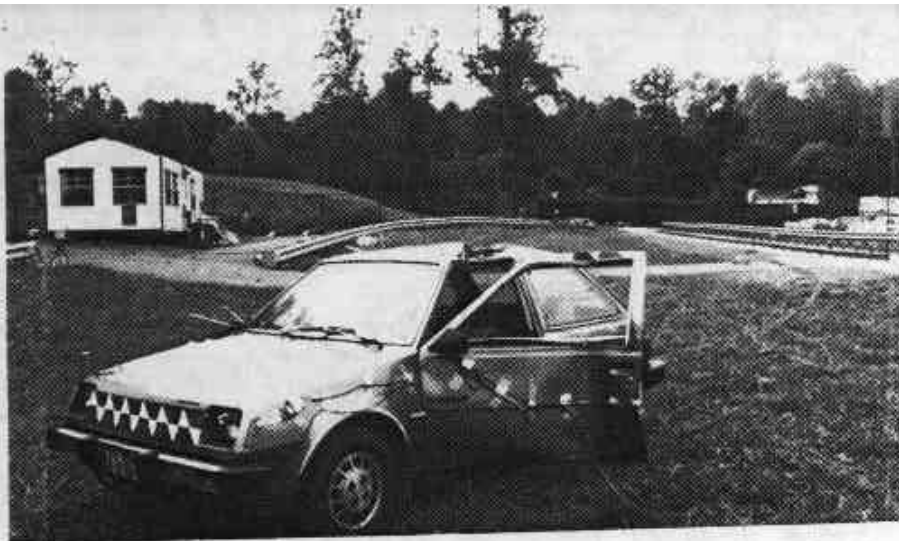
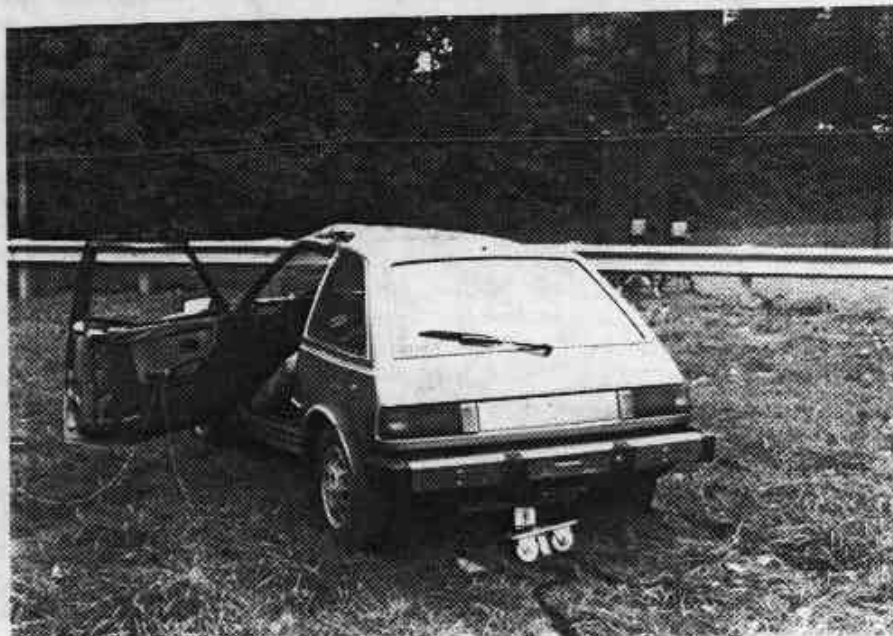
Figure 3. Post-Test Photos of Vehicle

The impact conditions were 29.45 mph (13.18 m/s) at a point on the left door in line with the occupant 28 in (.71 m) behind the longitudinal location of the center of gravity of the vehicle measured without the dummy in the vehicle. The vehicle had a 5.9° roll angle as it leaned toward the test pole due to the side sliding forces acting on the tires. The maximum residual crush of the vehicle at the impact point was 10.0 inches (.25 m). Photographs of the vehicle and luminaire support after the collision event are shown in Figure 3.

The test vehicle momentum change due to impacting the pole at a speed of 30.48 mph (13.63 m/s) was 559 lb-sec. The velocity change corresponding to the observed vehicle momentum change was 6.11 mph or 8.96 ft/sec. The integrity of the vehicle was maintained throughout the test although severe intrusions occurred at the center of the driver's door. Maximum residual crush of the side of the vehicle was 10.0 inches.
