REPORT NO. CAL-88-N10

**NEW CAR ASSESSMENT PROGRAM (NCAP)  
FRONTAL BARRIER IMPACT TEST**

VOLVO CAR CORPORATION  
1988 VOLVO 740 GLE  
4 Door Sedan

NHTSA NO. MJ5900  
CALSPAN TEST NO. 7626-10

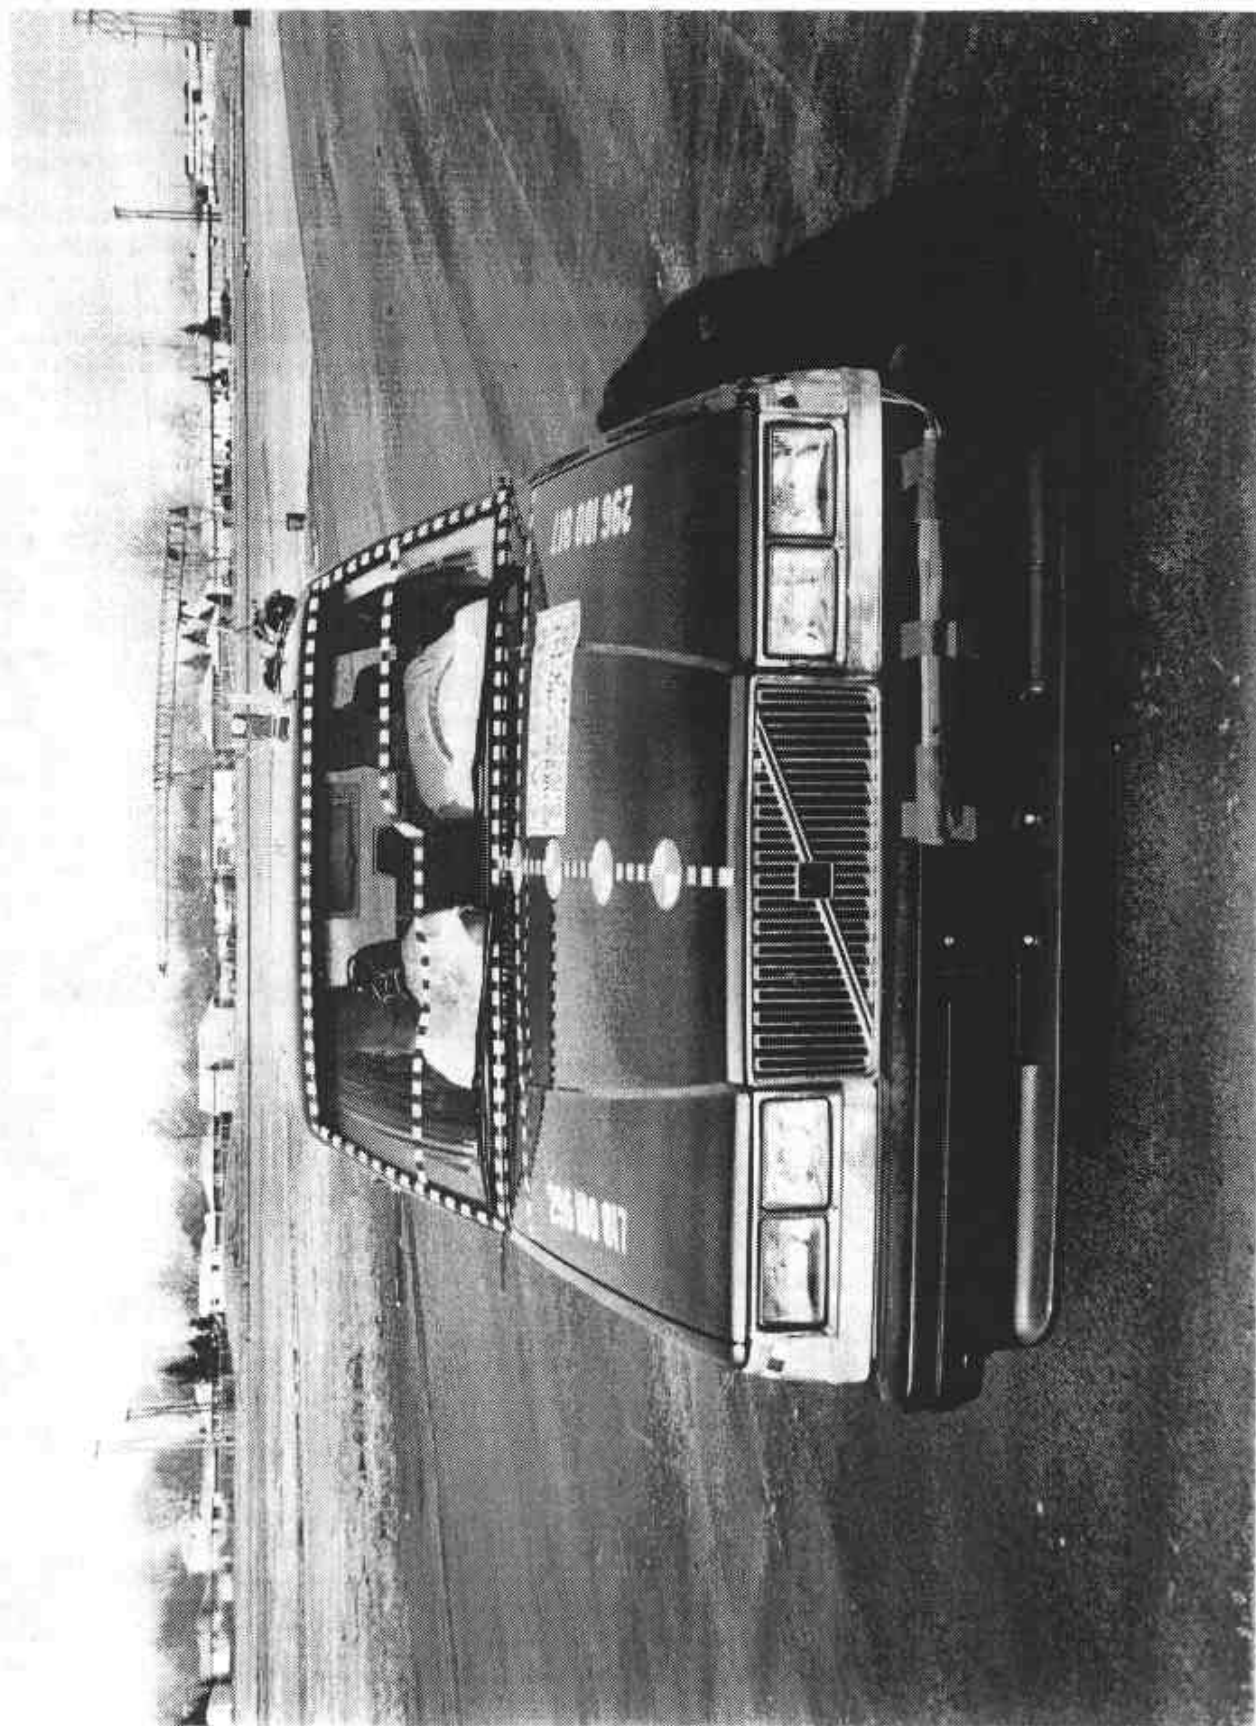
A-1 Pre-Test Front View

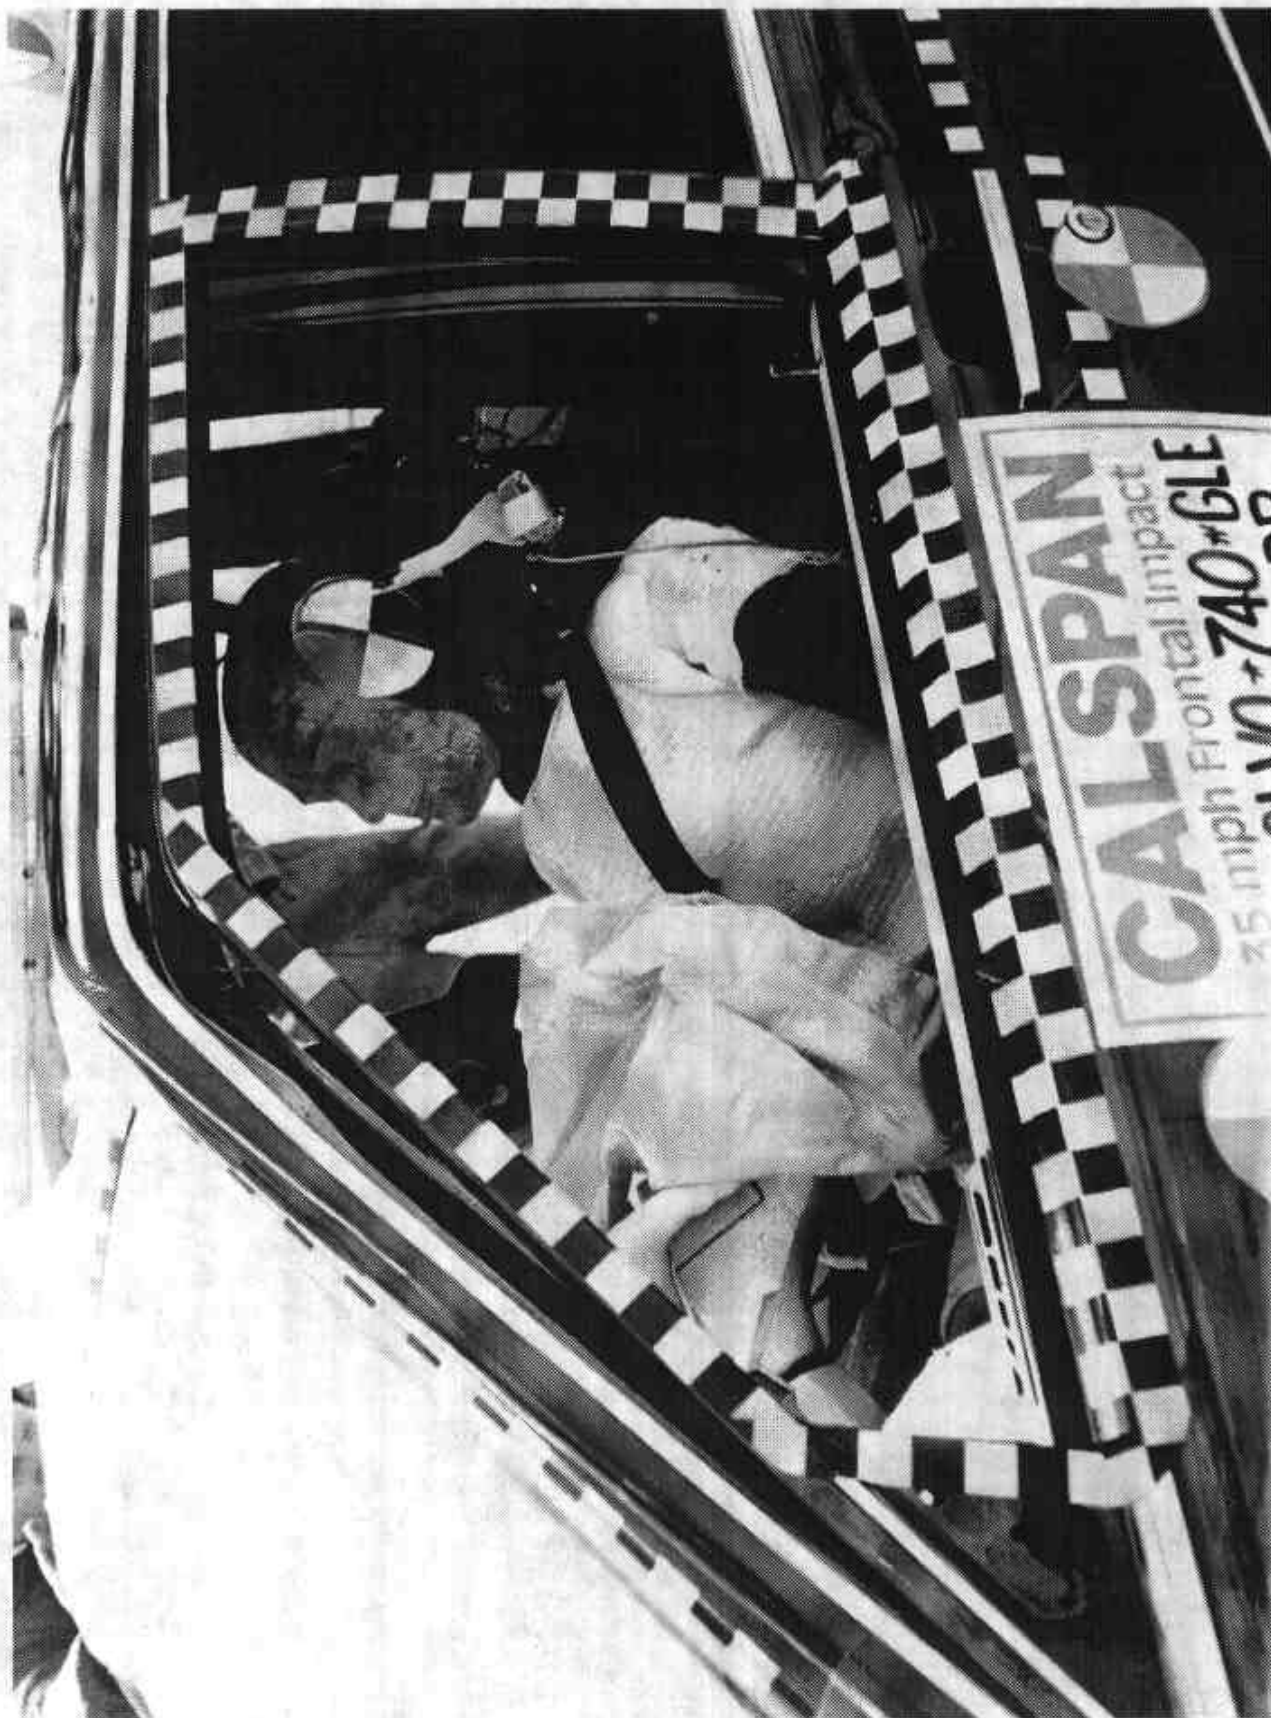
The driver's head struck the steering wheel air bag and his HIC was 519. The maximum chest deceleration over 3 milliseconds was 42 g's and femur loads were 1793 and 1143 pounds.

A-21 Post-Test Driver Position View
