VEHICLE SAFETY COMPLIANCE TESTING  
FOR OCCUPANT CRASH PROTECTION,  
WINDSHIELD MOUNTING, WINDSHIELD ZONE  
INTRUSION, AND FUEL SYSTEM INTEGRITY

1988 NISSAN MAXIMA

NHTSA NO. CJ5200

FINAL REPORT

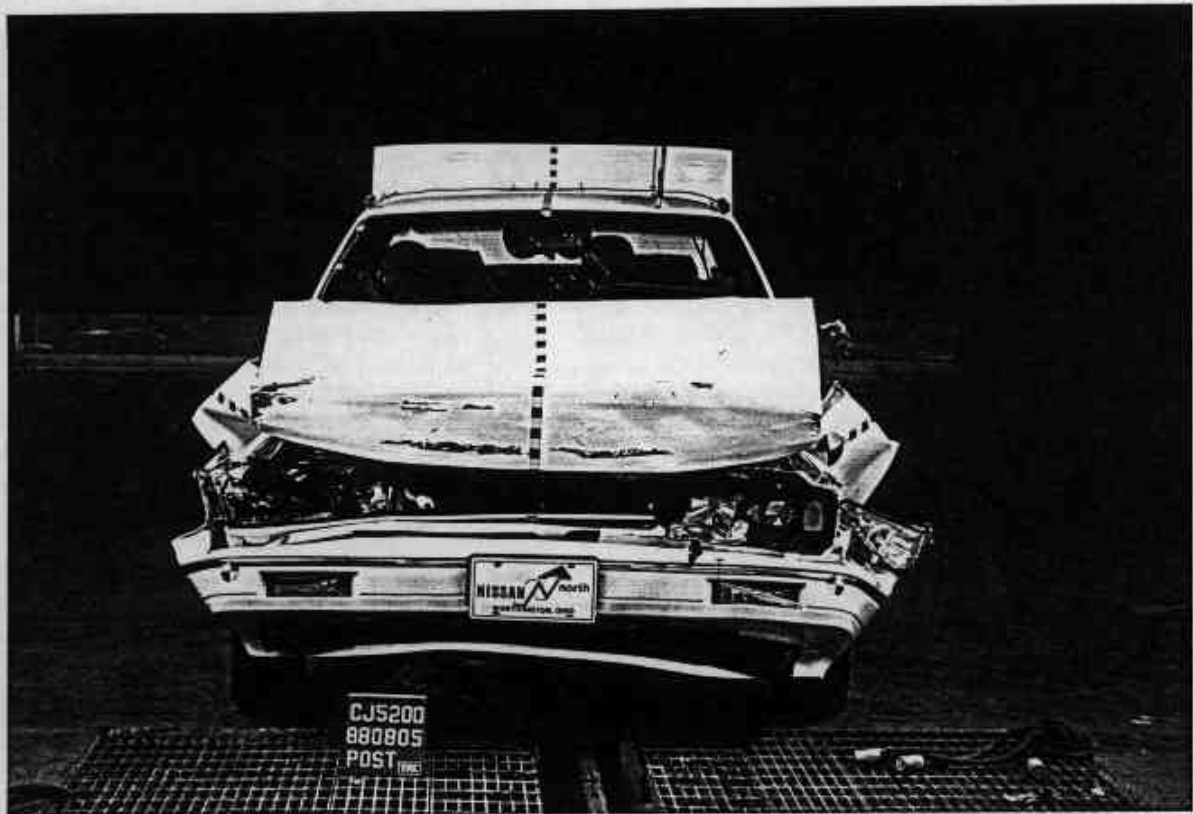
Figure A-2. POST-TEST FRONT VIEW

The vehicle was impacted into the rigid, flat frontal barrier at the Transportation Research Center of Ohio on August 5, 1988. The test vehicle's impact speed was 29.3 mph. The vehicle sustained 18.1 inches of static crush.

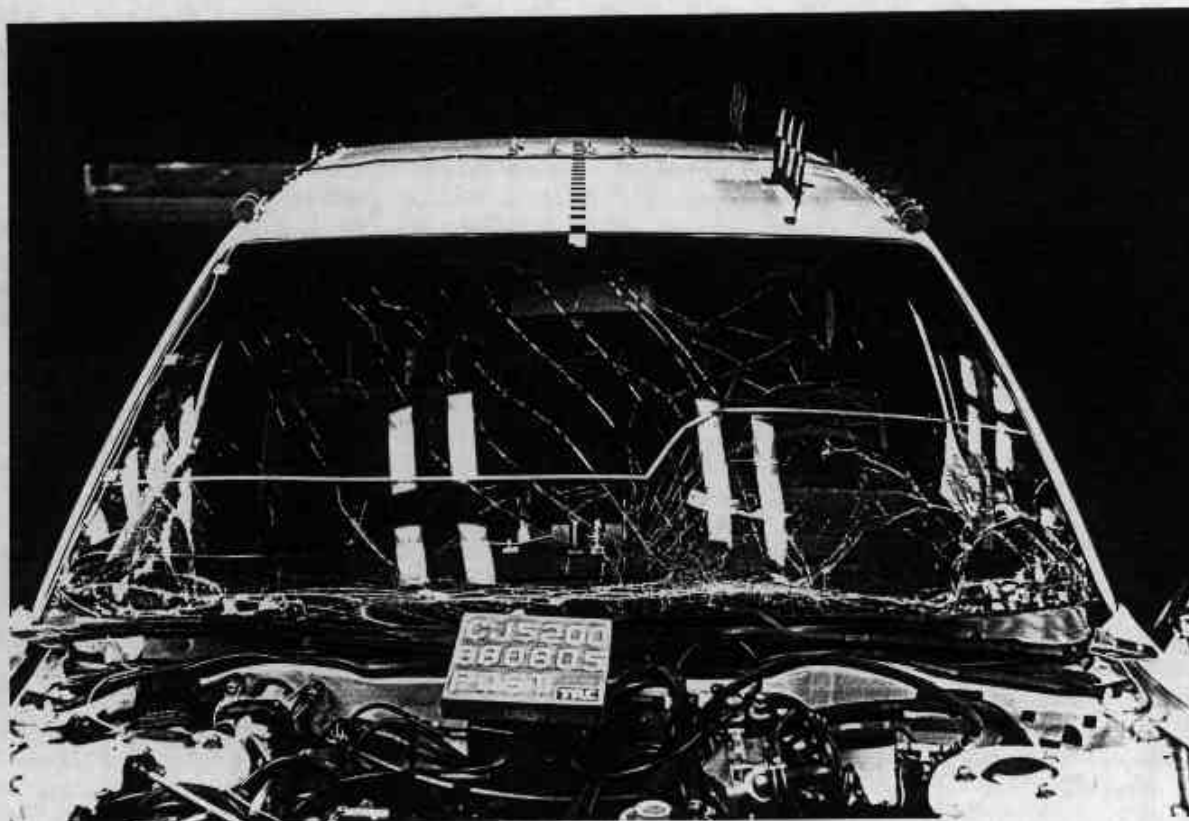
Figure A-14. POST-TEST WINDSHIELD VIEW  
A-9

The windshield was cracked upon impact.
