REPORT NOS. 208-TRC-88-007  
212-TRC-88-007  
301-TRC-88-007

VEHICLE SAFETY COMPLIANCE TESTING  
FOR OCCUPANT CRASH PROTECTION,  
WINDSHIELD MOUNTING, WINDSHIELD ZONE  
INTRUSION, AND FUEL SYSTEM INTEGRITY

GENERAL MOTORS CORPORATION  
1988 OLDSMOBILE CUTLASS SUPREME  
2-DOOR COUPE  
NHTSA NO. CJ0110  
TRC TEST NO. 881014

FINAL REPORT

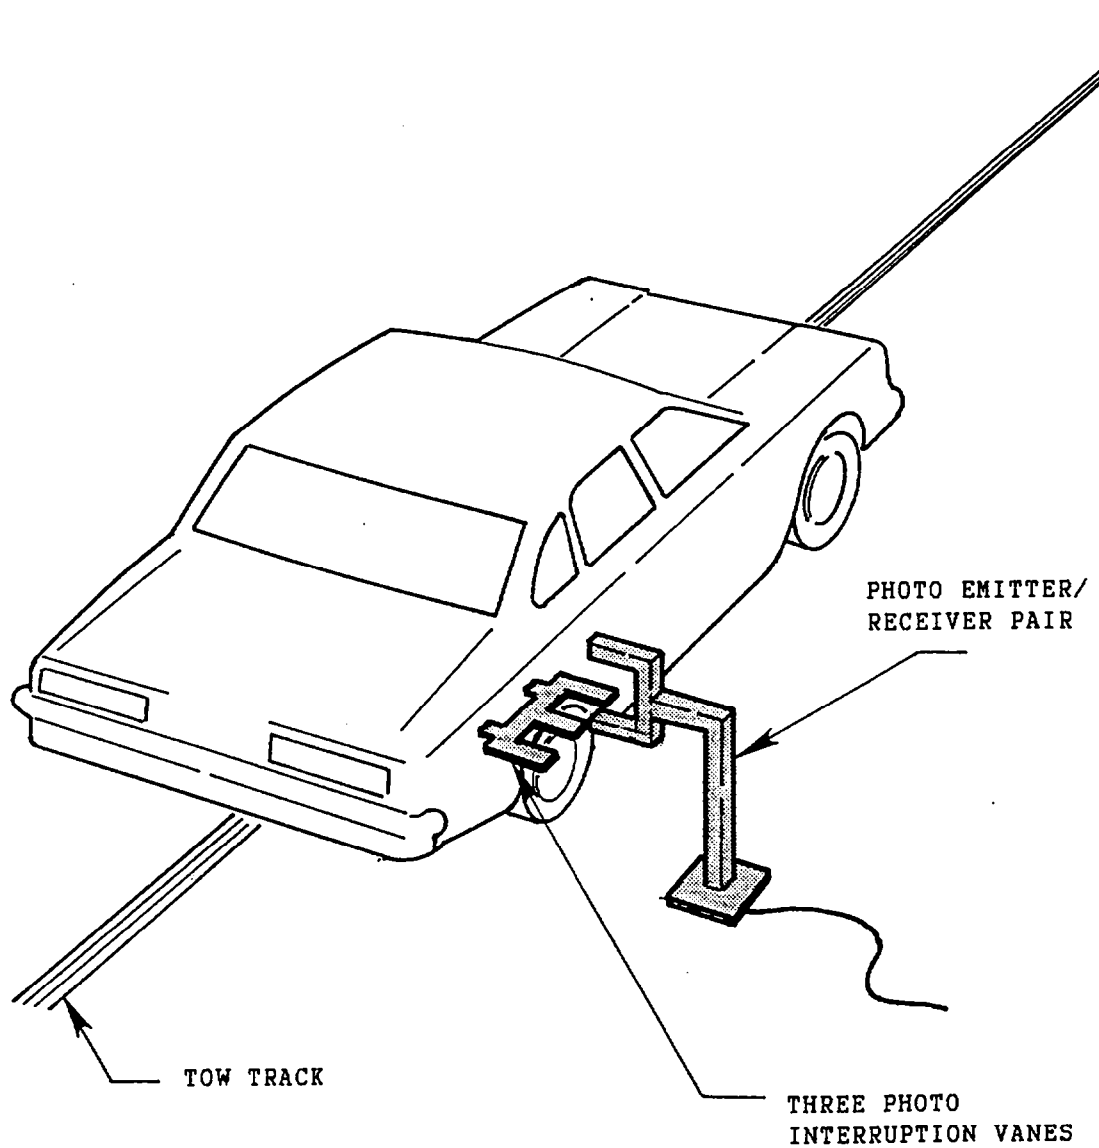
FIGURE 1 IMPACT VELOCITY MEASUREMENT SYSTEM

The final vane clears emitter/receiver two inches before impact.

The vanes have one foot spacing.

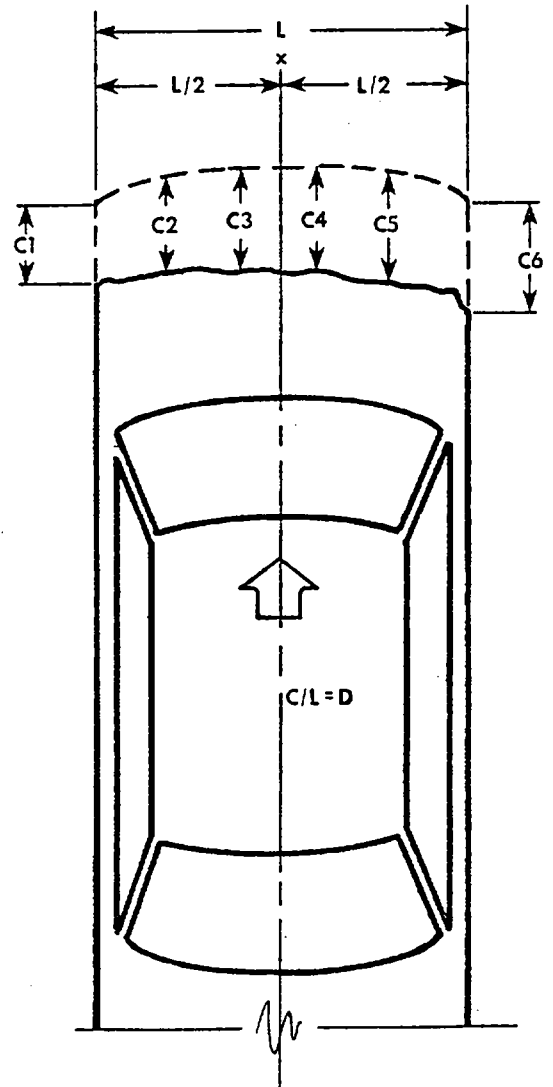
FIGURE 3 ACCIDENT INVESTIGATION DIVISION DATA  
FOR 30 MPH FRONTAL BARRIER IMPACT

COLLISION DEFORMATION  
CLASSIFICATION (CDC) CODE: 12FDEW2

F (Frontal)  
CRUSH DEPTH  
DIMENSIONS:

C1 =	<u>10.8</u>	inches
C2 =	<u>12.7</u>	inches
C3 =	<u>13.2</u>	inches
C4 =	<u>13.7</u>	inches
C5 =	<u>14.1</u>	inches
C6 =	<u>13.1</u>	inches

MIDPOINT OF DAMAGE: D = Vehicle Centerline (Longitudinal)

LENGTH OF DAMAGED REGION: L = 56.9 inches

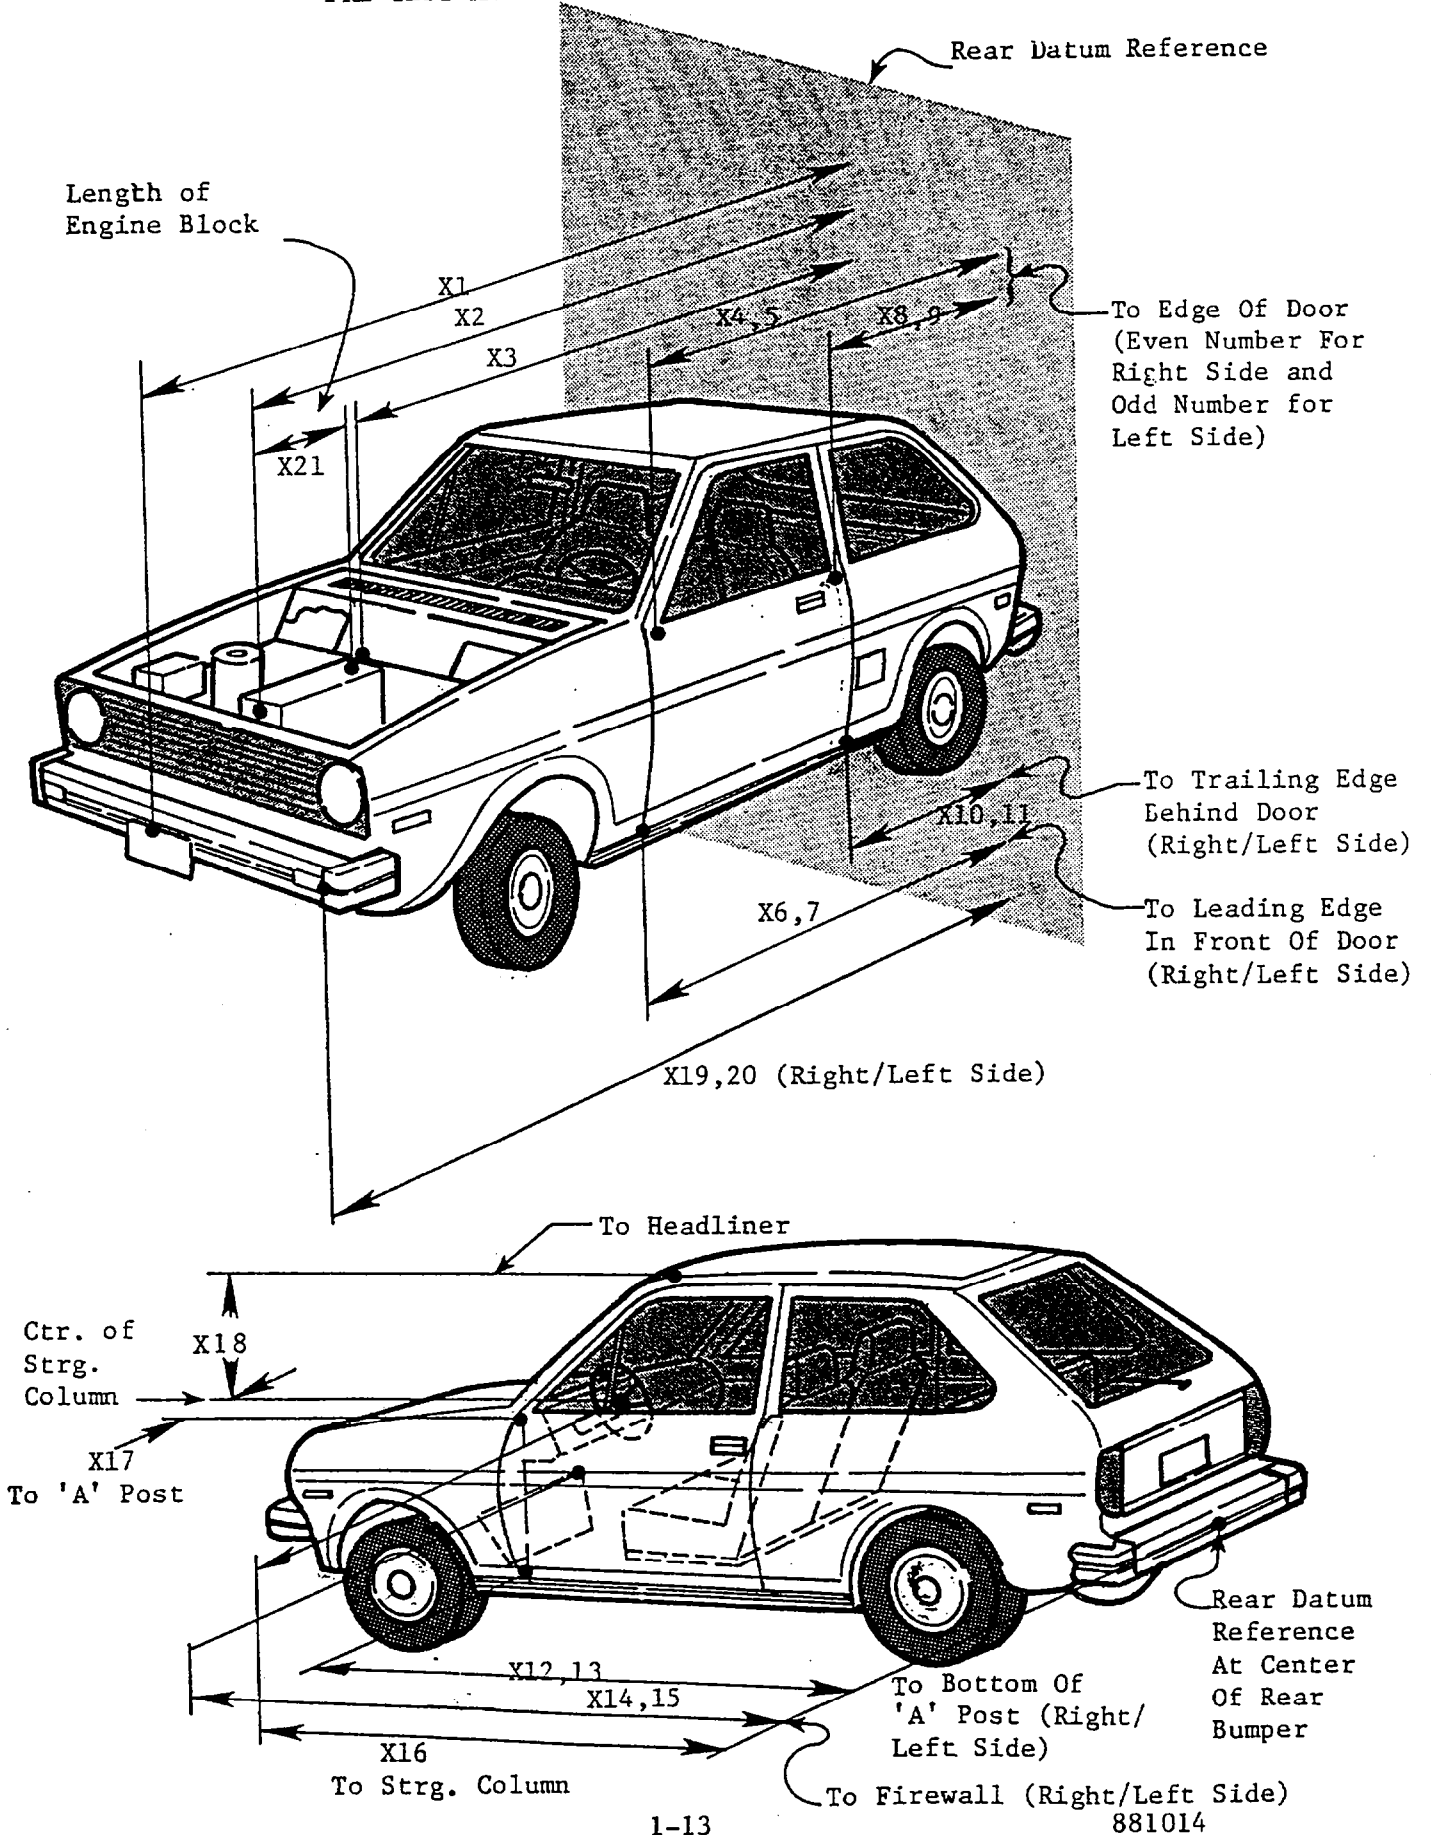
FIGURE 4

PRE-TEST AND POST-TEST MEASUREMENT POINTS

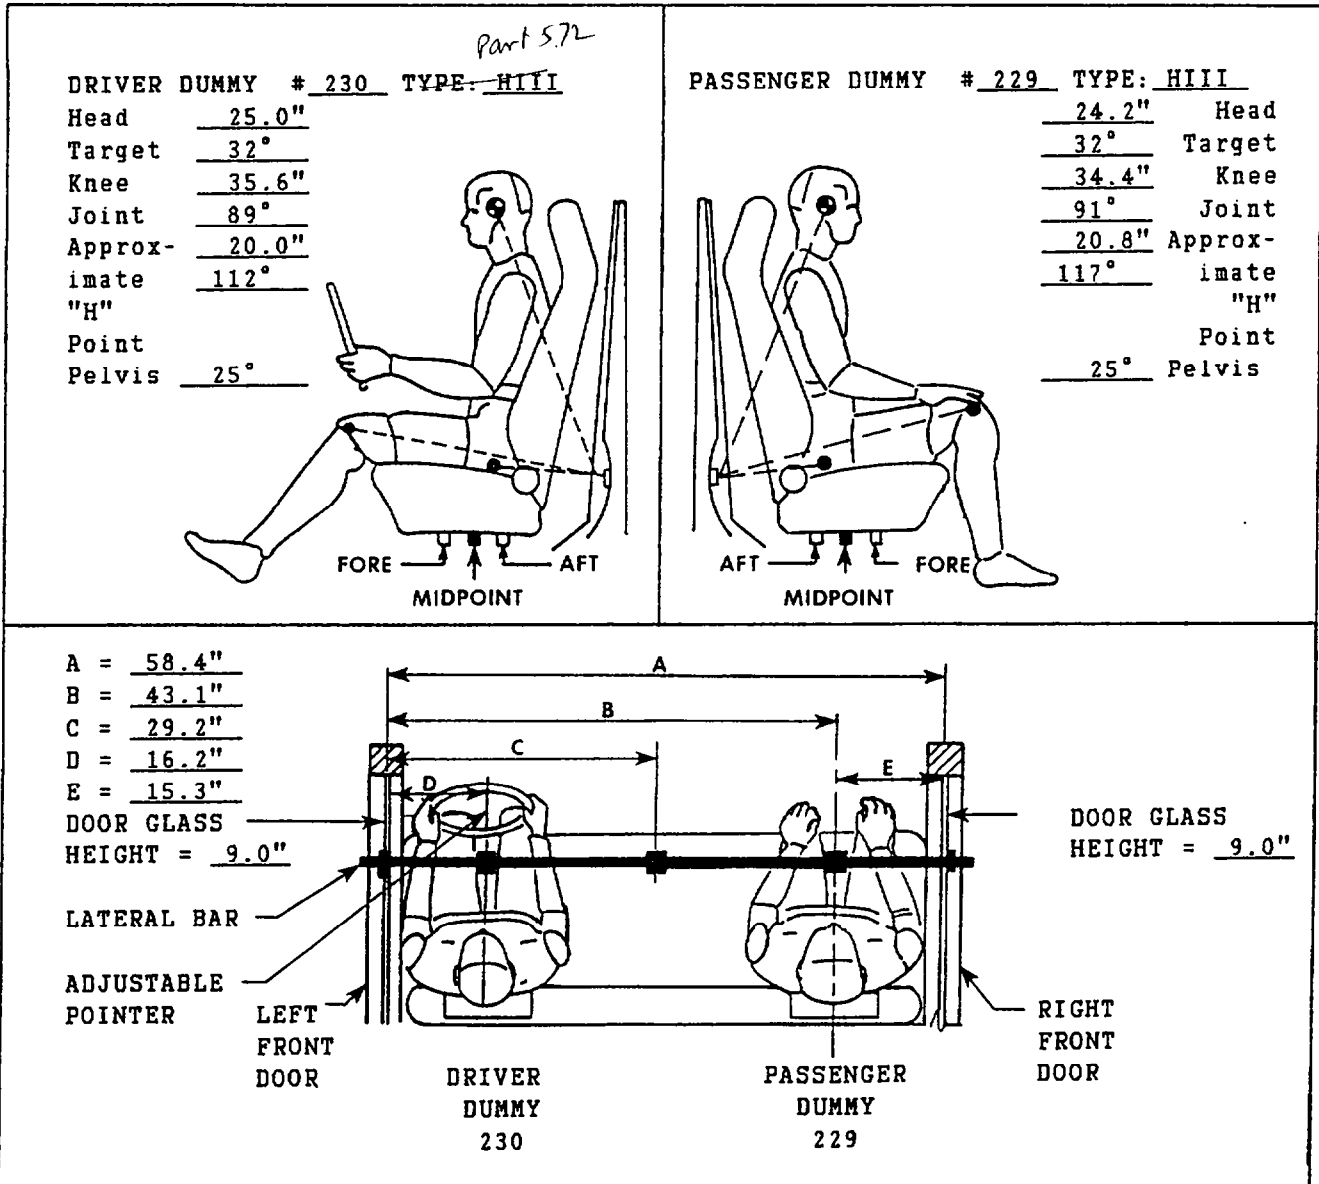
**FIGURE 7 DUMMY IN-VEHICLE POSITION RECORDING SHEET**

DRIVER	PASSENGER
HH	12.1	13.1
HW	21.8	21.8
CD	22.6	20.5
CS	12.8	NA
KDL	3.9	6.0
KDR	4.8	6.9
TA	16°	17°
SA	26°	26°
HA	19.2	20.4

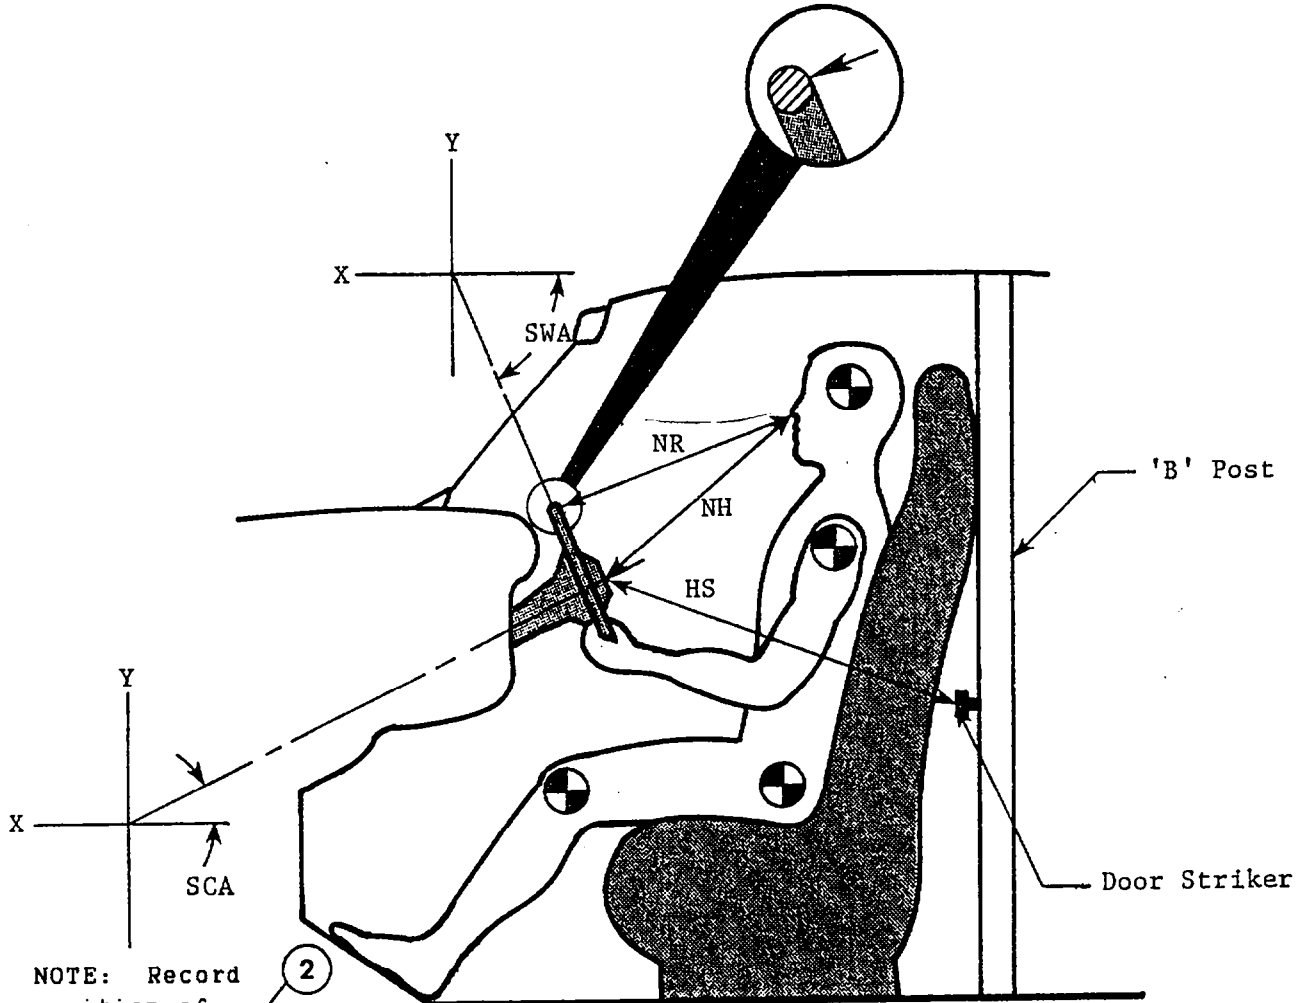
**FIGURE 8 DRIVER DUMMY TO STEERING COLUMN/WHEEL ASSY. REFERENCE DIMENSIONS**

REMARKS: Steering column was a non-tilt column

NR	- Distance from tip of dummy's nose to top rear surface of steering wheel rim. (in.)	14.8	16.09
NH	- Distance from tip of dummy's nose to center of steering column hub. (in.)	16.1	17.9?
HS	- Distance from center of steering column hub to the forward surface of the door lock striker pin. (in.)	32.7	
SCA	- Angle of steering column relative to the horizontal X axis	19°	
SWA	- Angle of steering wheel relative to the horizontal X axis	71°

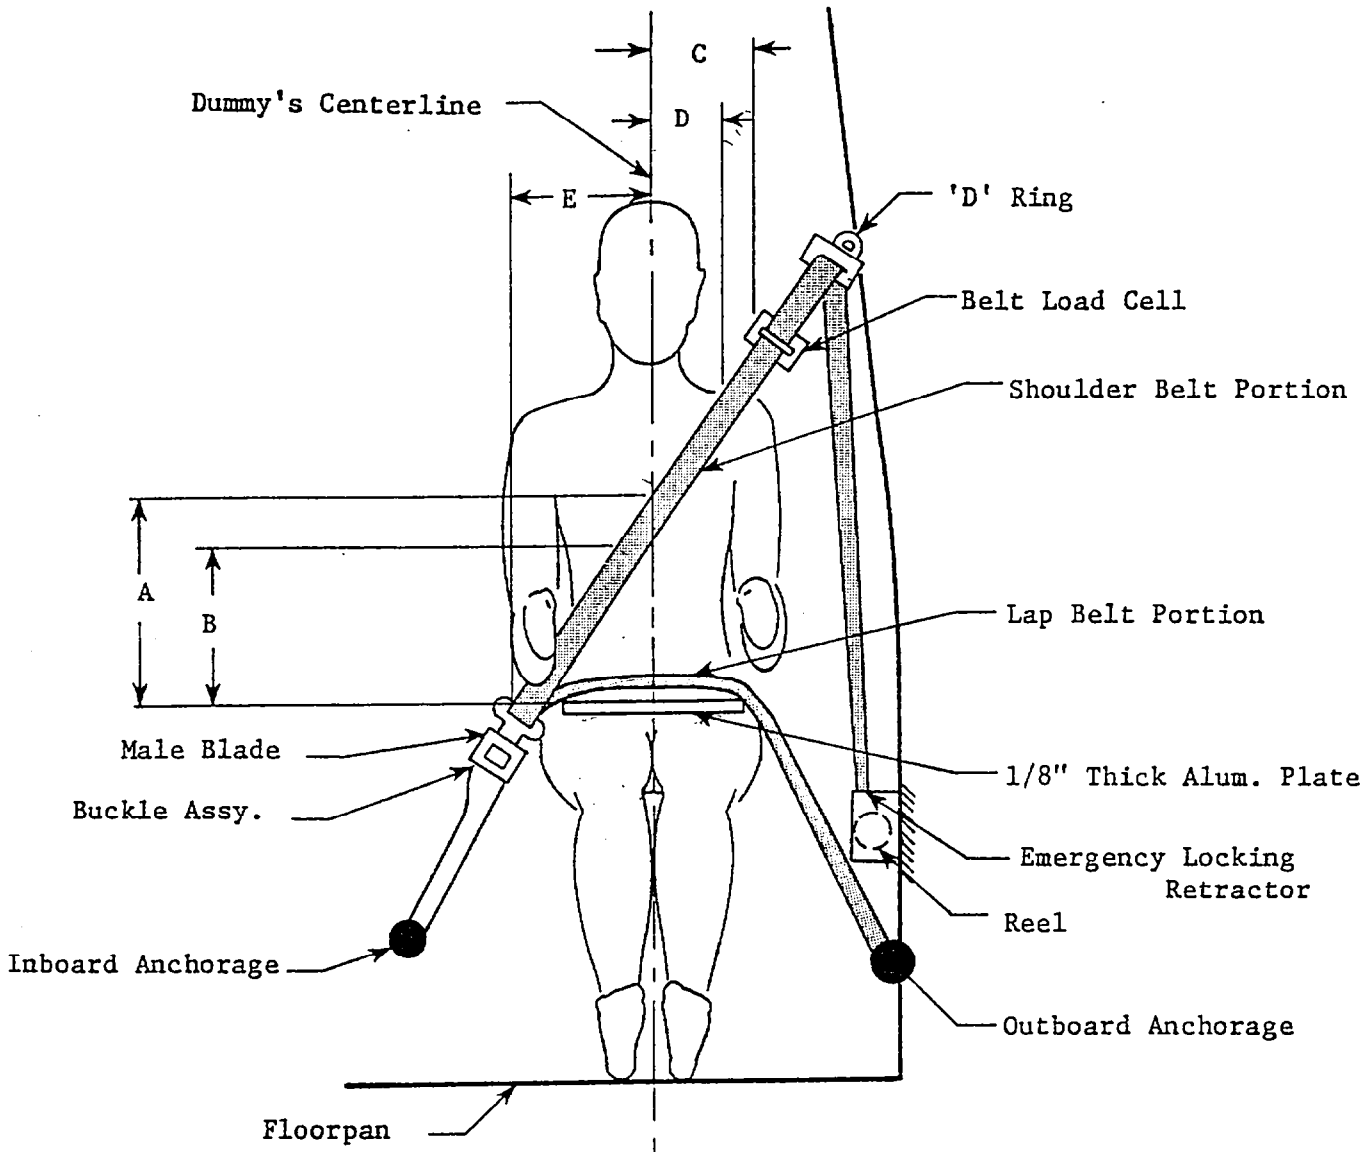
FIGURE 9 SEAT BELT POSITIONING DATA

DRIVER DUMMY	PASSENGER DUMMY
A - Top surface of alum. plate to belt upper edge (in)	10.9	12.0
B - Top surface of alum. plate to belt lower edge (in)	7.9	8.5
C - Dummy centerline to outer edge of belt at chest flesh top (in)	6.0	5.0
D - Dummy centerline to inner edge of belt at chest flesh top (in)	3.8	2.8
E - Dummy centerline to intersection of upper torso belt and lap belt (in)	4.6	6.6

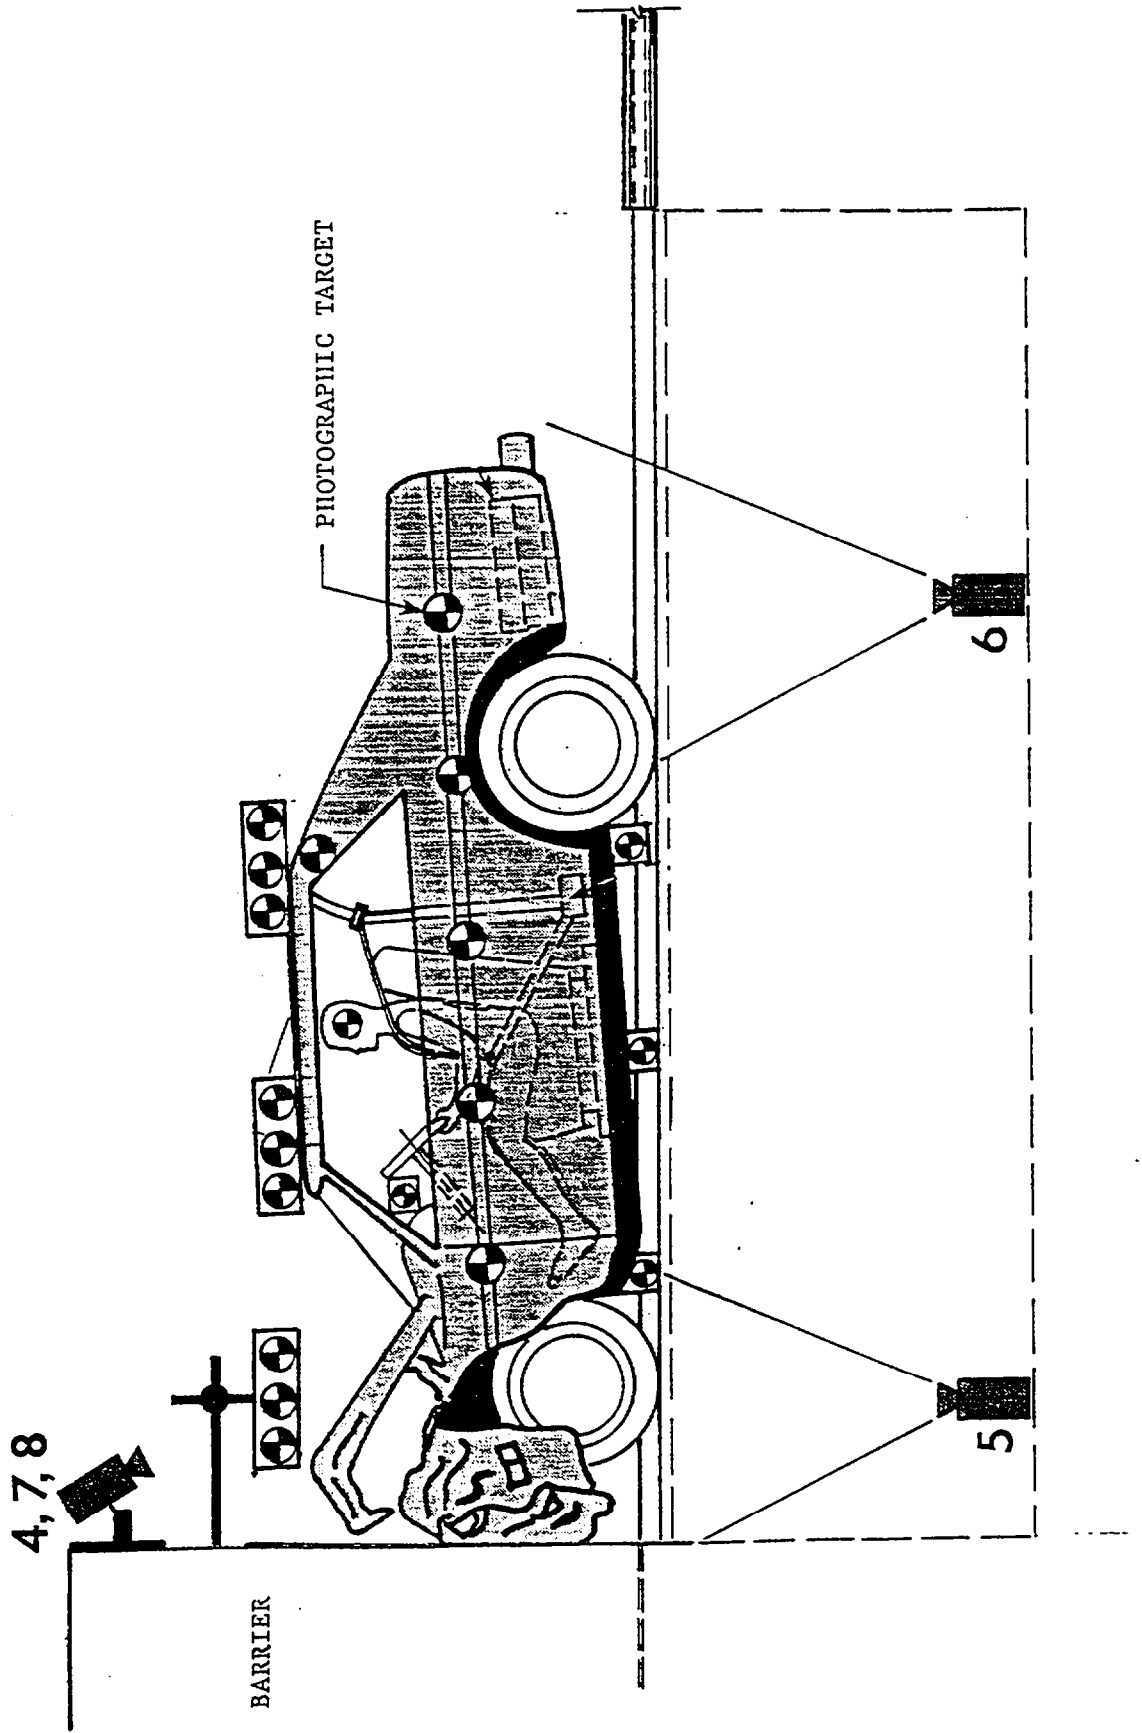
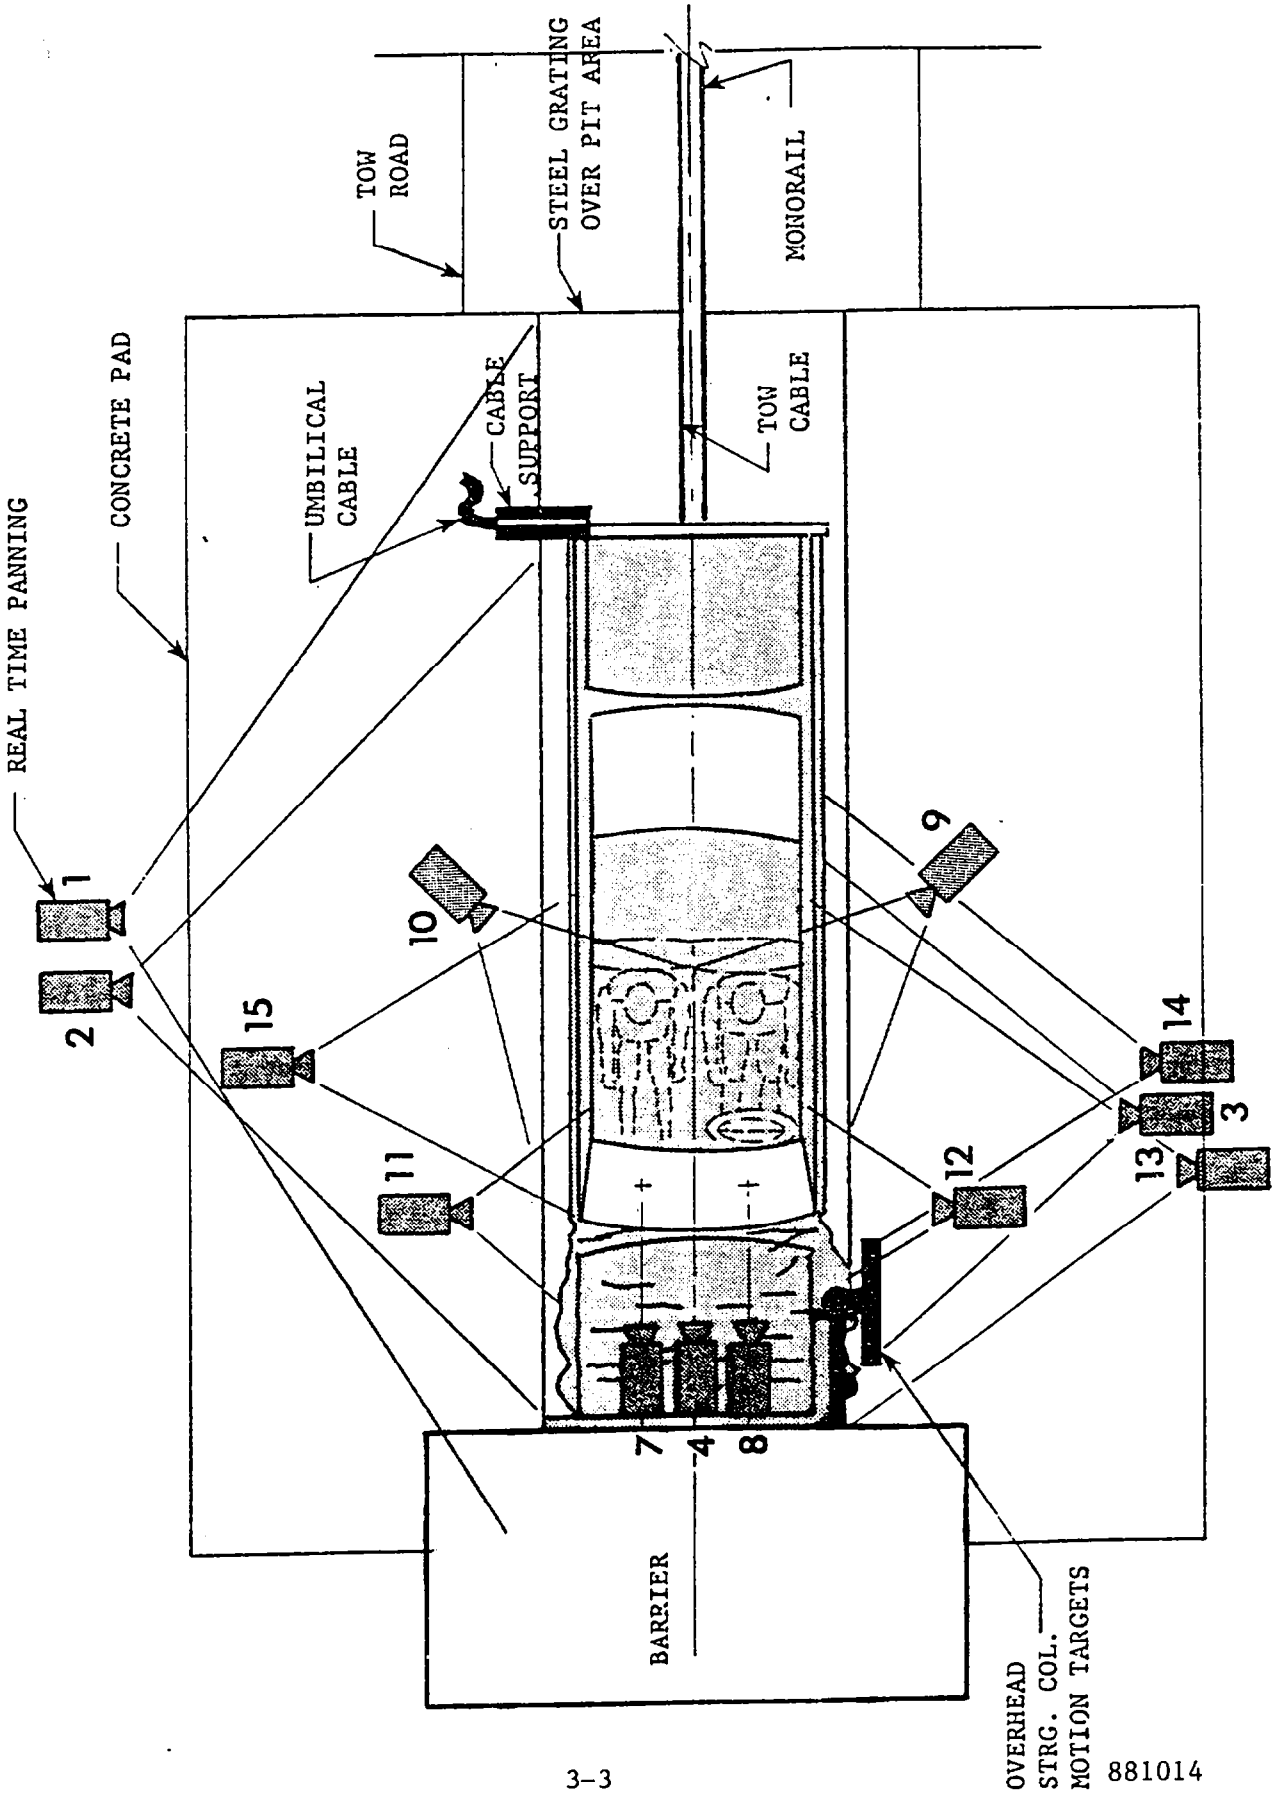
FIGURE 13

CAMERA POSITIONS

TEST NO.:	881014	VEHICLE:	1988 Oldsmobile Cutlass Supreme			FILM PLANE			
			CAMERA NO.	VIEW	CAMERA POSITIONS (IN)*	ANGLE** (DEG)	TO HEAD TARGET	LENS (MM)	SPEED (FPS)
			X	Y	Z				
1	Real time panning		-142.0	504.0	61.0	NA	NA	16	24
2	Vehicle crush		-81.3	266.4	37.1	-2	NA	13	500
3	Dummy kinematics		-41.5	-295.0	44.0	-4	275.0	25	517
4	Windshield damage		-6.0	0.0	89.0	-40	NA	13	497
5	Crush & fluid spillage		-50.5	0.0	-92.4	90	NA	13	1000
6	Fluid spillage		-99.3	0.0	-99.0	90	NA	13	1002
7	Passenger kinematics		-4.5	13.8	93.0	-50	NA	17	500
8	Driver kinematics		-6.8	-14.5	93.0	-50	NA	17	500
9	Driver kinematics		-157.3	-116.0	87.0	-27	105.0	25	500
10	Passenger kinematics		-152.1	116.0	87.0	-26	102.0	25	497
11	Windshield intrusion		-38.1	306.1	44.0	0	NA	50	497
12	Windshield intrusion		-53.0	-309.4	42.3	0	NA	50	500
13	Column movement		-106.0	-286.0	103.0	-14	NA	25	502
14	Column movement		-106.0	-286.0	75.1	-9	NA	25	500

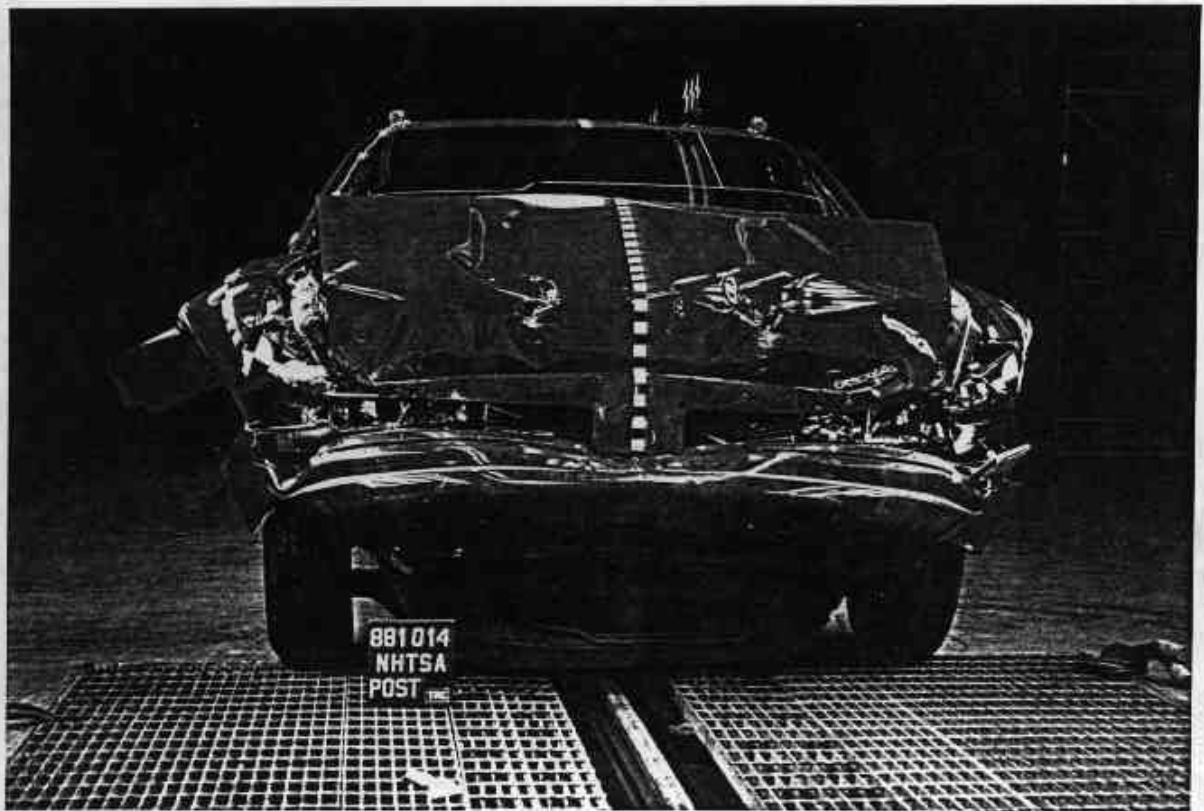
Figure A-2. POST-TEST FRONT VIEW  
A-3

The vehicle was impacted into the rigid, flat frontal barrier at the Transportation Research Center of Ohio on October 14, 1988. The test vehicle's impact speed was 29.3 mph. The vehicle sustained 14.1 inches of static crush.

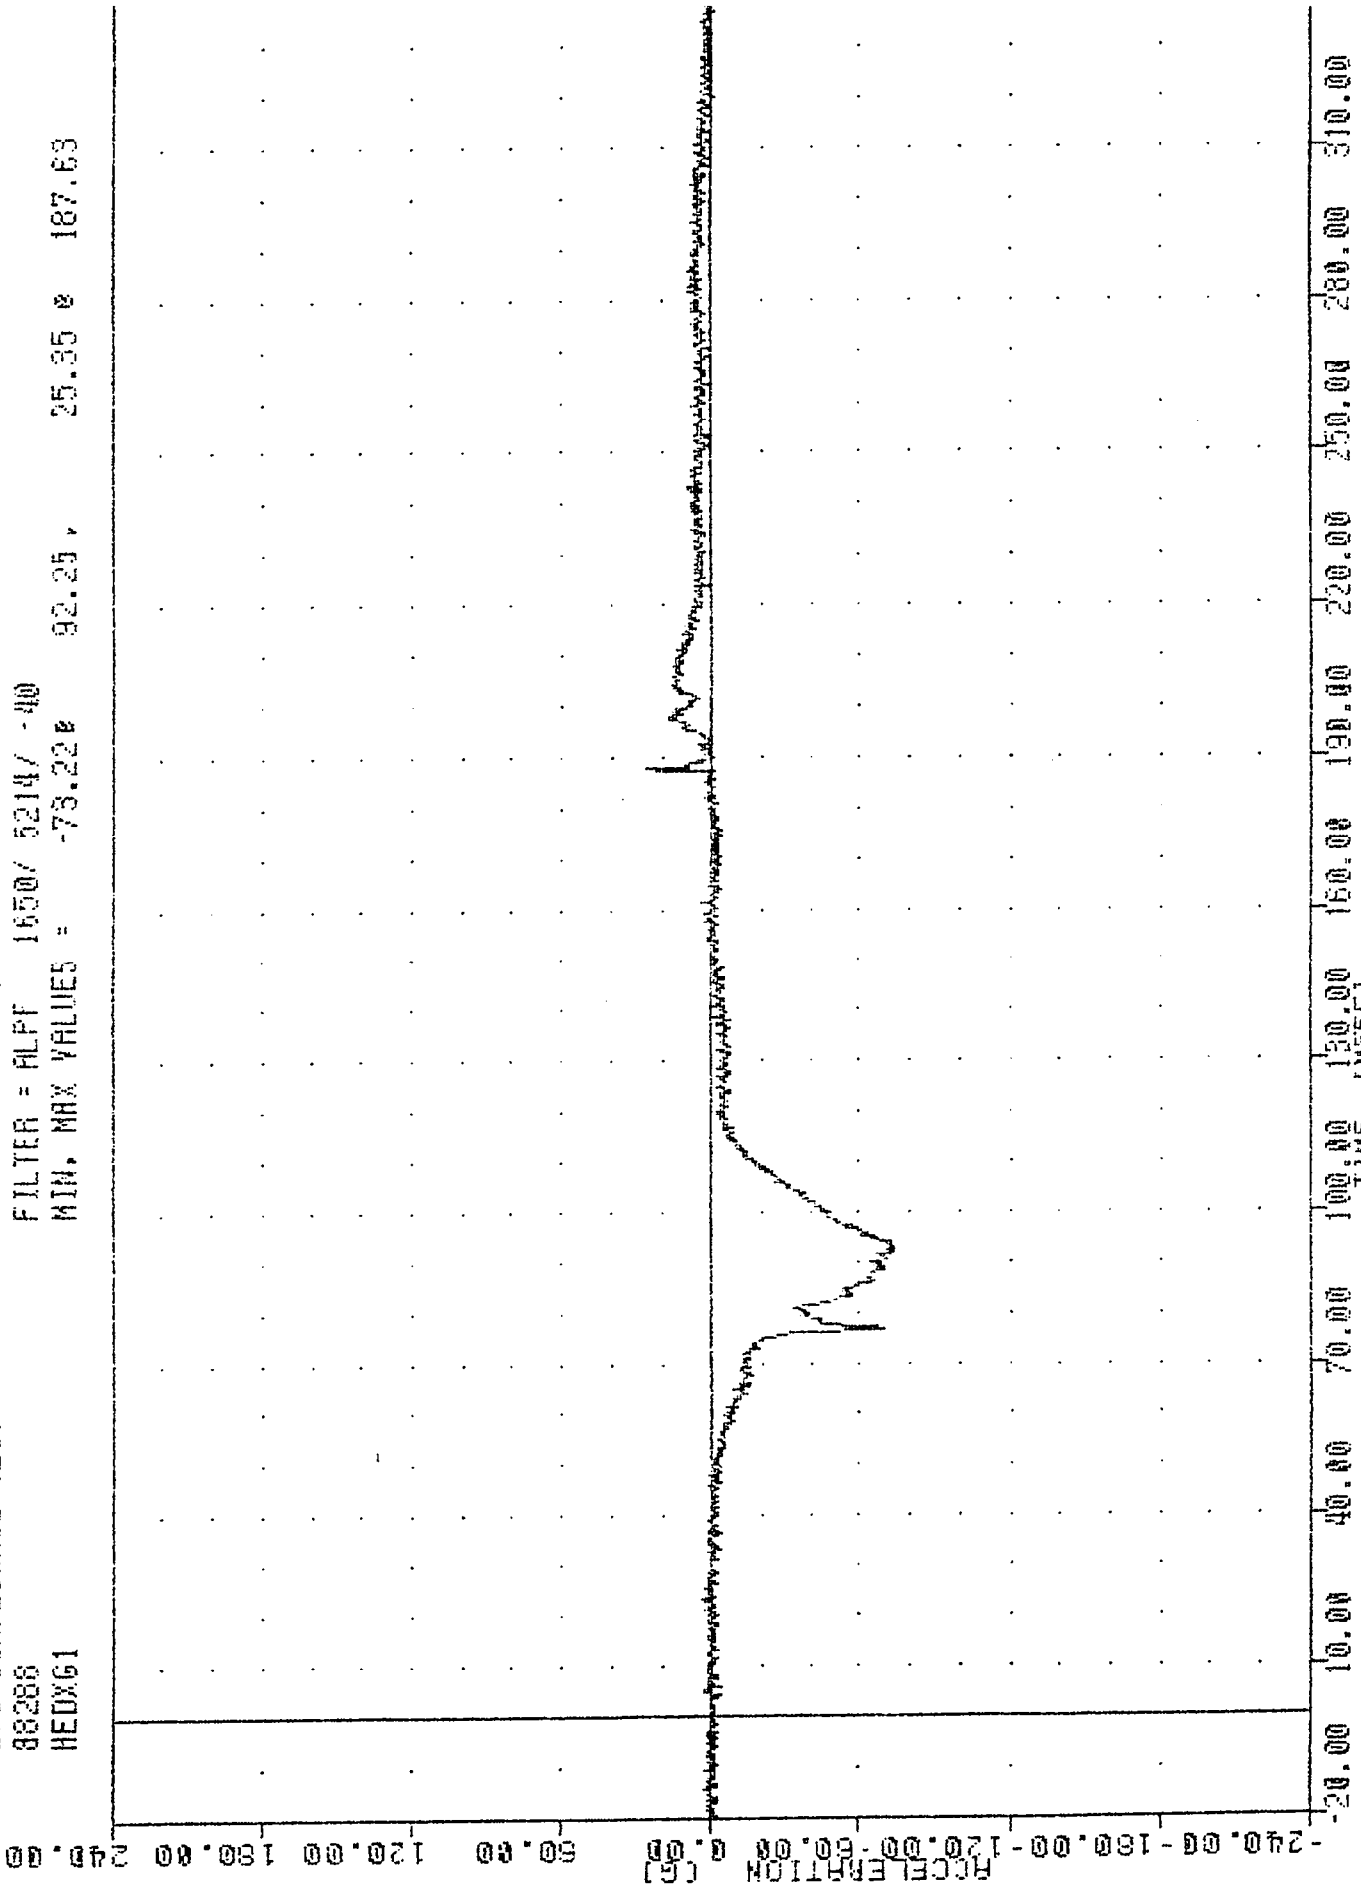
MIN, MAX VALUES = -73.22 92.25

OLDSMOBILE CUTLASS SUPREME INTO FRONTAL BARRIER  
DRIVER HEAD X AXIS ACCELERATION

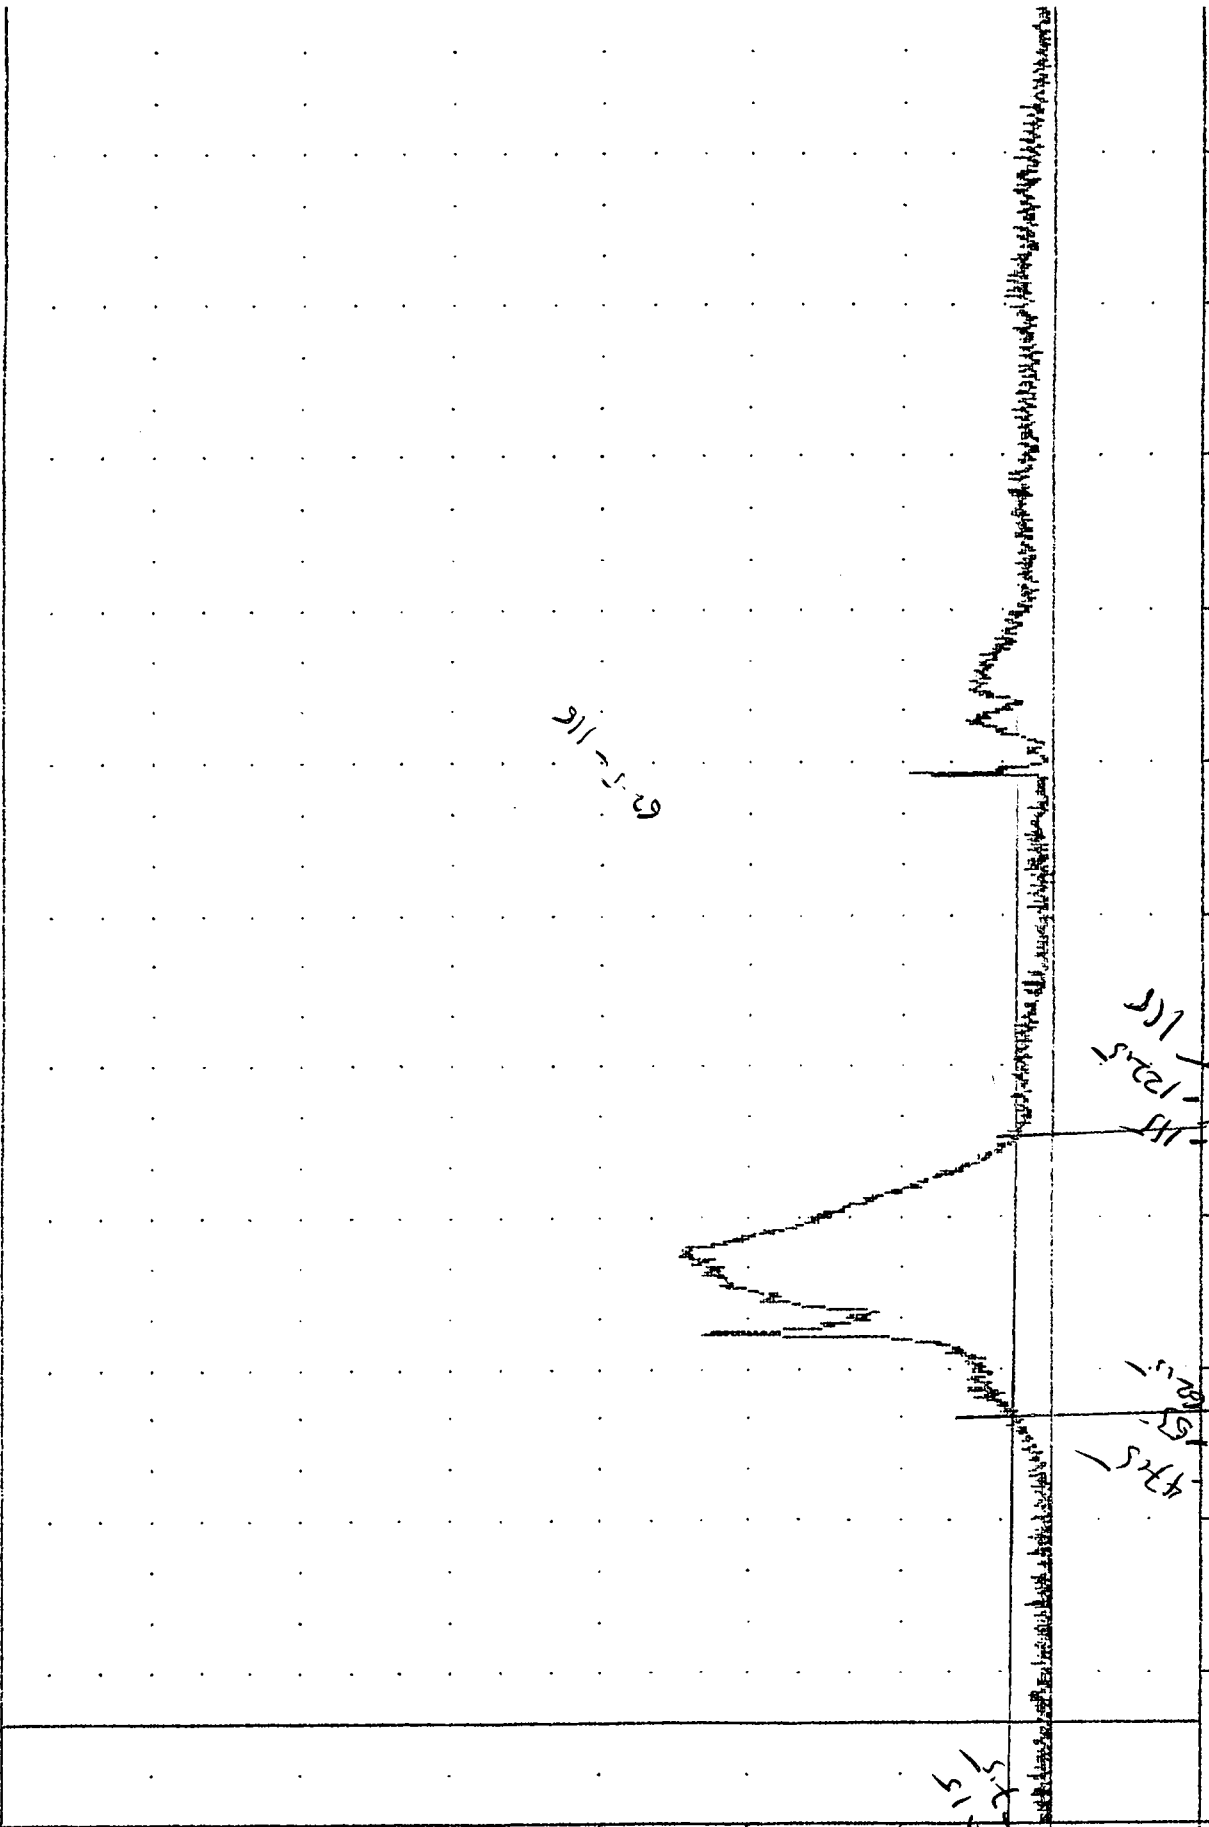
OLDSMOBILE CUTLASS SUPREME INTO FRONTAL BARRIER  
DRIVER HEAD RESULTANT ACCELERATION

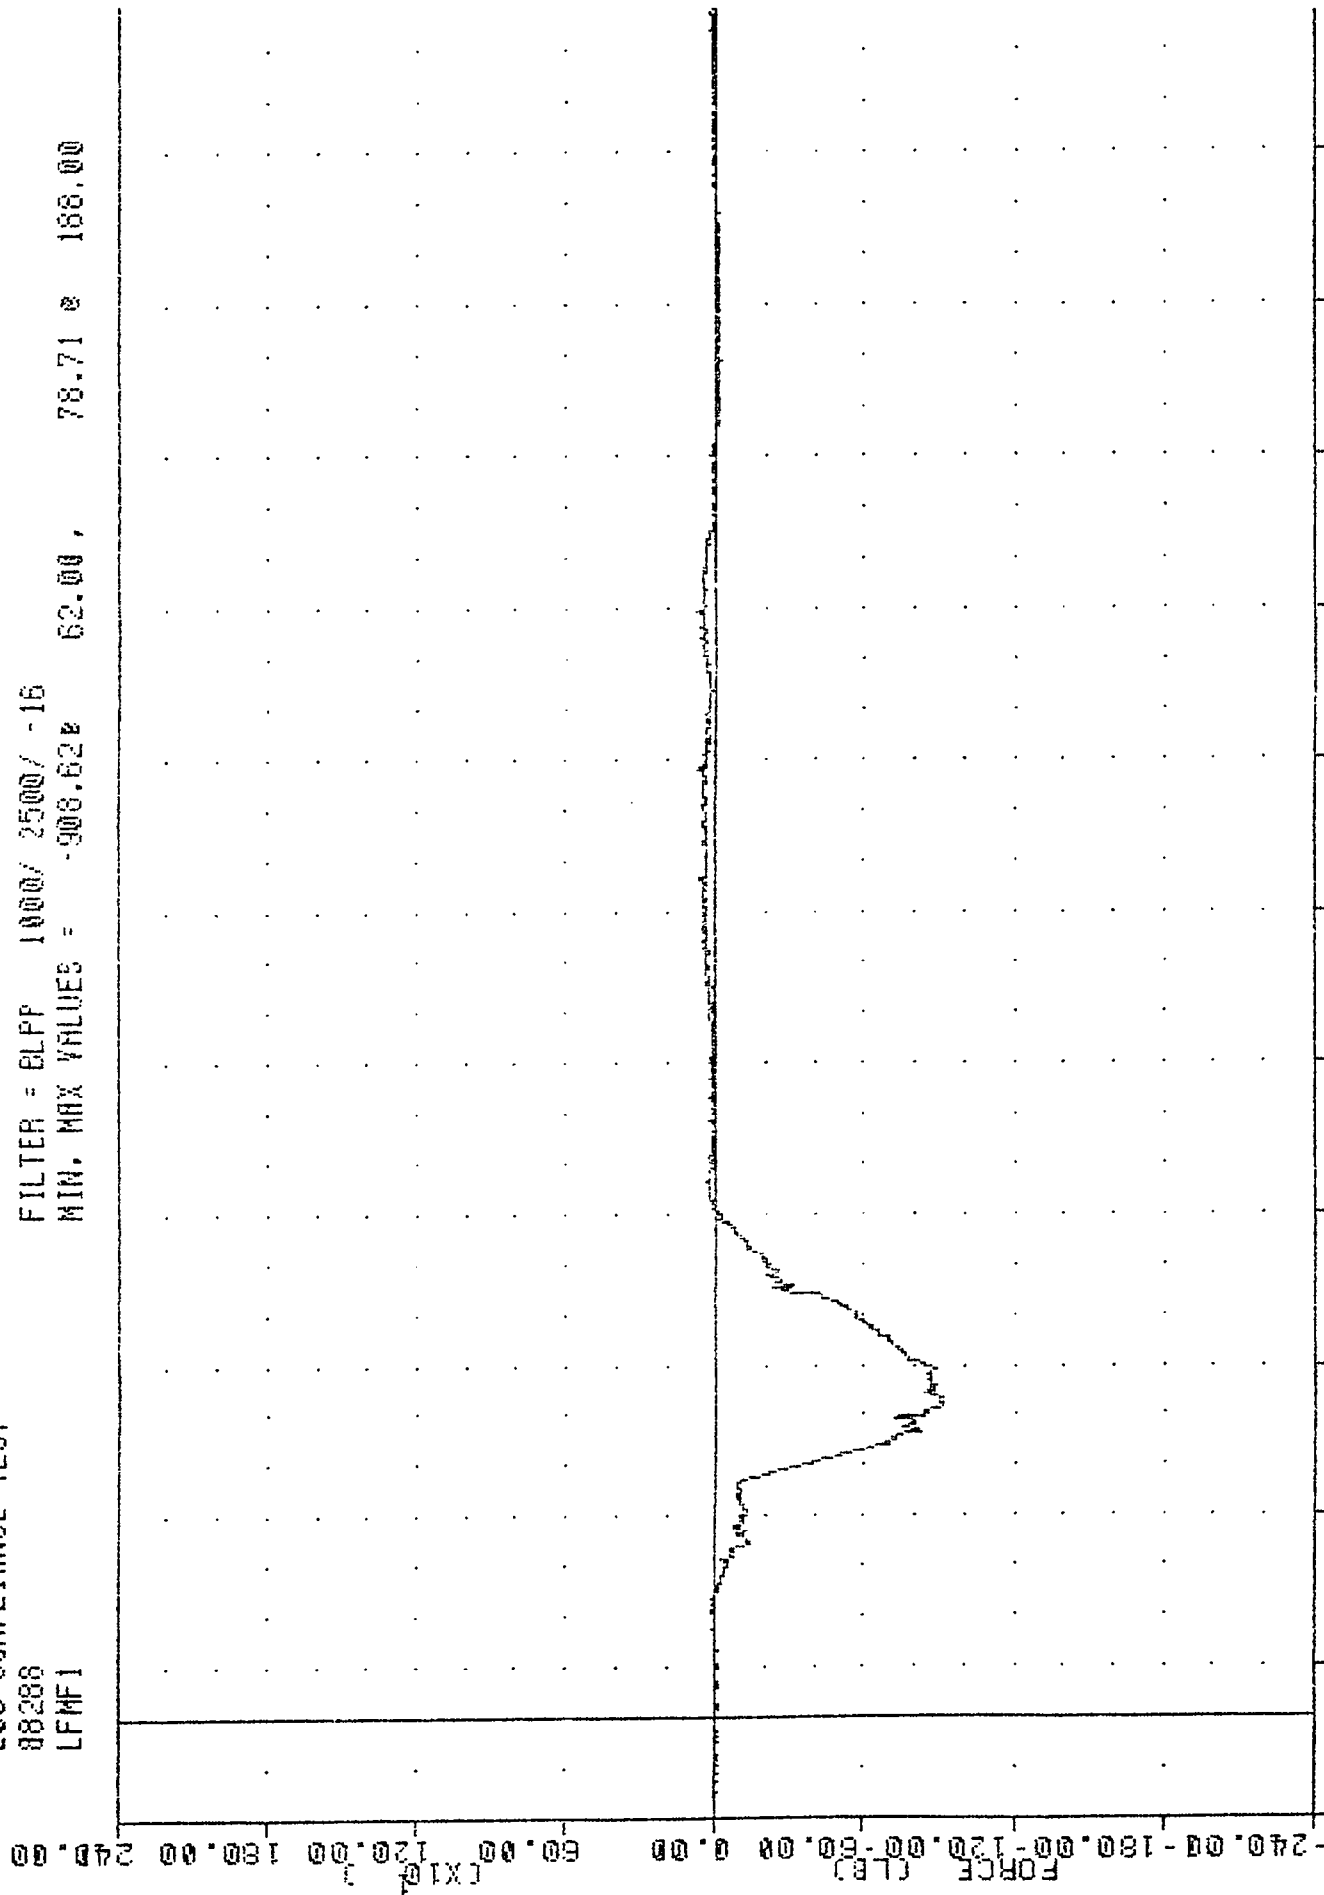
OLDSMOBILE CUTLASS SUPREME INTO FRONTAL BARRIER  
DRIVER LEFT FEMUR FORCE

MIN. MAX VALUES = -722.73# 61.25 , 25.56 e 145.63
