REPORT NOS. 208-TRC-88-007  
212-TRC-88-007  
301-TRC-88-007

VEHICLE SAFETY COMPLIANCE TESTING  
FOR OCCUPANT CRASH PROTECTION,  
WINDSHIELD MOUNTING, WINDSHIELD ZONE  
INTRUSION, AND FUEL SYSTEM INTEGRITY

GENERAL MOTORS CORPORATION  
1988 OLDSMOBILE CUTLASS SUPREME  
2-DOOR COUPE  
NHTSA NO. CJ0110  
TRC TEST NO. 881014

FINAL REPORT

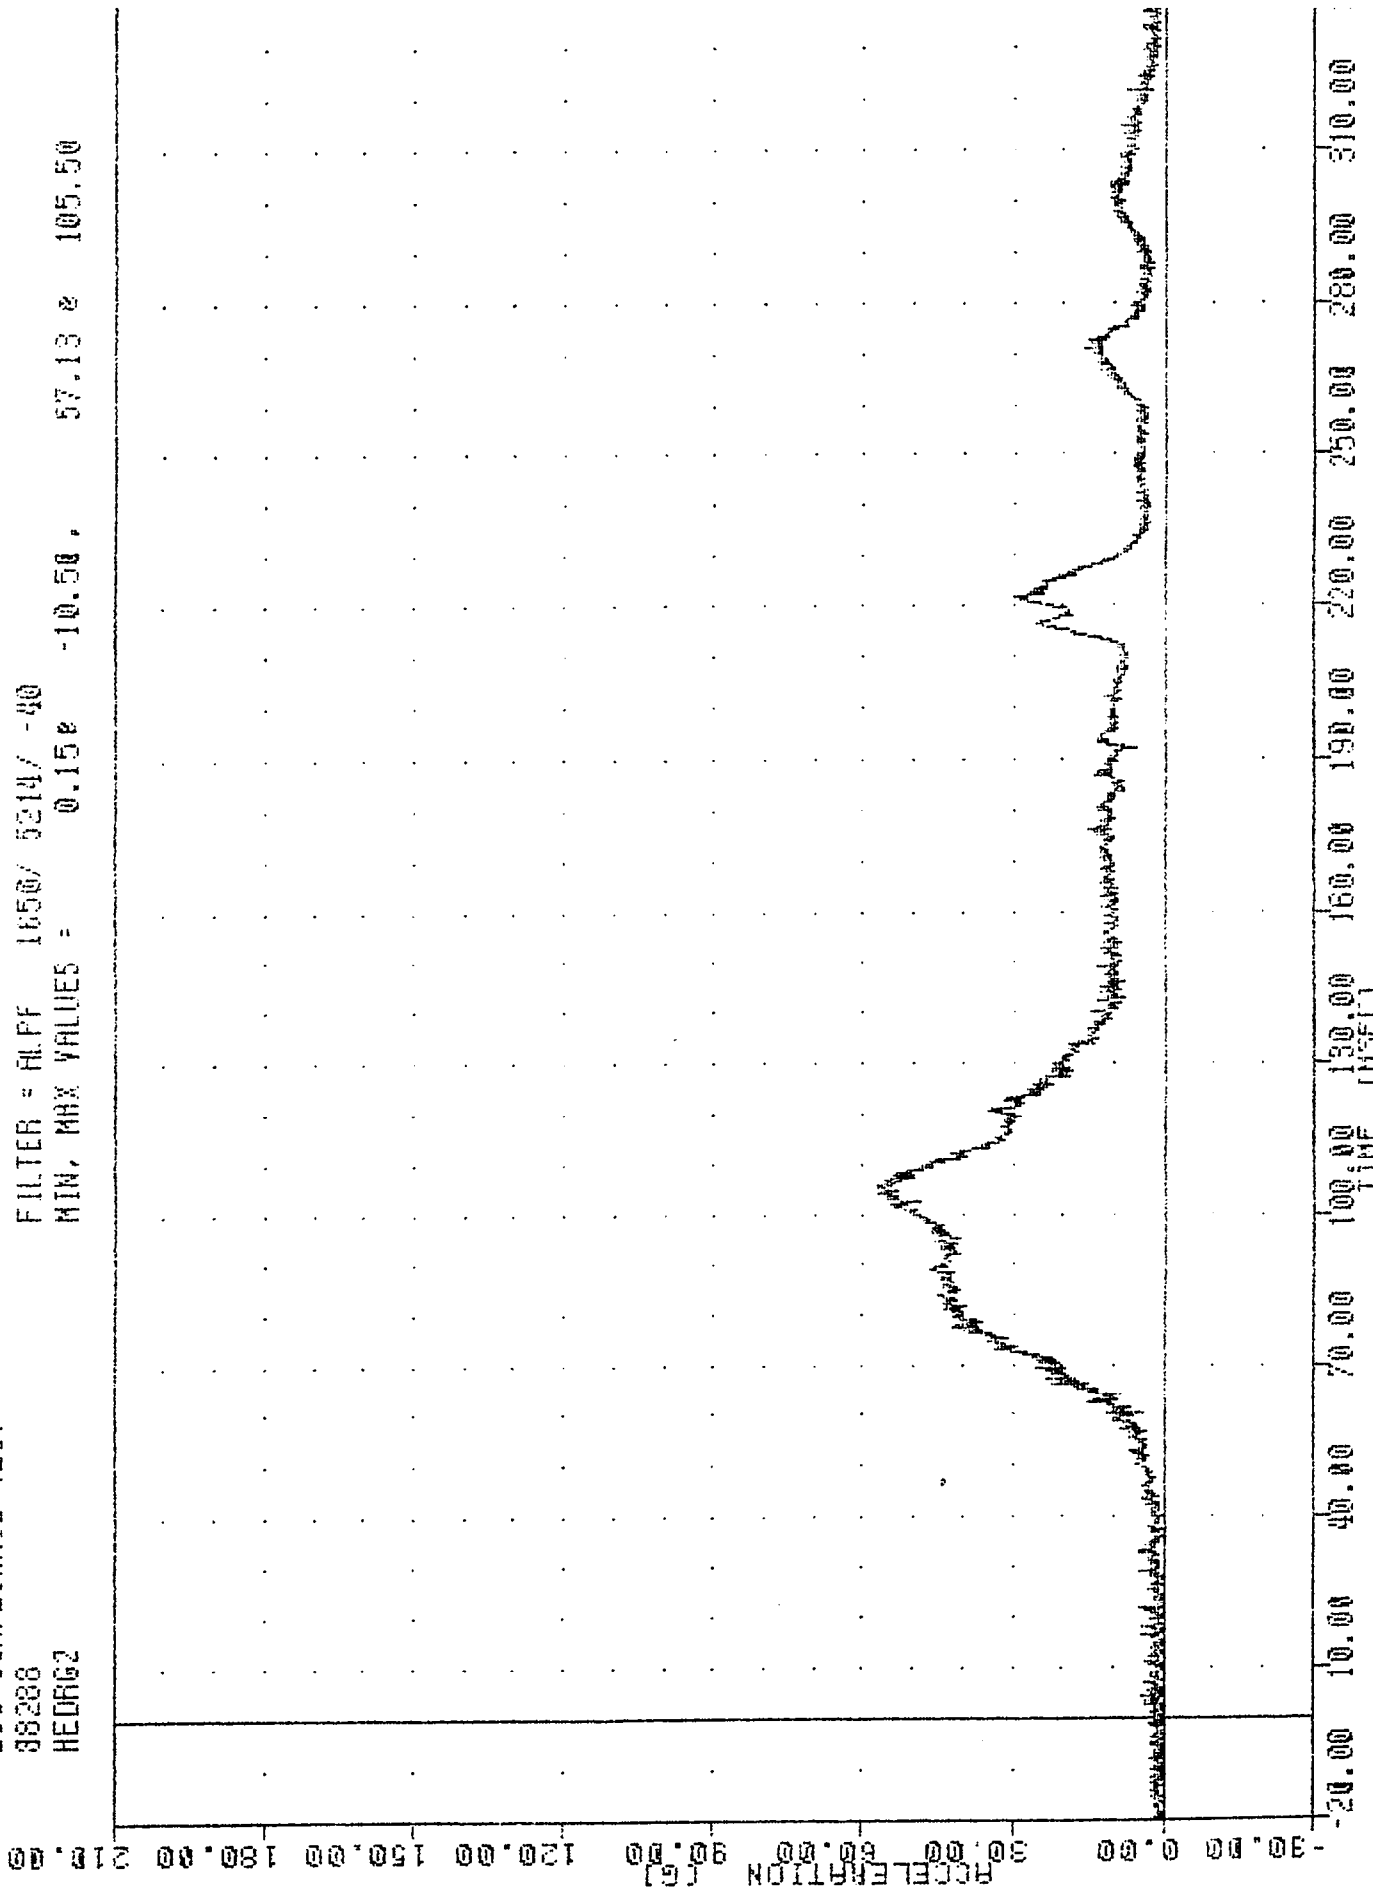
OLDSMOBILE CUTLASS SUPREME INTO FRONTAL BARRIER  
RIGHT FRONT PASSENGER HEAD RESULTANT ACCELERATION

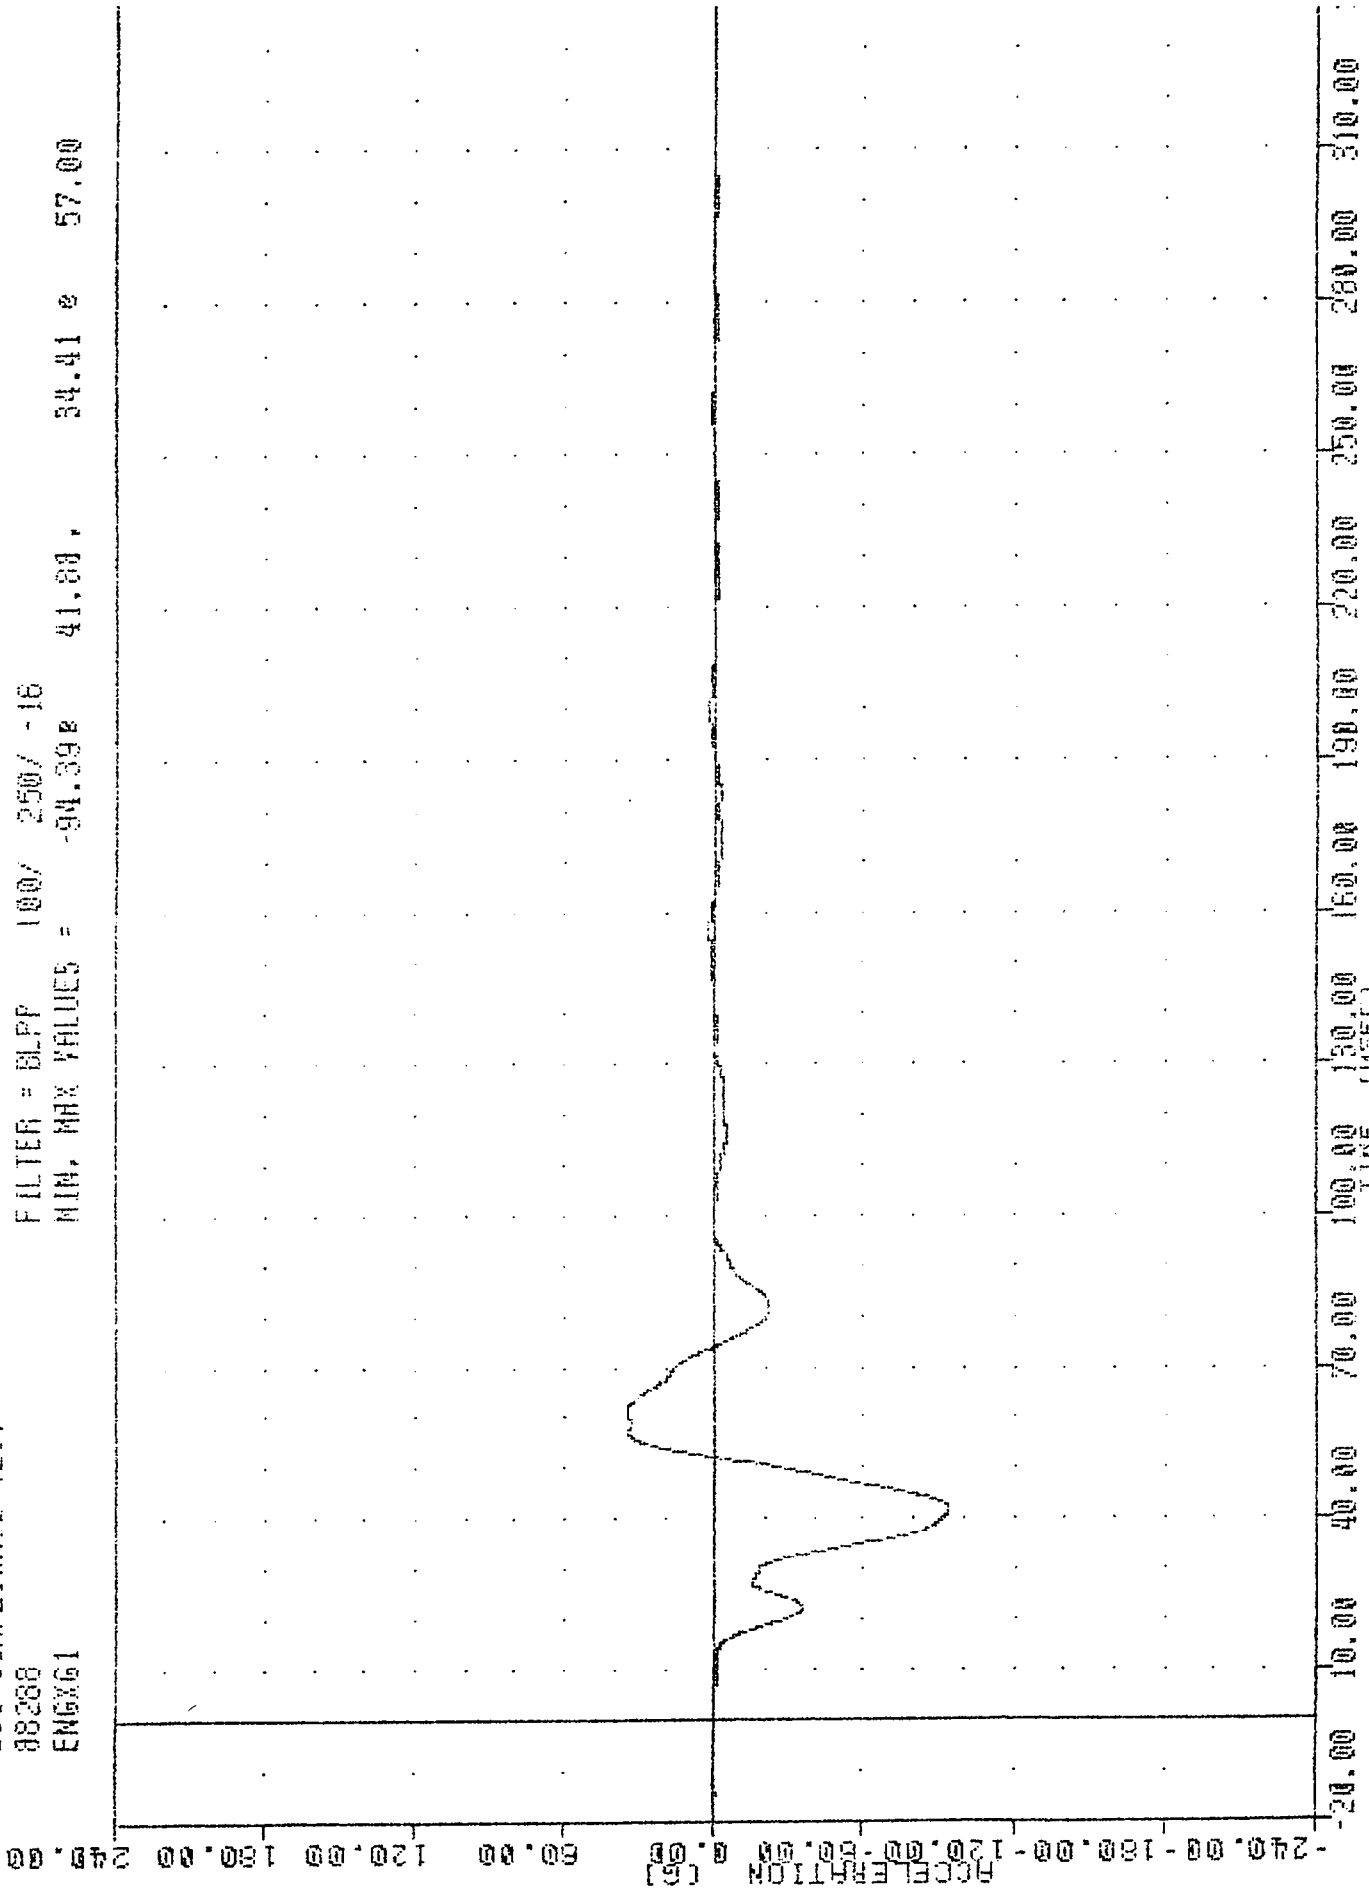
OLDSMOBILE CUTLASS SUPREME INTO FRONTAL BARRIER  
ENGINE UPPER BLOCK X AXIS ACCELERATION

FILTER = BLPP 100/ 250/ -16  
MIN. MAX VALUES = -68.49e 40.13 , 30.32 e 66.63
