THIRTY MPH BROADSIDE
IMPACT OF A MINI-SIZED VEHICLE
AND A BREAKAWAY LUMINAIRE SUPPORT

TEST RESULTS REPORT.

TEST NUMBER 1785-SI#6-88

ENSCO, INC.
Applied Technology and Engineering Division
5400 Port Royal Road
Springfield, VA 22151

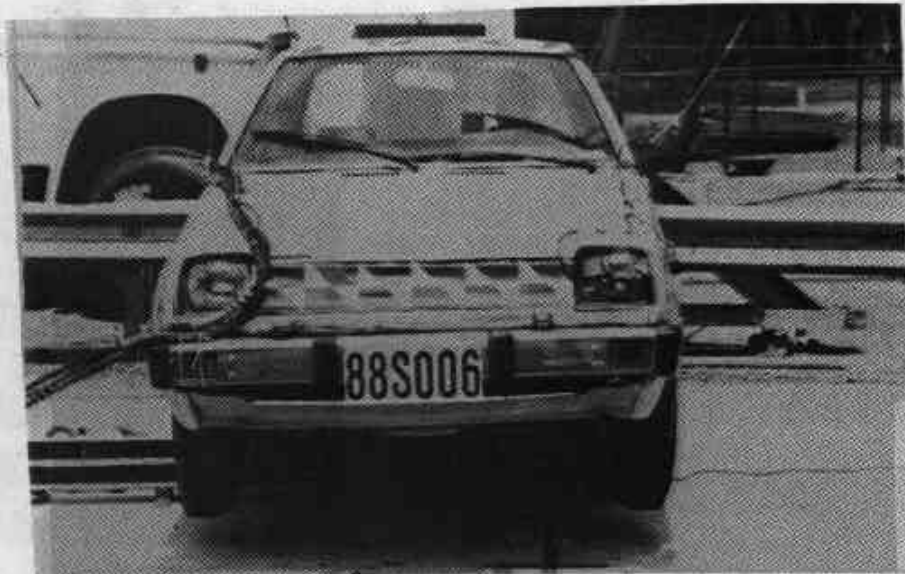
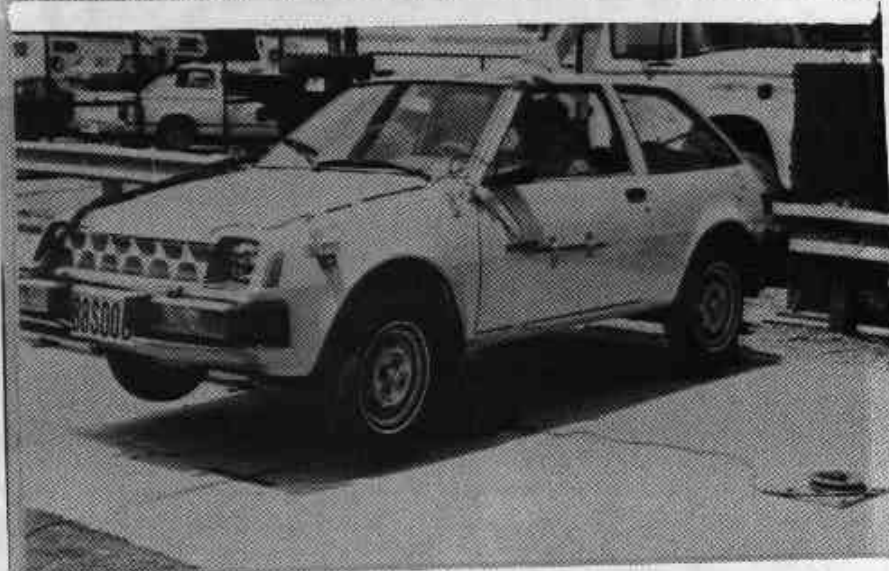
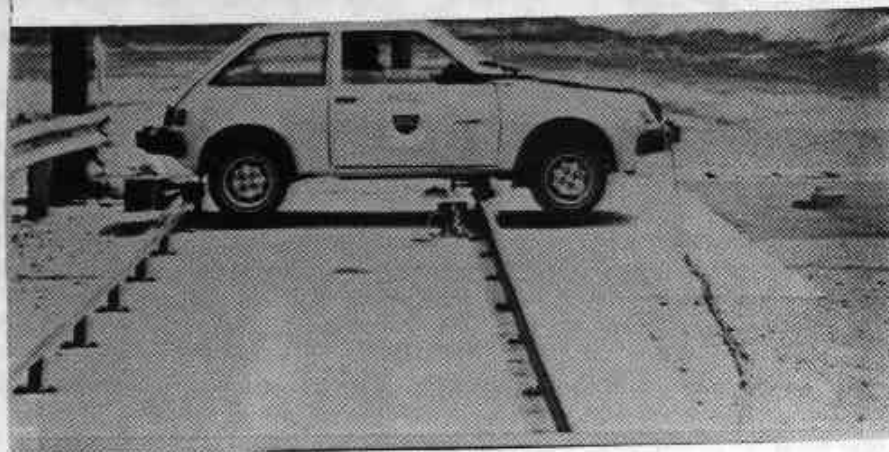
Figure 2. Pre-Test Photos of Vehicle

The vehicle used for this test was a 1980 Plymouth Champ. A triaxial accelerometer package was mounted on the lateral centerline of the vehicle near the longitudinal location of the center of gravity of the vehicle in its inertial test configuration. The data from these accelerometers were used to measure vehicle impact behavior and occupant injury potential based upon criteria set forth in TRC 191 and NCHRP 230. Rate gyros were also mounted to the accelerometer block to measure the roll and yaw rates. The vehicle also was instrumented with a contact switch mounted on the left door to permit vehicle and occupant data to be measured relative to the time of impact.

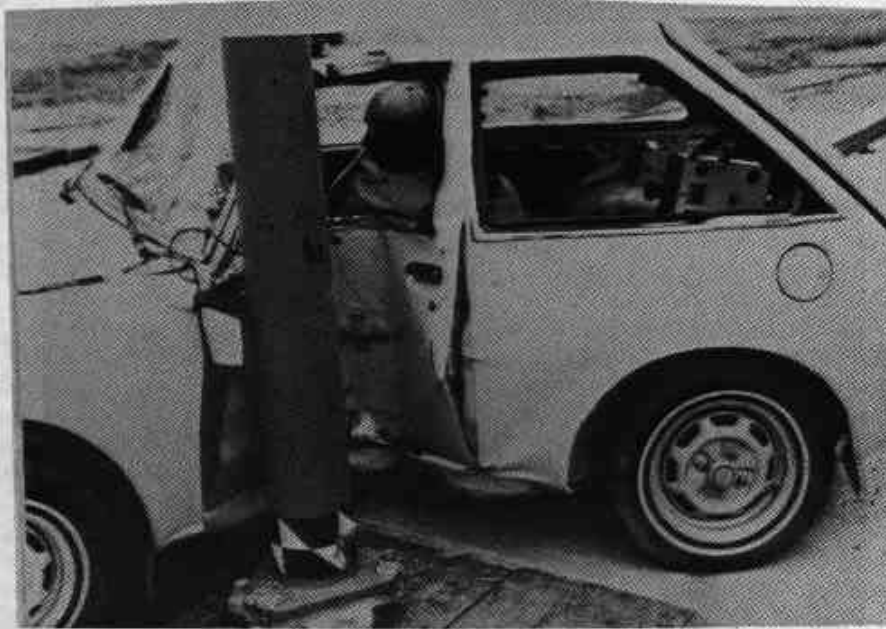
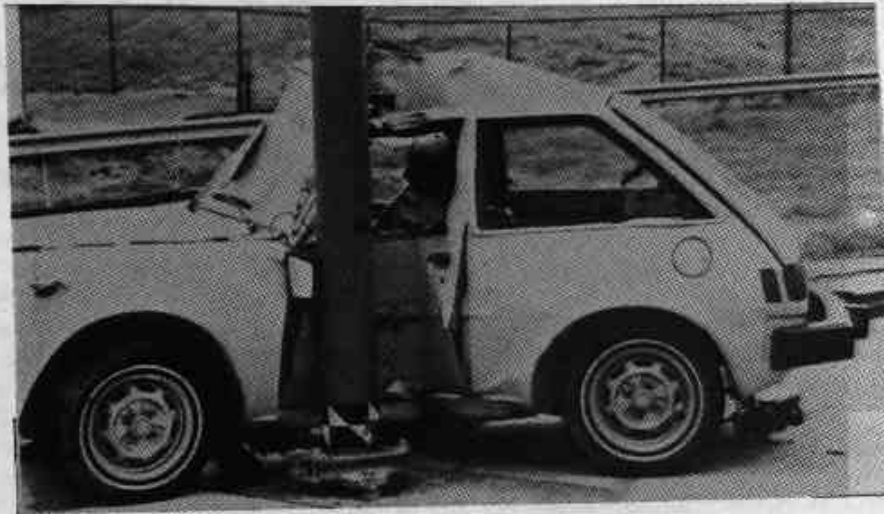
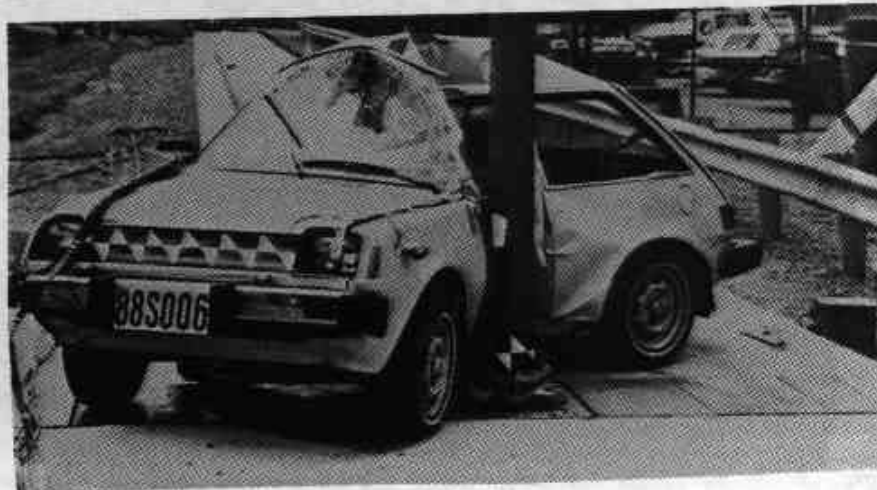
Figure 3. Post-Test Photos of Vehicle

The impact conditions were 28.25 mi/h (12.64 m/s) at a point on the left door 12 inches (0.3 m) forward of the occupant, 16 in (.41 m) behind the longitudinal location of the center of gravity of the vehicle measured without the dummy in the vehicle. The vehicle had a 6.1° roll angle as it leaned toward the test pole due to the side sliding forces acting on the tires. The maximum residual crush of the vehicle at the impact point was 36 inches (.91 m). Crush was measured from a straight line cord running from front bumper to rear bumper on the impact side. This was done because the vehicle was bent very severely. Photographs of the vehicle and luminaire support after the collision event are shown in Figure 3.

The vehicle impacted the pole in the desired location, 12 inches forward of the driver's shoulder. The vehicle crushed inward as it slowed. The vehicle stopped without breaking away the pole, thus causing a very large intrusion. The vehicle yawed slightly as it came to a rest. The residual test vehicle crush measured using the 6 point NHTSA guide is given in Table 7. See figure 4 for reference.

The test pole did not activate causing the vehicle to stop. There was severe penetration of the passenger compartment (approximity 1/2 of the car) due to the fact that the pole did not release. No undue hazard was generated to other traffic.

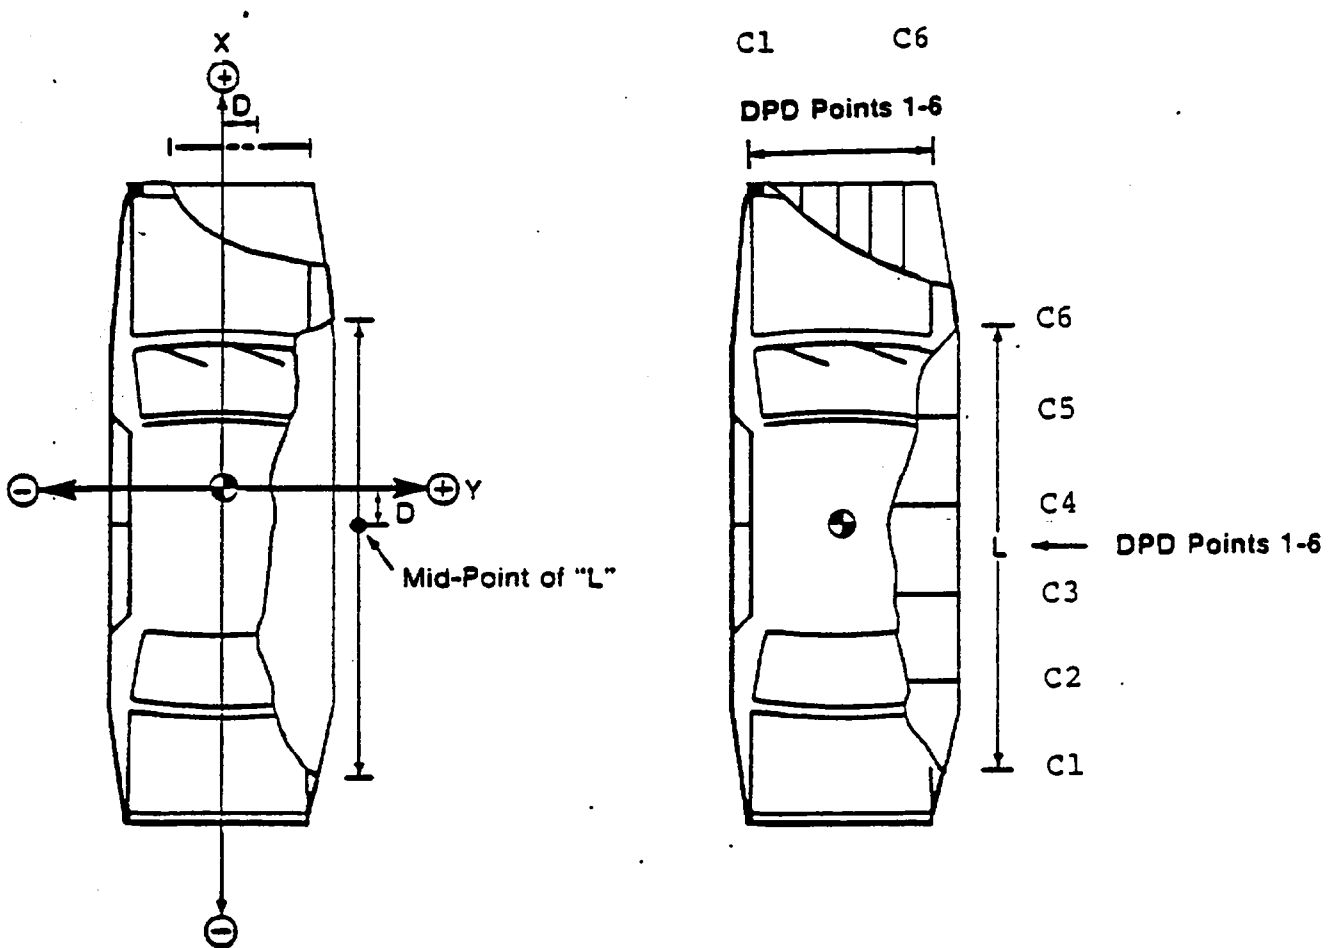
Figure 4. NHTSA Vehicle Damage Measurements

C1 = 0.0"
C2 = 5.0"
C3 = 12.0"
C4 = 10.0"
C5 = 4.0"
C6 = 0.0"

L = 157"
D = -18.5"
Maximum crush = 36"

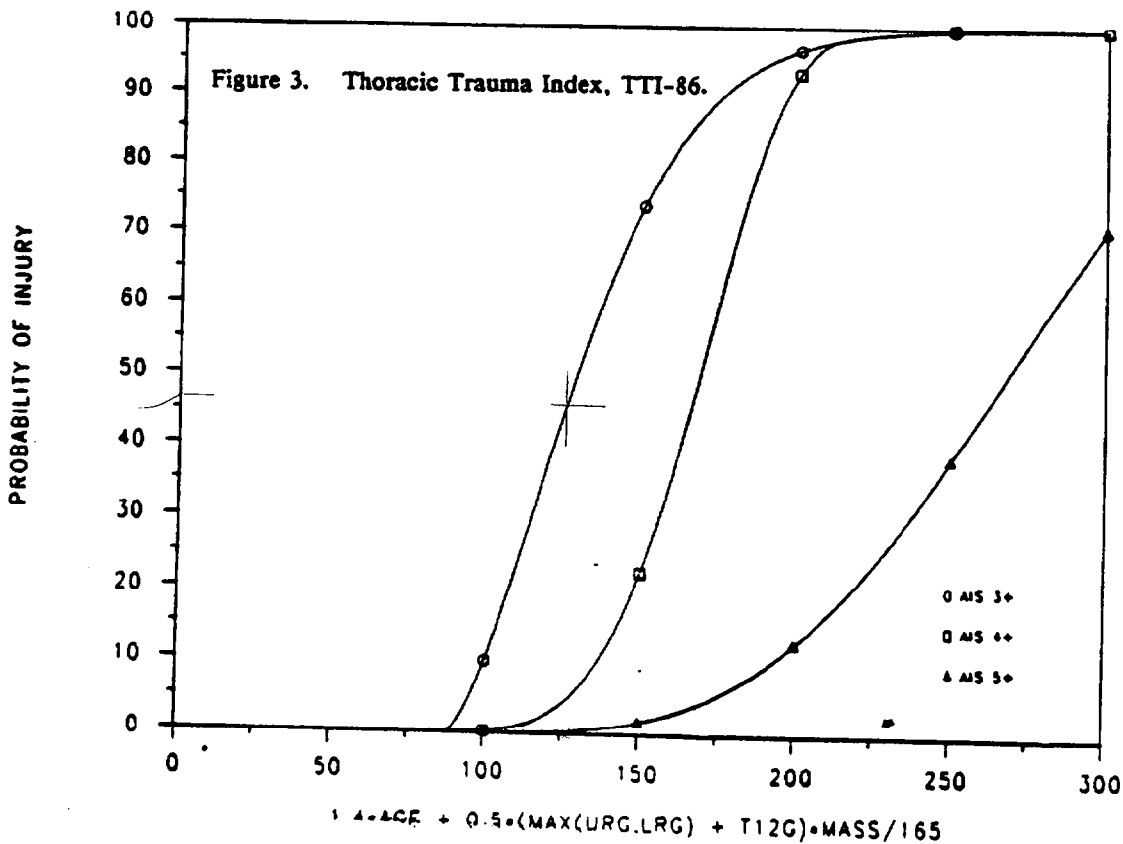
Figure 5. Thoracic Trauma Index-86 Scale

AGE	TTI -86	Probability of Injury		
		AIS 3+	AIS 4+	AIS 5+
0	126	47%	4%	0%
23	158	82%	34%	3%
41	183	93%	77%	7%

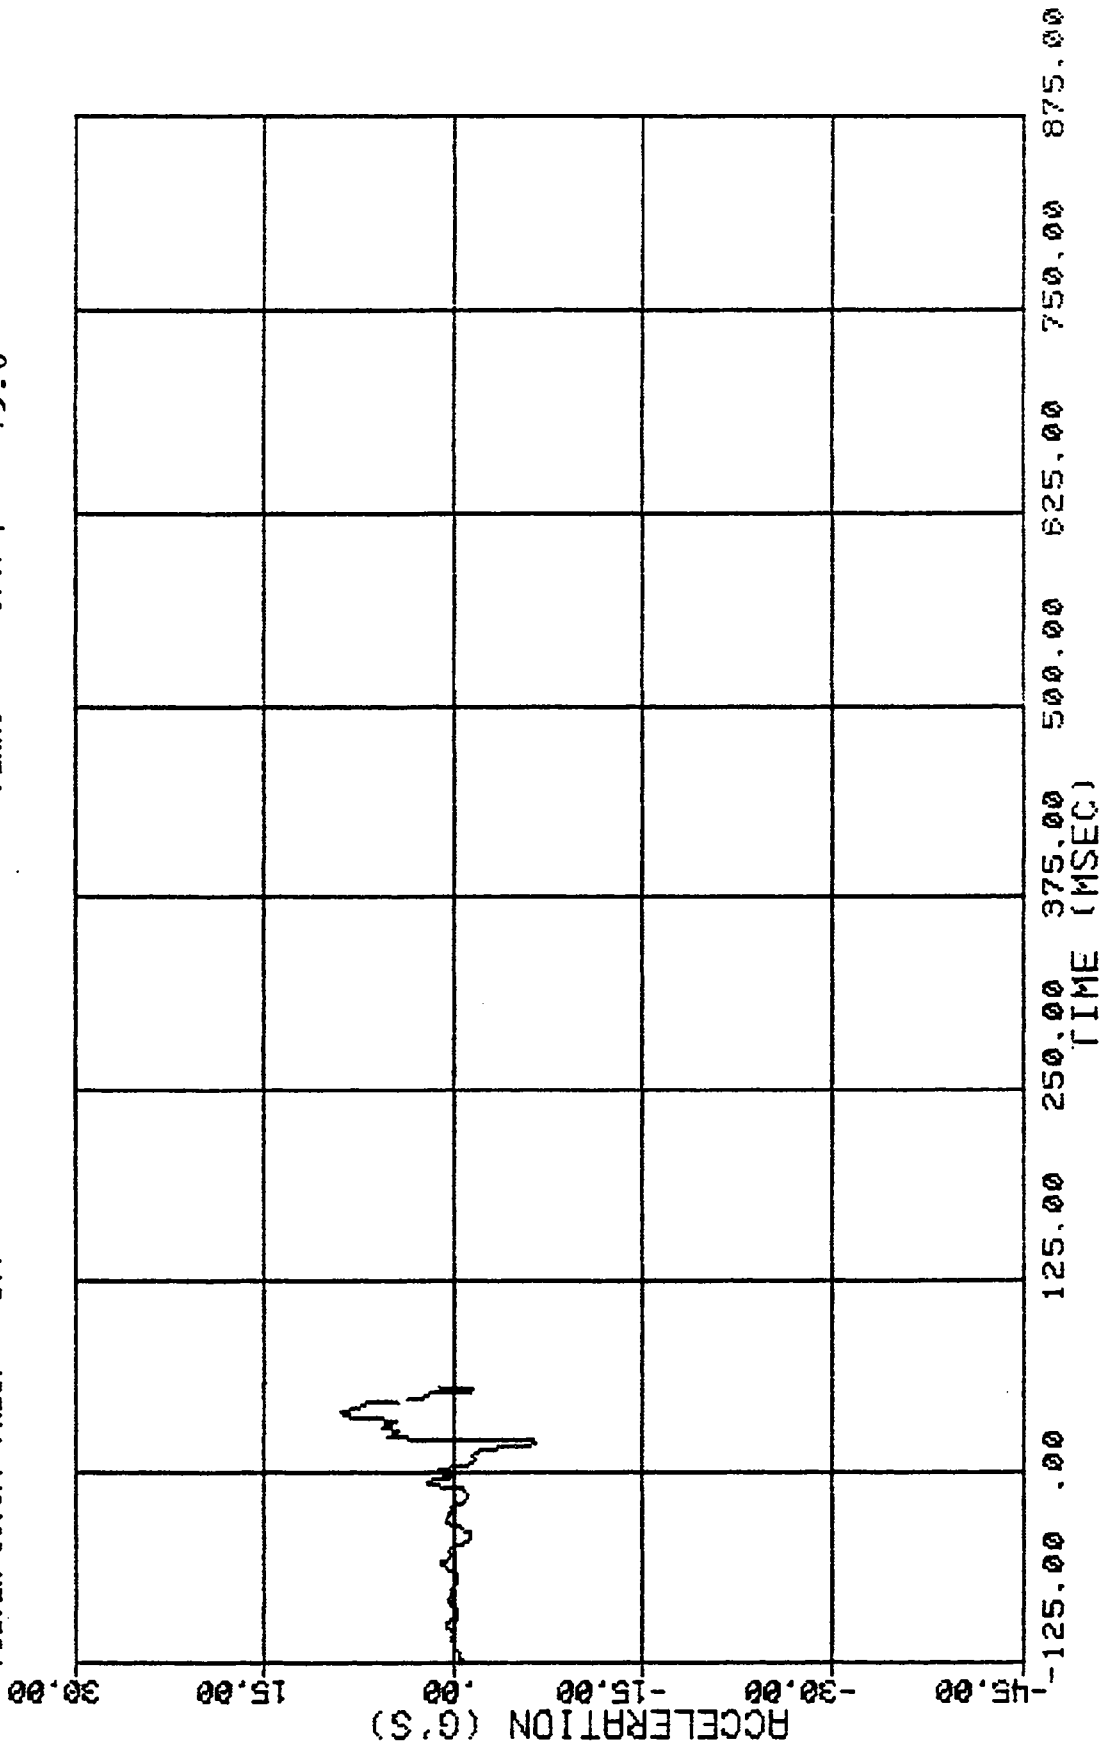
Figure A1. Vehicle X Acceleration, 100 Hz

ENSOO, INC. CONTRACT NUMBER DTFH61-86-Z-00047 TEST # 1785-SI-6-88
 30 MI/H BROADSIDE IMPACT OF 80 PLYMOUTH CHAMP INTO LUMINAIRE SUPPORT
 CHANNEL 18 VEHICLE X
 FILTER CUTOFF FREQ. 100 PEAKS -6.40 , +9.0

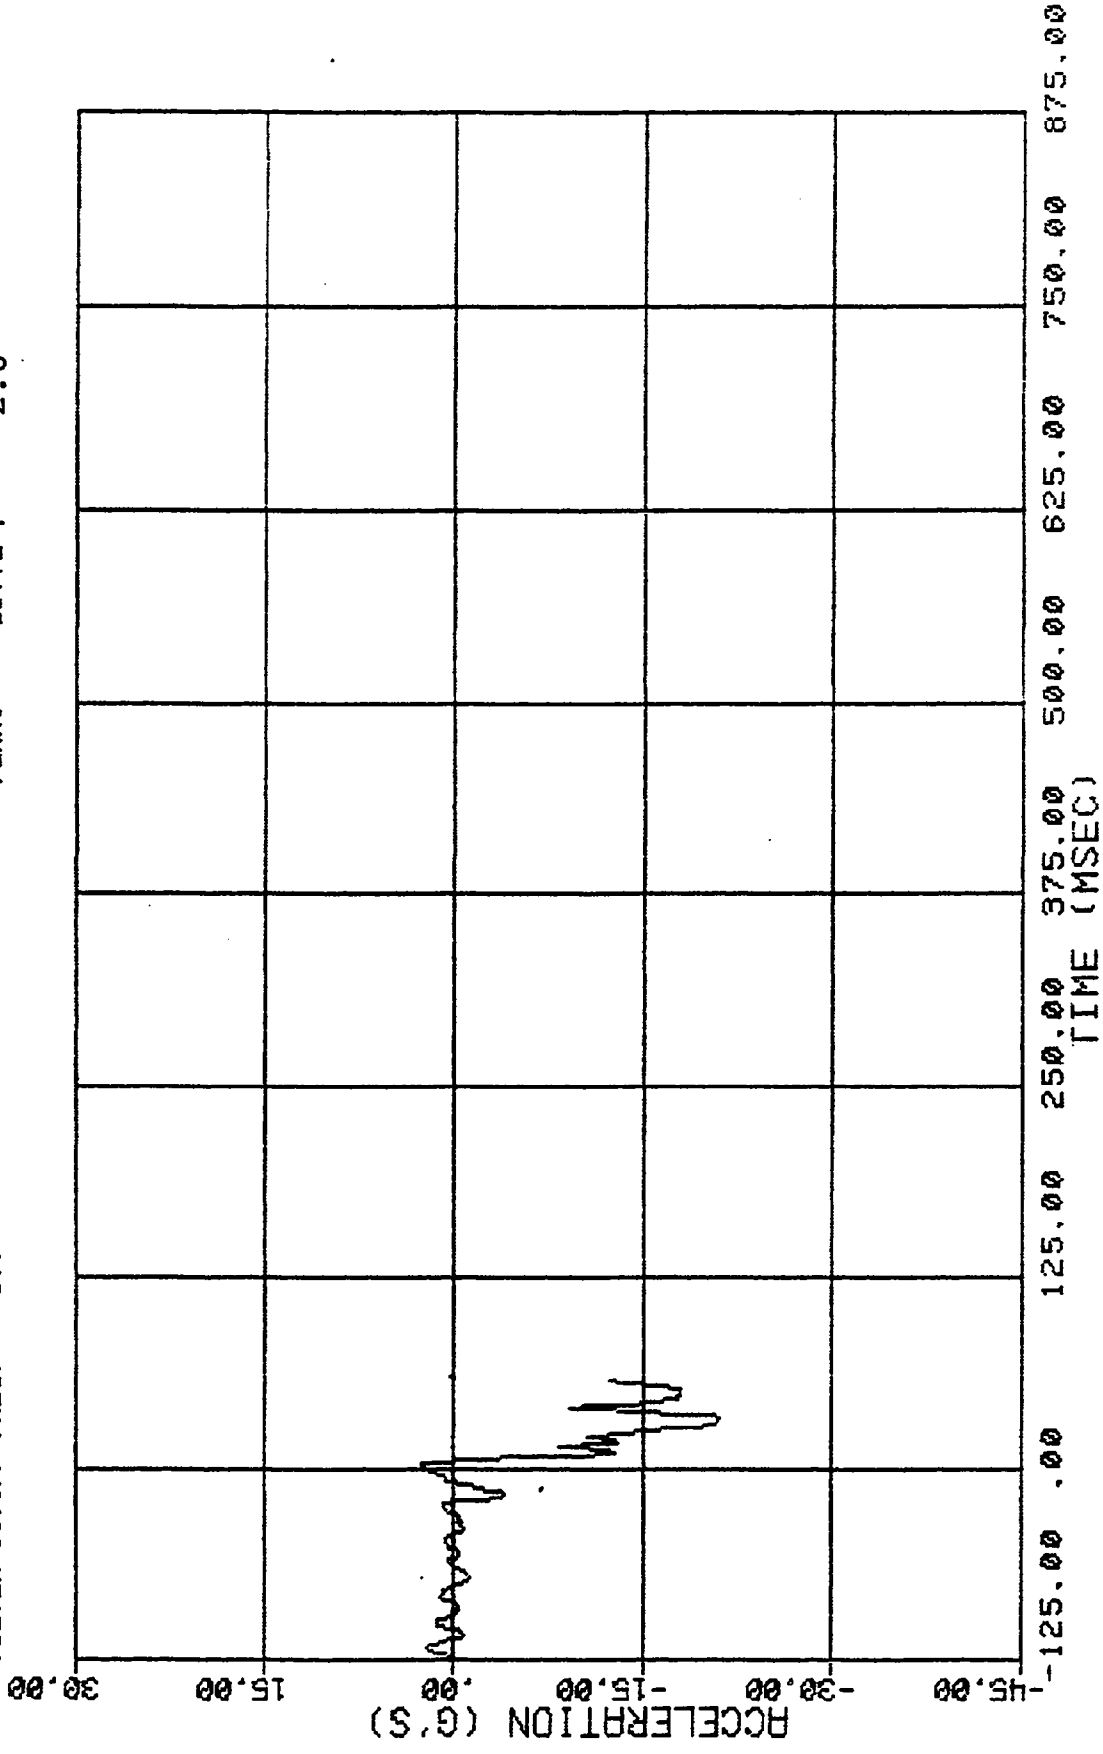
Figure A2. Vehicle Y Acceleration, 100 Hz

ENSOO, INC. CONTRACT NUMBER DTFH61-86-Z-00047 TEST # 1785-SI-6-88
 30 MI/H BROADSIDE IMPACT OF 80 PLYMOUTH CHAMP INTO LUMINAIRE SUPPORT
 CHANNEL 19 VEHICLE Y
 FILTER CUTOFF FREQ. 100 PEAKS -21.02 2.6

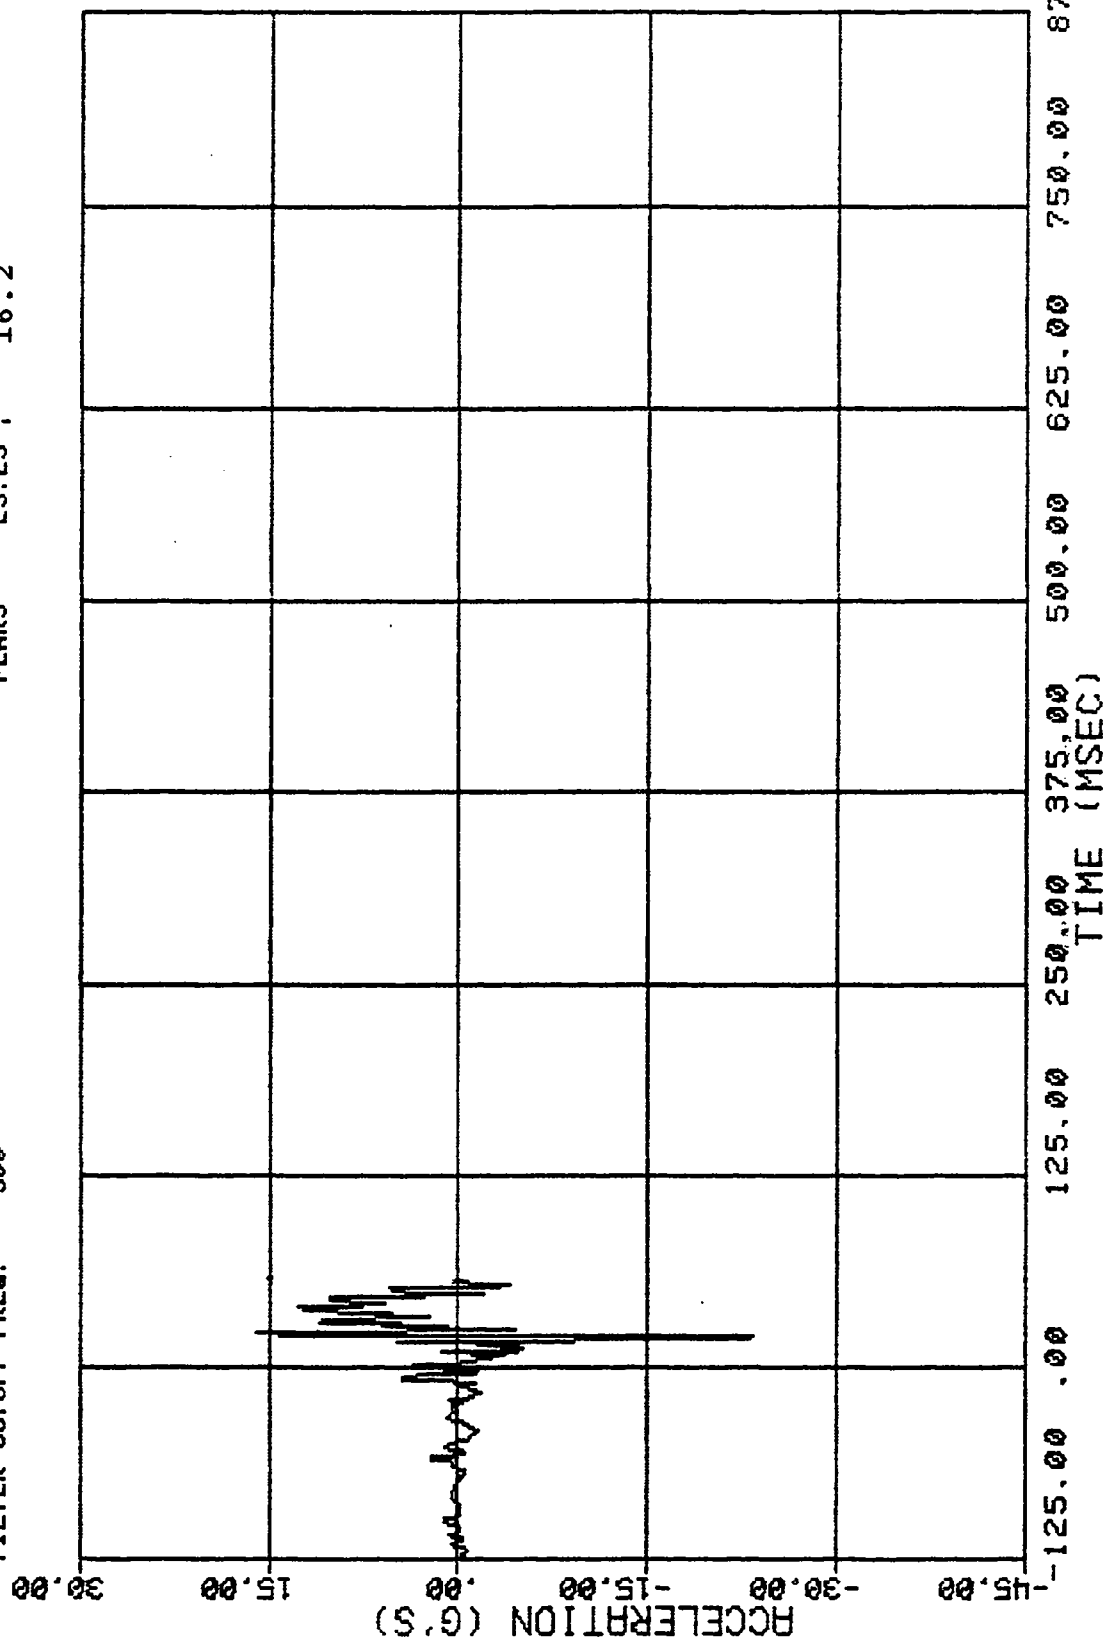
Figure A3. Vehicle X Acceleration, 300 Hz

ENSOO, INC. CONTRACT NUMBER DTFH61-86-Z-00047 TEST # 1785-SI-6-88
 30 MI/H BROADSIDE IMPACT OF 80 PLYMOUTH CHAMP INTO LUMINAIRE SUPPORT
 CHANNEL 18 VEHICLE X
 FILTER CUTOFF FREQ. 300 PEAKS -23.29 , 16.2

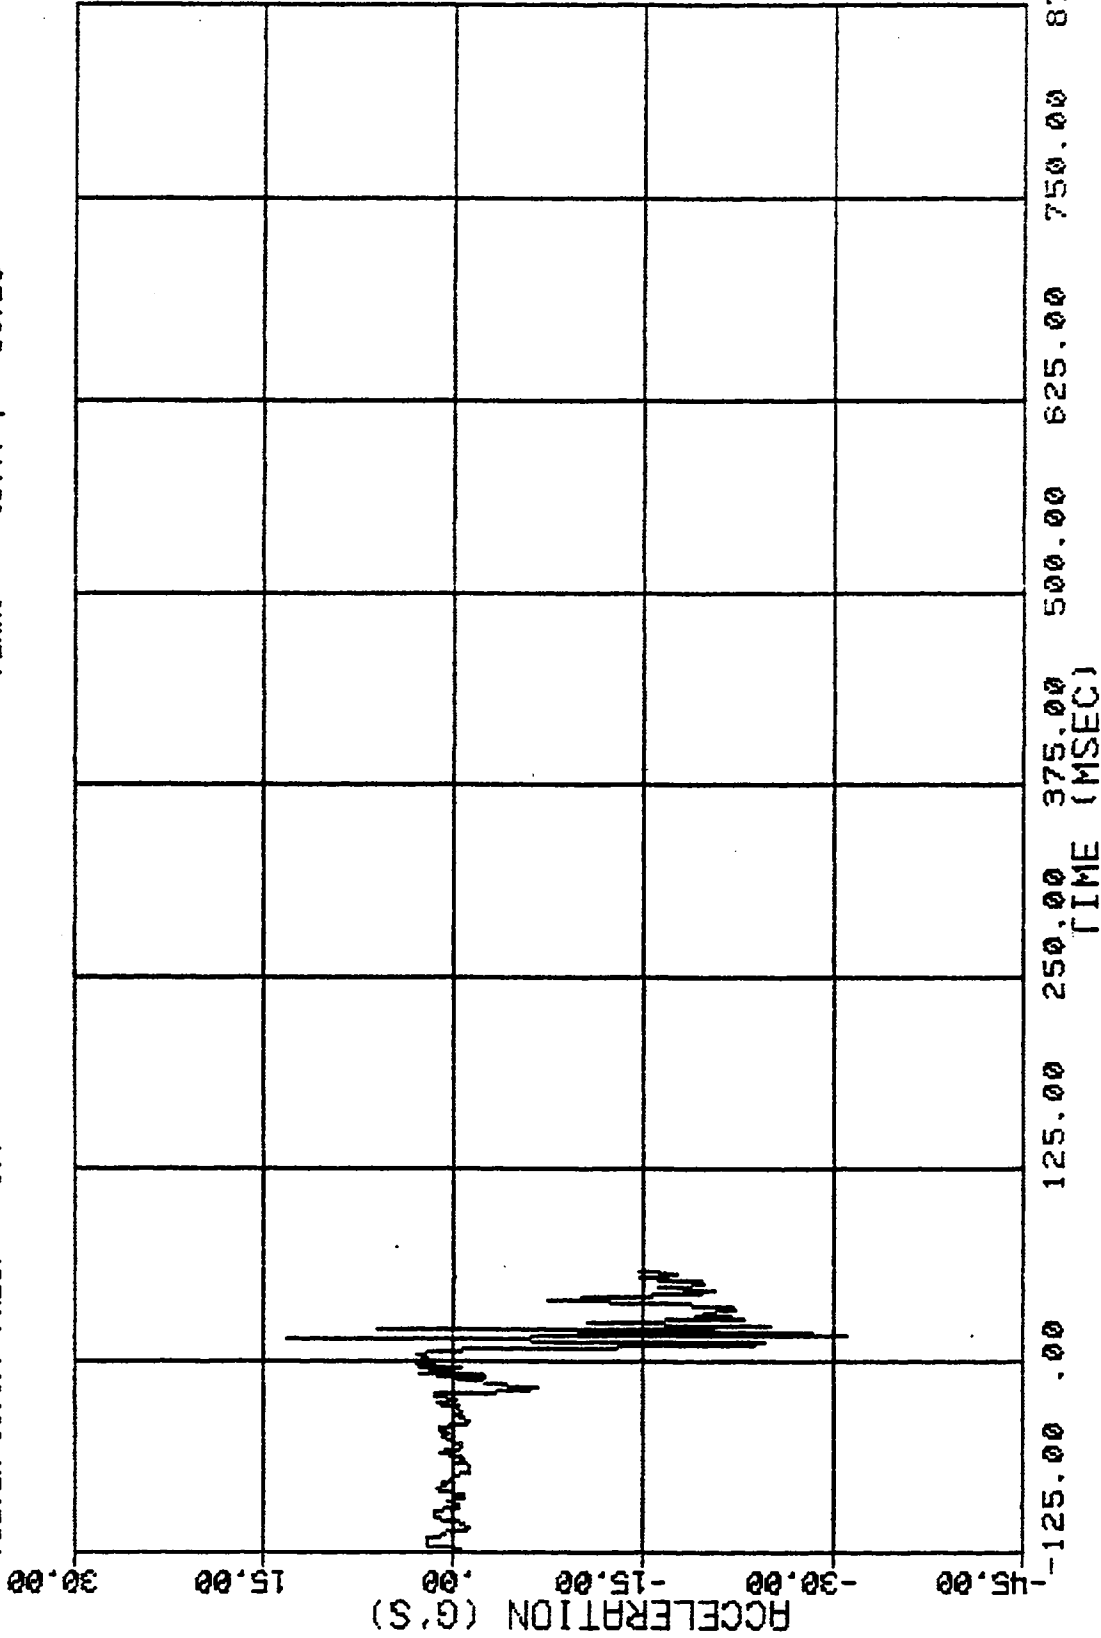
Figure A4. Vehicle Y Acceleration, 300 Hz

ENSOO, INC. CONTRACT NUMBER DTFH61-86-3-00047 TEST # 1785-SI-6-88
 30 MI/H BROADSIDE IMPACT OF 80 PLYMOUTH CHAMP INTO LUMINAIRE SUPPORT
 CHANNEL 13 VEHICLE Y
 FILTER CUTOFF FREQ. 300 PEAKS -31.00 , 13.23

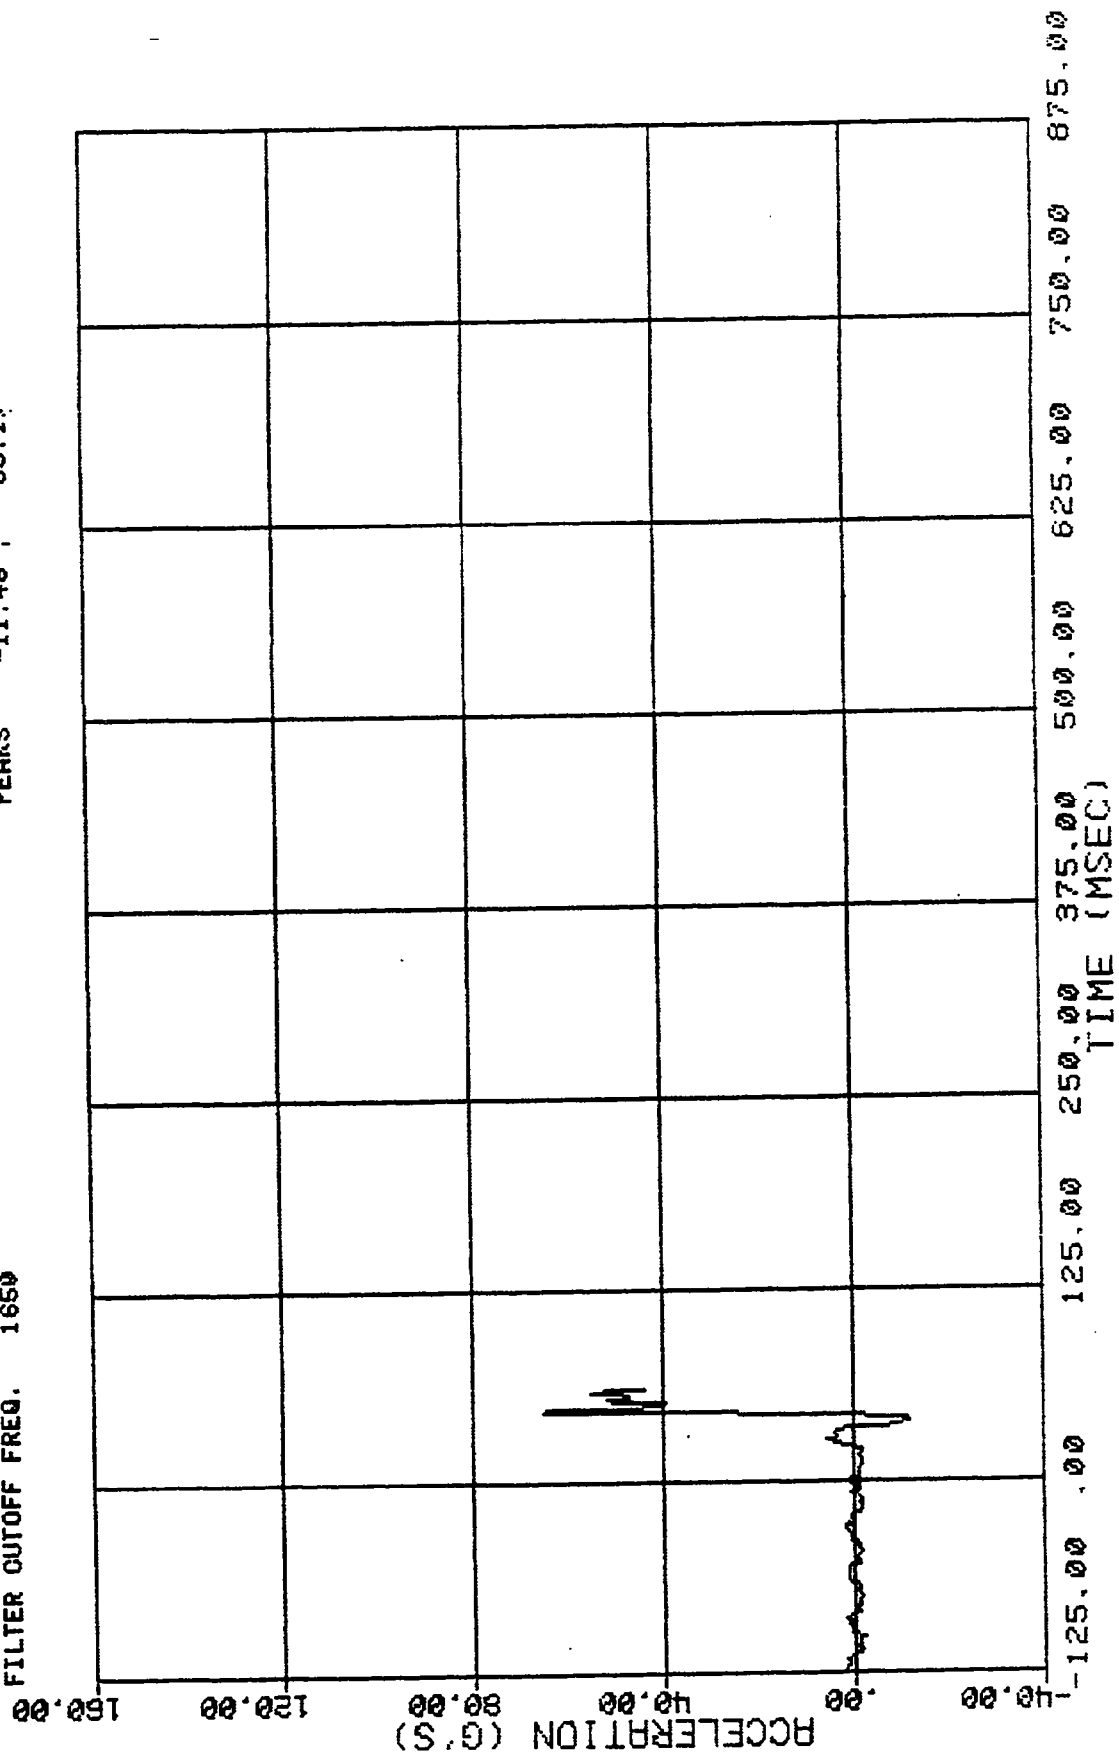
Figure A21. Head X Acceleration, 1650 Hz

ENSO, INC. CONTRACT NUMBER D1FH61-26-1-00047
 30 MI/H BROADSIDE IMPACT OF 80 PLYMOUTH CHAMP INTO LUMINAIRE SUPPORT
 CHANNEL 12 HEAD X
 FILTER CUTOFF FREQ. 1650
 PEAKS -11.48 65.17

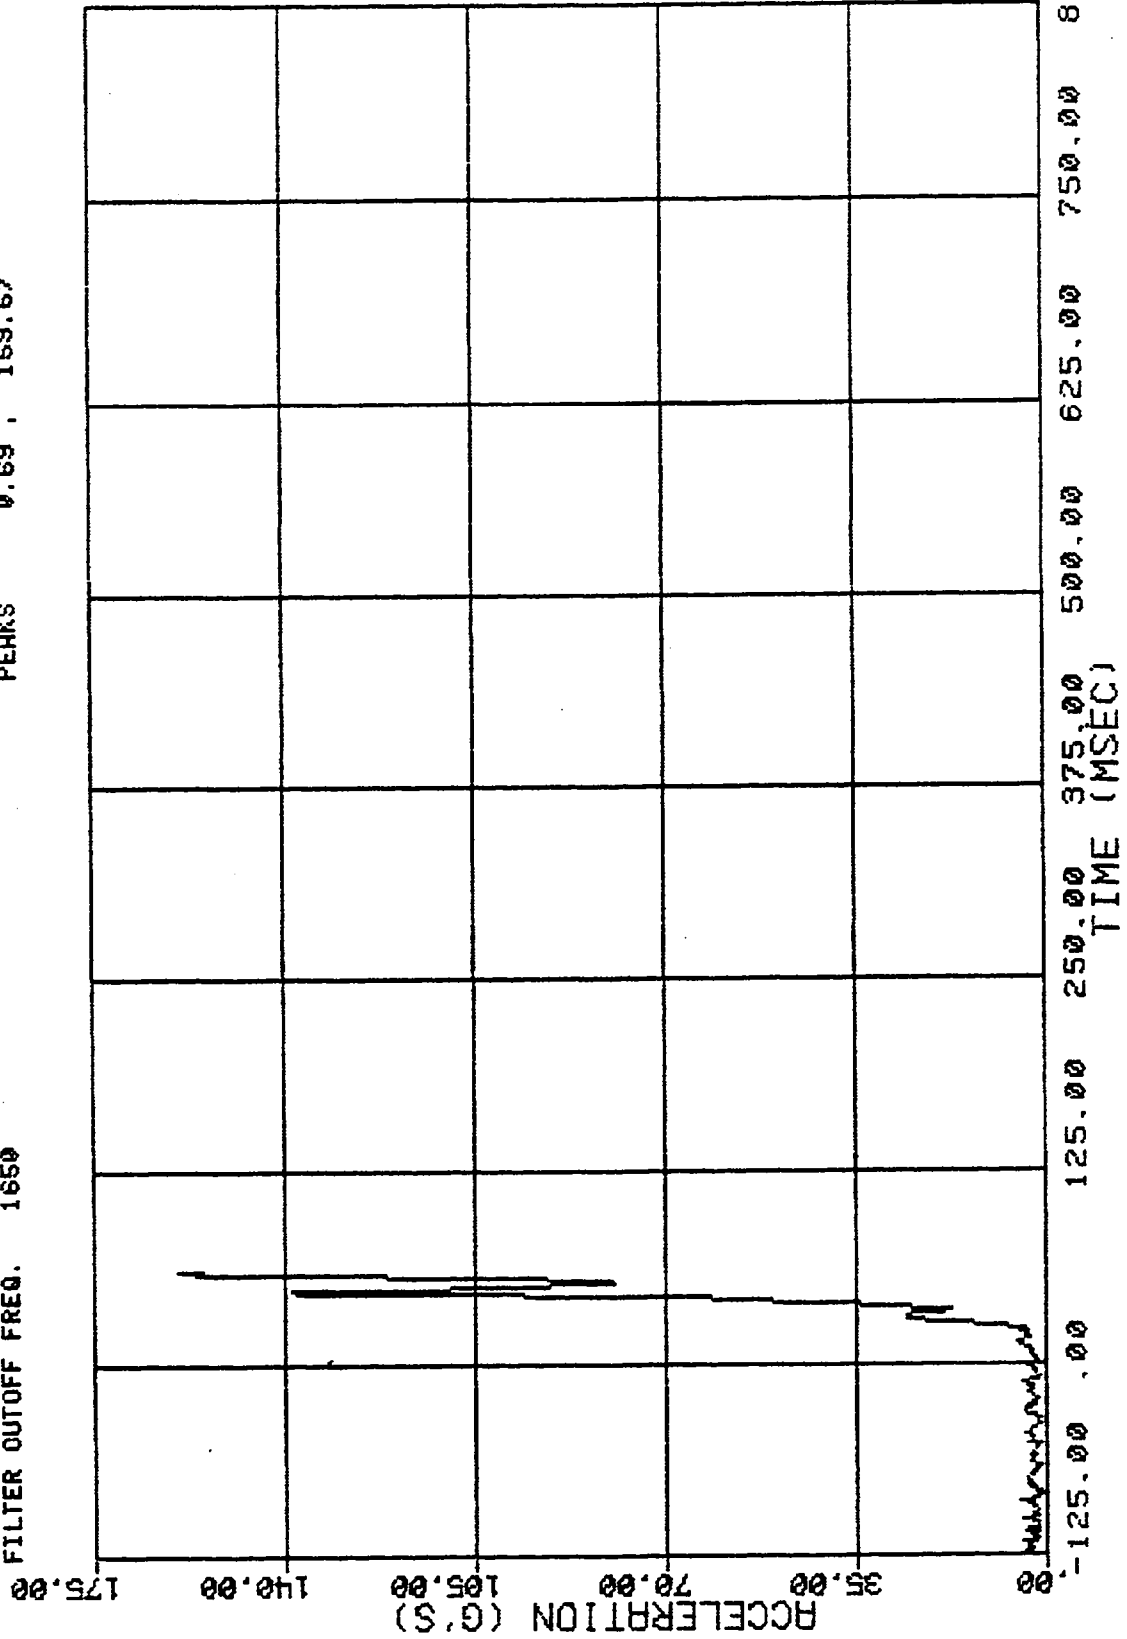
Figure A24. Head Resultant Acceleration, 1650 Hz

ENSU, 110. SERIAL NUMBER 01101 00 1 0047
 30 MI/H BROADSIDE IMPACT OF 80 PLYMOUTH OHAMP INTO LUMINAIRE SUPPORT
 CHANNEL Ø HEAD RESULTANT
 FILTER CUTOFF FREQ. 1650 PEAKS 0.69 , 159.67

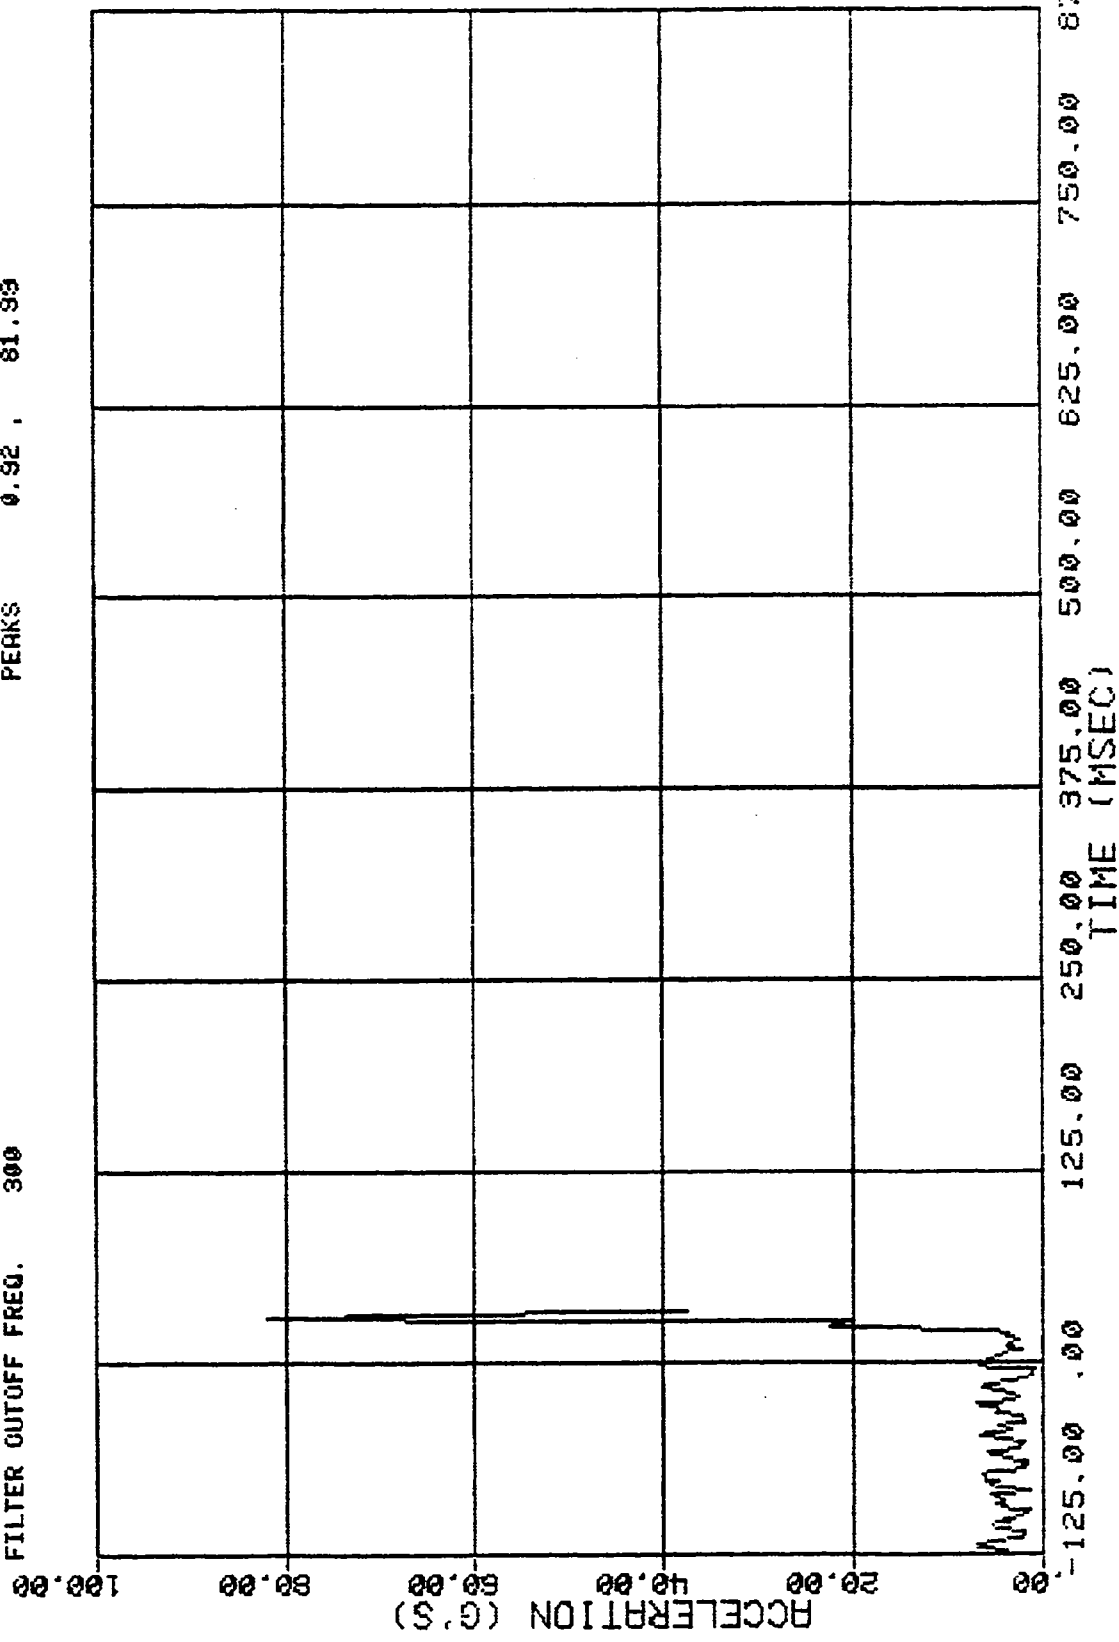
Figure A28. T01 Resultant Acceleration, 300 Hz

ENSOO, INC. CONTRACT NUMBER DTFH61-86-Z-00047 TEST # 1785-SI-6-88
 30 MI/H BROADSIDE IMPACT OF 80 PLYMOUTH CHAMP INTO LUMINAIRE SUPPORT
 CHANNEL 0 T01 RESULTANT PEAKS 0.92 , 81.93
 FILTER CUTOFF FREQ. 300

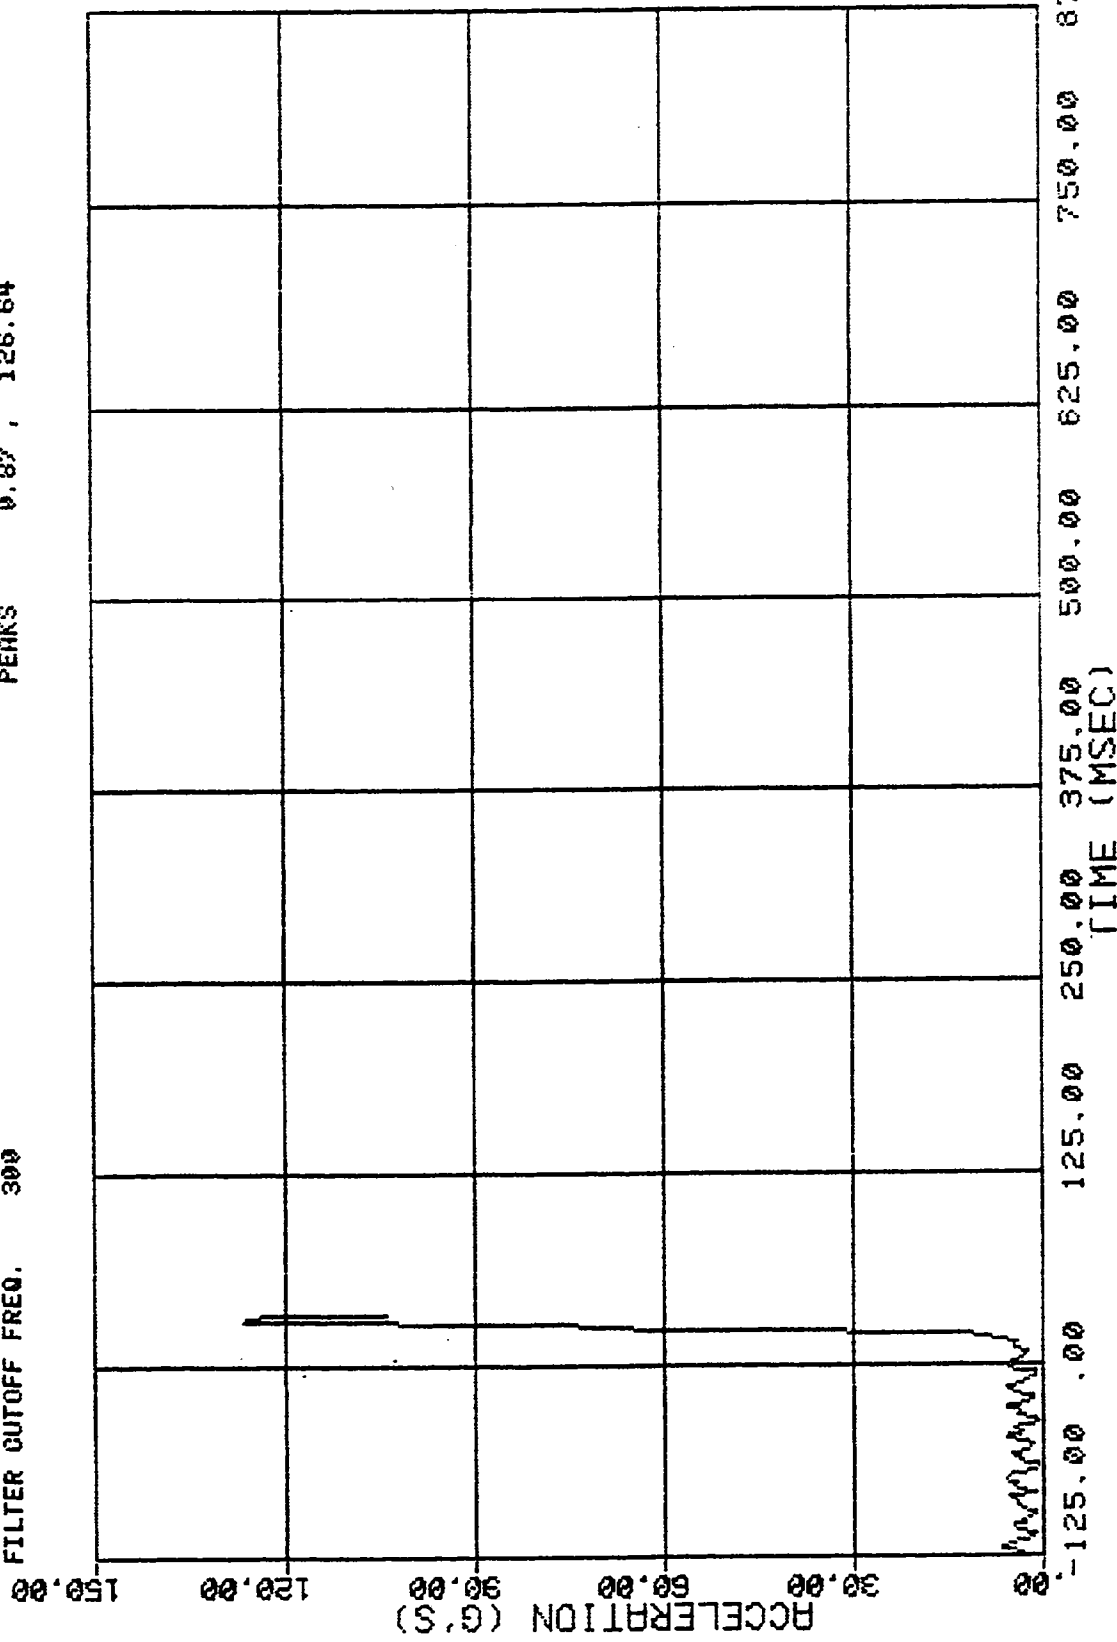
Figure A32. T12 Resultant Acceleration, 300 Hz

ENSCO, INC. CONTRACT NUMBER DTFH61-66-2-00047 TEST # 1785-SI-6-58
 30 MI/H BROADSIDE IMPACT OF 80 PLYMOUTH CHAMP INTO LUMINAIRE SUPPORT
 CHANNEL 0 T12 RESULTANT PEAKS 0.87, 126.64
 FILTER CUTOFF FREQ. 300
