THIRTY MPH BROADSIDE  
IMPACT OF A MINI-SIZED VEHICLE  
AND A BREAKAWAY LUMINAIRE SUPPORT

TEST RESULTS REPORT.

TEST NUMBER 1785-SI#8-88

Prepared by:  
ENSCO, INC.  
Applied Technology and Engineering Division  
5400 Port Royal Road  
Springfield, VA 22151

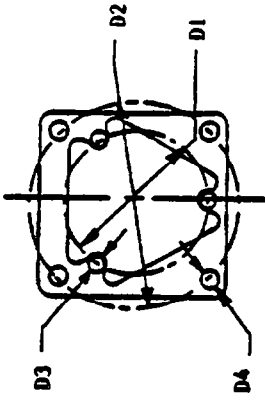
Figure 1. Mechanical Properties of Pole

Poles: 275 (W1)  
Mast Arms: 90 (W2)  
Luminaires: 51 (W3)  
Total Assys: 416 (WT)

Mounting Heights: 36' (H1) No. Slip Bolts: 3  
Pole Heights: 30'3" (H2) Slip BC Dia (in): 14 (D1)  
Pole CB Heights: 12'4" (H6) Dia of Slip Bolts (in): 1 (D3)  
Mast Arm CB Hts: 33'2" (H5) No. Foundation Bolts: 3  
Mast Arm CB Offsets: 6' (L2) Found BC Dia (in): 14 (D2)  
Lumin CB Hts: 35'10" (H4) Dia Found Bolt (in): 1 (D4)  
Lumin CB Offsets: 15'9" (L1) 8 Bolt Clamp Force (lb): LOOSE  
Stub Ht: 4.0 (H7) Keeper Plate, Y/N: Y

Total Assy CB Ht = 21' (H3)  
Total Assy CB Offset = 3'4" (L3)

Manufacturer:	Ameron
Material:	Steel
Weight:	416 lbs
Height, c.g.:	21 ft
Top diameter:	3-1/2 in
Bottom diameter:	7.5 in
Mast Arm Length:	15 ft - 9 in.
Luminaire Height:	35 ft - 10 in.
Luminaire Weight:	51 lbs
Base Type:	California Type 31 slip base
Number of bolts:	3
Size:	1 in diameter
Bolt Clamp Load:	loose

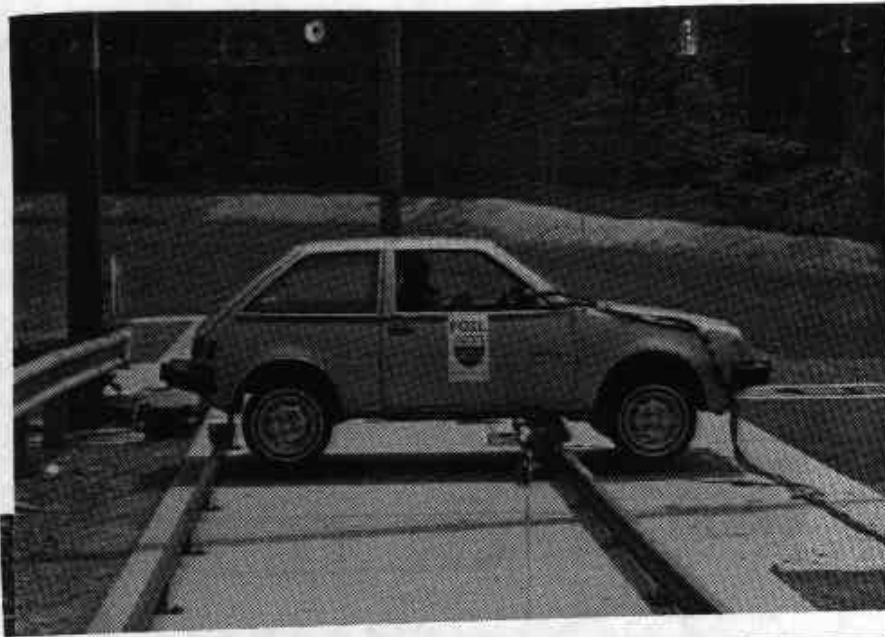
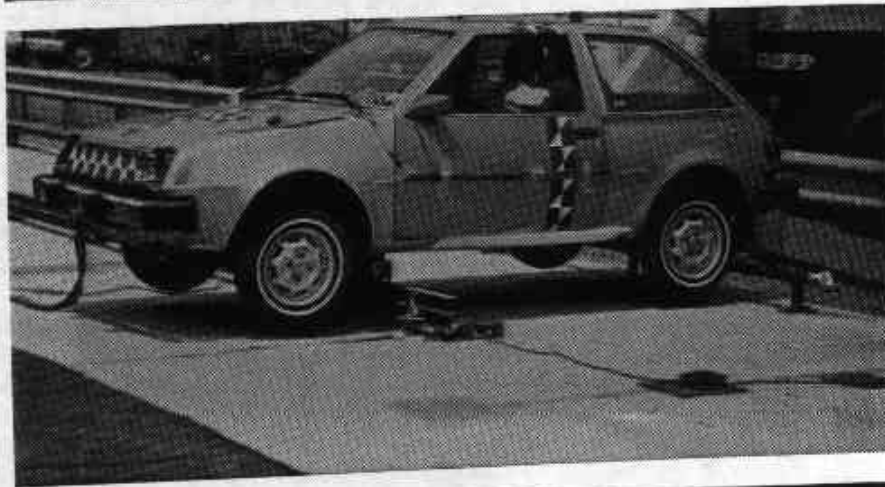
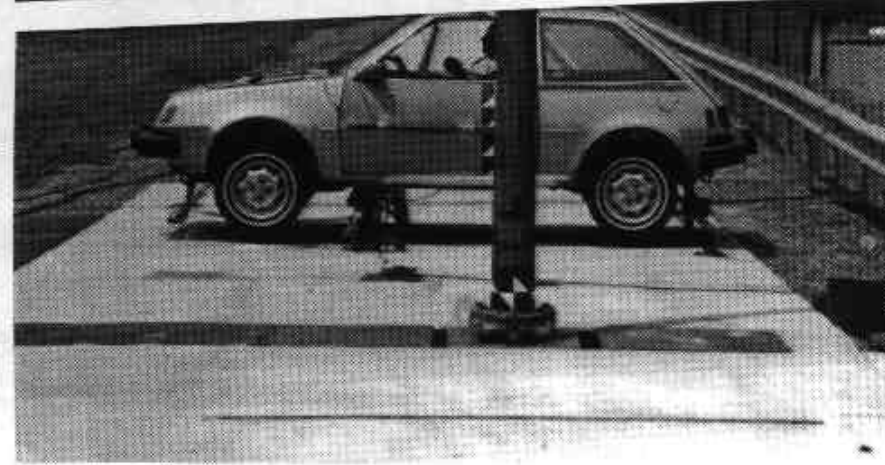
Figure 2. Pre-test Photos of Vehicle

The vehicle was equipped with a triaxial accelerometer package mounted on the lateral centerline of the vehicle at the longitudinal location of the center of gravity. One rate gyro was also installed to the same mounting block to measure yaw rate. The vehicle was also equipped with a contact switch mounted on the left door to permit vehicle and occupant data to be measured relative to the time of impact. A second triaxial accelerometer package was attached to the floor board located in front of the front right hand seat. Two gyros were also attached to this block to measure yaw and roll rates. This data was collected using the FOIL data system. The test vehicle is shown in Figure 2.

The test vehicle was a 1981 Plymouth Champ. The weight of the vehicle prior to incorporating the instrumentation for the test was 1885 lbs. The test inertial weight for the vehicle was 1848 lbs and the gross static weight when the occupant was included in the vehicle was 2008 lbs. The longitudinal center of gravity of the vehicle without the occupant was located approximately 32 inches behind the centerline of the front axle. The weight and inertial data of the vehicle in its as delivered and instrumented configuration are given in table 4. Inertial data was measured using the IMD.

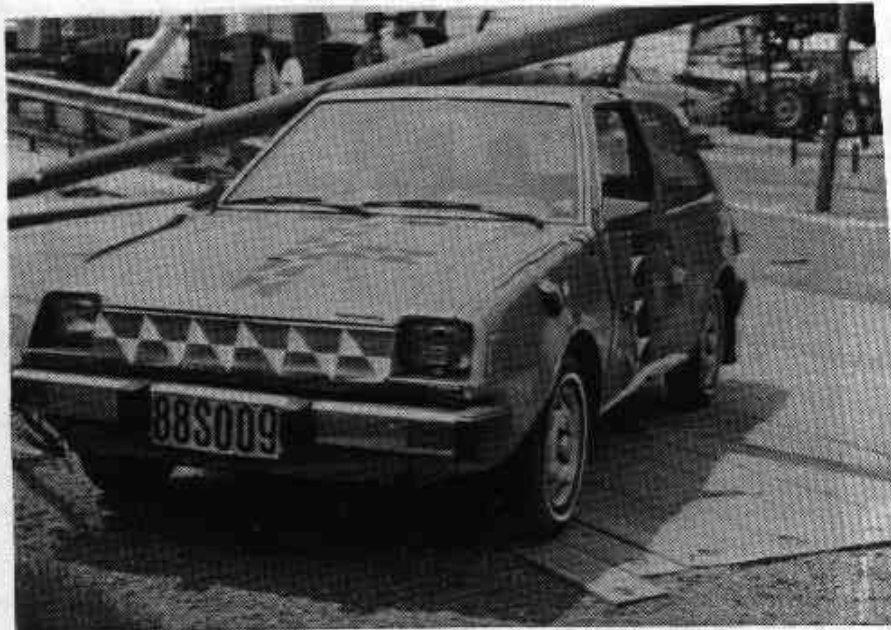
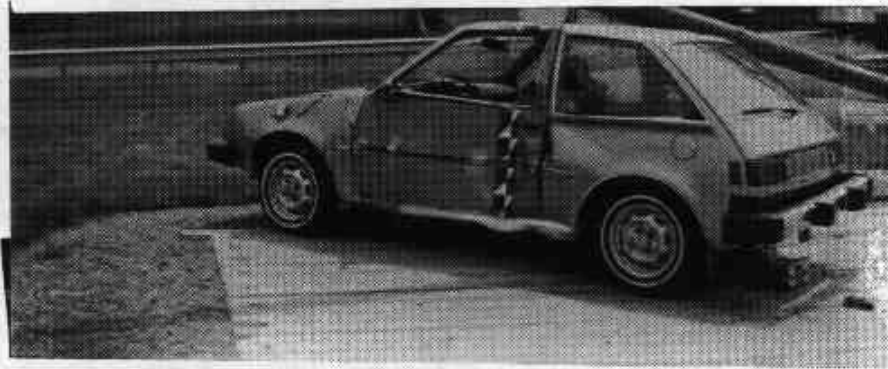
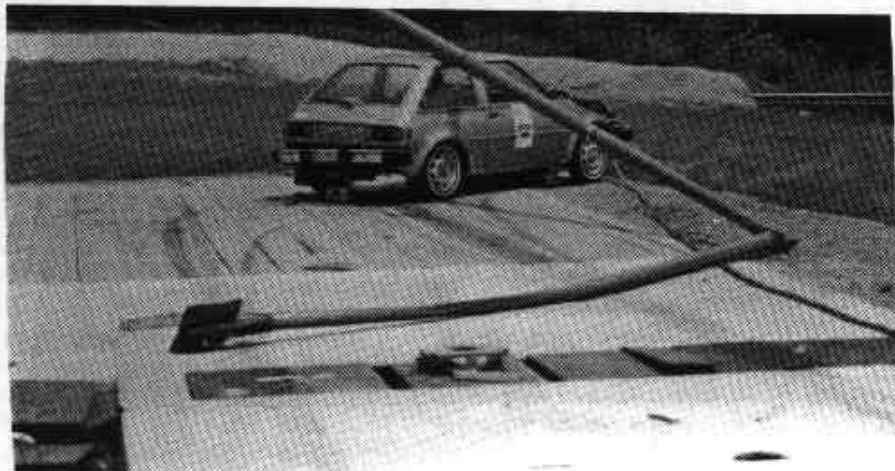
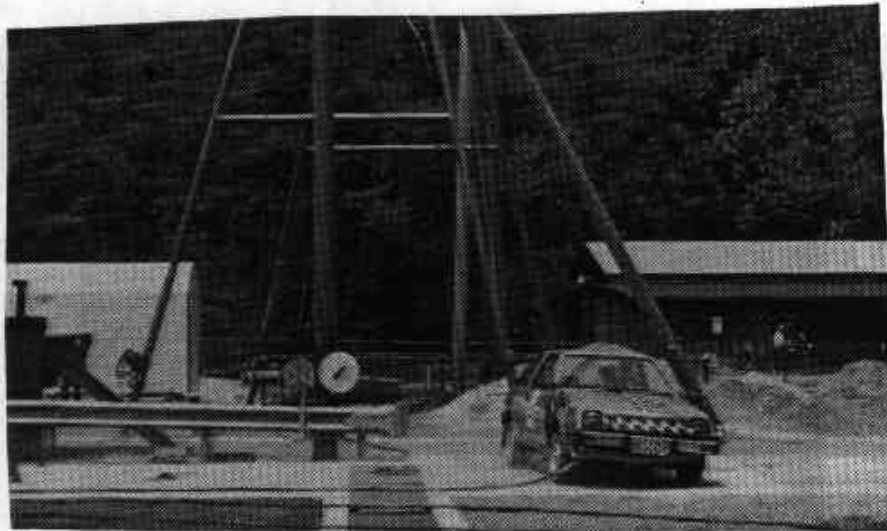
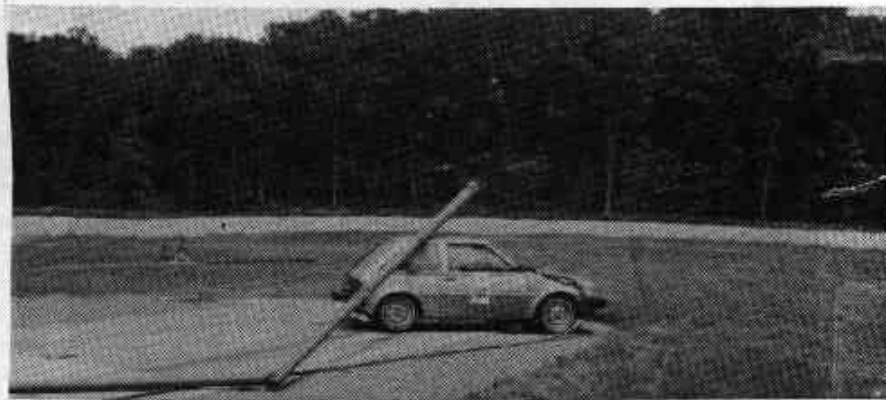
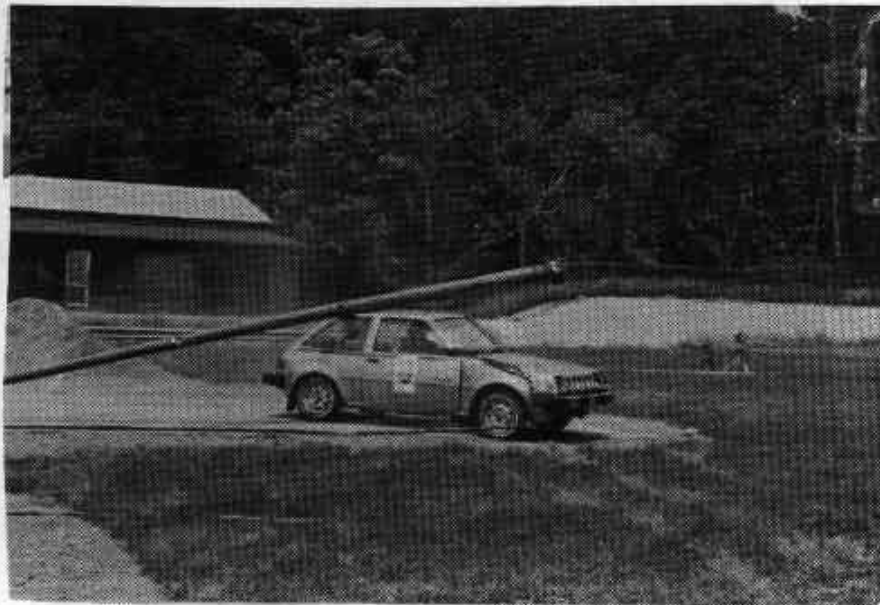
Figure 3. Post-Test Photos of Vehicle

The impact conditions were 29.59 mph (13.24 m/s) at a point on the left door aligned with the occupant, 28 in (.71 m) behind the longitudinal location of the center of gravity of the vehicle measured without the dummy in the vehicle. The vehicle had a  $5.5^{\circ}$  roll angle as it leaned toward the test pole due to the side sliding forces acting on the tires. The maximum residual crush of the vehicle at the impact point was 7.5 inches (.19 m). Photographs of the vehicle and luminaire support after the collision event are shown in Figure 3.

After the initial separation from the vehicle the luminaire support rotated up and over the test vehicle with the top of the pole hitting the ground about 1.08 seconds after impact. Just prior to impact with the ground, the center portion of the pole impacted the roof of the car. As the support rotated away, vehicle yawed counter clockwise, continued forward away from the impact area after yawing a total of about  $45^{\circ}$ . The vehicle did not pitch or roll very much but remained stable during this transition. The final resting position of the vehicle was about 36 feet downstream and 8 ft to the right of the impact point with the pole resting on the roof. The top of the pole was just past the end of the runway. The residual test vehicle crush measured using the 6 point NHTSA guide is given in Table 7. See figure 4 for reference.

The test vehicle momentum change due to impacting the pole at a speed of 29.6 mi/h (13.24 m/s) was 450 lb-sec. The velocity change corresponding to the observed vehicle momentum change was 4.9 mi/h or 7.2 ft/sec. The integrity of the vehicle was maintained throughout the test with the exception of the drivers door being crushed in. Maximum residual crush of the side of the vehicle was 7.5 inches.

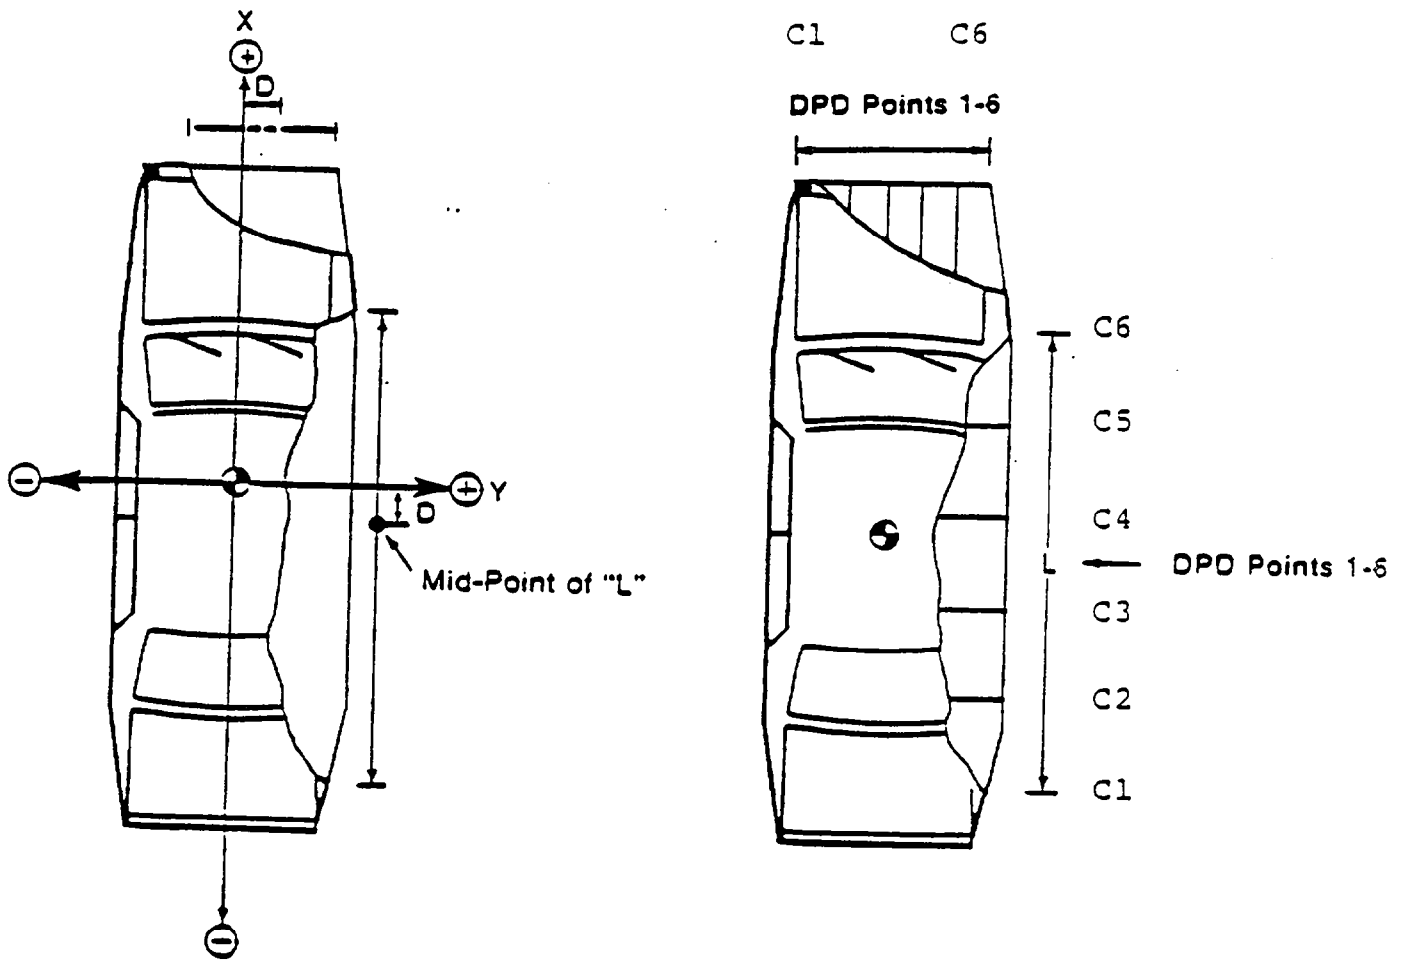
Figure 4. NHTSA Vehicle Damage Measurements

Table 7  
Residual Vehicle Crush

C1	=	0.0 in	L	=	64 in
C2	=	2.5 in	D	=	-19 in
C3	=	6.0 in	Maximum crush	=	7.5 in
C4	=	5.0 in			
C5	=	3.0 in			
C6	=	0.0 in

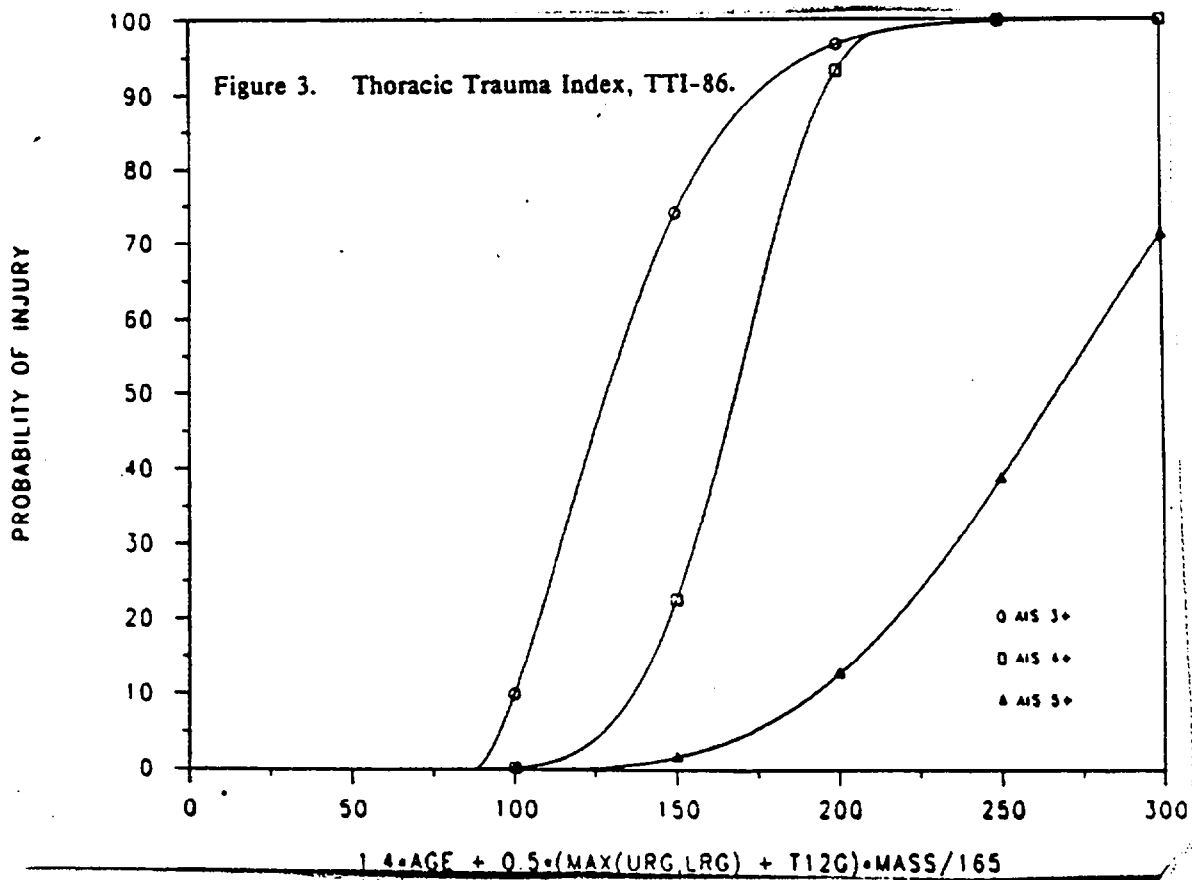
Figure 5. Thoracic Trauma Index Scale

TABLE 11  
Matrix of TTI- 86 vs AIS Values

<u>Age</u>	<u>TTI-86</u>	<u>Probability of Inquiry</u>		
		<u>AIS +3</u>	<u>AIS +4</u>	<u>AIS + 5</u>
0	91	3%	0%	0%
23	123	47%	4%	0%
41	148	74%	23%	2%

The acceleration data from the anthropomorphic dummy was also analyzed using NHTSA techniques to determine impact severity based on thoracic measurements. Results of this analysis indicate that from the standpoint of thoracic injuries the occupant suffered a very mild injury as measured on the American Association of Automotive Medicine's Abbreviated Injury Scale

(AIS). The probability of an injury level of AIS greater than 3, was 4 percent. The probability of AIS greater than 4 or 5 was 0 percent. This value, based on the T12Y, LLRY and LURY accelerometers, is well within the basic design goal for occupant responses of an AIS less than or equal to 3.0. Analysis of the acceleration data from the head of the anthropomorphic dummy yielded a Head Injury Criteria (HIC) of 1996. This result is greater than the limit specified in FMVSS 208. It should be noted that HIC's obtained during side impacts may not measure the head injury correctly since the head form of the dummy was designed for frontal impacts.

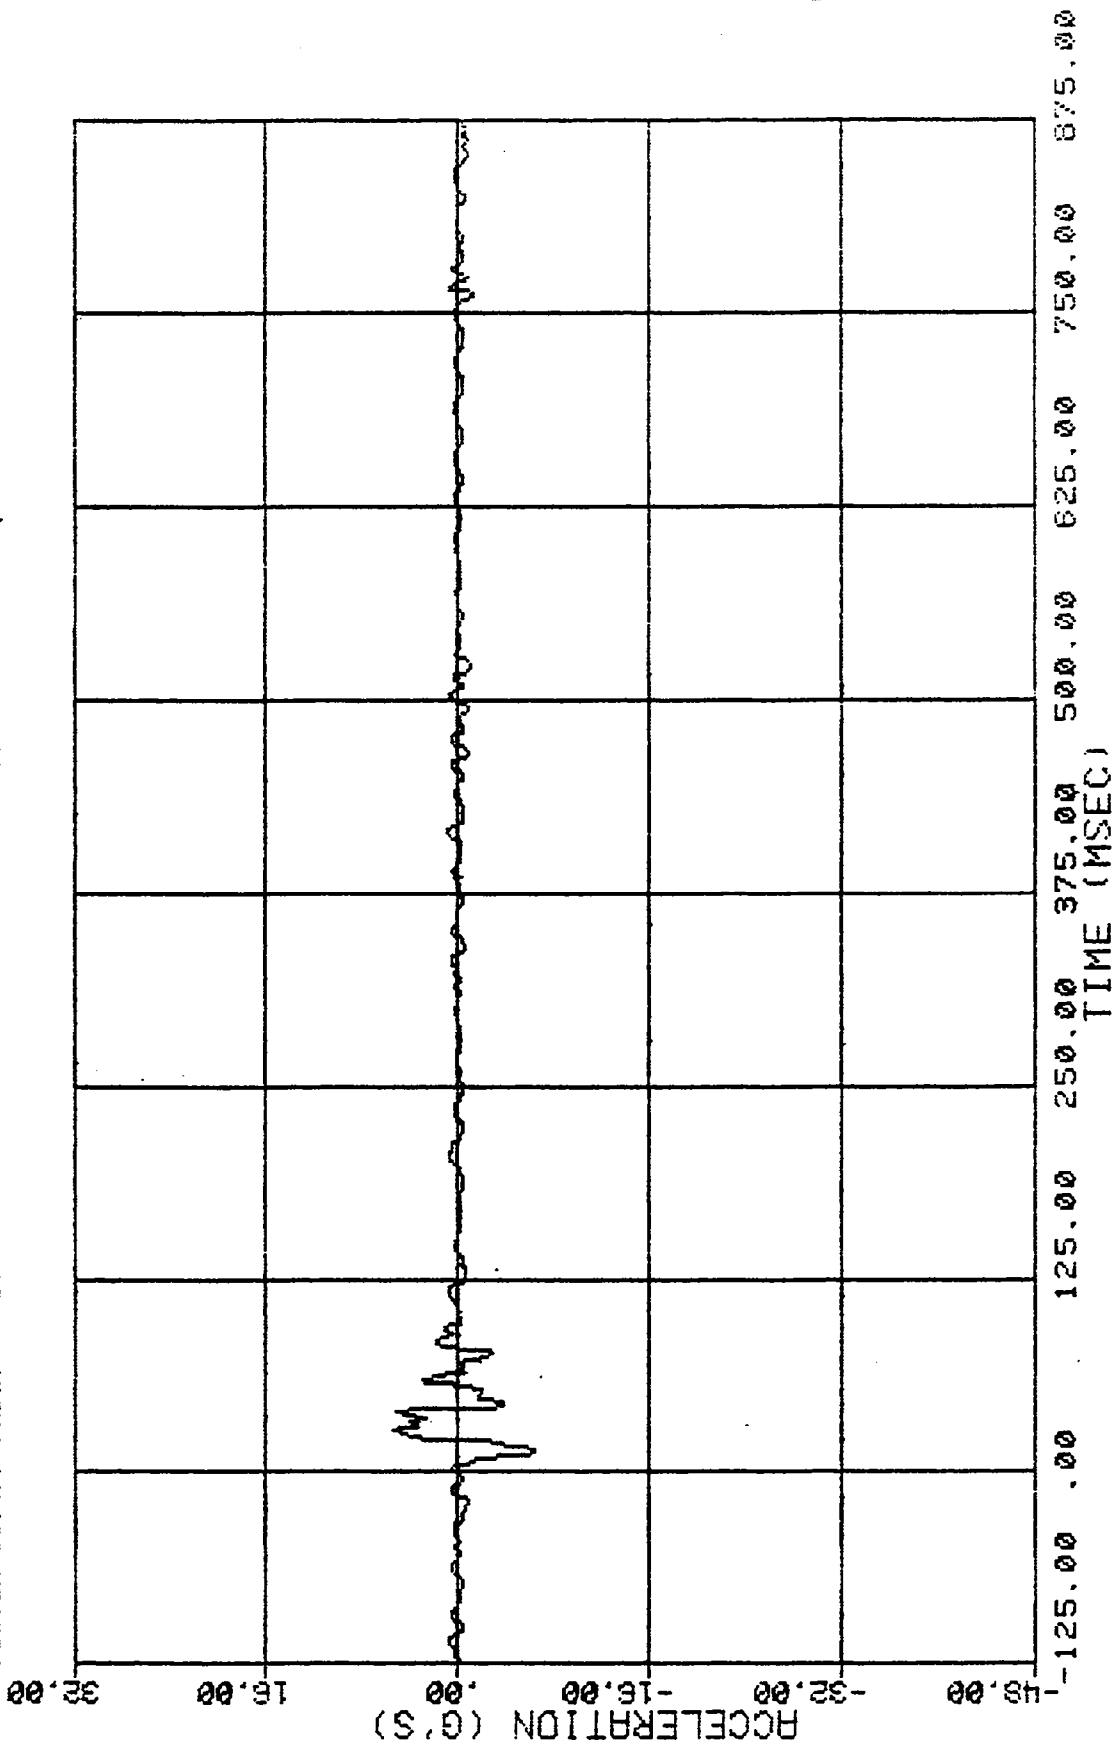
Figure A1. Vehicle X Acceleration, 100 Hz

ENSO, INC. CONTRACT NUMBER DTFH61-86-Z-00047 TEST # 1785-SI-8-88  
 30 MI/H BROADSIDE IMPACT OF 81 PLYMOUTH CHAMP INTO LUMINAIRE SUPPORT  
 CHANNEL 18 VEHICLE X  
 FILTER CUTOFF FREQ: 100 PEAKS -0.53 , 5.30

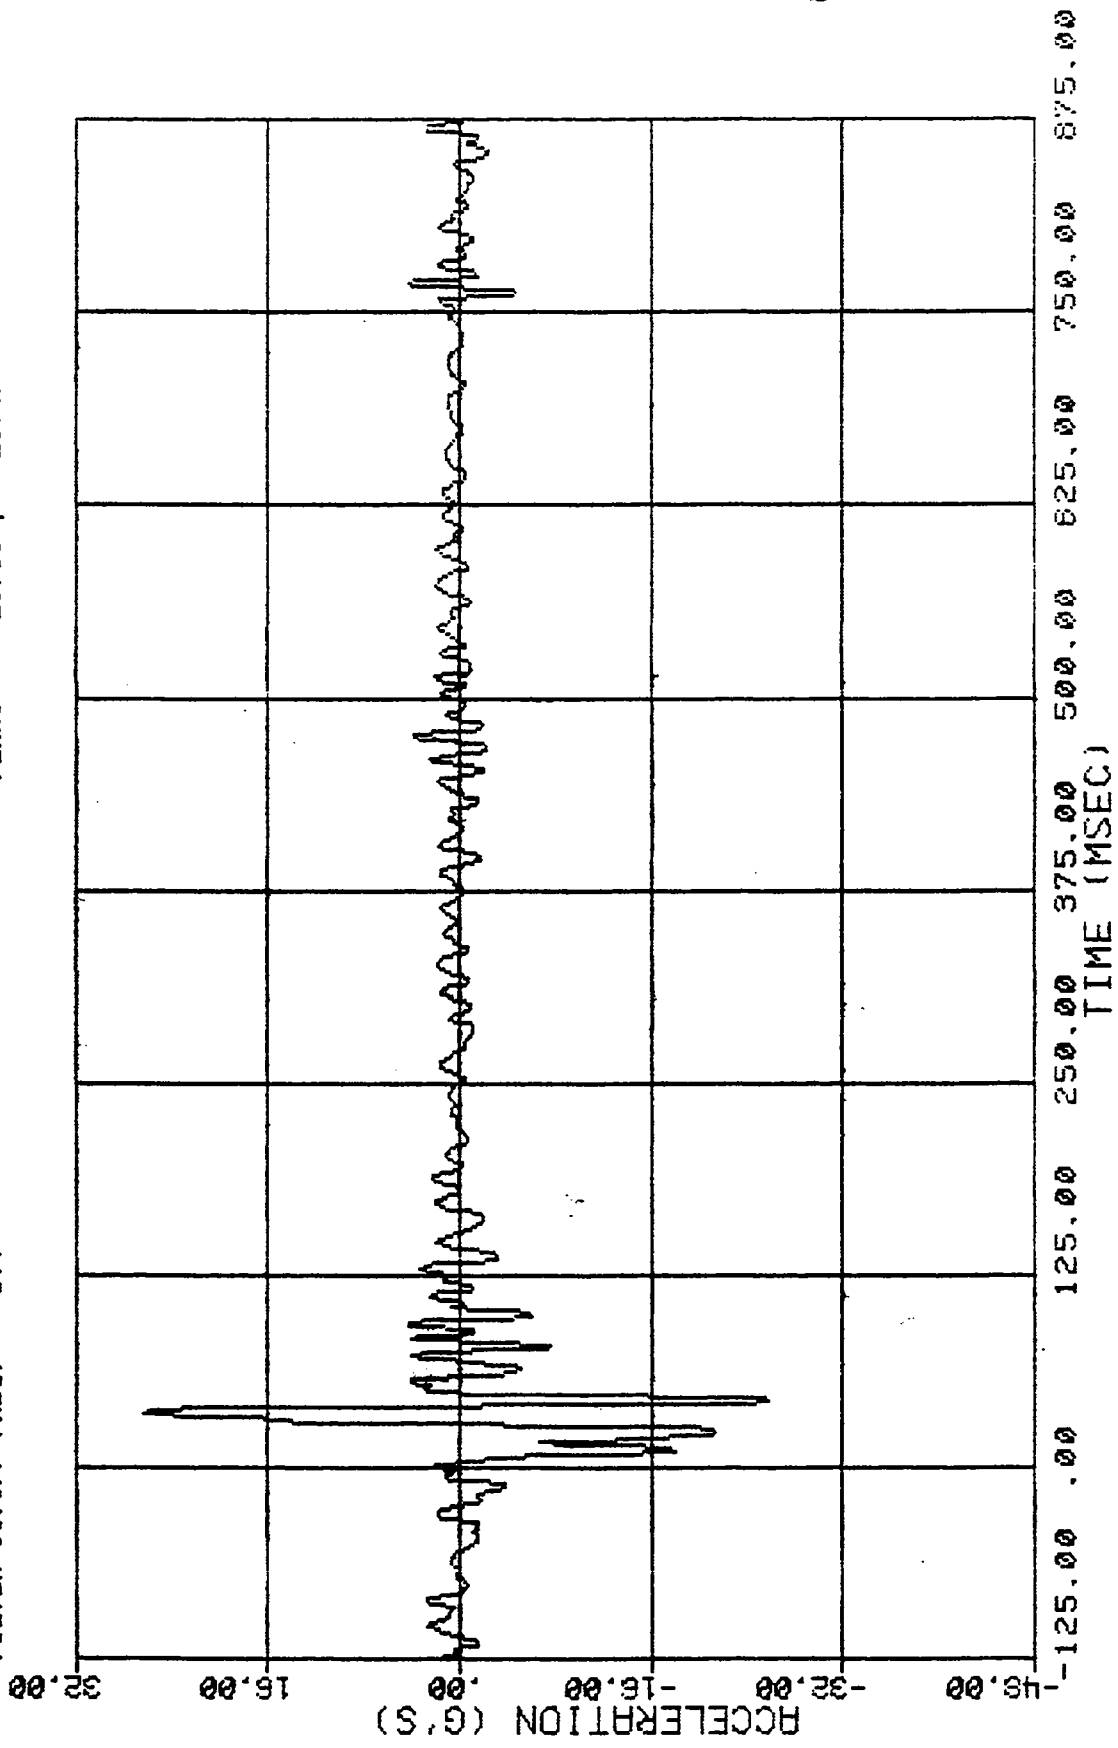
Figure A2. Vehicle Y Acceleration, 100 Hz

ENSCO, INC.    CONTRACT NUMBER    DTFH61-86-Z-00047    TEST # 1785-SI-8-88  
 30 MI/H BROADSIDE IMPACT OF 81 PLYMOUTH CHAMP INTO LUMINAIRE SUPPORT  
 CHANNEL 19    VEHICLE Y  
 FILTER CUTOFF FREQ:    100    PEAKS    -25.86 ,    26.47

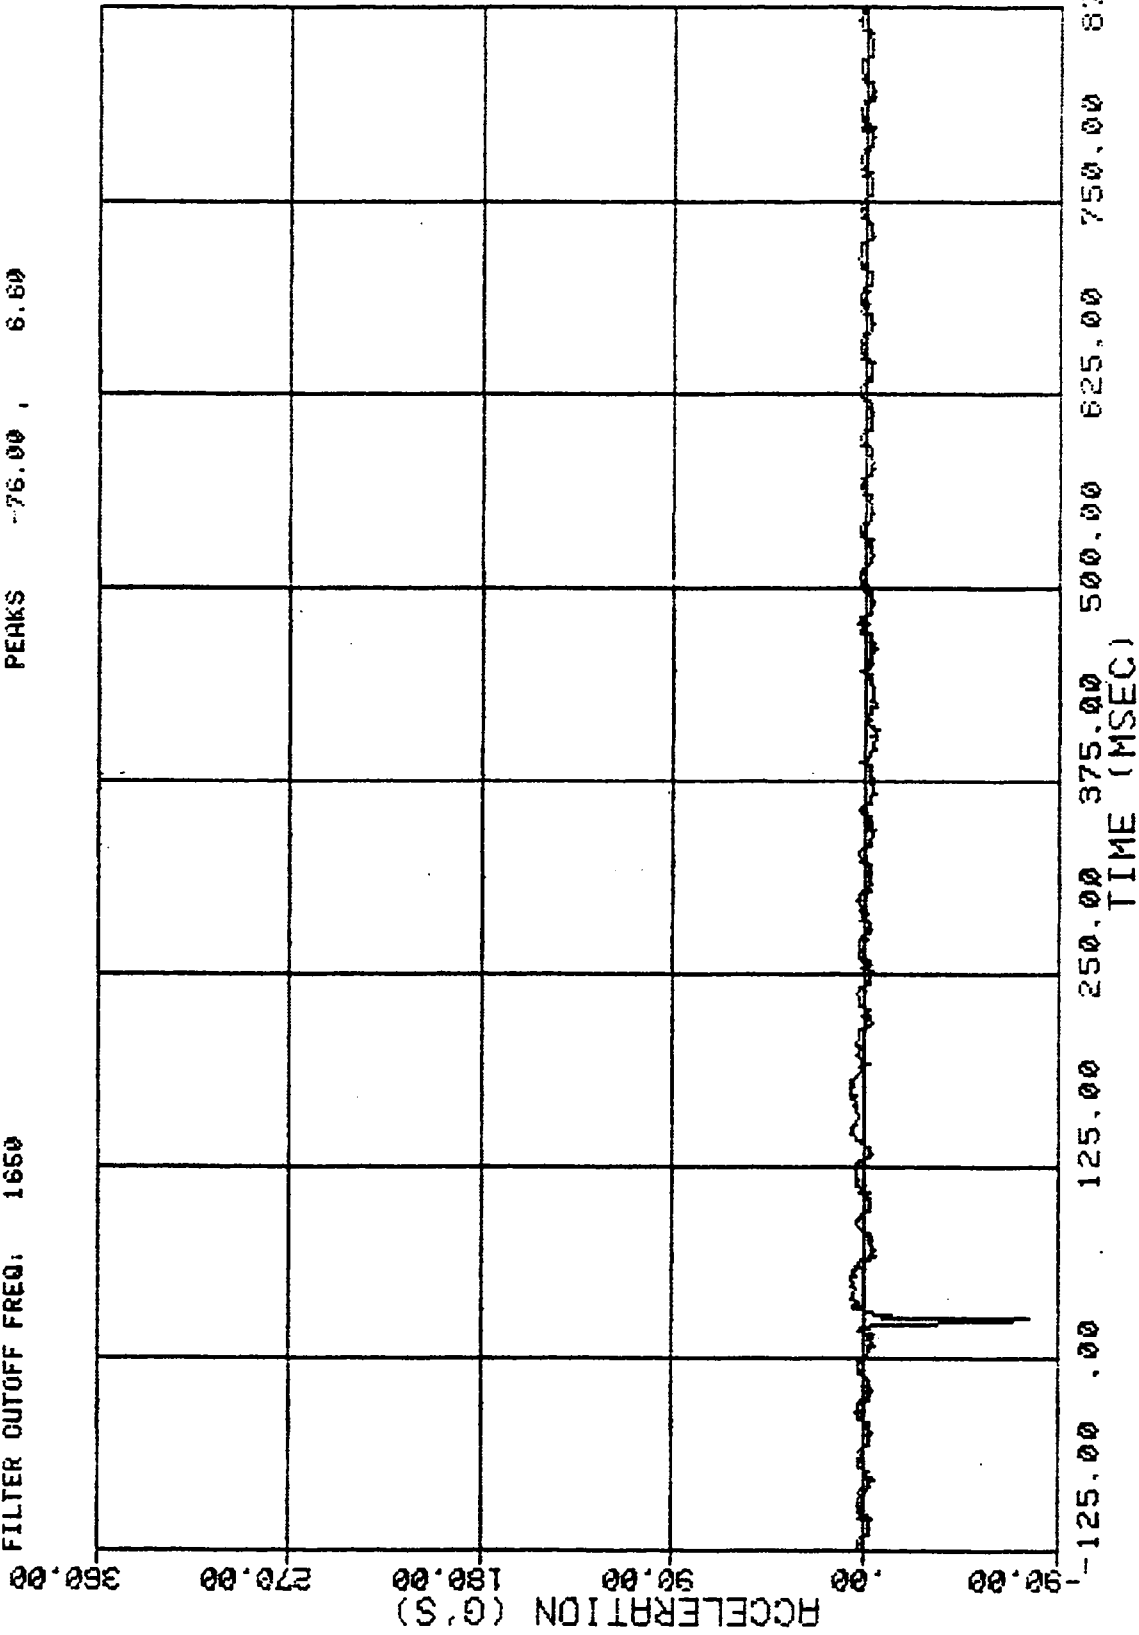
Figure A9. Head X Acceleration, 1650 Hz

ENSCO, INC.    CONTRACT NUMBER    DTFH61-86-Z-00047    TEST \* 1786-SI-8-88  
 30 MI/H BROADSIDE IMPACT OF 81 PLYMOUTH CHAMP INTO LUMINAIRE SUPPORT  
 CHANNEL 12    HEAD X  
 FILTER CUTOFF FREQ. 1650    PEAKS    -76.00 ,    6.60

The data from the triaxial accelerometer sensor assembly in the head of the test dummy was filtered at SAE Class 1000 and used to evaluate the HIC. The data obtained from the triaxial accelerometer sensor assemblies located in the upper spine of the occupant was filtered at SAE Class 180 and was used to evaluate severity indices and maximum sustained accelerations experienced by the occupant. The data obtained from the accelerometers located on the ribs of the occupant were filtered at SAE Class 180. In addition, thoracic injury parameters associated with side impact conditions were analyzed using NHTSA techniques to determine side impact occupant injury.

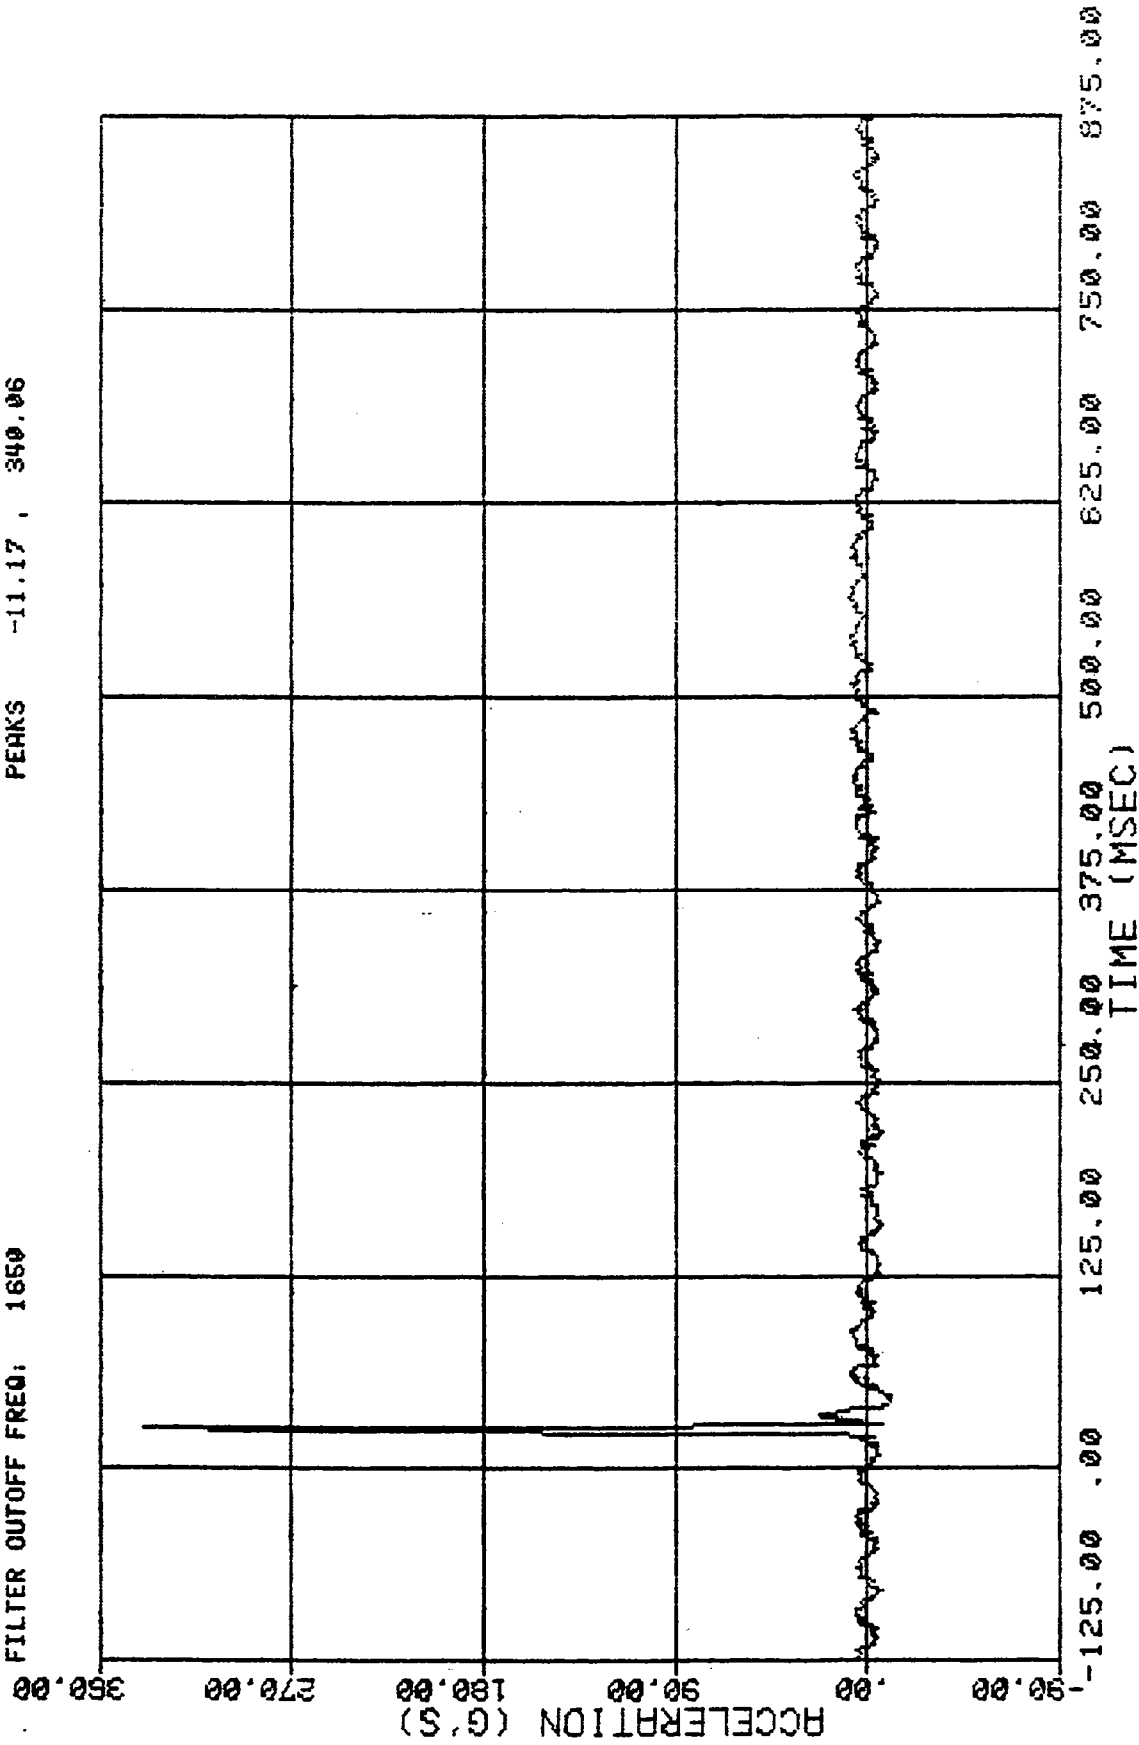
Figure A10. Head Y Acceleration, 1650 Hz

ENSCO, INC. CONTRACT NUMBER DTFH61-86-Z-00047 TEST # 1785-SI-8-88  
 30 MI/H BROADSIDE IMPACT OF 81 PLYMOUTH CHAMP INTO LUMINAIRE SUPPORT  
 CHANNEL 13 HEAD Y  
 FILTER CUTOFF FREQ: 1650 PEAKS -11.17, 340.06

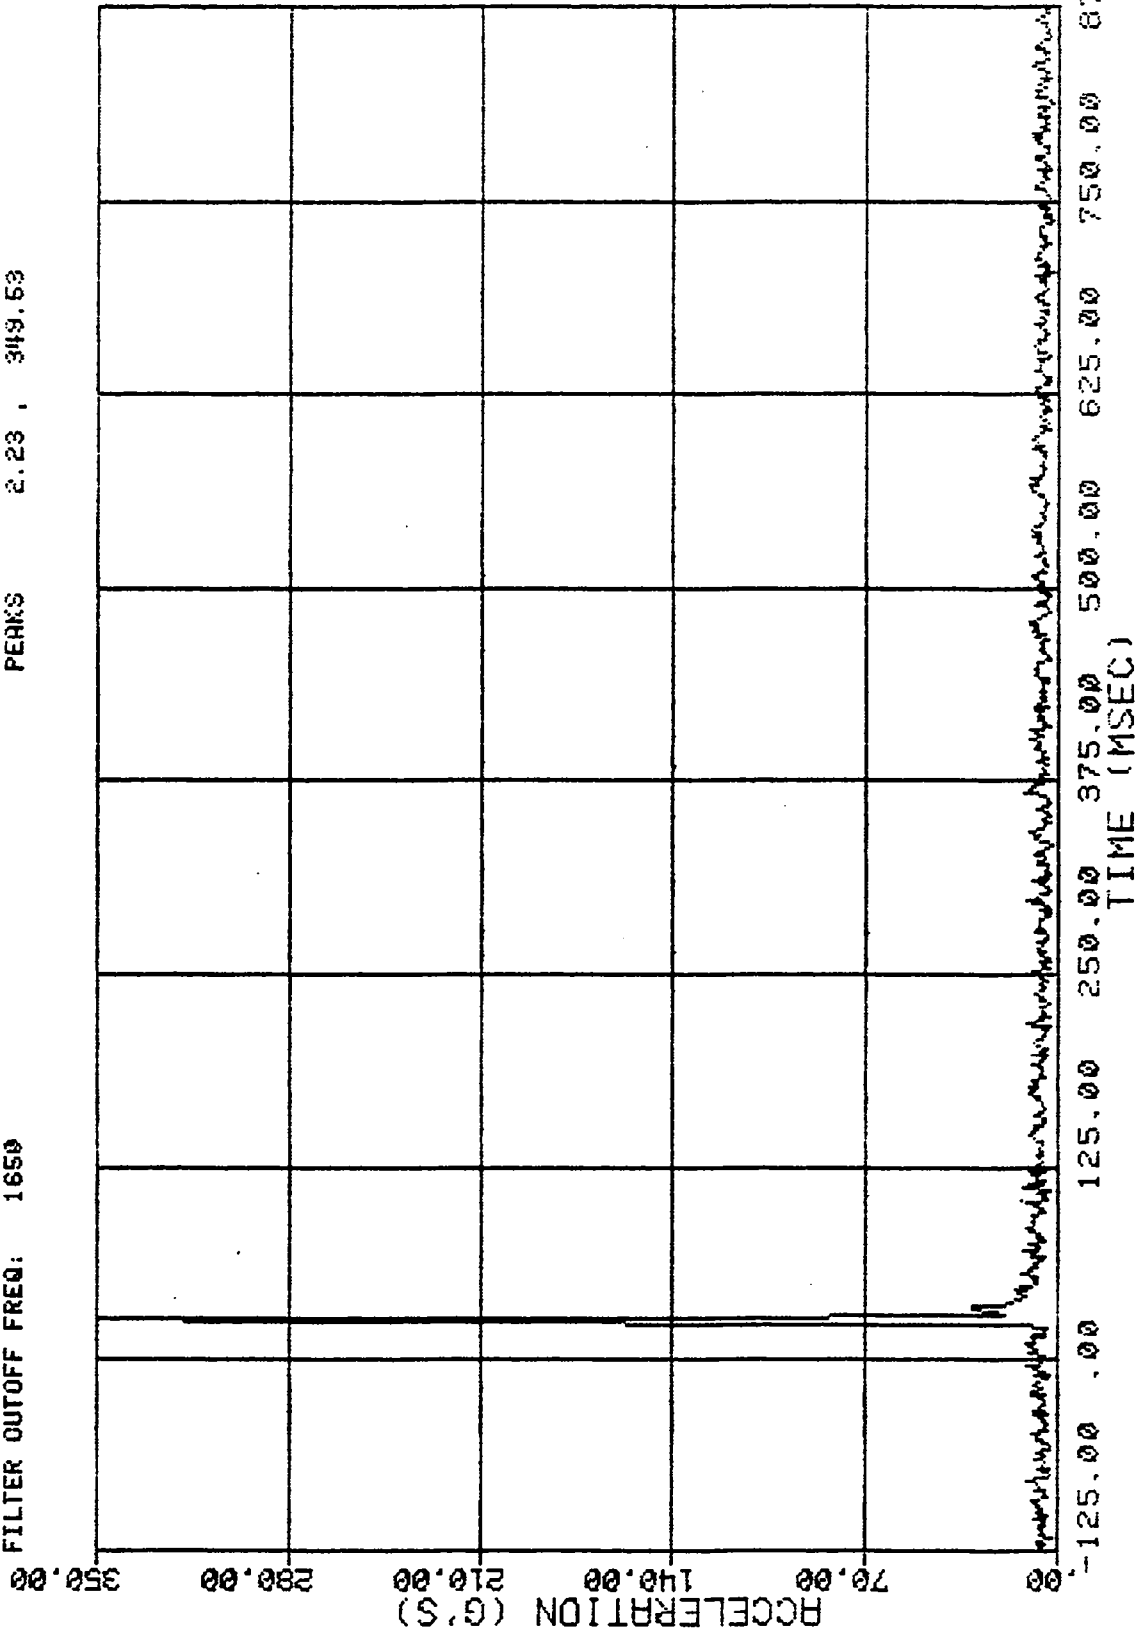
Figure A12. Head Resultant Acceleration, 1650 Hz

ENSCO, INC. CONTRACT NUMBER DTFH61-66-Z-00047 TEST # 1785-SI-8-88  
 30 MI/H BROADSIDE IMPACT OF 81 PLYMOUTH CHAMP INTO LUMINAIRE SUPPORT  
 CHANNEL 0 HEAD RESULTANT PEAKS 2.23 349.53  
 FILTER CUTOFF FREQ: 1650

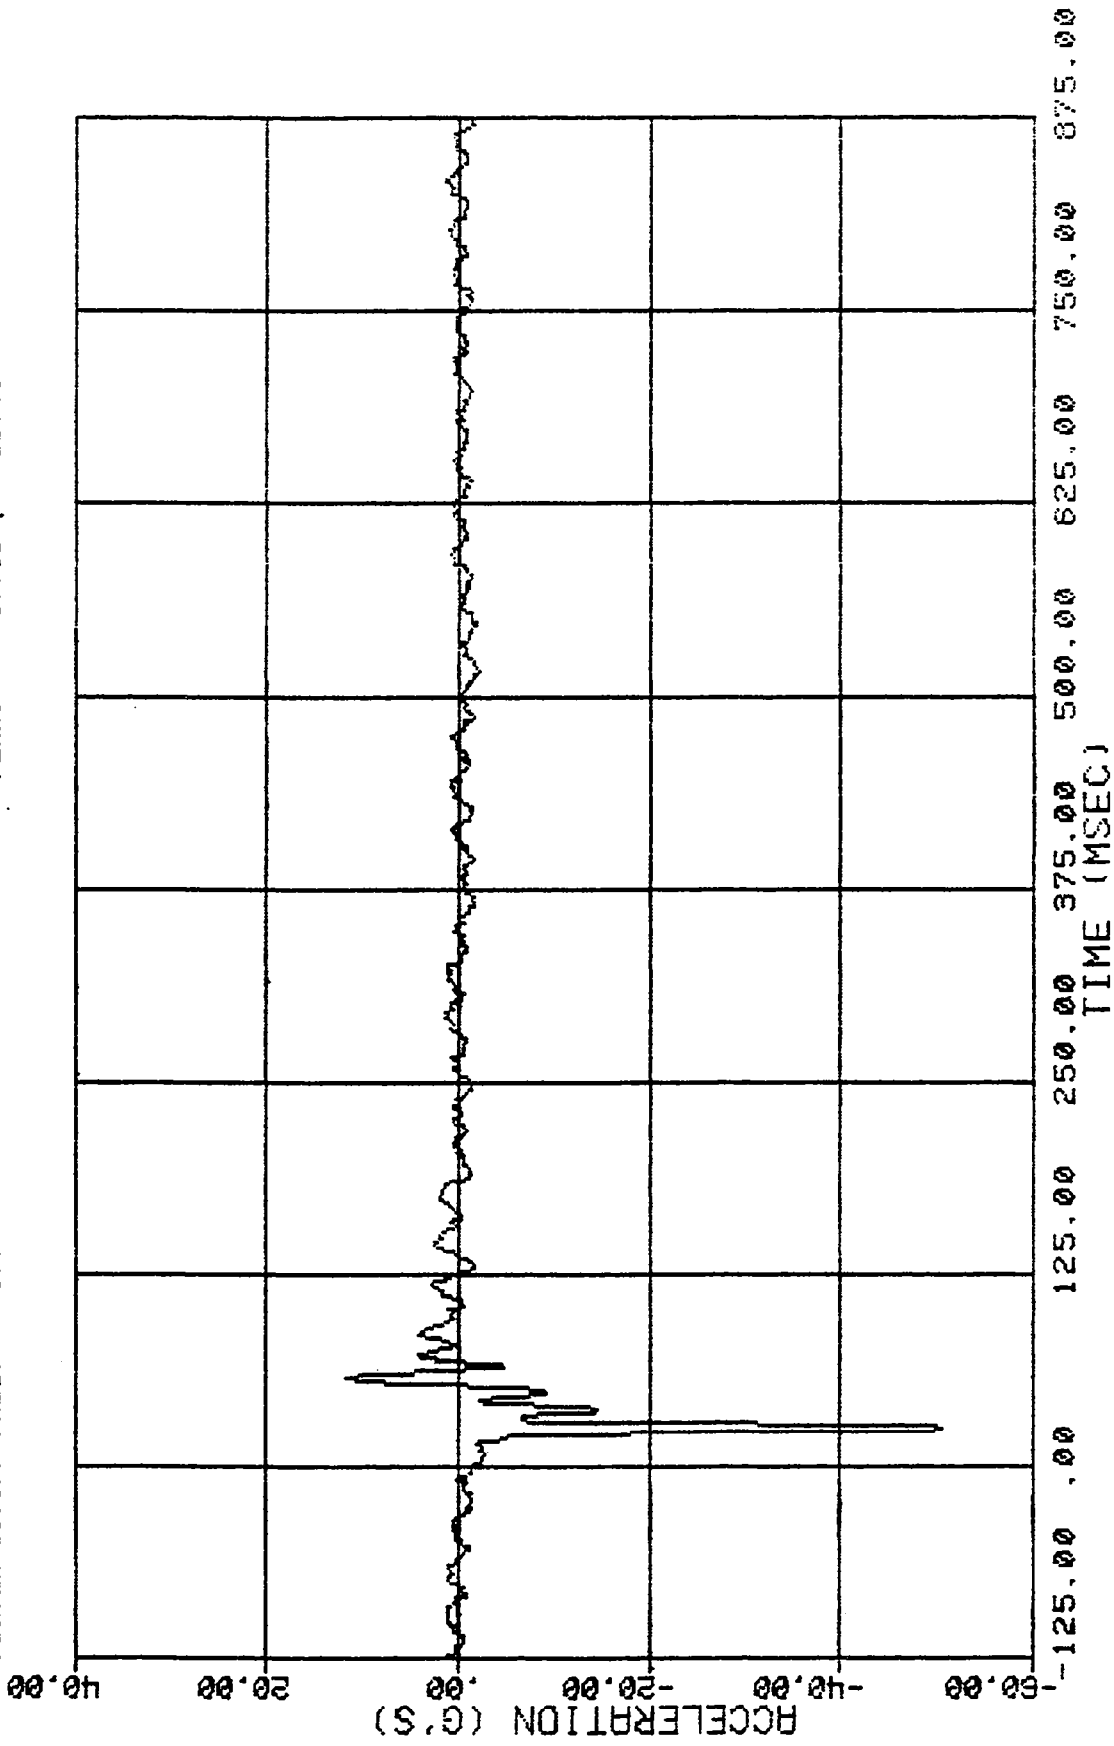
Figure A18. T12 - Y Acceleration, 300 Hz

ENSCO, INC.    CONTRACT NUMBER    DTFH61-86-Z-00047    TEST \* 1785-SI-0-88  
 30 MI/H BROADSIDE IMPACT OF 81 PLYMOUTH CHAMP INTO LUMINAIRE SUPPORT  
 CHANNEL    7    T12Y  
 FILTER CUTOFF FREQ:    300    PEAKS    -50.51 ,    11.58

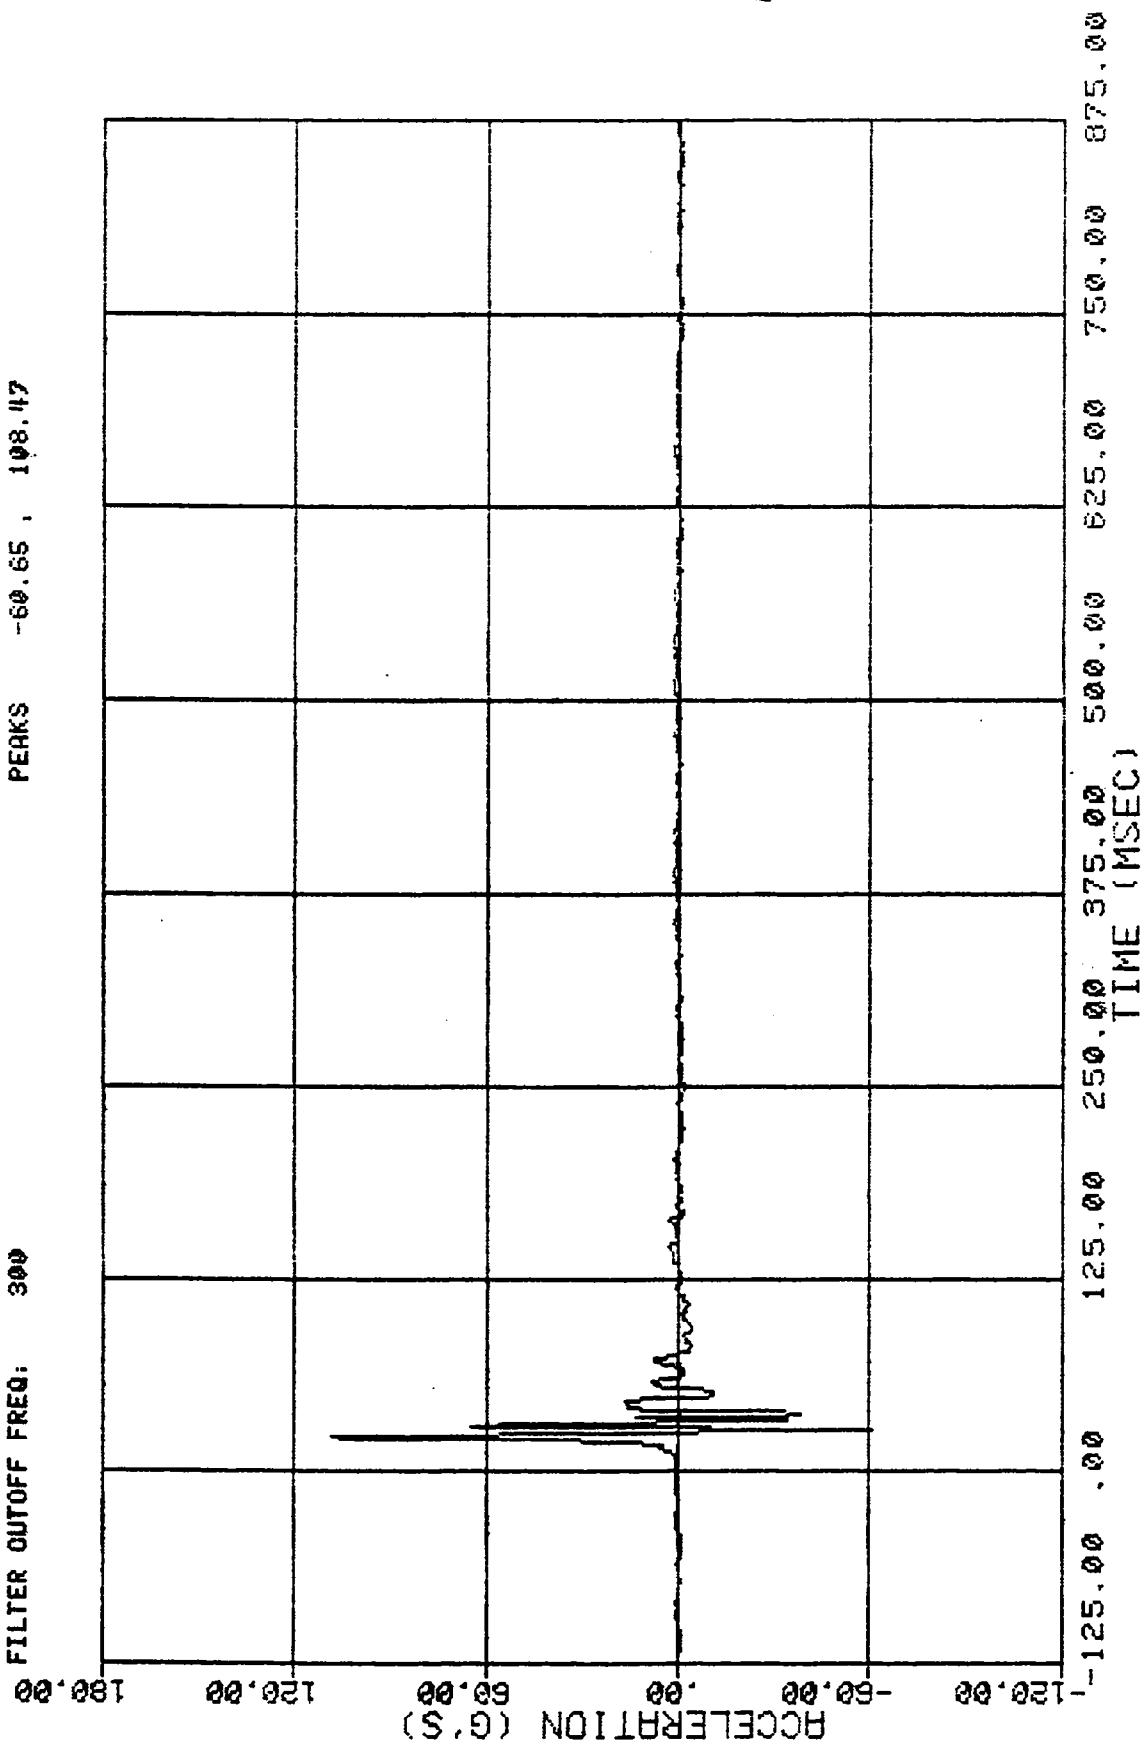
Figure A26. LLR - Y01 Acceleration, 300 Hz

ENSO, INC. CONTRACT NUMBER DTFH61-86-Z-00047 TEST # 1785-SI-8-88  
 30 MI/H BROADSIDE IMPACT OF 81 PLYMOUTH CHAMP INTO LUMINAIRE SUPPORT  
 CHANNEL 1 LLRY01 PEAKS -60.65 , 108.17  
 FILTER CUTOFF FREQ: 300
