THIRTY MPH BROADSIDE  
IMPACT OF A MINI-SIZED VEHICLE  
AND A BREAKAWAY LUMINAIRE SUPPORT

TEST RESULTS REPORT.

TEST NUMBER 1785-SI#8-88

Prepared by:  
ENSCO, INC.  
Applied Technology and Engineering Division  
5400 Port Royal Road  
Springfield, VA 22151

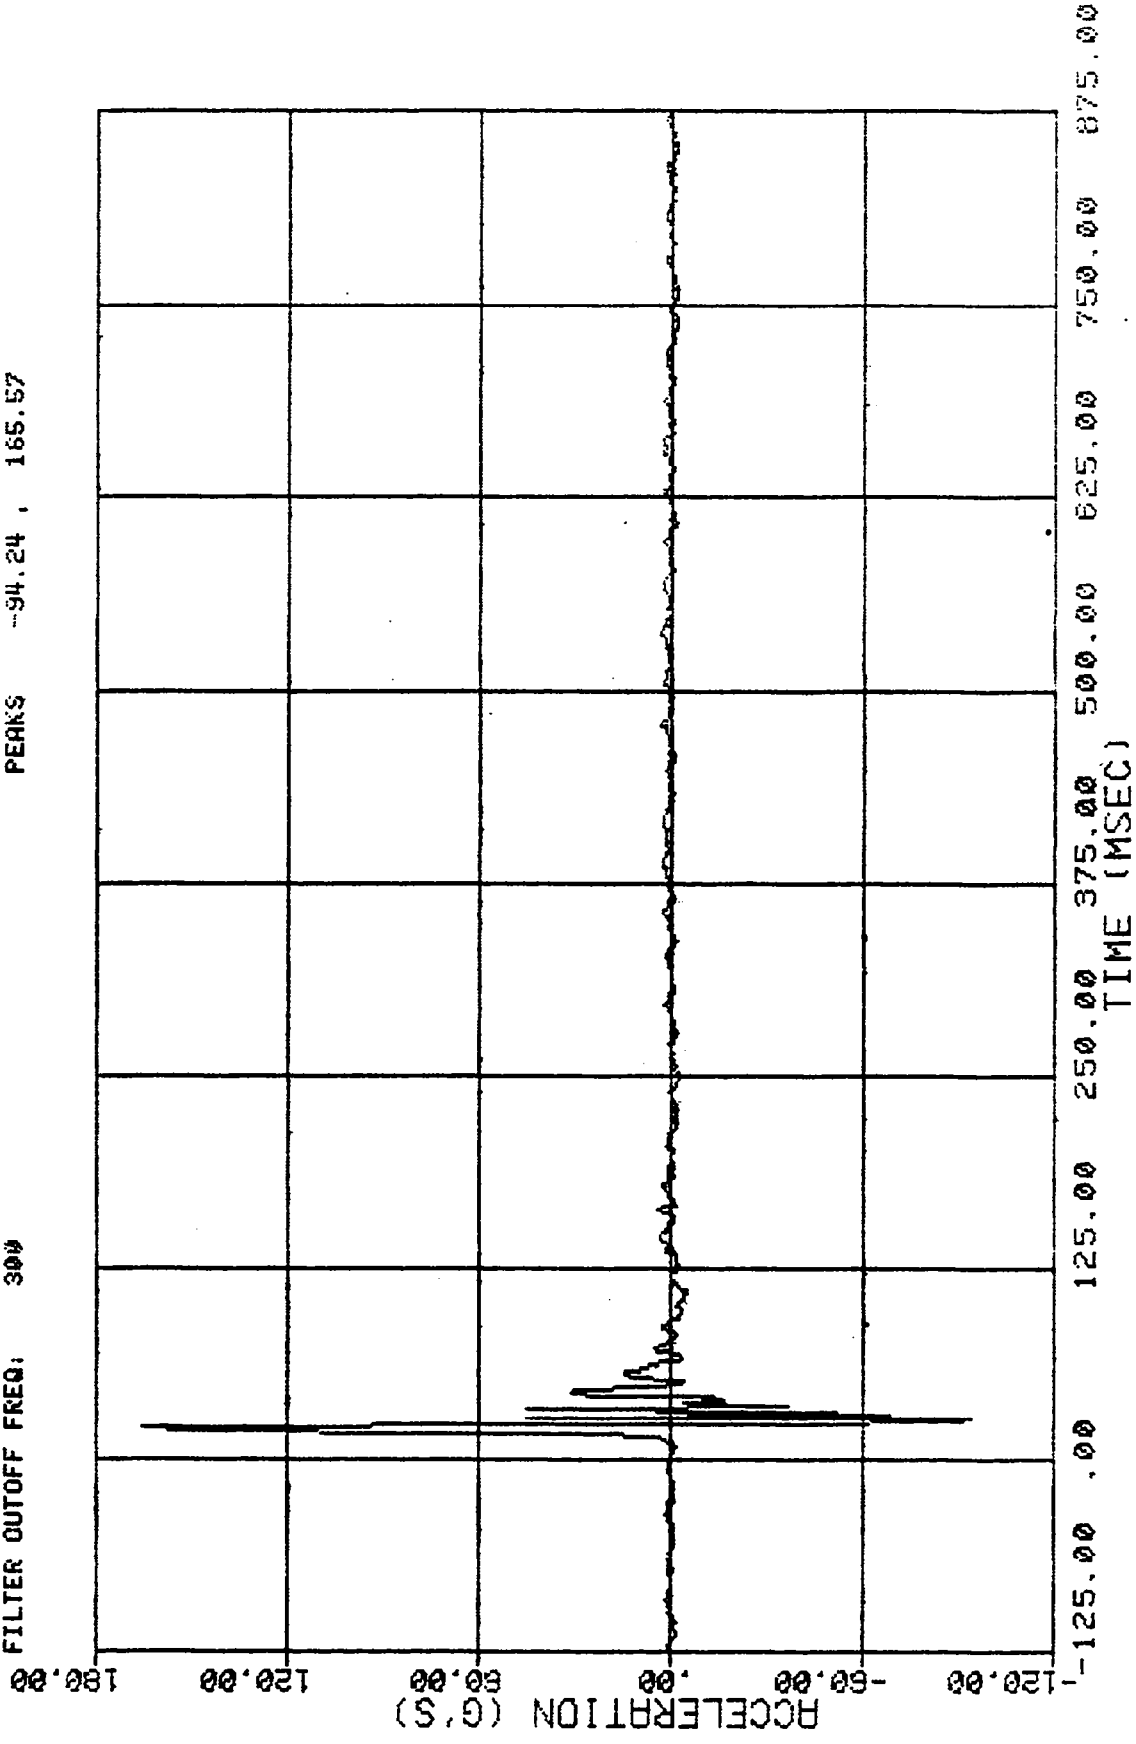
Figure A28. LUR - YG1 Acceleration, 300 Hz

ENSCO, INC. CONTRACT NUMBER DTFH61-86-Z-00047 TEST # 1785-SI-8-88  
 30 MI/H BROADSIDE IMPACT OF 81 FLYMOOTH CHAMP INTO LUMINAIRE SUPPORT  
 CHANNEL 2 LURY01 PEAKS -94.24 , 165.57  
 FILTER CUTOFF FREQ: 300

(AIS). The probability of an injury level of AIS greater than 3, was 4 percent. The probability of AIS greater than 4 or 5 was 0 percent. This value, based on the T12Y, LLRY and LURY accelerometers, is well within the basic design goal for occupant responses of an AIS less than or equal to 3.0. Analysis of the acceleration data from the head of the anthropomorphic dummy yielded a Head Injury Criteria (HIC) of 1996. This result is greater than the limit specified in FMVSS 208. It should be noted that HIC's obtained during side impacts may not measure the head injury correctly since the head form of the dummy was designed for frontal impacts.
