SIDE IMPACT PROTECTION  
IN PRODUCTION VEHICLES

MDB-TO-CAR SIDE IMPACT TEST OF  
A 26° CRABBED MOVING DEFORMABLE BARRIER  
TO A 1984 FORD RANGER  
AT 33.5 MPH

MOBILITY SYSTEMS AND EQUIPMENT COMPANY  
9920 LA CIENEGA BOULEVARD SUITE 708  
INGLEWOOD, CALIFORNIA 90301

TEST REPORT

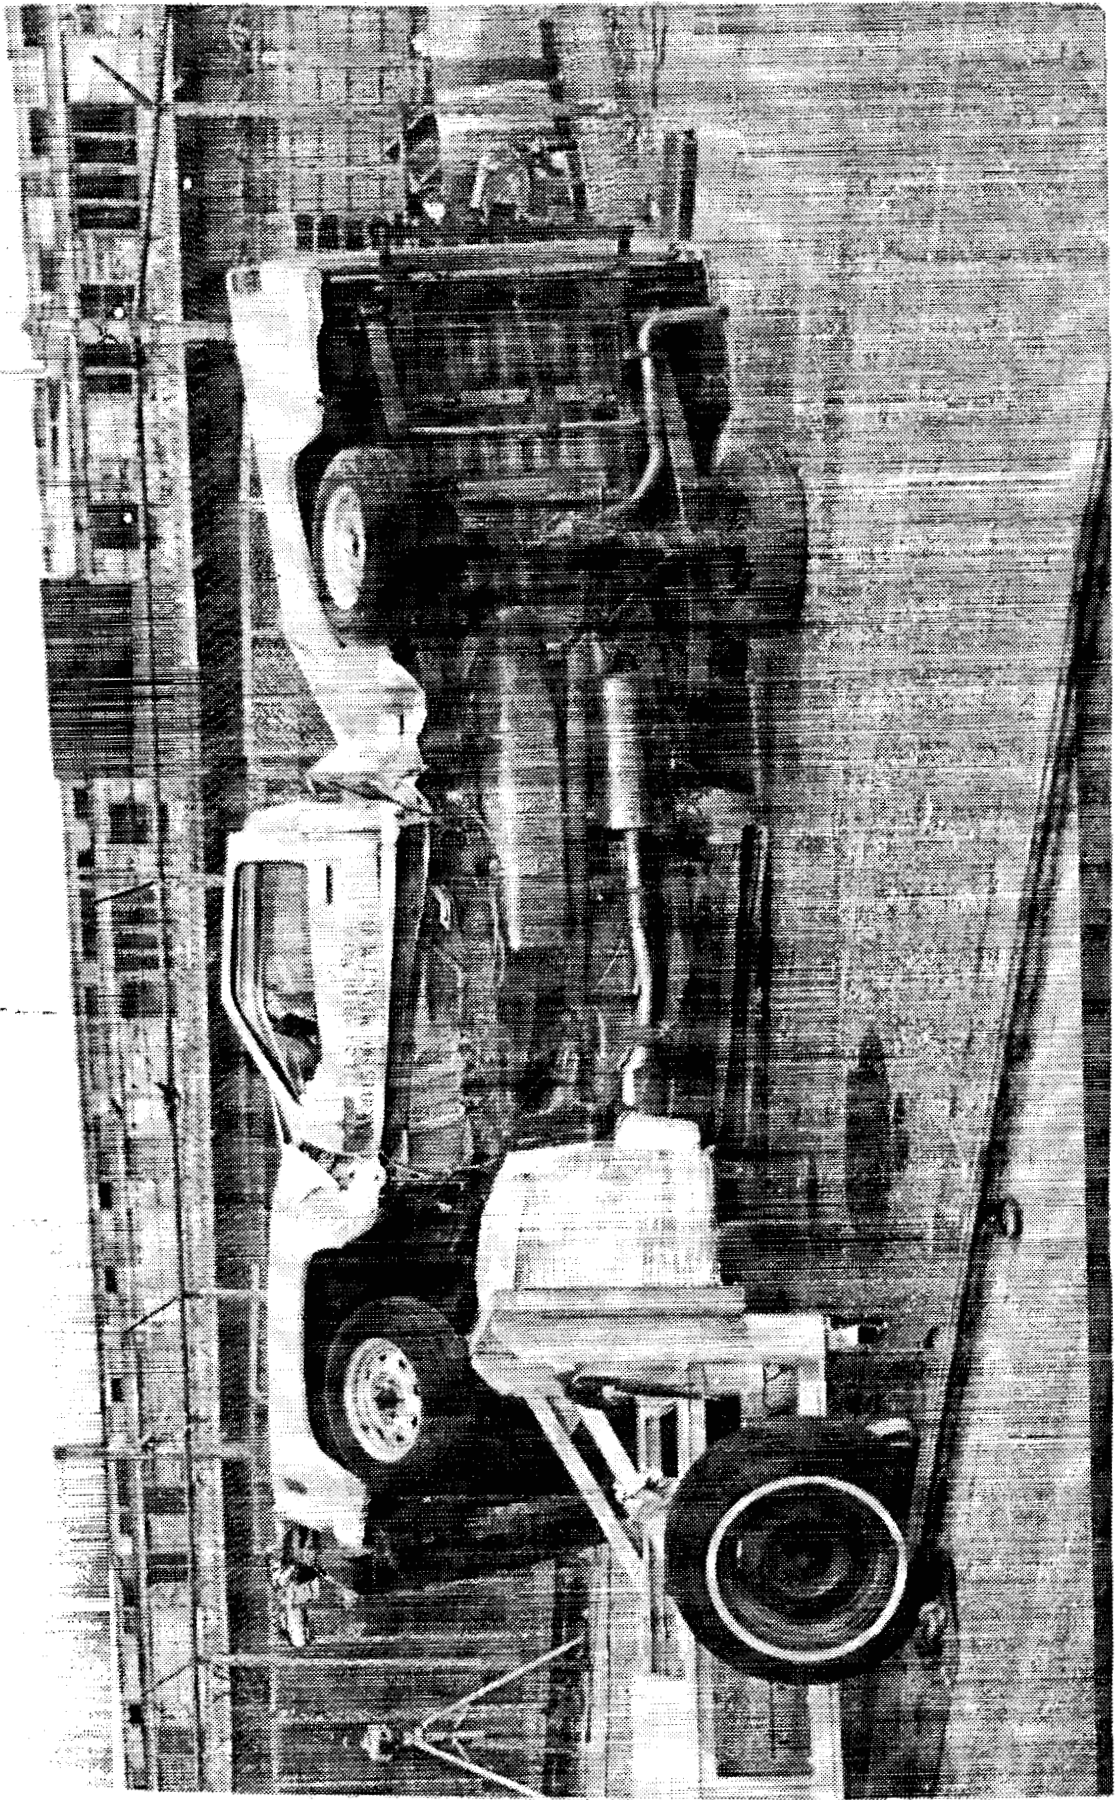
FIGURE A-8 MDB AND TEST VEHICLE, OVERALL VIEW - POSTTEST

The MDB impacted the test vehicle and was stopped by the remote brake system to prevent a second impact. The aluminum deformable barrier received minor damage with a maximum crush of 10.4 inches on the left front corner. The crush details for the MDB are given in Table 3-6.
