VEHICLE SAFETY COMPLIANCE TESTING  
FOR OCCUPANT CRASH PROTECTION.  
WINDSHIELD MOUNTING, WINDSHIELD ZONE  
INTRUSION, AND FUEL SYSTEM INTEGRITY

1989 PONTIAC GRAND PRIX

NHTSA NO. CK0108

TRC TEST NO. 890206

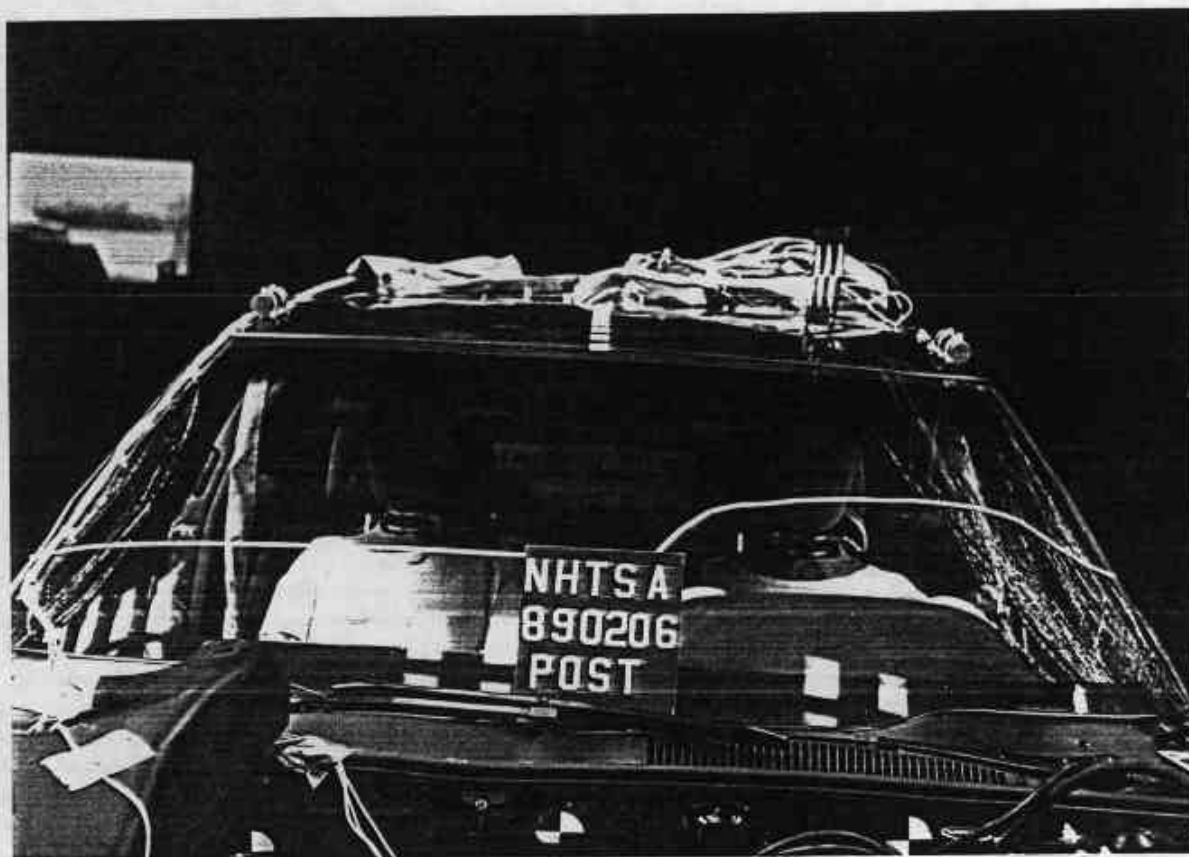
The windshield was cracked along each side upon  
impact.

Figure A-14. POST-TEST WINDSHIELD VIEW  
A-8
