REPORT NO. 301-MSE-88-10-TR8001-10

**SAFETY COMPLIANCE TEST FOR  
301-75  
REAR IMPACT**

1988 NISSAN KINGCAB PICKUP

NHTSA NO. CJ0601

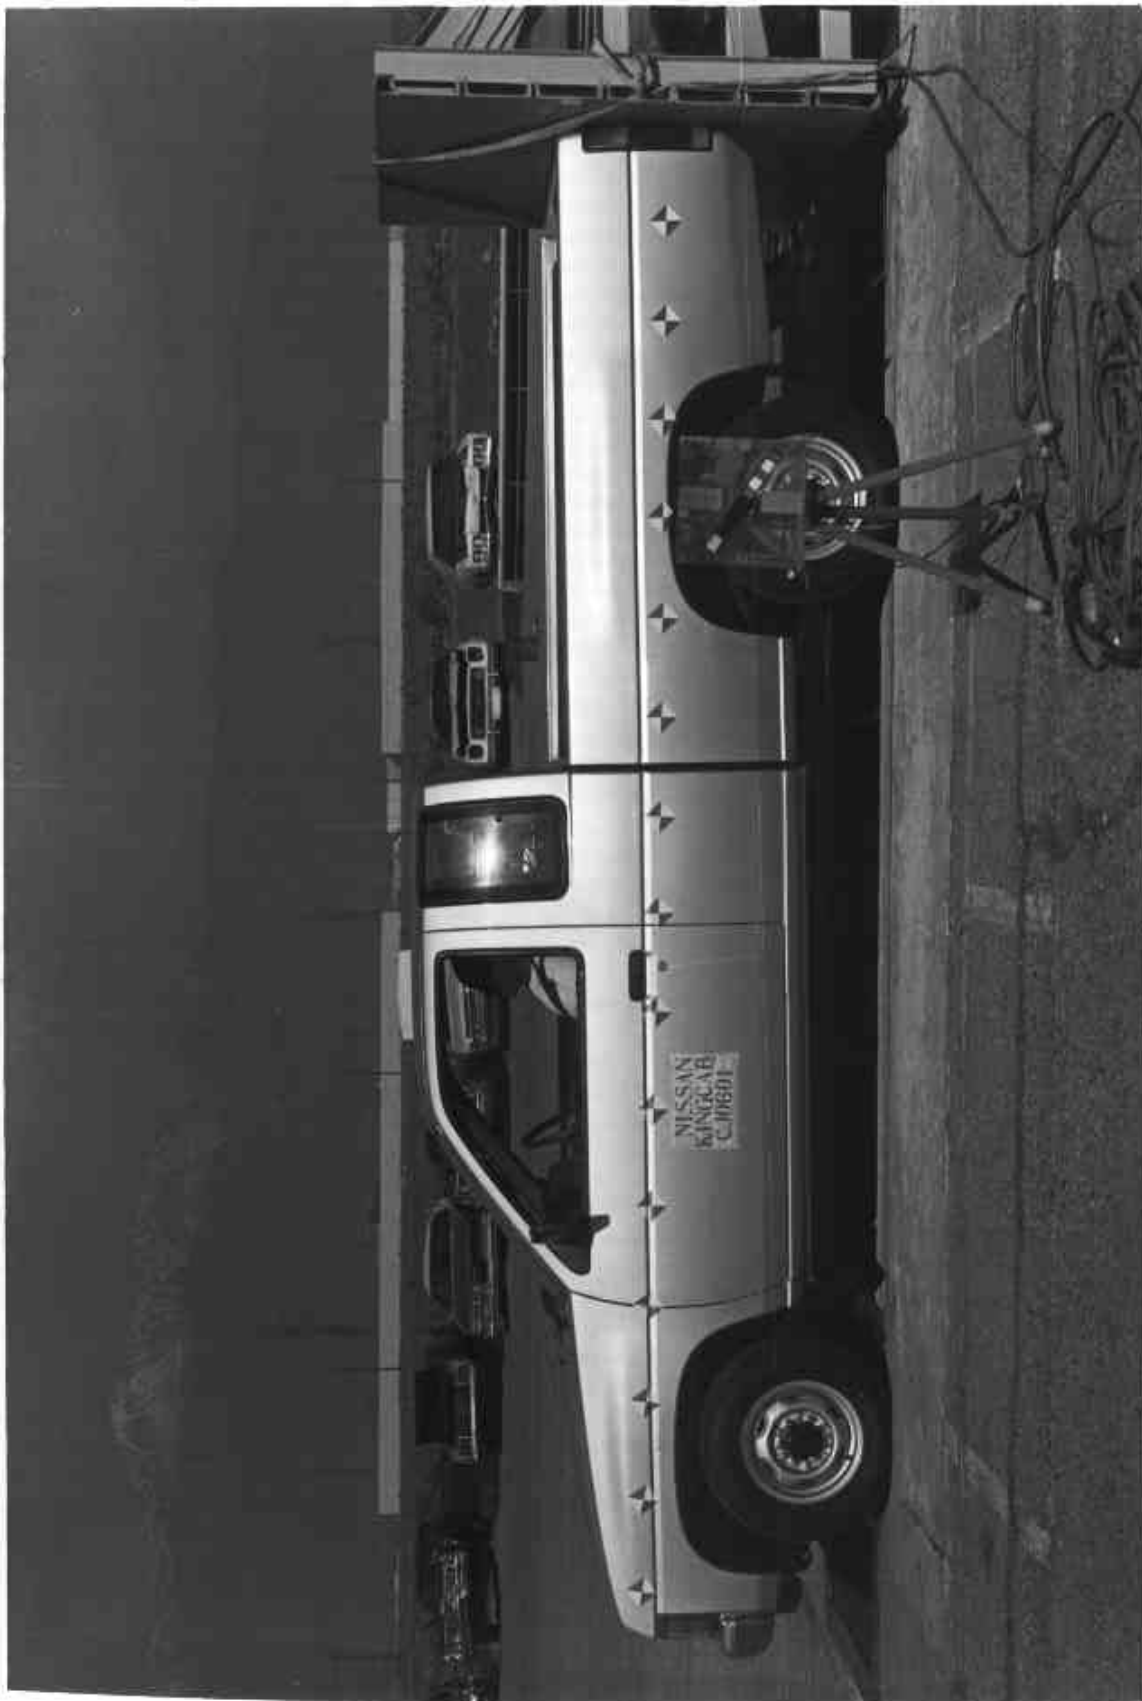
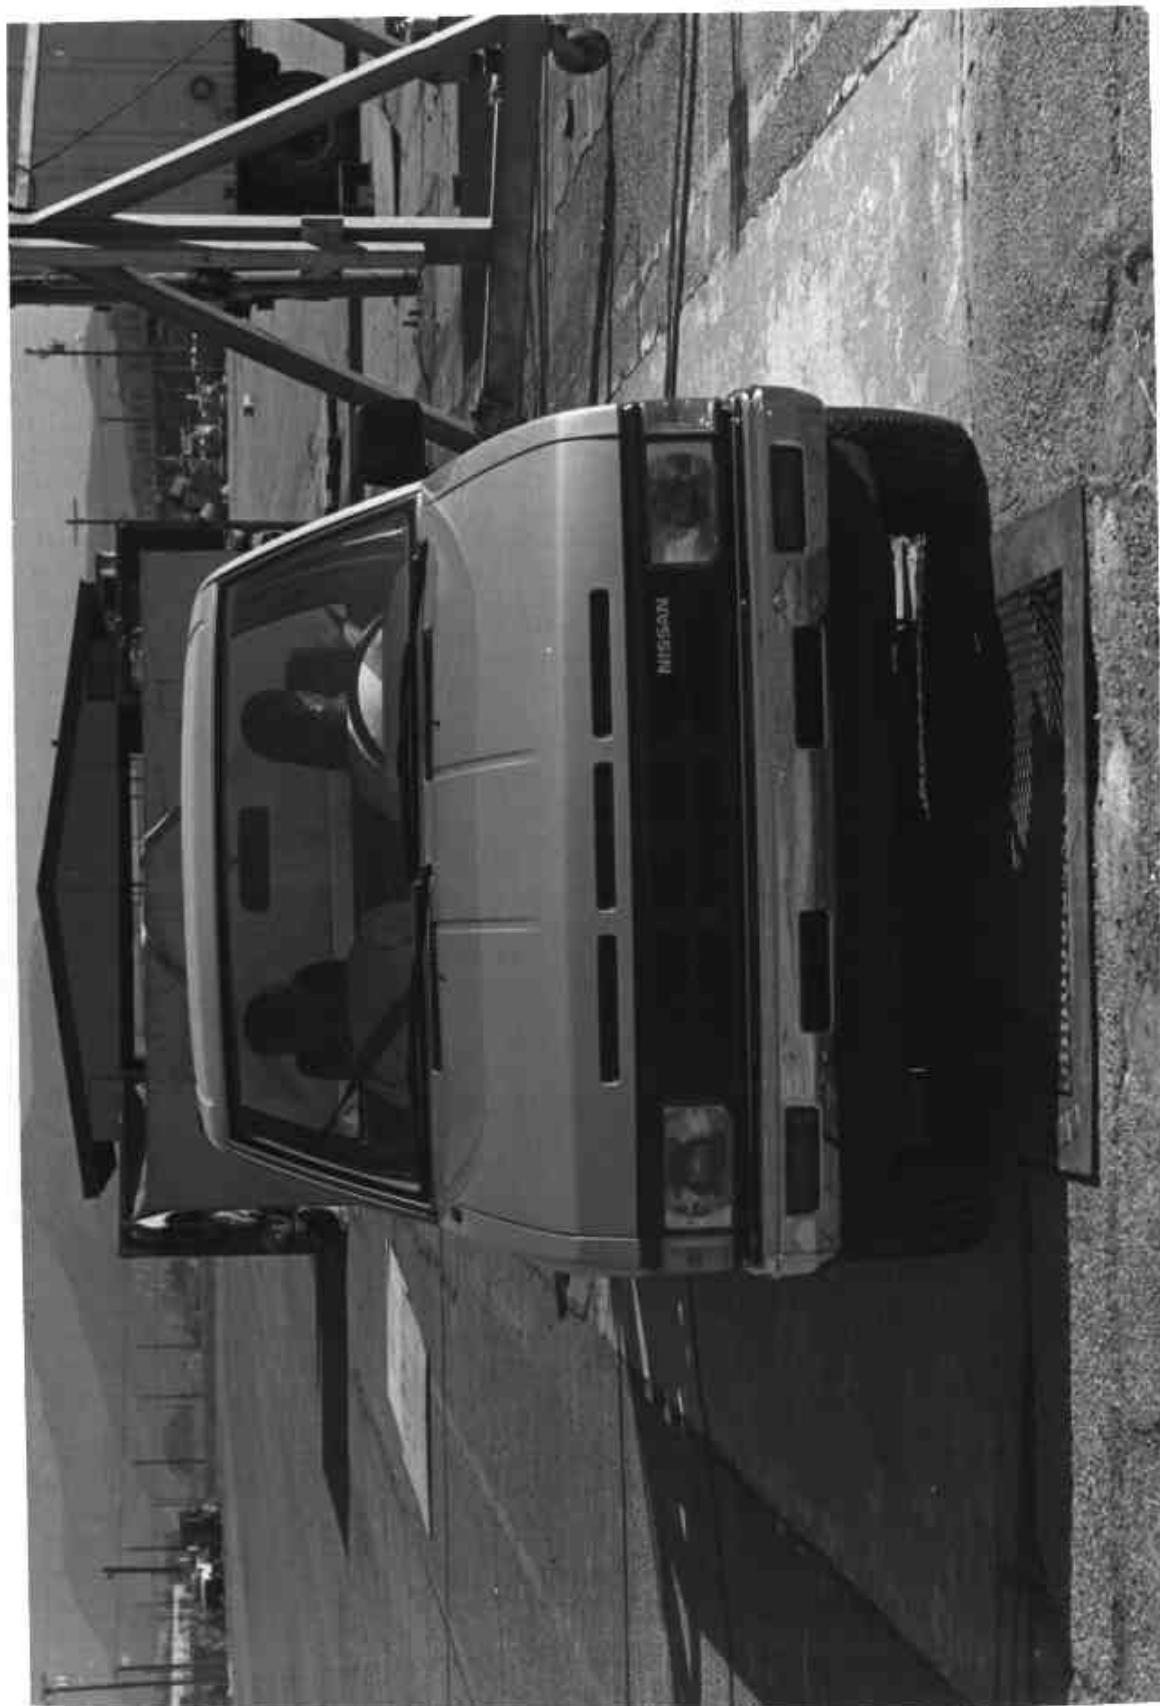
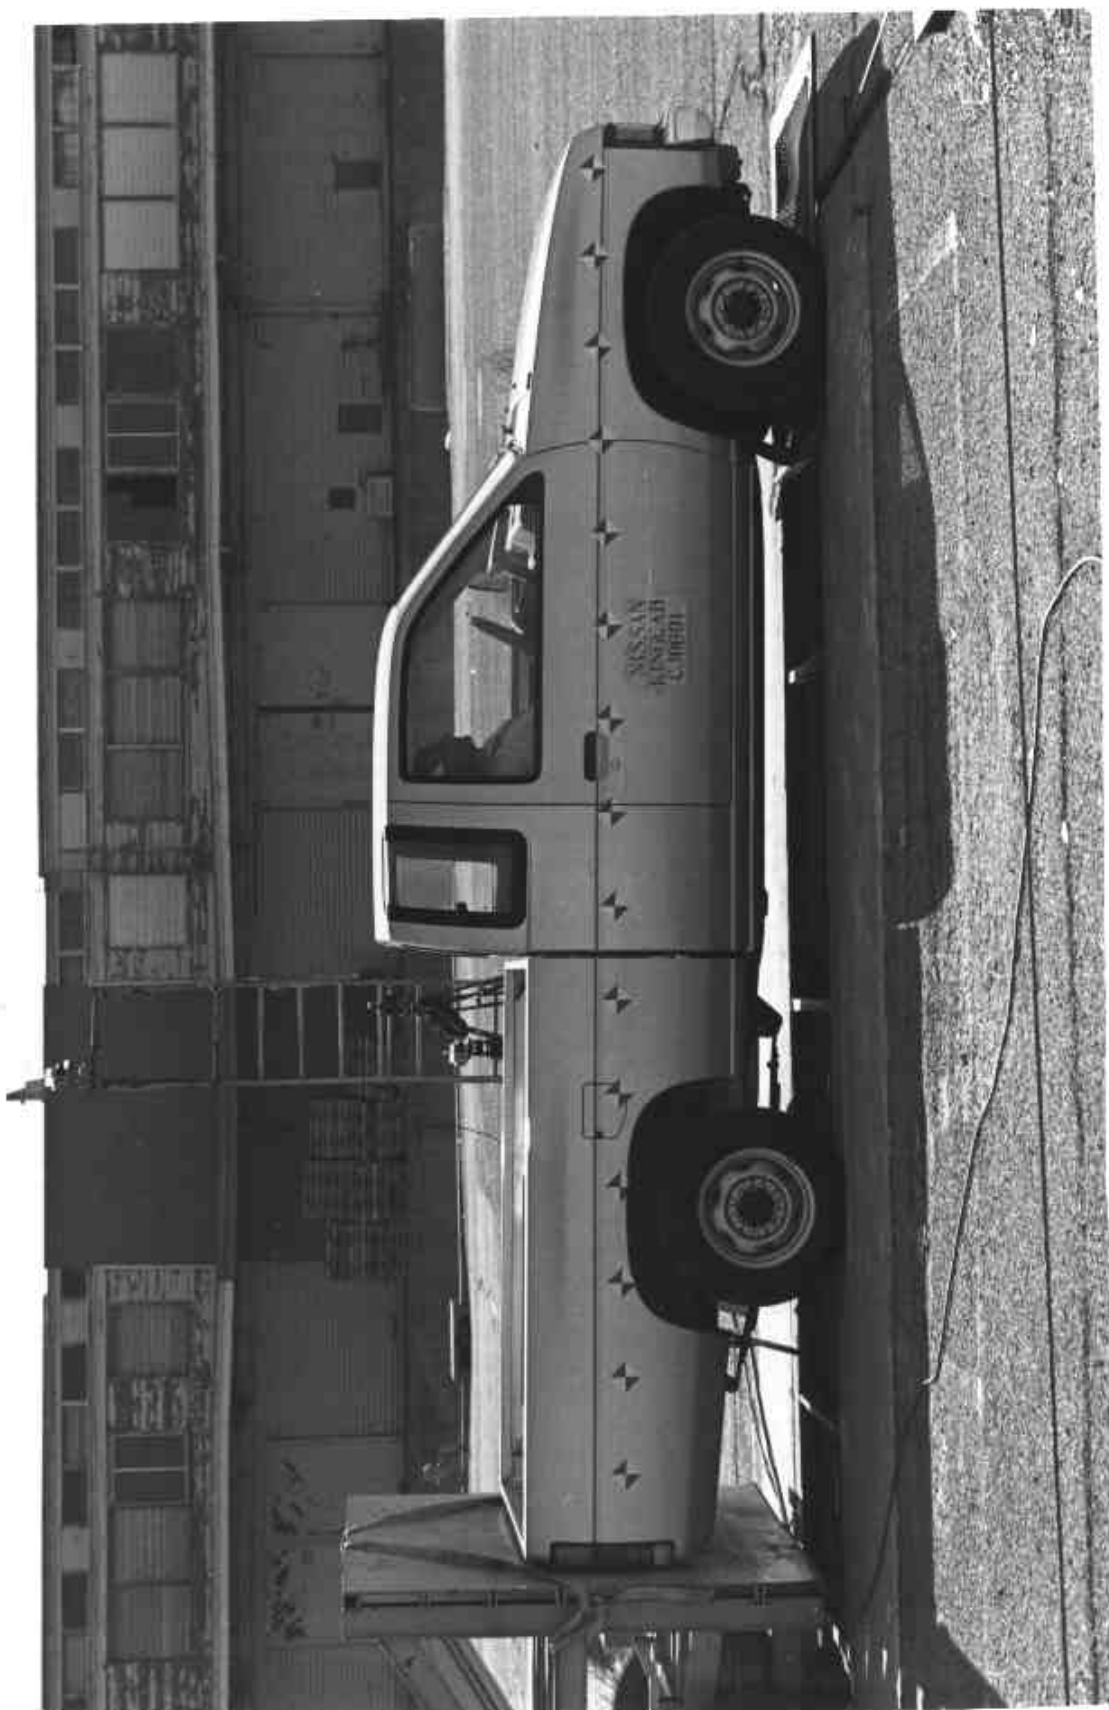
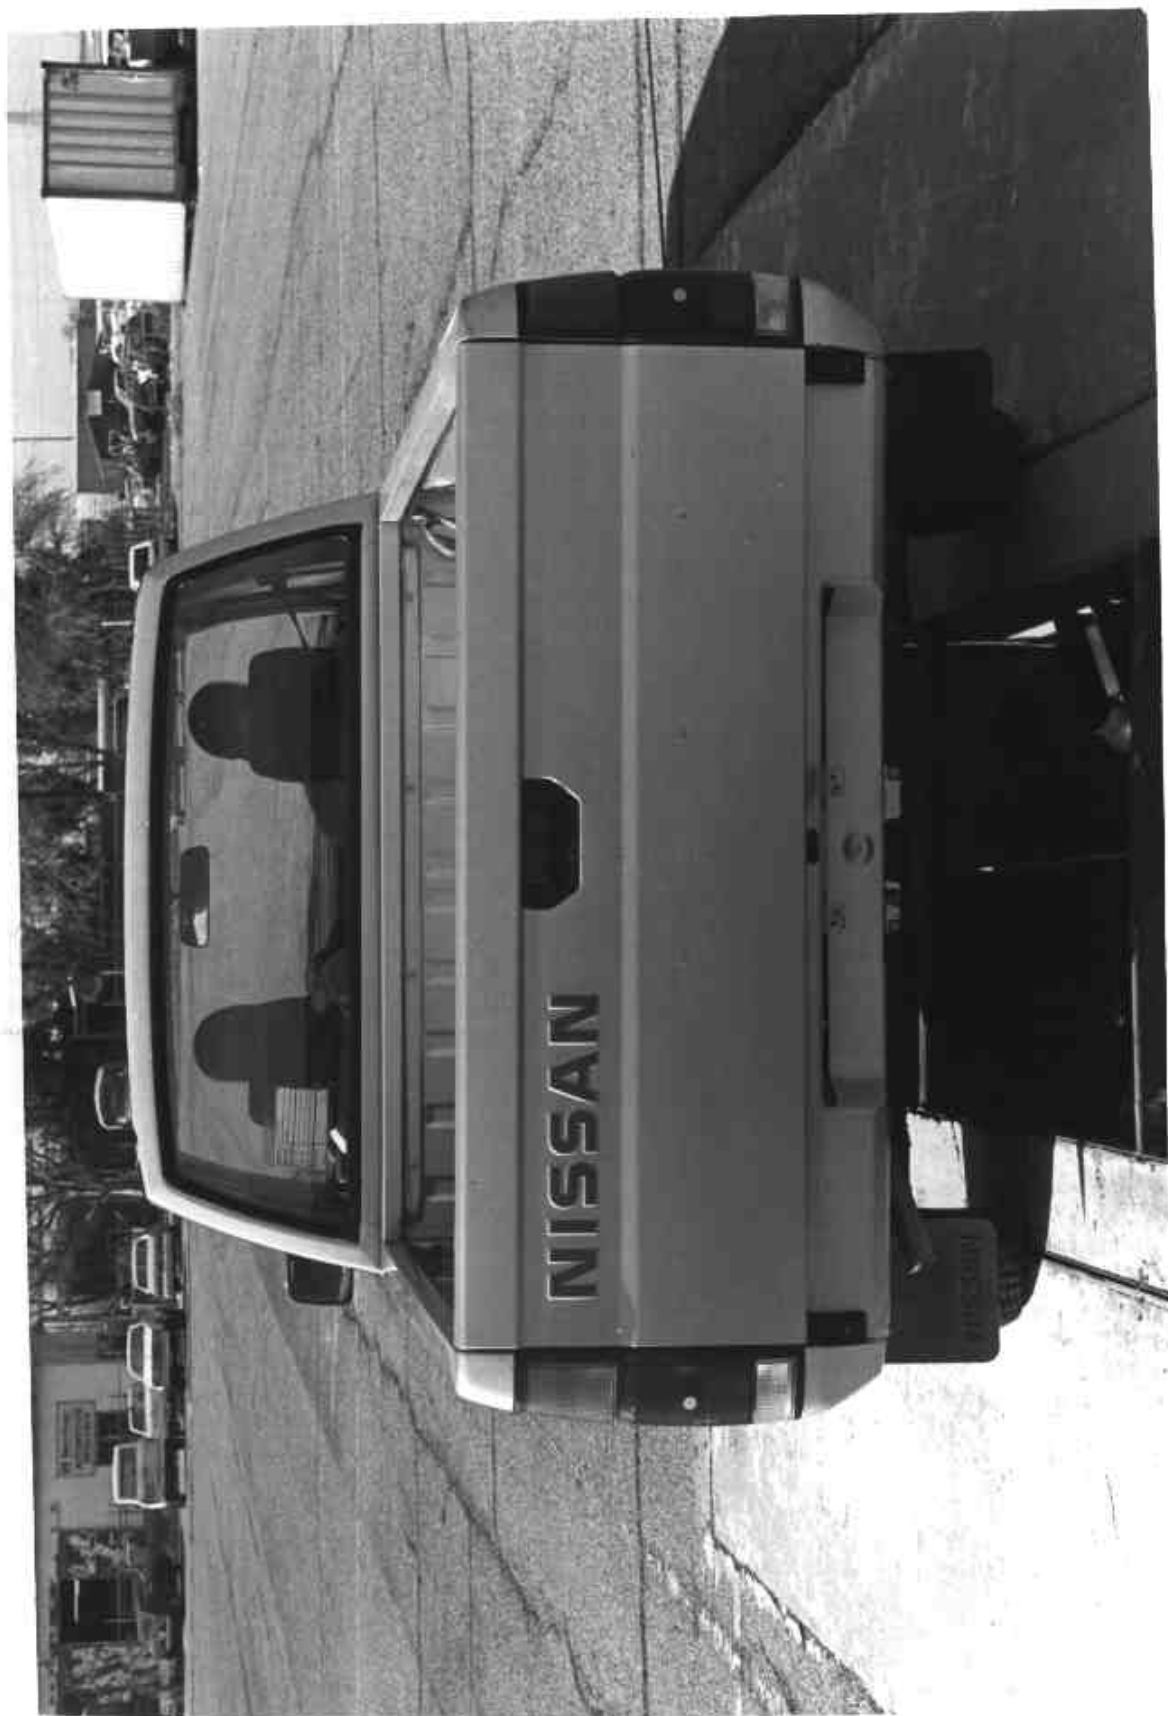
FIGURE 2-1 FULL LEFT SIDE VIEW - PRETEST

FIGURE 2-2 FULL FRONT VIEW - PRETEST

FIGURE 2-3 FULL RIGHT SIDE VIEW - PRETEST

FIGURE 2-4 FULL REAR VIEW - PRETEST

The 1988 Nissan King Cab Pickup, NHTSA No. CJ0601 was subjected to FMVSS 301-75 Rear testing on 13 January 1989. The vehicle is shown in pretest condition in Figures 2-1 to 2-4. Manufacturer's and tire placard labels are shown in Figures 2-5 and 2-6.

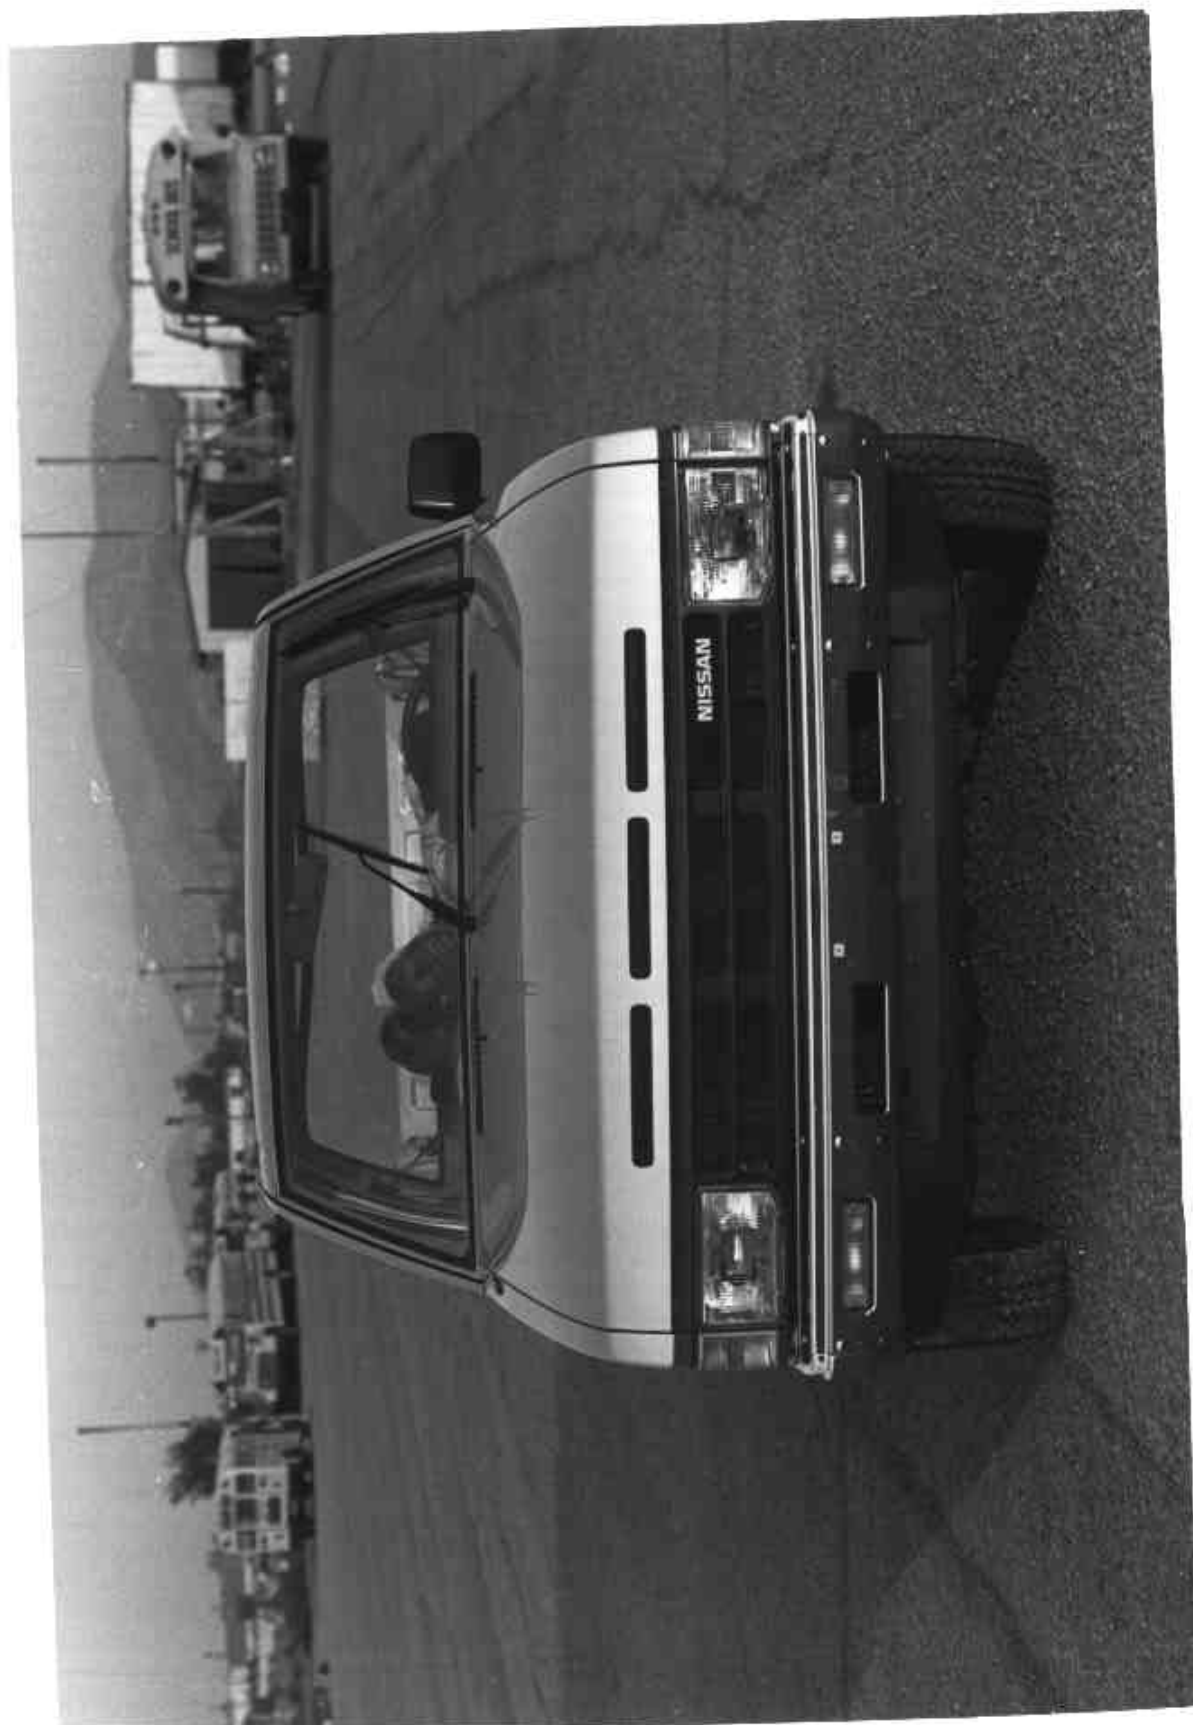
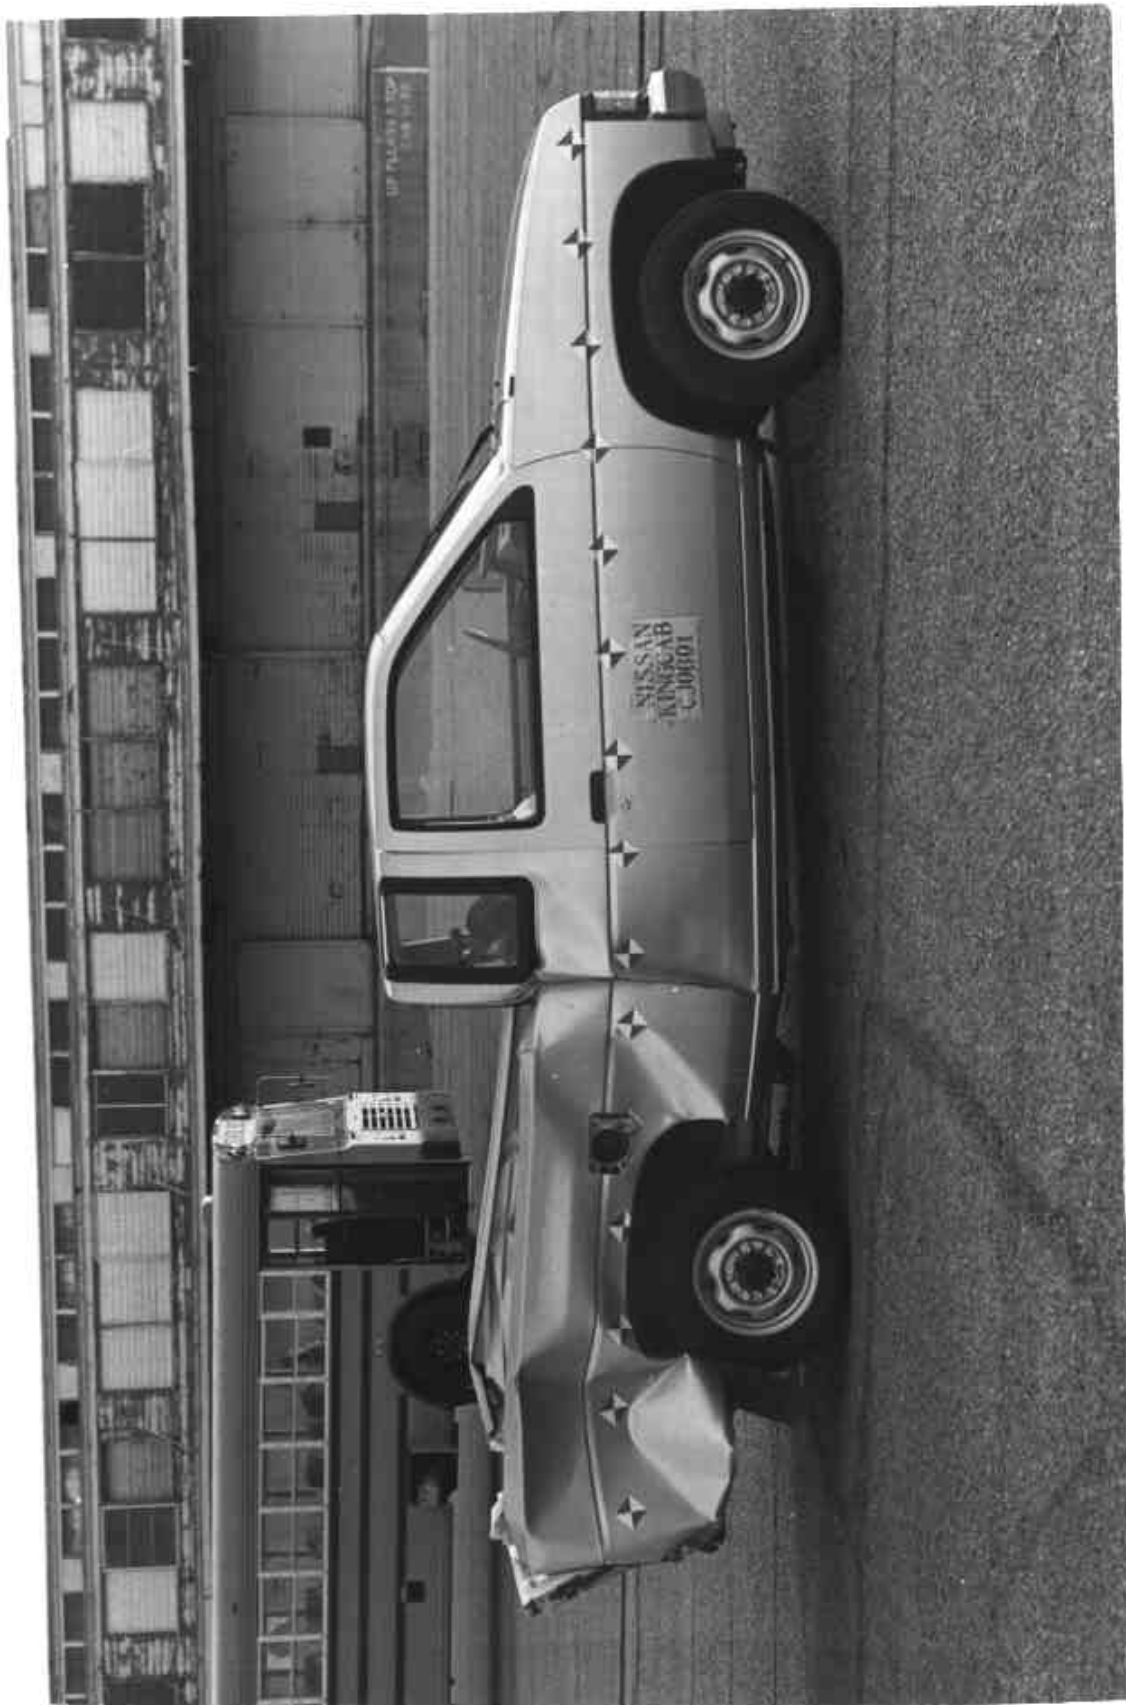
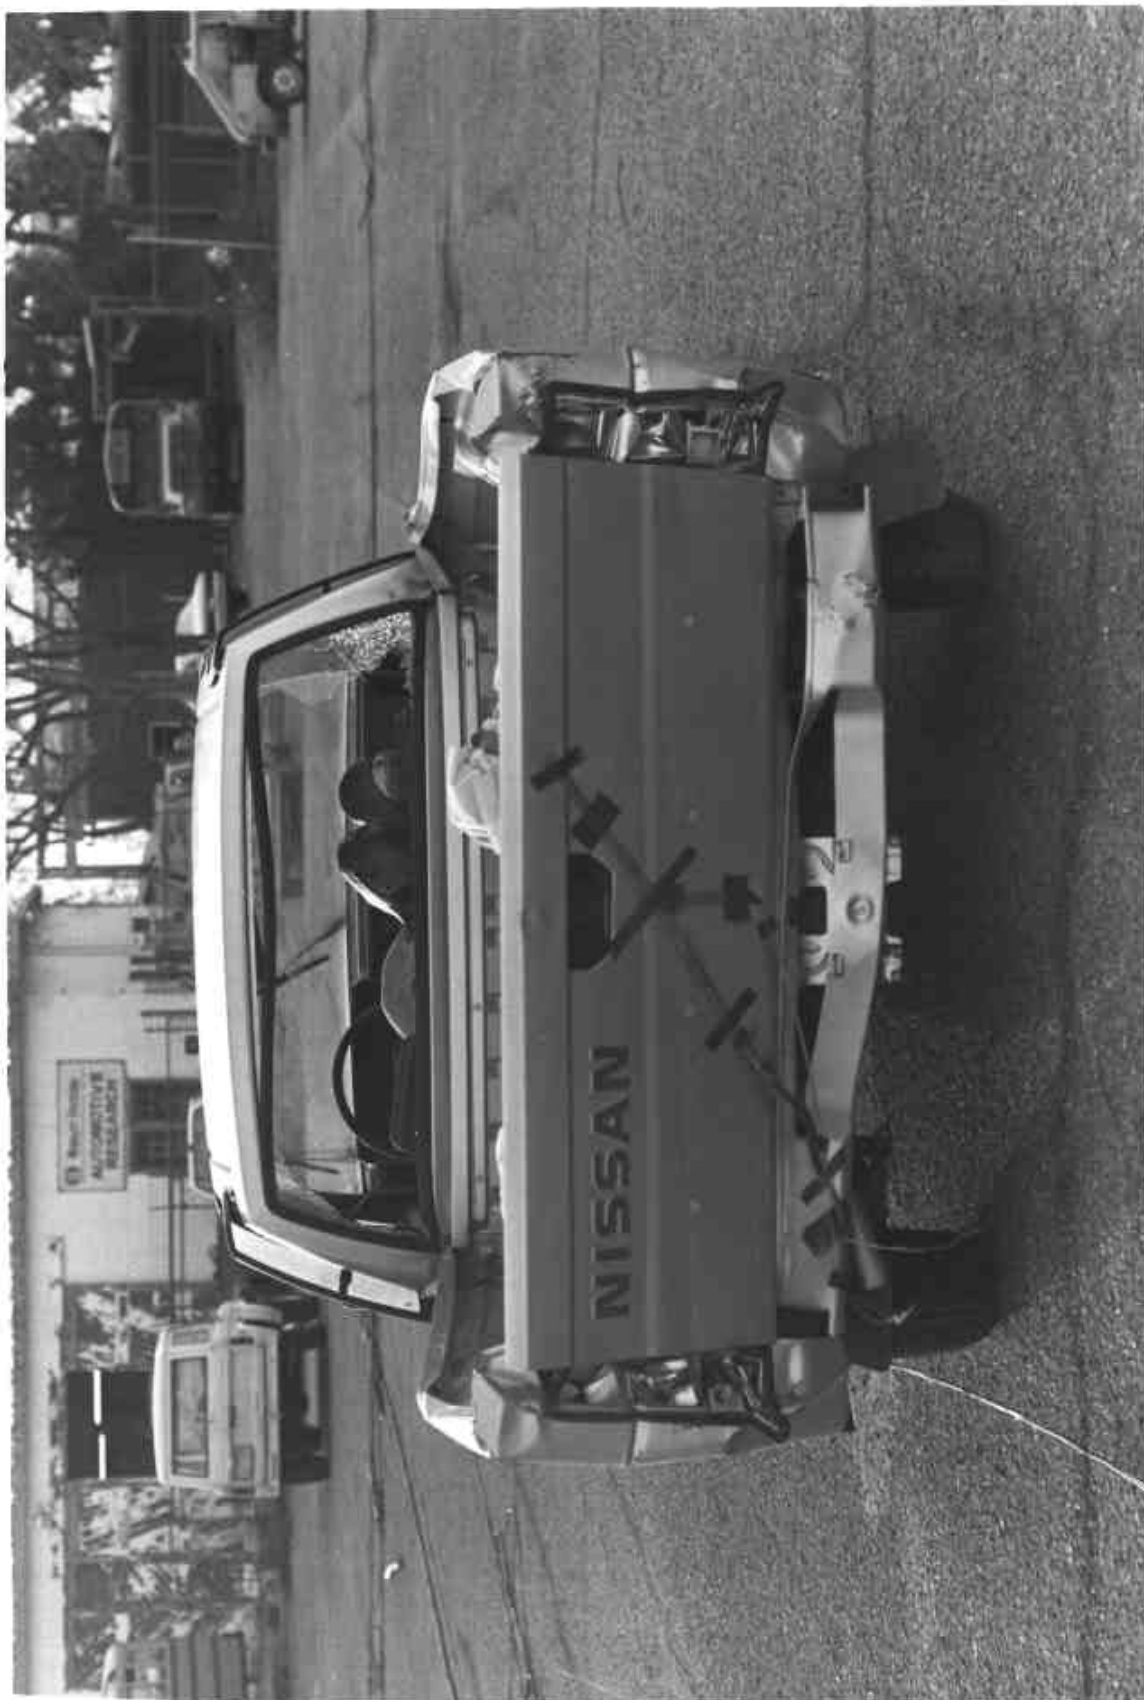
Crush Details:  
The fuel tank and filler neck were not damaged or deformed in any way.  
All other fuel system components are also undamaged. The impact force  
buckled the rear 10 inches of the bed downwards and pushed the bed into  
the cab area.

FIGURE 3-1 FULL LEFT SIDE VIEW -- POSTTEST

FIGURE 3-2 FULL FRONT VIEW - POSTTEST

FIGURE 3-3 FULL RIGHT SIDE VIEW - POSTTEST

FIGURE 3-4 FULL REAR VIEW - POSTTEST

The test velocity of the rear impact sled was 29.29 mph. Test velocity information and posttest crush details are given in Table 3-3. Posttest left side, front, right side, and rear views of the test vehicle are given in Figures 3-1 to 3-4.
