R7050-04

SIDE IMPACT PROTECTION  
IN PRODUCTION VEHICLES

MDB-TO-VAN SIDE IMPACT TEST OF  
A 26° CRABBED MOVING DEFORMABLE BARRIER  
TO A 1988 DODGE CARAVAN  
AT 33.5 MPH

TEST REPORT

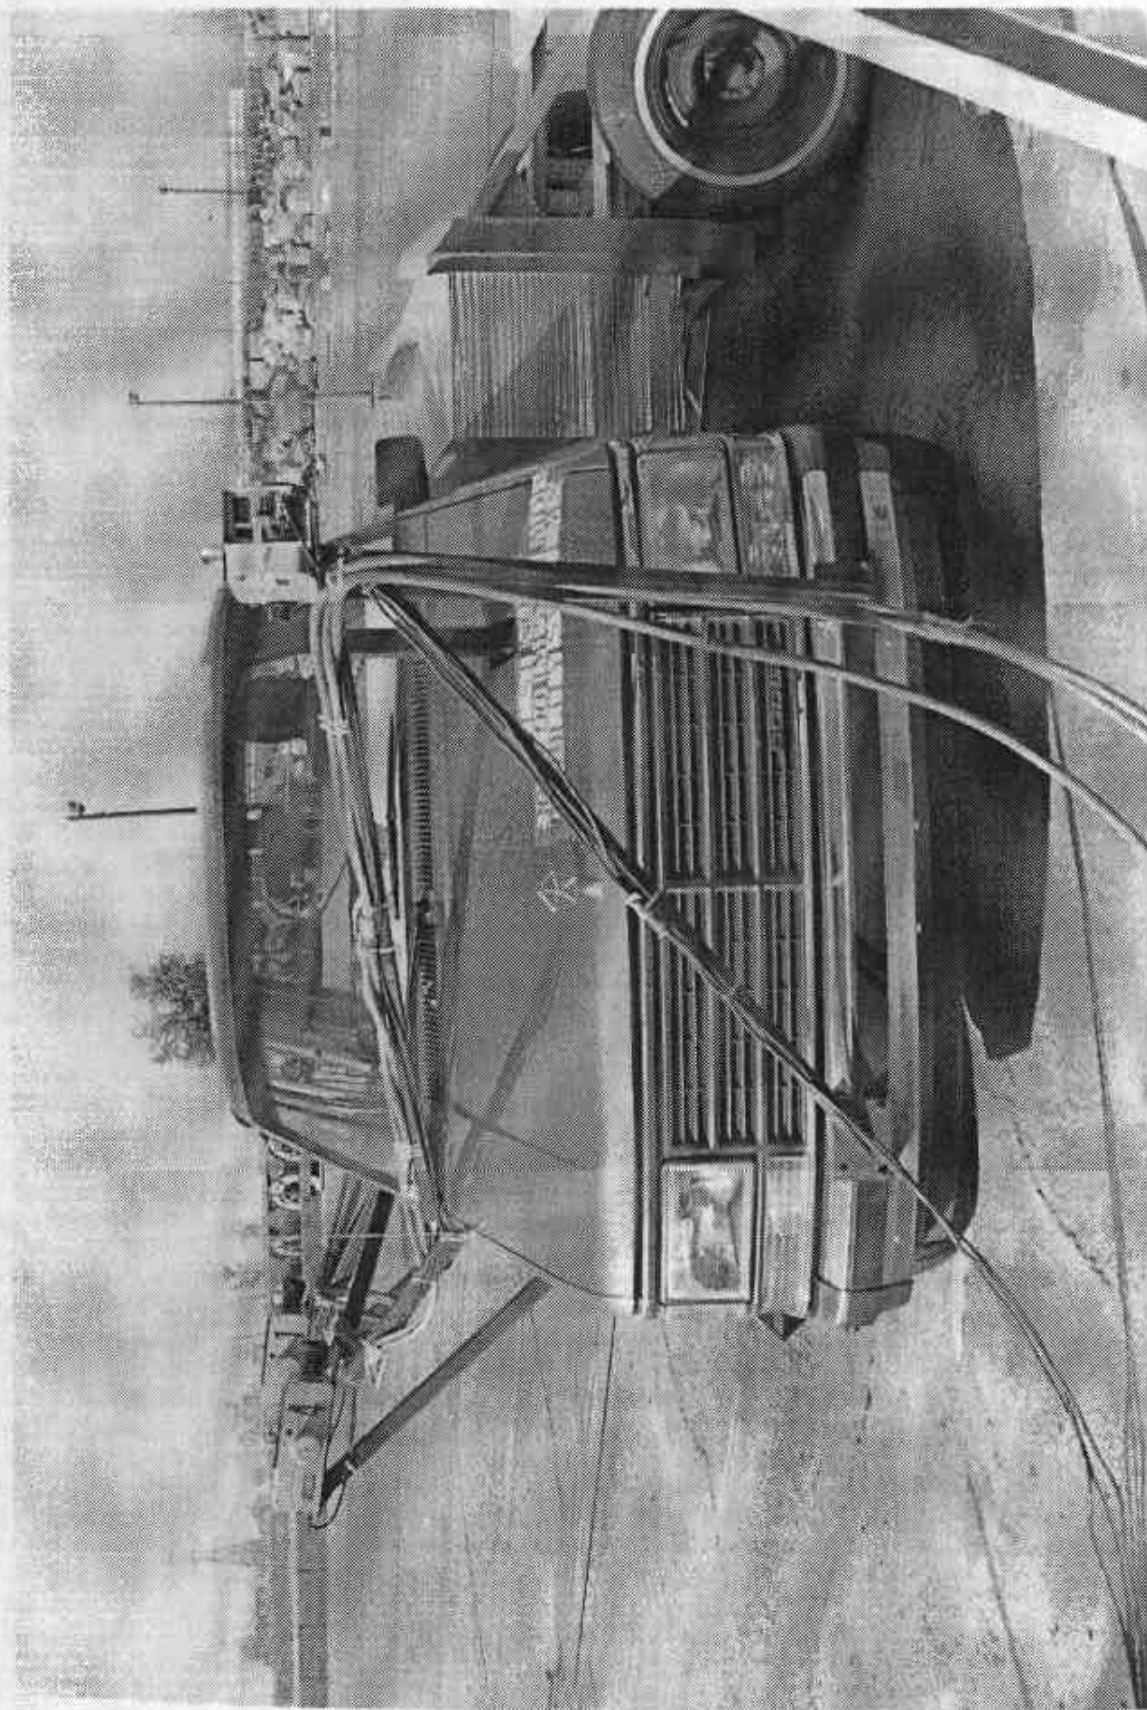
FIGURE A-3 TEST VEHICLE AND MDB, FRONT VIEW - PRETEST

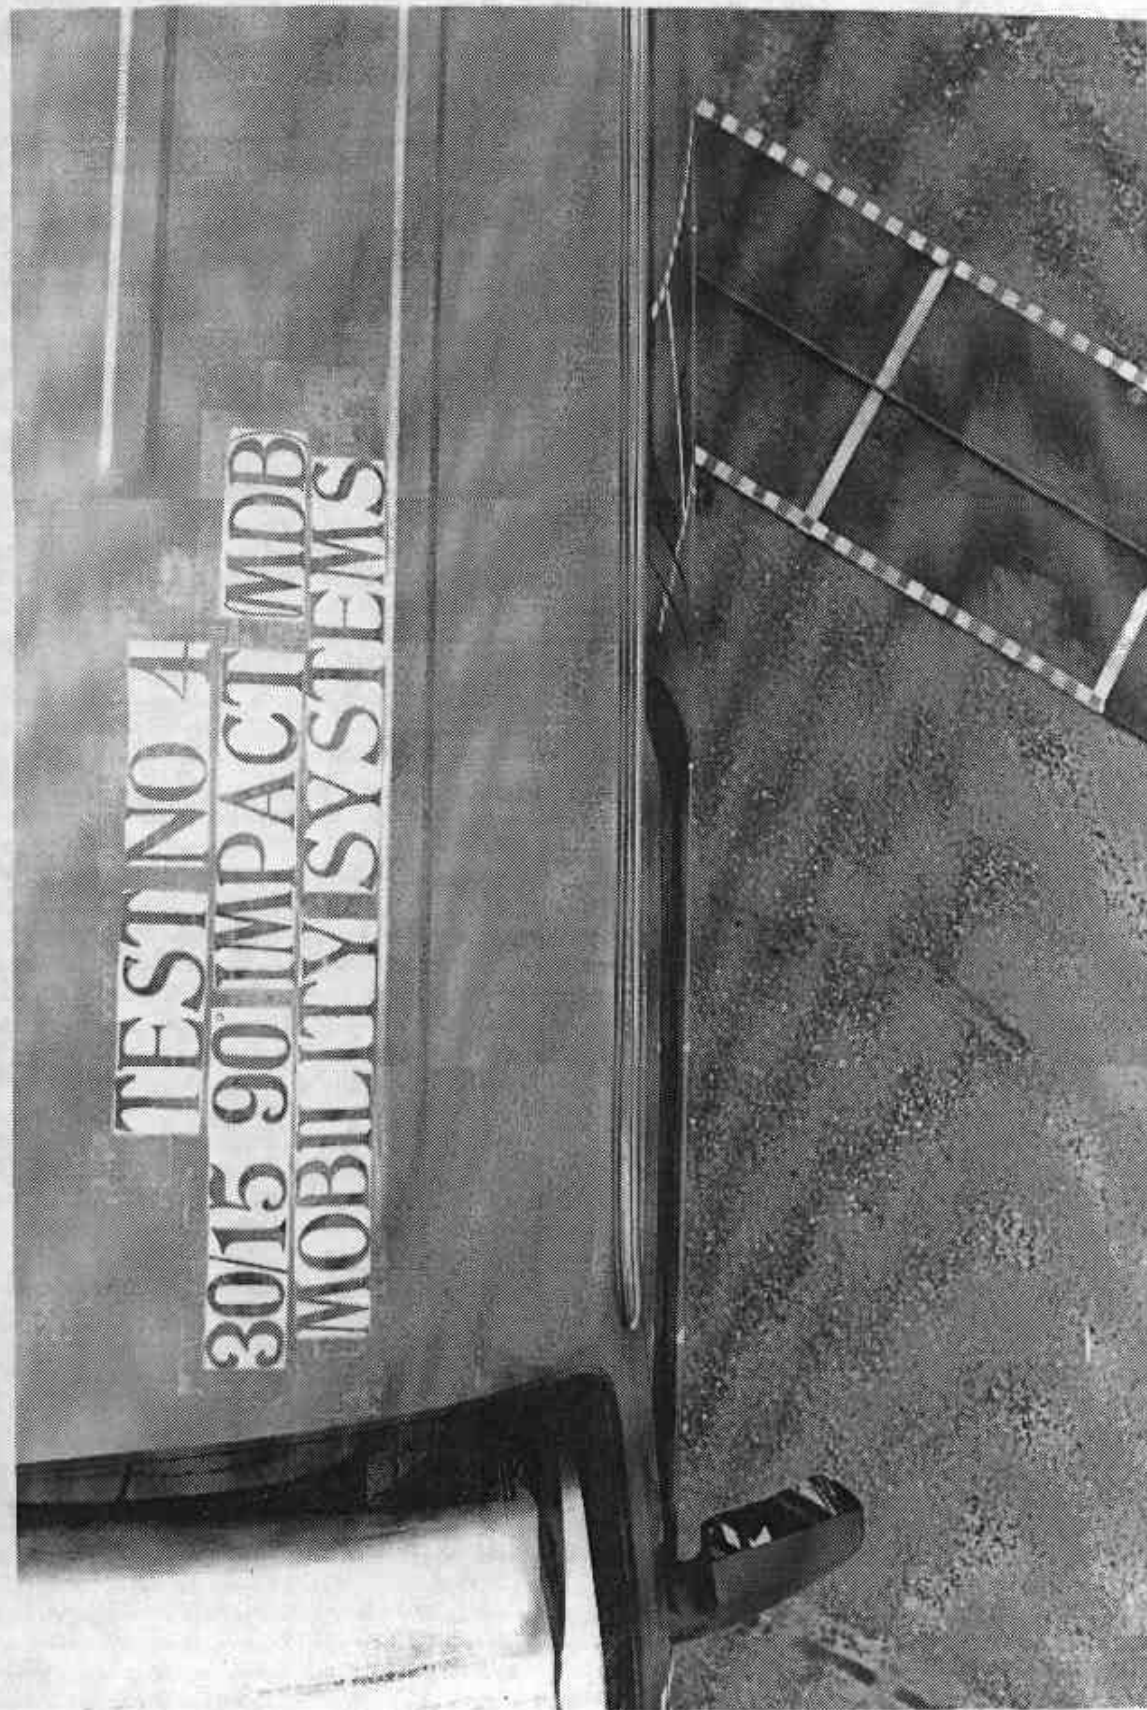
FIGURE A-5 TEST VEHICLE OVERHEAD VIEW - PRETEST

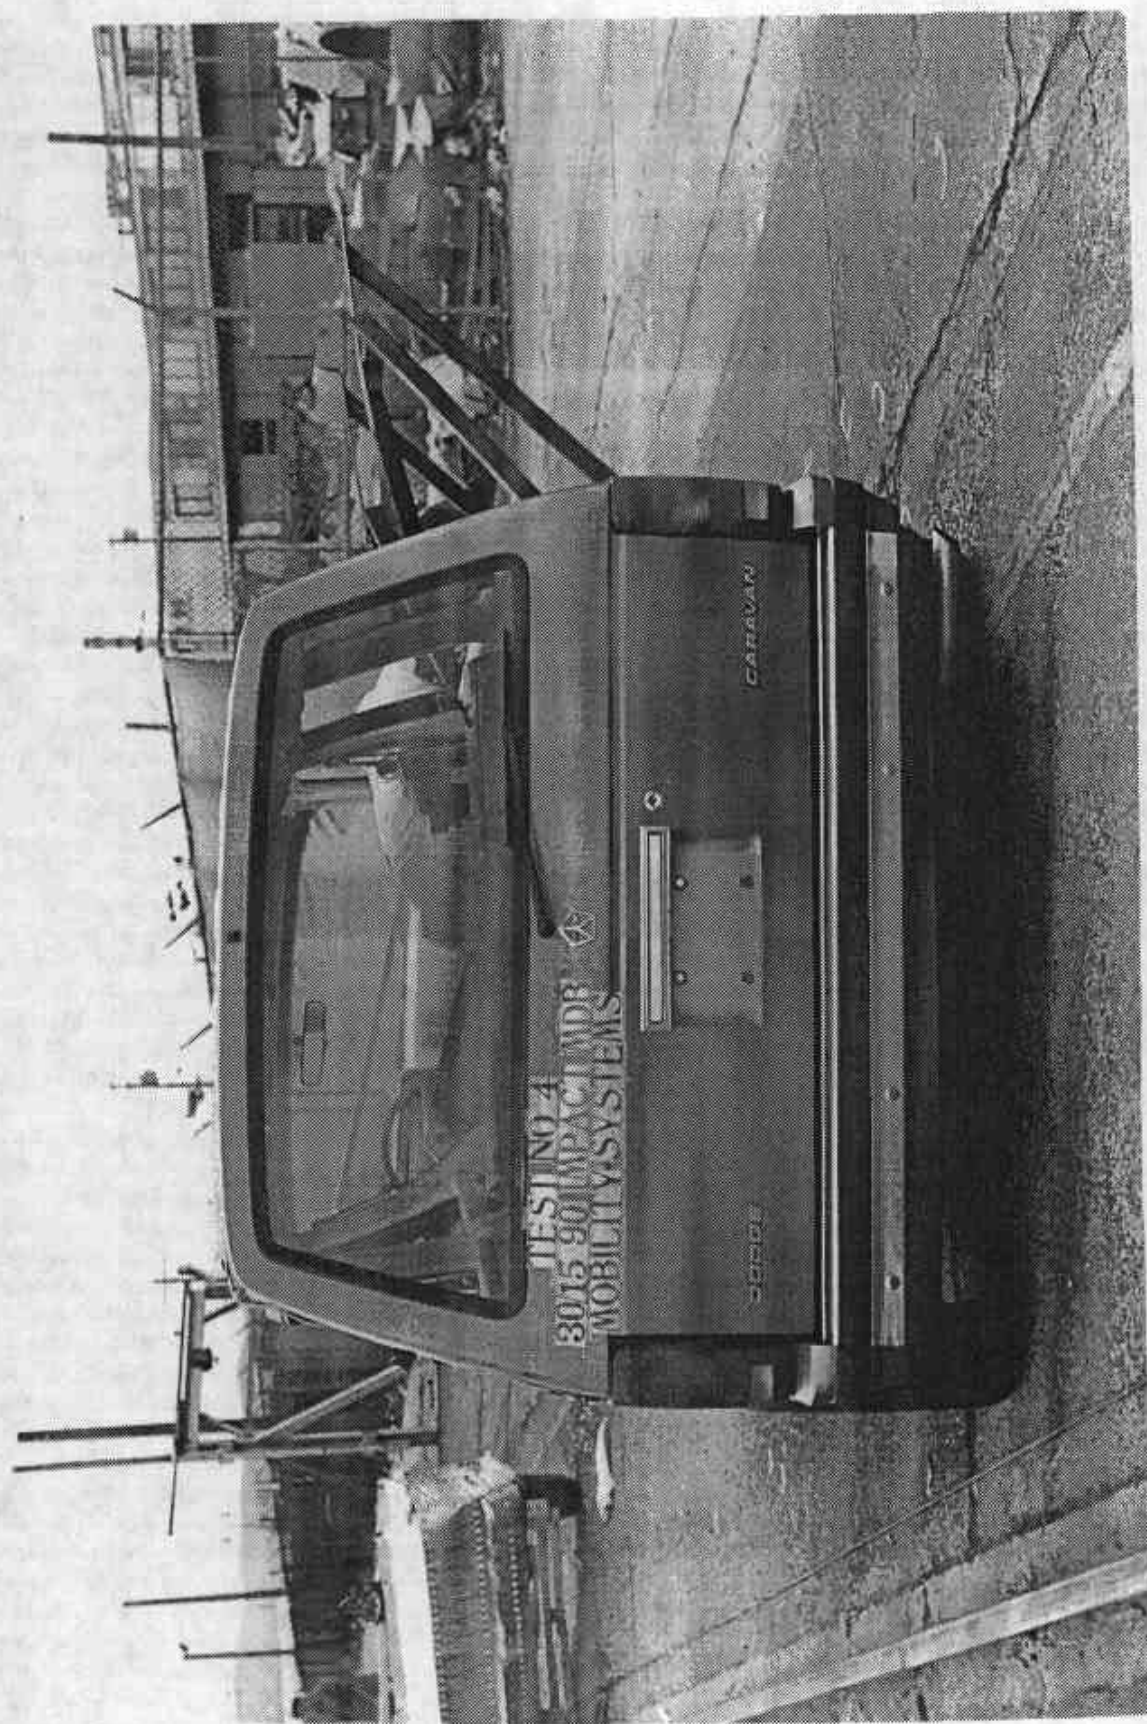
FIGURE A-9. MDB AND TEST VEHICLE, REAR VIEW - POSTTEST

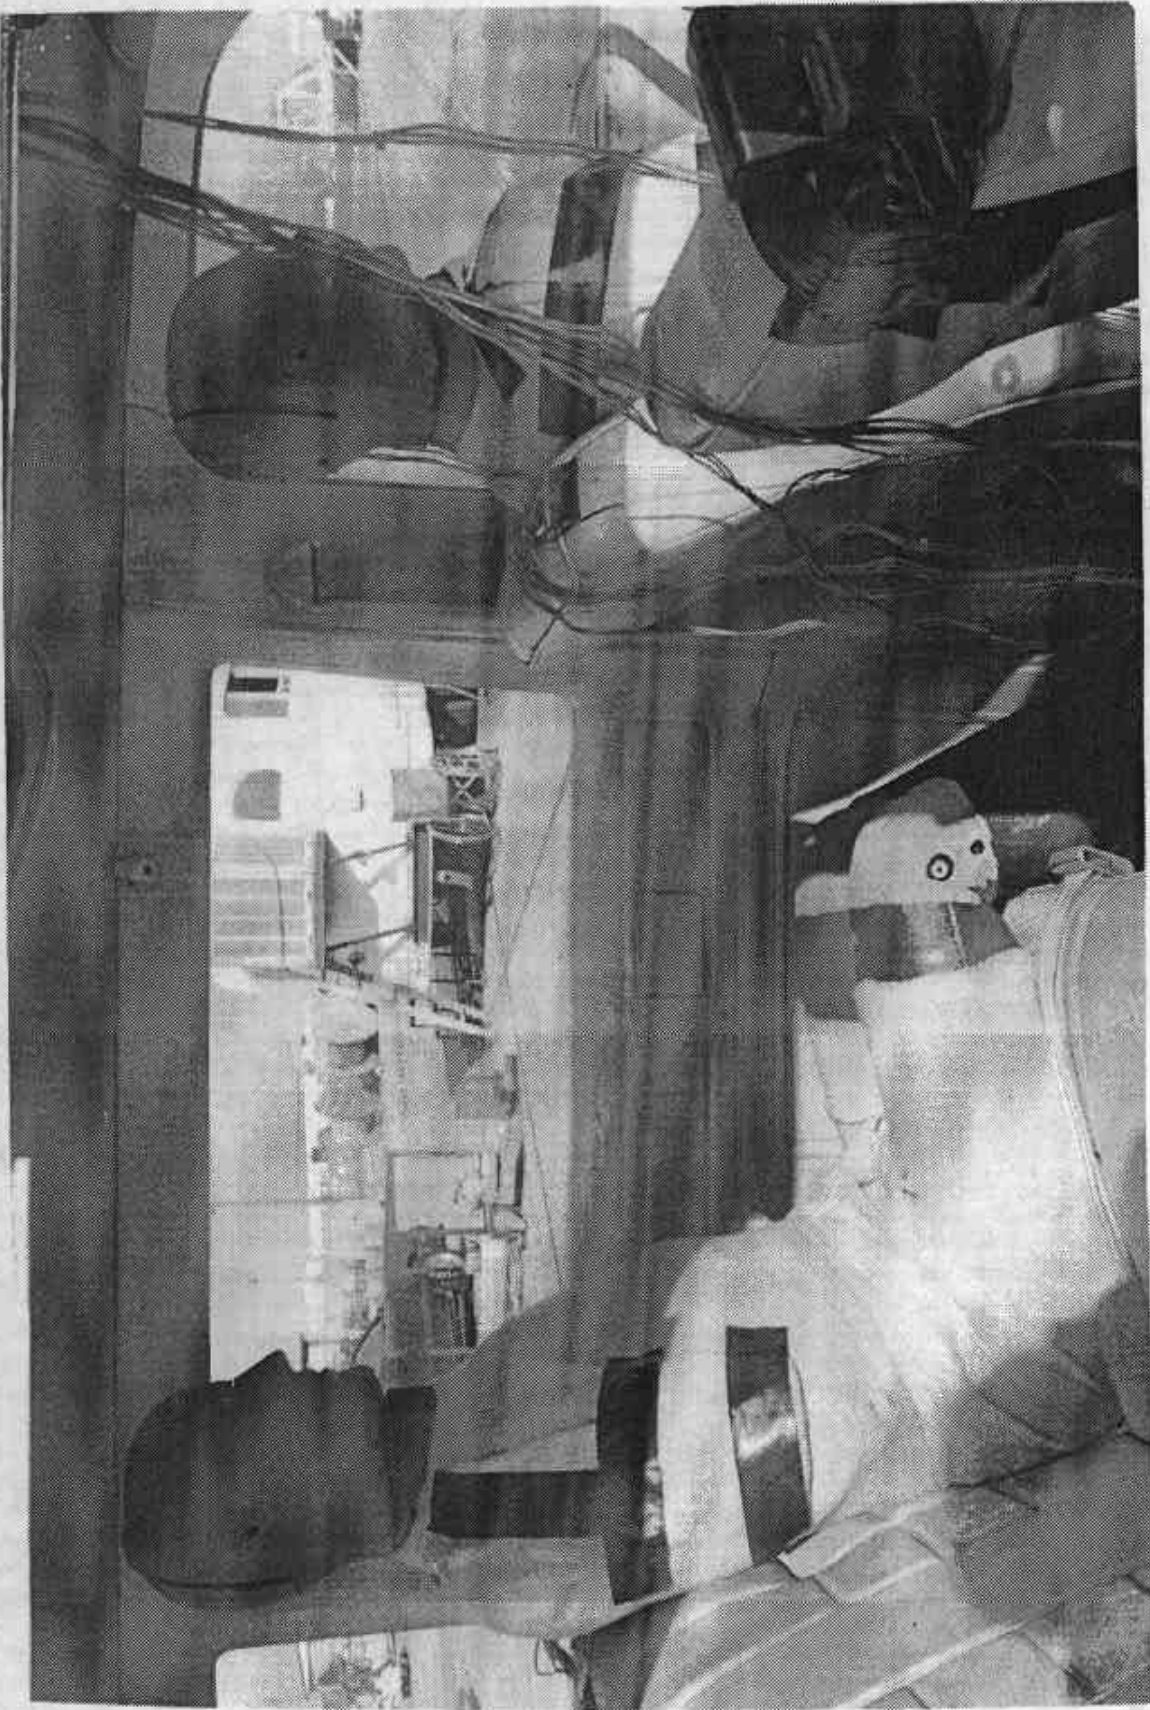
FIGURE A-11 REAR SID IN LEFT REAR PASSENGER POSITION - PRETEST

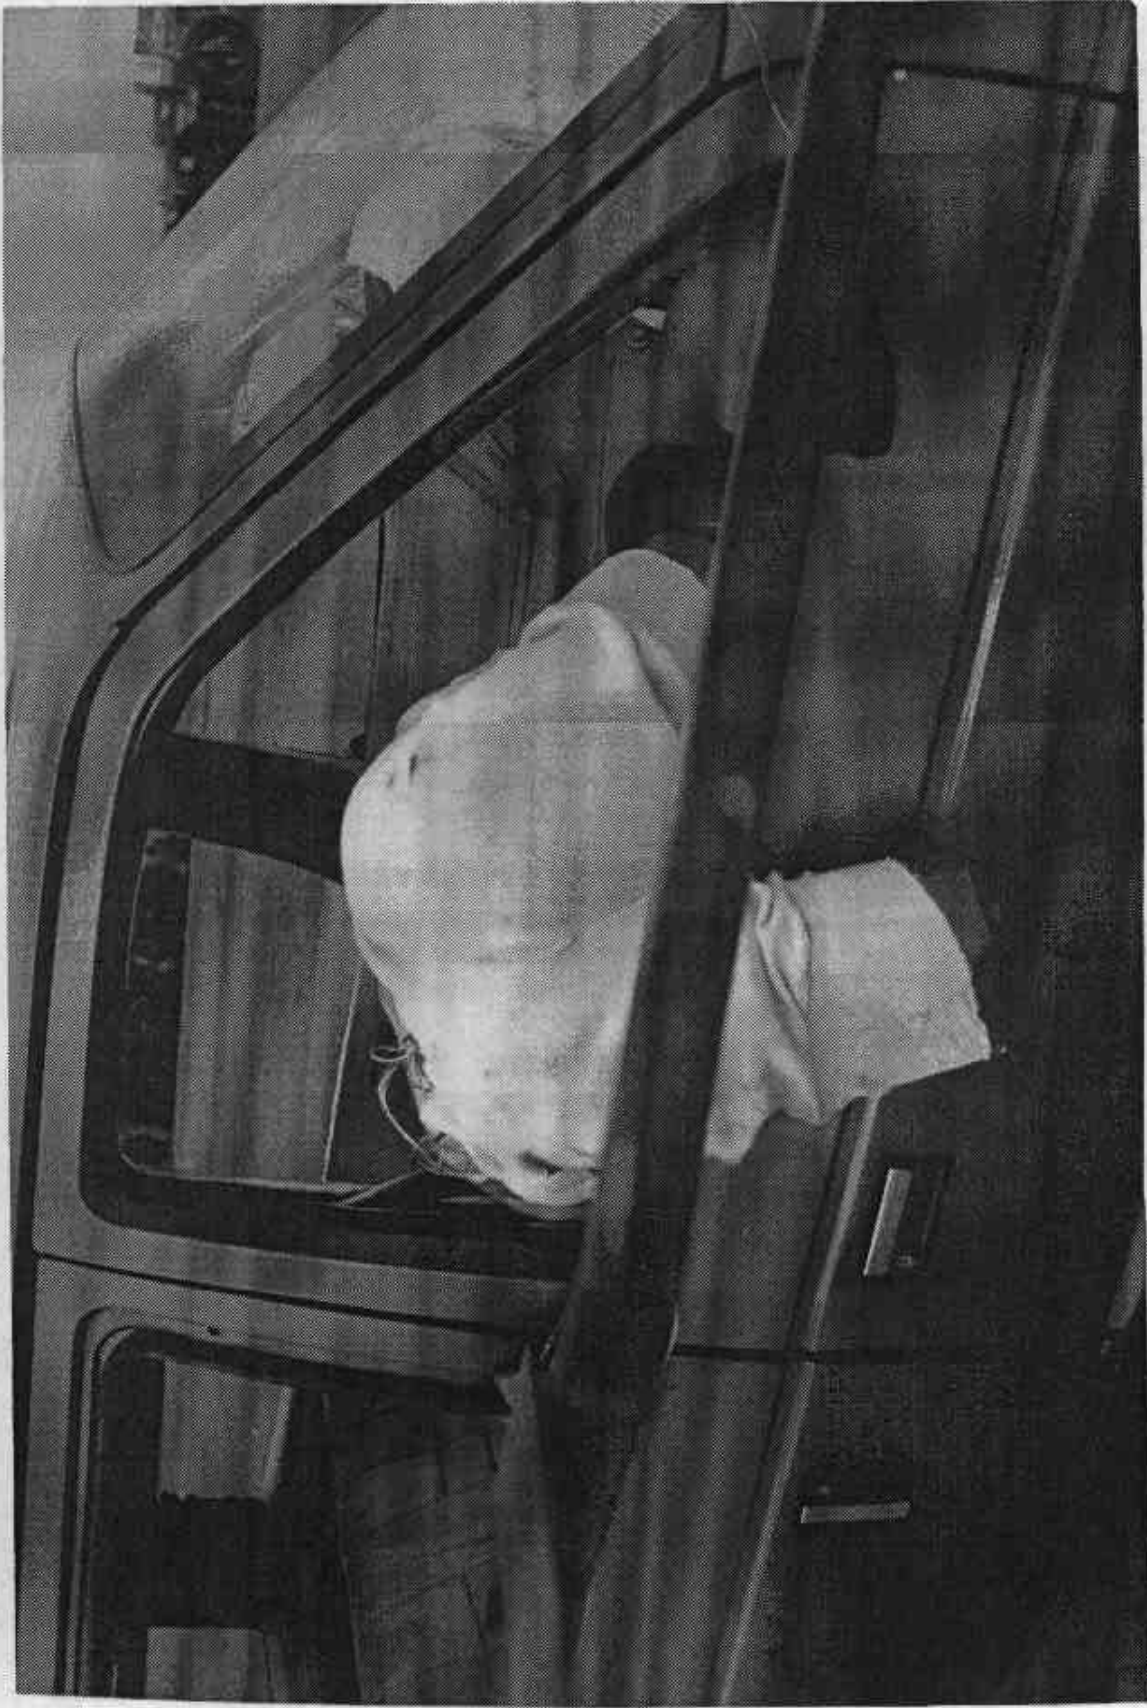
FIGURE A-13 FRONT SID FINAL POSITION - POSTTEST (EXTERIOR VIEW)

The front SID impacted the driver door with the left knee, hip and shoulder. The neck and body were rotated far enough by the impact force to allow the SID head to go through the driver side window. The SID head contacted the aluminum barrier during this action. The SID then rotated to its left while being thrown across the cab interior. The front SID's left foot and ankle were pinned by the driver door during the initial impact. This caused the bolt securing the left leg above the knee joint to be sheared off as the SID body was rotated and thrown across the vehicle. The left lower leg remained in the driver footwell area. The front SID came to rest straddling the right front window sill with his right leg inside the vehicle and head against the passenger seat.

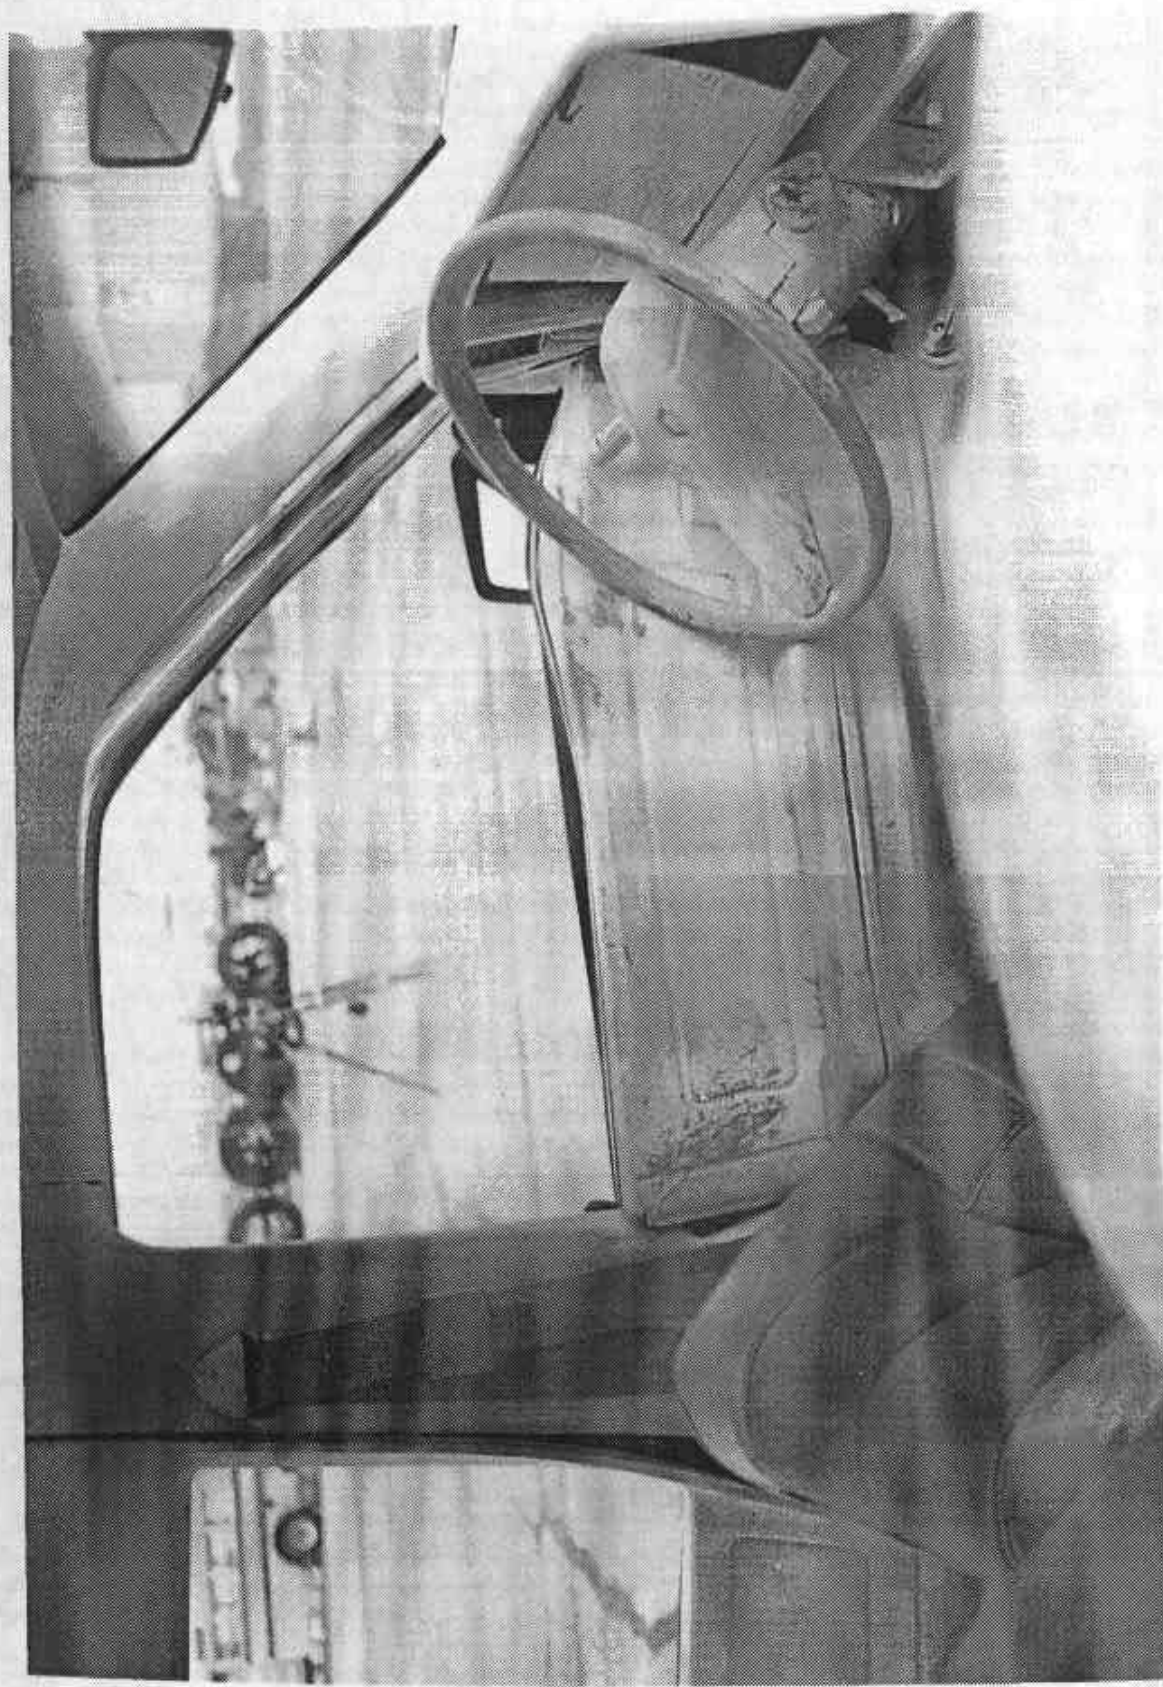
FIGURE A-16 FRONT OCCUPANT COMPARTMENT INTERIOR - POSTTEST

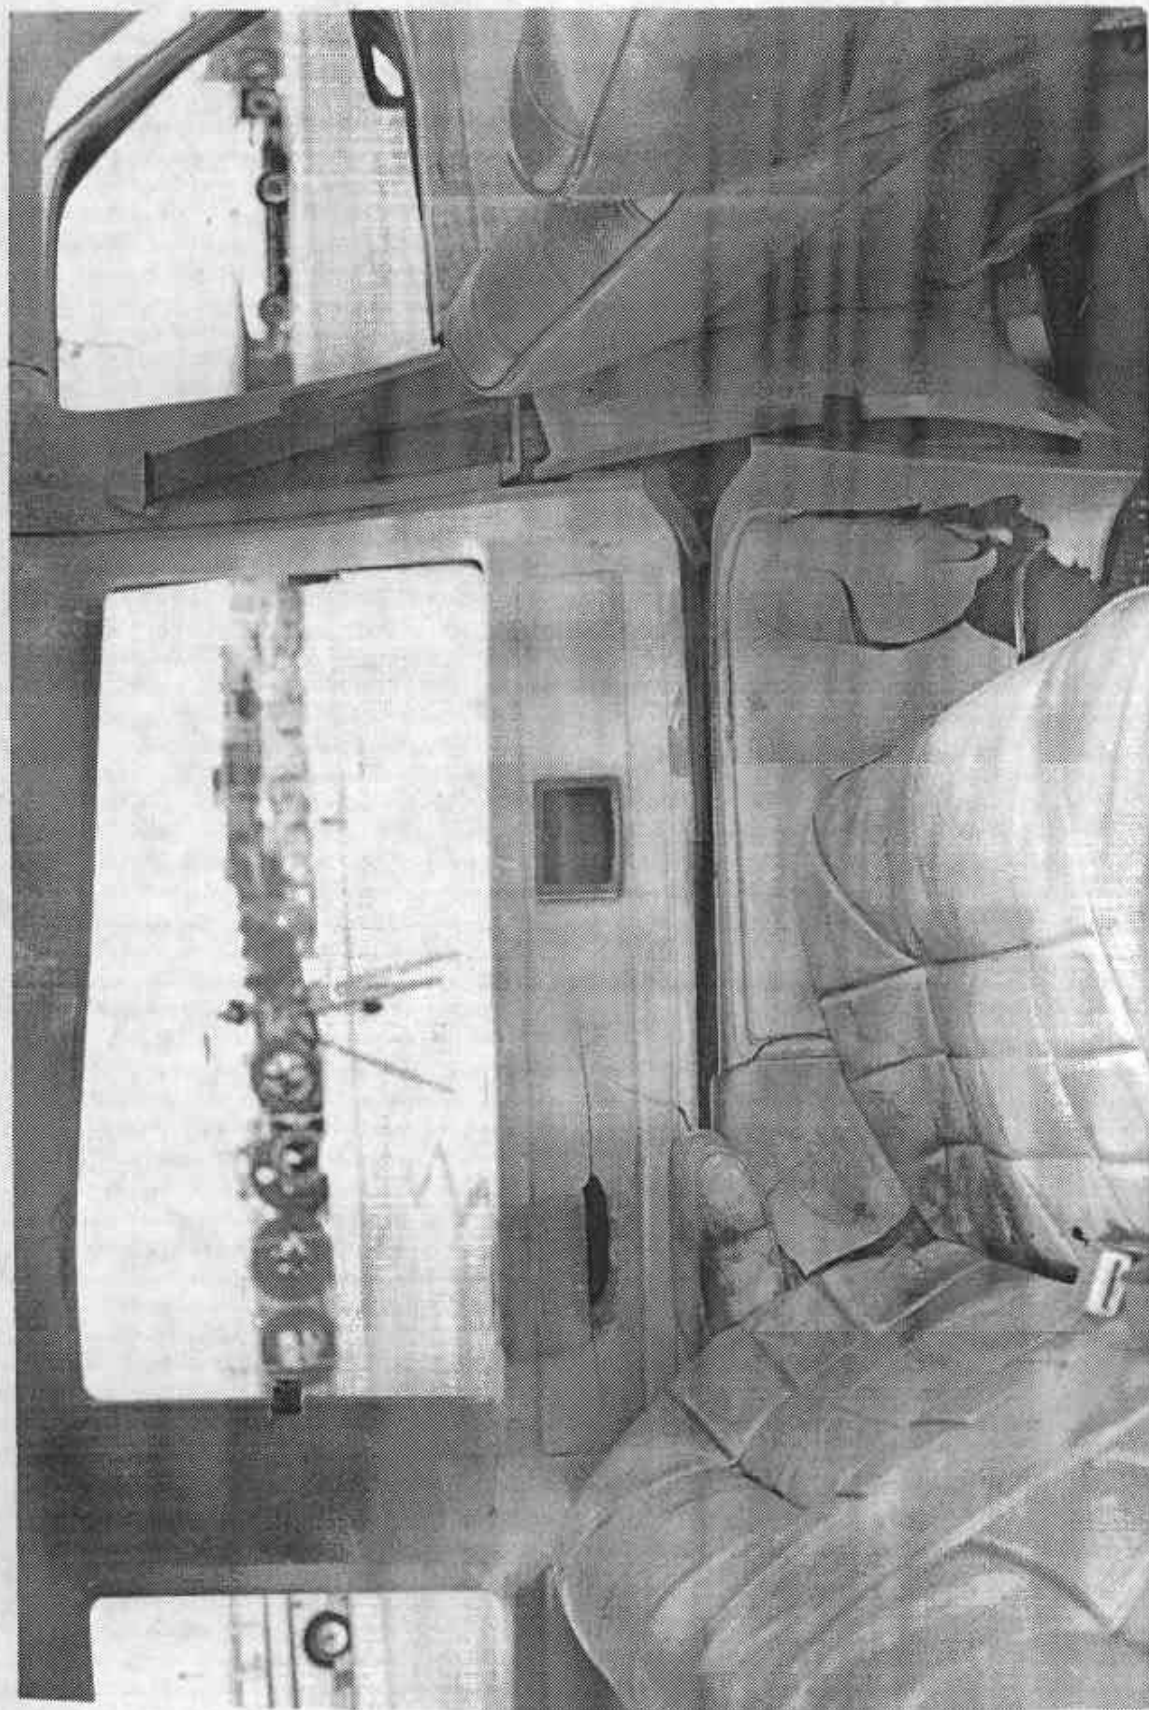
FIGURE A-17 REAR OCCUPANT COMPARTMENT INTERIOR - POSTTEST

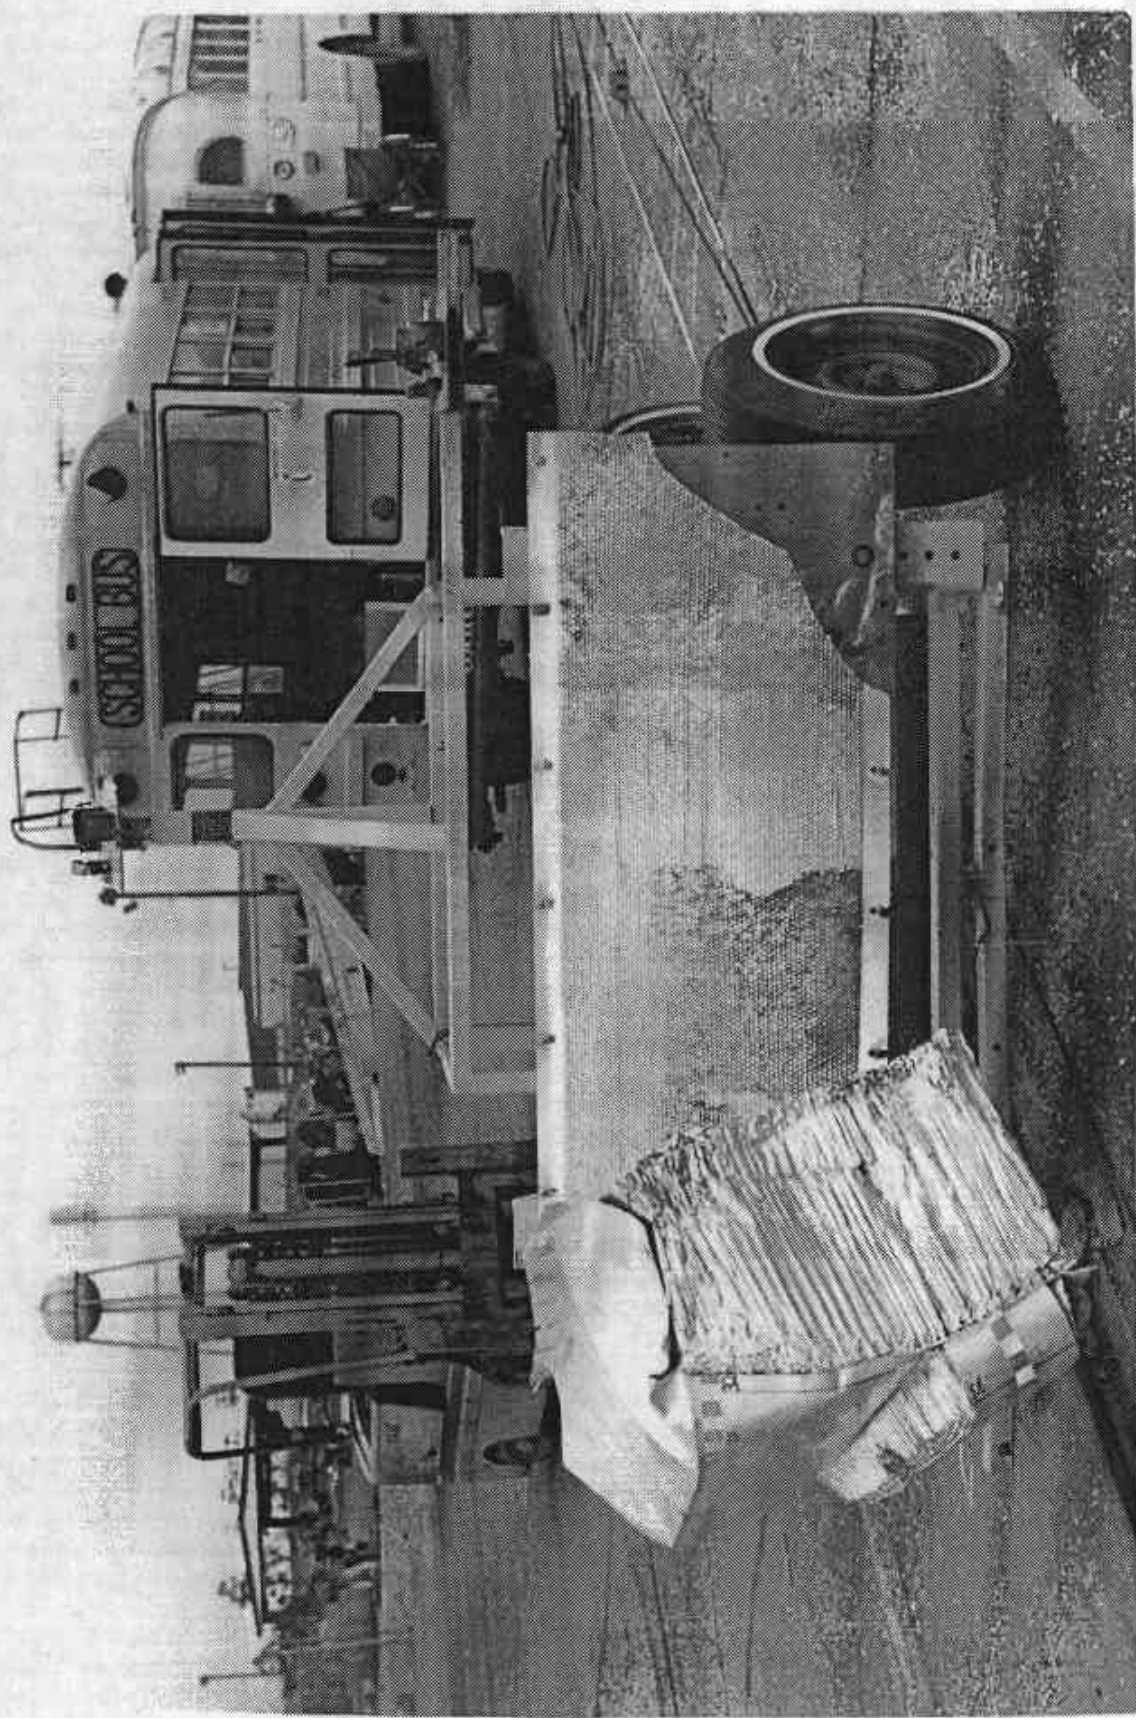
FIGURE A-21 MDB CLOSEUP VIEW OF BARRIER FACE - POSTTEST

The MDB impacted the test vehicle and was stopped by the remote brake system to prevent a second impact. The aluminum deformable barrier received minor to the front face with a maximum crush of 5.0 inches. The left side of the impactor was momentarily pinned in the vehicle driver door which caused the hexcel face to be ripped from its aluminum backing plate. The crush details for the MDB are given in Table 3-7.

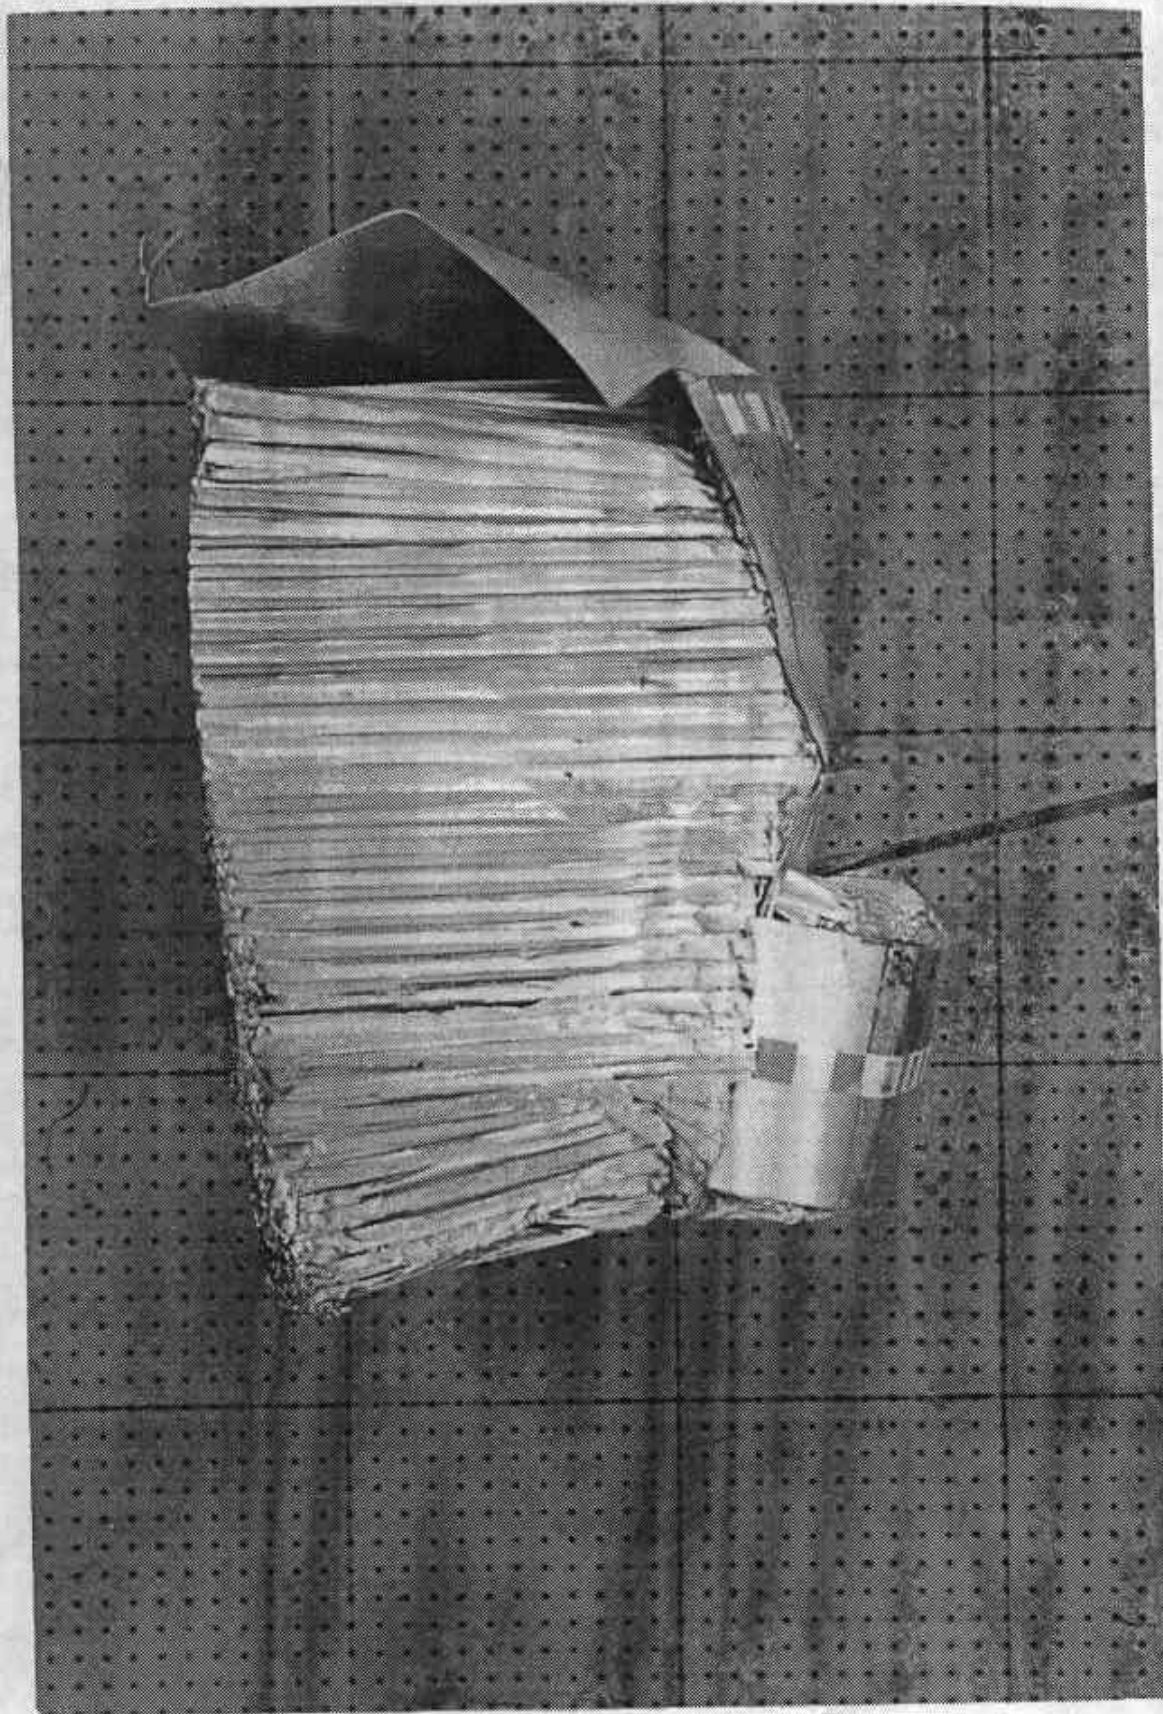
FIGURE A-26 MDB FACE, VIEW NO. 1 - POSTTEST
