REPORT NOS. 208-TRC-89-003

VEHICLE SAFETY COMPLIANCE TESTING  
FOR OCCUPANT CRASH PROTECTION,  
WINDSHIELD MOUNTING, WINDSHIELD ZONE  
INTRUSION, AND FUEL SYSTEM INTEGRITY

CHRYSLER CORPORATION  
1989 DODGE DIPLOMAT  
4-DOOR SEDAN  
NHTSA NO. CK0304  
TRC TEST NO. 890313

FINAL REPORT

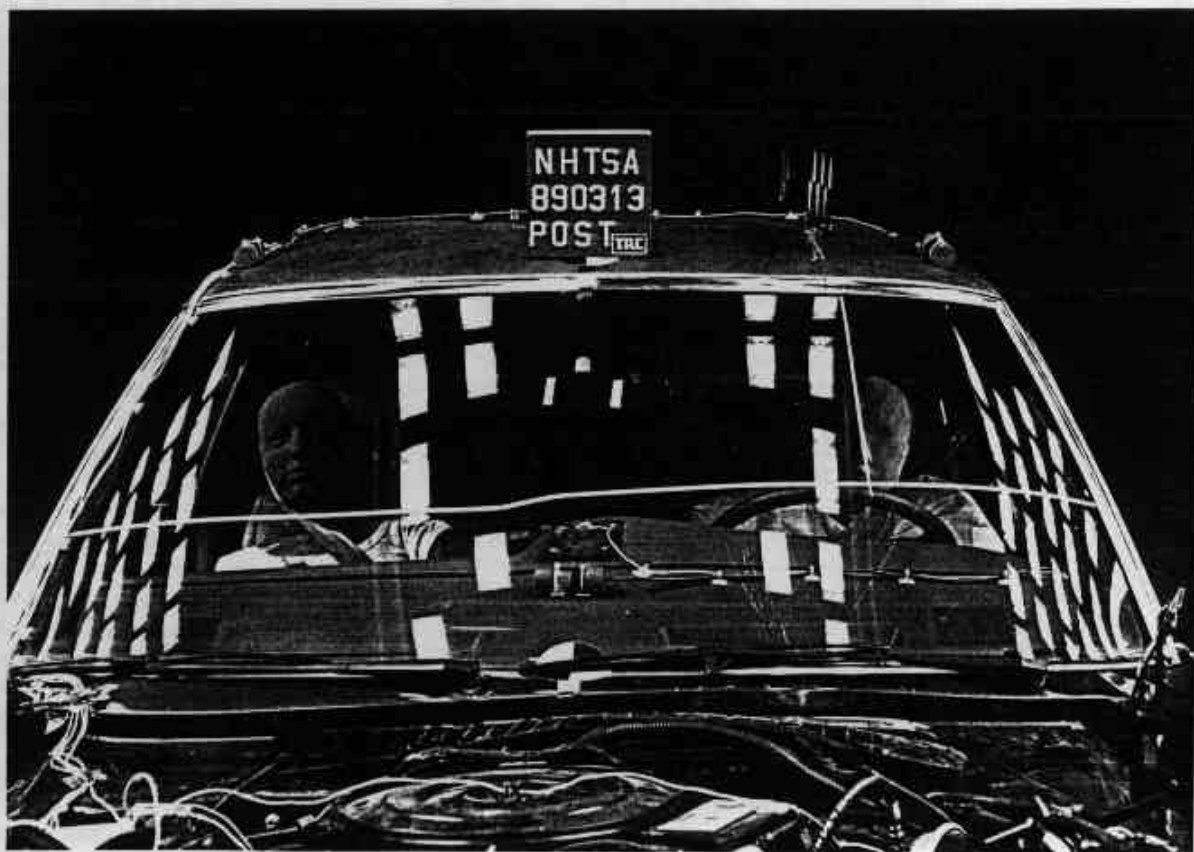
Figure A-14. POST-TEST WINDSHIELD VIEW

The left side of the windshield was cracked upon  
impact.

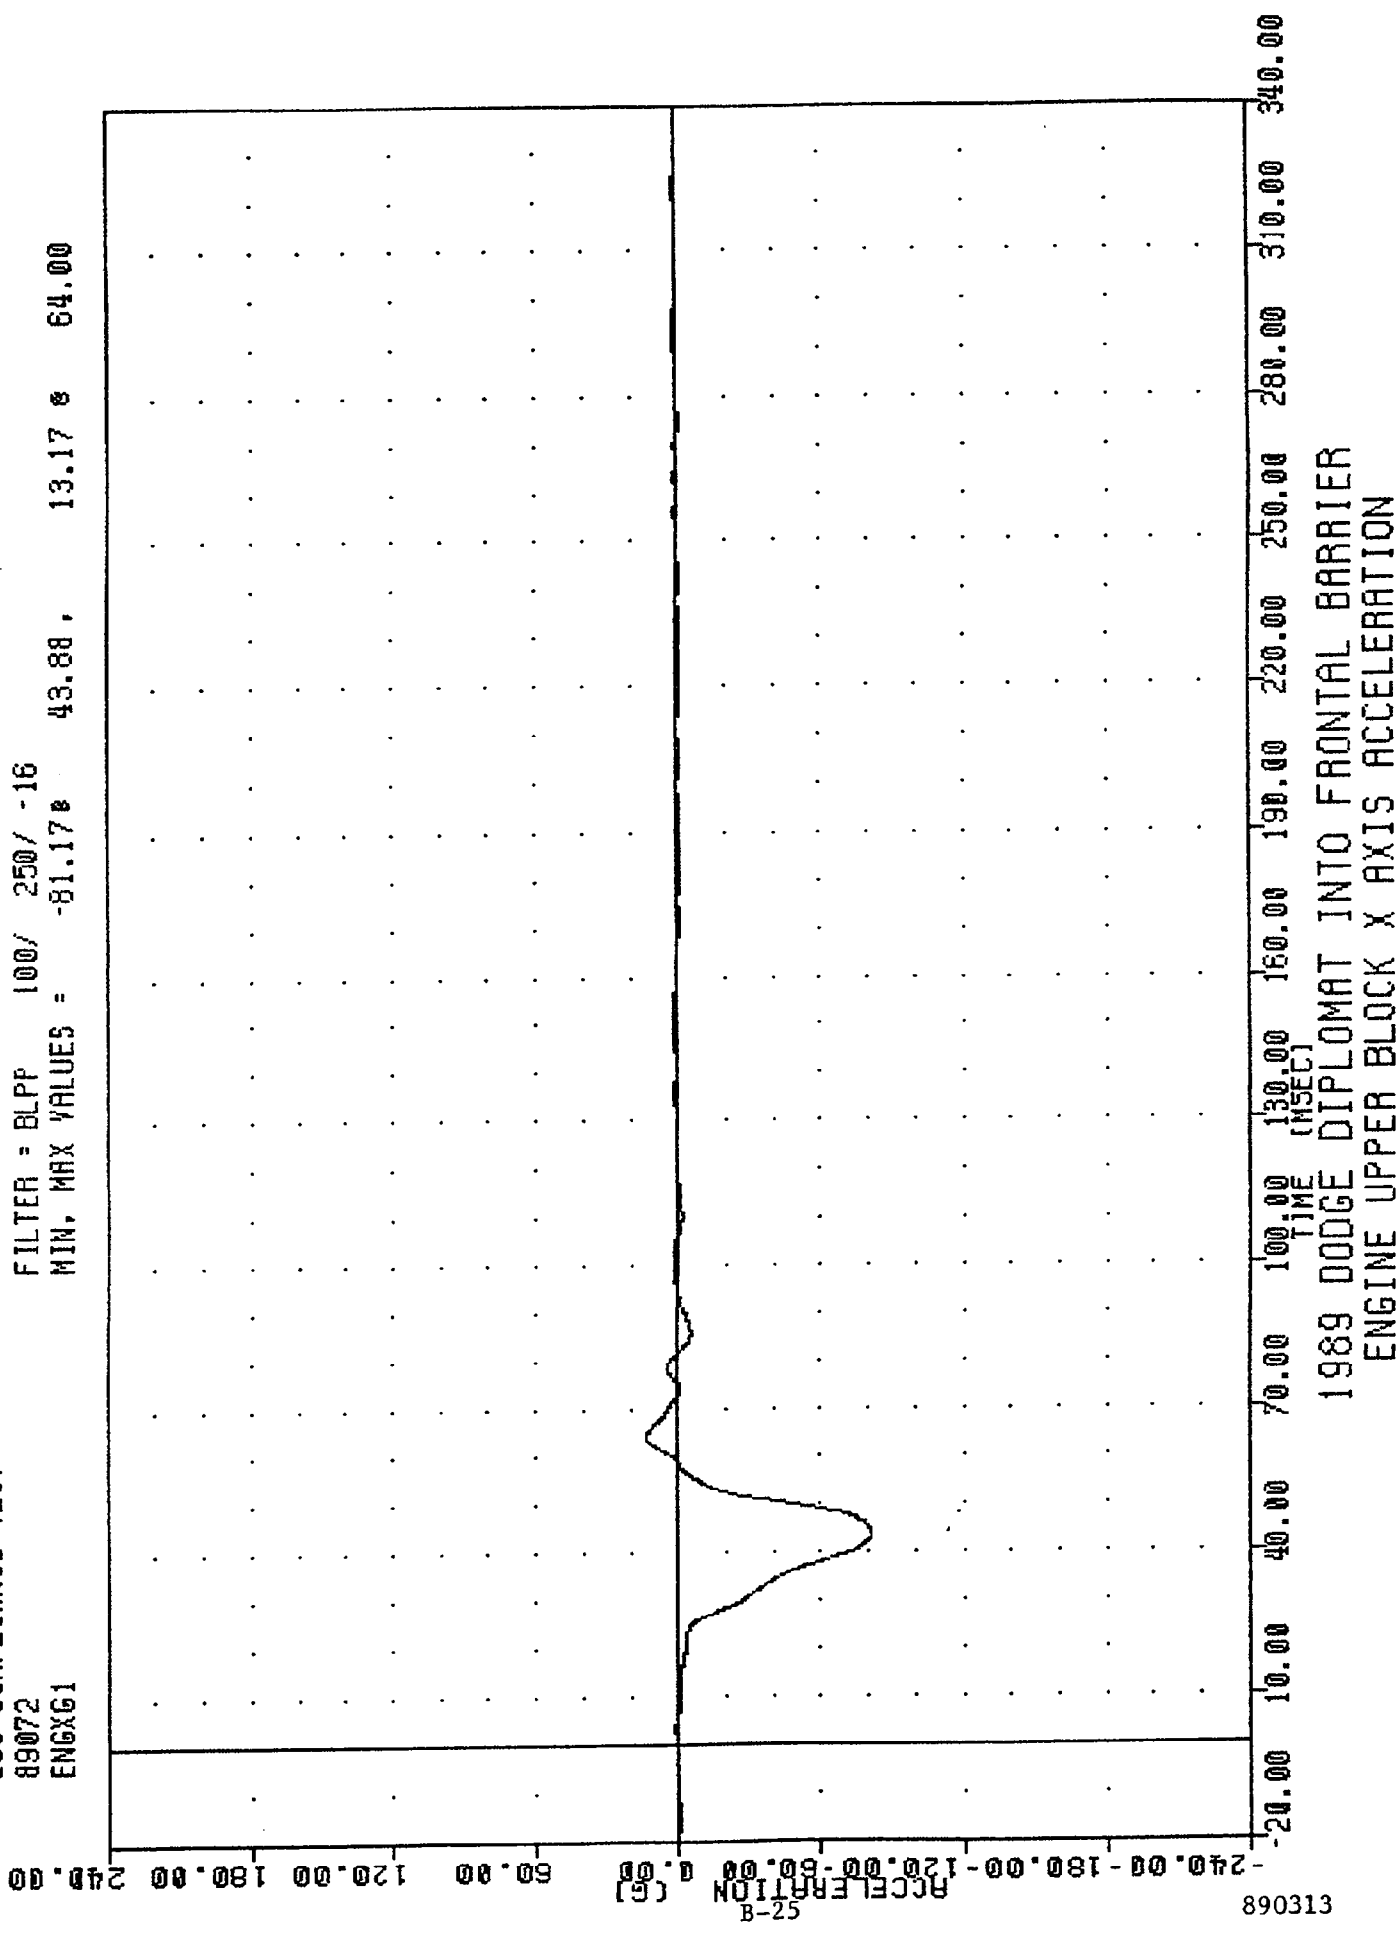
FILTER = BLPP 100/ 250/ -16  
MIN. MAX VALUES = -81.17e 43.88 , 13.17 e 64.00

1989 DODGE DIPLOMAT INTO FRONTAL BARRIER  
ENGINE UPPER BLOCK X AXIS ACCELERATION
