VEHICLE SAFETY COMPLIANCE TESTING  
FOR OCCUPANT CRASH PROTECTION,  
WINDSHIELD MOUNTING, WINDSHIELD ZONE  
INTRUSION, AND FUEL SYSTEM INTEGRITY

FUJI HEAVY INDUSTRIES, LTD.

1989 SUBARU GL

NHTSA NO. CK5501

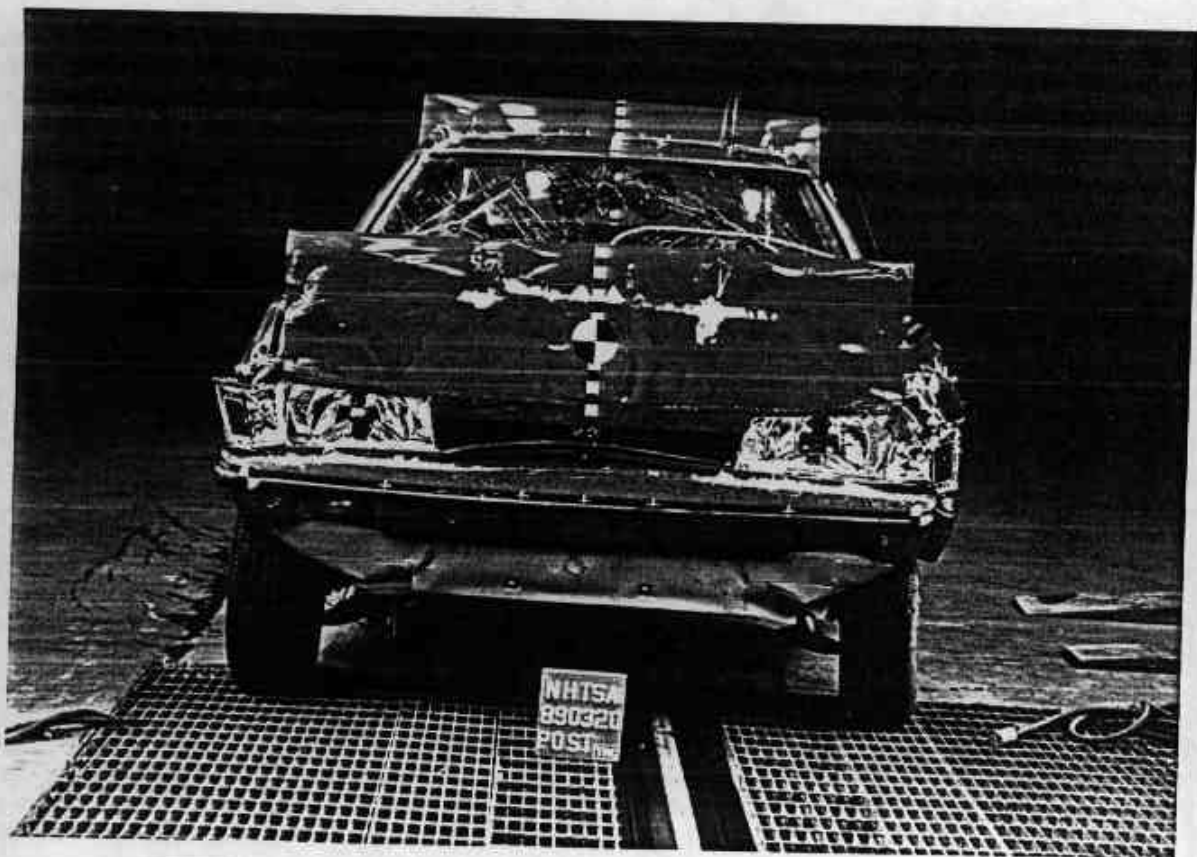
Figure A-2. POST-TEST FRONT VIEW  
A-2

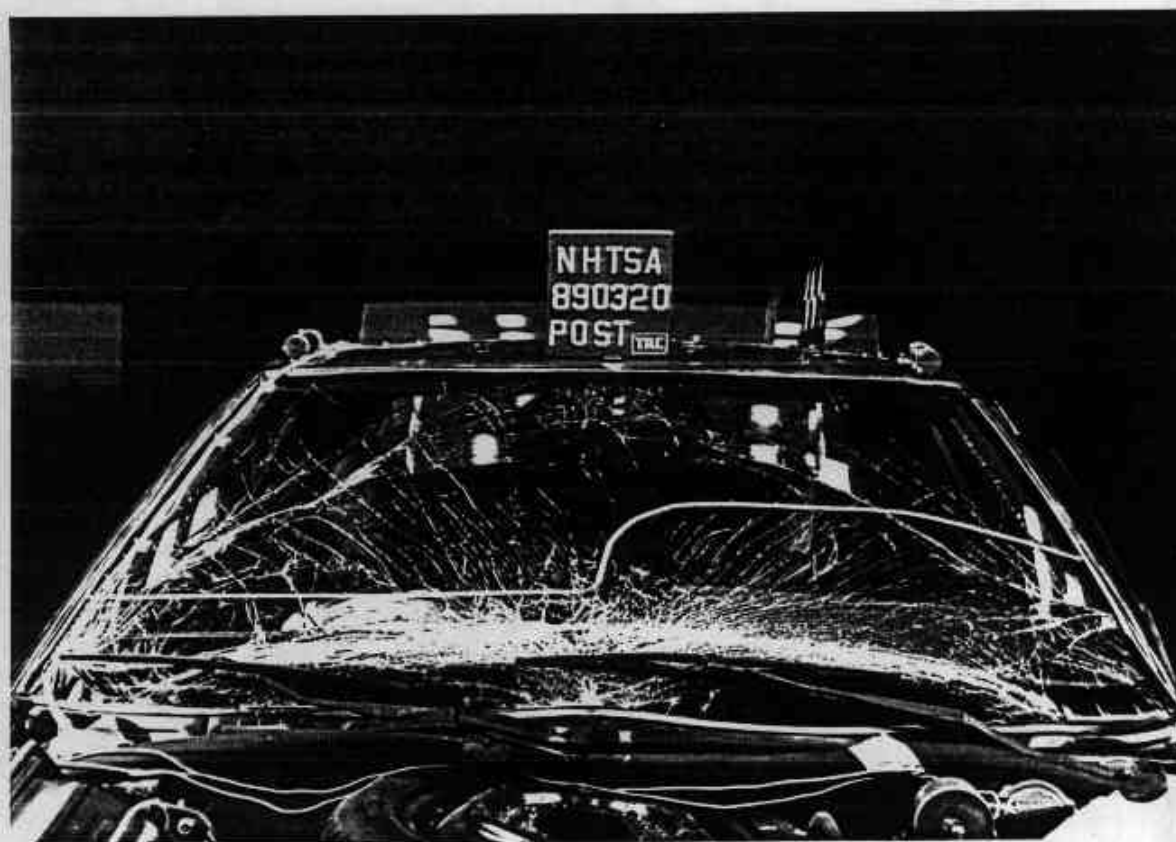
The entire windshield was cracked upon impact.

Figure A-14. POST-TEST WINDSHIELD - VIEW 1  
A-8
