VEHICLE SAFETY COMPLIANCE TESTING
FOR OCCUPANT CRASH PROTECTION,
WINDSHIELD MOUNTING, WINDSHIELD ZONE
INTRUSION, AND FUEL SYSTEM INTEGRITY

1989 AUDI 200

NHTSA NO. CK0506

TRC TEST NO. 890327

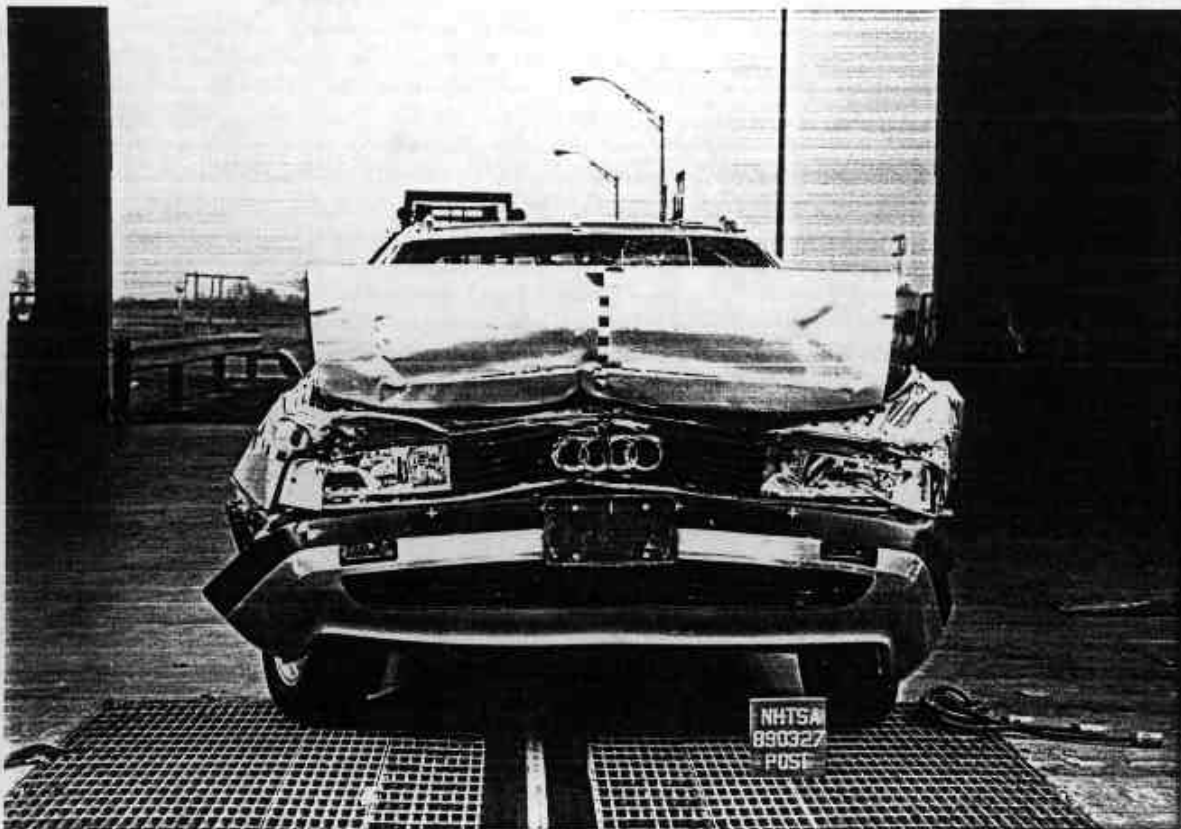
Figure A-2. POST-TEST FRONT VIEW
A-2

MIDPOINT OF DAMAGE: D = Vehicle Centerline (Longitudinal)

LENGTH OF DAMAGED REGION: L = 60.8 inches

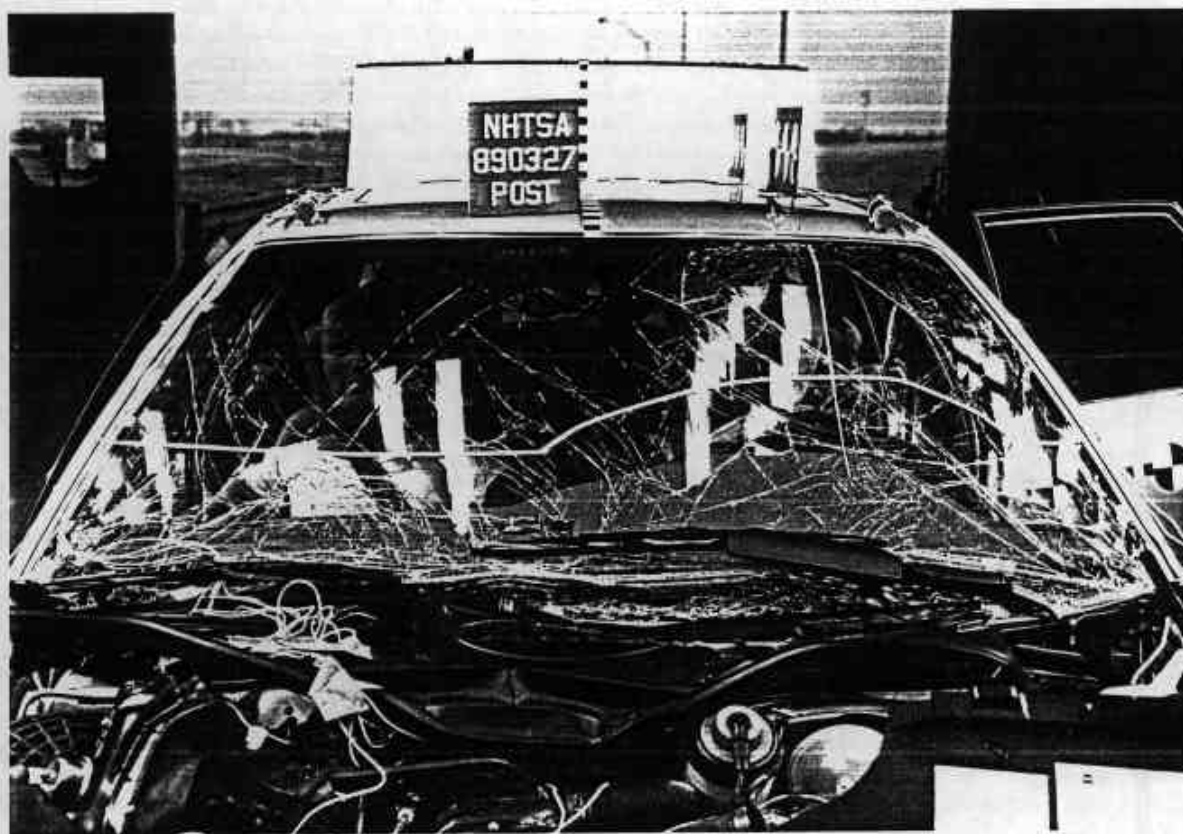
Figure A-14. POST-TEST WINDSHIELD VIEW

The entire windshield was cracked upon impact.

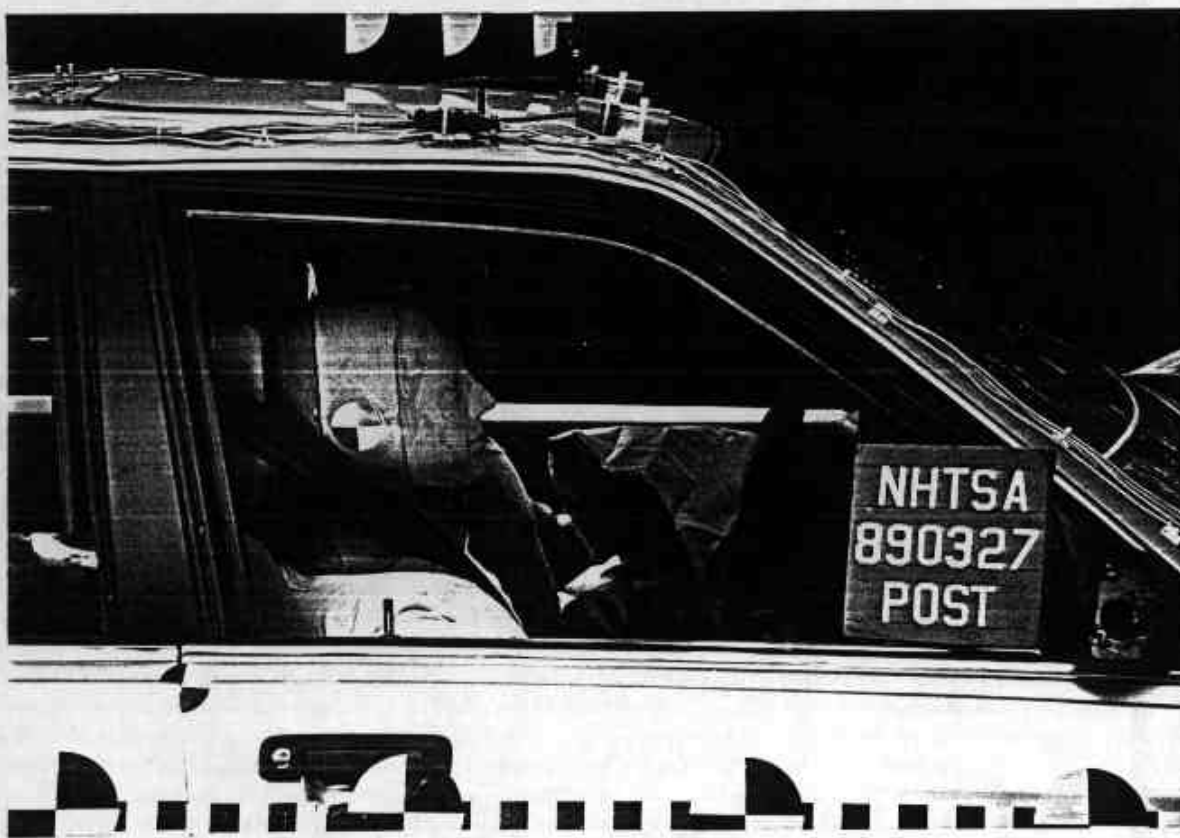
Figure A-30. POST-TEST PASSENGER DUMMY POSITION VIEW

SEAT BACK FAILURE	SEAT SHIFT
Front	<u>None</u>	<u>Passenger's shifted 1 inch forward</u>
Rear	<u>NA</u>	<u>NA</u>

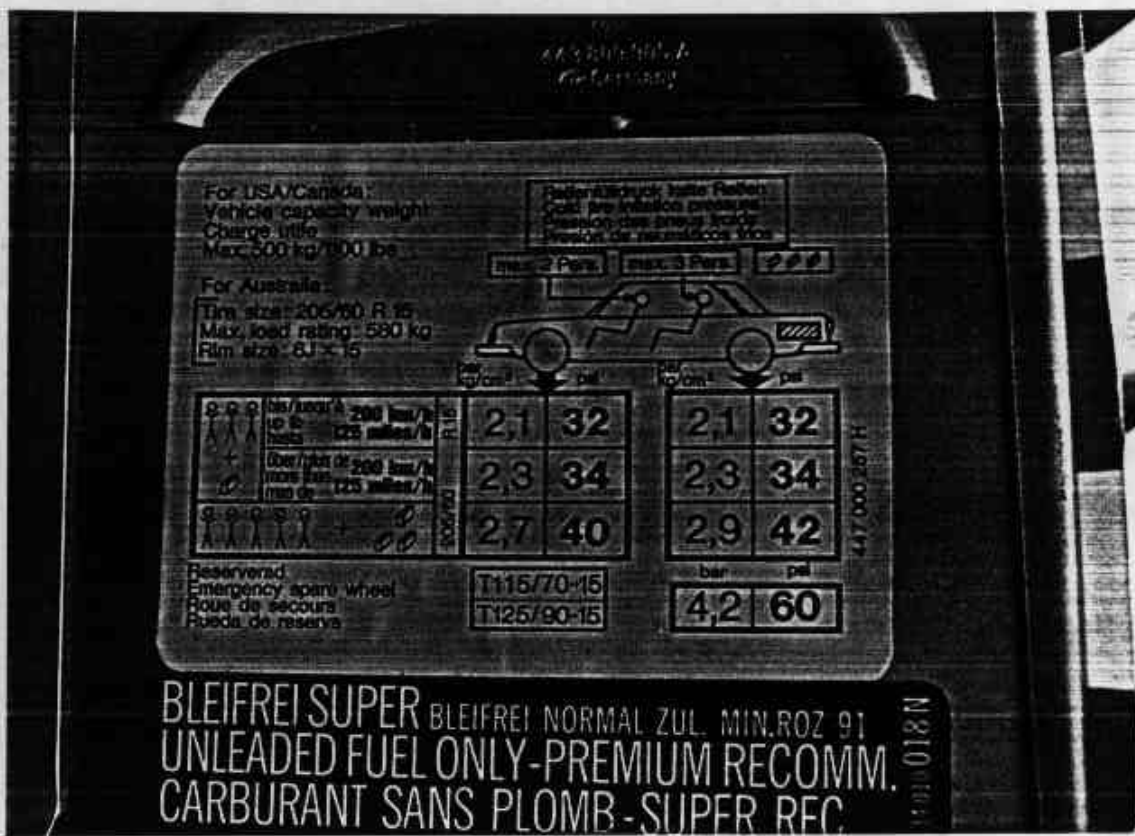
Figure A-47. PRE-TEST VEHICLE TIRE LOAD LABEL VIEW

DATA FROM "RECOMMENDED TIRE PRESSURE" LABEL ON DOOR, POST, GLOVEBOX, ETC.

RECOMMENDED TIRE SIZE: 205/60R15 LOAD RANGE X B, C, D
