REPORT NOS. 208-TRC-89-009  
212-TRC-89-009  
301-TRC-89-009

VEHICLE SAFETY COMPLIANCE TESTING  
FOR OCCUPANT CRASH PROTECTION,  
WINDSHIELD MOUNTING, WINDSHIELD ZONE  
INTRUSION, AND FUEL SYSTEM INTEGRITY

SAAB-SCANIA  
1989 SAAB 9000  
4-DOOR SEDAN  
NHTSA NO. CK0504  
TRC TEST NO. 890505

MAY 23, 1989  
FINAL REPORT

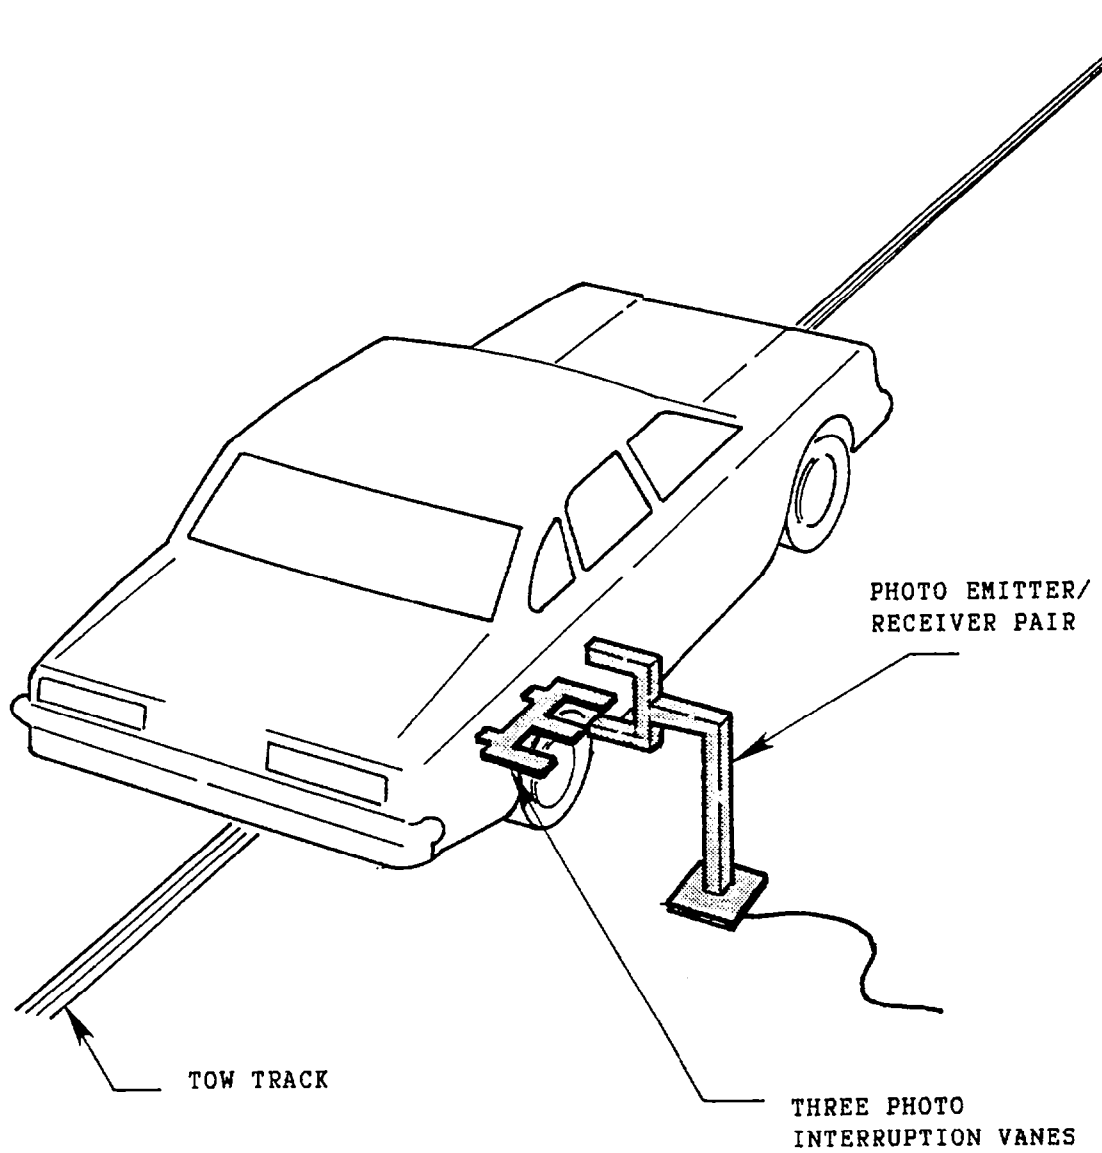
FIGURE 1 IMPACT VELOCITY MEASUREMENT SYSTEM

The final vane clears emitter/receiver two inches before impact.

The vanes have one foot spacing.
