**VEHICLE SAFETY COMPLIANCE TESTING FOR OCCUPANT CRASH PROTECTION,
WINDSHIELD MOUNTING, WINDSHIELD ZONE INTRUSION (PARTIAL)
AND FUEL SYSTEM INTEGRITY**

NISSAN MOTOR COMPANY
1989 NISSAN PULSAR NX SE
2-DOOR HATCHBACK

NHTSA NO. CK5201
CALSPAN TEST NO. 7715-10
JULY 17, 1989

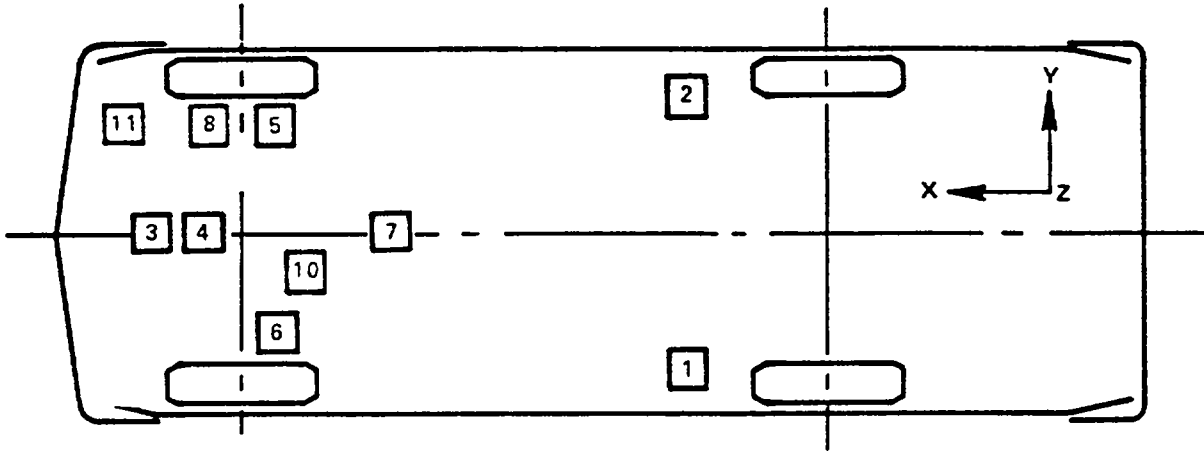
VEHICLE ACCELEROMETER LOCATIONS

ACCELEROMETER NUMBER*	ACCELEROMETER LOCATION	DIRECTION		
		X	Y	Z
1	Left Rear Seat Crossmember	x		
2	Right Rear Seat Crossmember	x		
3	Top of Engine	x		
4	Bottom of Engine	x		
5	Right Disc Brake Caliper	x		
6	Left Disc Brake Caliper	x		
7	Instrument Panel	x		
8	Front Shock Tower	x		
9	Firewall	x		
10	Cradle Frame	x		
11	Radiator Support	x

* The accelerometer pack number can be correlated with the vehicle response data traces found in Appendix B.

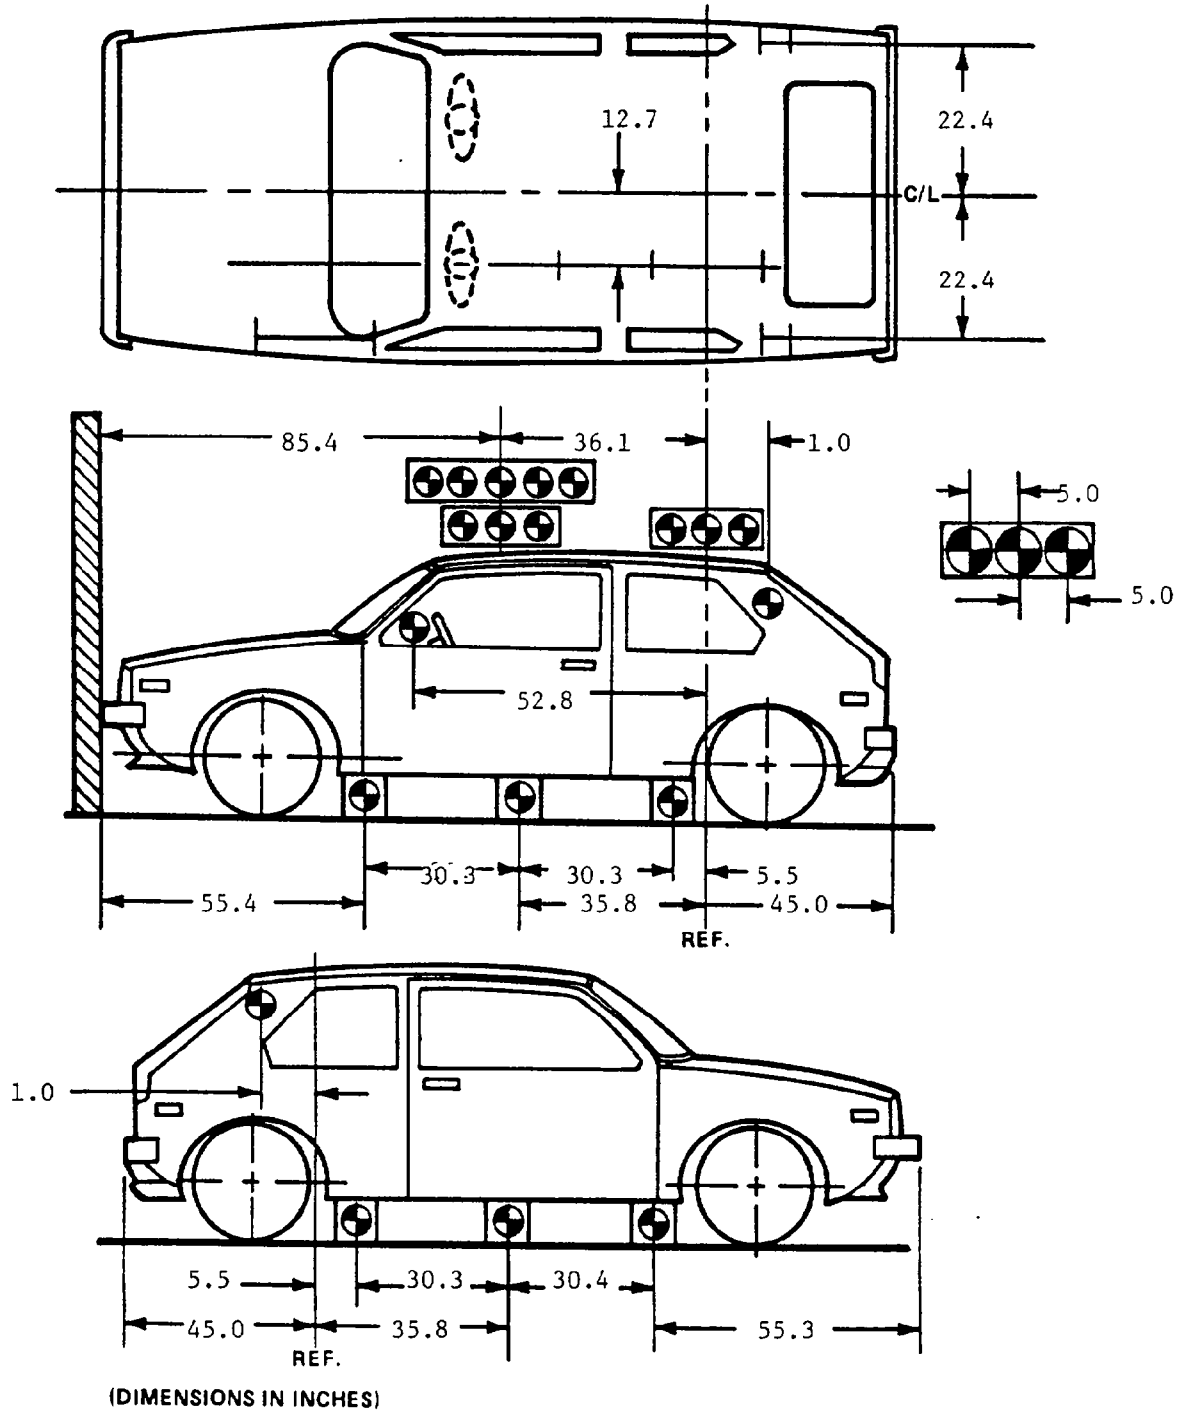
Figure 8

VEHICLE TARGET LOCATIONS

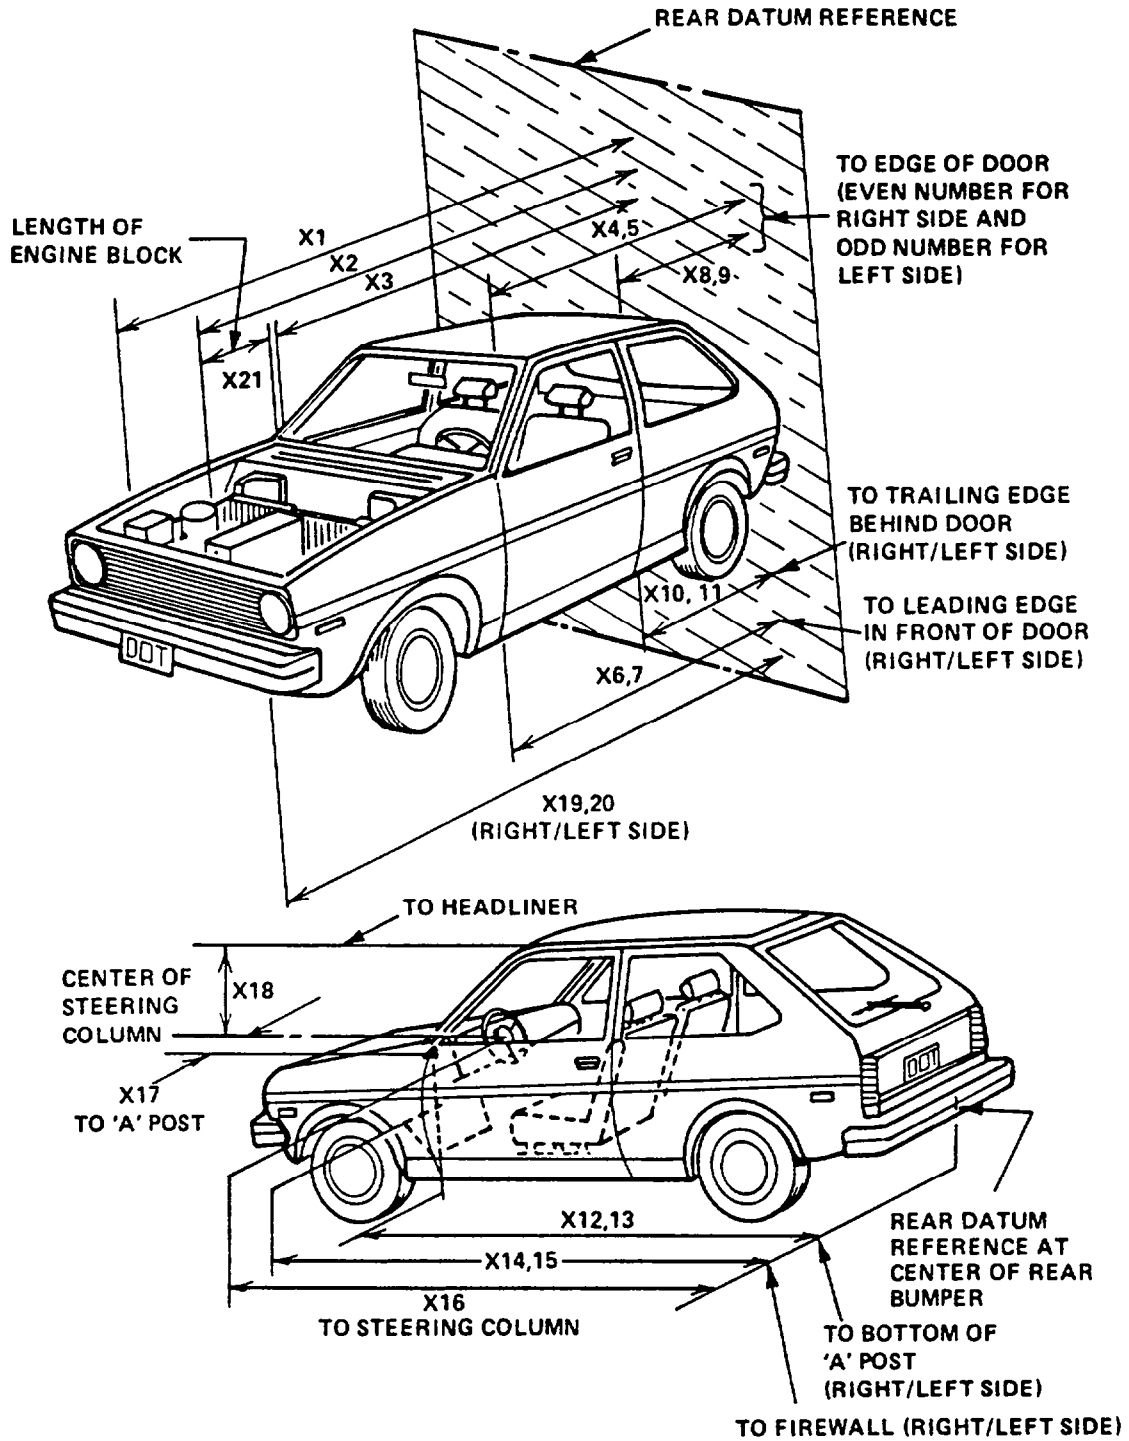
Figure 9

TEST VEHICLE MEASUREMENTS

No.		All Dimensions in Inches		
		Pre-Test	Post-Test	Differences
X1	Total Length of Vehicle at Centerline	166.5	149.7	16.8
X2	Rear Surface of Vehicle to Front of Engine	143.2	136.7	6.5
X3	Rear Surface of Vehicle to Firewall	121.5	119.8	1.7
X4	Rear Surface of Vehicle to Upper Leading Edge of Right Door	111.7	110.3	1.4
X5	Rear Surface of Vehicle to Upper Leading Edge of Left Door	110.8	110.6	0.2
X6	Rear Surface of Vehicle to Lower Leading Edge of Right Door	109.5	109.2	0.3
X7	Rear Surface of Vehicle to Lower Leading Edge of Left Door	109.3	109.2	0.1
X8	Rear Surface of Vehicle to Upper Trailing Edge of Right Door	60.4	60.0	0.4
X9	Rear Surface of Vehicle to Upper Trailing Edge of Left Door	60.5	60.3	0.2
X10	Rear Surface of Vehicle to Lower Trailing Edge of Right Door	64.3	63.8	0.5
X11	Rear Surface of Vehicle to Lower Trailing Edge of Left Door	64.2	63.7	0.5
X12	Rear Surface of Vehicle to Bottom of "A" Post of Right Side	109.8	109.4	0.4

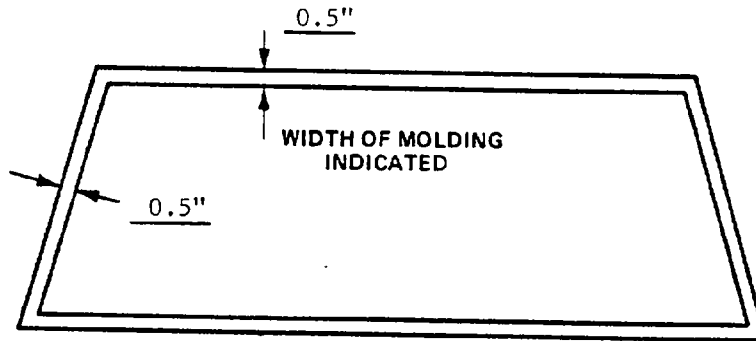
WINDSHIELD PERIPHERY		
	PRE-TEST (in.)	POST-TEST (in.)	PERCENT RETENTION
RIGHT SIDE	79.55	79.55	100
LEFT SIDE	79.55	79.55	100
TOTAL	159.1	159.1	100

AREA OF RETENTION FAILURE:

FRONT VIEW

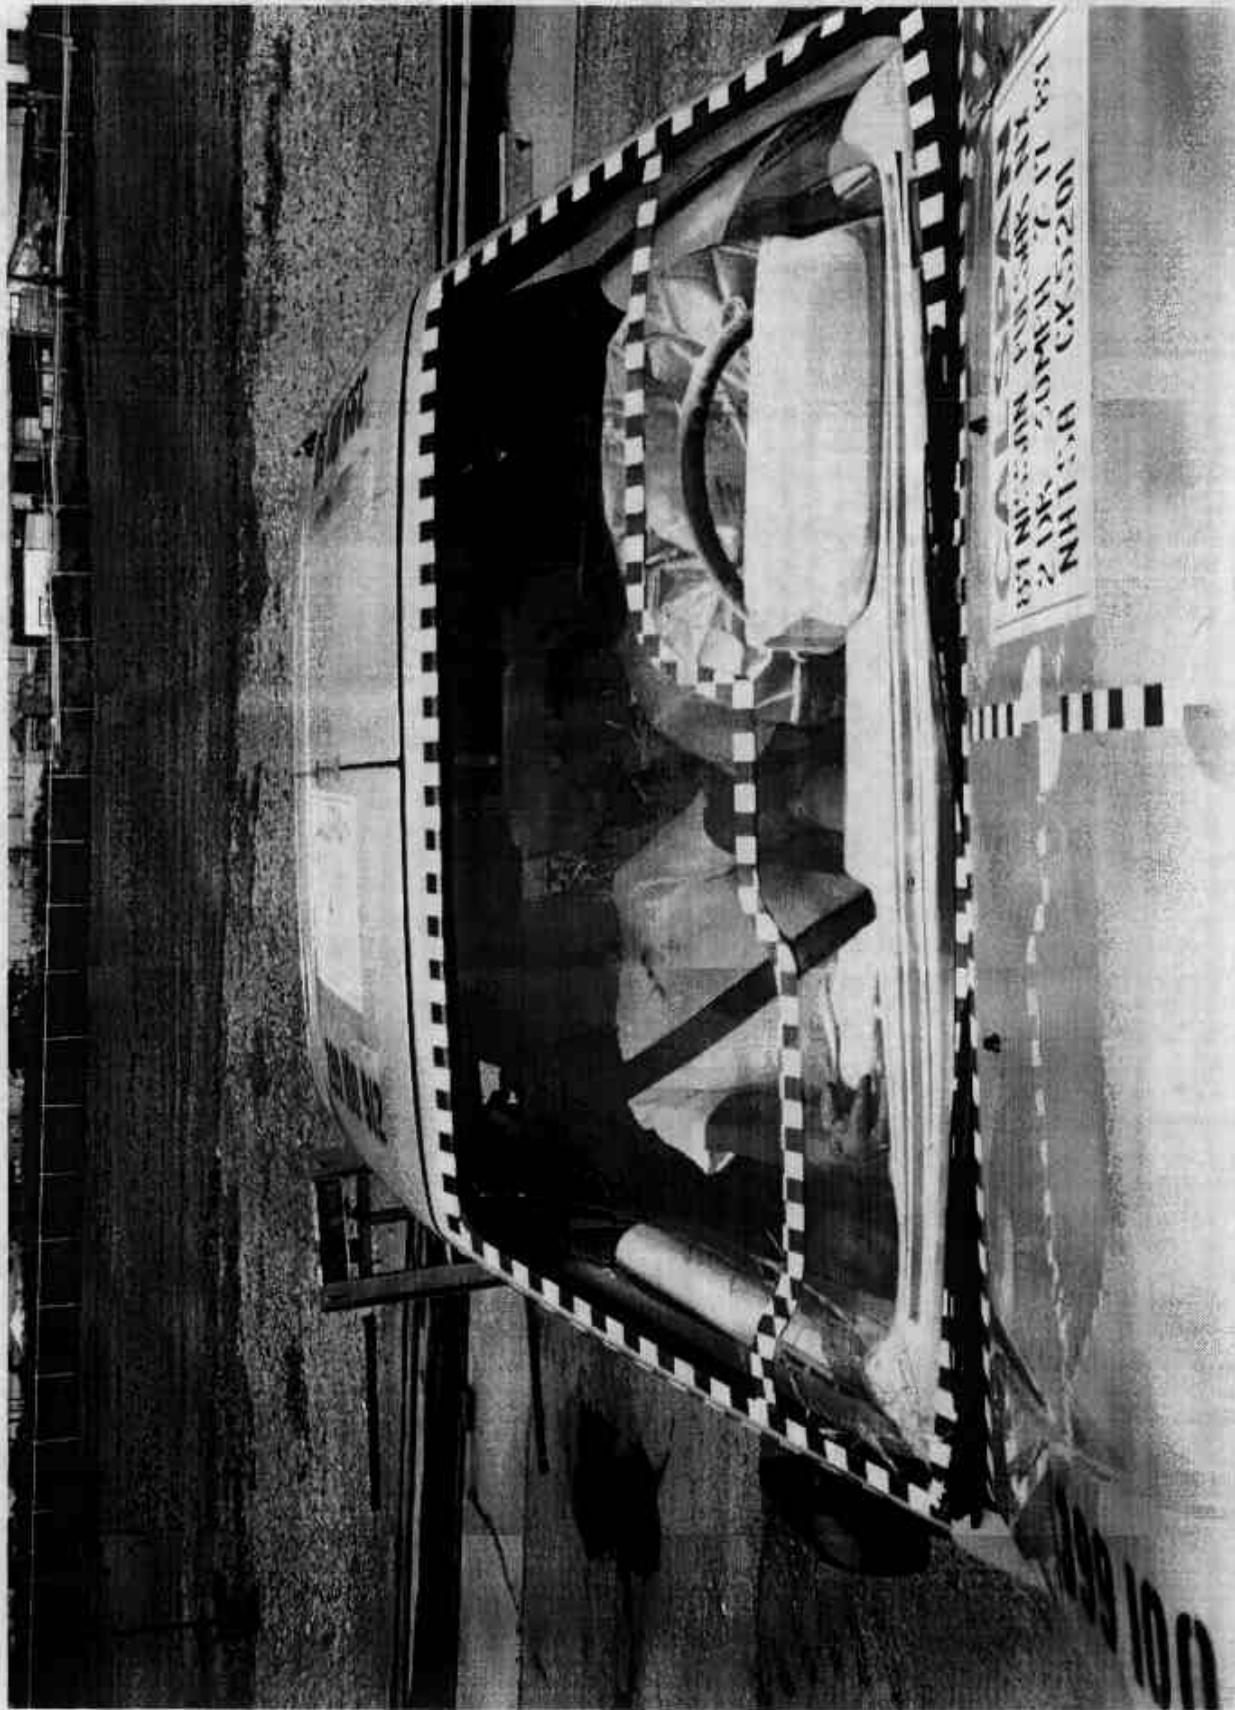
Figure A-13 POST-TEST WINDSHIELD VIEW

GLAZING DAMAGE: Right side of windshield cracked.

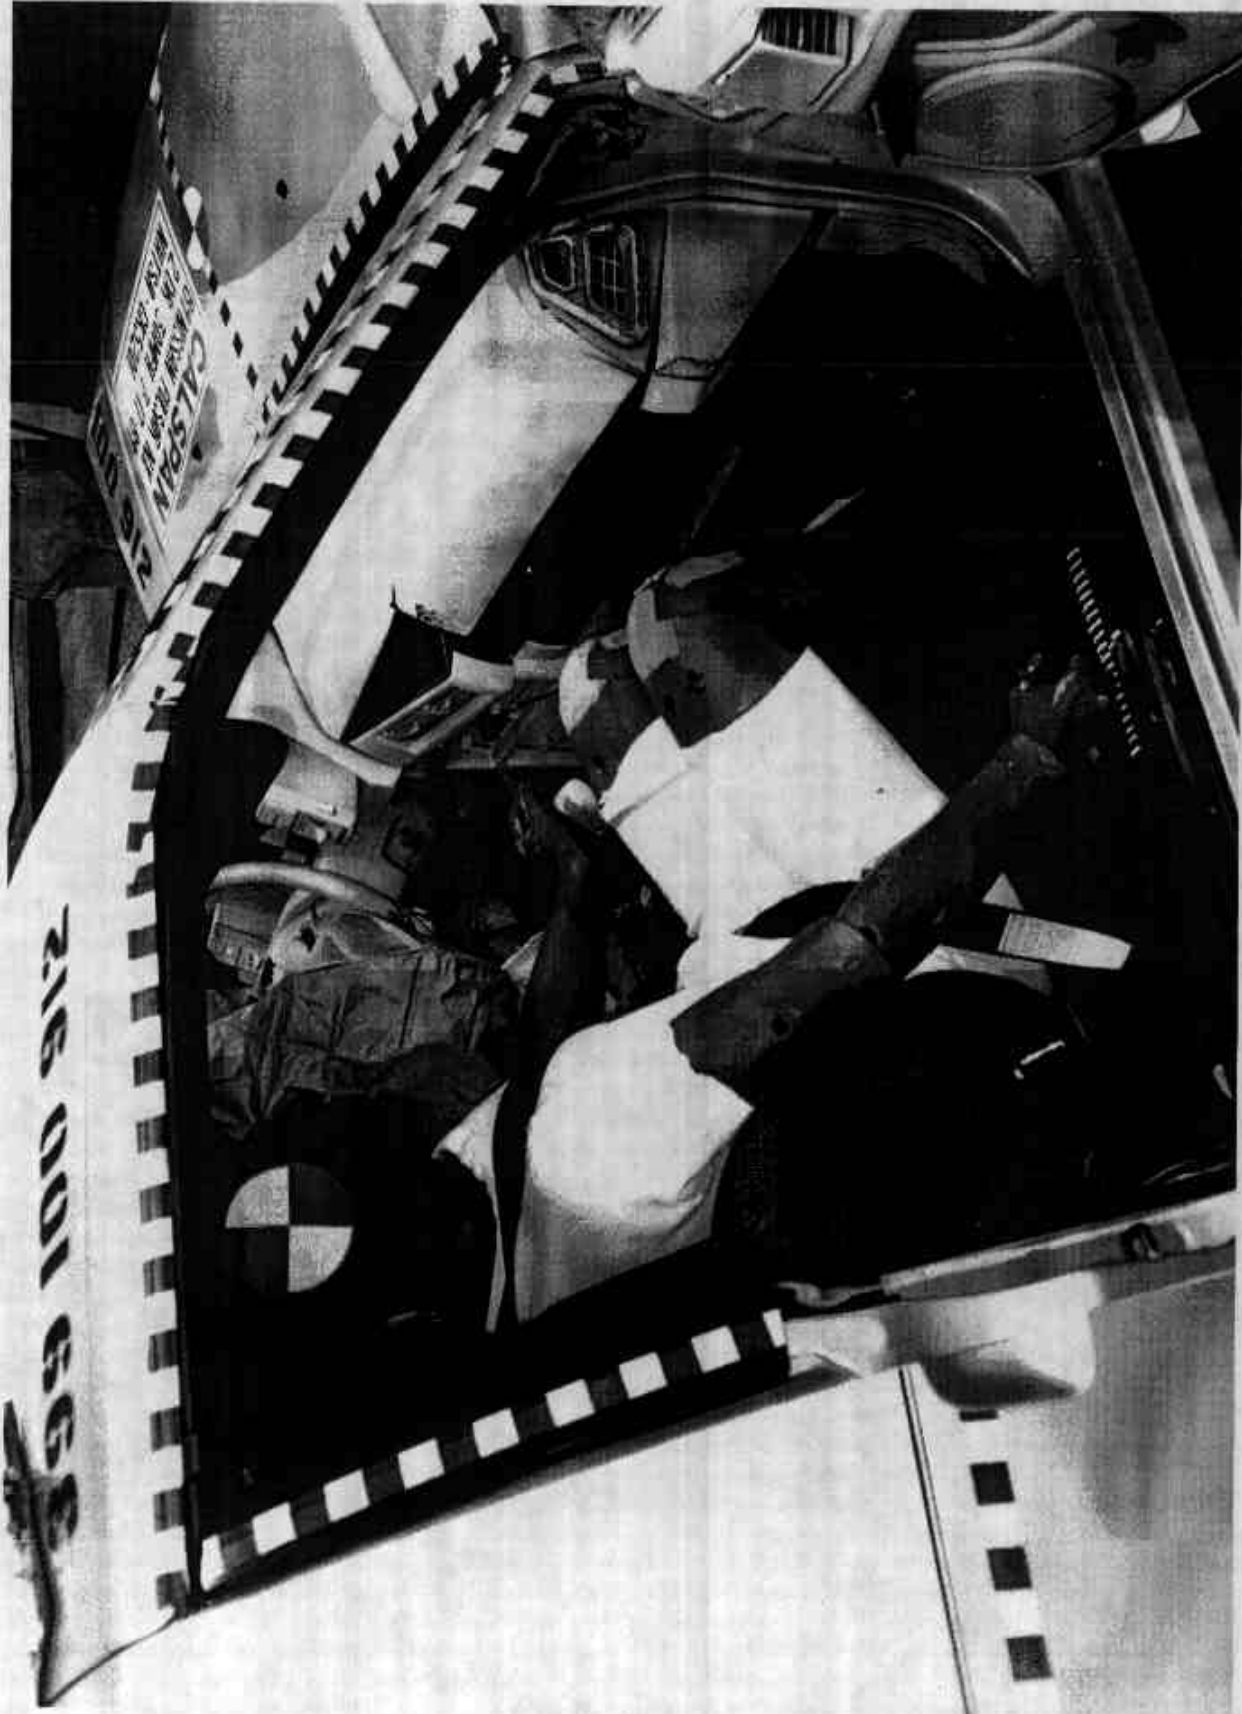
Figure A-31 POST-TEST PASSENGER DUMMY AND INTERIOR VIEW

The Pos #2 right front passenger right femur experienced intermittent data between 60 and 108 msec. Visual inspection of the glove box door indicates the right femur would not have exceeded the FMVSS 208 femur criteria. Accelerometer #7(x) passed the pre-test checkout however did not record any data.

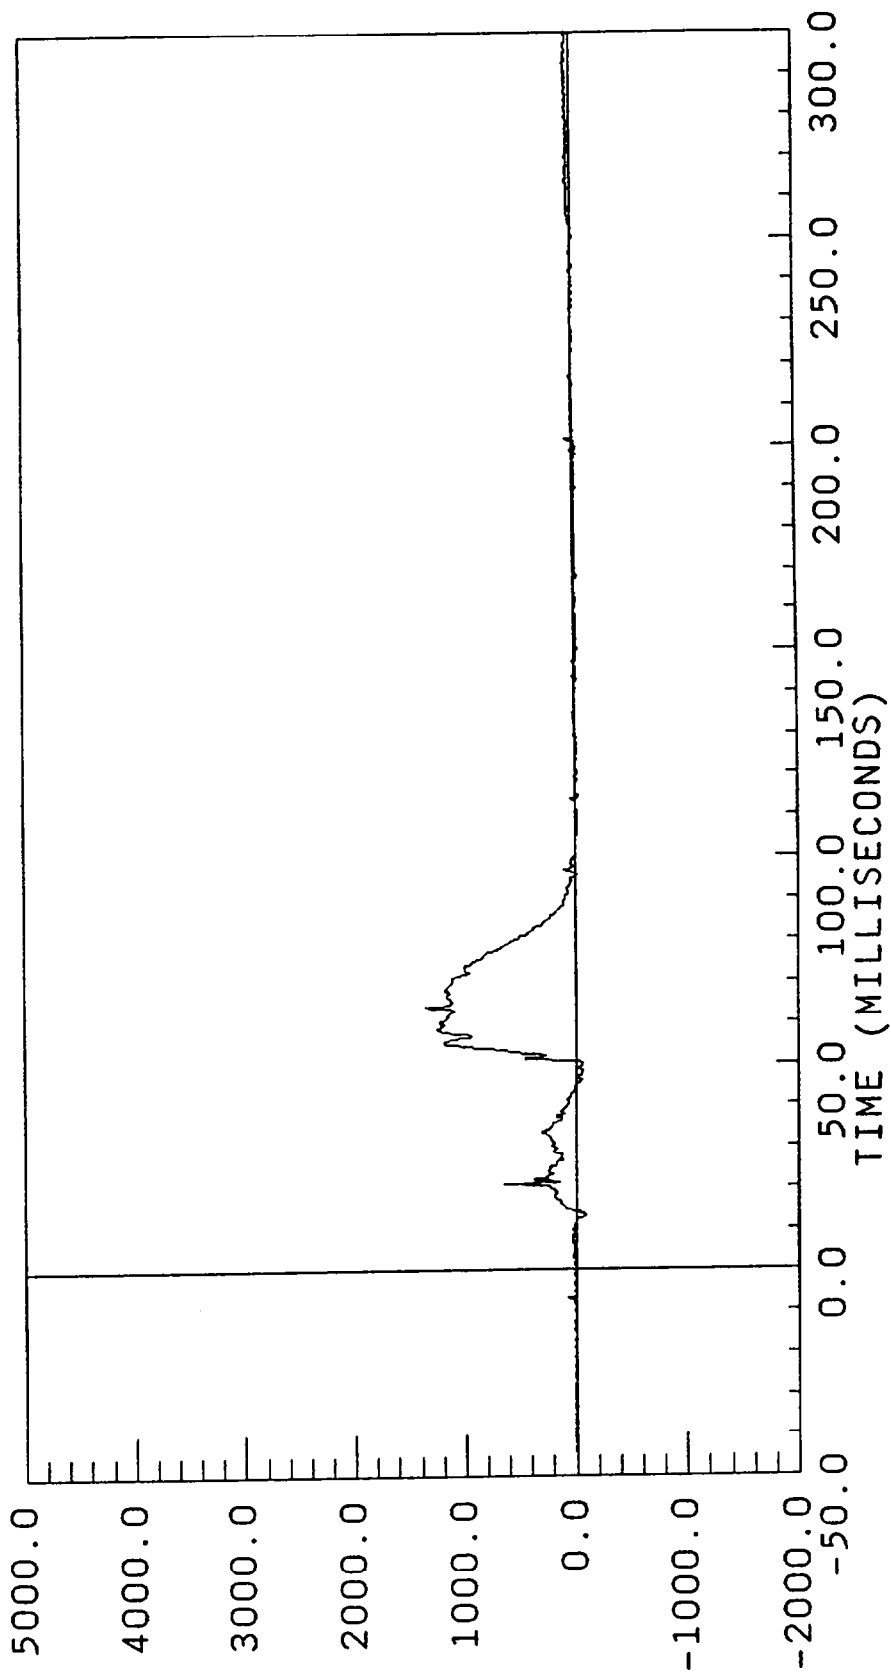
The driver's HIC was 408. The maximum chest deceleration over 3 milliseconds was 49.6 g's. The maximum force on the driver's left femur was 1363 lbs and 2030 lbs on the right femur.

POS#1 LEFT FEMUR
FILTERED
FILTER CUTOFF: 1000HZ
NA AXIS
YMIN = -82.35471 at 13.05000
YMAX = 1362.523 at 63.75000

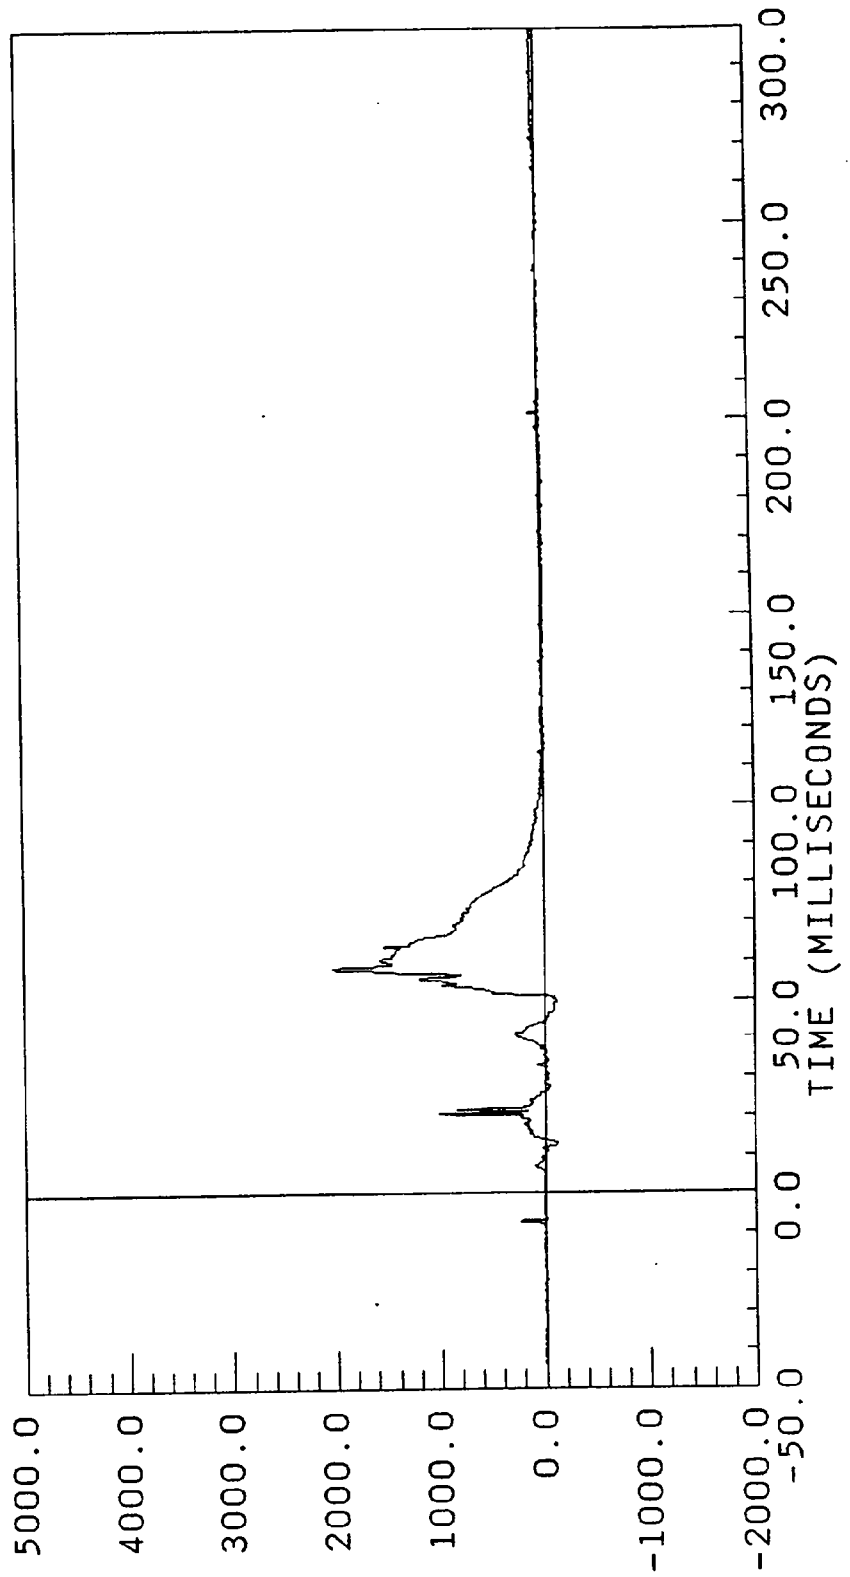
POS#1 RIGHT FEMUR NA AXIS
FILTERED YMIN = -128.9014 at 12.90000
FILTER CUTOFF: 1000HZ YMAX = 2029.954 at 58.05000

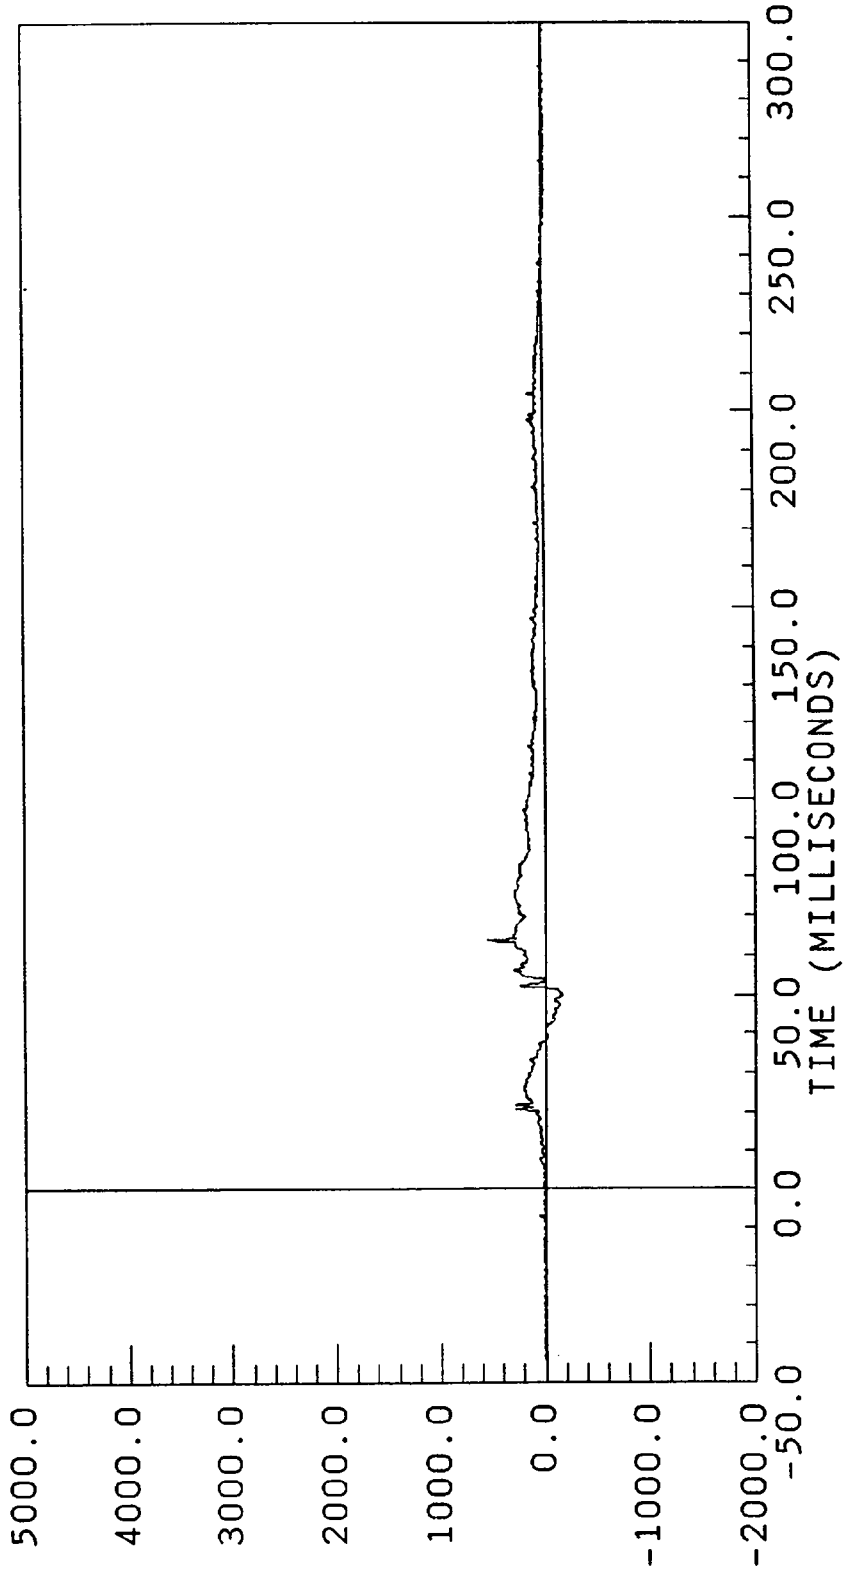
The right-front passenger's HIC was 304. The maximum chest deceleration over 3 milliseconds was 34.8 g's and the left femur load was 559 lbs.

POS#2 LEFT FEMUR
FILTERED
FILTER CUTOFF: 1000HZ
NA AXIS
YMIN = -170.0410 at 50.02500
YMAX = 559.4886 at 63.75000

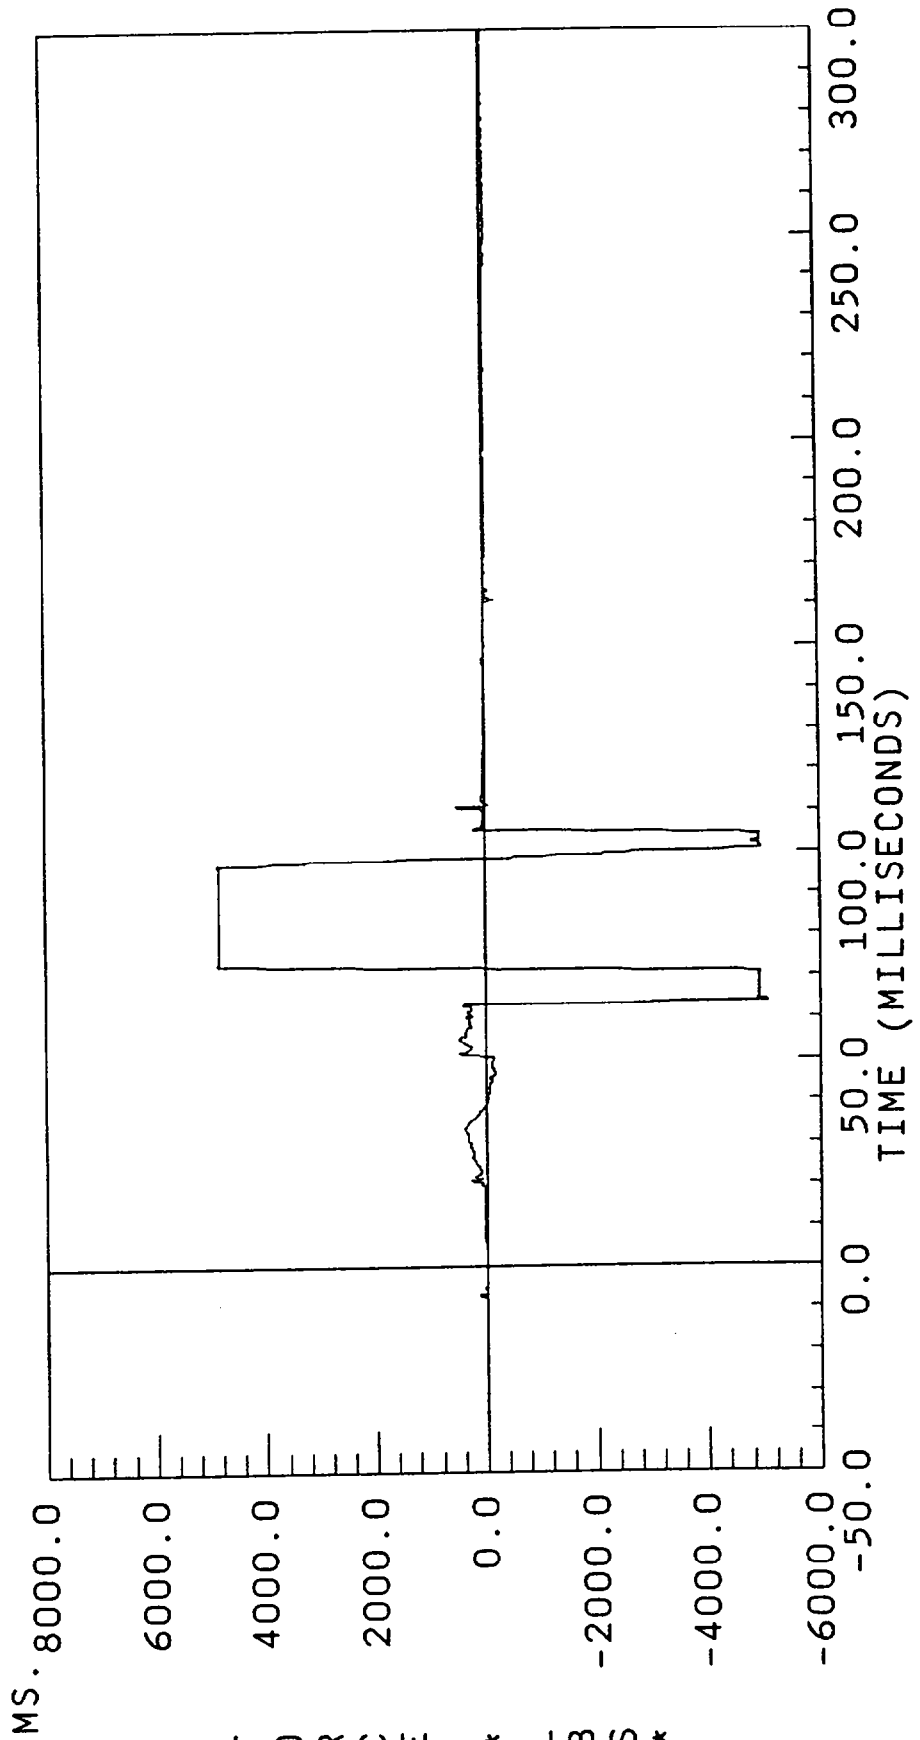
POS#2 RIGHT FEMUR
FILTERED
FILTER CUTOFF: 1000HZ
ACCELEROMETER EXPERIENCED INTERMITTENT DATA BETWEEN 60 AND 108
NA AXIS
YMIN = -5068.253 at 64.05000
YMAX = 4882.490 at 97.05000
