REPORT NOS. 208-TRC-90-006  
212-TRC-90-006  
301-TRC-90-006

VEHICLE SAFETY COMPLIANCE TESTING  
FOR OCCUPANT CRASH PROTECTION,  
WINDSHIELD MOUNTING, WINDSHIELD ZONE  
INTRUSION, AND FUEL SYSTEM INTEGRITY

NISSAN MOTOR COMPANY, LTD.

1990 NISSAN STANZA

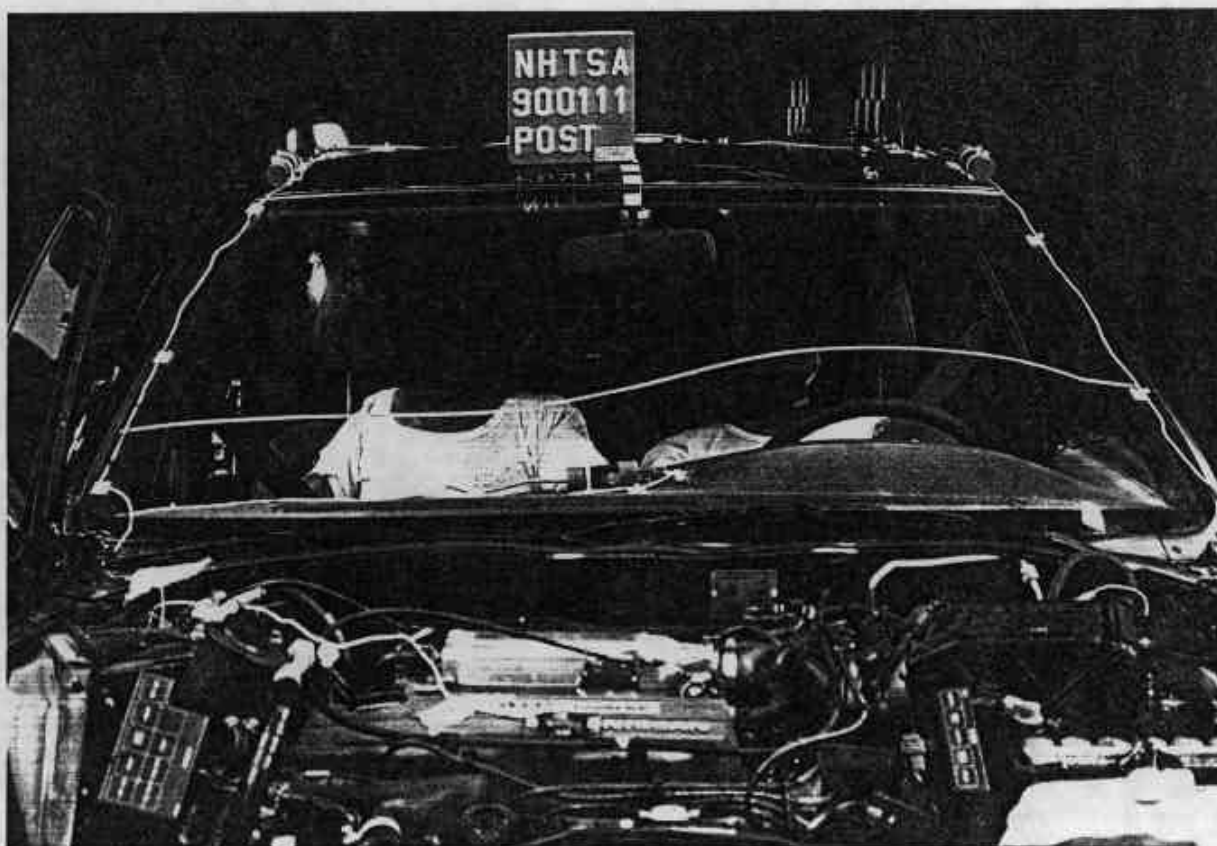
Figure A-14. POST-TEST WINDSHIELD VIEW
