CALSPAN REPORT NUMBER: 7883-5

VEHICLE-TO-VEHICLE FRONTAL 60% OVERLAP  
35 MPH IMPACT OF A  
1991 SUZUKI SWIFT 2-DOOR HATCHBACK  
AND  
1991 FORD CROWN VICTORIA LTD 4-DOOR SEDAN

CALSPAN TEST NUMBER: Y42-5-1042

FINAL REPORT

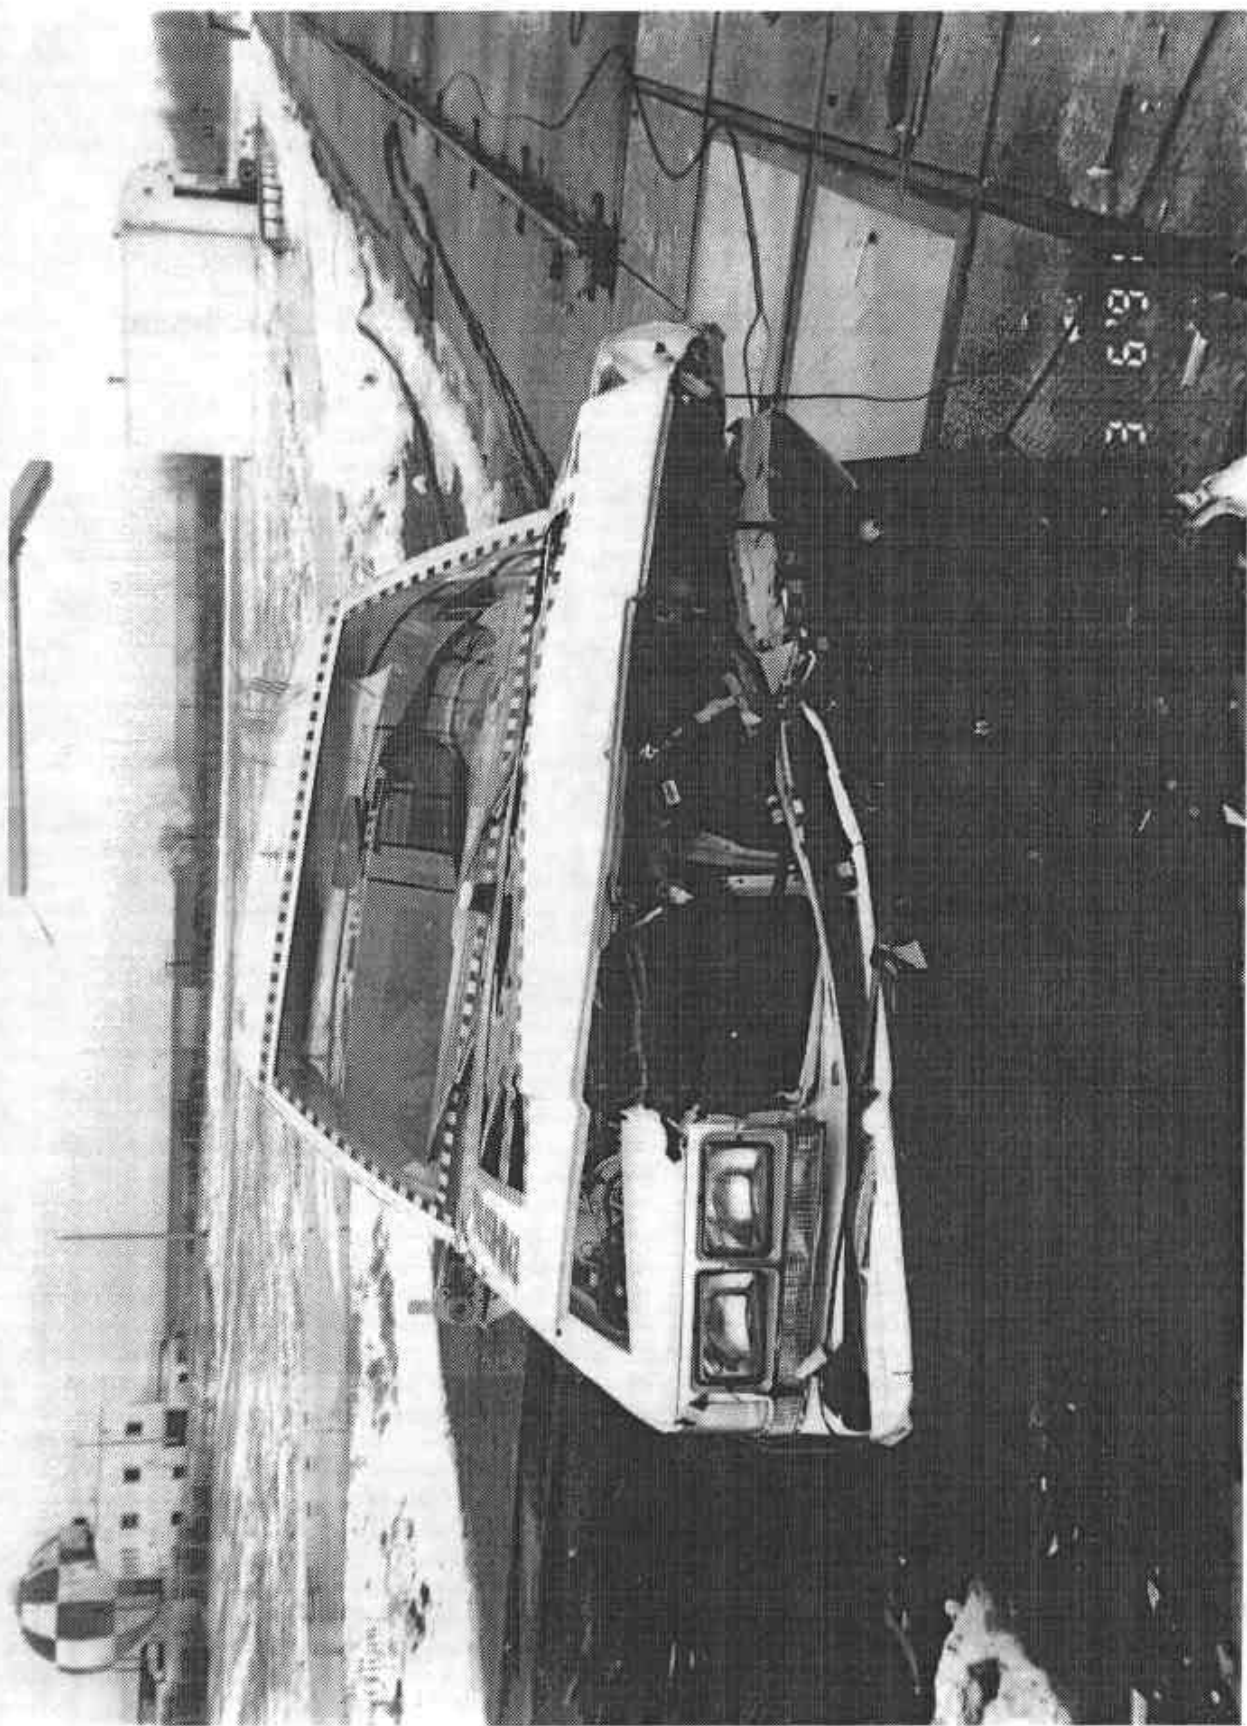
FIGURE A-39 VEHICLE 2 POST-TEST FRONT VIEW
