CALSPAN REPORT NUMBER: 7883-4

VEHICLE-TO-VEHICLE FRONTAL 60% OVERLAP  
35 MPH IMPACT OF A  
1991 SUBARU JUSTY 2-DOOR HATCHBACK AND  
1991 FORD CROWN VICTORIA LTD 4-DOOR SEDAN

CALSPAN TEST NUMBER: Y42-4-1041

FINAL REPORT

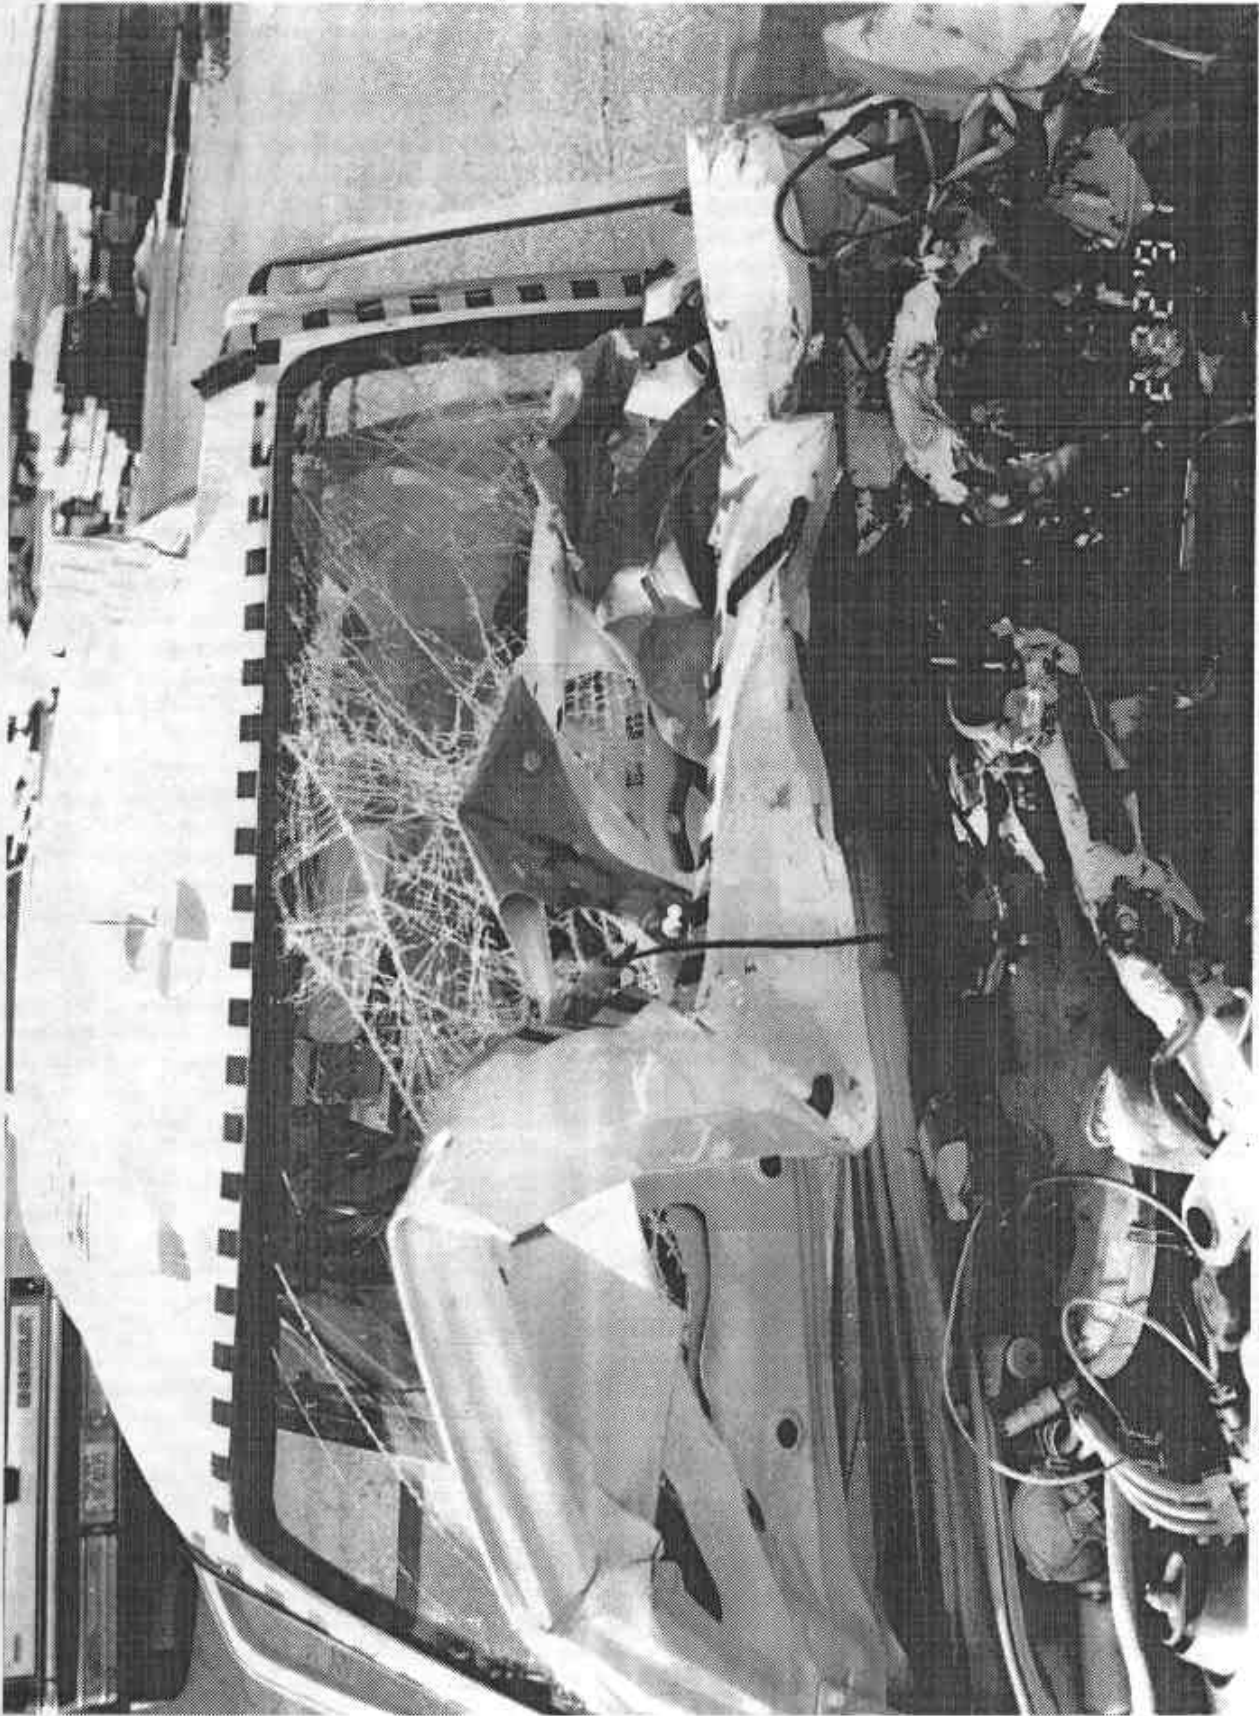
FIGURE A-23. VEHICLE 1. POST-TEST WINDSHIELD VIEW

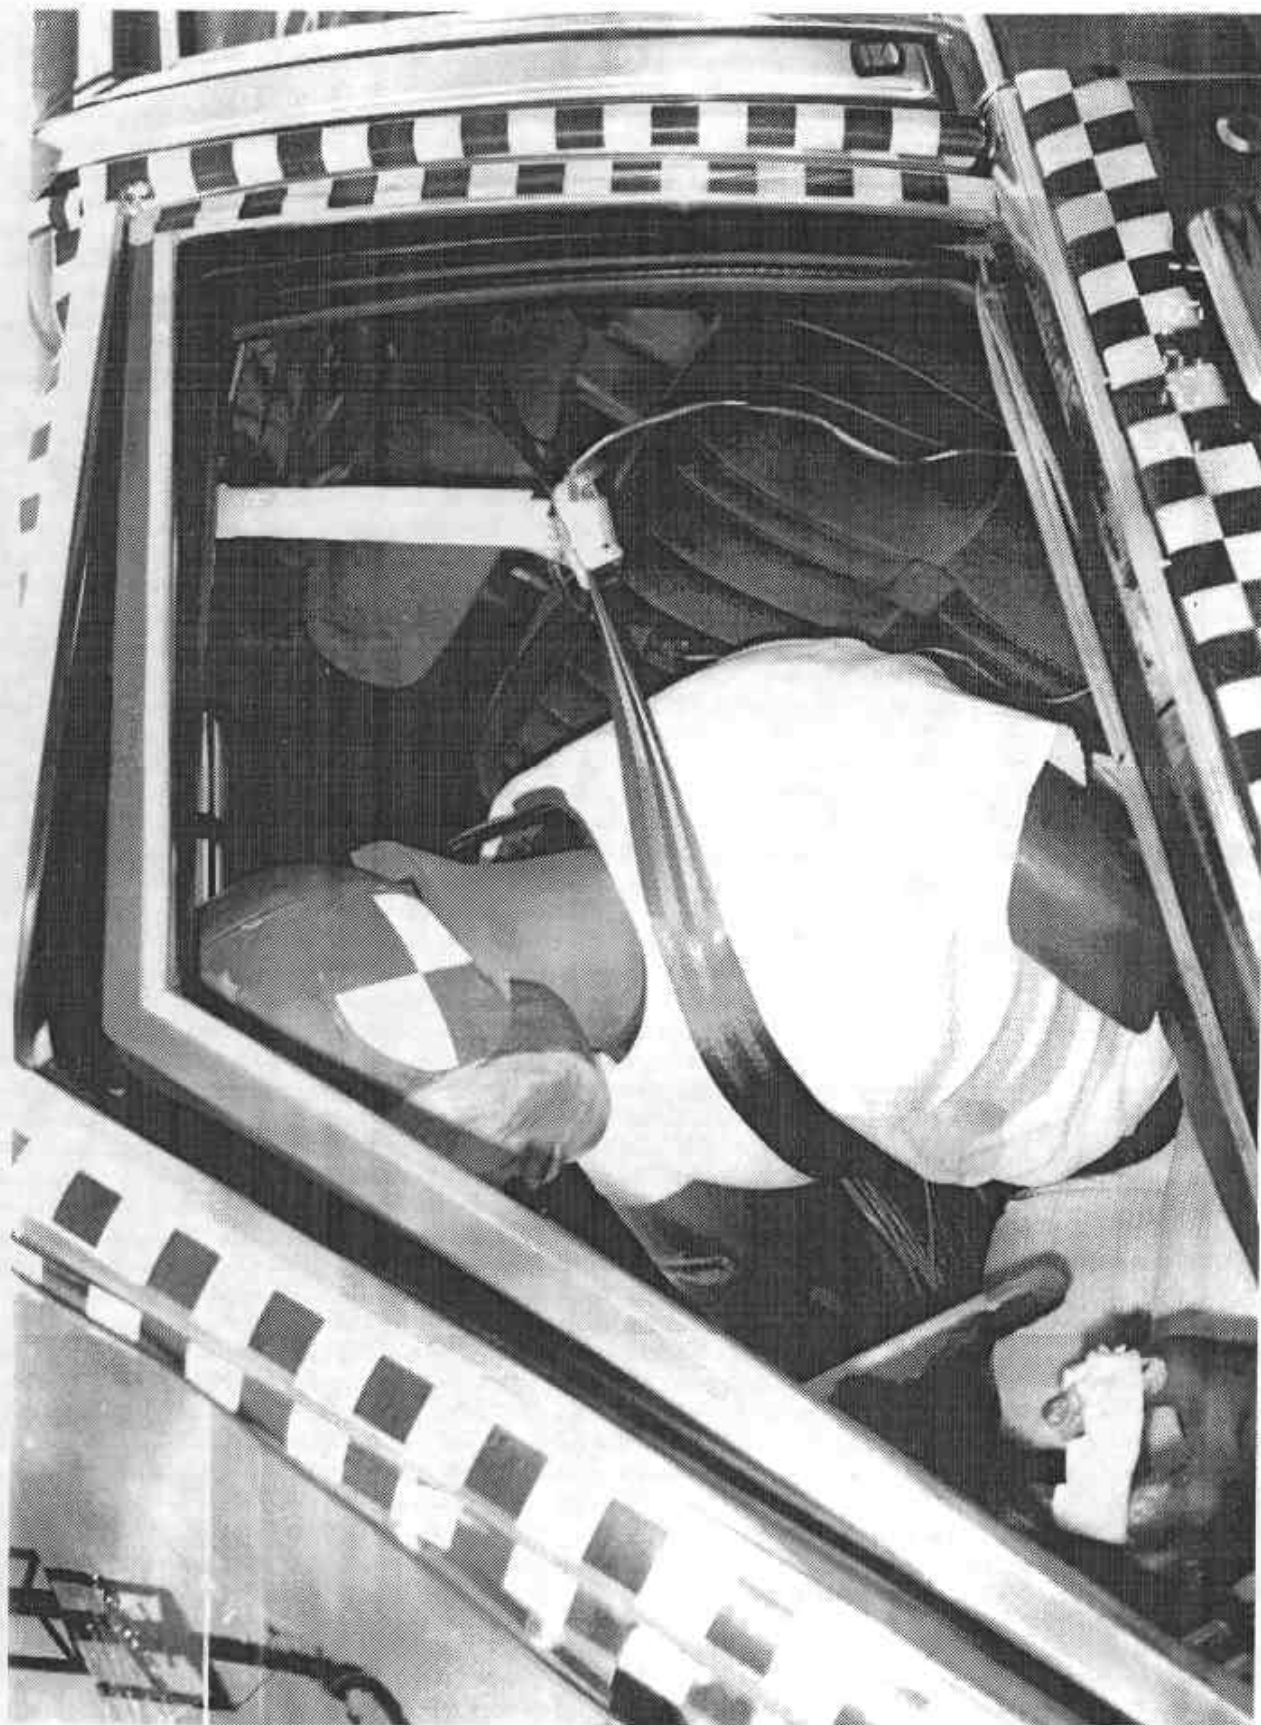
Figure A-65 VEHICLE 2 POST-TEST DRIVER POSITION VIEW

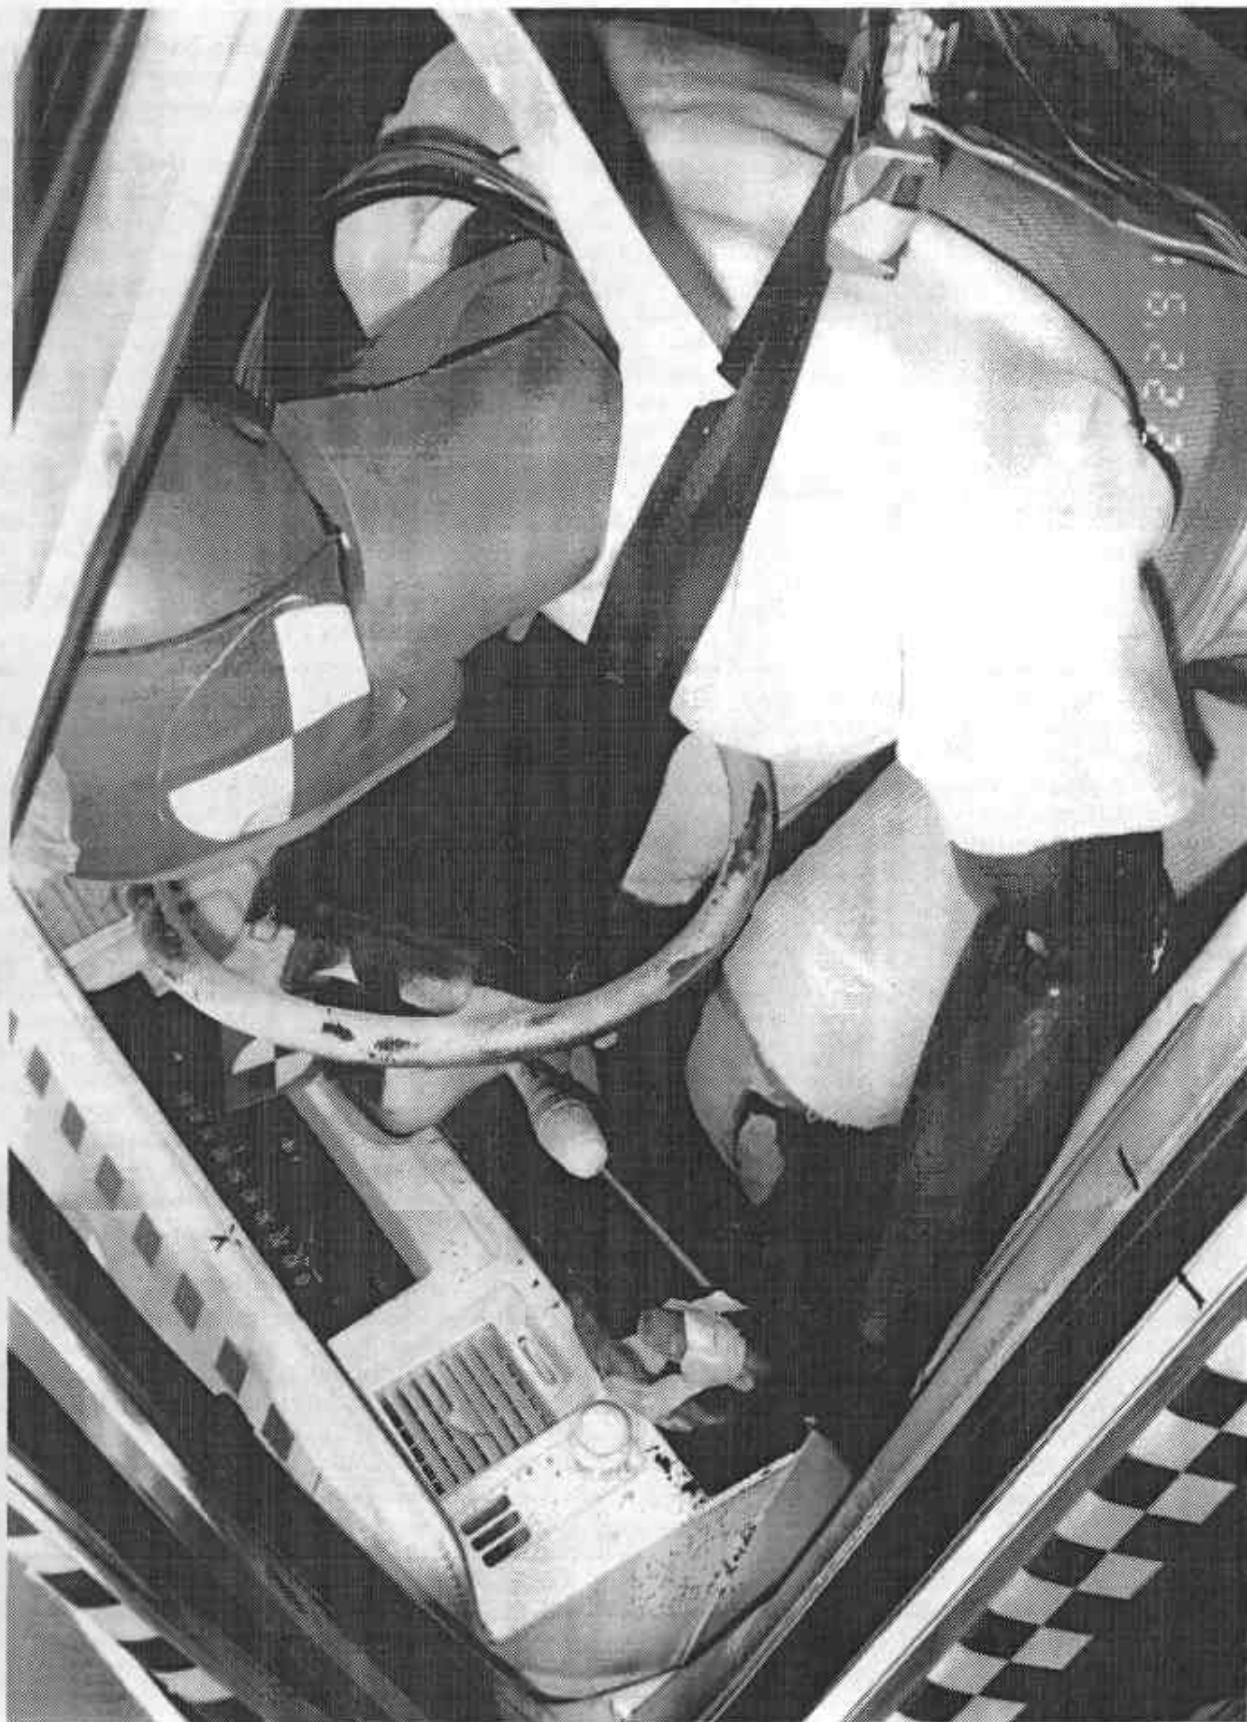
Figure A-67 VEHICLE 2 POST-TEST DRIVER AND OCCUPANT COMPARTMENT VIEW

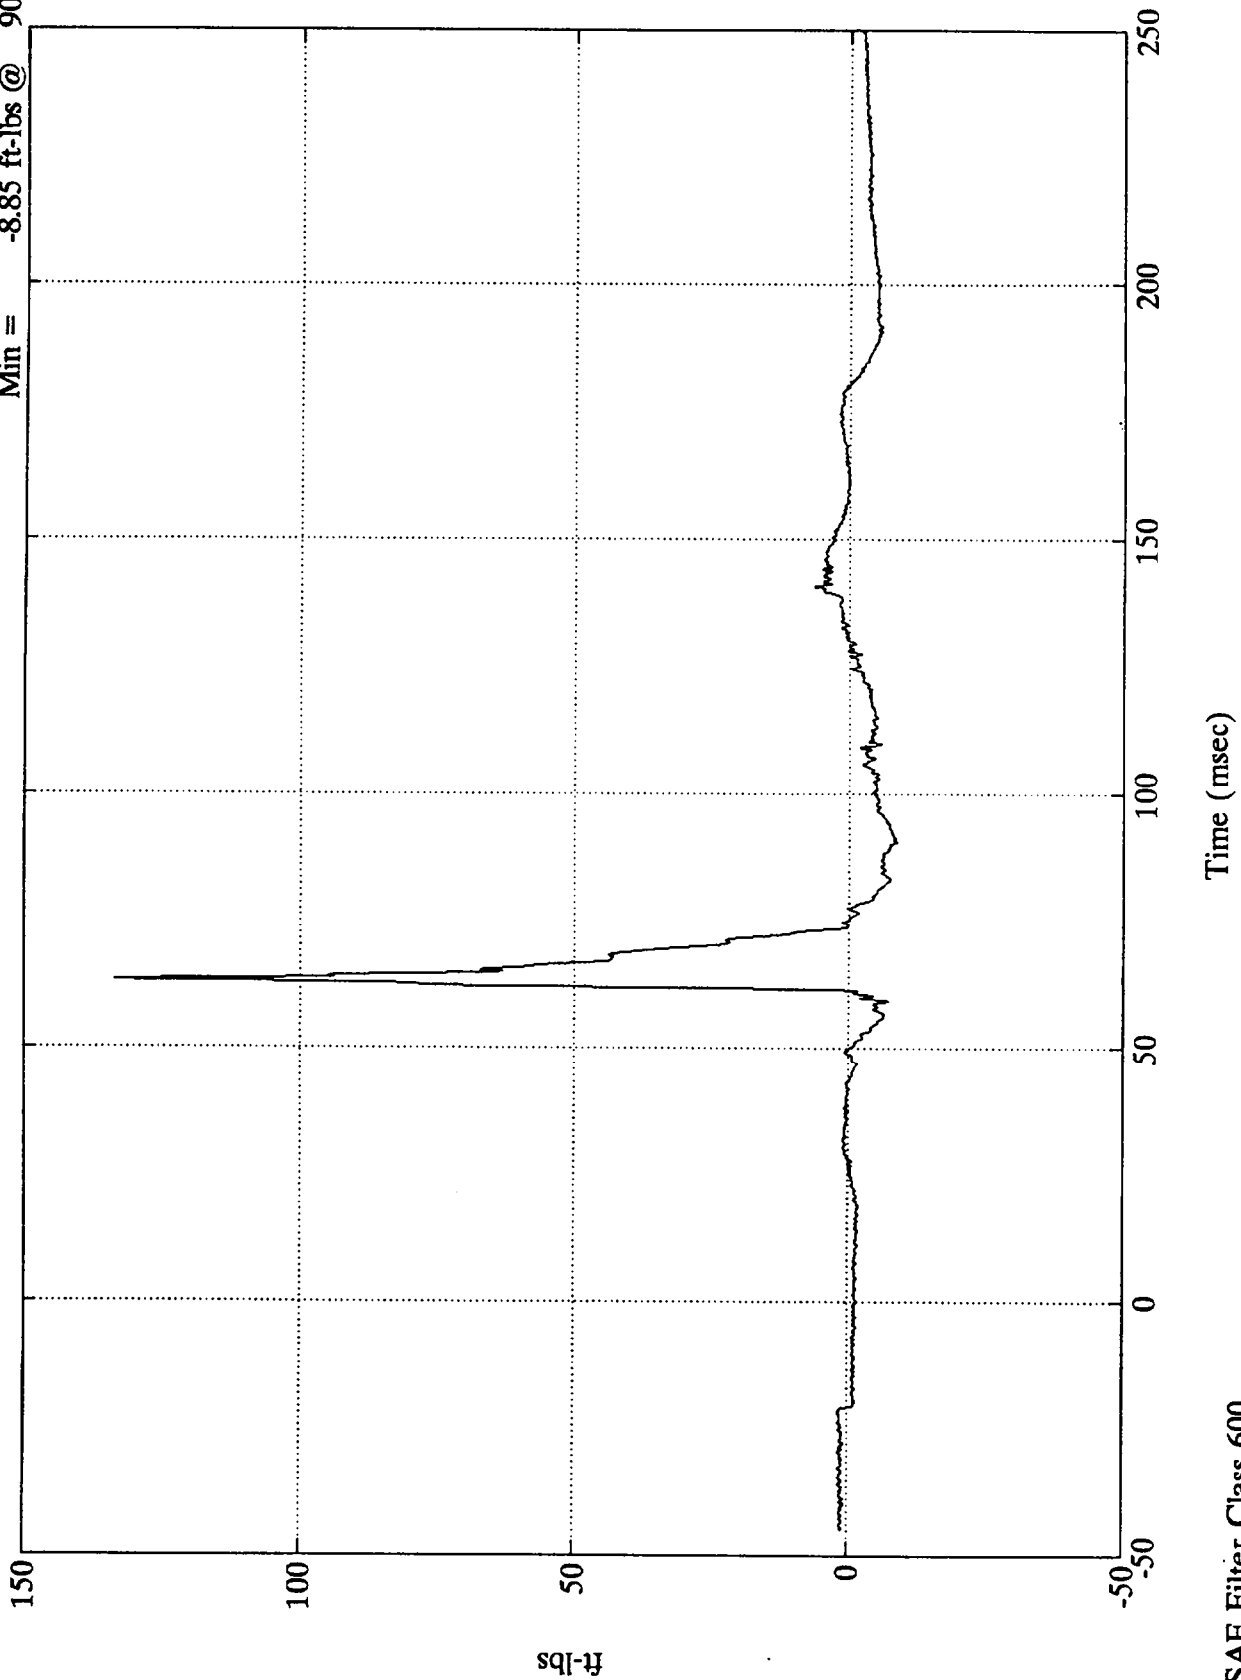
Veh. 2 Rt L Tibia Mx  
Max = 133.42 ft-lbs @ 63.35 msec  
Min = -8.85 ft-lbs @ 90.59 msec

Vehicle 2, position 1 left upper tibia moment X transducer did not record correctly.
