VEHICLE SAFETY COMPLIANCE TESTING  
FOR OCCUPANT CRASH PROTECTION,  
WINDSHIELD MOUNTING, WINDSHIELD ZONE  
INTRUSION, AND FUEL SYSTEM INTEGRITY

MAZDA MOTOR CORPORATION

1991 MAZDA MIATA

NHTSA NO. CM5403

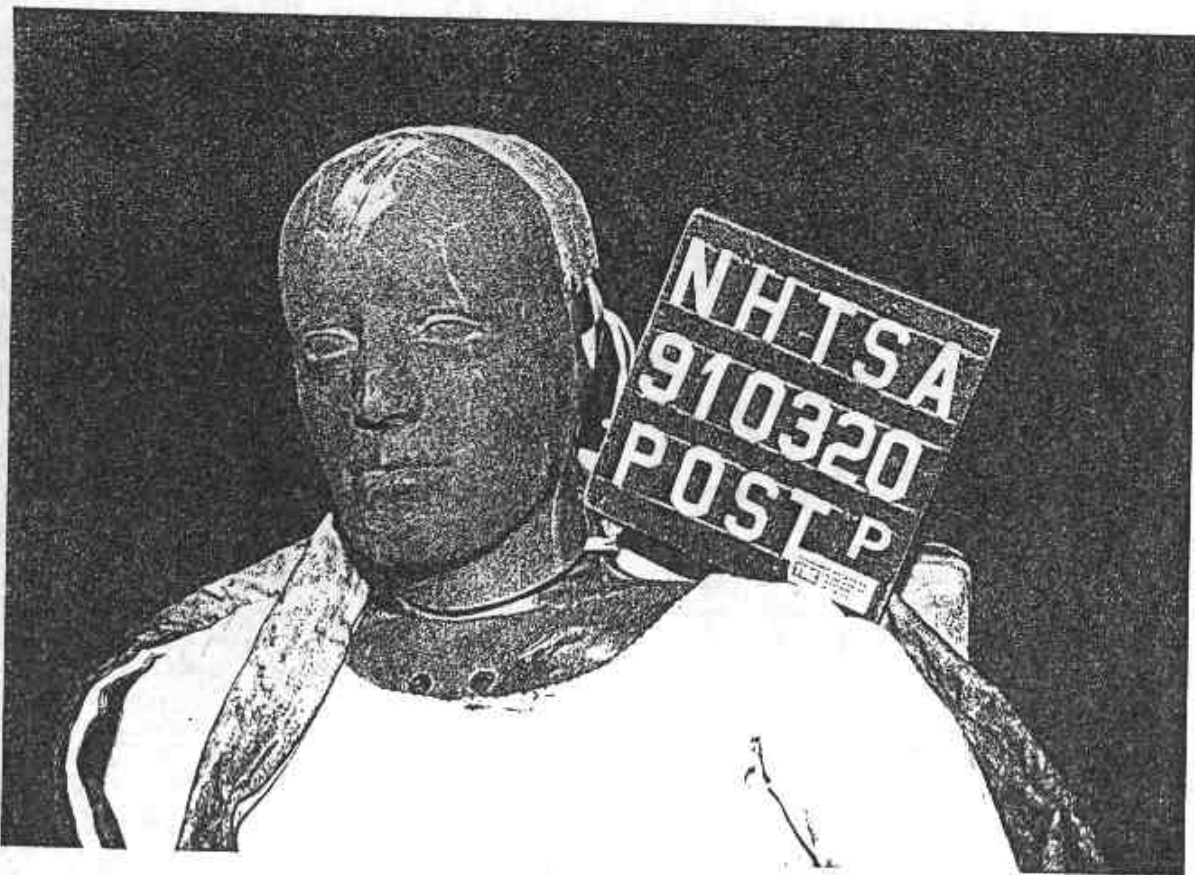
Figure A-40. POST-TEST PASSENGER DUMMY HEAD CONTACT VIEW

The right front passenger's HIC was 326. The right front passenger's maximum chest resultant acceleration over three (3) milliseconds was 38.5 g. The right front passenger's maximum left and right femur forces were 549 pounds and 1008 pounds, respectively.
