**SIDE IMPACT PROTECTION  
IN PRODUCTION VEHICLES**

**MDB-TO-CAR SIDE IMPACT TEST OF  
A 27° CRABBED MOVING DEFORMABLE BARRIER  
TO A 1991 TOYOTA PICKUP  
AT 33.5 MPH**

**MOBILITY SYSTEMS AND EQUIPMENT COMPANY  
9920 LA CIENEGA BOULEVARD SUITE 708  
INGLEWOOD, CALIFORNIA 90301**

**TEST REPORT**

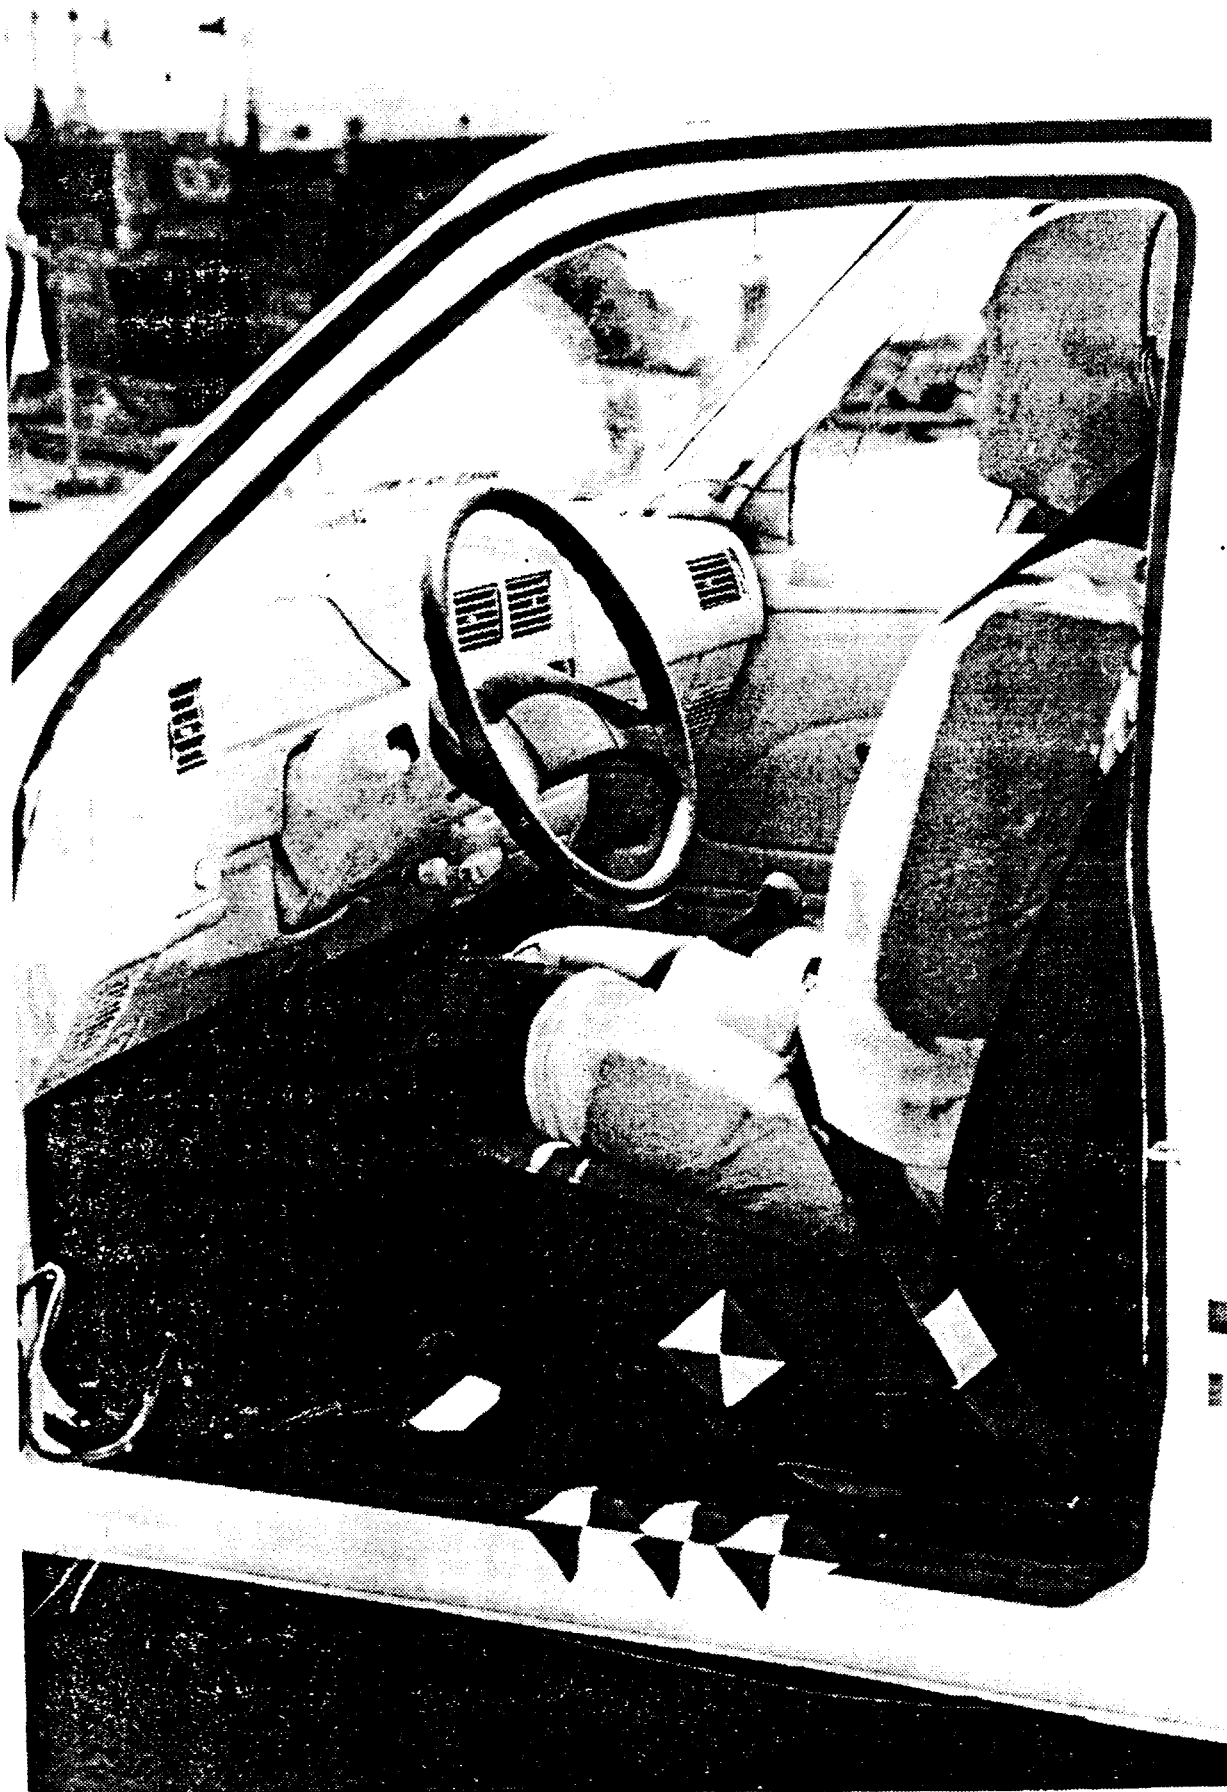
FIGURE A-7 SID IN DRIVER POSITION, PRETEST  
A-7

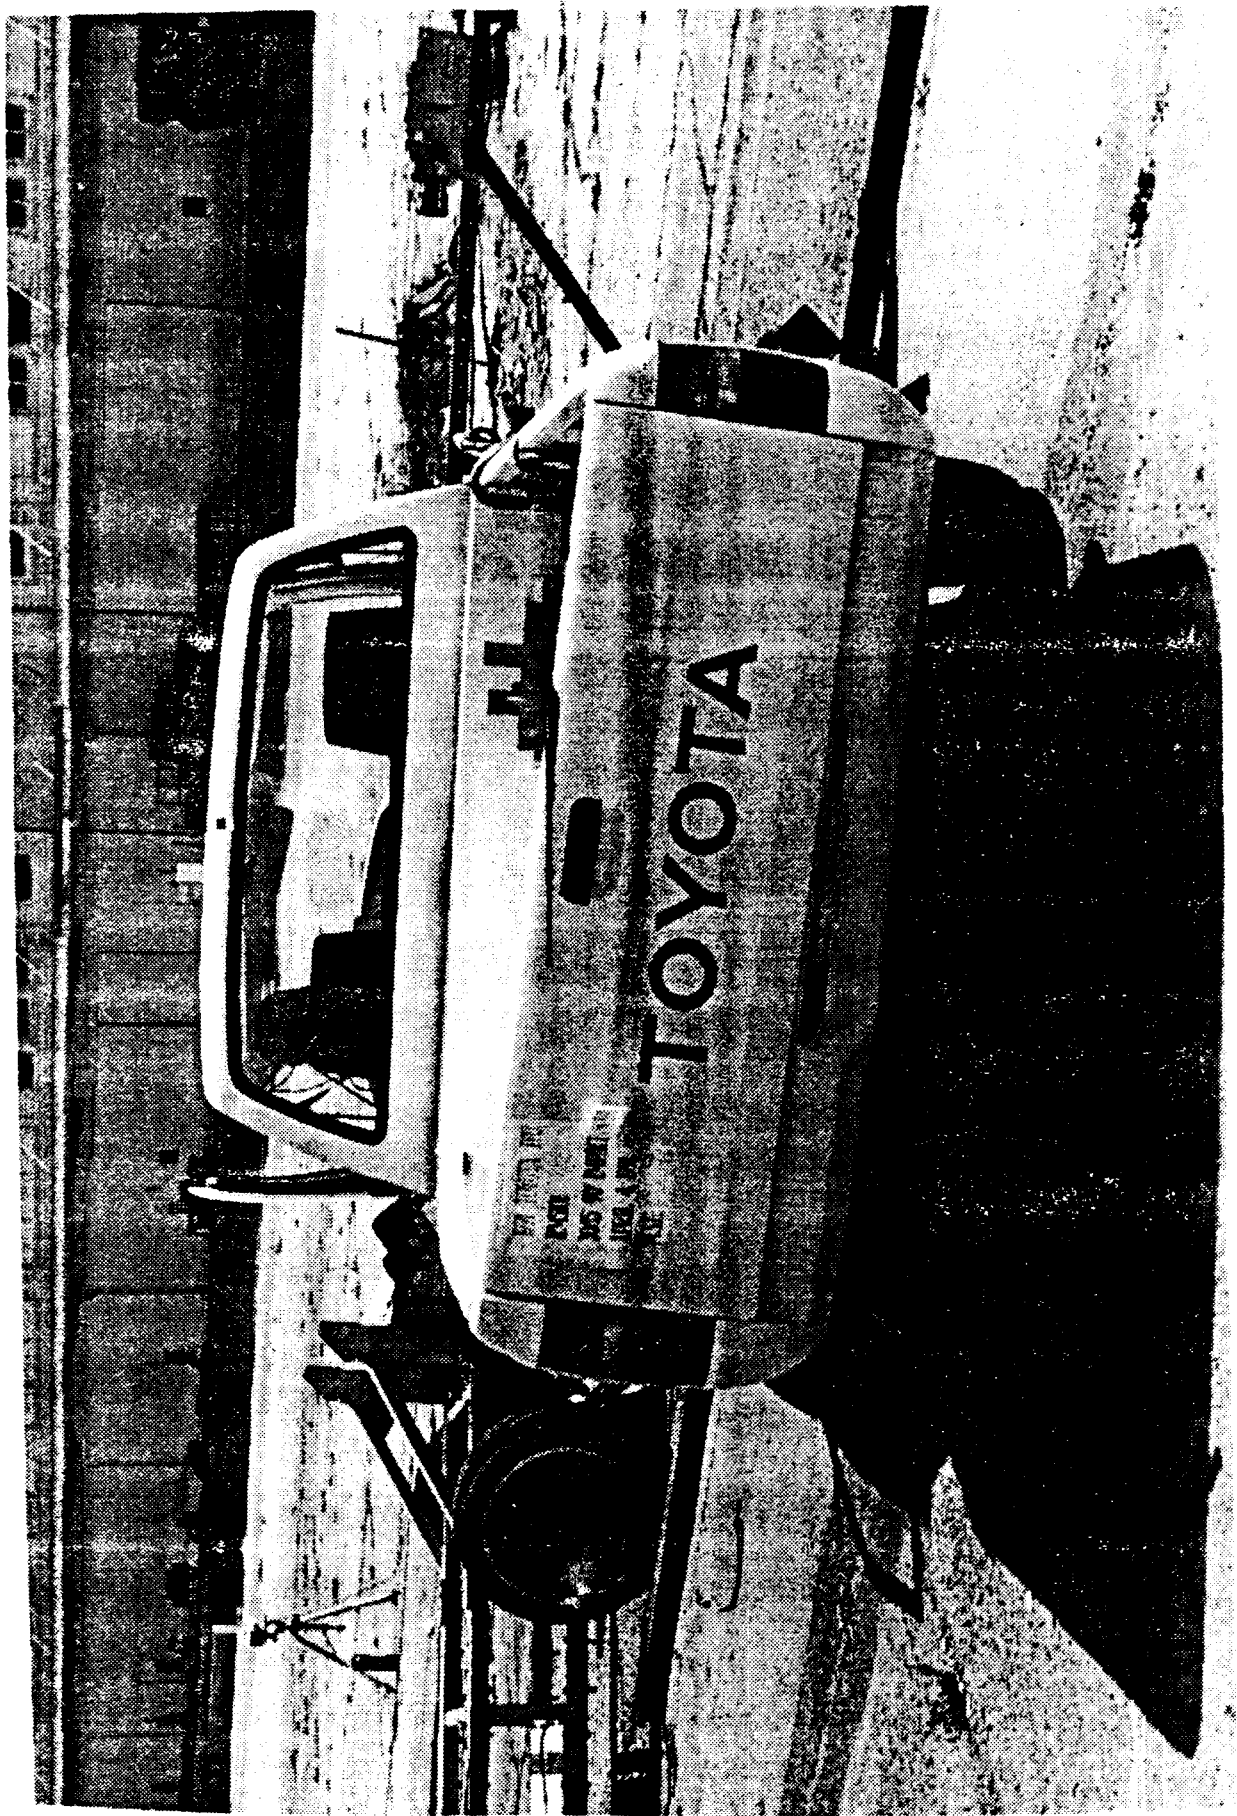
FIGURE A-11 MDE AND TEST VEHICLE, REAR VIEW - POSTTEST

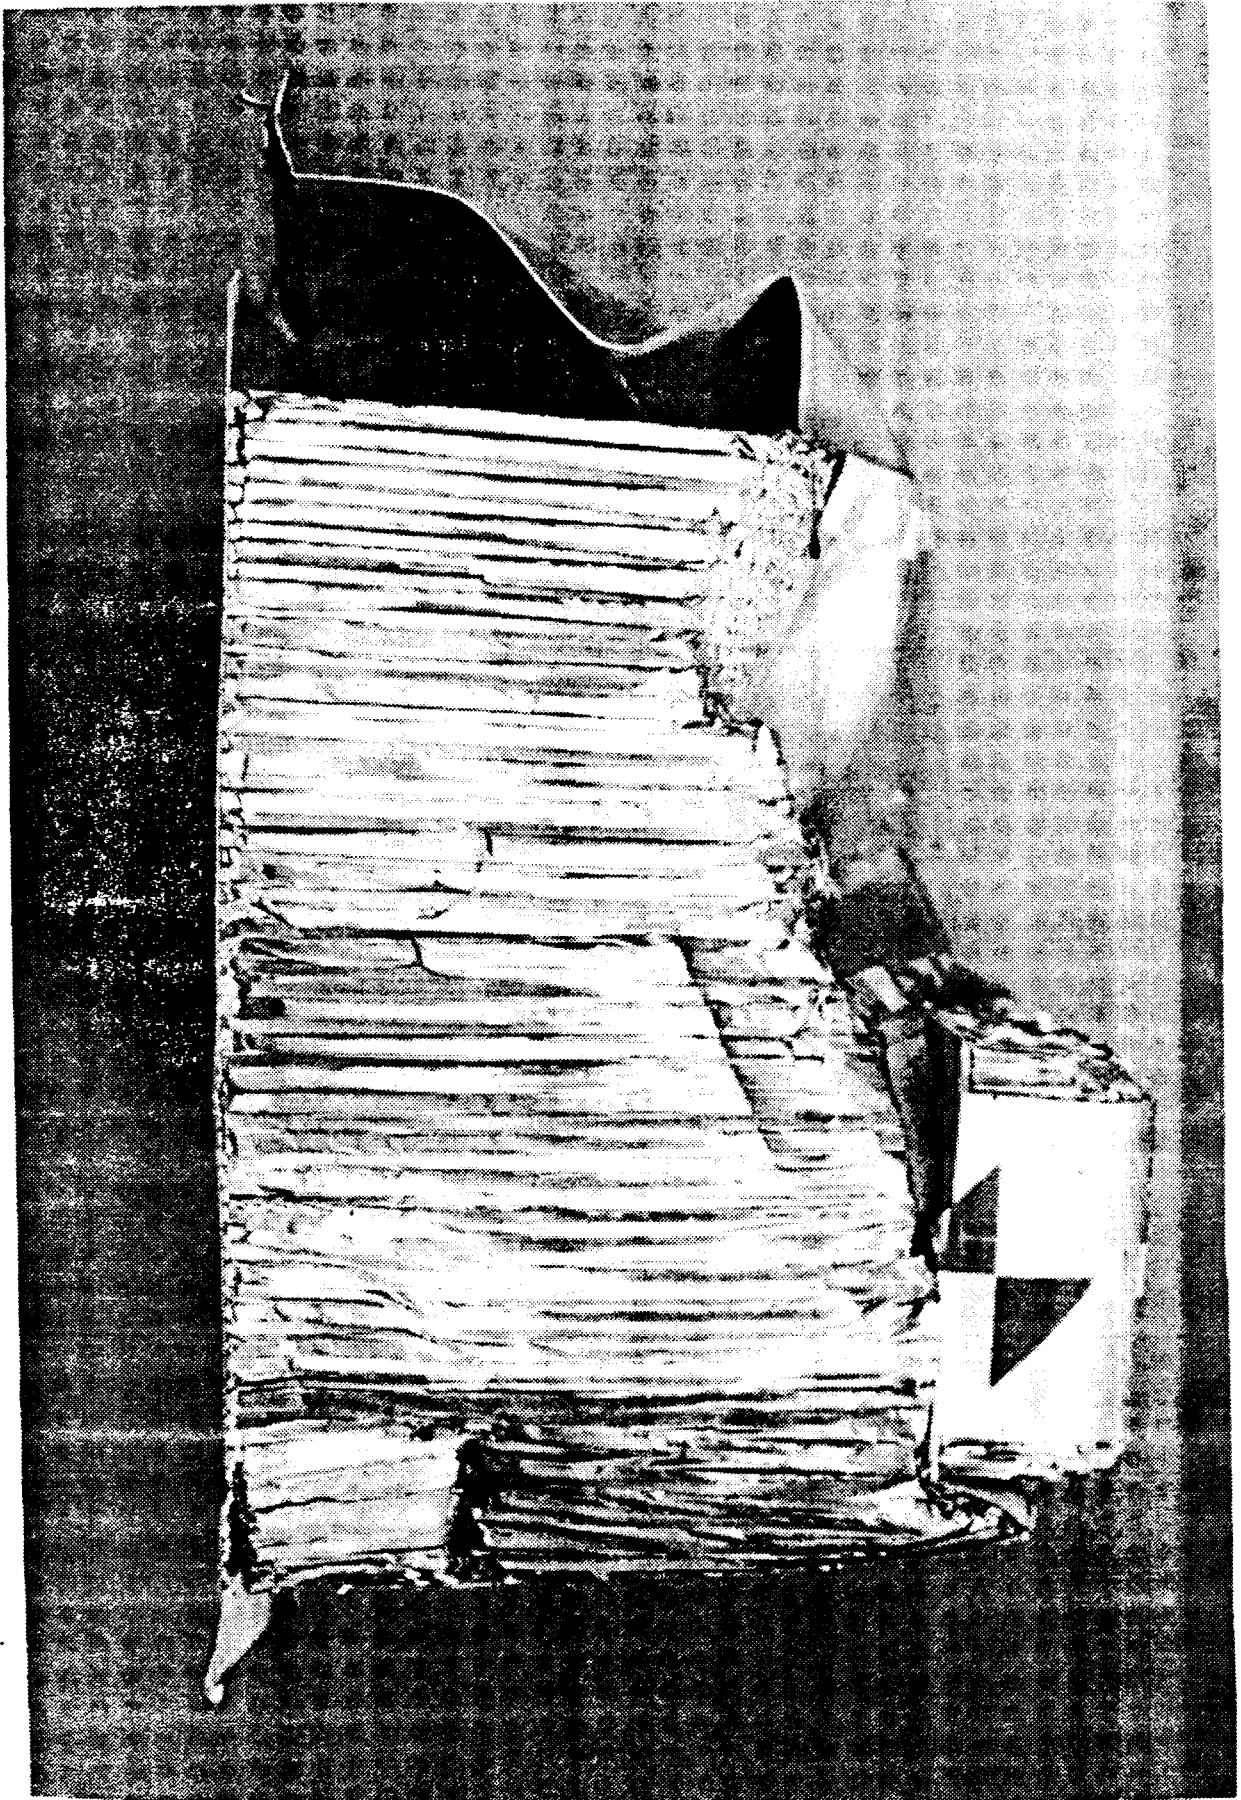
FIGURE A-20 MDB FACE, VIEW NO. 1 - POSTTEST

The MDB impacted the test vehicle and was stopped by the remote brake system to prevent a second impact. The aluminum deformable barrier received minor damage with a maximum crush of 3.33 inches on the left-hand corner of bumper level. The crush details for the MDB are given in Table 3-7.

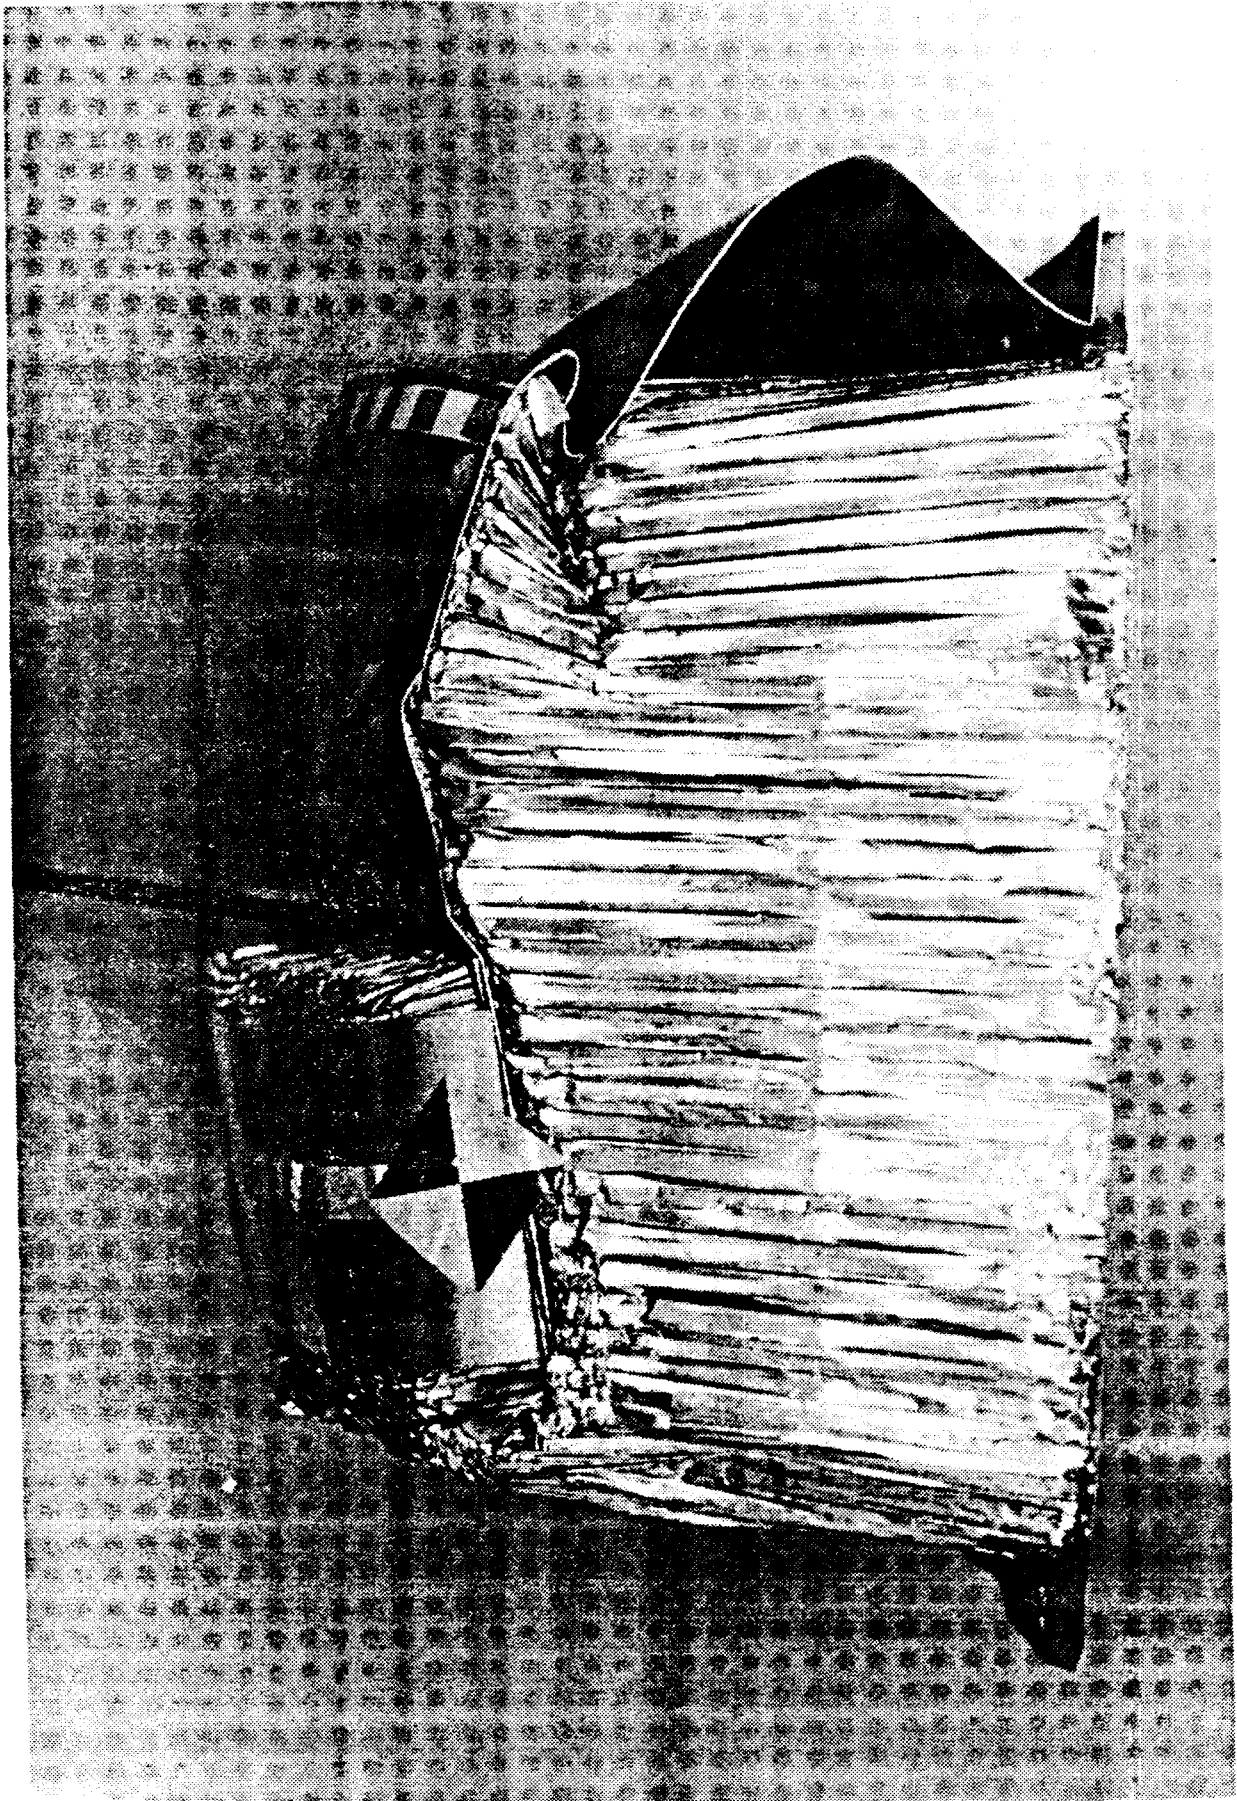
FIGURE A-21 MDB FACE, VIEW NO. 2 -.POSTTEST
