VEHICLE SAFETY COMPLIANCE TESTING  
FOR OCCUPANT CRASH PROTECTION.  
WINDSHIELD MOUNTING, WINDSHIELD ZONE  
INTRUSION, AND FUEL SYSTEM INTEGRITY

1991 AUDI 100

NHTSA NO. CM5804

FINAL REPORT

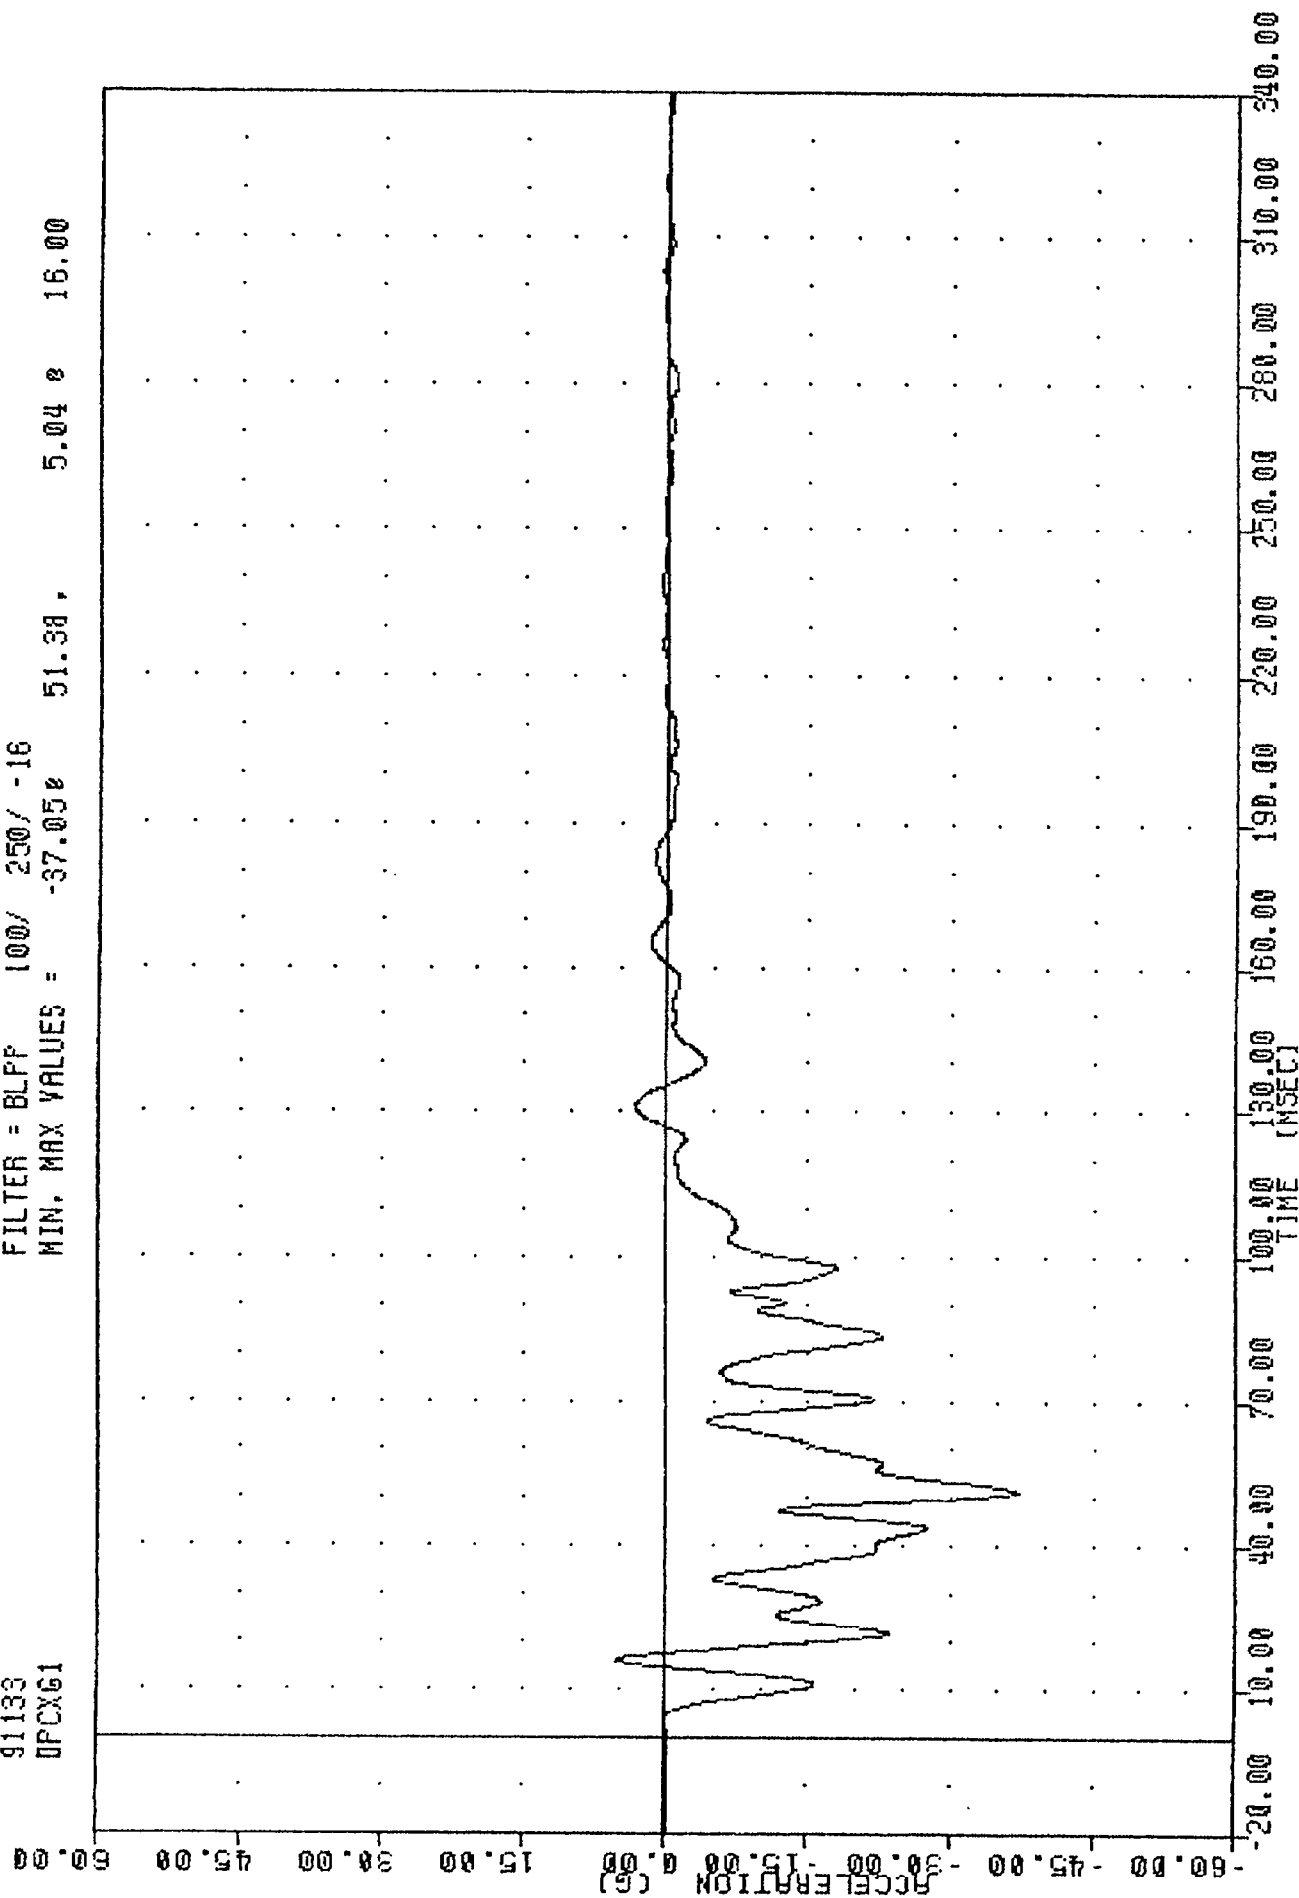
TRC  
208 COMPLIANCE TESTING  
91133  
DPCXG1

FILTER = BLPP 100/ 250/ -16  
MIN. MAX VALUES = -37.05% 51.38, 5.04 @ 16.00
