**SIDE IMPACT PROTECTION  
IN PRODUCTION VEHICLES**

**MDB-TO-CAR SIDE IMPACT TEST OF  
A 27° CRABBED MOVING DEFORMABLE BARRIER  
TO A 1991 SUZUKI SIDEKICK  
AT 33.5 MPH**

MOBILITY SYSTEMS AND EQUIPMENT COMPANY  
9920 LA CIENEGA BOULEVARD SUITE 708  
INGLEWOOD, CALIFORNIA 90301

**TEST REPORT**

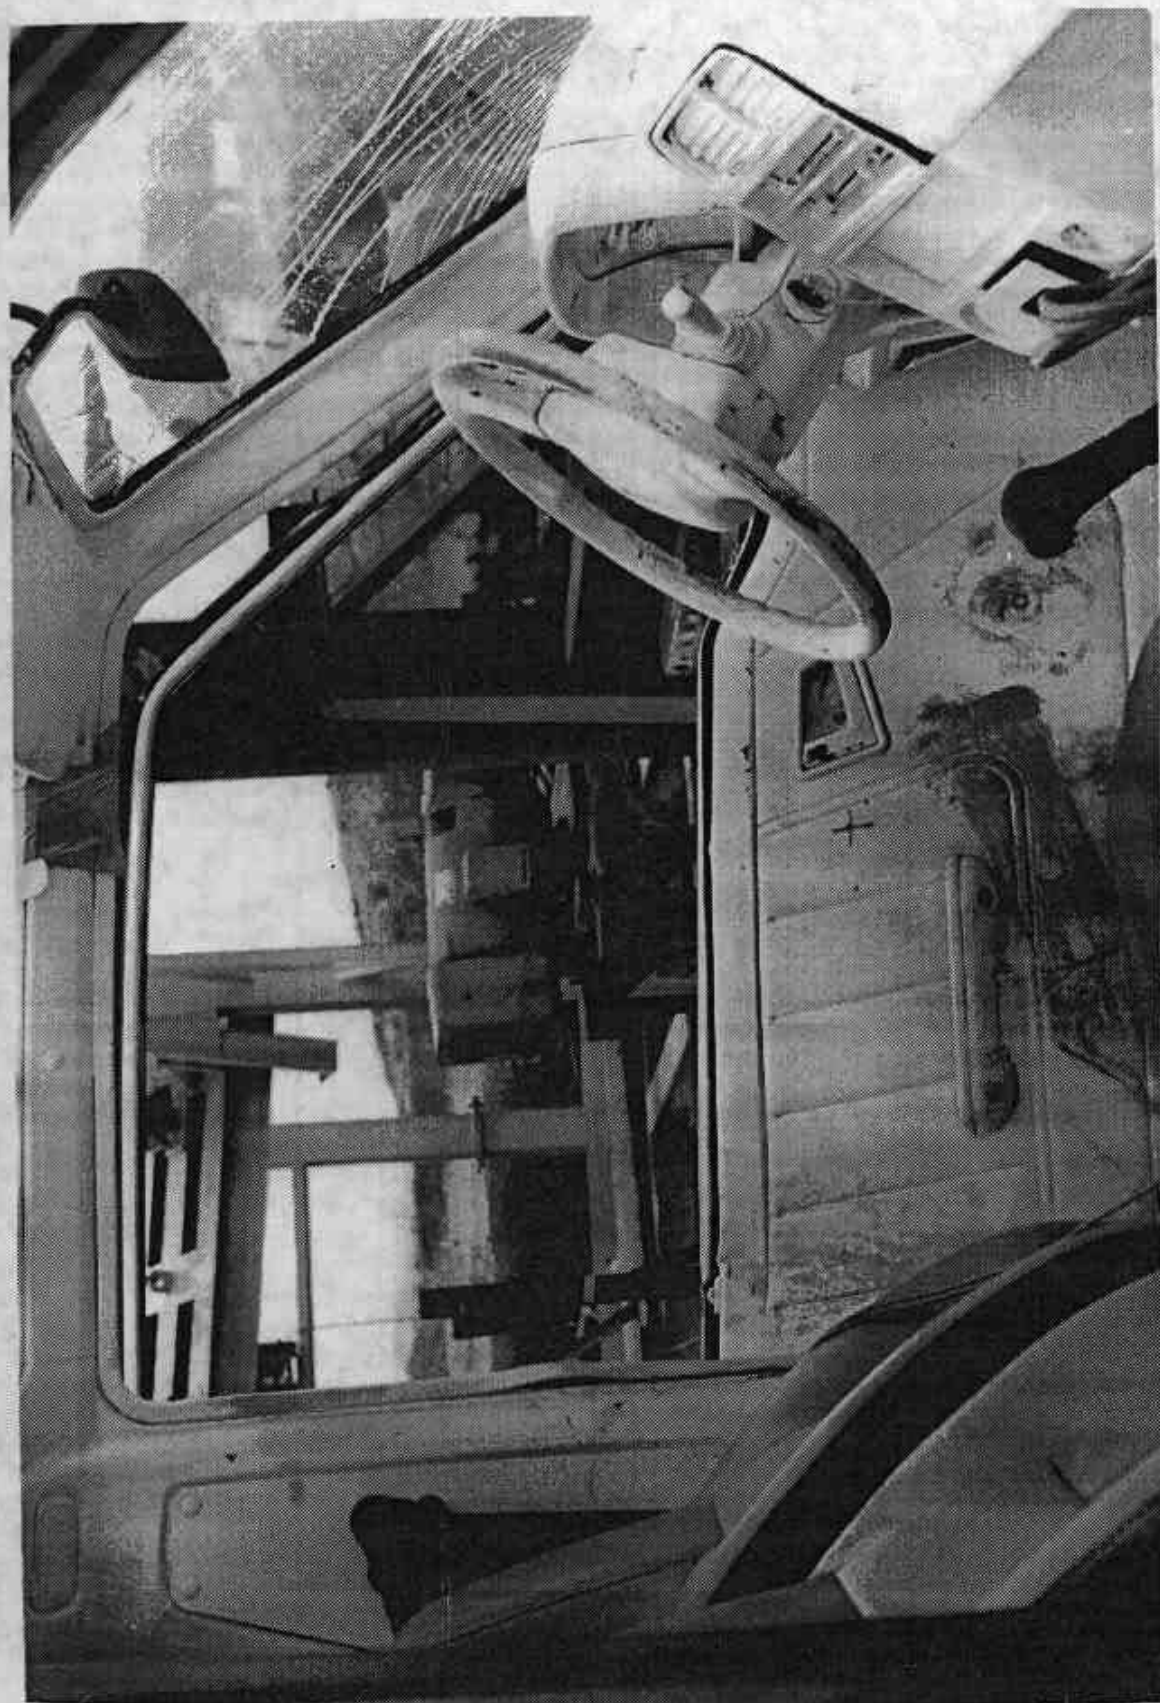
FIGURE A-14 OCCUPANT COMPARTMENT INTERIOR - POSTTEST
